***MHI's Steam Generator  
Operating Experience with  
Tube Vibration and Wear***

***February 7, 2013***

***Mitsubishi Heavy Industries, Ltd.***

# ***2012 In-Plane Fluid Elastic Instability at SONGS RSGs***

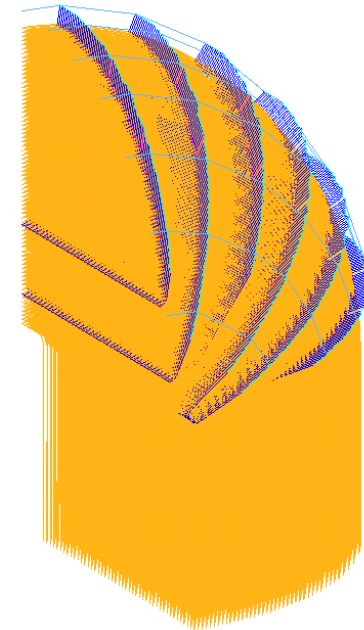
**Contact Force Analysis including all components**

# ***Differences in tube-to-tube wear in Units 2 and 3***

- ***Fabrication process improvements in Unit 3 after Unit 2 RSGs***
- ***More uniform AVB gap control in Unit 3 resulted in half or less of the contact forces at Unit 2, based on current 3-D analysis***
- ***Unit 2 AVB supports are more effective***

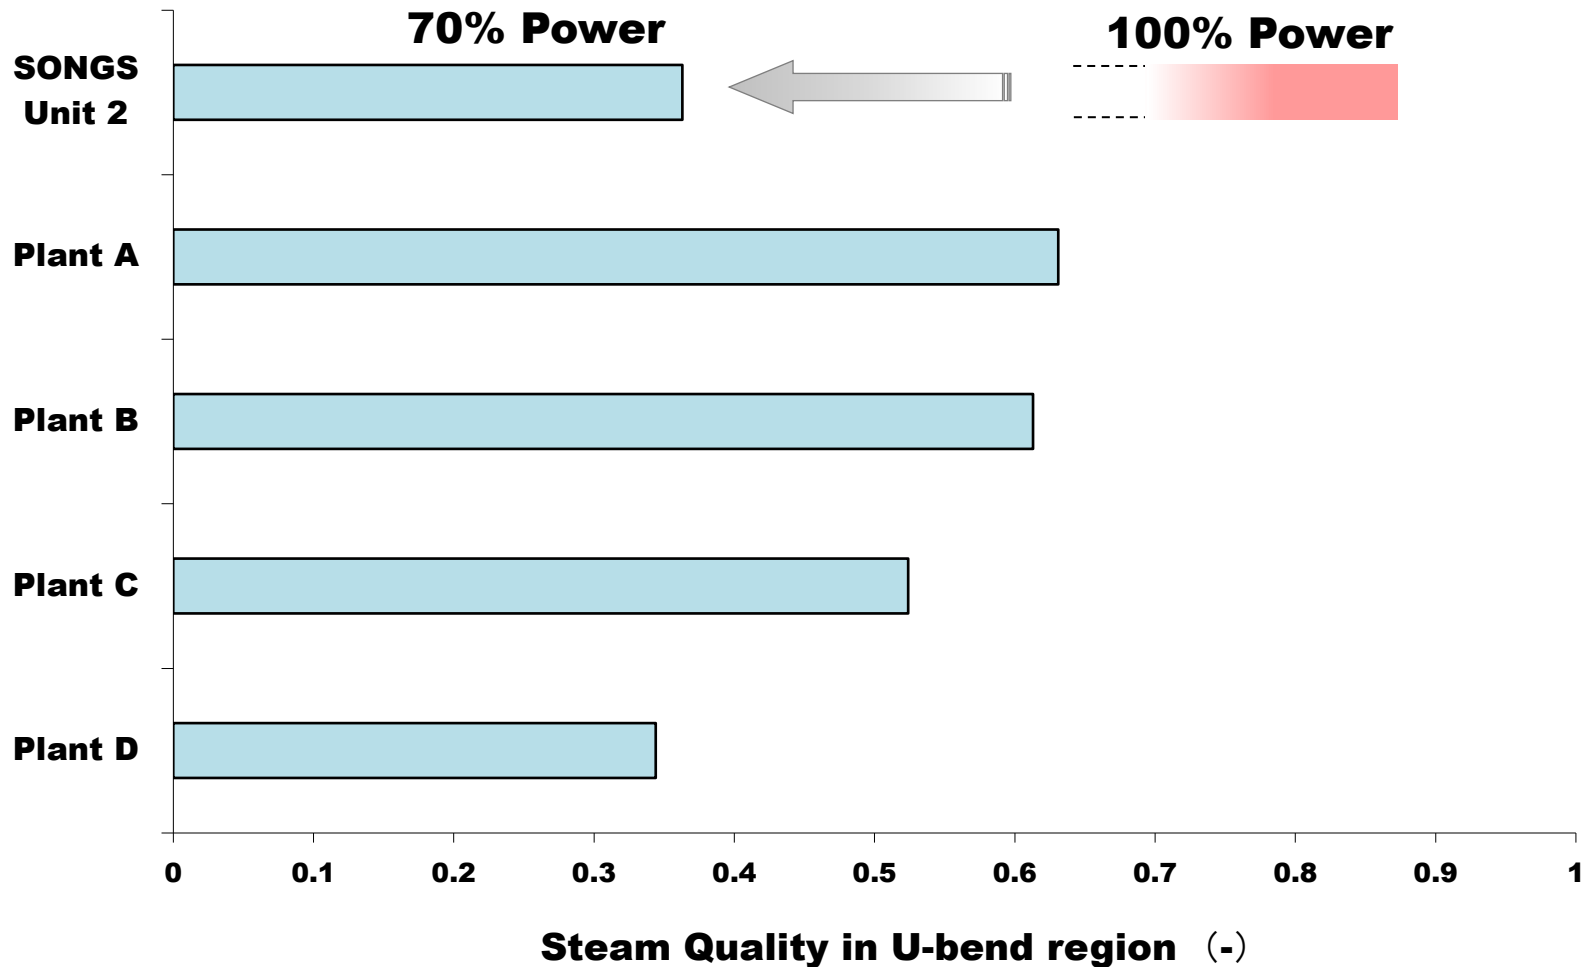
# ***Potential Countermeasures for In-plane FEI at SONGS Unit 2***

***Reduced power operation improves steam quality (wetter steam)***

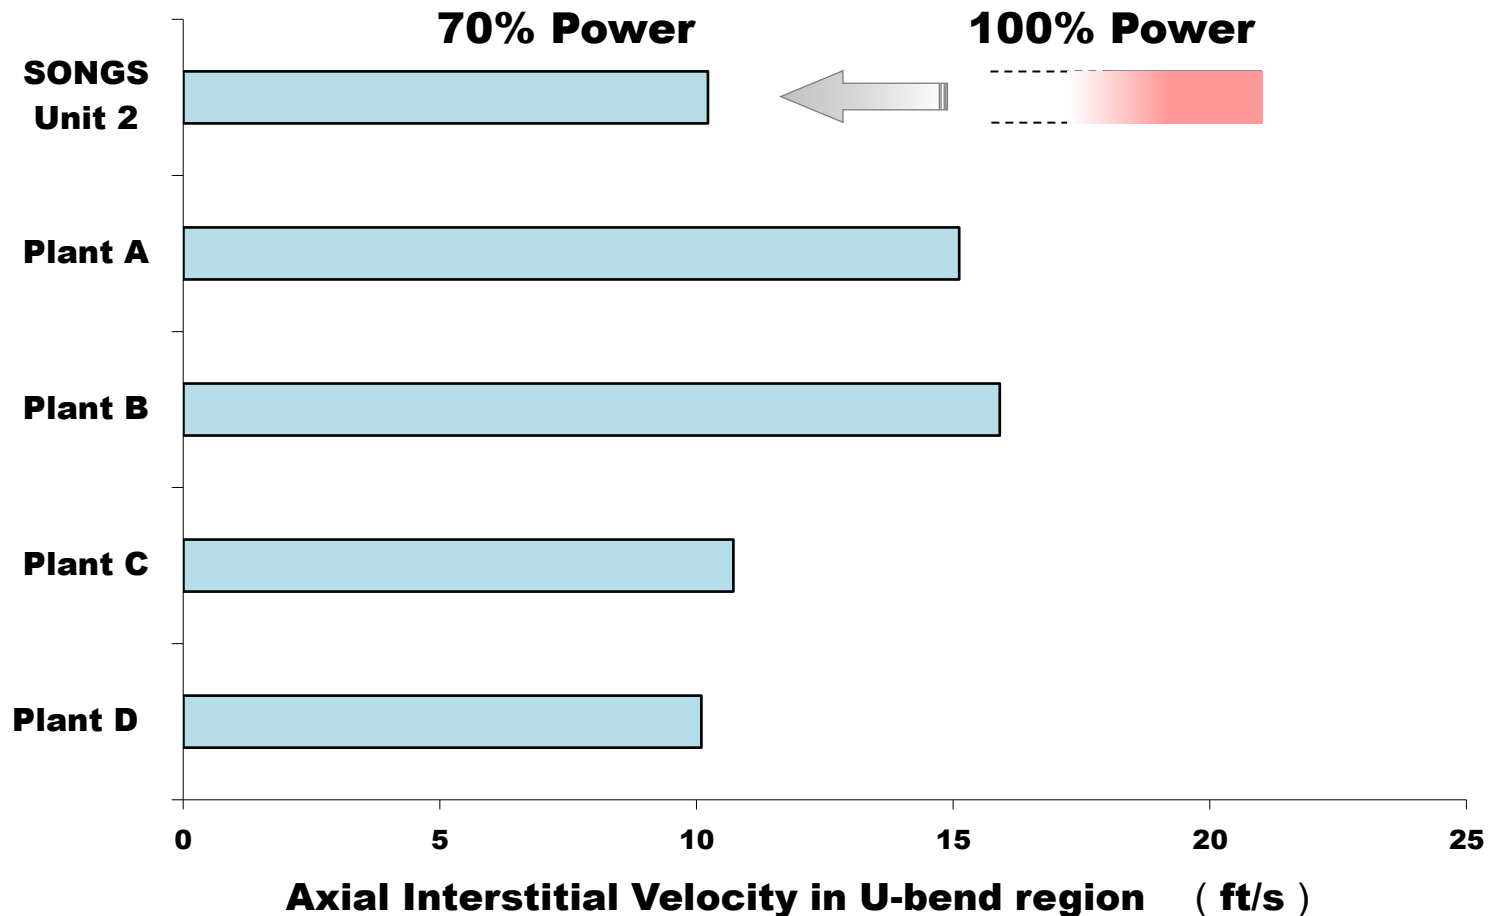
# ***Potential Countermeasures for In-plane FEI at SONGS Unit 2***

***Reduced power operation improves flow velocity (lower velocity)***
