UNITED STATES  
NUCLEAR REGULATORY COMMISSION

**FACILITIES:** Calvert Cliffs Nuclear Power Plant, (CCNPP) Unit Nos. 1 and 2

**SUBJECT:** SUMMARY OF OCTOBER 12, 1999, MEETING WITH BGE REGARDING  
LICENSE RENEWAL ACTIVITIES FOR CCNPP UNIT NOS. 1 AND 2

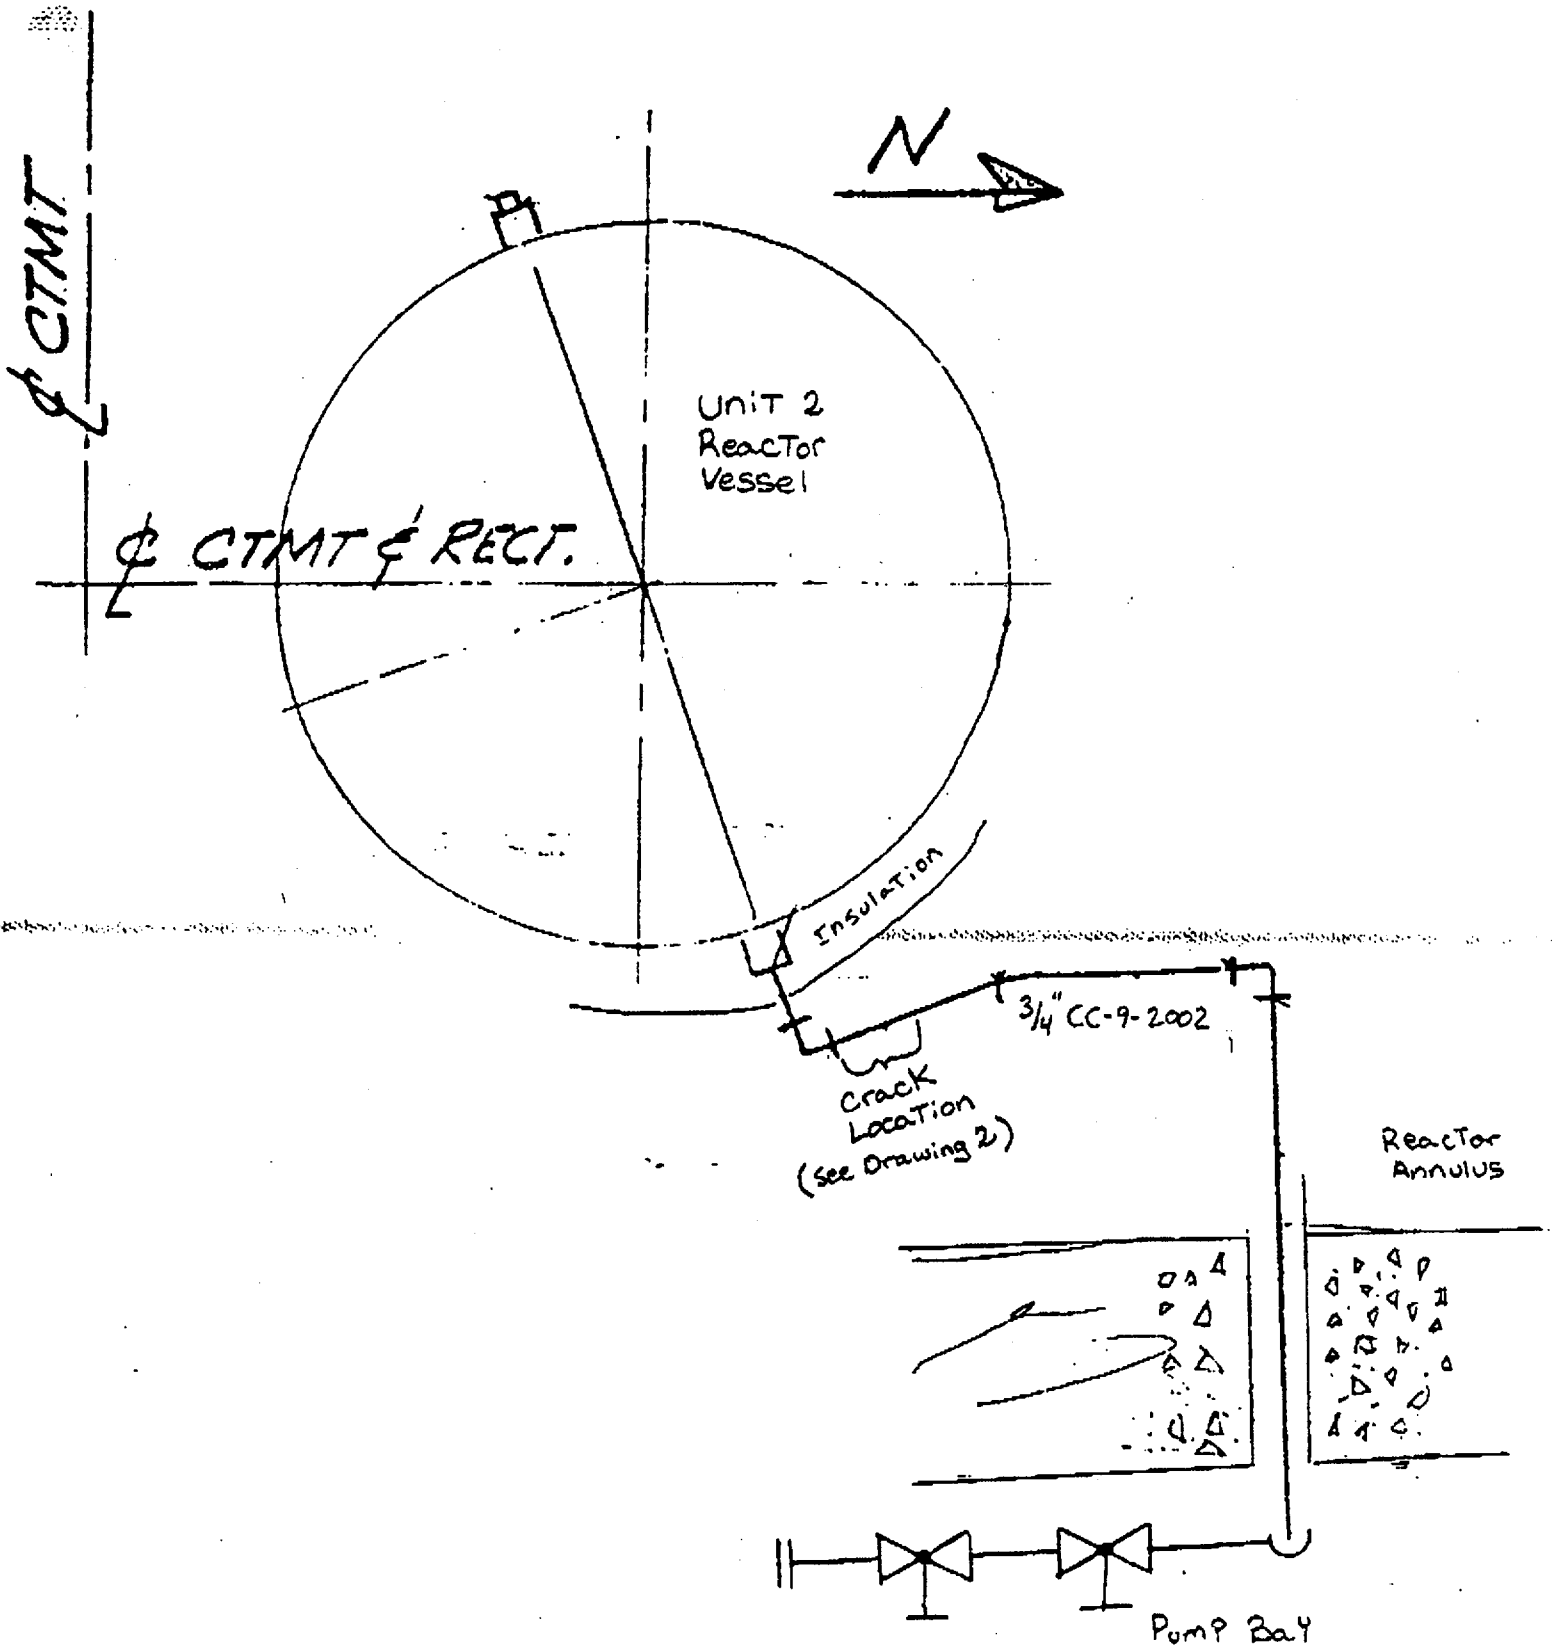
Drawing 1

Chloride Ion Stress Corrosion Cracking (CISCC) of the Reactor Vessel o-ring leak-off pipe was caused by elevated levels of chlorides in the pipe. The chlorides in Refueling Pool water trapped in the pipe following Reactor Vessel head installation can become concentrated on the inside of the pipe by boiling of the water during plant operation. The high chloride source may have been present inside of the pipe since initial plant construction.

# U-2 RV LEAKAGE MONITORING LINE

All corrective actions and recommendations have been implemented; no additional actions are necessary. The following is a list of actions taken.

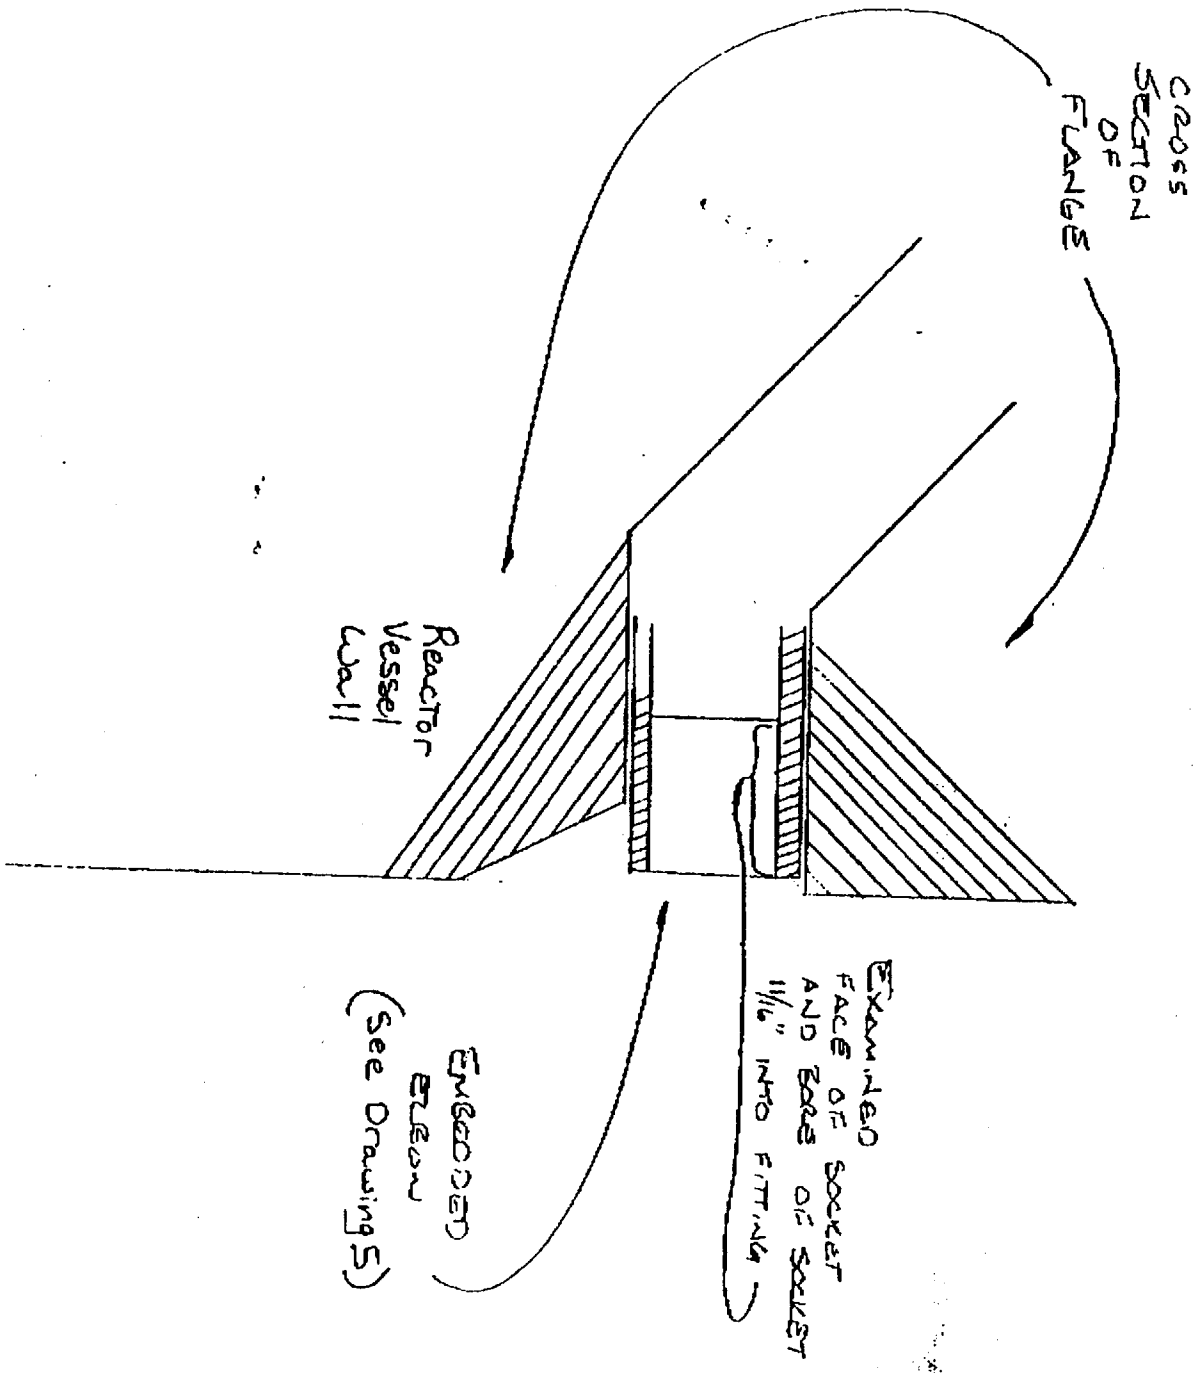
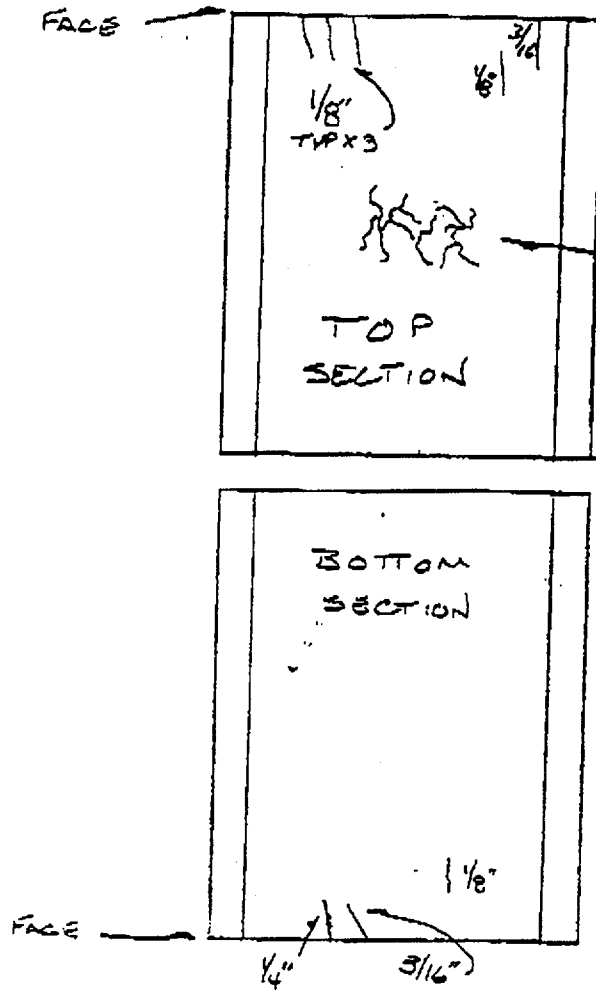
# ENLARGEMENT OF SOCKET BORE ONLY

FAINT  
DENDRITIC  
INDICATIONS.  
AREA IS ABOUT  
3/8" X 3/8"

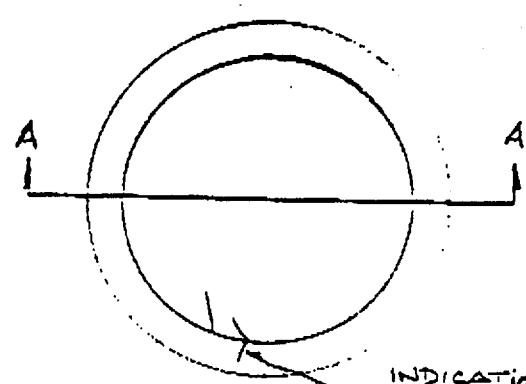
SOCKET  
FACE

INDICATION  
EXTENDS  
1/8" INTO FACE.

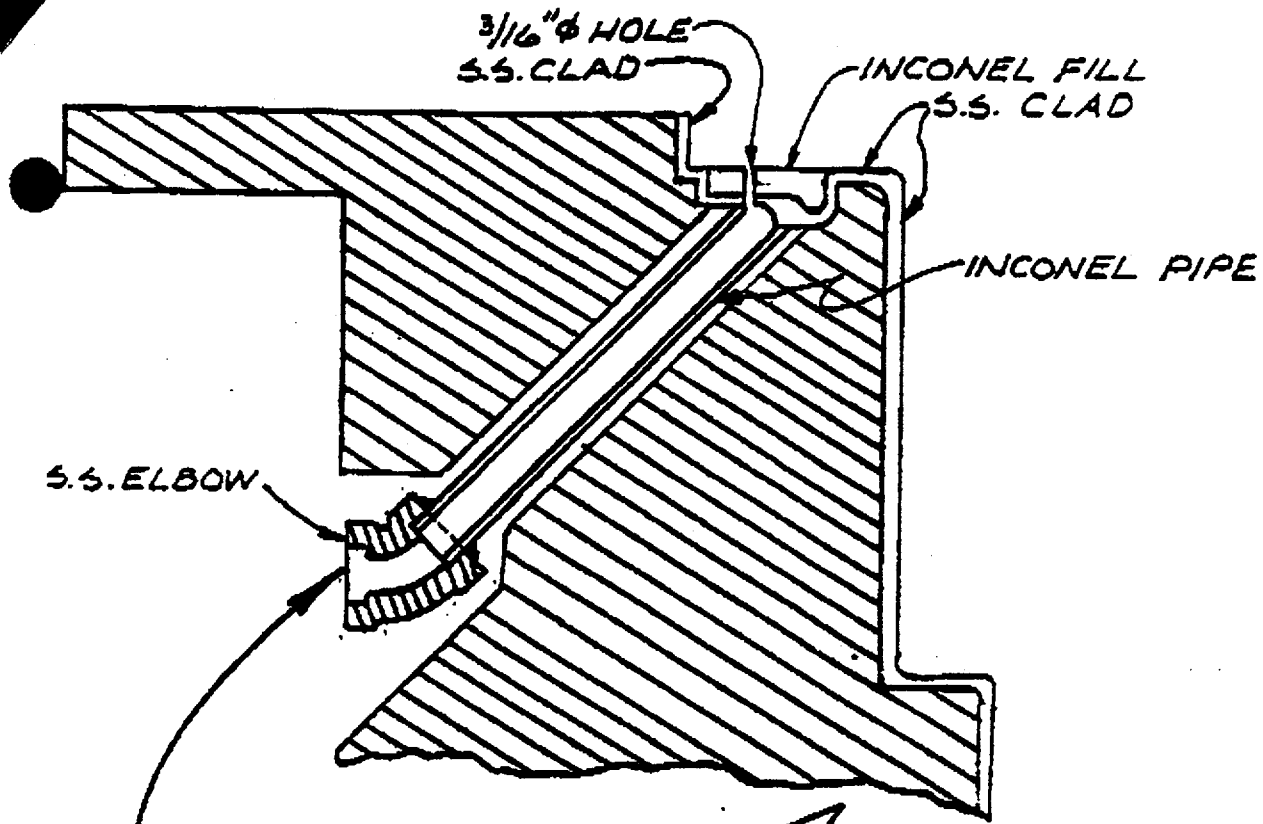
REACTOR VESSEL NO. 11  
LEAKAGE MONITOR TUBE  
(N. T. S.)
