RS-13-189

Braidwood Station, Units 1 and 2
Facility Operating License Nos. NPF-72 and NPF-77
NRC Docket Nos. STN 50-456 and STN 50-457

Byron Station, Units 1 and 2
Facility Operating License Nos. NPF-37 and NPF-66
NRC Docket Nos. STN 50-454 and STN 50-455

Subject: Additional Information Supporting Request for License Amendment
Regarding Measurement Uncertainty Recapture Power Uprate

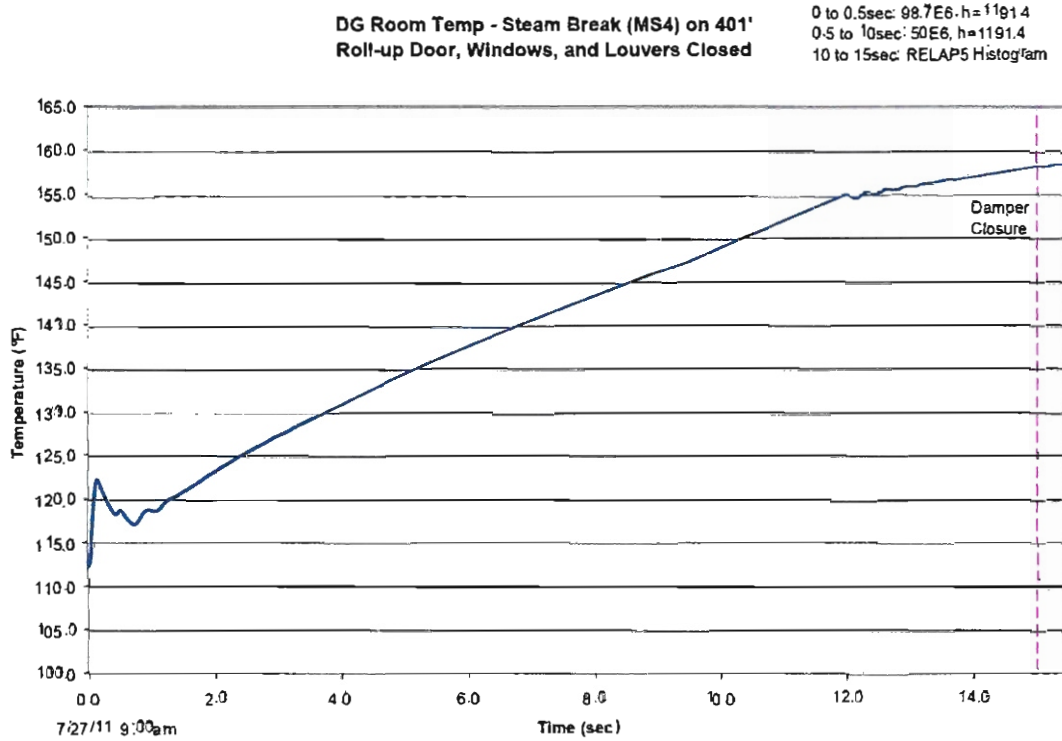
Figure 3-1a: Previous Analysis – EDG Temperature Profile – To Fire Damper Closure

The operability evaluations that address the non-conformances only address the transient temperature conditions in the EDG Rooms, the ESF Switchgear Rooms, and the MEER. A comparison is provided for the transient temperature profiles for these rooms under the previous analyses and the analyses which implement the revised TB HELB mitigation strategy.

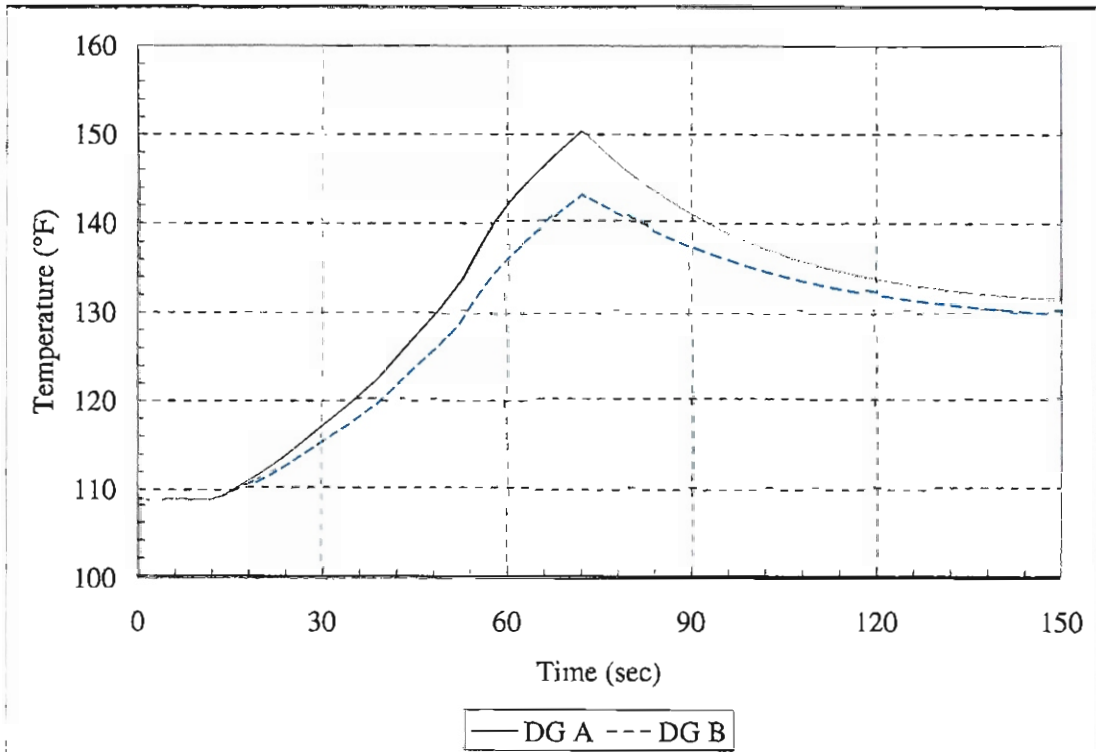
Peak HELB Temperature	TRM Operating Limit
EDG Rooms	150°F	132°F
ESF Switchgear Rooms	131°F	108°F
MEER	114°F	108°F
Division 12/22 Lower Cable Spreading Room	112°F	108°F
DOST	140°F	132°F

**Figure 3-2: New Analysis – EDG Room Temperatures – Worst Case
Following 0.5 ft² MS Break on TB 401' Elevation**

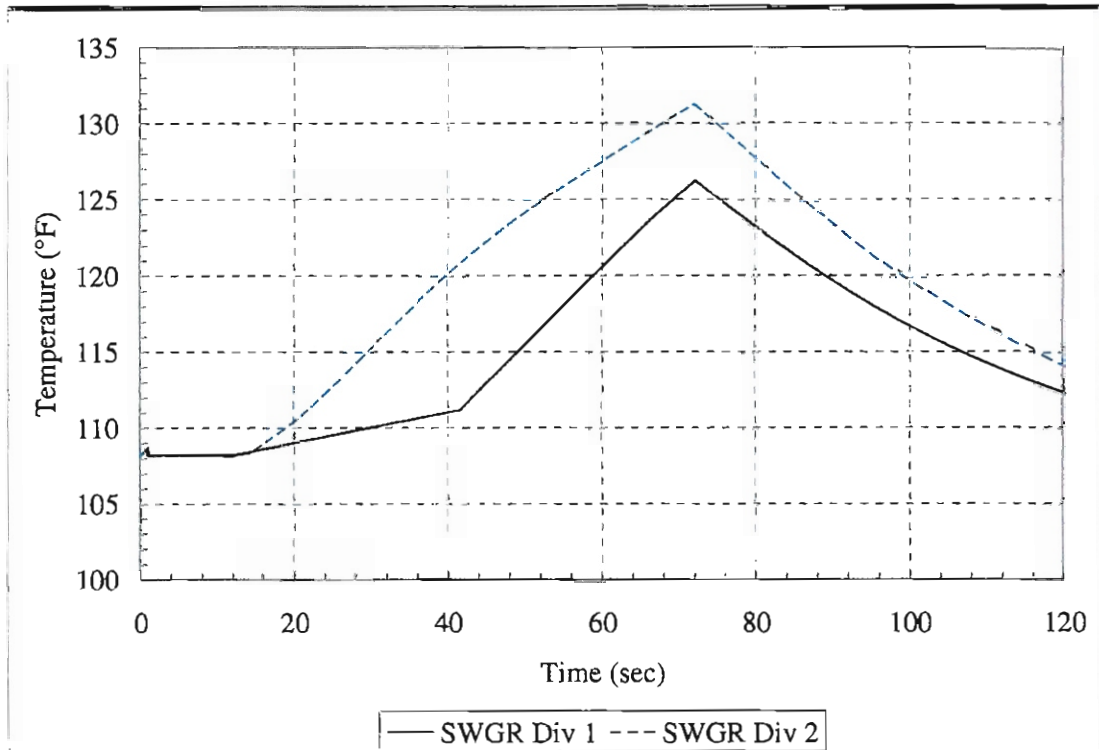
Figure 3-4: New Analysis – ESF Switchgear Room Temperatures – Worst Case Following 0.5 ft² MS Break on TB 426' Elevation

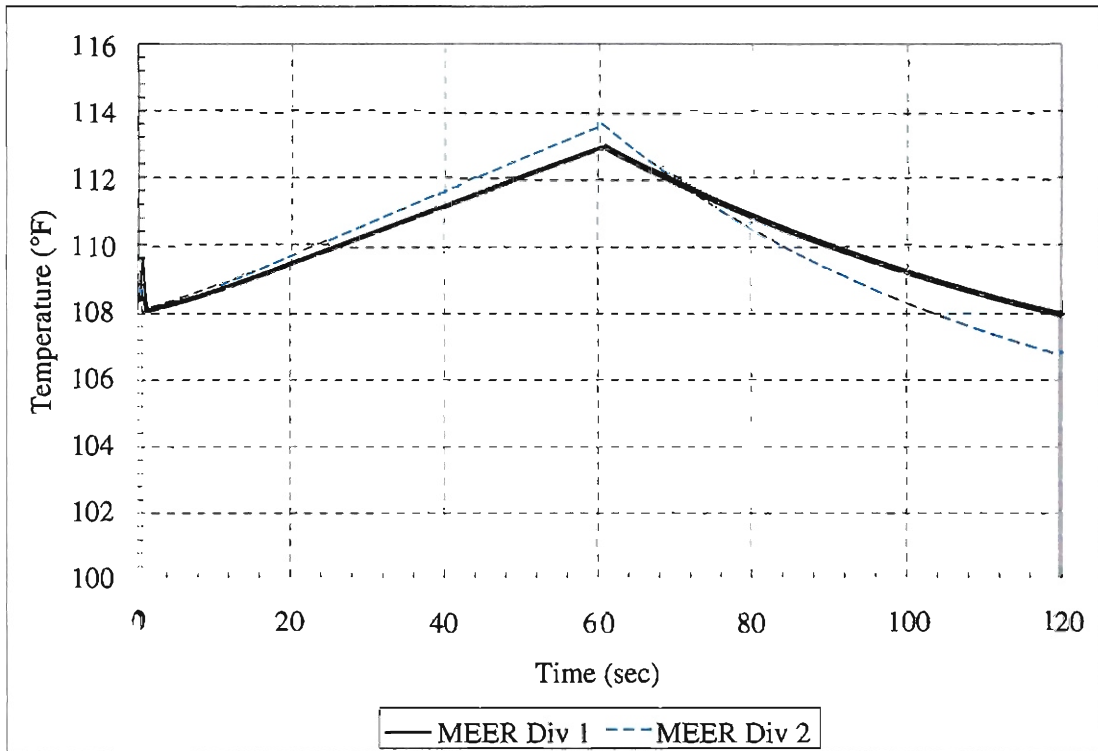
Figure 3-6: New Analysis - MEER Temperatures – Worst Case Following 26” HD Break on TB 451’ Elevation

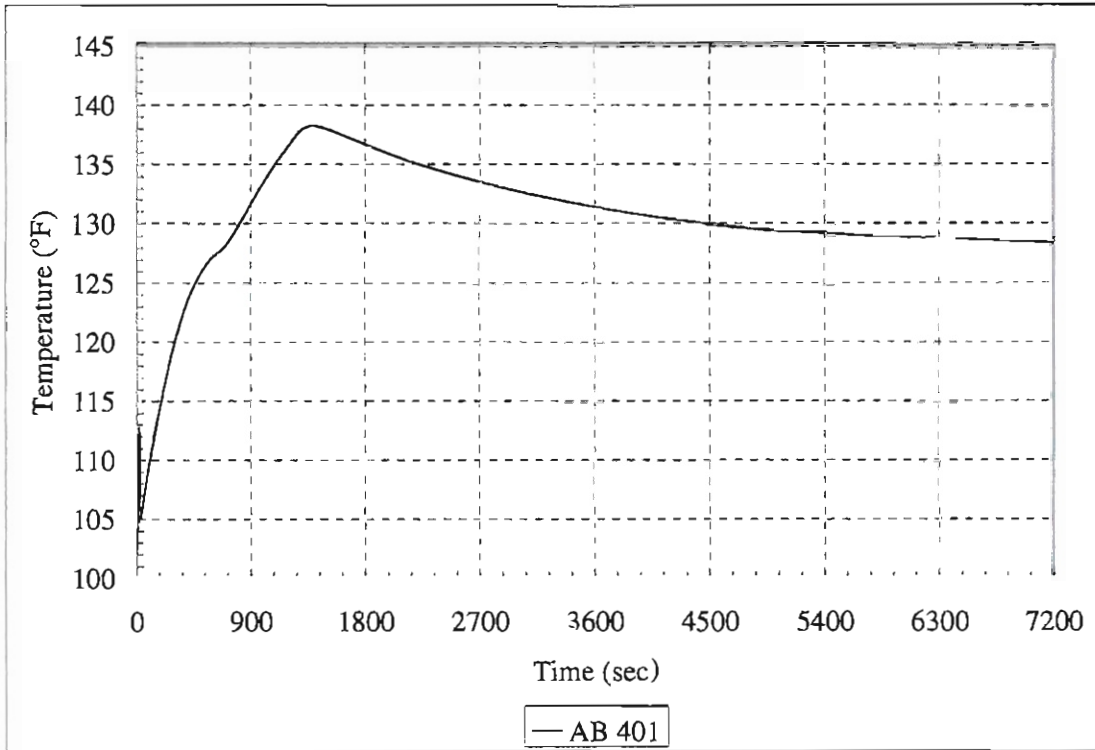
Figure 3-7: New Analysis – Braldwood 401' Auxiliary Bldg. Temperatures – Worst Case Following 0.3 ft² MS Break on TB 401' Elevation

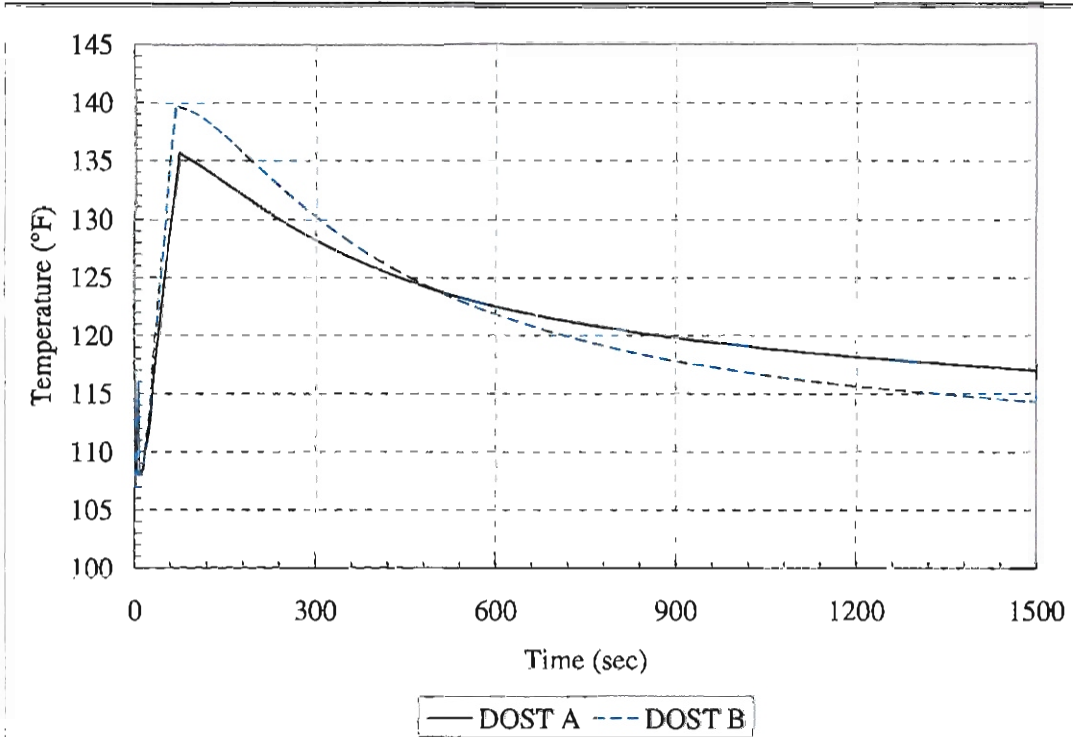
Figure 3-8: New Analysis – Diesel Oil Storage Tank Room Temperatures – Worst Case Following 1.4 ft² MS Break on TB 401' Elevation

- 6) Install a HELB sensor to automatically shut-off the DOST Room exhaust fans. During normal operation, the DOST Room exhaust fans draw air into the rooms from the Turbine Building and shutting down the fans limits the introduction of hot air and steam following a HELB. The DOST Rooms do not require HELB dampers to maintain acceptable environmental conditions in the rooms.

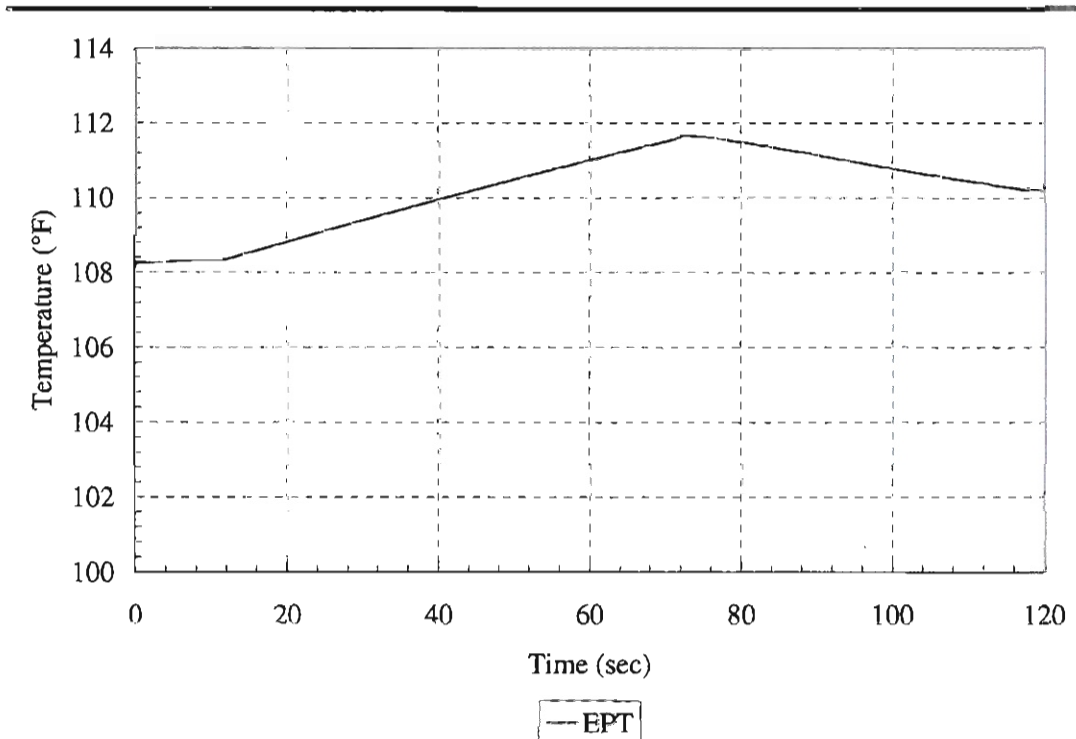
Figure 3-9: New Analysis – Electrical Pipe Tunnel Temperatures – Worst Case Following 0.5 ft² MS Break on TB 401' Elevation

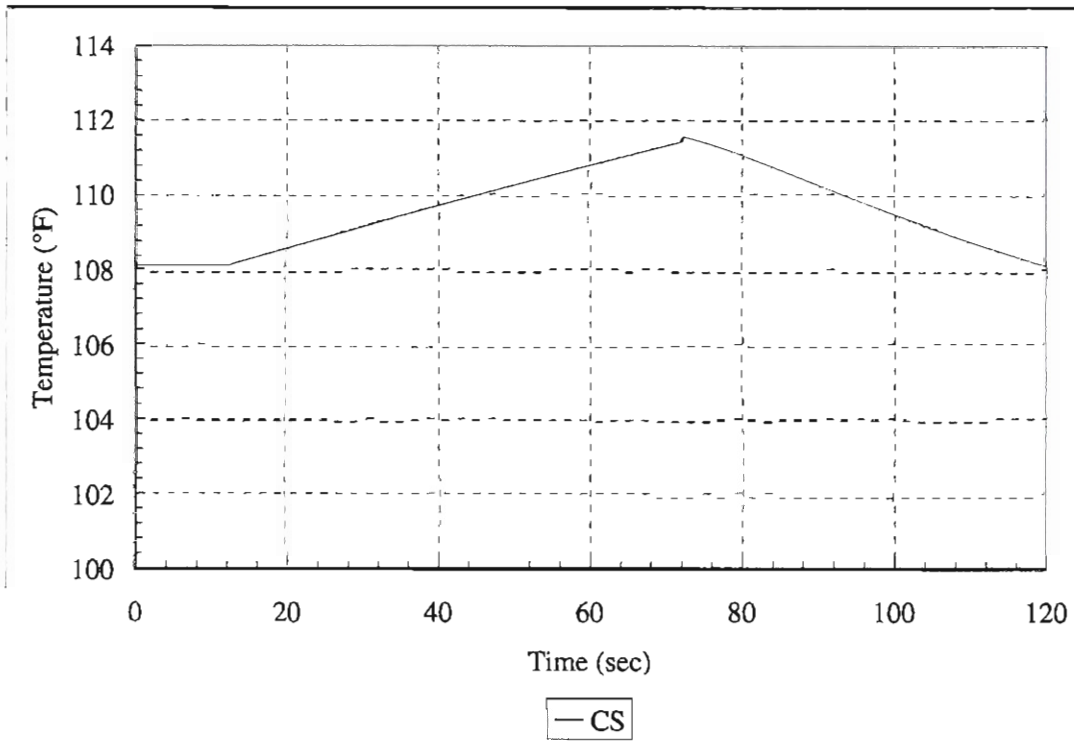
Figure 3-10: New Analysis – Division 12/22 Lower Cable Spreading Room Temperatures – Worst Case Following 0.5 ft² MS Break on TB 401' Elevation

- 1) Install a single-failure proof HELB damper and fire damper assembly in place of the fire damper in the ventilation exhaust openings from the EDG Rooms, the Electrical Cable Tunnel, the ESF Switchgear Rooms, the Division 12/22 Lower Cable Spreading Rooms, the MEERs and the non-ESF Switchgear Rooms.
