Title Davis Besse Reactor Protection System Single Failure Analysis

SINGLE FAILURE ANALYSIS

FOR TOLEDO EDISON DAVIS-BESSE UNIT 1

REACTOR PROTECTION SYSTEM FIELD CHANGES

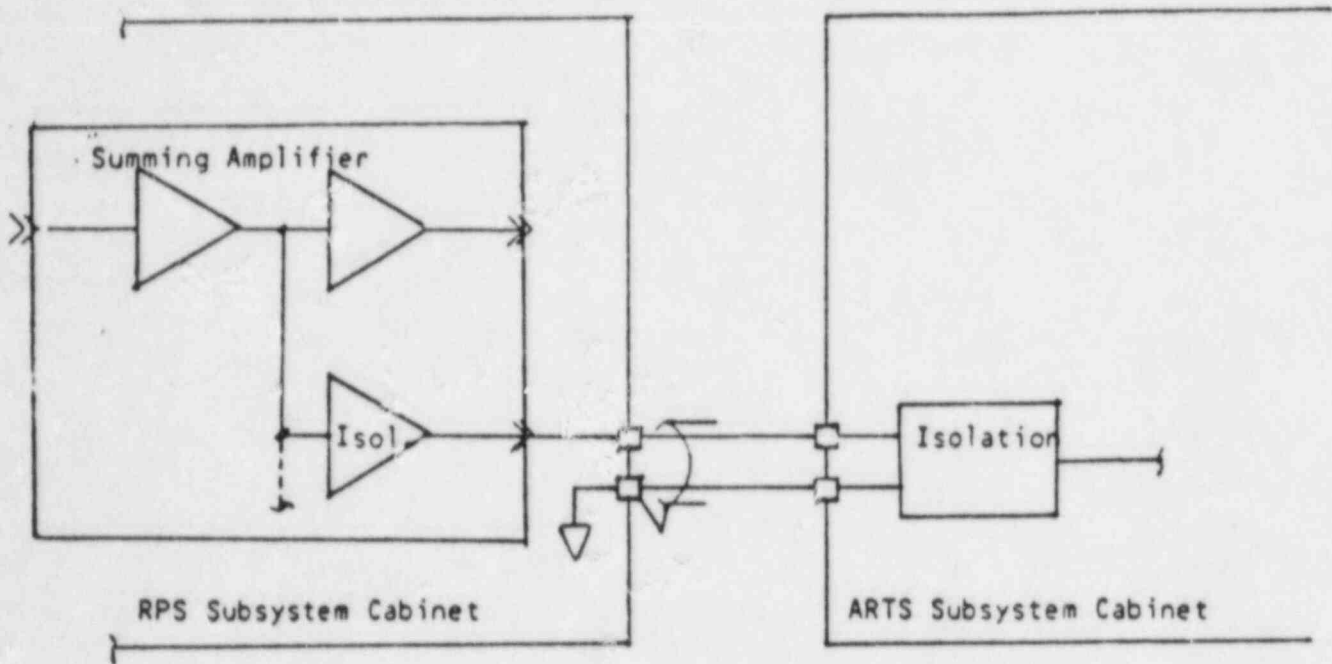
FIGURE 1
ARTS FLUX SIGNAL INTERFACE

Figure 1 is a simplified schematic of the interface (typical for all four vital power divisions) and identifies the points at which faults are postulated.

Section 7.2.2.1 (4.7) of the Davis-Besse USAR states the isolation capabilities of a buffer/isolation amplifier identical to the one used to isolate the flux signal sent to the ARTS.

Misperformance of the RPS subsystem is precluded if the connection between the RPS and ARTS subsystems is accomplished in a way that eliminates the possibility of fault voltages greater than those stated in the USAR appearing at the RPS flux output terminals.

It is concluded, therefore, that no single failure of the flux signal interface can prevent the RPS from performing its safety function. Also, no single failure of the flux signal interface within the isolation capability of the RPS buffer/isolation amplifier (as given in the USAR) can cause a spurious subsystem trip.

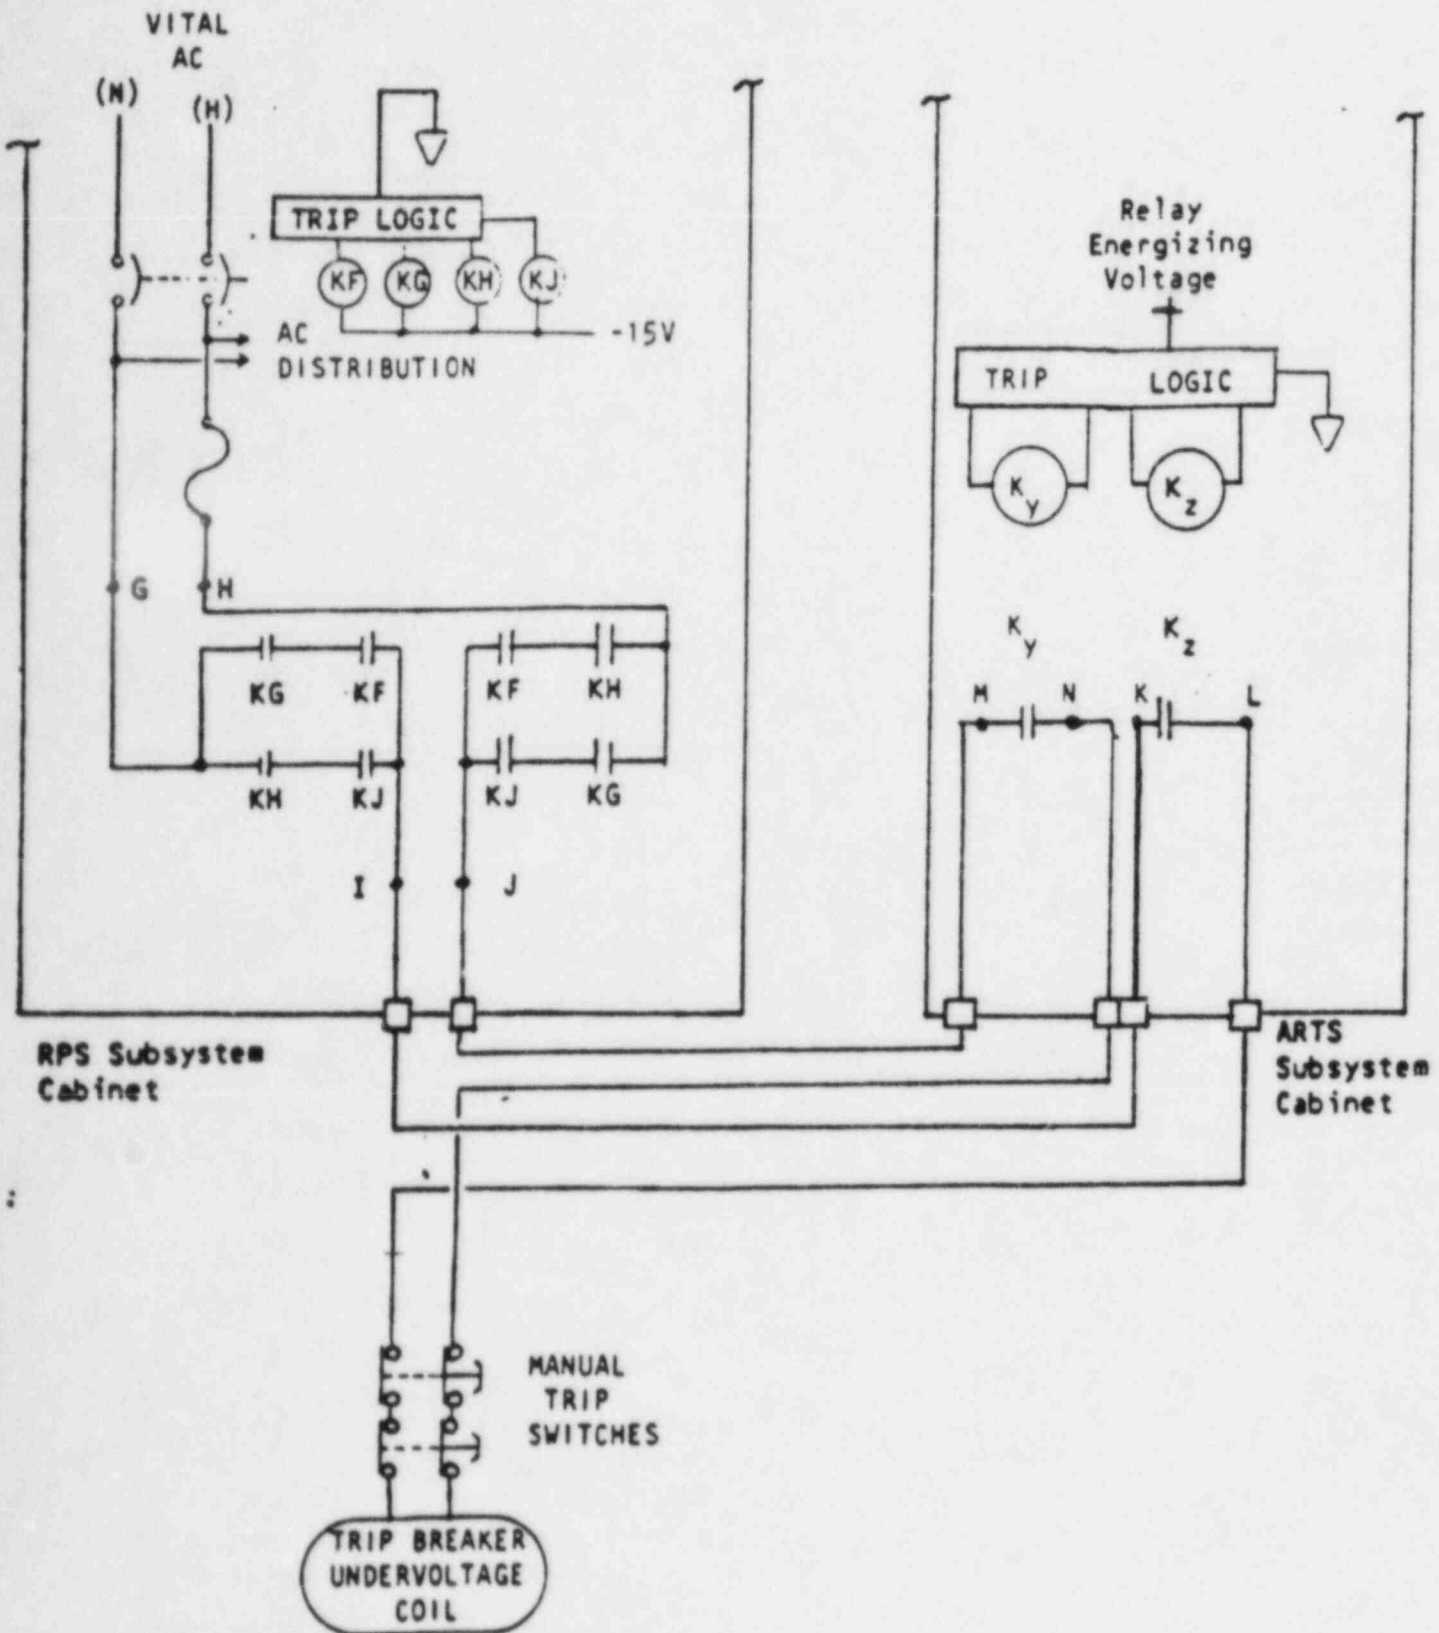
FIGURE 2

Figure 2 is a simplified schematic of the interface (typical for all four vital power divisions) and identifies the points at which faults are postulated.

The tabulated results of the analysis show that no single failure within the ARTS to RPS trip signal interface can prevent the RPS from performing its safety function.

Single failures within the trip signal interface can cause trip commands to be sent to the undervoltage coil of a single trip breaker but will not cause a reactor trip.

Single failures of equipment involved in the ARTS Trip Signal Interface can result in a spurious trip command being sent to one (of four) trip breakers, but because the interface is downstream of the reactor trip module, only one subsystem is involved and the RPS system trip logic remains 2/4.

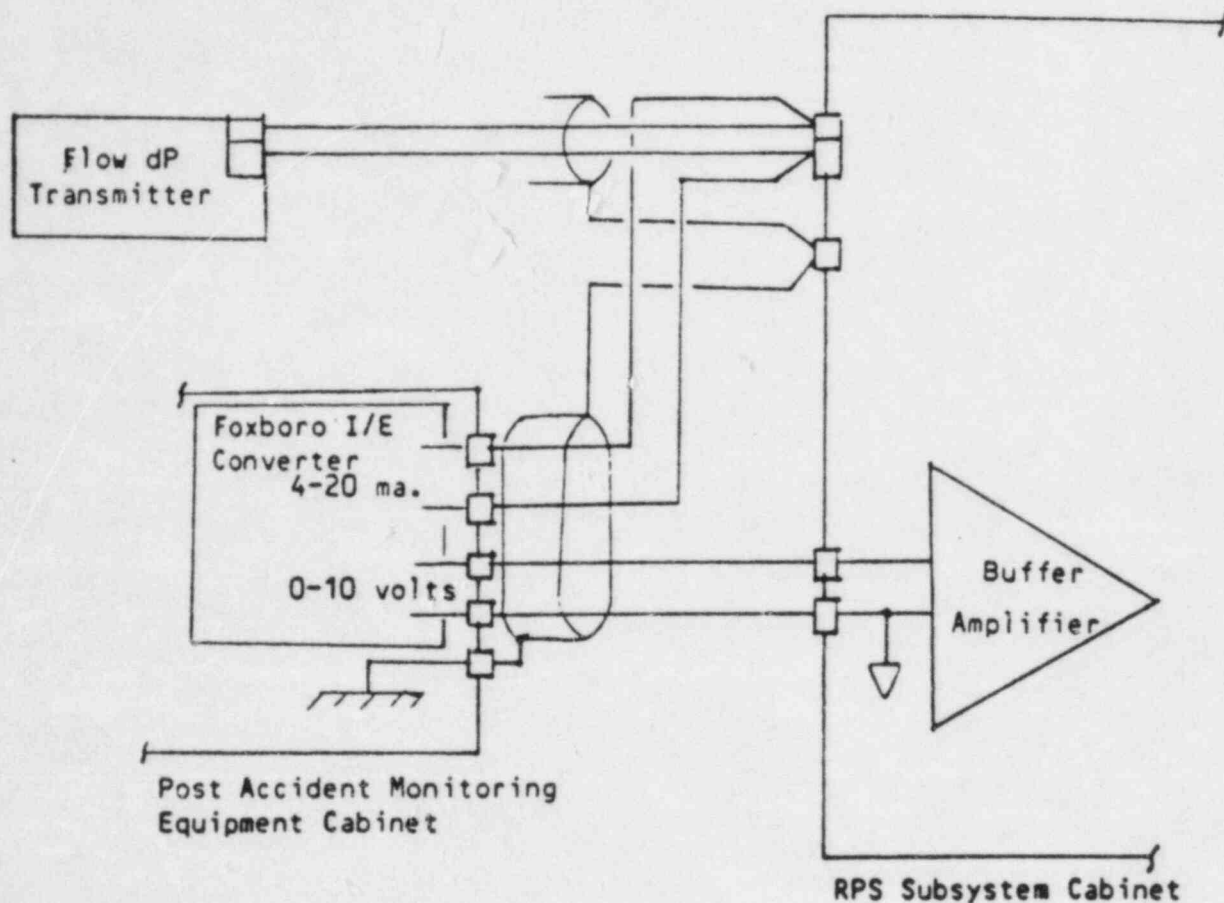
FIGURE 3
RPS INTERFACE FOR
FLOW TRANSMITTER REPLACEMENT

Figure 3 is a simplified schematic of the interface (typical for all four vital power divisions).

The physical and electrical separation of the flow dP signals associated with each RPS subsystem is equal to the separation which existed prior to the change in transmitters.

Because of this maintained separation, any single failure is confined within the bounds of the power division in which it occurs. Therefore, no single failure within the reactor coolant flow dP strings in the RPS can prevent the RPS from performing its safety function.

Also, single failures of equipment involved in the Flow Transmitter Replacement may cause a spurious trip signal to be sent to Reactor Trip Module in the affected channel providing one input to the 2/4 logics in each RPS Subsystem. This is consistent with a similar failure analyzed in BAW 10003. The RPS system trip logic becomes effectively 1/3.
