## Test Report

### F390 Lead Pot and Therasphere Acrylic Shield Drop Tests

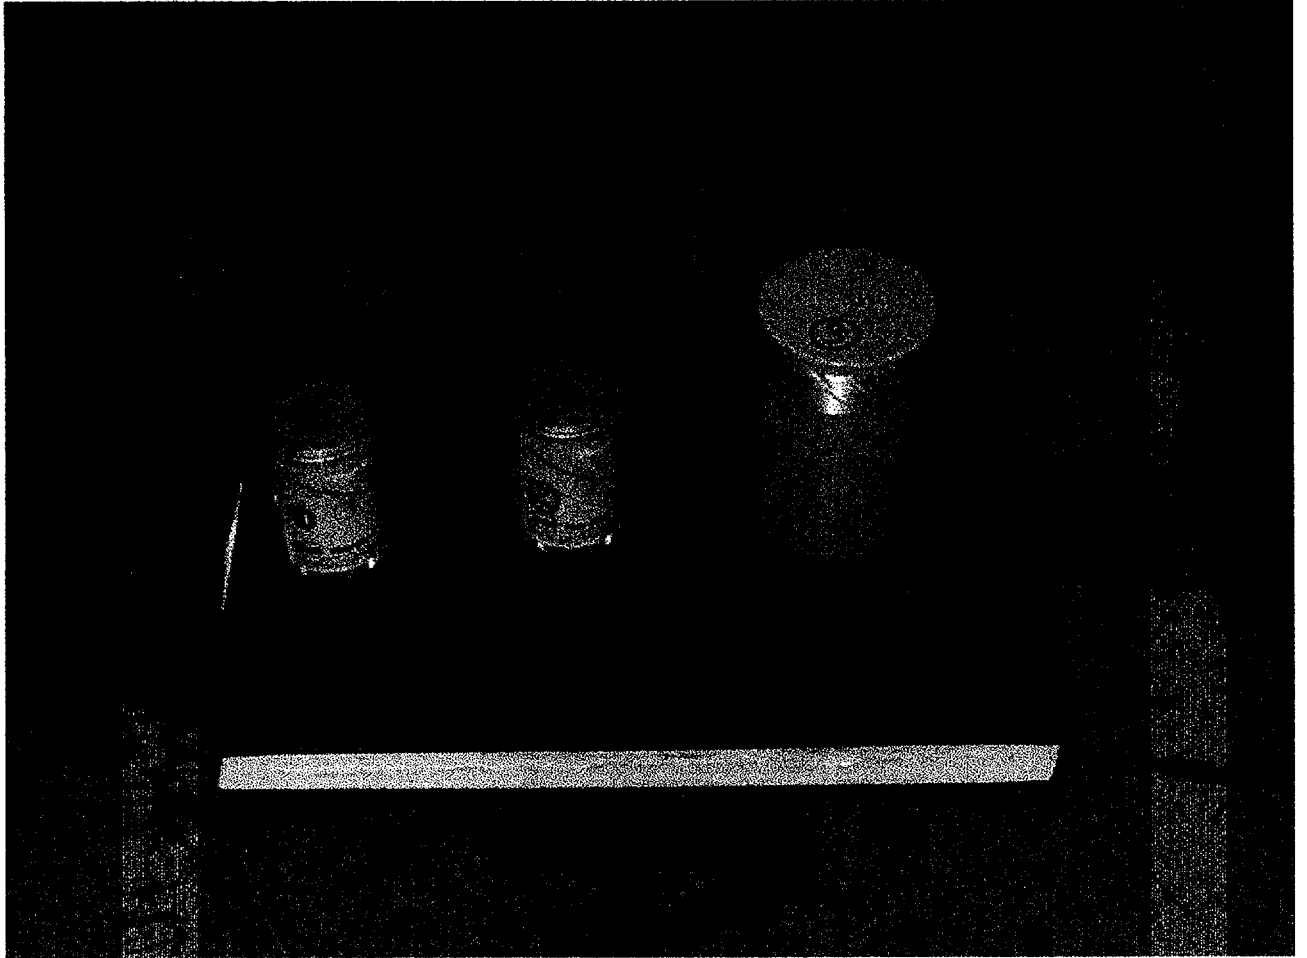
Figure 1. Specimens Prior to Drop Tests.  
Photo P001739

Specimen #1 was prepared by crimping a septum and aluminum cap on a Wheaton 0.3 mL V-Vial. The glass vial was installed inside an acrylic shield (p/n K120612-003). The top was pressed into the body of the shield. A blank Therasphere product label was applied to the acrylic shield. The Shield Access Plug was installed and taped in place with a tamper-evident seal.

Specimen #2 was identical to Specimen #1.

Specimen #3 was the same as Specimen #1, excepted that the acrylic shield was installed in an F-390 lead pot. The lid was taped on the lead pot using 3/4" wide fibre tape.

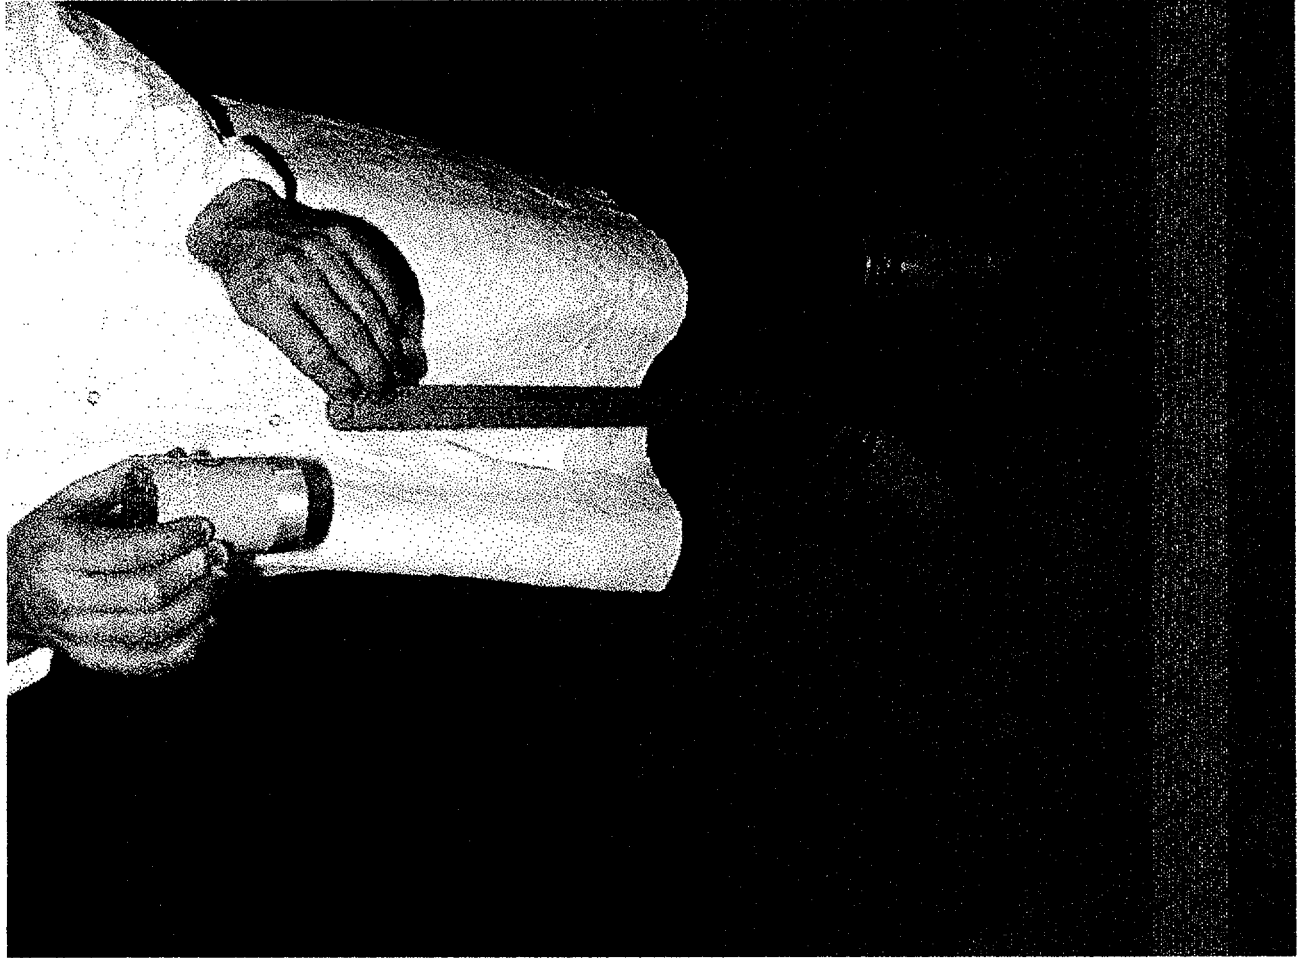
Figure 2. Test Setup, Specimen #3, Upright Drop.  
Photo P001751

The testing was performed on the concrete floor in the Nuclear Medicine Shipping Area. A meter stick was used to measure the height of the drops.

The specimens were released by hand.

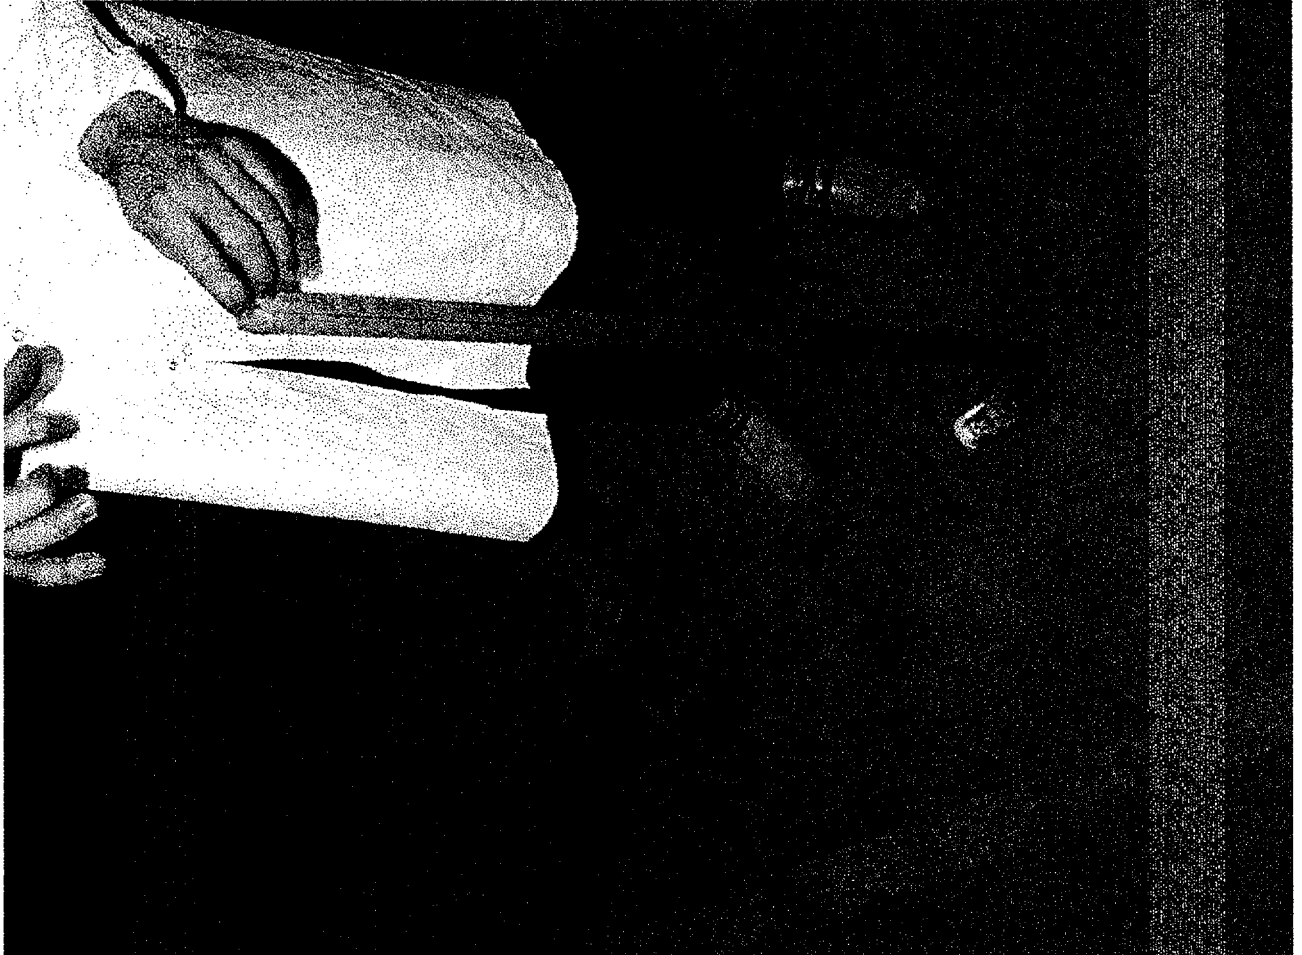
Figure 3. Specimen #2, Horizontal Drop, Prior to Impact.  
Photo P001748

Specimen #2 was subjected to the following 1 m drops:

1. Vertical, upright orientation
2. Horizontal orientation
3. Corner drop, inverted, with centre of gravity over top of the point of impact.

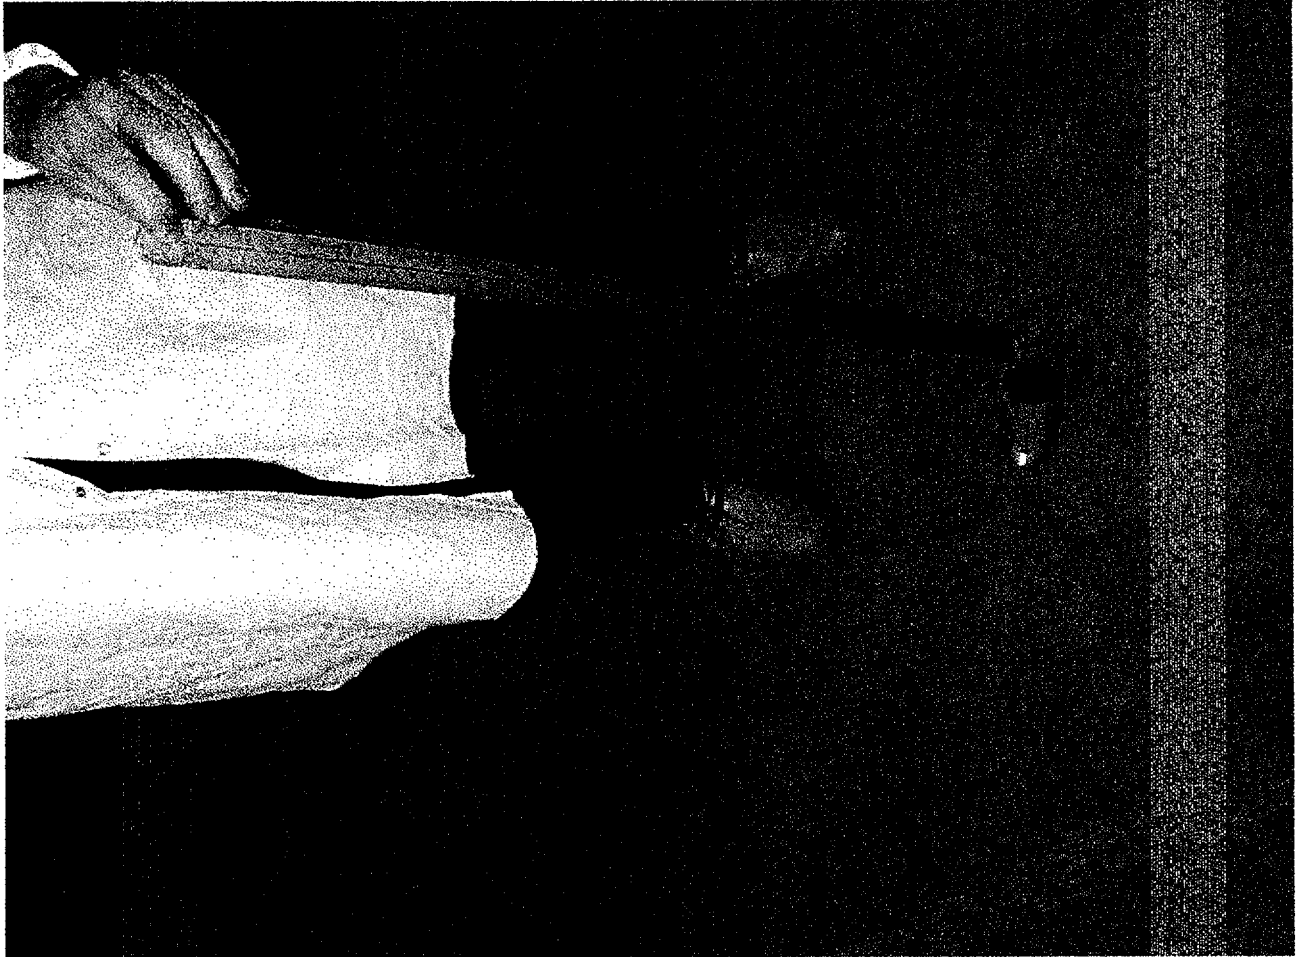
Figure 4. Specimen #3, Corner Drop, Prior to Impact.  
Photo P001754

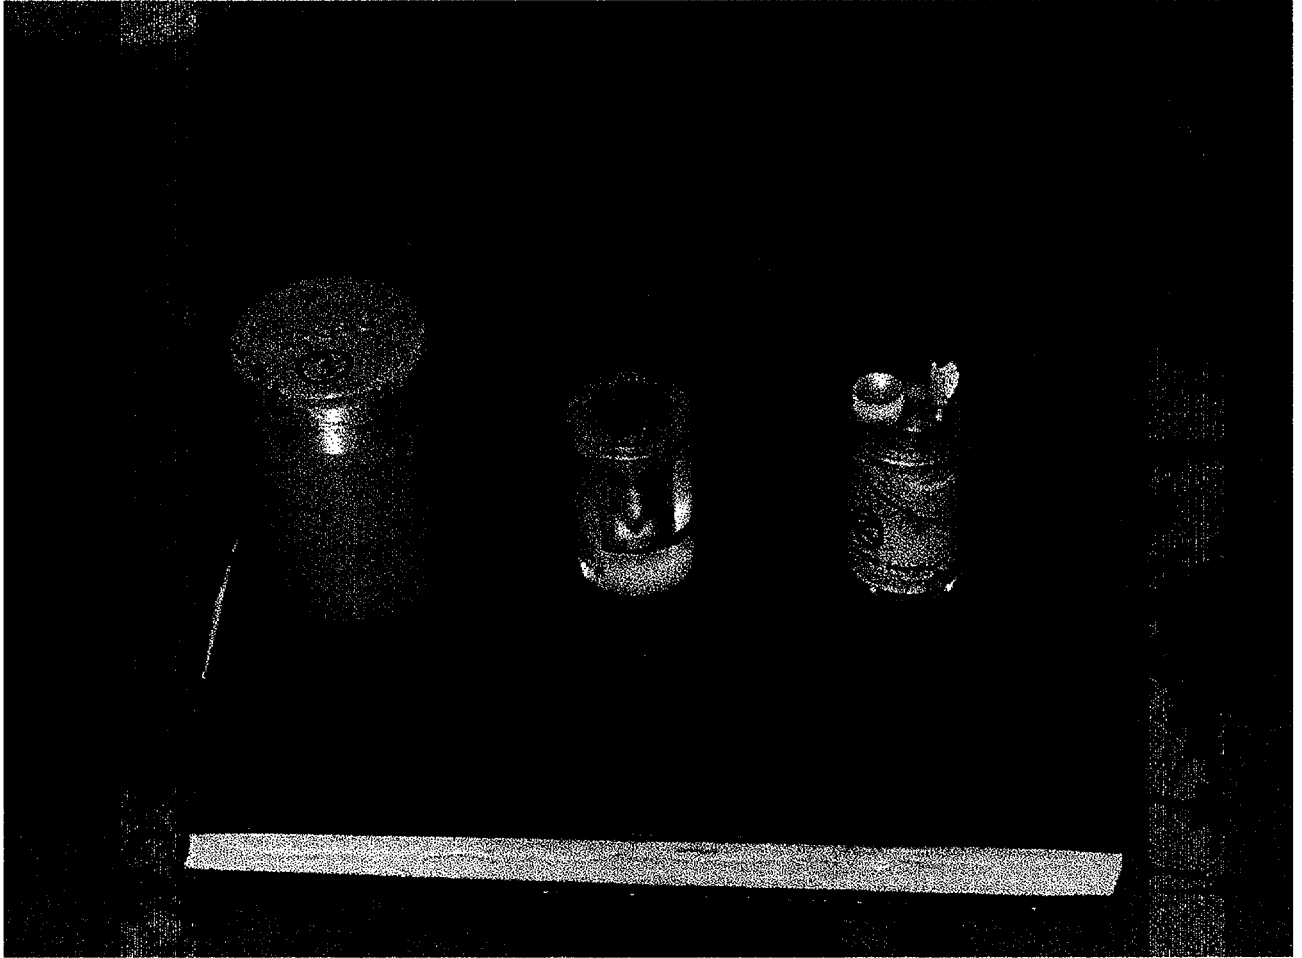
Figure 5. Specimens After Drop Tests.  
Photo P001755

Other than minor scratches to the acrylic shield, test specimen #1 was undamaged. There was no damage to the glass vial.

The tamper-evident seal on specimen #2 was torn as a result of the tests. The tearing was almost complete, and the top plug was dislodged by two swift slaps by hand on the base of the acrylic shield. There were minor scratches on the acrylic shield. The glass vial was undamaged.

Specimen #3's lead pot suffered some dents as a result of the tests. The fibre tape held the pot lid firmly in place. The acrylic shield and glass vial were undamaged.
