Evaluation of the Refueling Water Storage Tank Bottom Plate Crack

Technical Report No. 00115-TR-001
Revision 0
Volume 1 of 1

South Texas Project Nuclear Operating Company

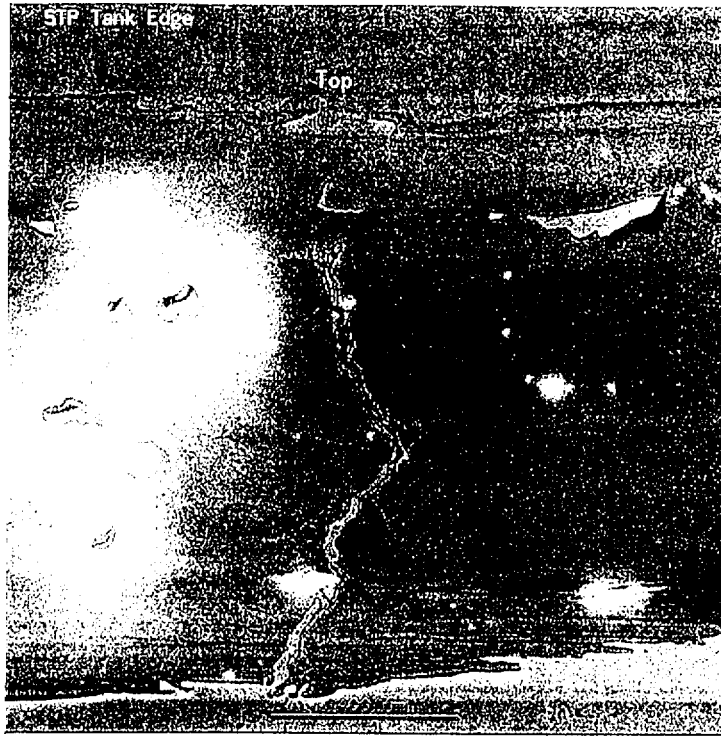
Figure 7. Scanning Electron Photomicrograph of replica showing Cracking in the Edge of the Base Plate

Figure 6 shows a photograph taken in the stereomicroscope of the replica of the main crack shown in Figure 4. In this image, other cracks as well as branching cracks are visible. Figure 7 shows a scanning electron micrograph taken of a replica of the edge of the plate shown in Figure 5. This photograph shows the crack initiating from the bottom tank exterior of the plate and propagating up through the thickness. It also shows evidence of transgranular crack propagation and branching which is characteristic of chloride stress corrosion cracking in austenitic stainless steels.

The initiation and propagation of external Stress Corrosion Cracks is likely to have occurred in the presence of residual stresses as a result of initial fabrication welds or applied loads. It is also possible that residual stresses may have been relieved over time due to local yielding and crack initiation.

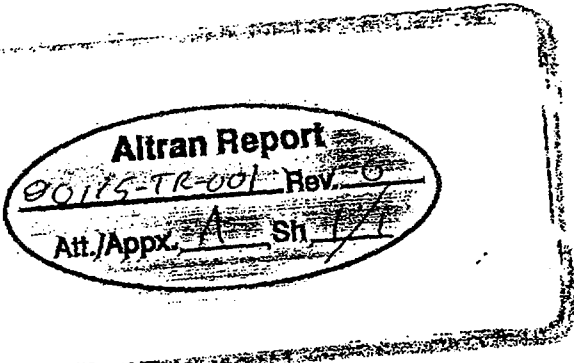
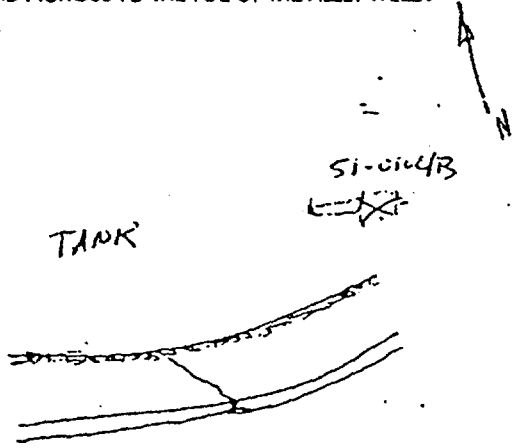
| TANK TO BASE PLATE FILLET | Reject | A FLAW WAS DETECTED ON THE BASE PLATE. THE FLAW EXTENDS FROM THE VERTICAL EDGE OF THE BASE PLATE AND ACROSS TO THE TOE OF THE FILLET WELD. | | |
