DOE/ET/34212-50  
BAW-1874

## THE HOT CELL EXAMINATION OF OCONEE 1 FUEL RODS AFTER FIVE CYCLES OF IRRADIATION

BABCOCK & WILCOX  
Nuclear Power Division  
P. O. Box 10935  
Lynchburg, Virginia 24506-0935

Babcock & Wilcox Mark B (15x15) fuel rods were examined in the hot cell after three, four, and five cycles of irradiation in the Oconee Unit 1 pressurized water reactor. The burnups of these rod groups were 31,940, 39,180, and 49,570 MWd/mtU, respectively. Nondestructive and destructive examinations were performed to gather fuel performance data, and to assess the impact of high burnup on key fuel and fuel rod characteristics. This effort is part of a Department of Energy program to improve uranium utilization and decrease the number of spent fuel assemblies discharged annually by extending the burnup of light water reactor fuel.

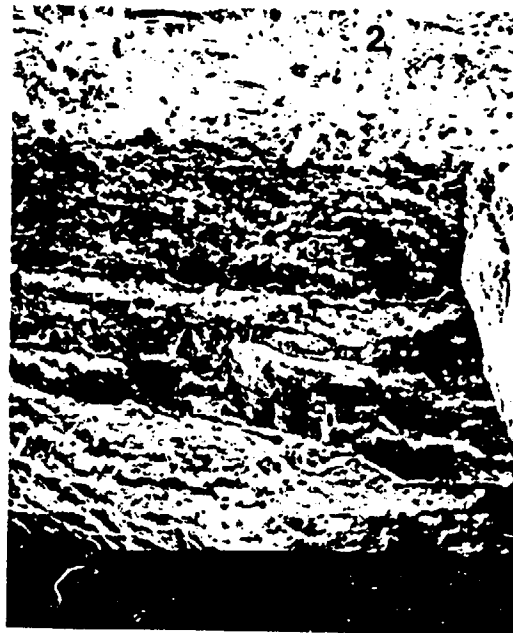
Figure 4-45. Fracture Surface Features of an Oxide Crater

Figure 4-45 shows a prominent spalled crater about 0.1 inch in diameter and 40 to 50 $\mu$  in depth. Typical fracture surface micrographs of the crater, its wall, and rim areas are shown in Figure 4-45. The crater wall has a clearly layered or laminar structure with many circumferential cracks between the layers of oxide. The OD oxide surface adjacent to the crater region showed a structure consisting of clusters of small granules (about 0.05 to 0.5 $\mu$ ) with a "cauliflower" appearance as shown in Figure 4-46. A transverse section from this region was metallographically polished and examined on the SEM. Electron images of that transverse section are shown at two magnifications in Figure 4-47. The primary feature within the oxide layer is the high concentration of short circumferential fissures or microcracks, occasionally interlinked to form a continuous longer crack. The fissures appear to be fairly uniformly distributed across the thickness of the oxide layer from the oxide-metal interface to the water-oxide surface. These microcracks are believed to form in the oxide to relieve the compressive stresses that develop during oxidation. The stresses form as a result of the volume increase upon conversion of the metal to its oxide.

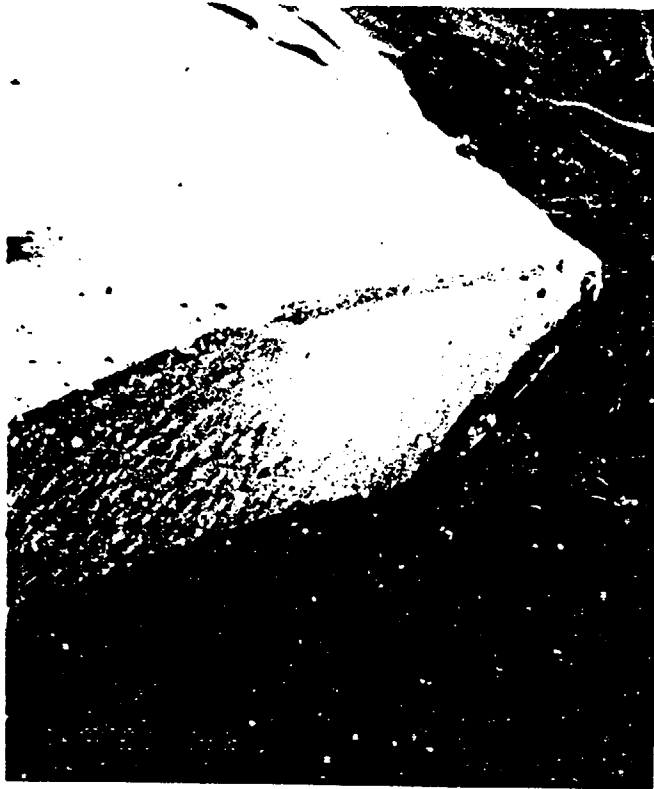
Figure 4-50. Minor Spallation in a Uniform Oxide Layer

The span 2 region on rod 15309 had an average oxide thickness of about 40 $\mu$ . The OD surface of this area (sample 15309-3A) was similar to that of 15189-5 in its retention of the pre-irradiation, circumferential grinding marks. However, minor spallation was also observed in this span 2 region as shown in Figure 4-50. At high magnification, Figure 4-51 shows that the unspalled surface areas of this sample had an oxide morphology with the same platelet structure mentioned earlier. However, in Figure 4-52, a spalled area from the same sample shows the granular, "cauliflower" structure similar to that from sample 15192-11.

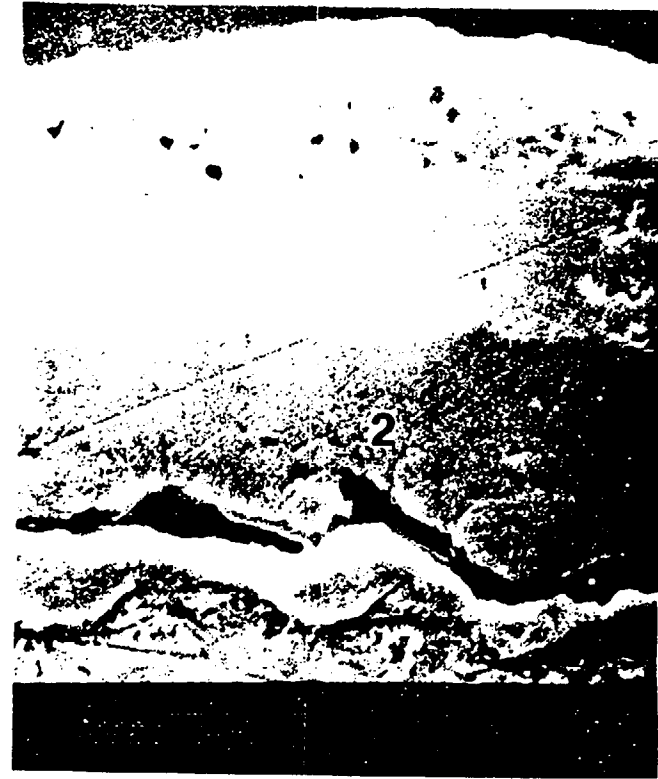
Figure 4-57. Transversed View of a Fuel Fragment Bonded to a Cladding ID Surface

A transverse section from sample 15192-11 was cut through an island of bonded fuel-cladding reaction product and was polished metallographically. Figure 4-57 shows the cross section of the fuel fragment and the surrounding denser oxide layer, including a backscatter electron image. Under backscatter imaging conditions, the higher atomic number material appears brighter due to the more efficient interaction of heavier atoms with the electron beam. The material in the porous deposit has the highest average atomic number, Z, and is diffusion bonded to a layer with a lower average Z value. The metallic substrate, Zircaloy-4, appears as an intermediate gray corresponding to an intermediate average Z. Thus, the porous deposit is U-rich, and the underlying layer is primarily an oxide of Zircaloy, as confirmed independently with energy dispersive spectrometry (EDS) dot maps for uranium and Zircaloy. However, traces of Zircaloy were seen in the U-rich porous deposit, and traces of uranium were detected in the underlying Zircaloy oxide layer.

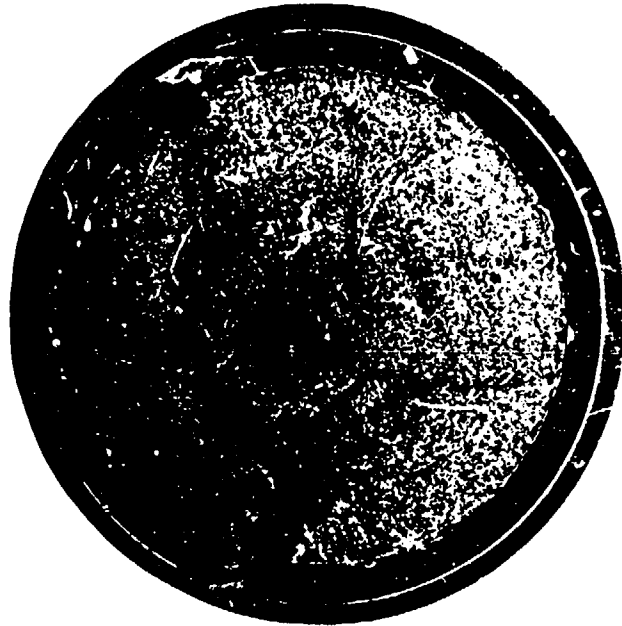
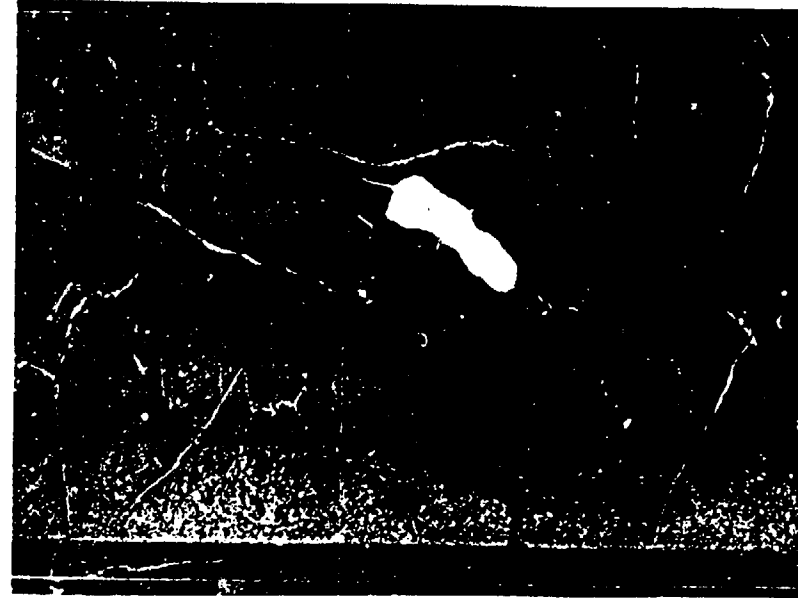
Figure 4-58. Typical Appearance of Five-Cycle Fuel Cross Sections (Etched Condition)

The typical appearance of etched five-cycle fuel samples is shown in Figure 4-58. Two distinct regions are visible in the central portion of the cross sections. These are seen as concentric rings in the transverse section and as bands in the longitudinal section. The inner area corresponds to the region of limited grain growth observed in the microstructure, and the outer area marks the onset of fission gas bubble formation on the grain boundaries.<sup>37</sup>

TRANSVERSE

LONGITUDINAL

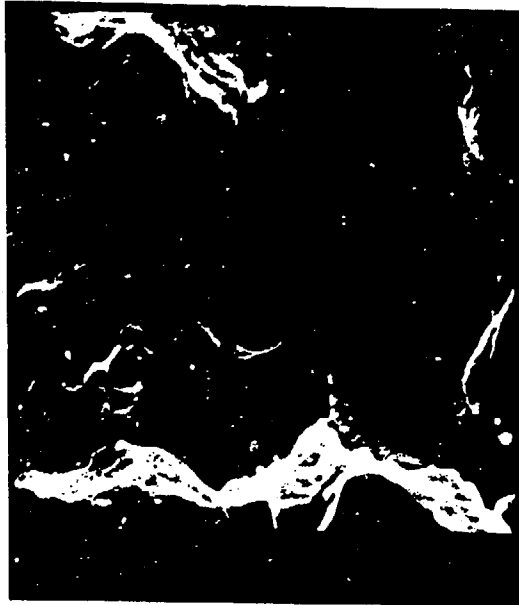
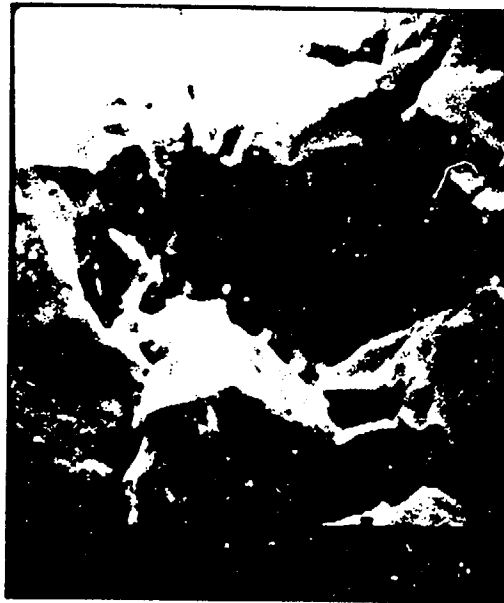
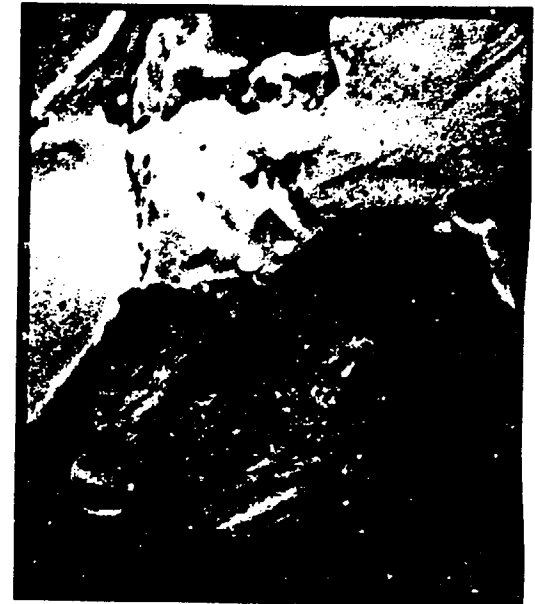
Figure 4-61. Typical SEM Views of the Center Region of Five-Cycle Fuel Cross Sections

A thin layer of fuel was removed from four of the mounted cross sections and examined in the SEM. Results of the SEM examination were consistent with ceramographic observations, and provided additional information on fuel porosity. Figure 4-61 shows fuel grains from the center of a sample from the higher gas release rod (15335). A fractured grain in the left of the figure clearly shows the fine intragranular porosity and the denuded zone adjacent to the grain boundaries. Grains in the far right of the figure show extensive porosity on the grain faces. The small nodules seen in the grain face pores are the metallic inclusions that were only observed in the center portion of the fuel cross sections. These are most likely insoluble metal fission products such as molybdenum that tend to diffuse up the thermal gradient.

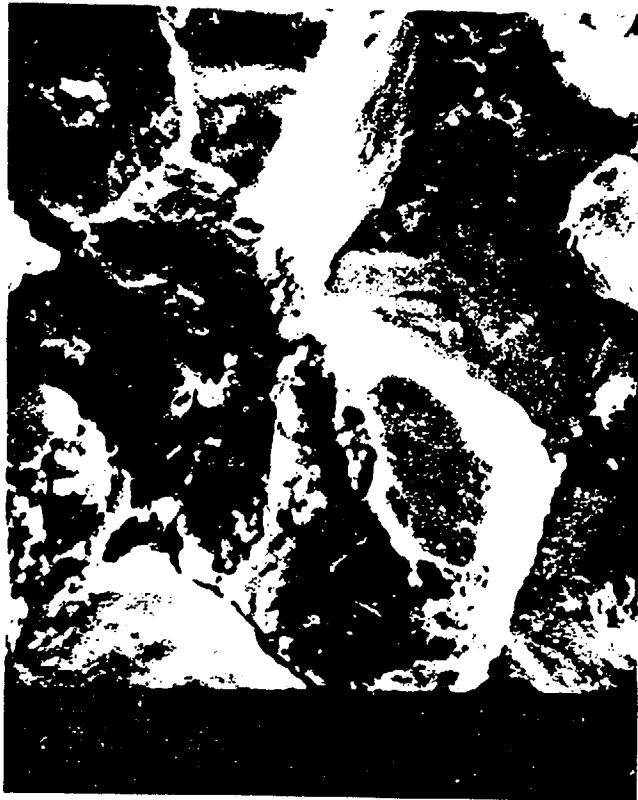
Figure 4-64. Typical SEM Photographs of the Edge Region of Five-Cycle Fuel Cross Sections

fission gas release. The pellet edge region (Figure 4-64) had pores at triple points, but only a few small pores on the edges or faces of the grains.
