**Second U.S. Nuclear  
Regulatory Commission  
International Steam Generator  
Tube Integrity Research  
Program**

**Final Project Summary Report**

**Argonne National Laboratory**

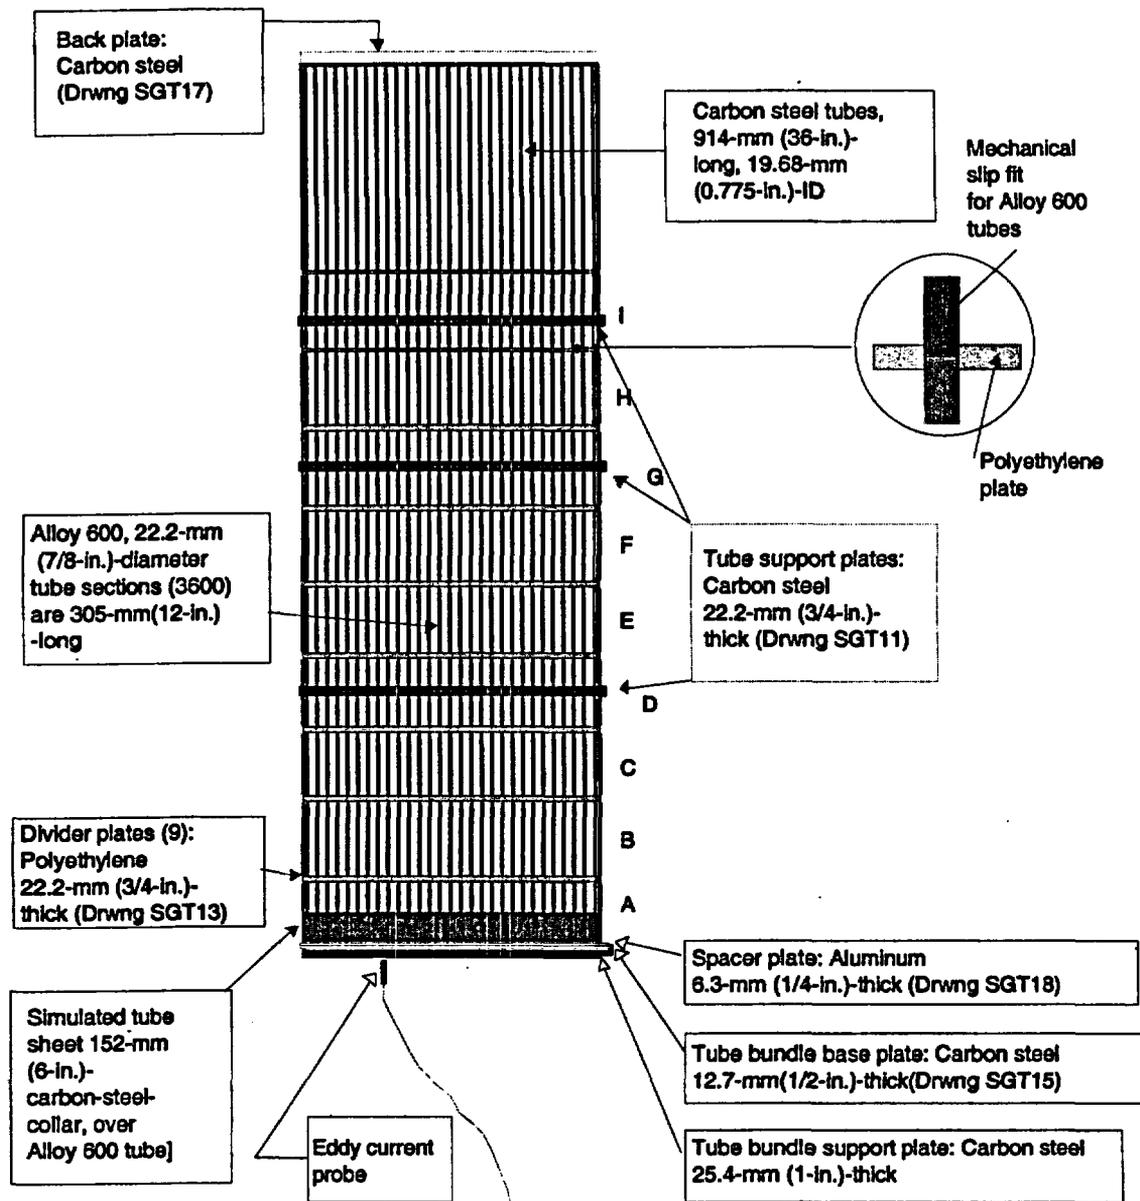
Figure 2.1. Schematic representation of tube bundle in steam generator mock-up.

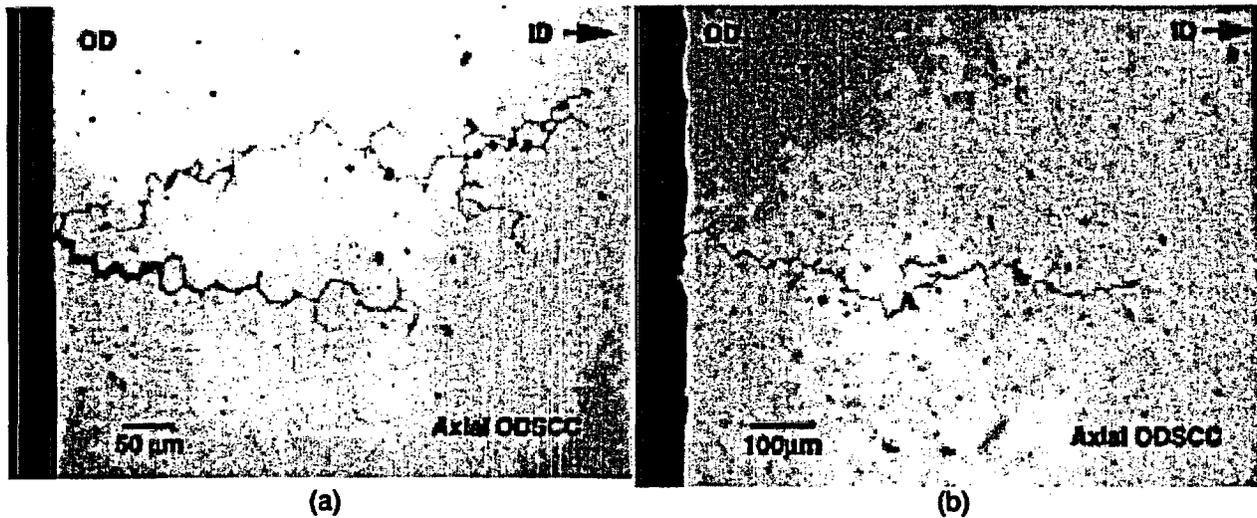
Figure 2.4 Cross-sectional optical metallography: (a) branched LODSCC and (b) LODSCC.

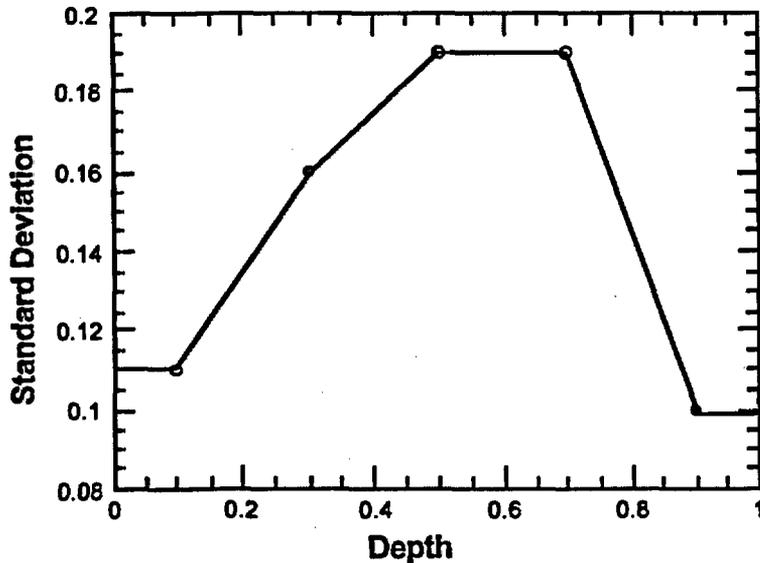
Figure 2.12.  
Standard deviation in percent throughwall as a function of maximum depth.

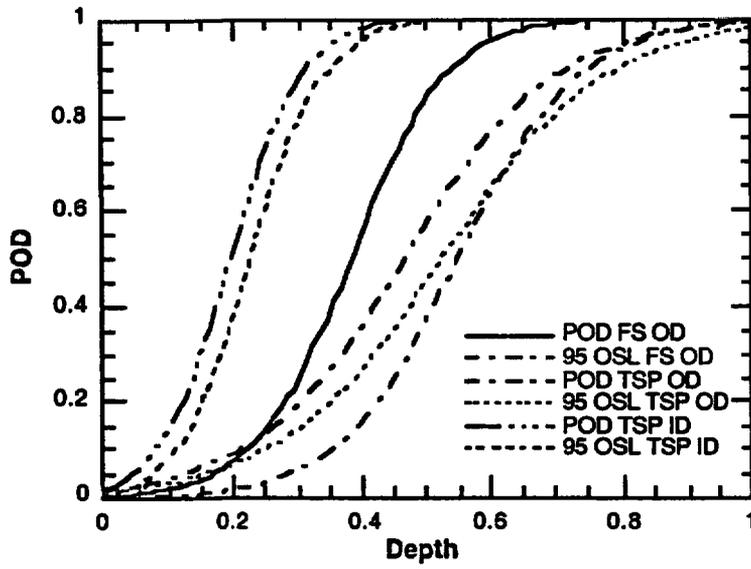
Figure 2.15. BC POD for freespan and TSP data as a function of maximum depth (as fraction throughwall) for LODSCC and LIDSCC by using maximum likelihood fit with the one-sided 95% confidence limit. Maximum depth uncertainty is included. Depths are determined with the multiparameter algorithm.

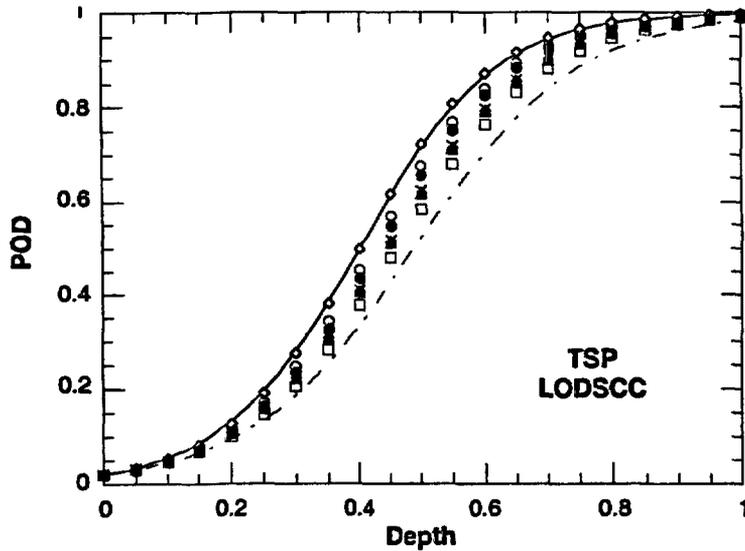
Figure 2.19.  
 BC POD by team for TSP LODSCC. The maximum crack depth (as fraction of wall) was determined by the multiparameter algorithm. The highest solid line represents the best team, the lowest dashed line represents the worst team, and the other symbols represent the remaining teams.

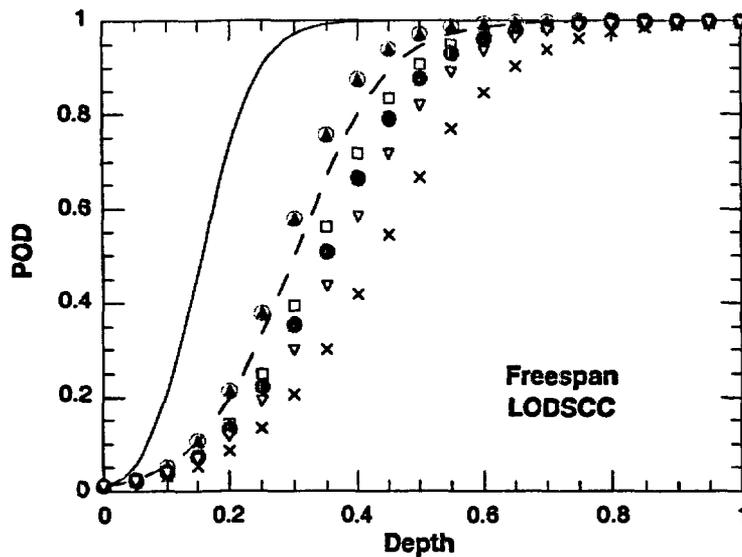
Figure 2.20.  
 BC POD by team for freespan LODSCC. The maximum crack depth (as fraction of wall) was determined by the multiparameter algorithm. The solid line represents the best team, while the symbols and dashed line represent the remaining teams.

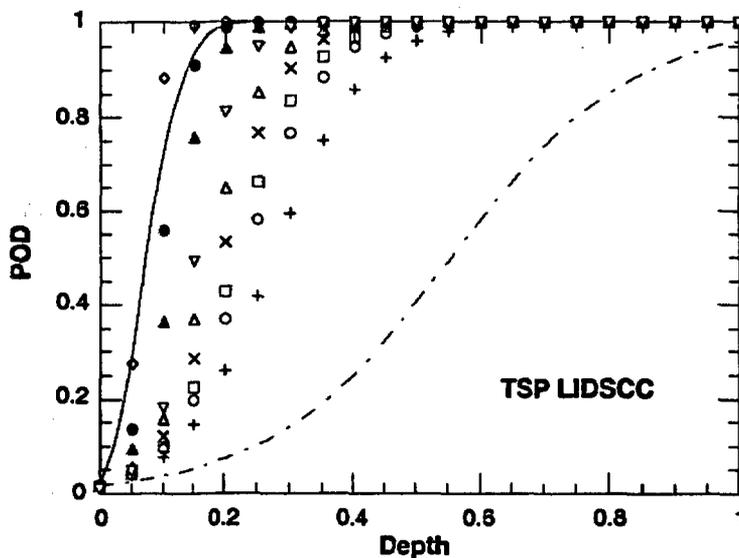
Figure 2.21.  
 BC POD by team for TSP LIDSCC. The maximum crack depth (as fraction of wall) was determined by the multiparameter algorithm. The solid line represents the best team, the dashed line represents the worst team, and the symbols represent the remaining teams.

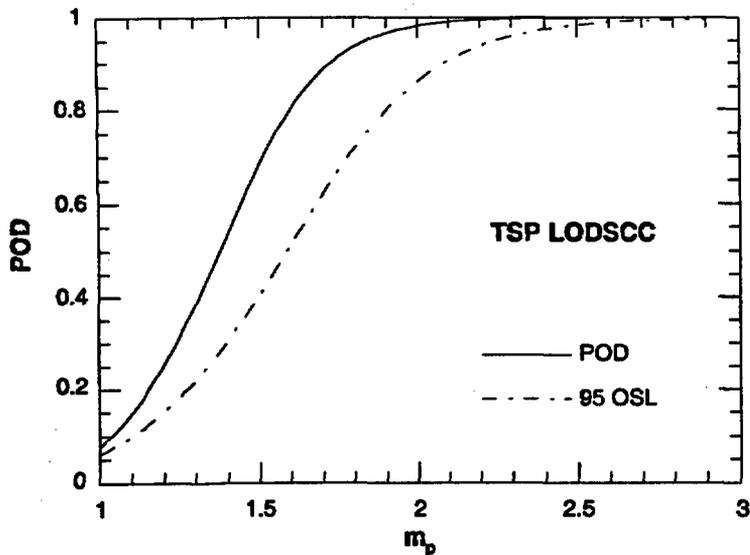
Figure 2.22.  
BC POD for TSP LODSCC as a function of  $m_p$  by using maximum likelihood fit with an estimate of the one-sided 95% confidence limit. The values of  $m_p$  are derived by using depths from the multiparameter algorithm.

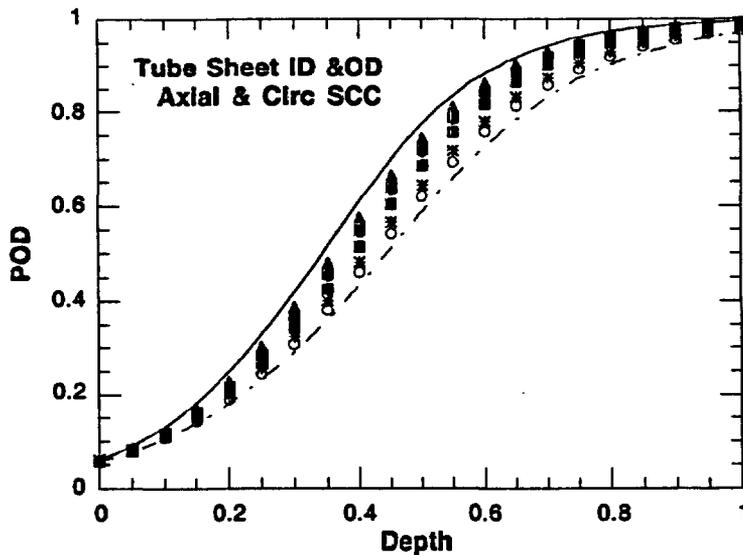
Figure 2.27. MRPC POD by team as a function of maximum depth (as fraction of wall) in the tube sheet. The solid line represents the best team, the dashed line represents the worst team, and the symbols represent the remaining teams. ID and OD are combined for the purpose of comparing teams.

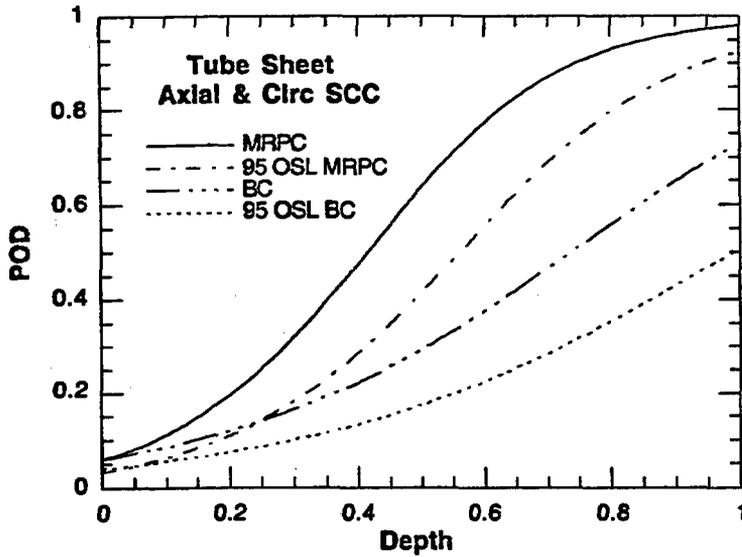
Figure 2.28. BC and MRPC POD for axial and circumferential IDSCC and ODSCC at the tube sheet. The lower 95% one-sided confidence limits (OSL) are shown (includes uncertainties in depths). Combined ID and OD should not be used except for comparison of relative effectiveness of probes.

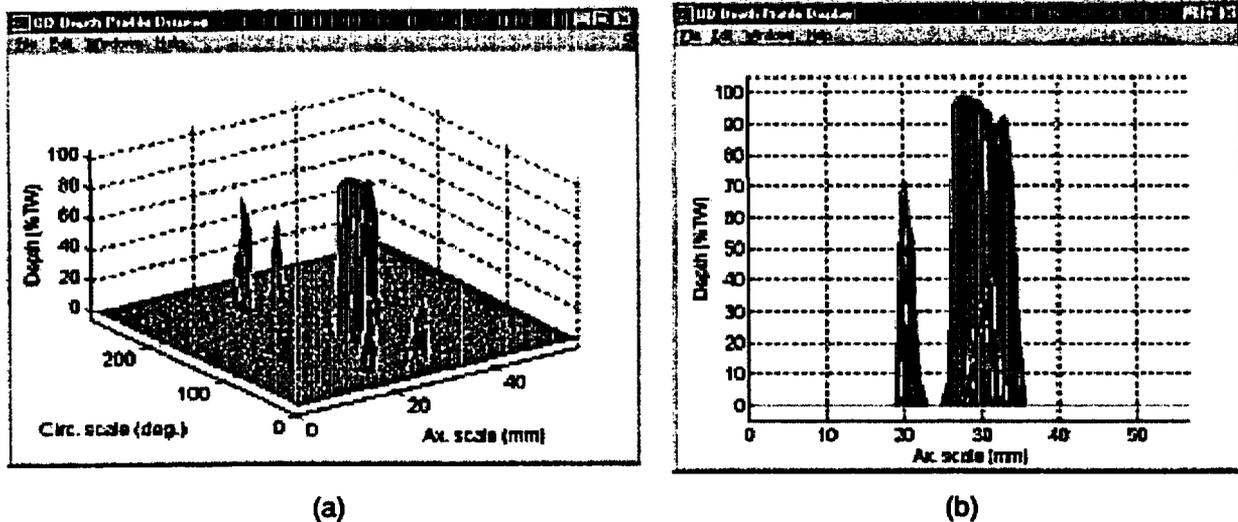
Figure 2.31. (a) TSP LODSCC with maximum depth of 99% TW that was missed by teams analyzing MRPC data. The largest piece of the segmented crack has a length of about 10 mm (0.4 in.). (b) Projection of the crack along the test section axis.

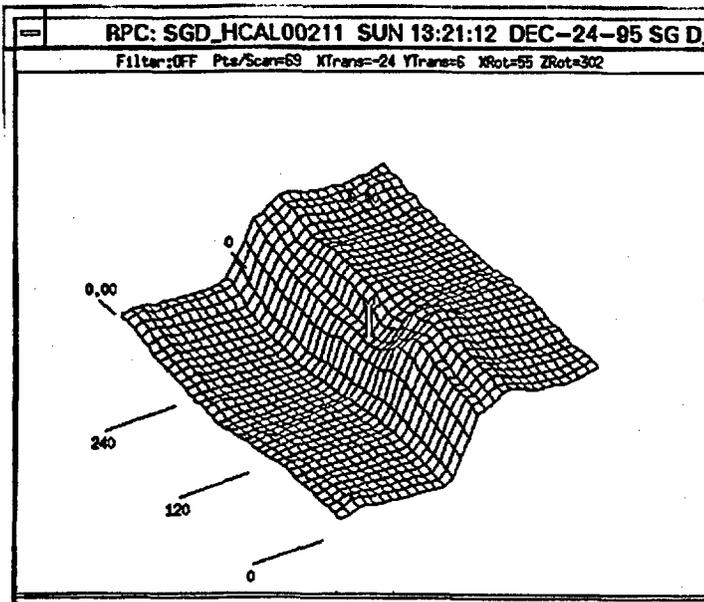
Figure 2.32.  
C-scan plot of tube R45C40 using a 2.92-mm (0.115-in.)-diameter MRPC showing top of tube sheet in December 1995. No crack call was made at that time. The tube axis is from lower left to upper right, with full 360° shown. The roll transition is indicated by the arrow.

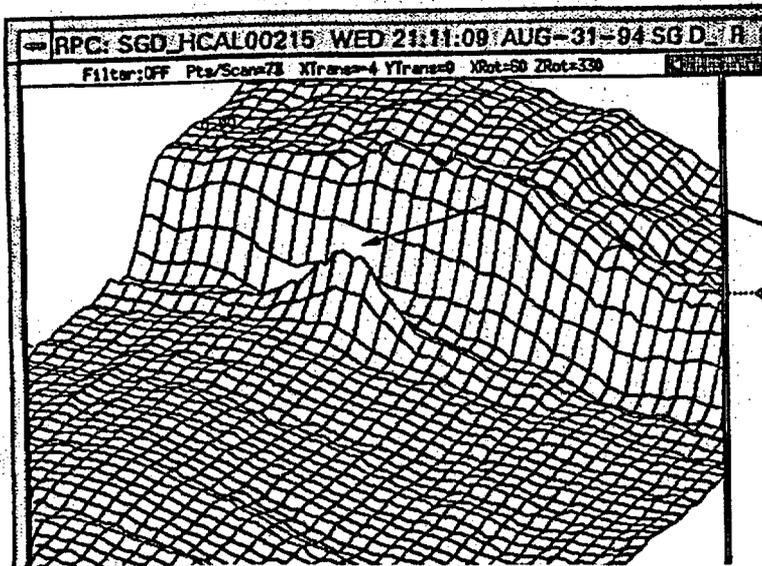
Figure 2.34.  
C-scan plot from a 2.92-mm (0.115-in.)-diameter MRPC; arrow points to indication at top of tube sheet (TTS) in tube R39 C46. This indication was called an SCC in August 1994. Tube axis is from lower left to upper right, with 360° of tube shown.

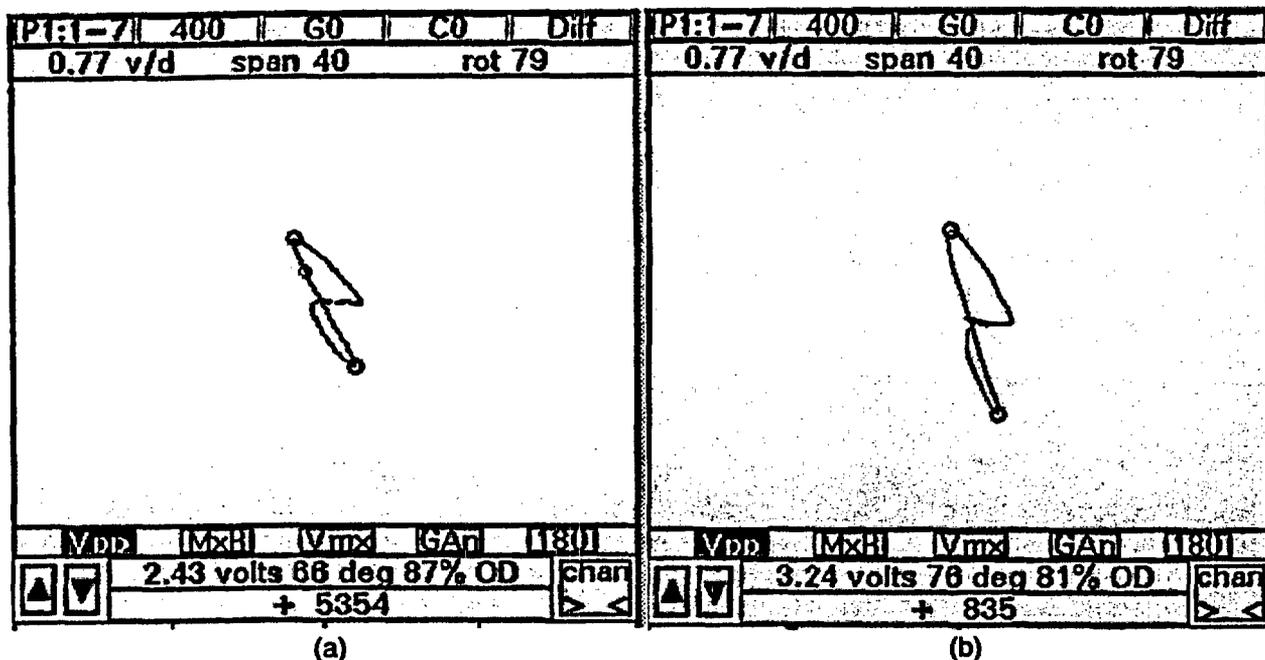
Figure 2.37. Mag-biased BC Lissajous figures before (top) and after (bottom) corrosion products (thin oxide film) were formed in a tube with axial ODSCC by exposing the tube to PWR conditions for about two months. Voltage increased from 2.43 to 3.24 V, suggesting less contact at crack faces. Estimated depth changed from 87 to 81% TW.

2.37	Mag-bias BC Lissajous figures before and after corrosion products were formed in a tube with axial ODSCC by exposing the tube to PWR conditions for about two months .....	40

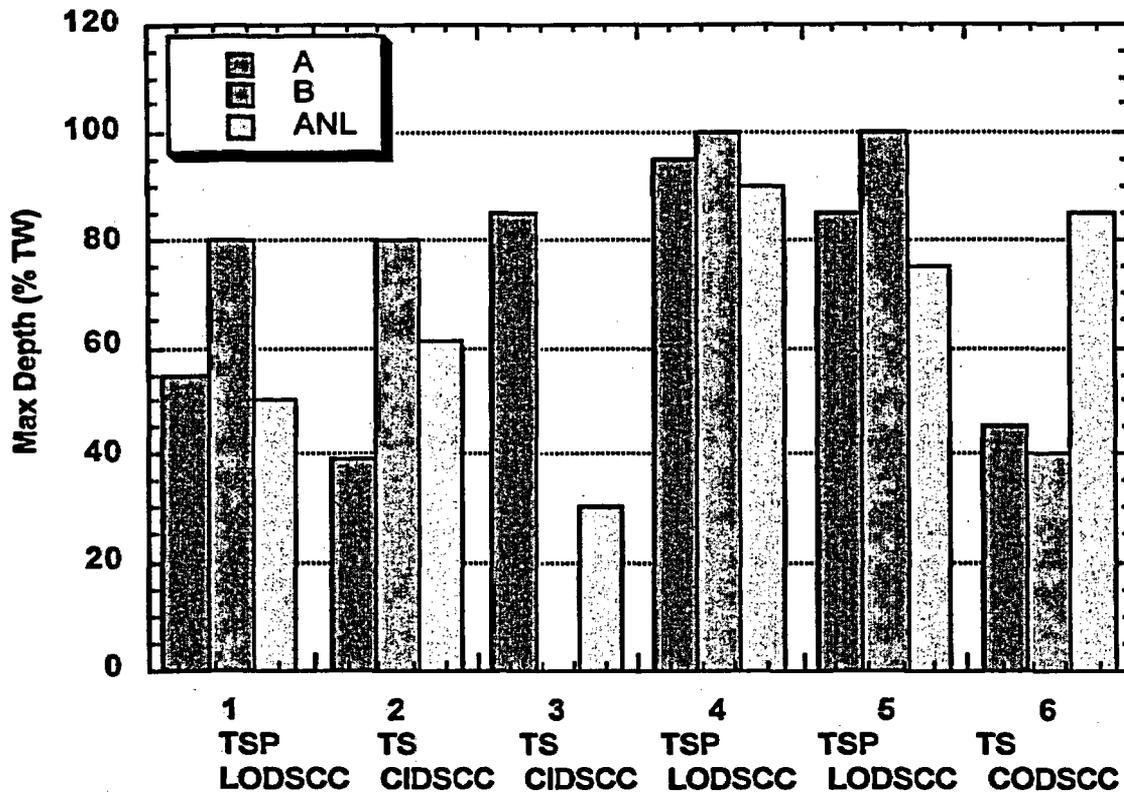
Figure 2.38. Maximum depths for a variety of crack morphologies estimated by two recognized EC NDE experts (A and B) using the same procedure with +Point data at 300 kHz and by Argonne using the multiparameter algorithm with input mainly from pancake phase and amplitude data.

2.38	Maximum depths for a variety of crack morphologies estimated by two recognized EC NDE experts using the same procedure with +Point data at 300 kHz and by Argonne using the multiparameter algorithm with input mainly from pancake phase and amplitude data.....	41

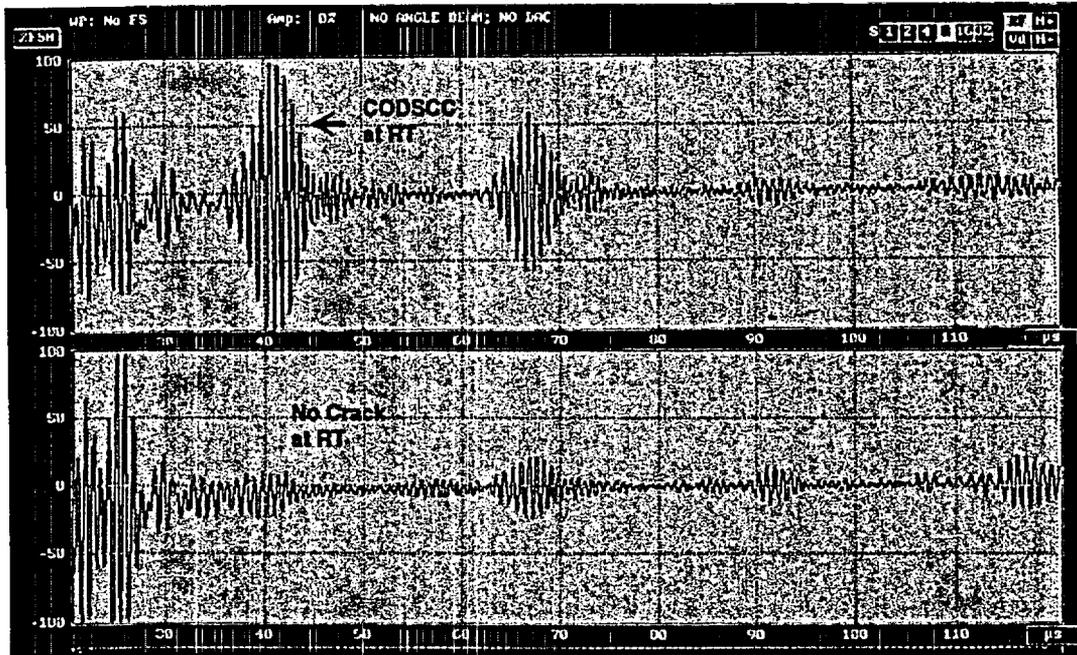
Figure 2.43. Ultrasonic Lamb wave echo (top half of figure) from a CODSCC in Alloy 600 tube with laboratory-grown crack in the roll transition. UT and EC evaluation of crack suggests a maximum depth of 80% TW.

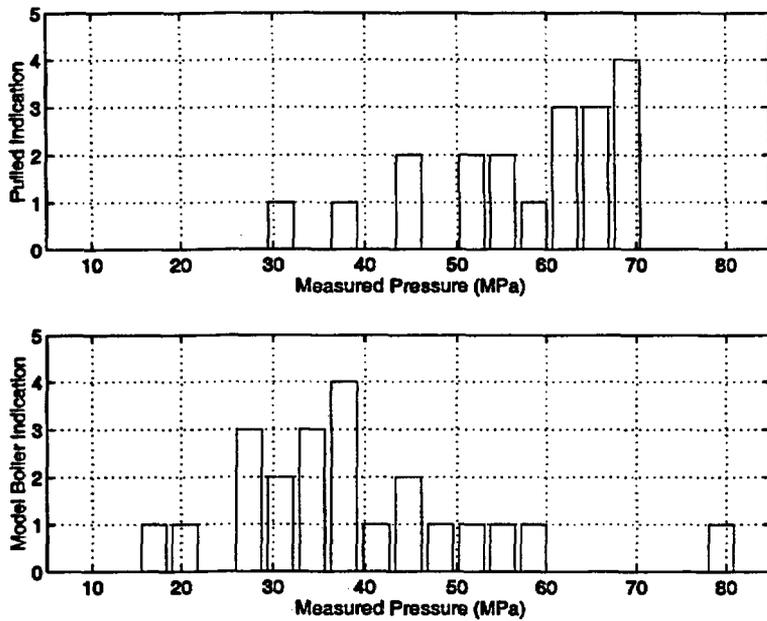
Figure 3.1. Distribution of pulled-tube (top) and model-boiler (bottom) indications as a function of failure pressure used for multivariate analysis.

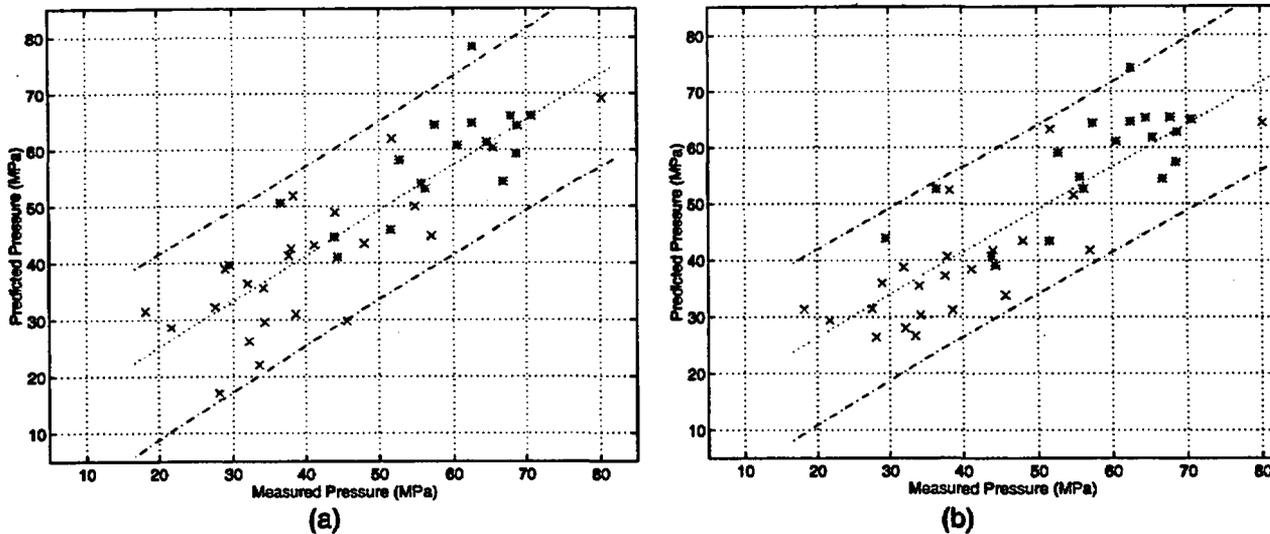
Figure 3.4. Predicted vs. measured failure pressures for (a) regression- and (b) neural-network fits for model-boiler (x) and pulled-tube (•) indications, with LOOT training and prediction method. Also shown are the upper and lower bounds of the 95% confidence interval based on a linear least-squares fit to the data.

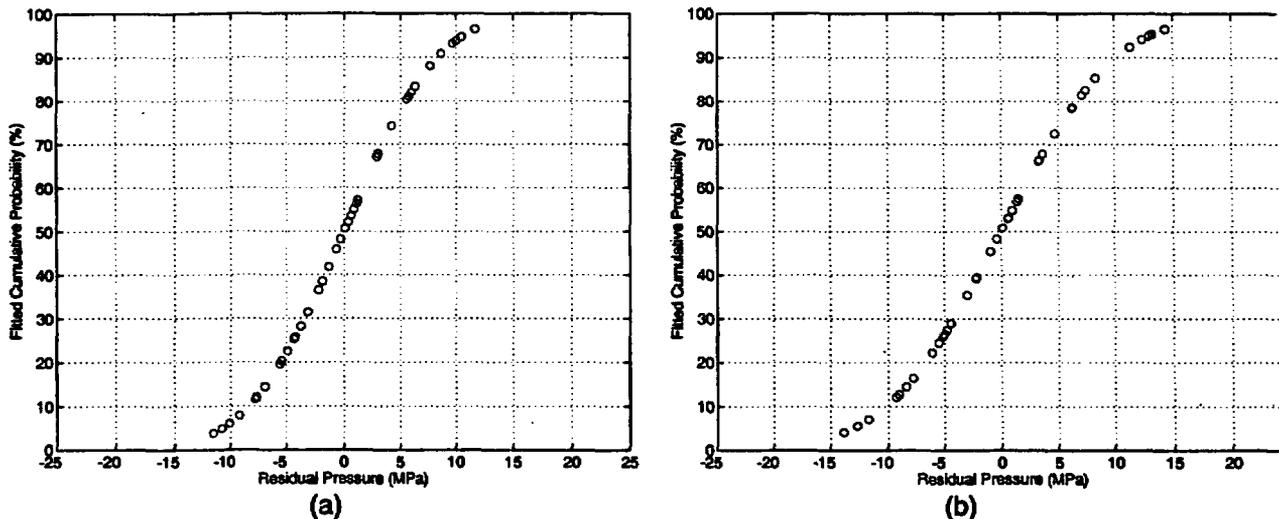
Figure 3.6. Cumulative distribution of residual failure pressure. Normal distribution function was assumed, with training and prediction based on (a) all indications and (b) LOOT.

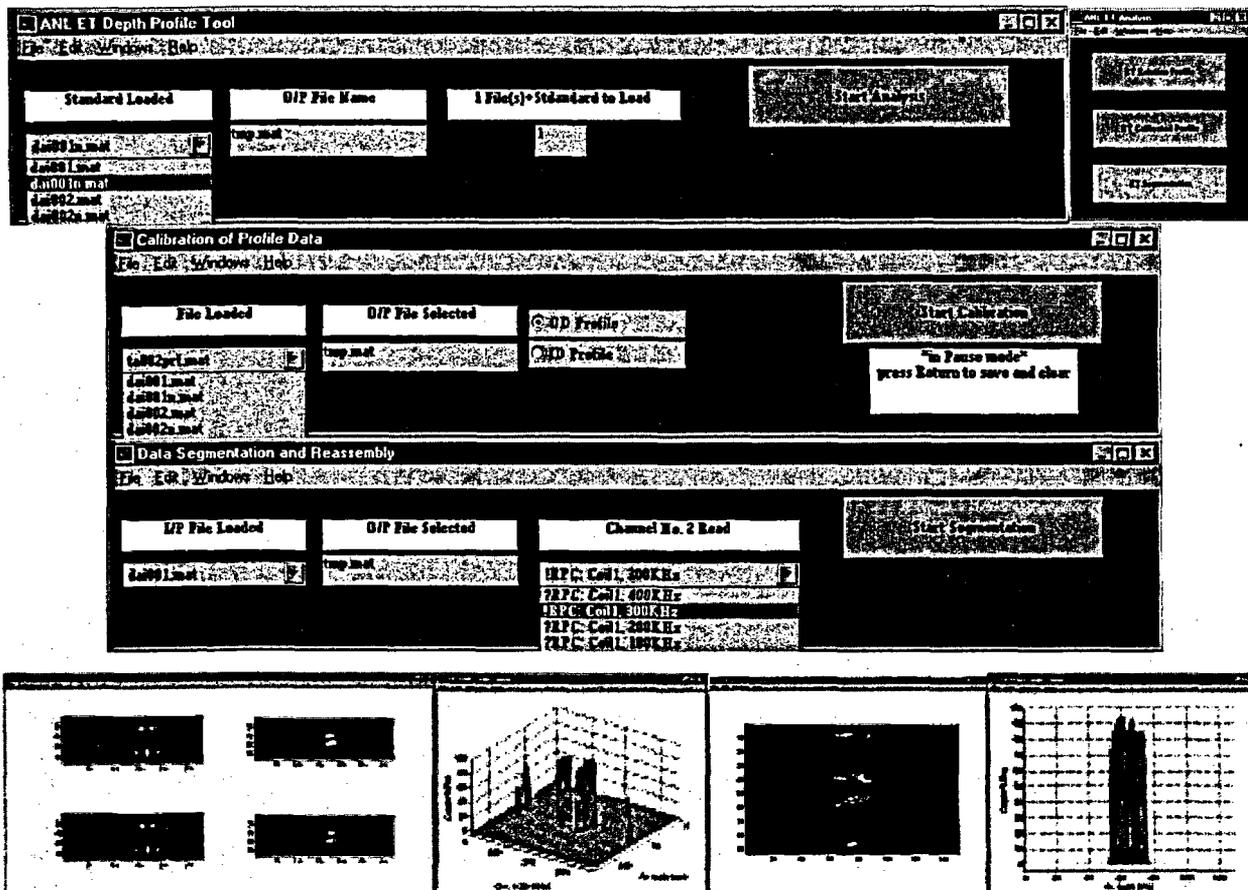
Figure 3.12. Series of MATLAB-based GUI tools (top four rows) for computer-aided analysis of EC inspection results acquired with standard commercial instruments. Also shown (bottom two rows) are several graphical display formats such as Image, terrain, and cross-sectional NDE profiles of tube test section at various stages of analysis.

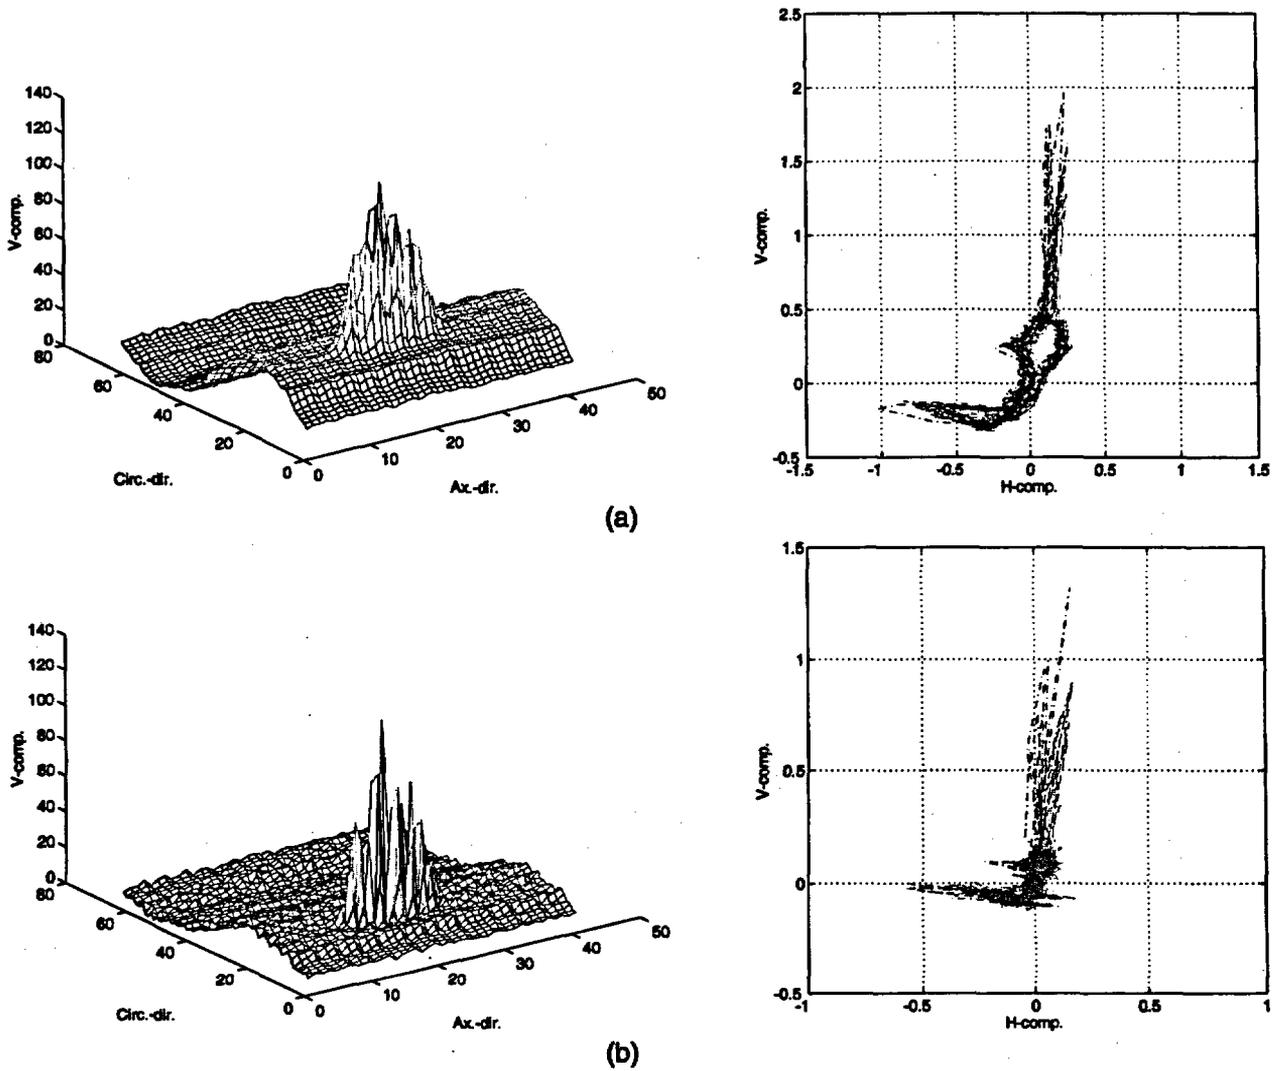
Figure 3.13. (a) Original and (b) restored signal for Type-3 laser-cut specimen #5528-3-3 with nominal OD flaw depth of 40% TW. NDE maximum depth estimates were 42% by bobbin coil (phase-angle) and 61% by multiparameter analysis of RPC (2.92-mm [0.115-in.] pancake) data.

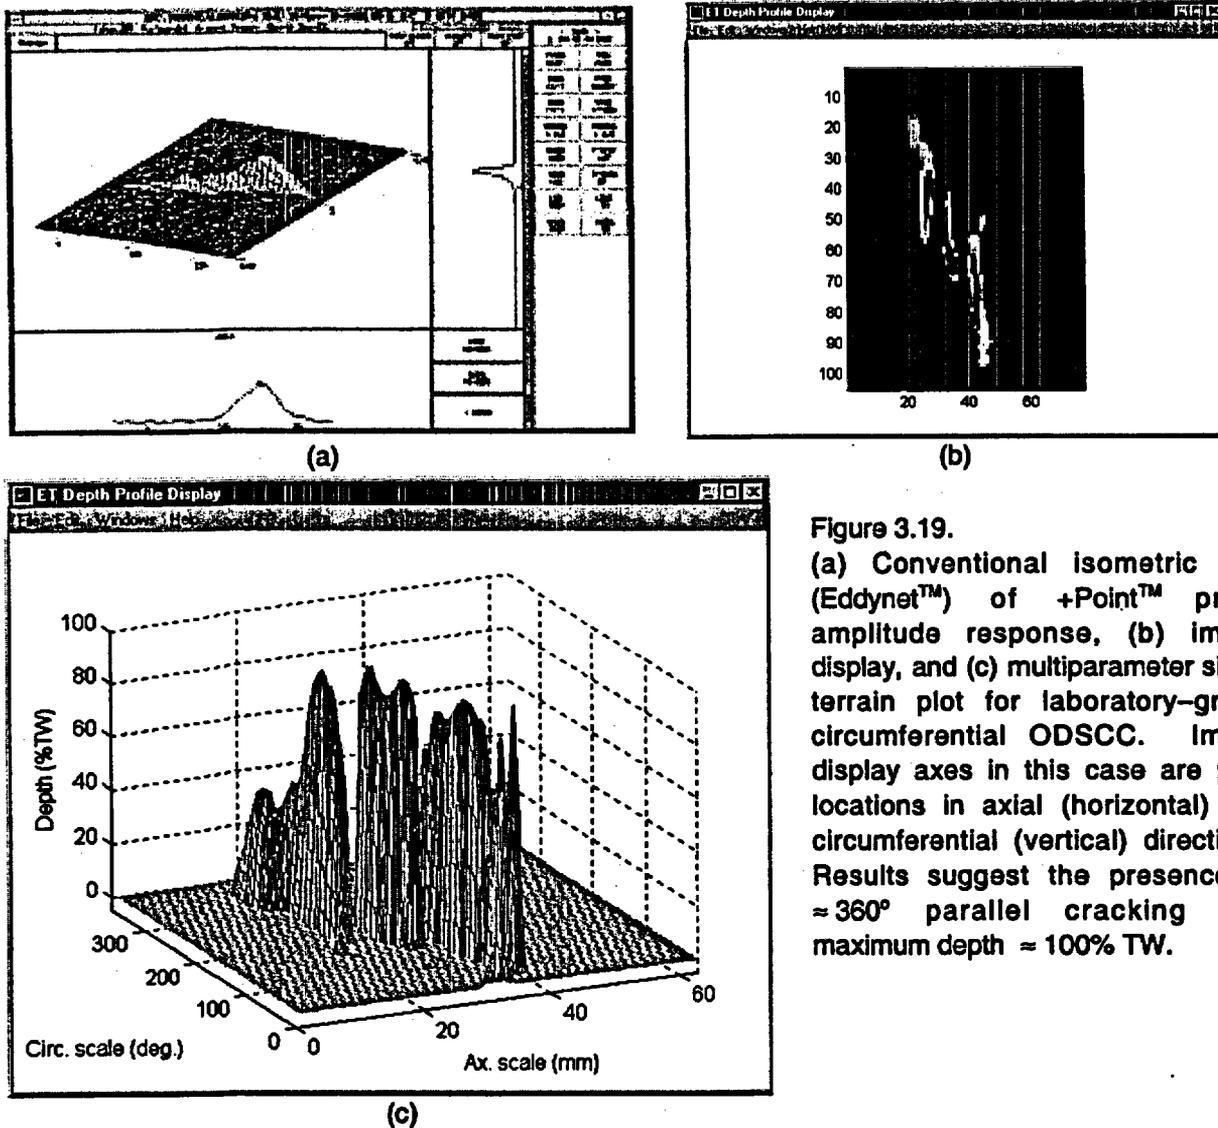
Figure 3.19. (a) Conventional isometric plot (EddyNet™) of +Point™ probe amplitude response, (b) image display, and (c) multiparameter sizing terrain plot for laboratory-grown circumferential ODSCC. Image display axes in this case are pixel locations in axial (horizontal) and circumferential (vertical) directions. Results suggest the presence of  $\approx 360^\circ$  parallel cracking with maximum depth  $\approx 100\%$  TW.

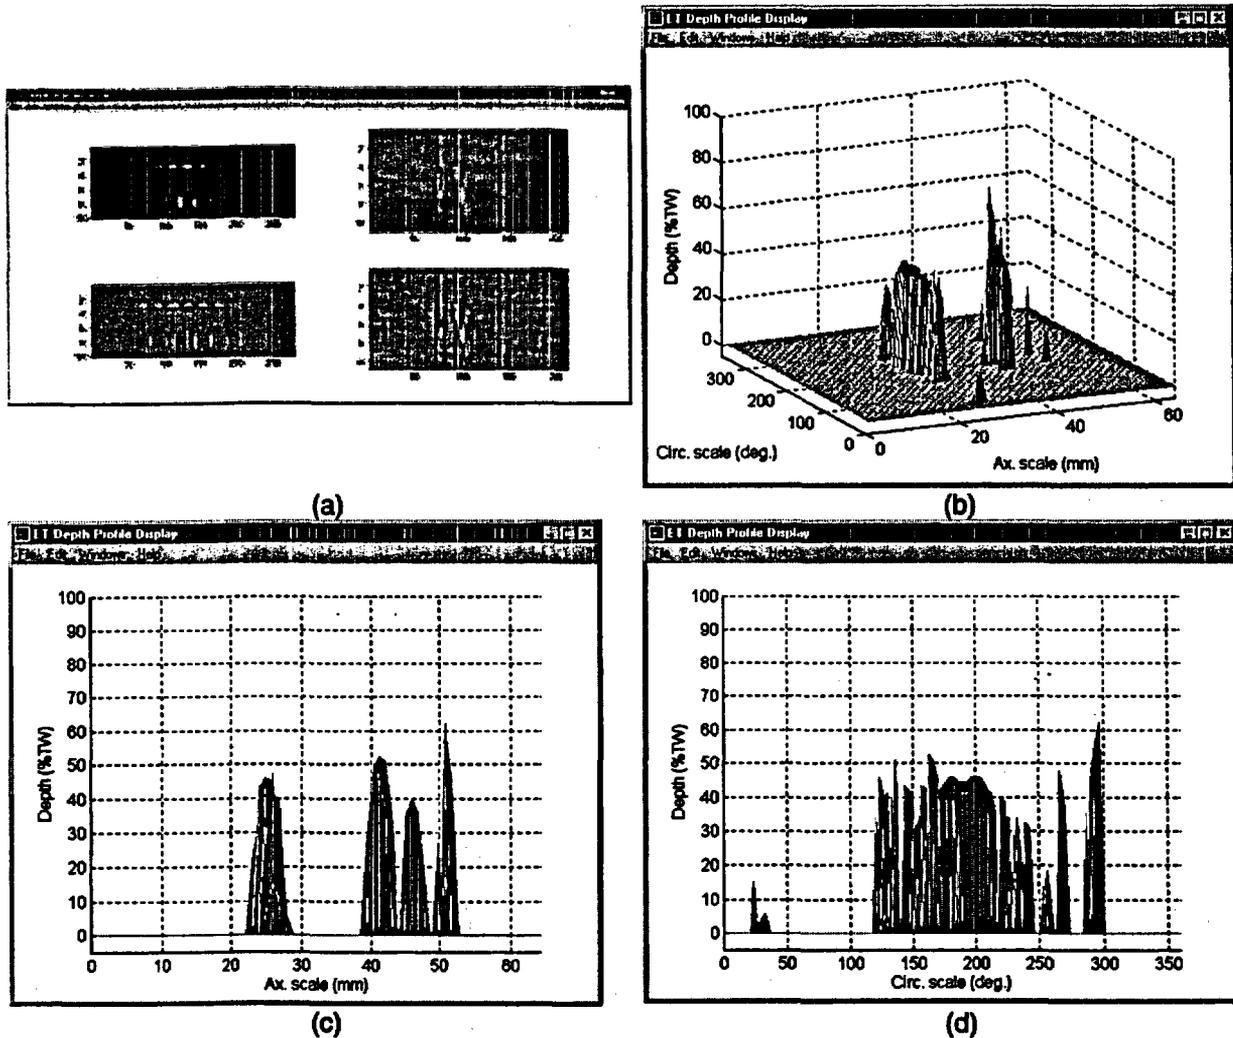
Figure 3.21. Representative display of data analysis results for specimen with laboratory-grown ODSCC degradation showing (a) image display, (b) terrain plot, (c) axial projection, and (d) circumferential projection. Results indicate multiple cracks at several axial locations around circumference, with maximum depth >60% TW.

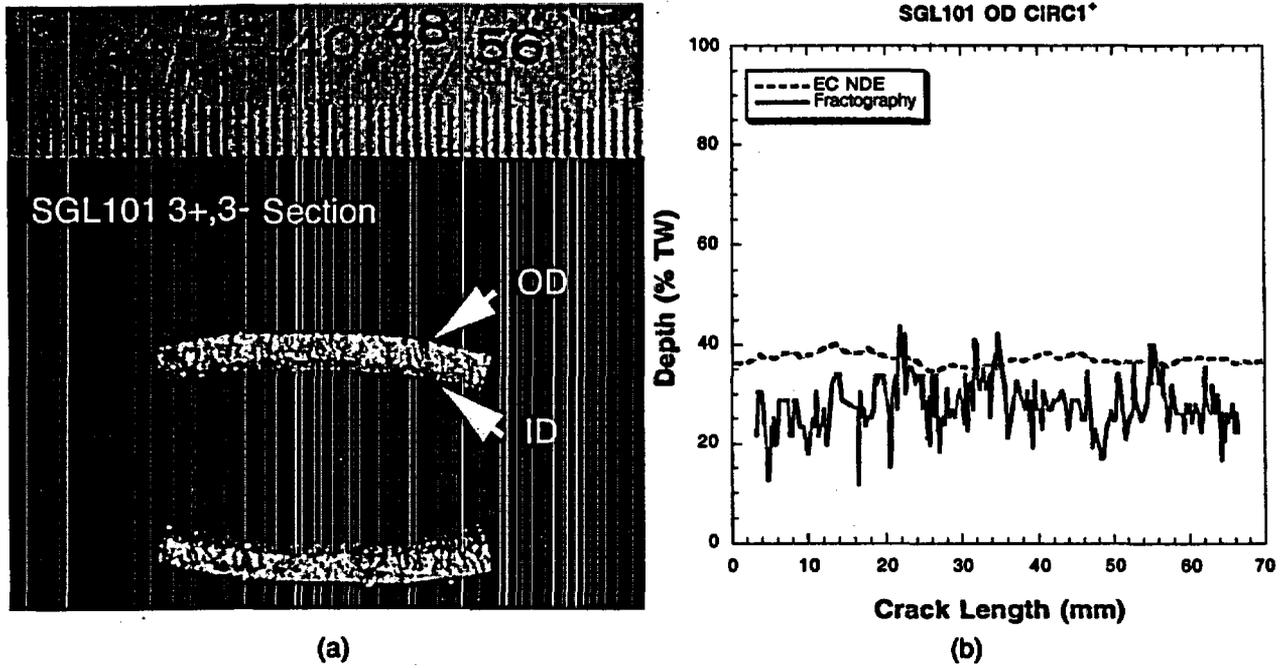
Figure 4.1. Fractography profile and NDE for circumferential IDSCC 1 in specimen SGL101.

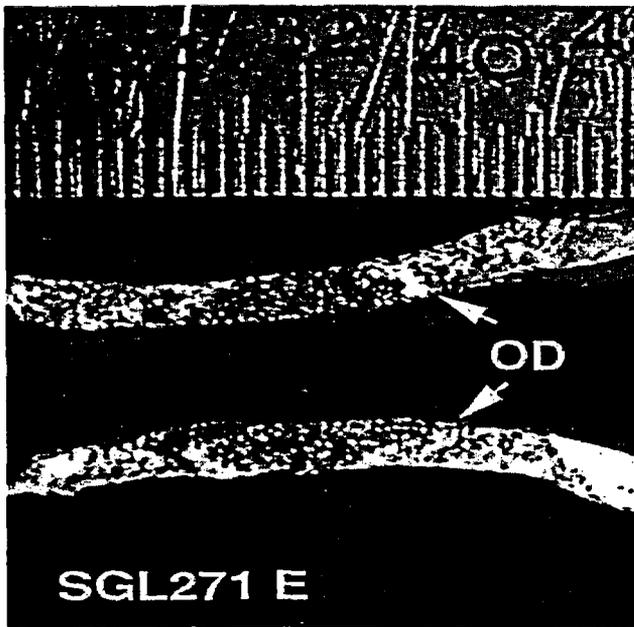
Figure 4.2. Fractography profile and NDE for circumferential IDSCC 2 in specimen SGL101.

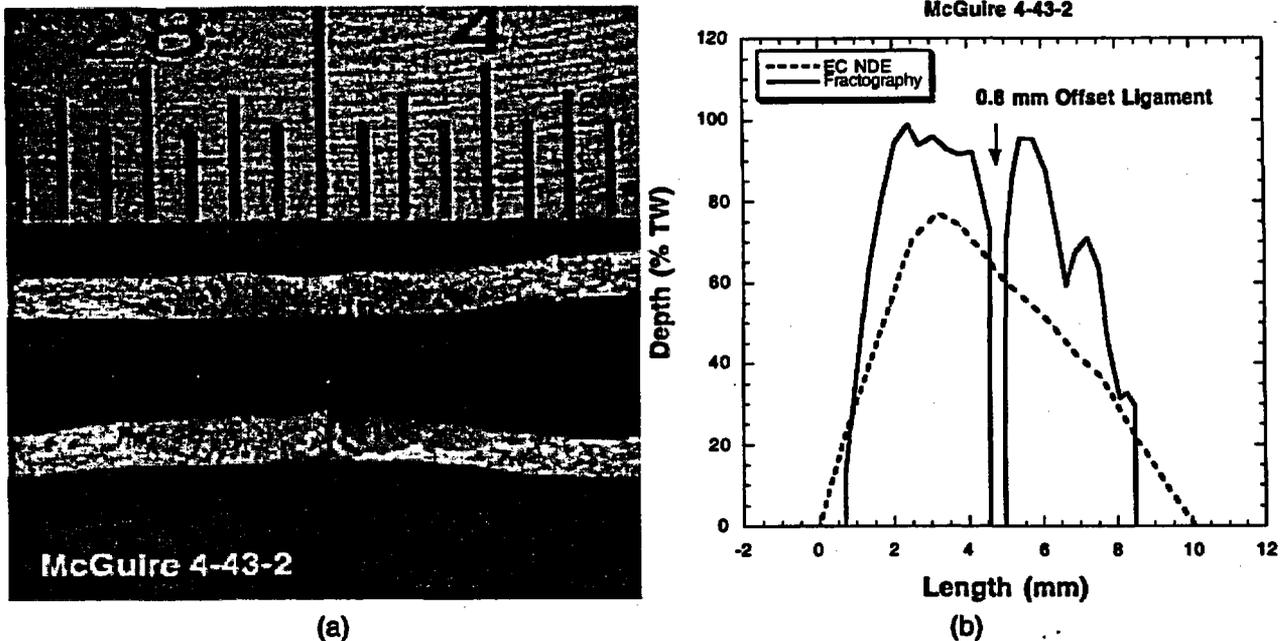
Figure 4.14. Fractography profile and NDE for axial ODSCC in McGuire tube specimen 4-43-2.

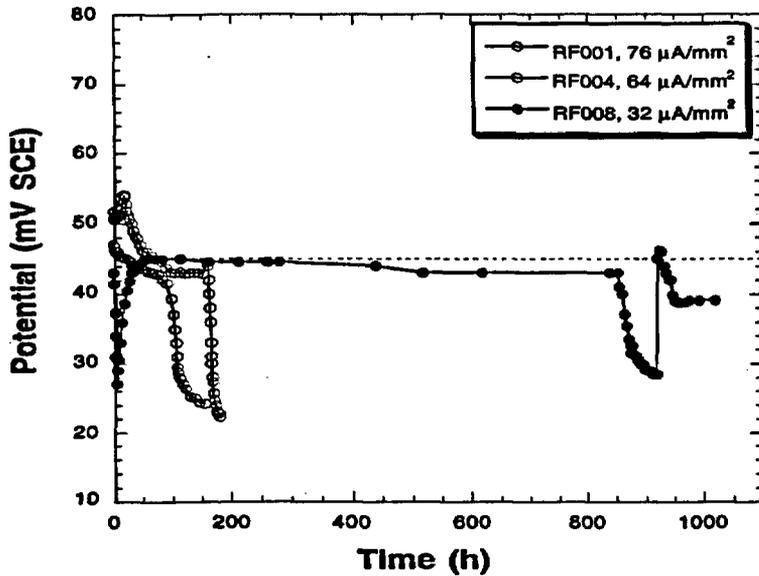
Figure 4.24. Accuracy and stability of Ag/AgCl reference electrodes that were manufactured with different oxidation current.

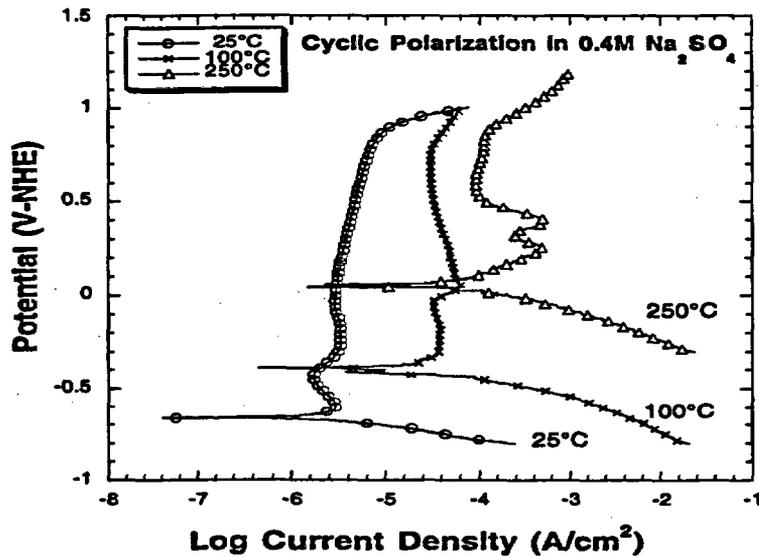
Figure 4.25. Electrochemical polarization curve for Alloy 600 specimen (Heat No. M81) in 0.4 M sodium sulfate aqueous solution at 25, 100, and 250°C.

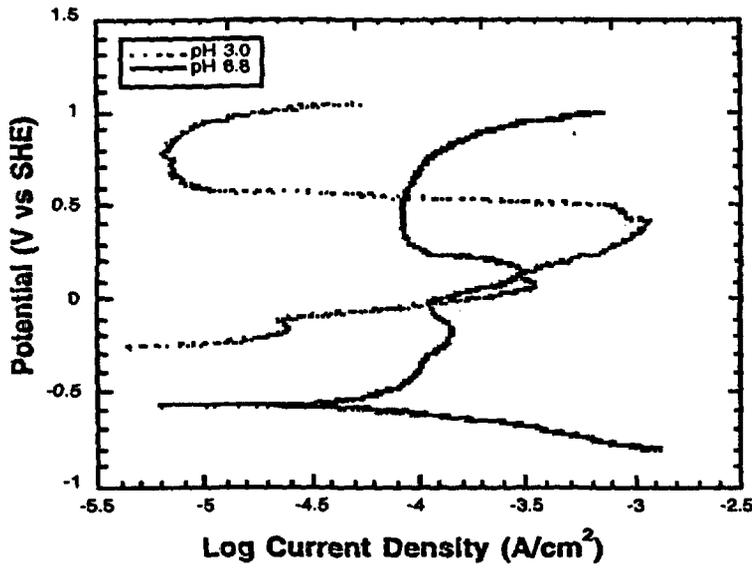
Figure 4.26.  
Anodic polarization of Alloy 600 (Heat 96834 M81 annealed at 926.7°C) in 0.4 M Na<sub>2</sub>SO<sub>4</sub> at pH 3.0 and pH 6.8.

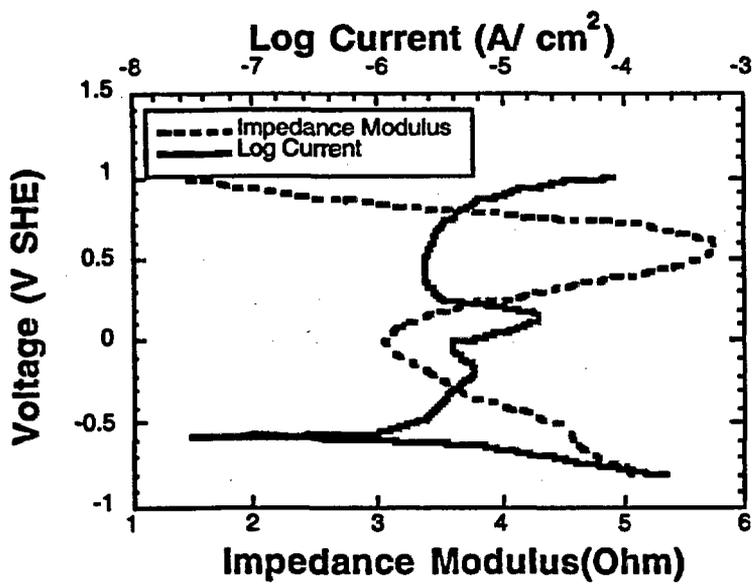
Figure 4.28.  
 Electrochemical impedance and current at 100 Hz for Alloy 600 (Heat 96834 M81 annealed at 926.7°C) in pH 6.8 and 0.4 M  $Na_2SO_4$  aqueous solution at room temperature.

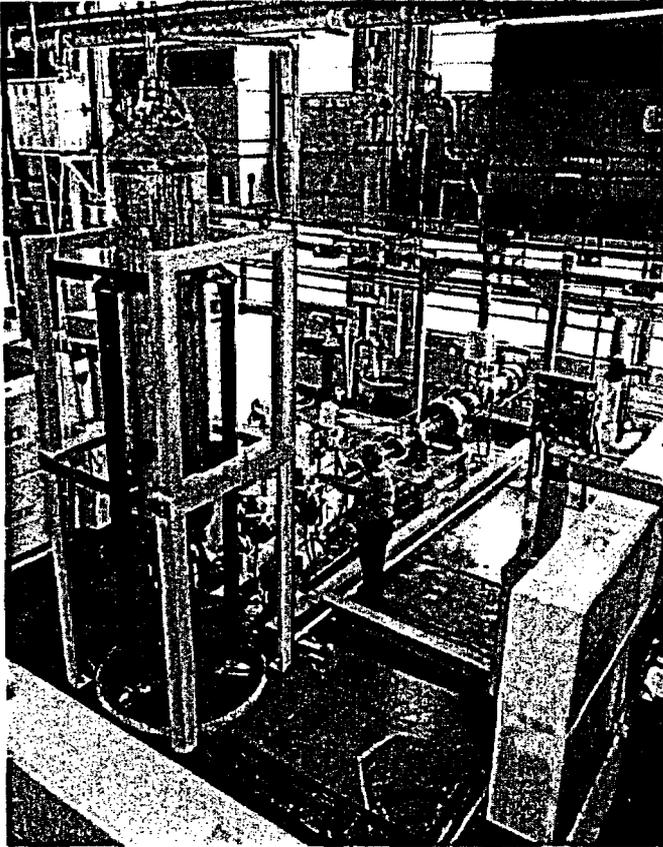
Figure 4.29  
ANL Pressure and Leak-Rate Test Facility.
