**Second U.S. Nuclear  
Regulatory Commission  
International Steam Generator  
Tube Integrity Research  
Program**

**Final Project Summary Report**

**Argonne National Laboratory**

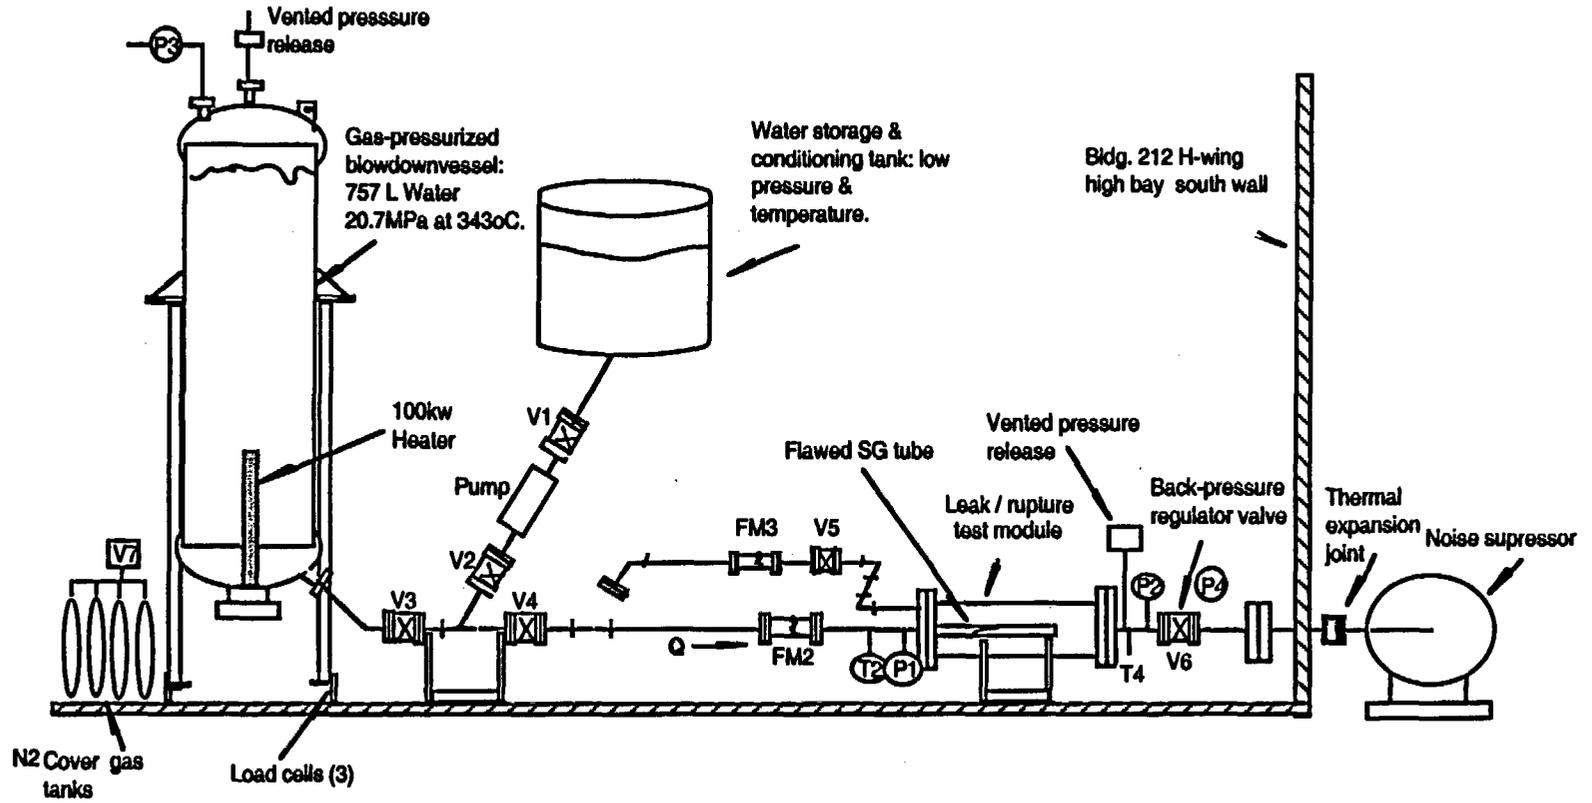
Figure 4.30. High-Temperature Pressure and Leak-Rate Test Facility.

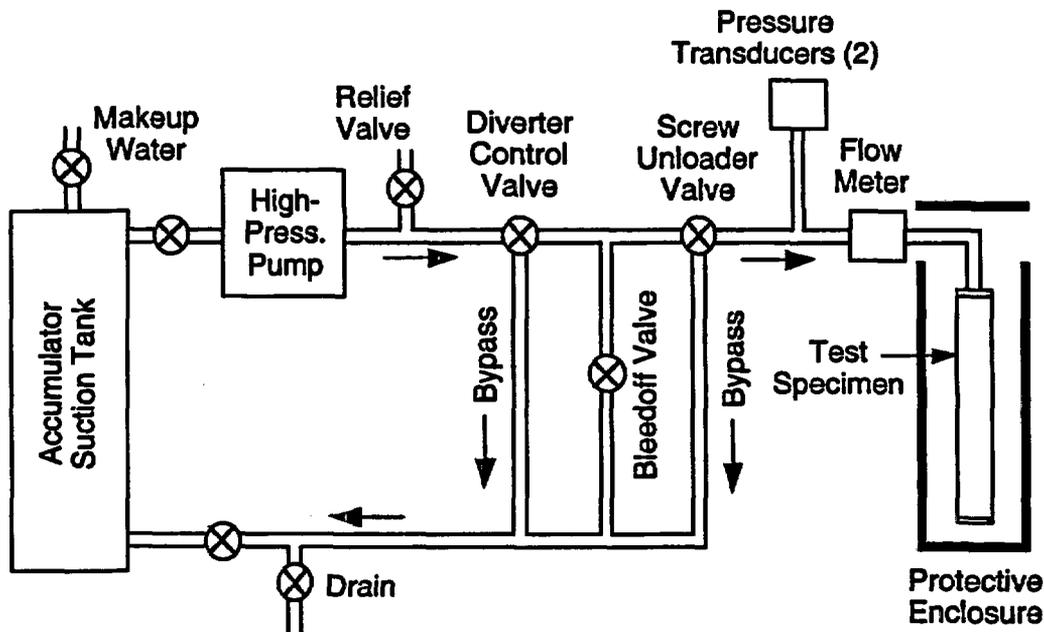
Figure 4.32. Schematic diagram of High-Pressure Test Facility pressurizer and associated components.

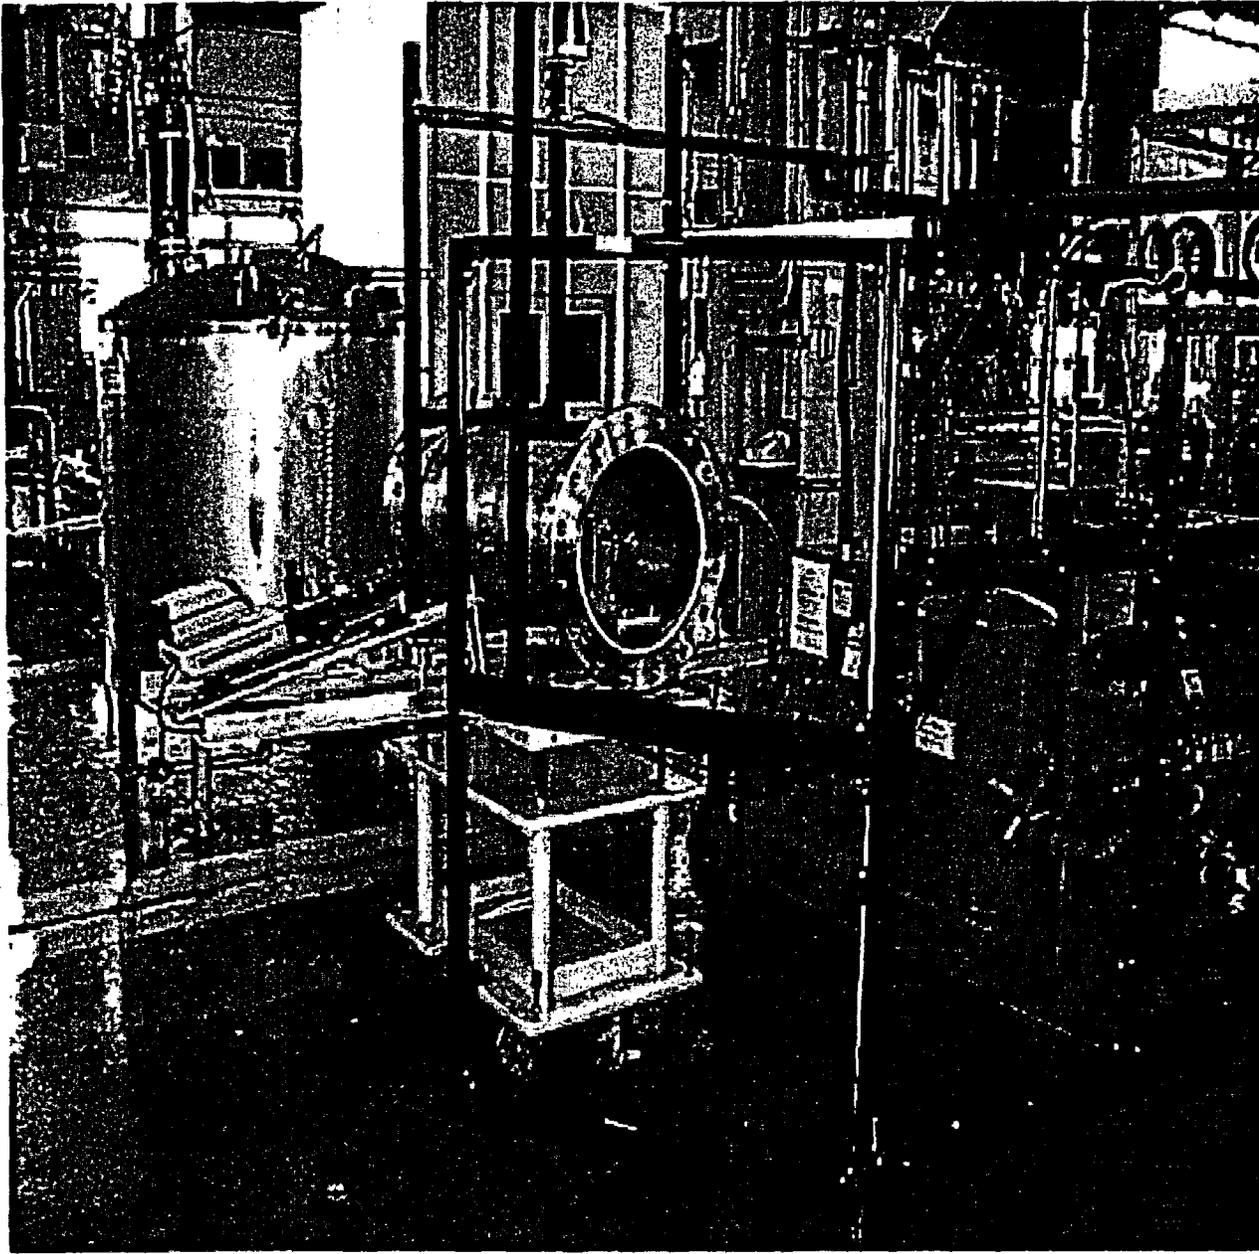
Figure 4.33 Overall view of major components of High-Pressure Test Facility. Visible are the water pump pressurizer, test module, tube support, video system, and 3000-L (800-gal) tank for conducting tests on field-pulled tubes. Also shown is Lexan™ personnel-protection barrier.

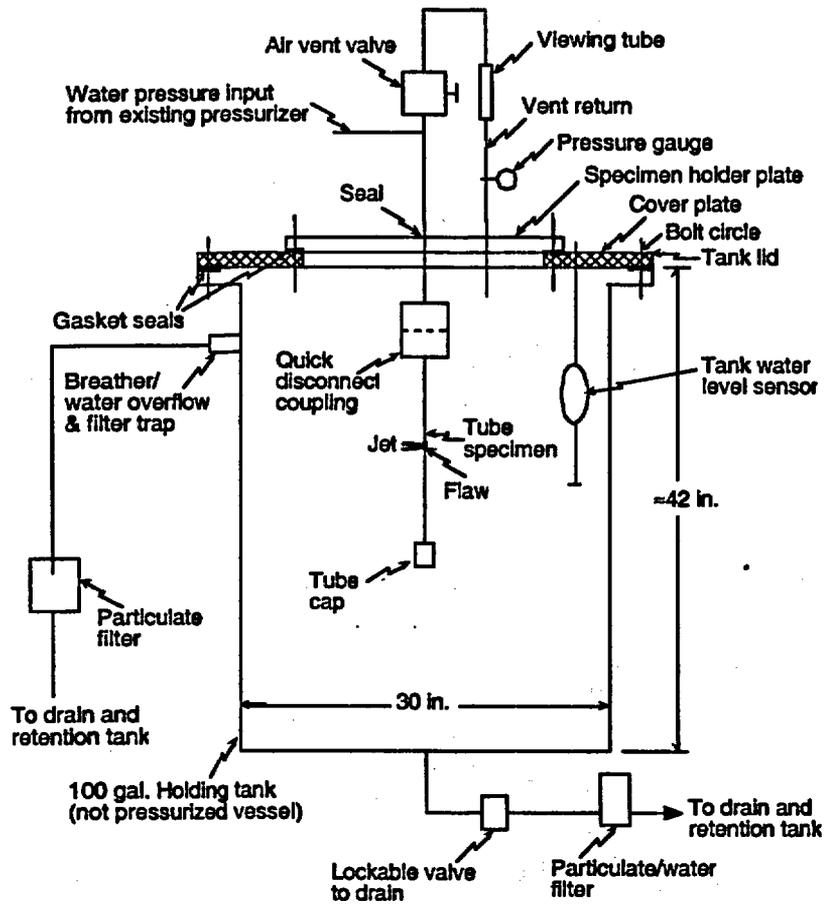
Figure 4.34. Containment module for testing radioactively-contaminated field-pulled tubes.

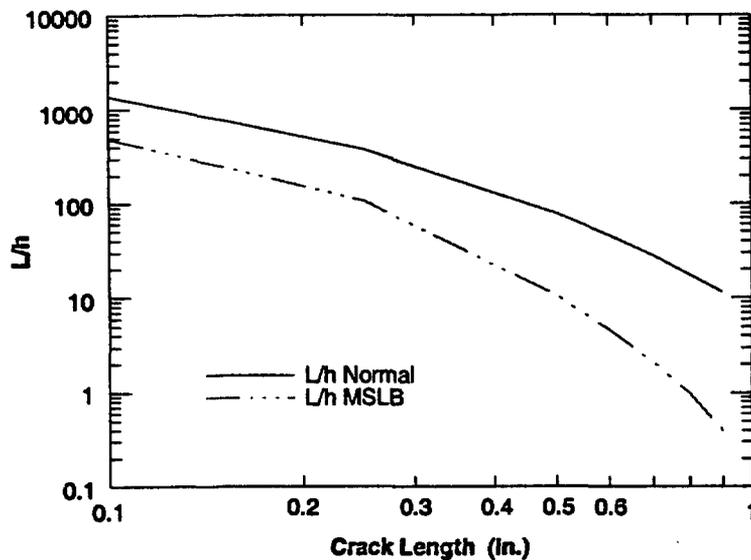
Figure 4.37. Variation of the ratio of flow path length to the crack opening width with crack length for normal operating and main steam line break conditions.

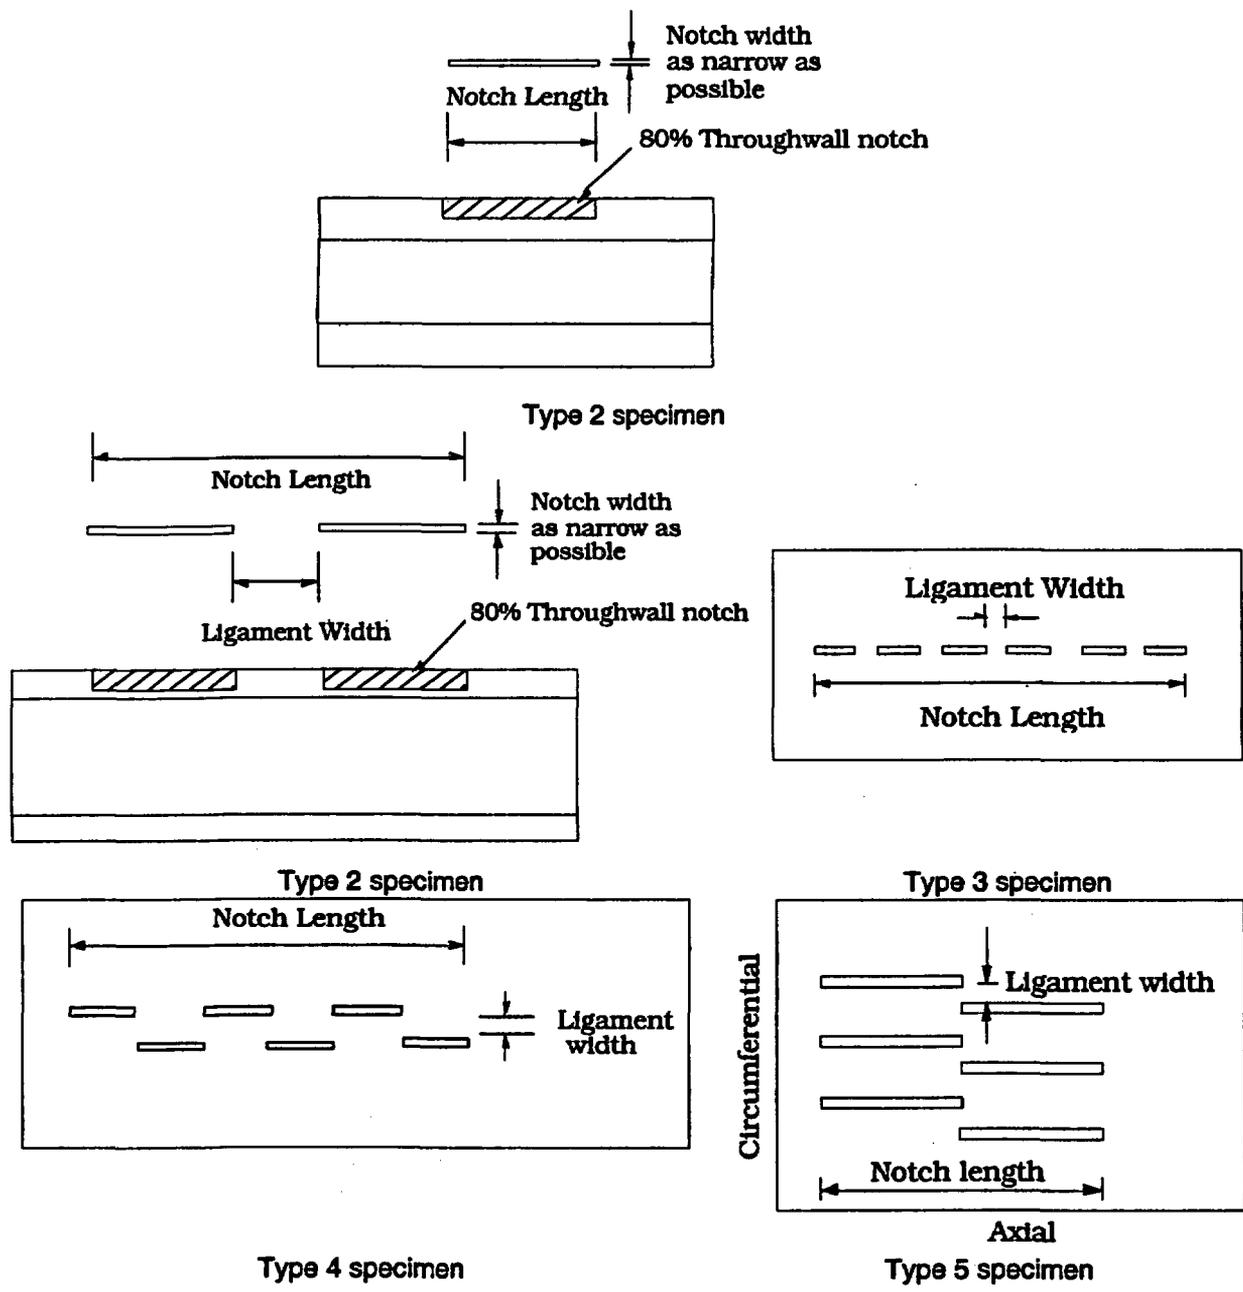
Figure 4.51. Configurations of notches in various types 1-5 of laser-cut tube specimens.

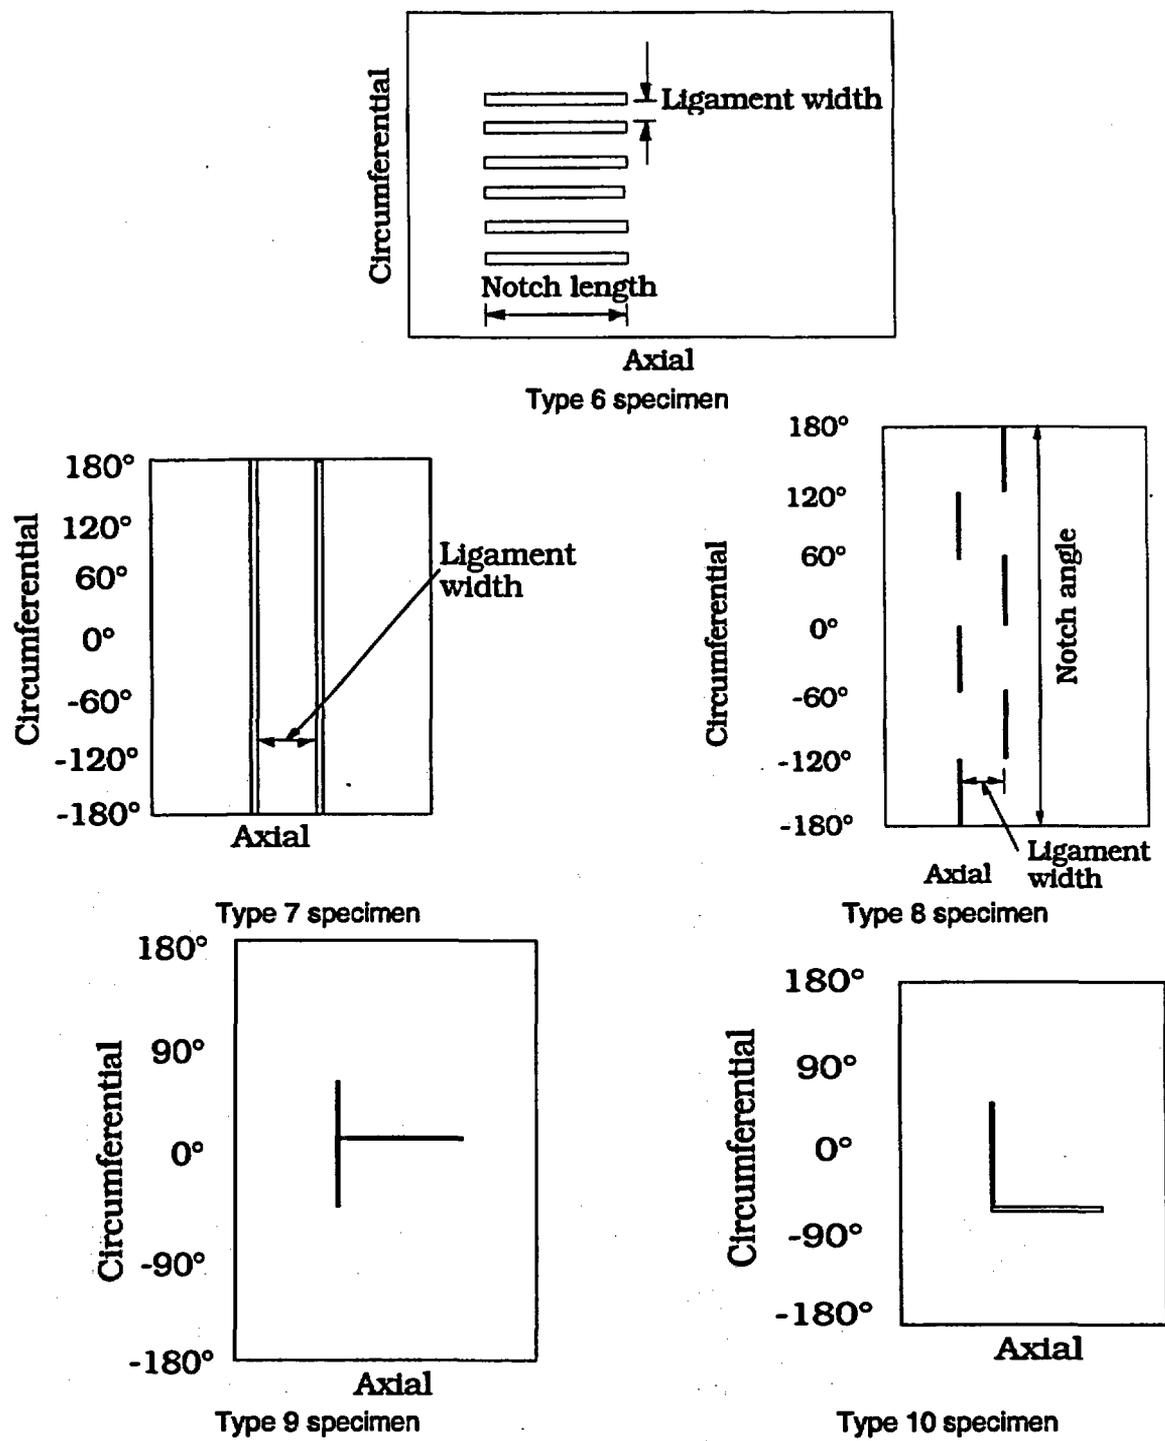
Figure 4.52. Configurations of notches in various types 6-10 of laser-cut tube specimens.

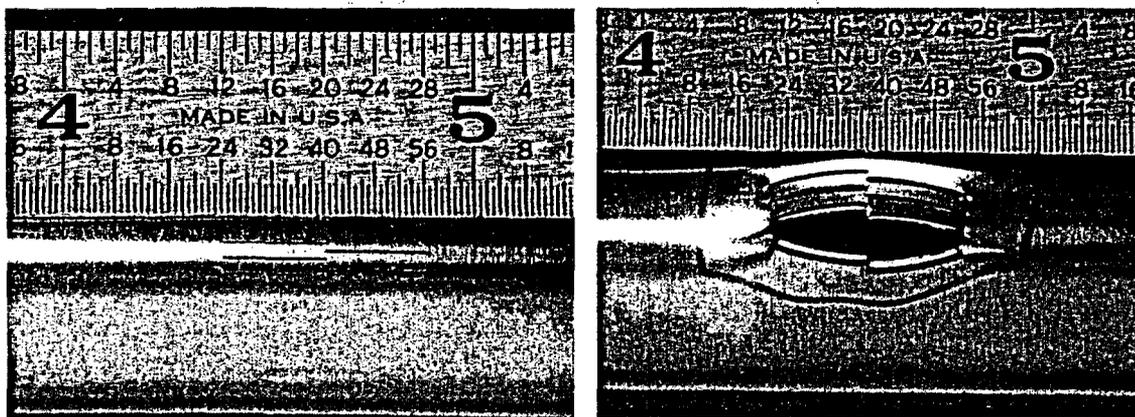
Figure 4.56. Appearance of Specimen 5469-2-4 with Type 5 flaw before (left) and after (right) Stage 1 testing.

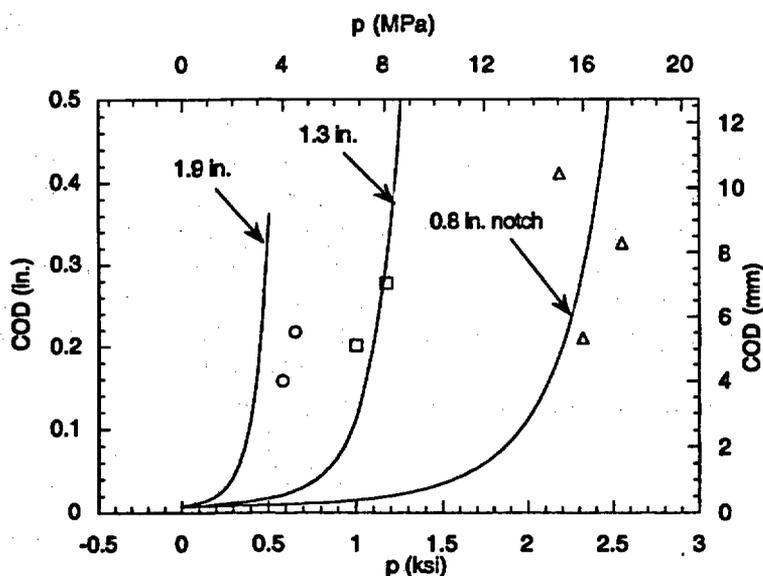
Figure 4.57. Calculated variations of crack opening displacements with pressure. Symbols denote measured COD values after the tests.

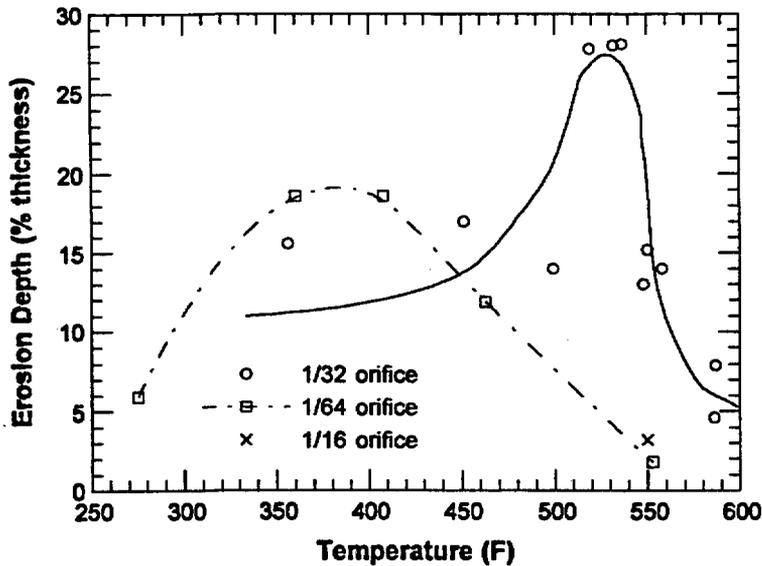
Figure 4.69. Jet erosion penetration depth as a function of water temperature for 0.40- (triangles), 0.79- (circles), and 1.59-mm (cross) ( $1/64$ -,  $1/32$ -, and  $1/16$ -in.)-diameter EDM holes. For all tests, the tube internal pressure was 16.8 MPa (2432 psig) with zero back pressure. Most tests were 123-min duration.

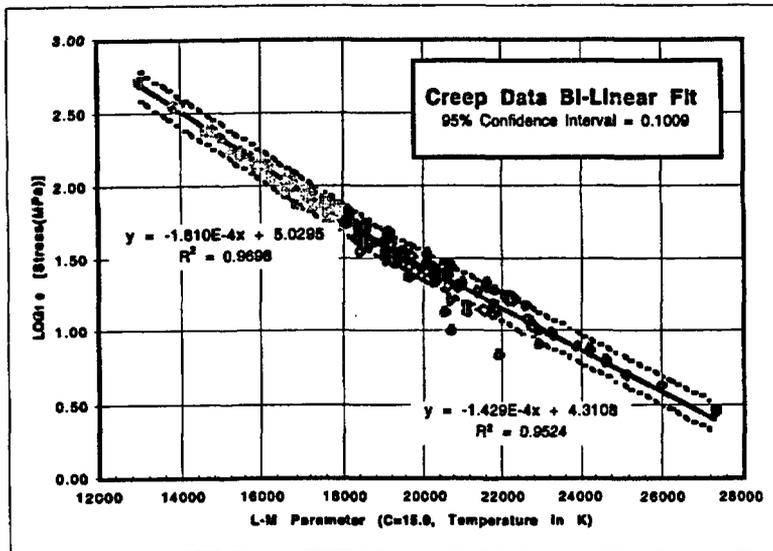
Figure 4.71. Bilinear fit to existing creep data for Alloy 600. The three low outliers were not included in the statistical analysis.

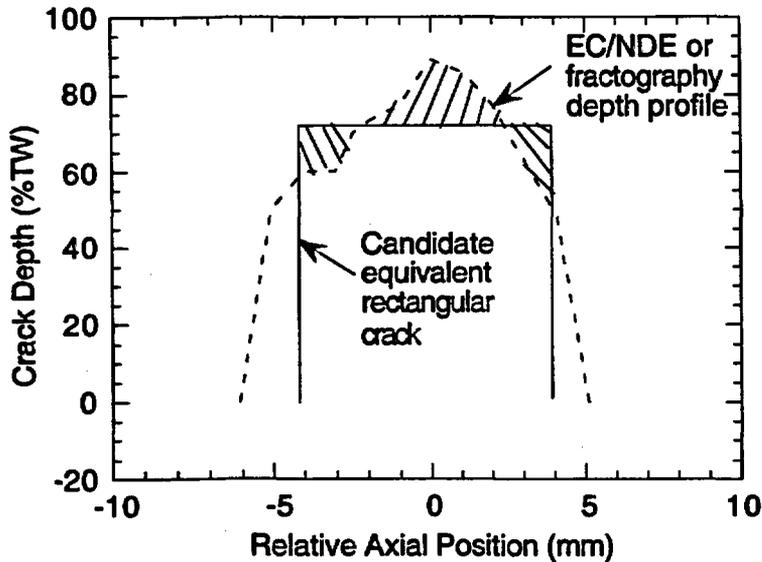
Figure 4.74.  
Determination of equivalent rectangular crack.

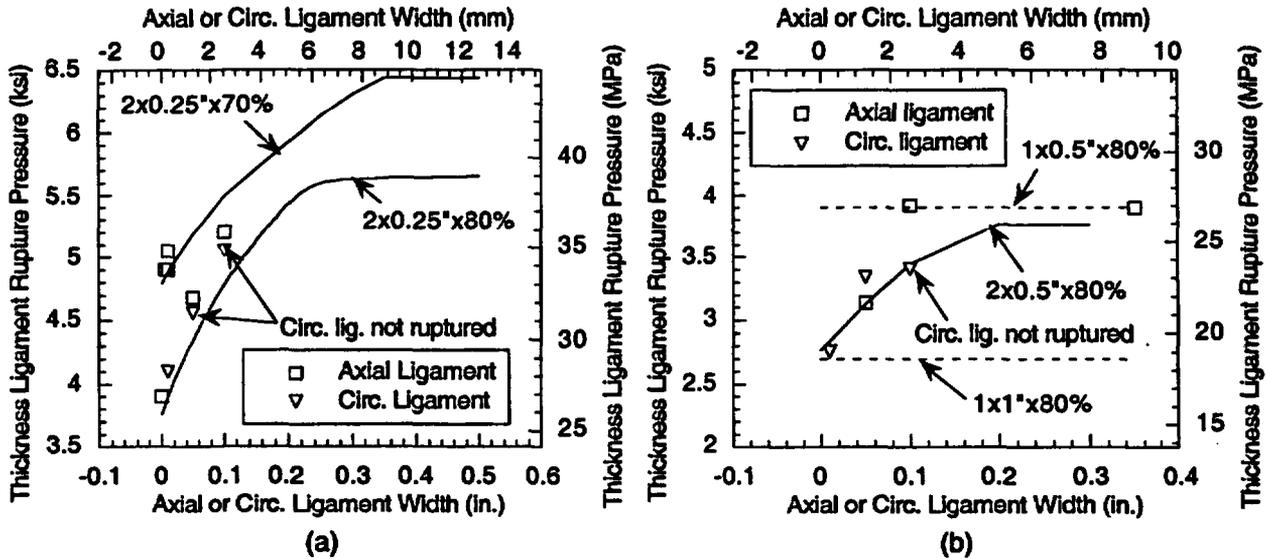
Figure 4.75. Predicted and observed rupture pressures for through-thickness ligaments as a function of axial or circumferential ligament widths for two part-throughwall EDM notches 6-mm (0.25-in.) and 13-mm (0.5-in.) long.

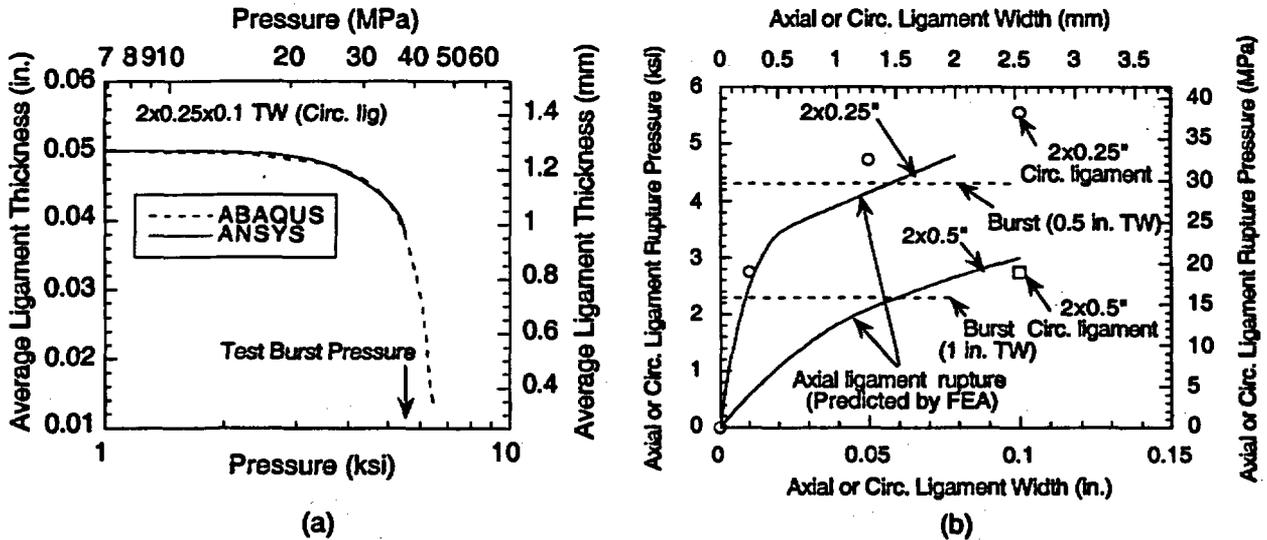
Figure 4.76. Variation of average ligament thickness with pressure for two 6-mm (0.25-in.)-long, 100% throughwall notches separated by 1.3-mm (0.05-in.)-wide ligament and variation of ligament rupture pressure with ligament width for two 13-mm (0.5-in.)-long and two 6-mm (0.25-in.)-long, 100% throughwall notches.

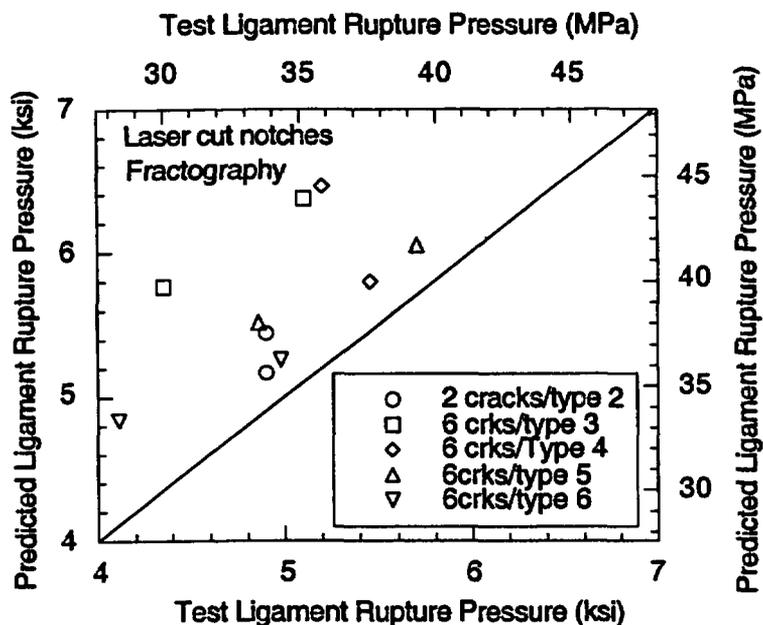
Figure 4.78. Observed vs. predicted ligament rupture pressures for multiple laser-cut notches.

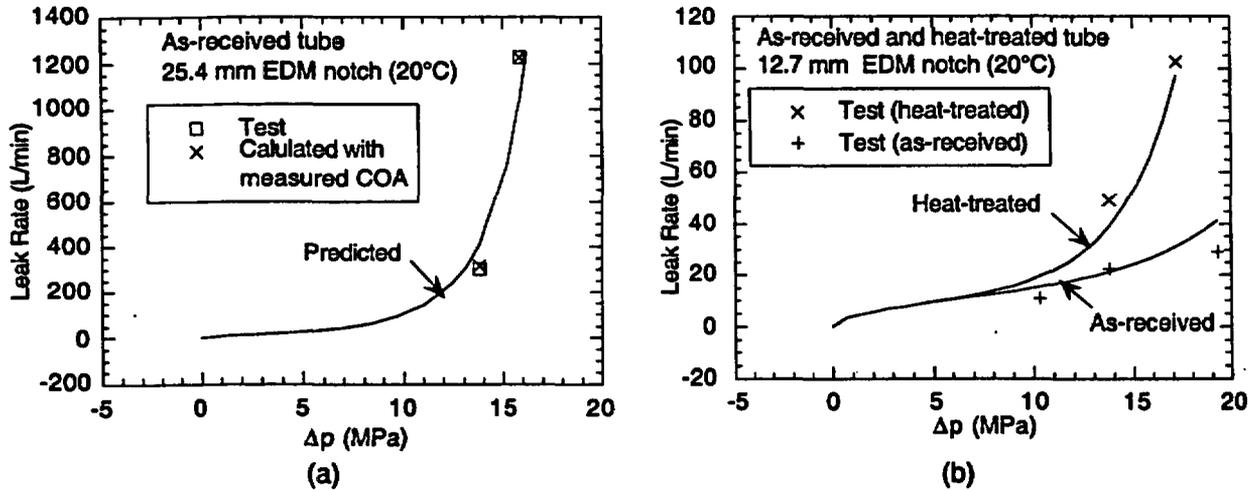
Figure 4.79. Calculated (solid line) and experimentally measured (symbols) leak rates at 20°C (68°F) for as-received and heat-treated 22-mm (0.875-in.)-diameter tubes with (a) 25.4 mm (1 in.) and (b) 12.7-mm (0.5-in.) throughwall axial EDM notches. Cross symbols (x) in Fig. 4.79a denote calculated leak rates using posttest measured crack opening areas.

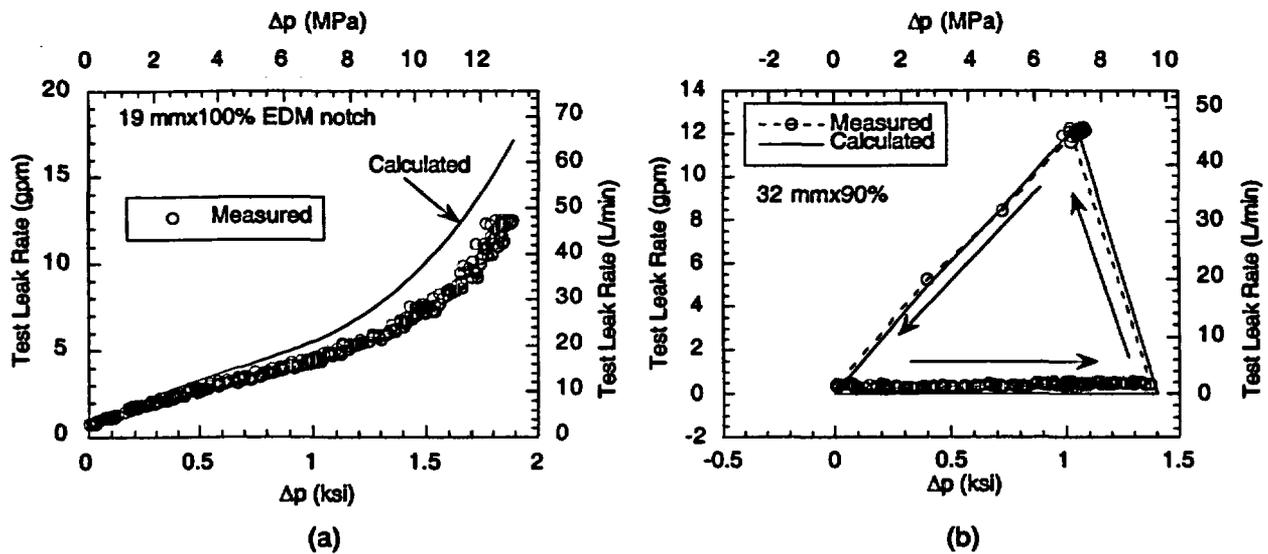
Figure 4.80. Calculated and measured pressure vs. leak rate plots for tests (a) OM169 (100% TW) and (b) OM171 (90% TW), both conducted on as-received tubes at 20°C.

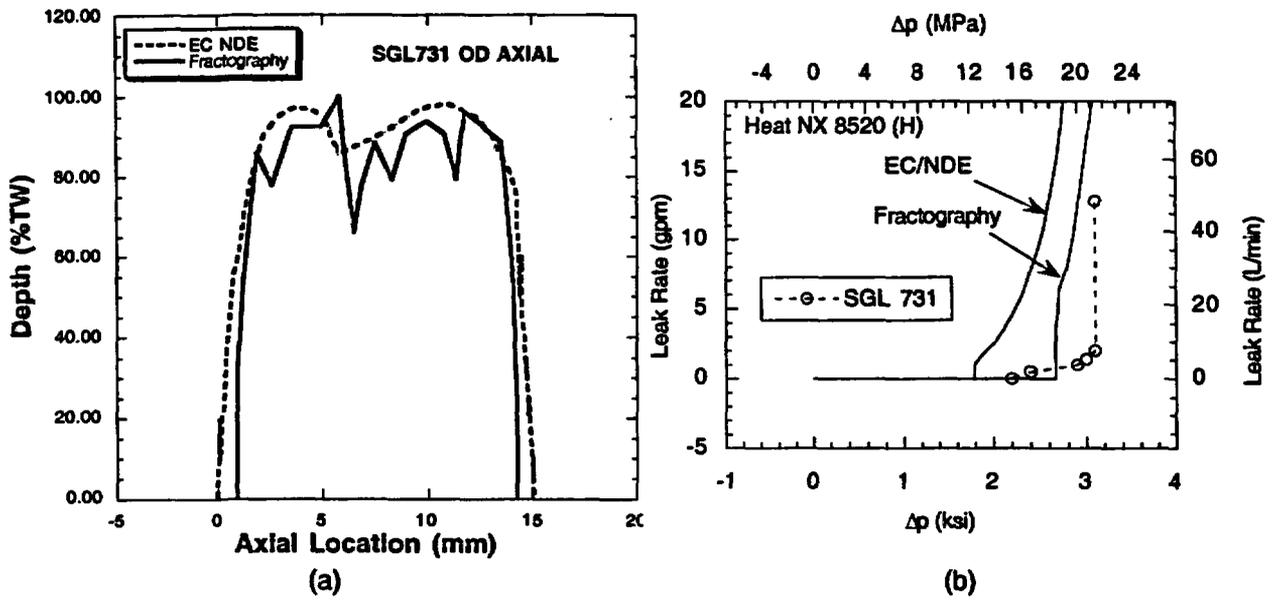
Figure 4.84. (a) Crack depth profiles (by EC/NDE and fractography) and (b) predicted and measured pressure vs. leak rate plots of Specimen SGL-731.

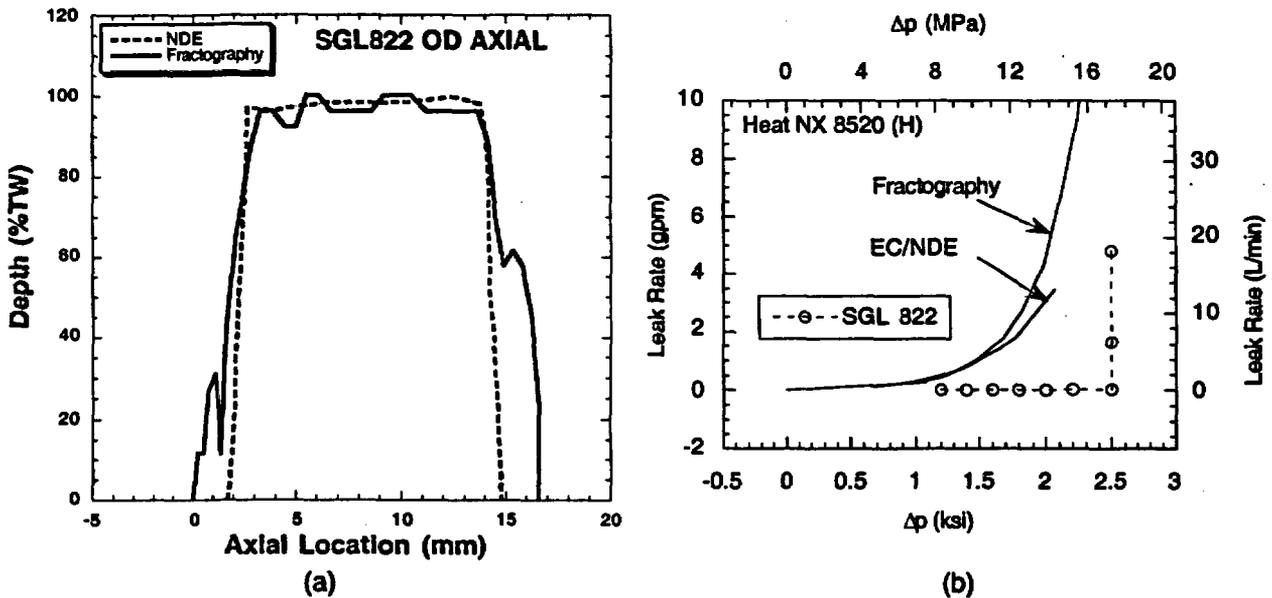
Figure 4.85. (a) Crack depth profiles (by EC/NDE and fractography) and (b) predicted and measured pressure vs. leak rate plots for Specimen SGL-822.

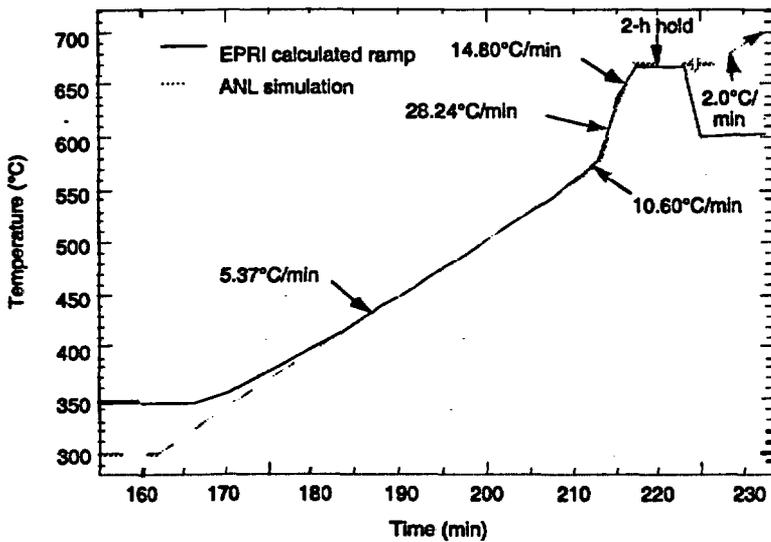
Figure 4.87, EPRI-calculated severe-accident temperature ramp and simulation used in ANL severe-accident tube-rupture tests. In the ANL simulation, the temperature is held constant at 670°C (1240°F) after ~217 min rather than following the subsequent drop shown in the calculated curve.

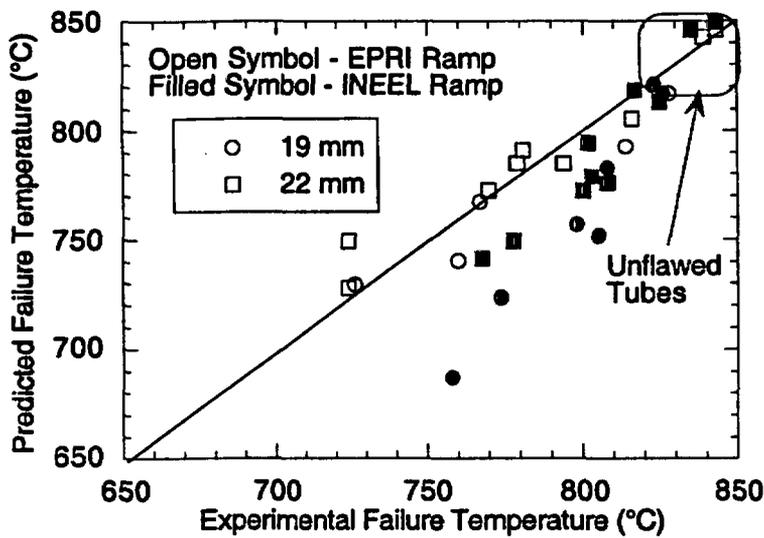
Figure 4.89. Flow-stress-model predicted vs. observed failure temperatures for high-temperature failure tests conducted with the INEEL and EPRI temperature ramps.

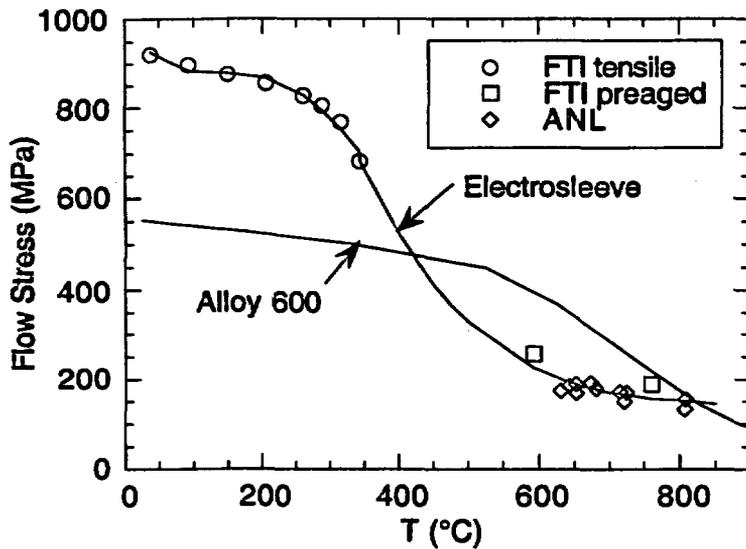
Figure 4.90. Flow stresses of Alloy 600 and Electrosleeve material as a function of temperature.

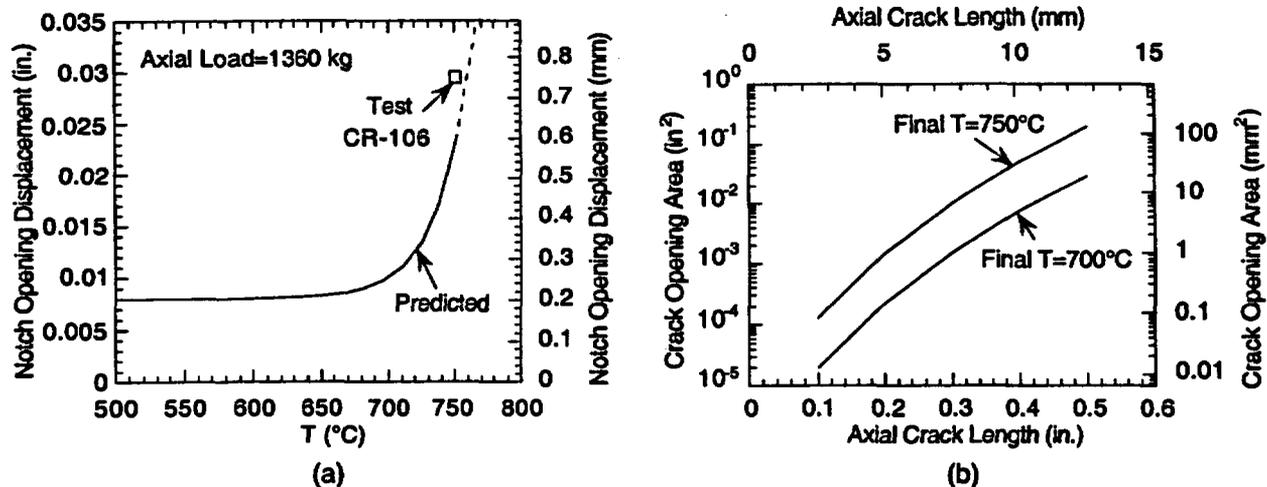
Figure 4.95. Predicted and experimentally measured (symbol) notch opening displacement for two 6.4-mm (0.253-in.) circumferential notches loaded axially and subjected to the Case 6RU (Fig. 4.92) temperature transient and predicted crack-opening area with crack length at final temperatures 700 and 750°C (1292 and 1382°F) for a tube subjected to Case 6RU transient.

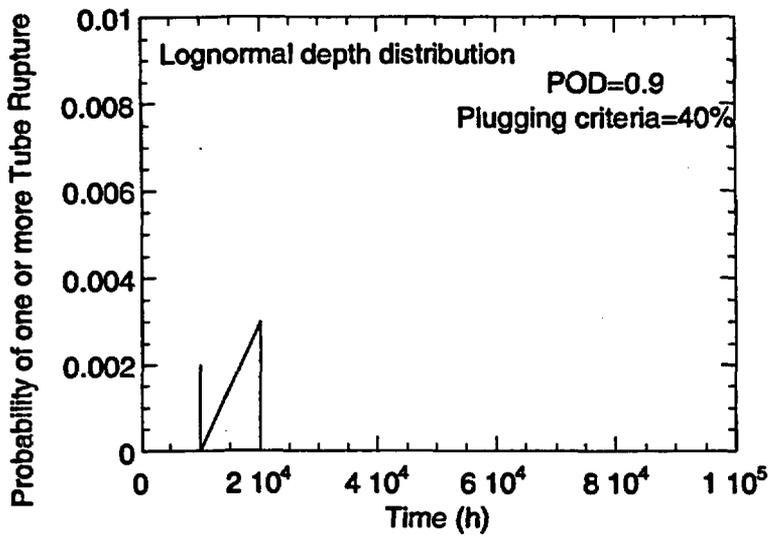
Figure 5.1. Variation of probability of burst of one or more tubes with time for initial residual stress = 30 ksi, POD = 0.9, and inspection interval of 10,000 h.

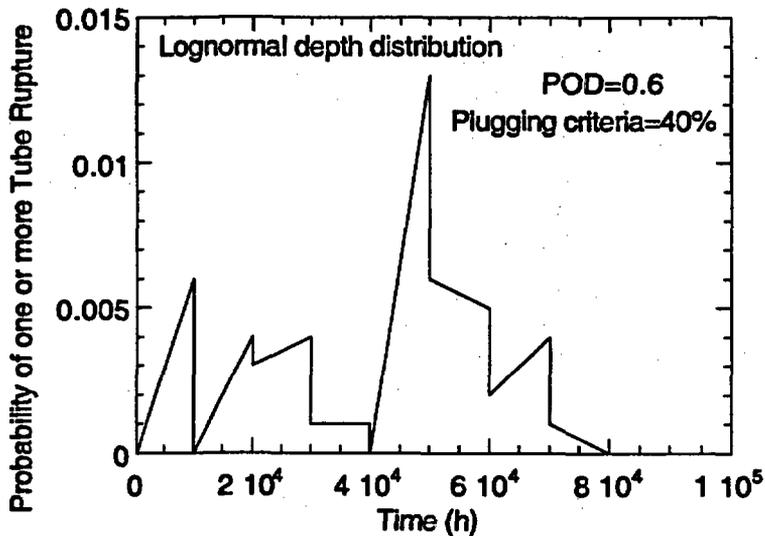
Figure 5.3. Variation of probability of burst of one or more tubes with time for initial residual stress = 30 ksi, POD = 0.6, and inspection interval of 10,000 h.

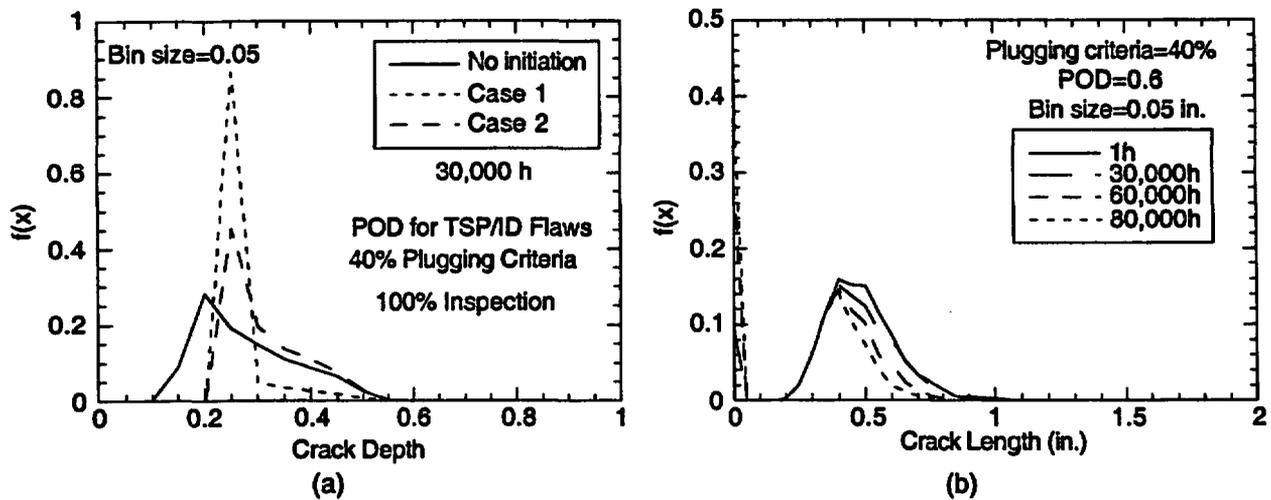
Figure 5.4. Variation of the distribution of (a) crack depth and (b) crack length with time for initial residual stress of 30 ksi and POD = 0.6.

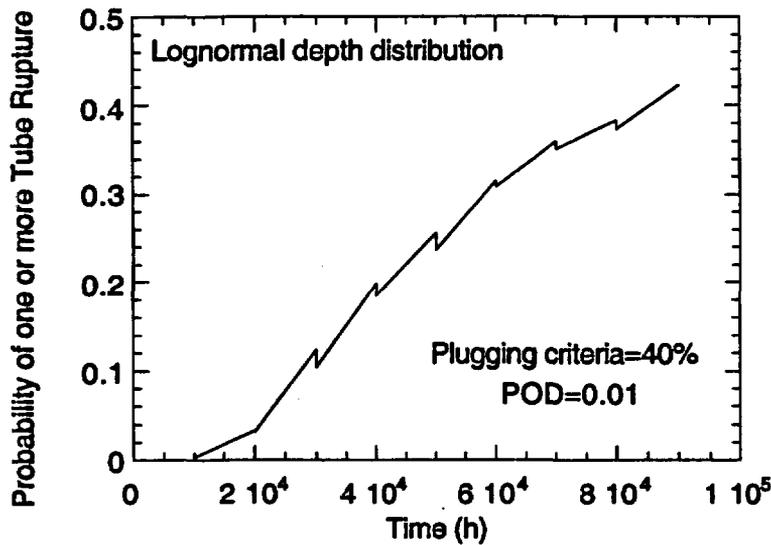
Figure 5.5. Variation of probability of burst of one or more tubes with time for initial residual stress = 30 ksi, POD = 0.01, and inspection interval of 10,000 h.

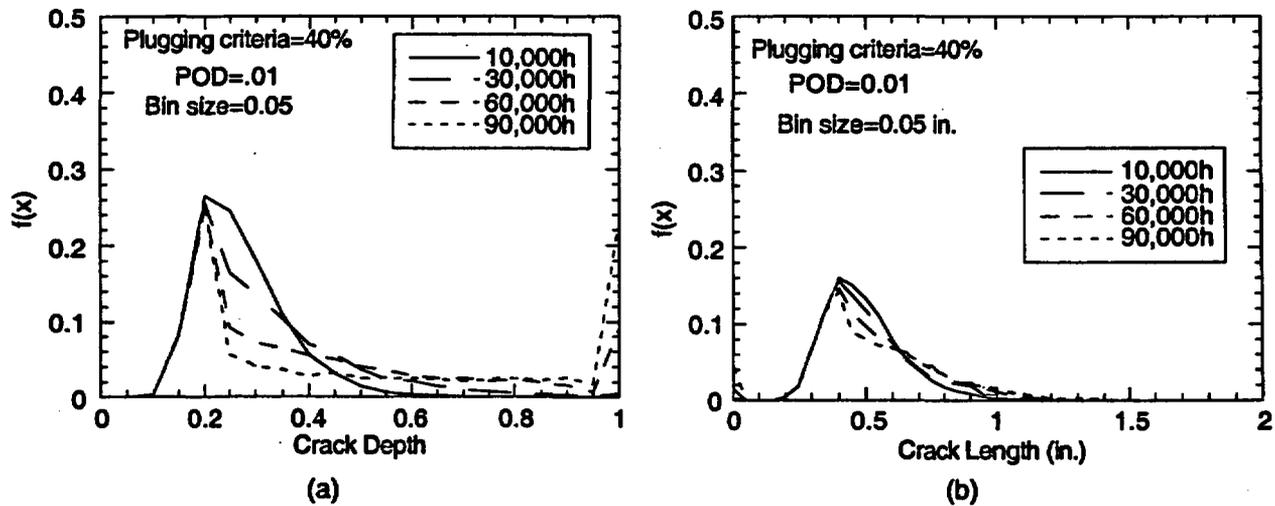
Figure 5.6. Variation of the distribution of (a) crack depth and (b) crack length with time for initial residual stress of 30 ksi and POD = 0.01.

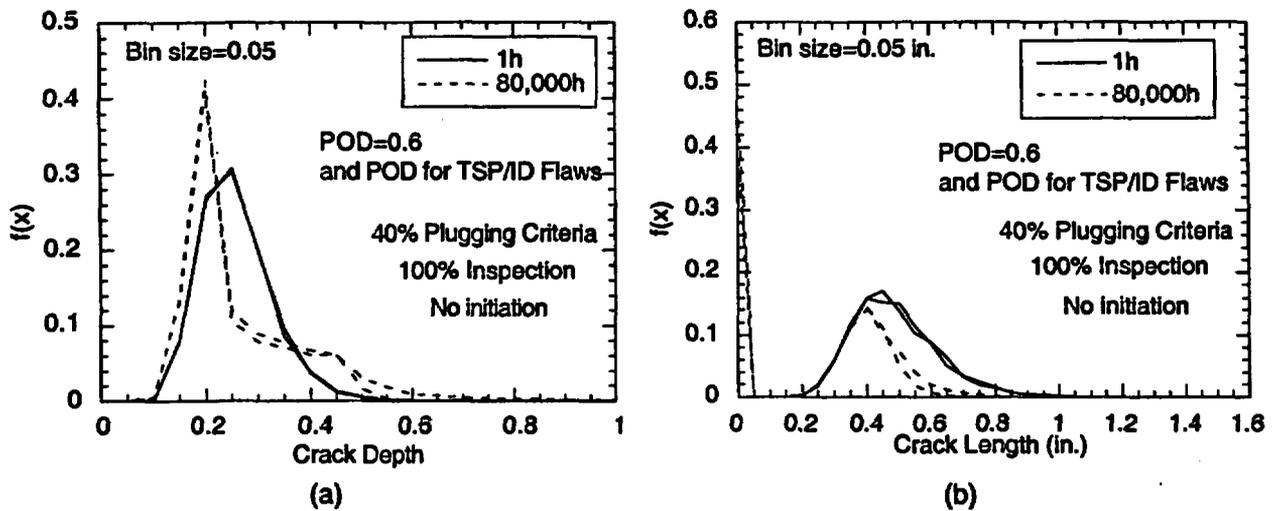
Figure 5.7. Variation of the distribution of (a) crack depth (bin size = 0.05) and (b) crack length (bin size = 0.05 in.) with time using POD curve for TSP ID flaws and a constant POD = 0.6. Initial residual stress is 20.7 MPa (30 ksi).

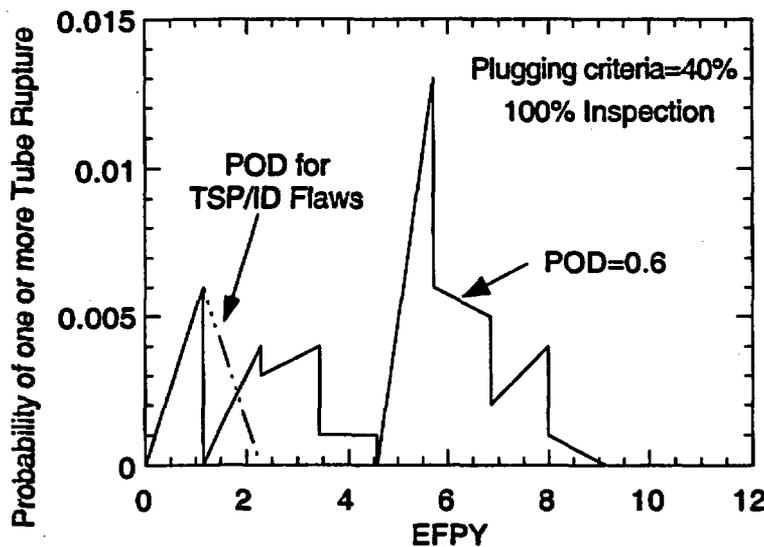
Figure 5.8. Variation of probability of rupture of one or more tubes with time in effective full power years (EFPY) for a constant POD = 0.6 and a POD curve for TSP/ID flaws. No new flaw initiation was assumed.

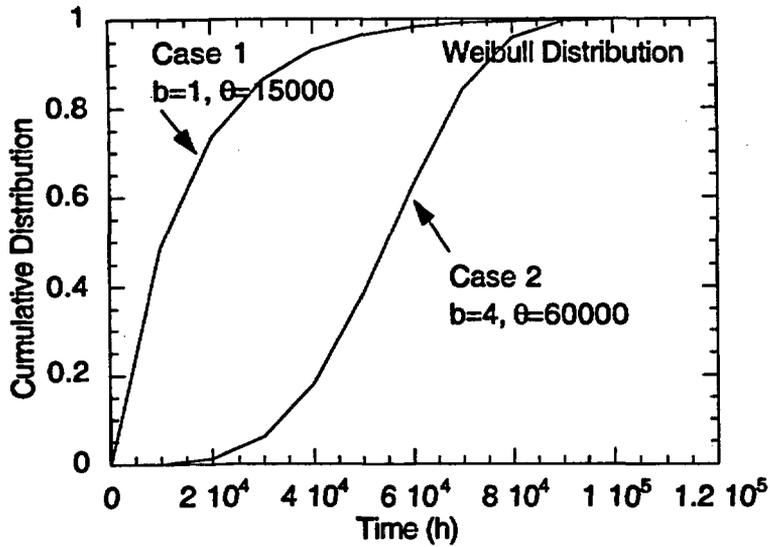
Figure 5.9. Two cases of cumulative Weibull distributions assumed for crack initiation times.

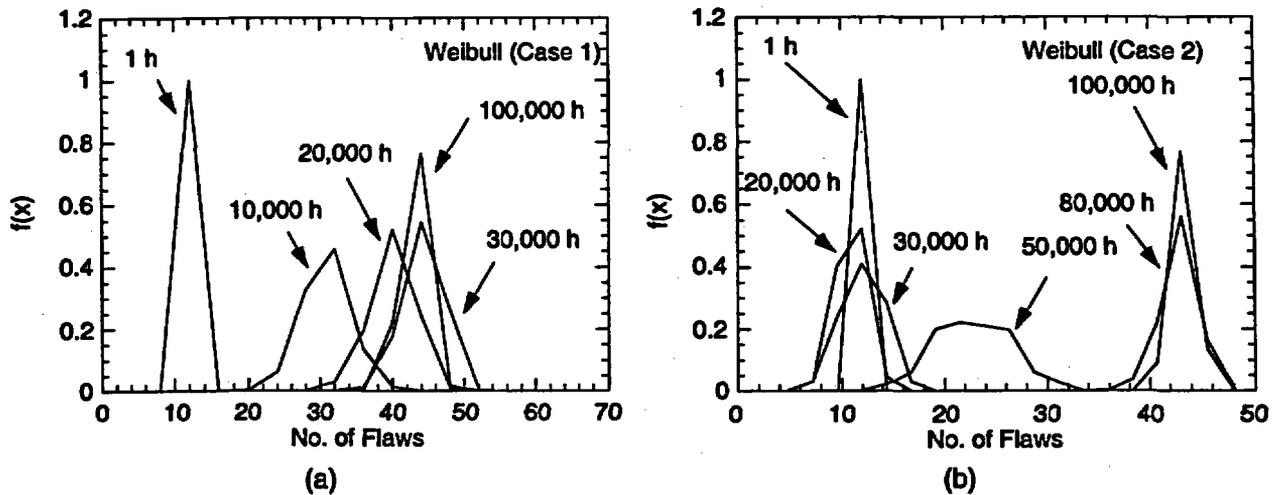
Figure 5.10. Evolution of the distribution for the number of flaws with time for Weibull initiation (a) Case 1 and (b) Case 2.
