**Second U.S. Nuclear  
Regulatory Commission  
International Steam Generator  
Tube Integrity Research  
Program**

**Final Project Summary Report**

**Argonne National Laboratory**

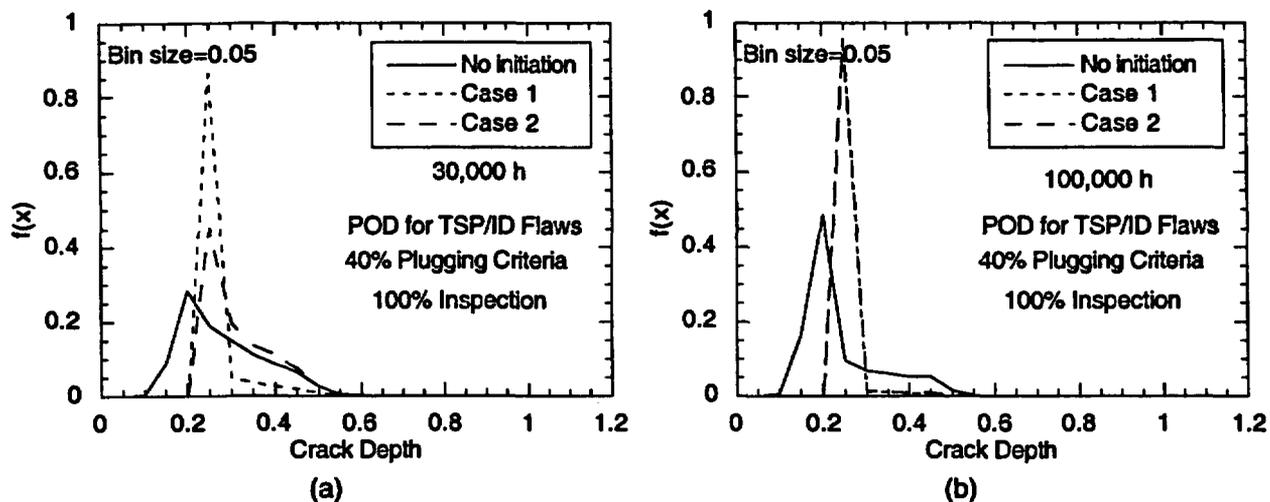
Figure 5.11. Distributions of crack depth calculated without initiation and with Weibull initiation Case 1 and Case 2 at (a) 30,000 and (b) 100,000 h.
