Traveller Safety Analysis Report**2.12.3 DROP ANALYSIS FOR THE TRAVELLER XL SHIPPING PACKAGE**

2.12.3.1 Analysis Results

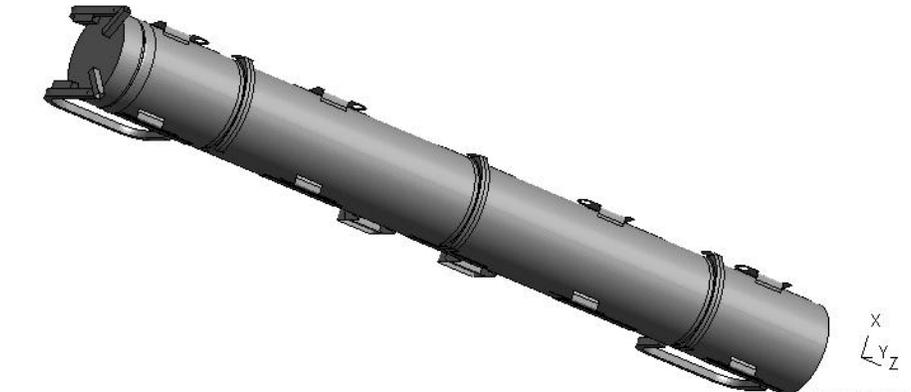
Figure 2-24 Low Angle Drop Orientation

Determining which drop orientations in the ZX plane most damage the shipping package was also facilitated by the Traveller XL design itself. In particular, “slap down” drops, low- to medium-angle impacts where one end of the package hits before the other, as shown in Figure 2-24, divide the impact energy primarily between the top and bottom impact limiters. Generally, this energy is absorbed in a manner that induces relatively little damage for this design. An example of the damage associated with a 15° slap down is shown in Figure 2-25. This figure reflects the damage obtained in Test 1.1 of the Prototype test campaign.

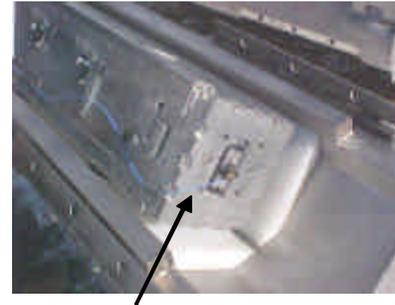
T/N Close-up:
No Significant Damage to Top head or Moderator Blocks.

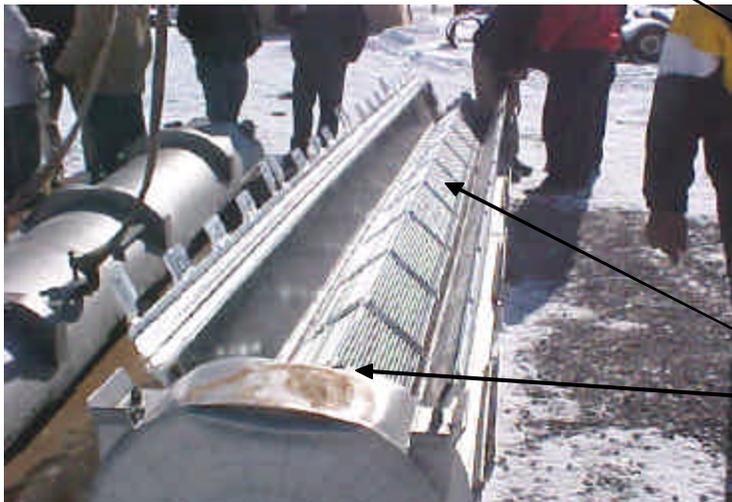
About 1/4" Local Bulge at Grid Locations (Section 54" Long)

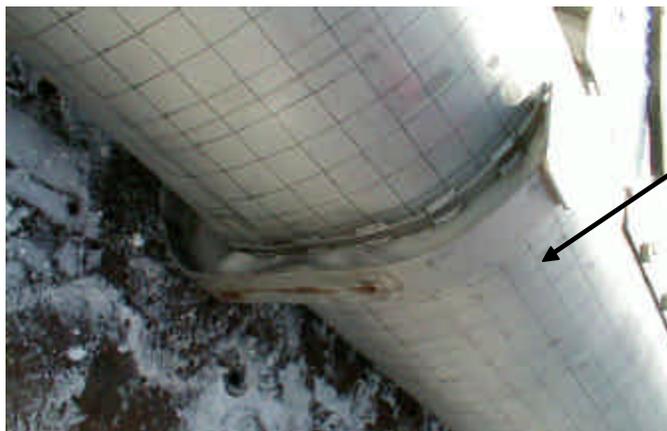
Stiffeners crushed about .75" and also dented OP about .75". Crush width 6".
