# Low Frequency Phased Array Methods for Crack Detection in Cast Austenitic Piping Components

**6<sup>th</sup> International Conference on NDE in Relation to Structural  
Integrity for Nuclear and Pressurised Components**

**October 8-10, 2007**

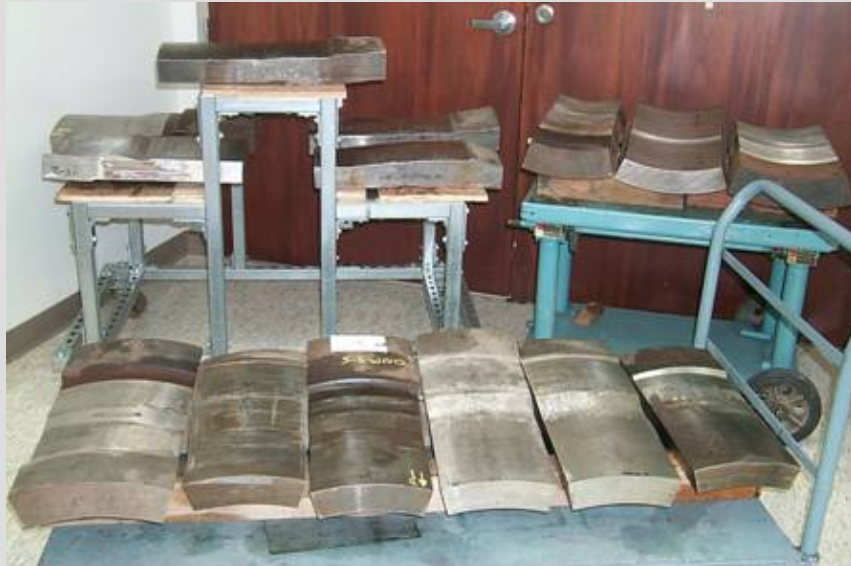
# Westinghouse Owners Group Welded Specimens

- ▶ Varied OD/ID geometries and weld configurations:
  - Elbow-to-safe end
    - (SCSS – FGSS)
  - Pipe-to-safe end
    - (CCSS – FGSS)
  - Nozzle-to-safe end-to -pipe
    - (CS – FGSS – CCSS)
  - Pipe-to-elbow
    - (CCSS – SCSS)
- ▶ Mixed/coarse grain structures in pipes and elbows
- ▶ Note OD/ID geometries
- ▶ Grain size 0.2 – 16.7 mm

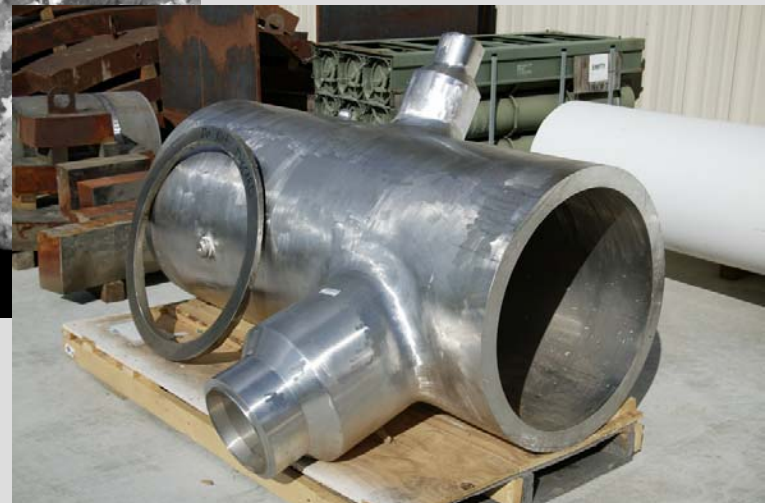
# CSS Microstructure – EPRI Base Metal Specimen

EPRI Pipe Sample @ 300° - shows mixed, but mostly equiaxed semi-coarse structure with 0.5 – 7.4 mm grain size

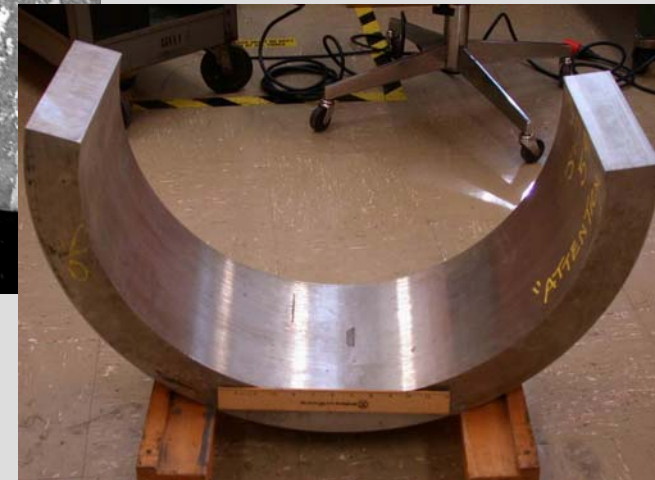
# CSS Microstructure – Westinghouse Base Metal Specimen

Westinghouse Sample in middle of arc; large dendritic grains from ID to OD, 0.6 – 16.3 mm grain size

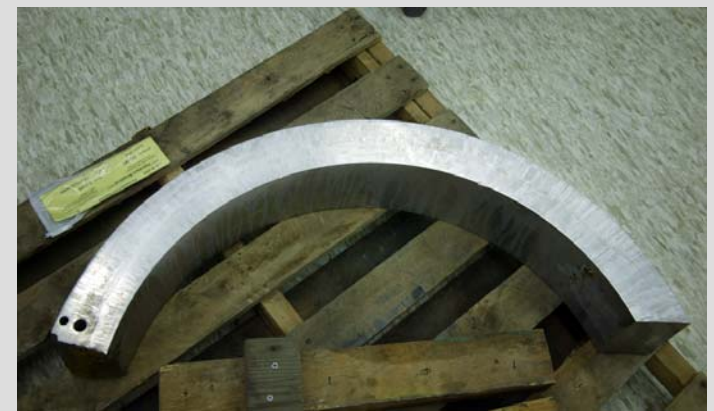
# CSS Microstructure – IHI Southwest Base Metal Specimen

IHI Southwest specimen grain structure:

- Large dendritic
- Mixed large/smaller grains and layering
- Dendritic, large/small grains, many layers
- Grain size 0.2 – 25.0 mm

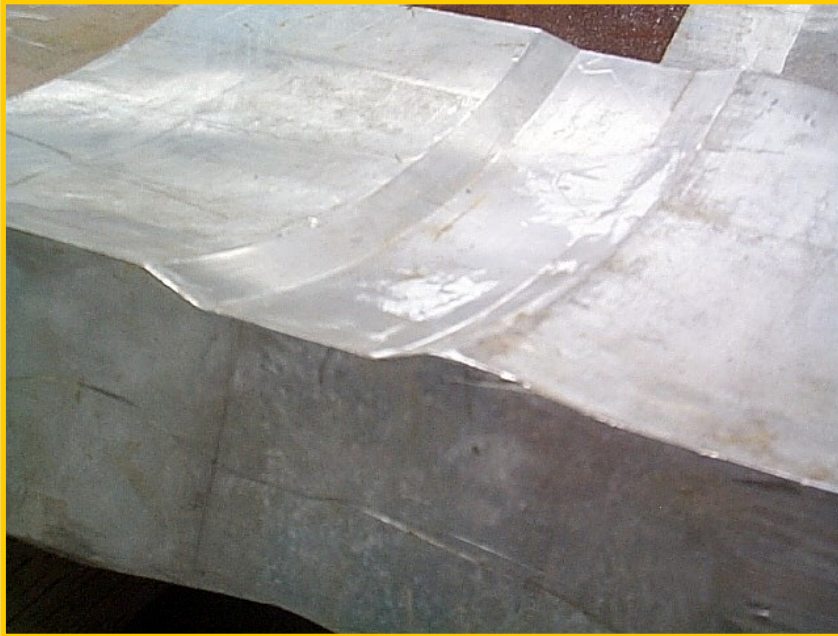
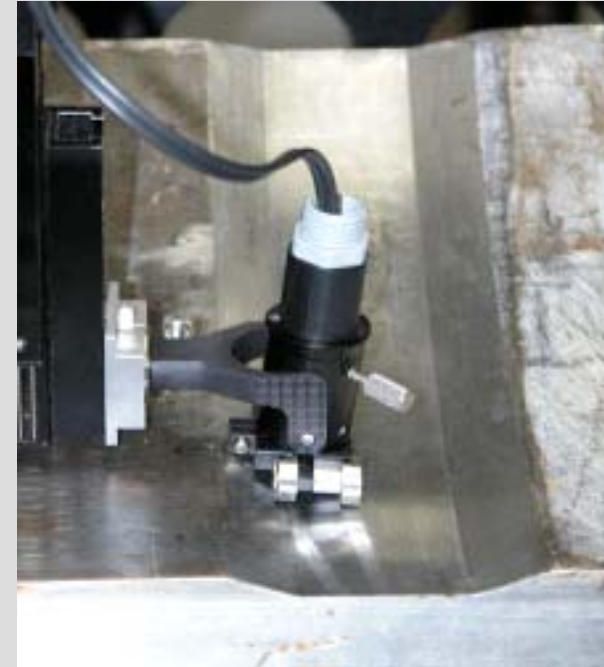
# Eddy Current Inspection on the ID Using Plus-Point Probe

Eddy current testing (ET) from the inside surface of CSS pipe weld using a ZETEC MIZ-27SI instrument and a ZETEC Plus-point™ probe operating at 250 kHz; examined all WOG and selected PNNL specimens having MF and TF cracks
