Attachment 2.7-1 Evaluation of Pumping Test

LOST CREEK REGIONAL HYDROLOGIC TESTING REPORT #1

LOST CREEK PROJECT, SWEETWATER COUNTY, WY

OCTOBER 2007

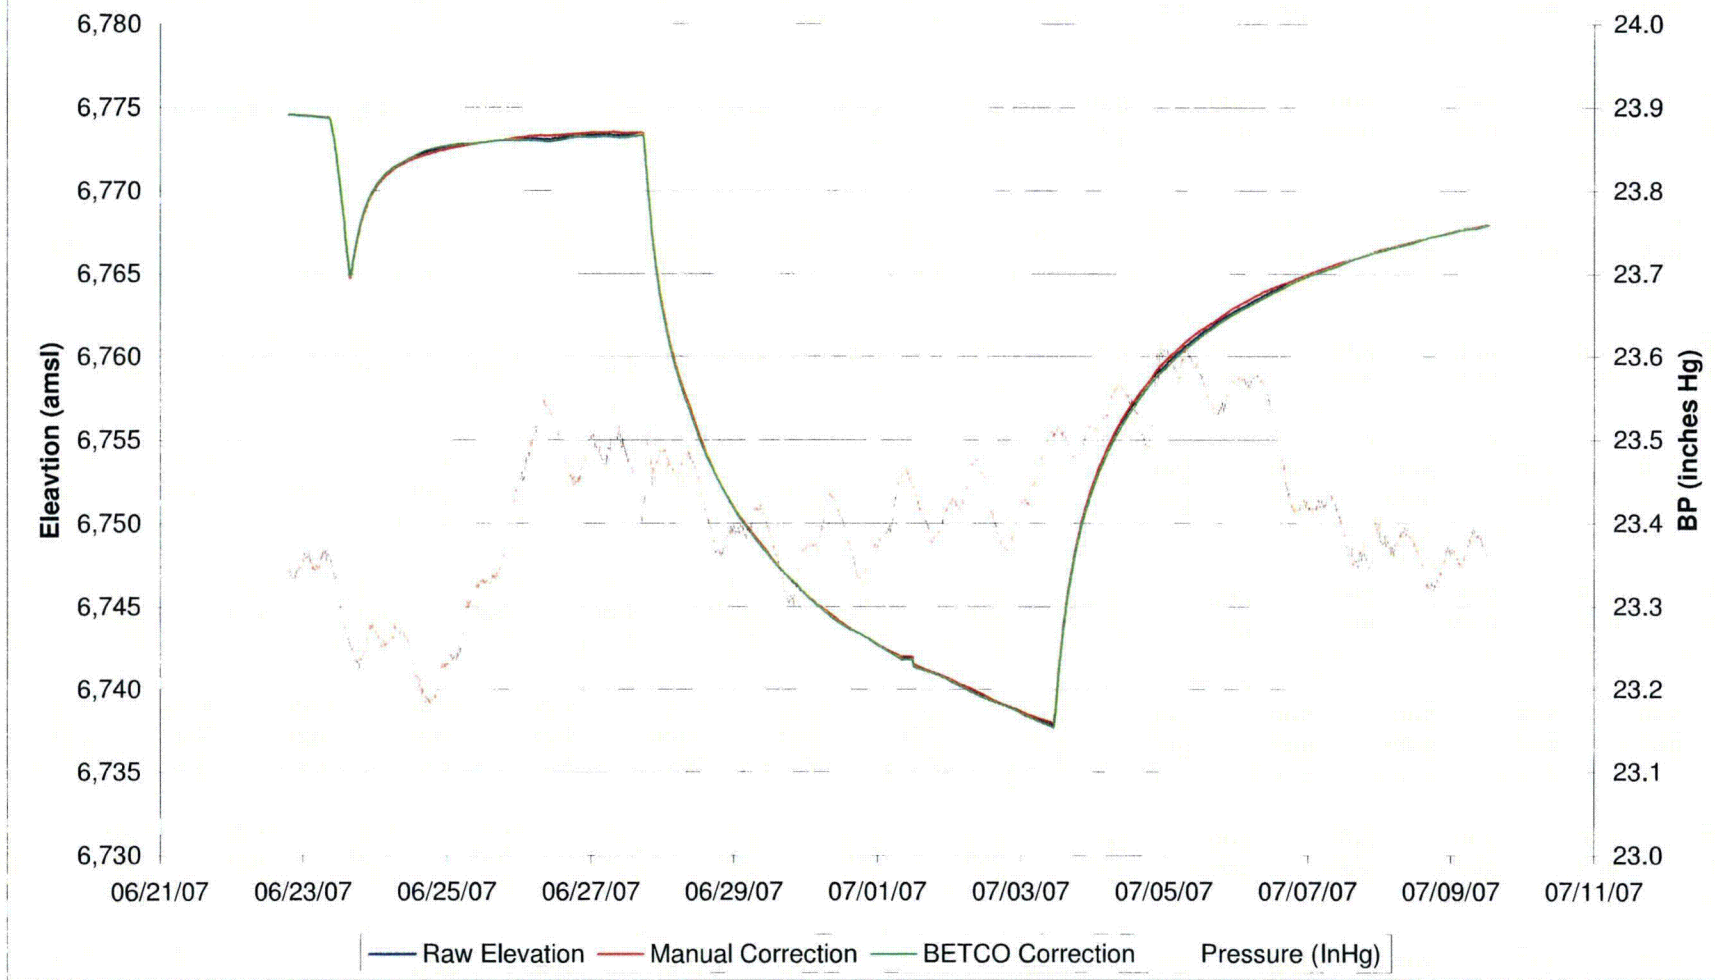
**Figure 5-3
Comparison of Barometric Corrections to Drawdown Observed at HJMP-107 (HJ sand)
South of Lost Creek Fault**

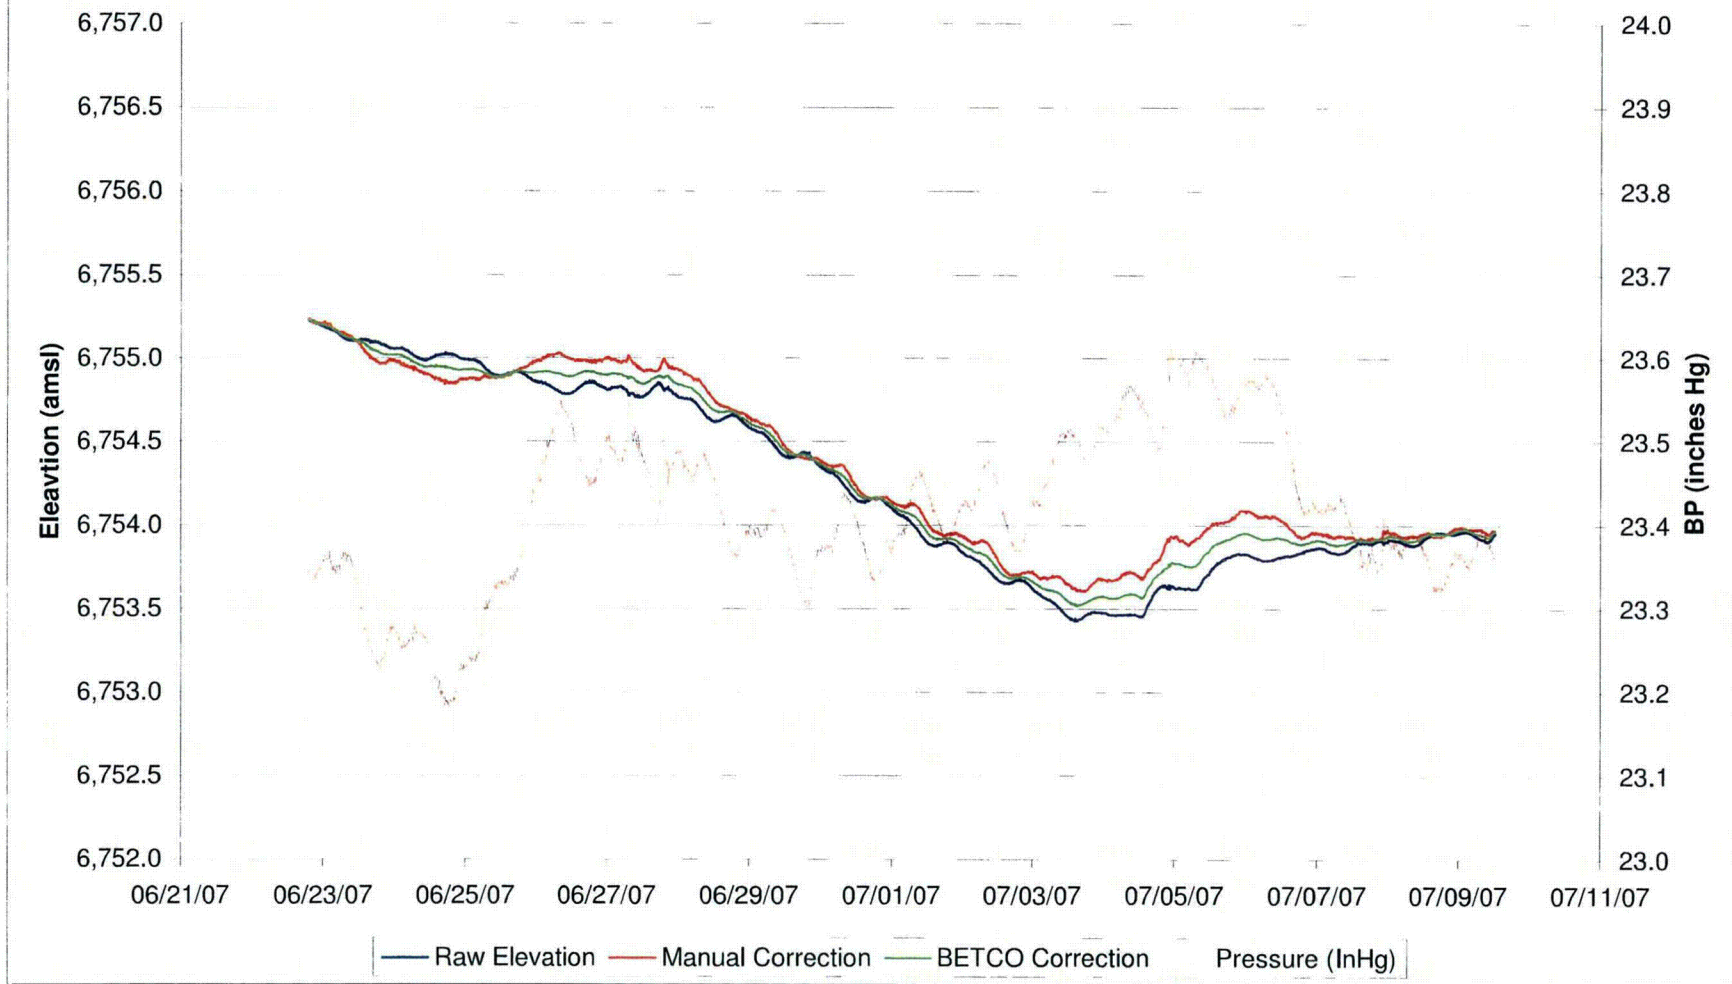
Figure 6-1
Lost Creek Regional Aquifer Test - North Test
Pumping well completed in HJ north of fault
