3.2 Run1ga - Side

3.3 Run1hl - Side

3.4 Run1hh - Side

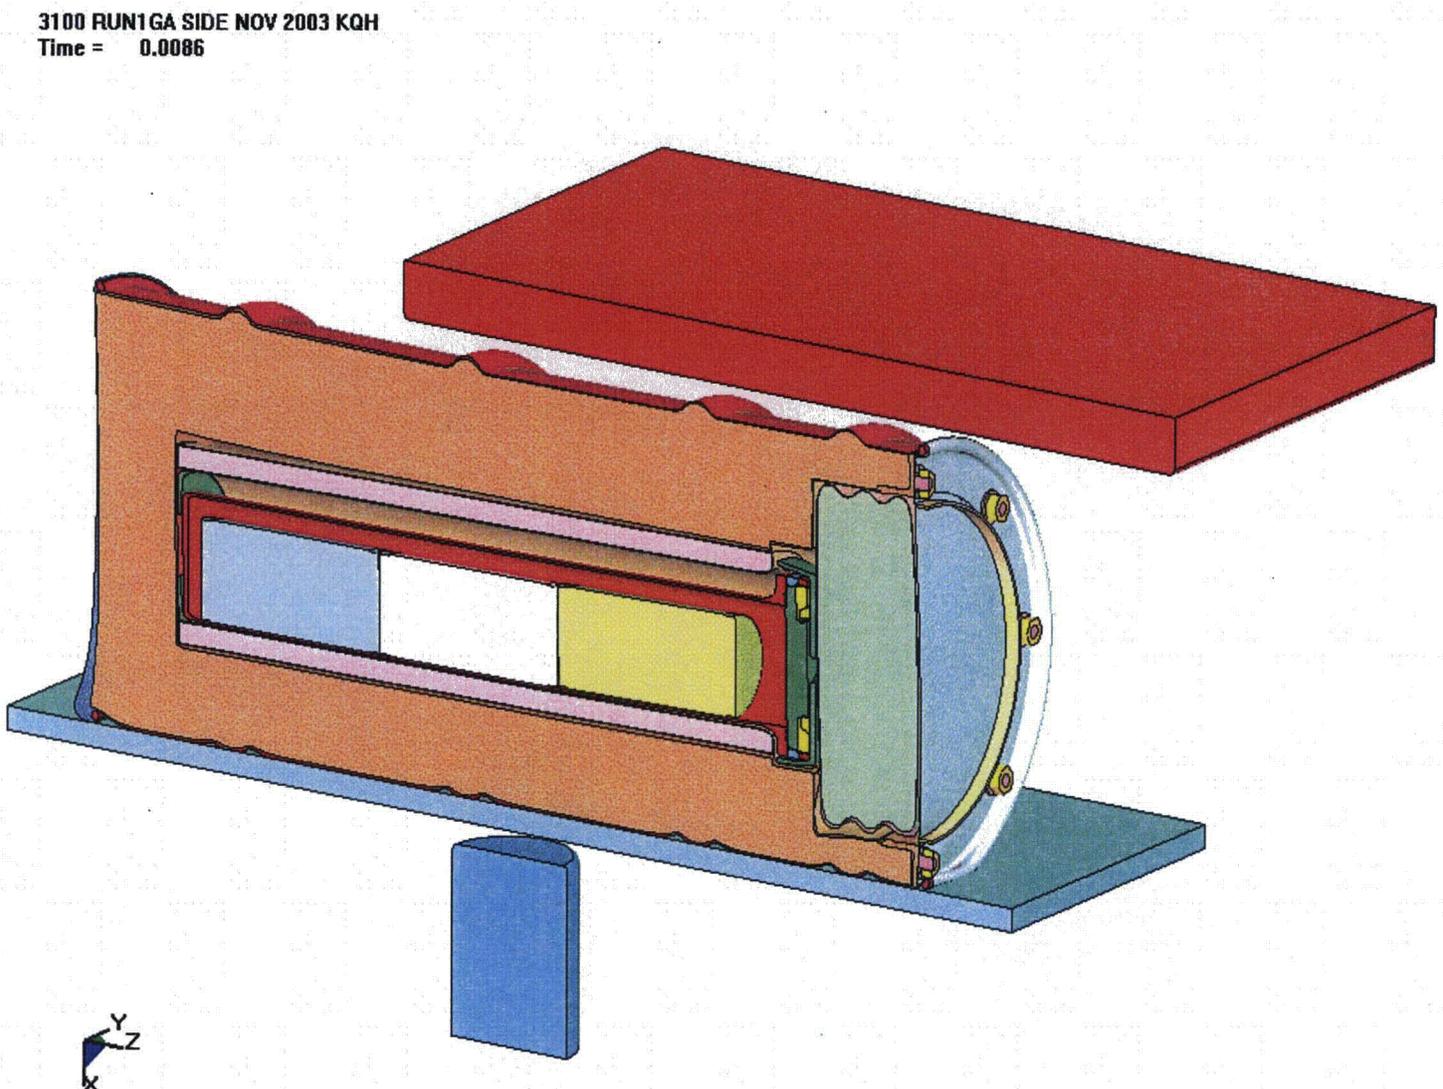
Figure 3.2.1 - Run1ga, Crush Impact, Initial Configuration for the Crush Impact

Figure 3.2.1 shows the configuration of the model after the crush plate was moved above the CV flange (time = 0.0086 sec). Figure 3.2.2 shows the model configuration after the run1ga crush impact. Figure 3.2.3 through Figure 3.2.6 show enlarged views in the lid and bottom regions of the package assembly.

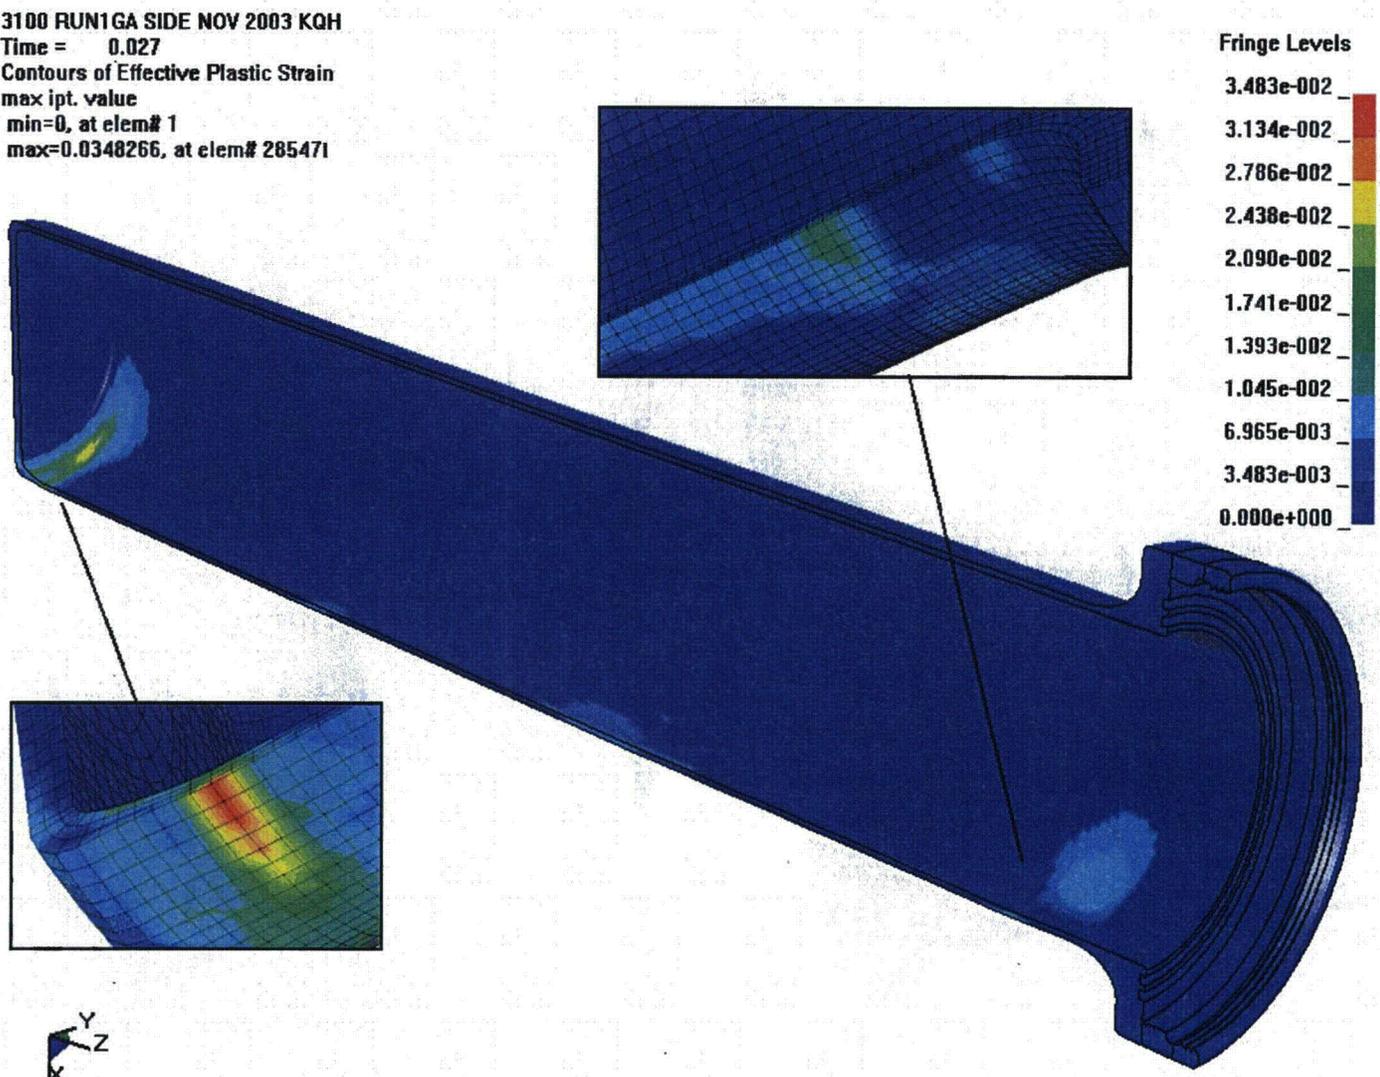
Figure 3.2.7 - Run1ga, Crush Impact, Effective Plastic Strain in the CV Body

Figure 3.2.7 shows that the maximum strain in the CV body for the run1ga crush impact is 0.0348 in/in. The effective plastic strain in the CV lid is 0.0002 in/in and is shown in Figure 3.2.8. The CV nut ring remains elastic for the crush impact of run1ga.

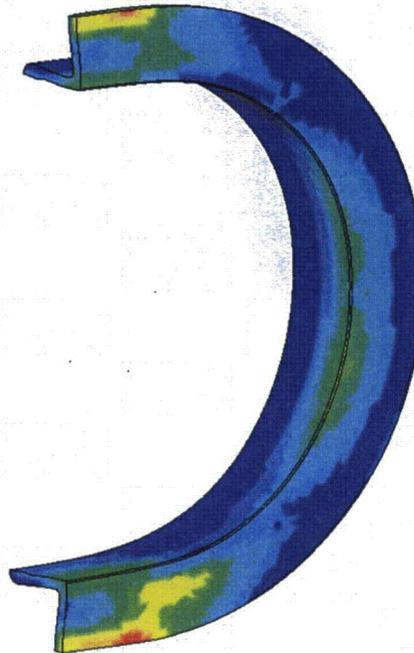
Figure 3.2.9 - Run1ga, Crush Impact, Effective Plastic Strain in the Drum Angle

The maximum effective plastic strain in the drum angle is shown in Figure 3.2.9 to be 0.1058 in/in. The maximum effective plastic strain in the drum is 0.3818 in/in and occurs in the top drum roll near the crush plate (Figure 3.2.10).

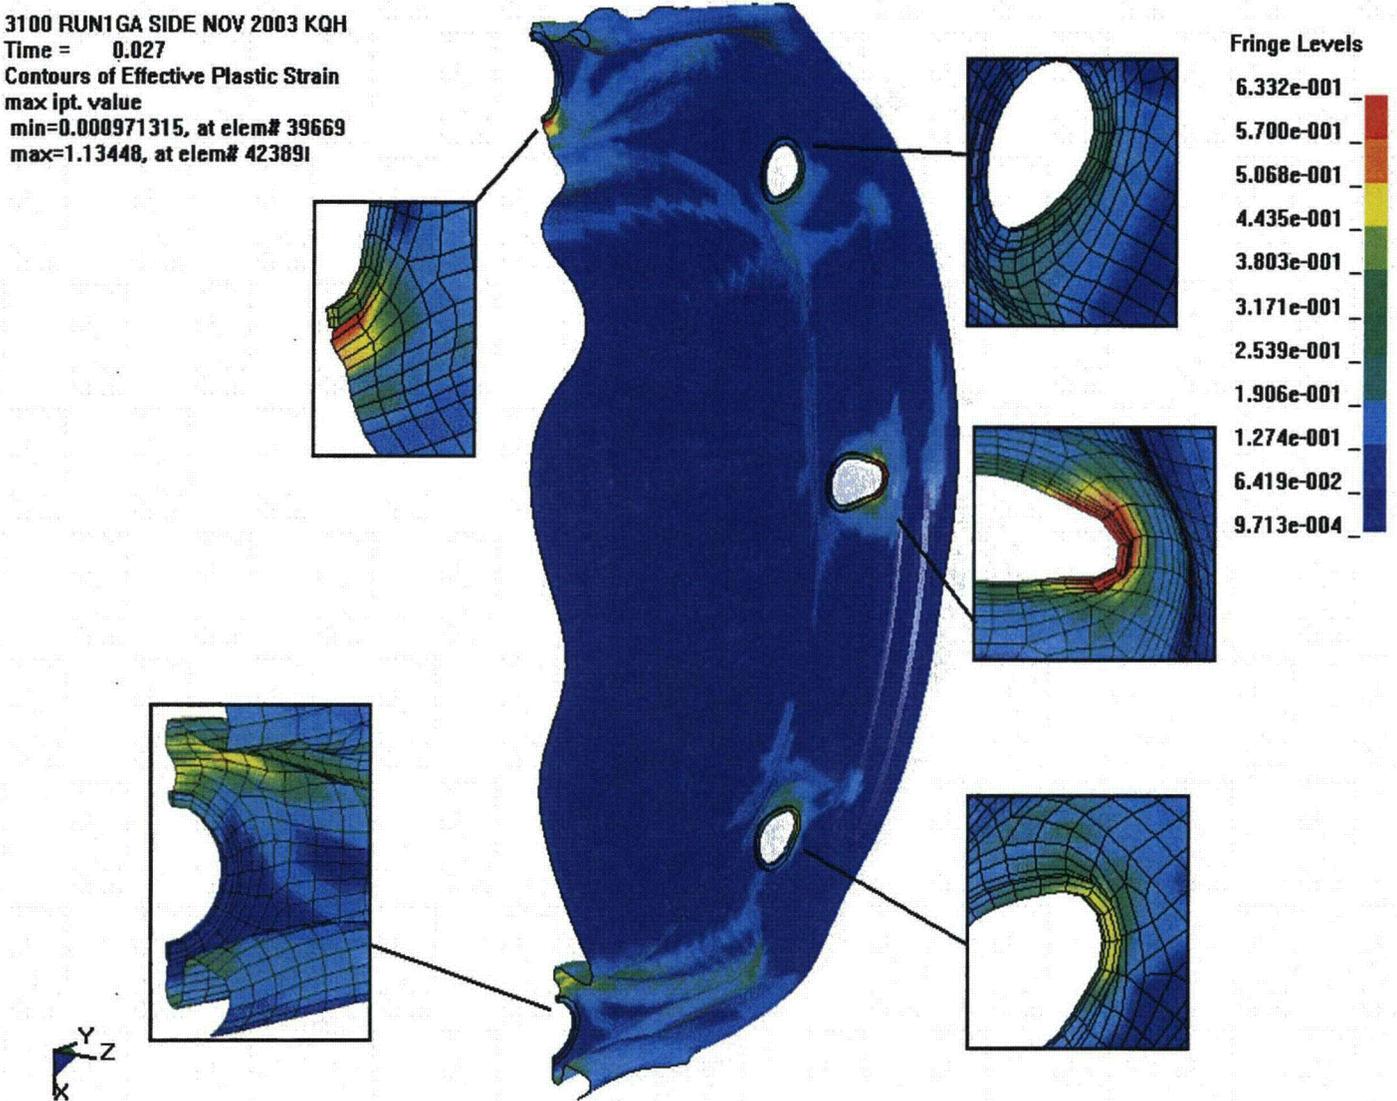
Figure 3.2.11 - Run1ga, Crush Impact, Effective Plastic Strain in the Lid

Figure 3.2.11 gives the maximum effective plastic strain in the lid to be 1.1345 in/in. This is a relatively high strain level and the maximum occurs near the stud hole at the 90° position (initially along Y axis). Another high region of strain is near the upper stud nearest the crush plate. The solid elements (used for contact bearing on the studs) around the stud holes show effective plastic strain maximum of 0.8745 in/in. The membrane effective plastic strain in the shell elements is a maximum of 0.8057 in/in and is highly localized near the stud hole at the 90° position. Some tearing of the lid could occur in the lid hole at the 90° position and at the lid hole nearest the crush plate (180°).

A study of the timing of the elevated effective plastic strain levels in the lid and the drum studs shows that the lid reaches failure magnitudes before the studs. At the stud hole in the drum lid nearest the crush plate (180°), the bending strain crosses the 0.57 in/in

strain at about 0.0122 seconds in the crush impact. The membrane strain in the lid elements at 180° reaches a maximum of .5295 in/in. The stud at 180° does not experience elevated strain levels (final maximum in this stud is 0.17 in/in). So at the 180° position, only the lid experiences relatively high levels of effective plastic strain.

At the 90° position in the lid, the membrane effective plastic strain exceeds the 0.57 in/in level near 0.0164 seconds in the crush impact. The surface maximum effective plastic strain exceeds 0.57 in/in at about 0.0161 seconds, slightly ahead of the membrane. At time 0.0164 seconds, the effective plastic strain levels in the stud at 90° is about 0.35 in/in maximum, with the through thickness levels between 0.104 in/in to 0.136 in/in. Therefore, at the 90° position, the lid reaches the failure level of 0.57 in/in before the stud.

From this timing data, it is shown that the lid would reach failure levels in bending and membrane before the stud effective plastic strain levels become relatively high. Therefore, it would be expected that the lid would locally tear before the bolting reached elevated effective plastic strain levels, thus possibly reducing the loadings on the studs. Due to the extent of the relatively high levels of effective plastic strain in the drum lid, it would be expected that any lid tearing would be localized and that the large washers would restrain the drum lid.

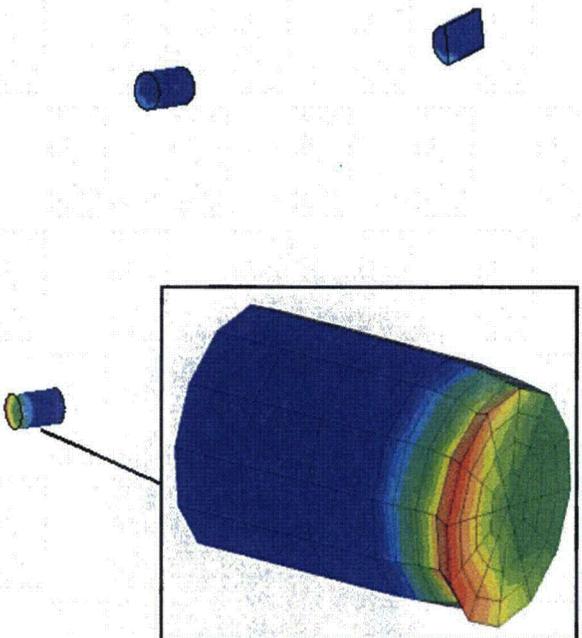
Figure 3.2.12 - Run1ga, Crush Impact, Effective Plastic Strain in the Drum Studs

Figure 3.2.12 shows the effective plastic strain levels in the drum studs. The maximum is shown to be 0.5207 in/in and occurs in the stud at the 90° position. From Figure 3.2.12 it is seen that the elevated strain occurs near the outer extreme of the stud, and that the through thickness strain levels between 0.3170 and 0.3802 in/in exist.

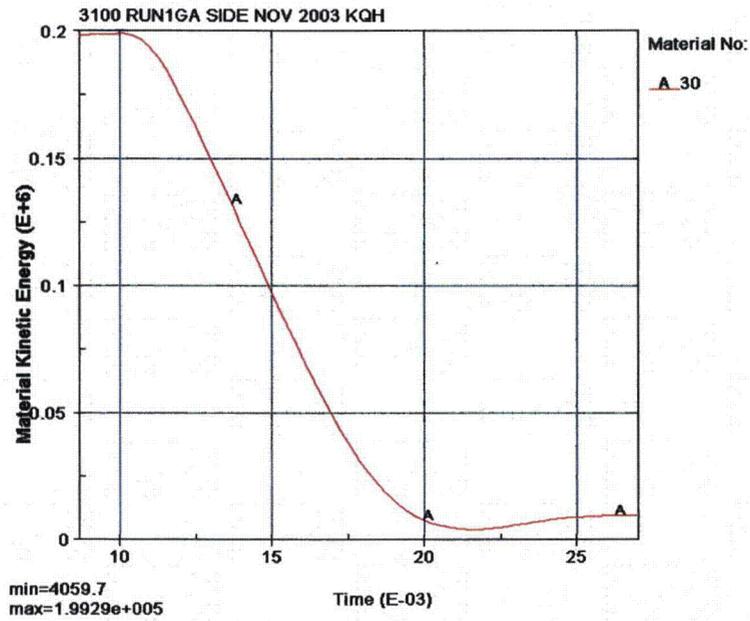
Figure 3.2.13 - Run1ga, Crush Impact, Kinetic Energy Time History

The kinetic energy time history for the crush plate impact is shown in Figure 3.2.13. The X velocity time history is shown in Figure 3.2.14.

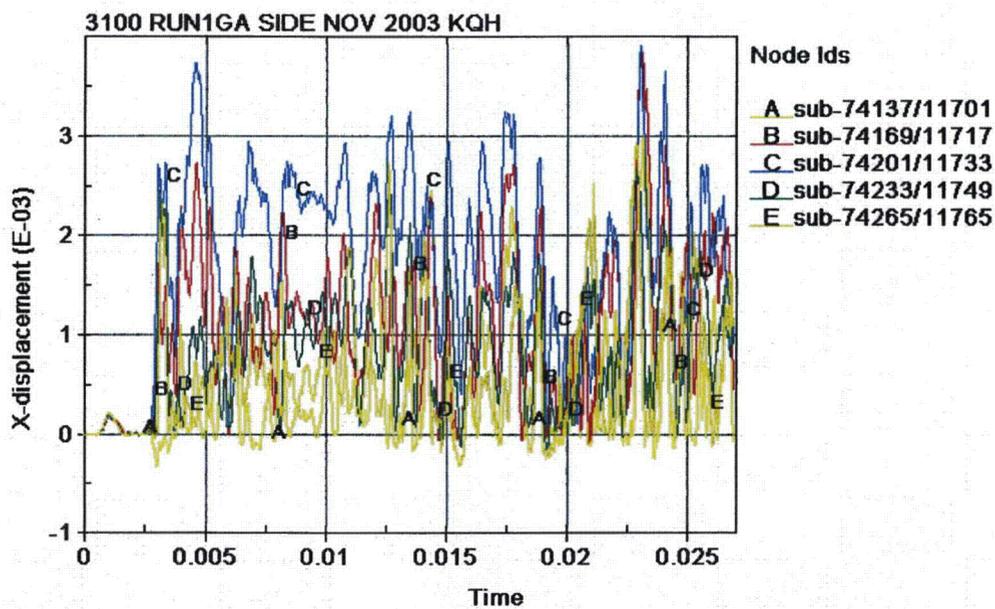
Figure 3.2.15 - Run1ga, Lid Separation Time History

The lid separation time history is shown in Figure 3.2.15 (nodes defined in Figure 3.1.30). From Figure 3.2.15 it is seen that the spike separation of just under 0.004 inches can occur with a final nominal separation of less than 0.002 inches expected.

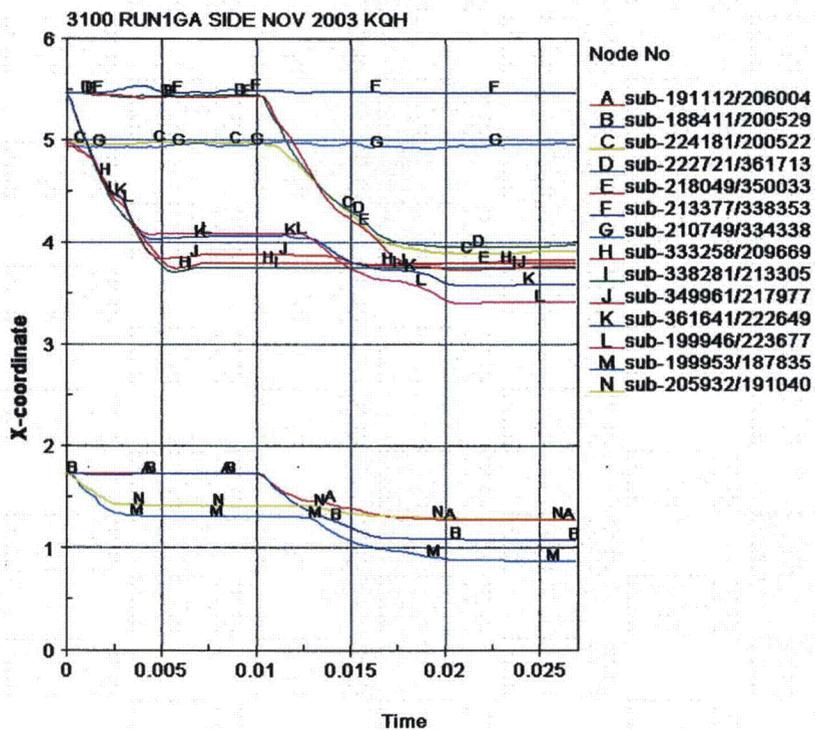
Figure 3.2.16 - Run1ga, Drum Kaolite Thickness Time Histories

The kaolite thickness time histories for the nodes defined in Figure 3.1.32 are given in Figure 3.2.16 for run1ga. The drum diameter time histories are given in Figures 3.2.17 and 3.2.18. The nodes defining this response are shown in Figure 3.1.34. As shown in Figure 3.2.17, the bottom head and the bottom drum roll remain at, or near 30-foot impact diameters for the crush impact. This response is expected as qualitatively shown in Figure 3.2.2. The response in the Y-direction is shown in Figure 3.2.18.

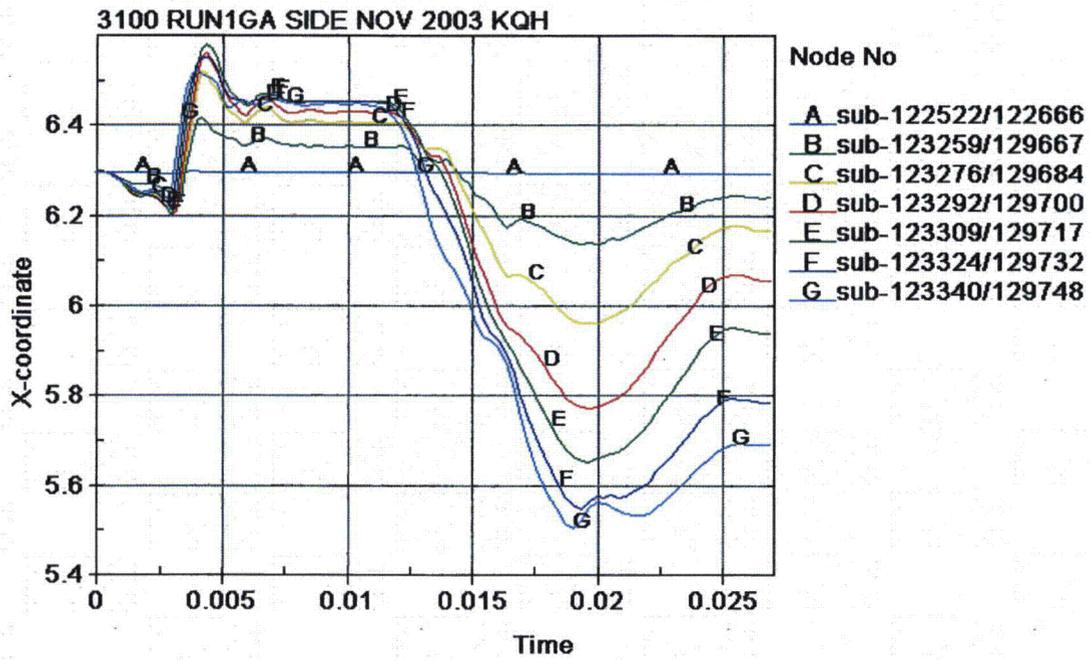
Figure 3.2.19 - Run1ga, Liner Diameter Time History

Figure 3.2.19 shows the diameter time history for various locations along the liner length. Figure 3.1.37 and Table 3.1.3 define the locations at which the diameters are obtained.

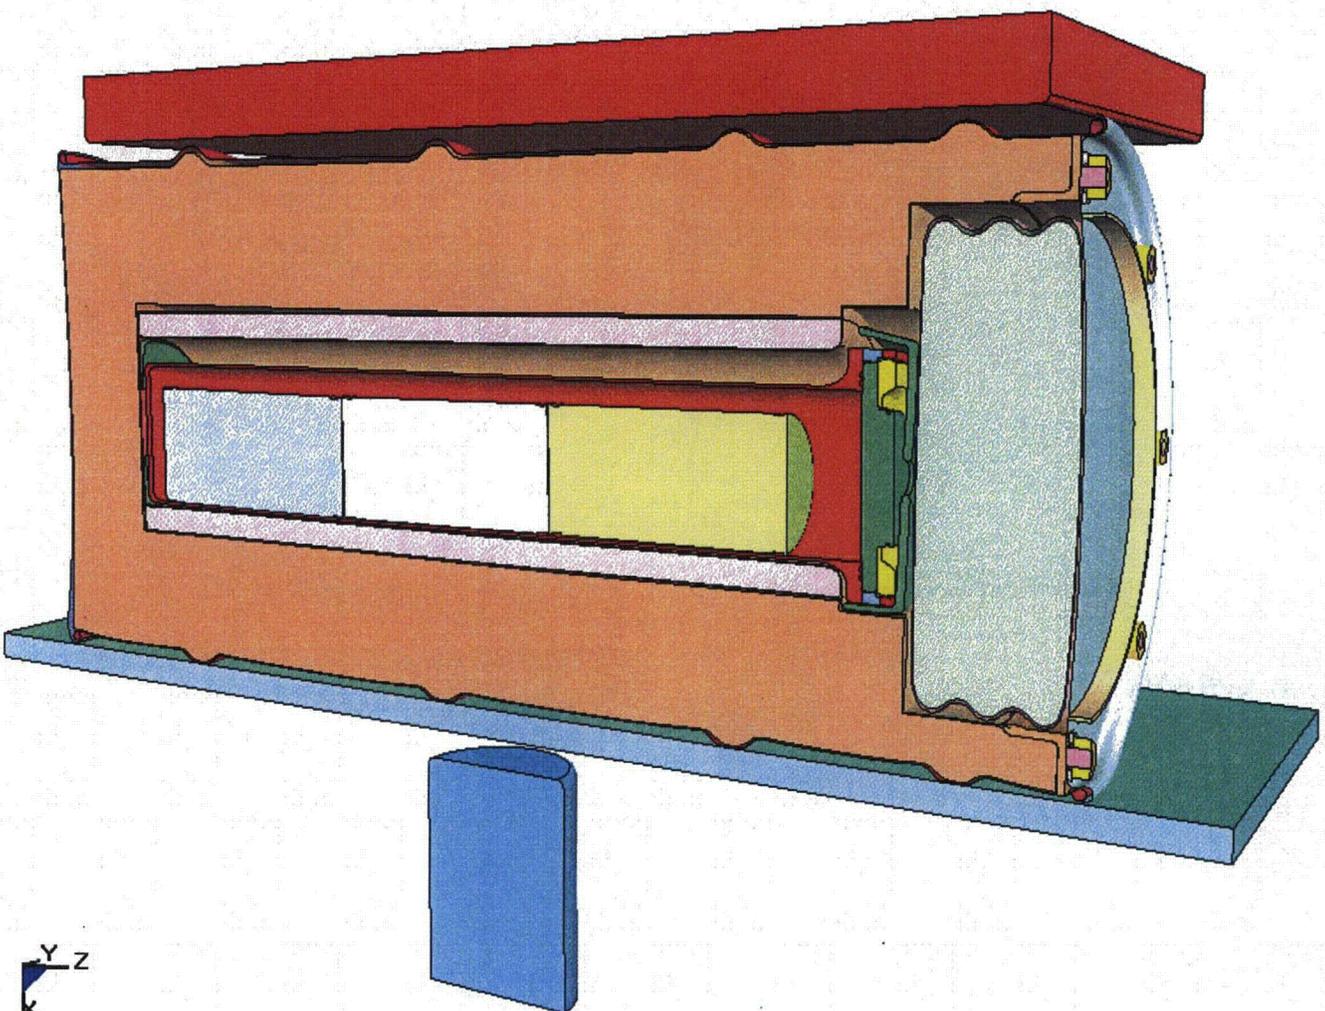
Figure 3.3.1 - Run1hl, 4-Foot Impact, Final Configuration

Run1hl is the lower bounding kaolite run (100°F). It is basically the run1g model, but with kaolite properties of section 2.3.5.2. It is a run with a 4-foot impact (time = 0 to 0.01 seconds), followed by a 30-foot impact (0.01 to 0.02 seconds), followed by a 30-foot crush impact (0.02 to 0.04 seconds), finally followed by a 40-inch punch impact (0.04 to 0.055 seconds). The initial configuration of run1hl is similar to Figure 3.1.1. The configuration after the 4-foot impact is shown in Figure 3.3.1. Figure 3.3.2 and 3.3.3 show the configuration at the extremes of the package.

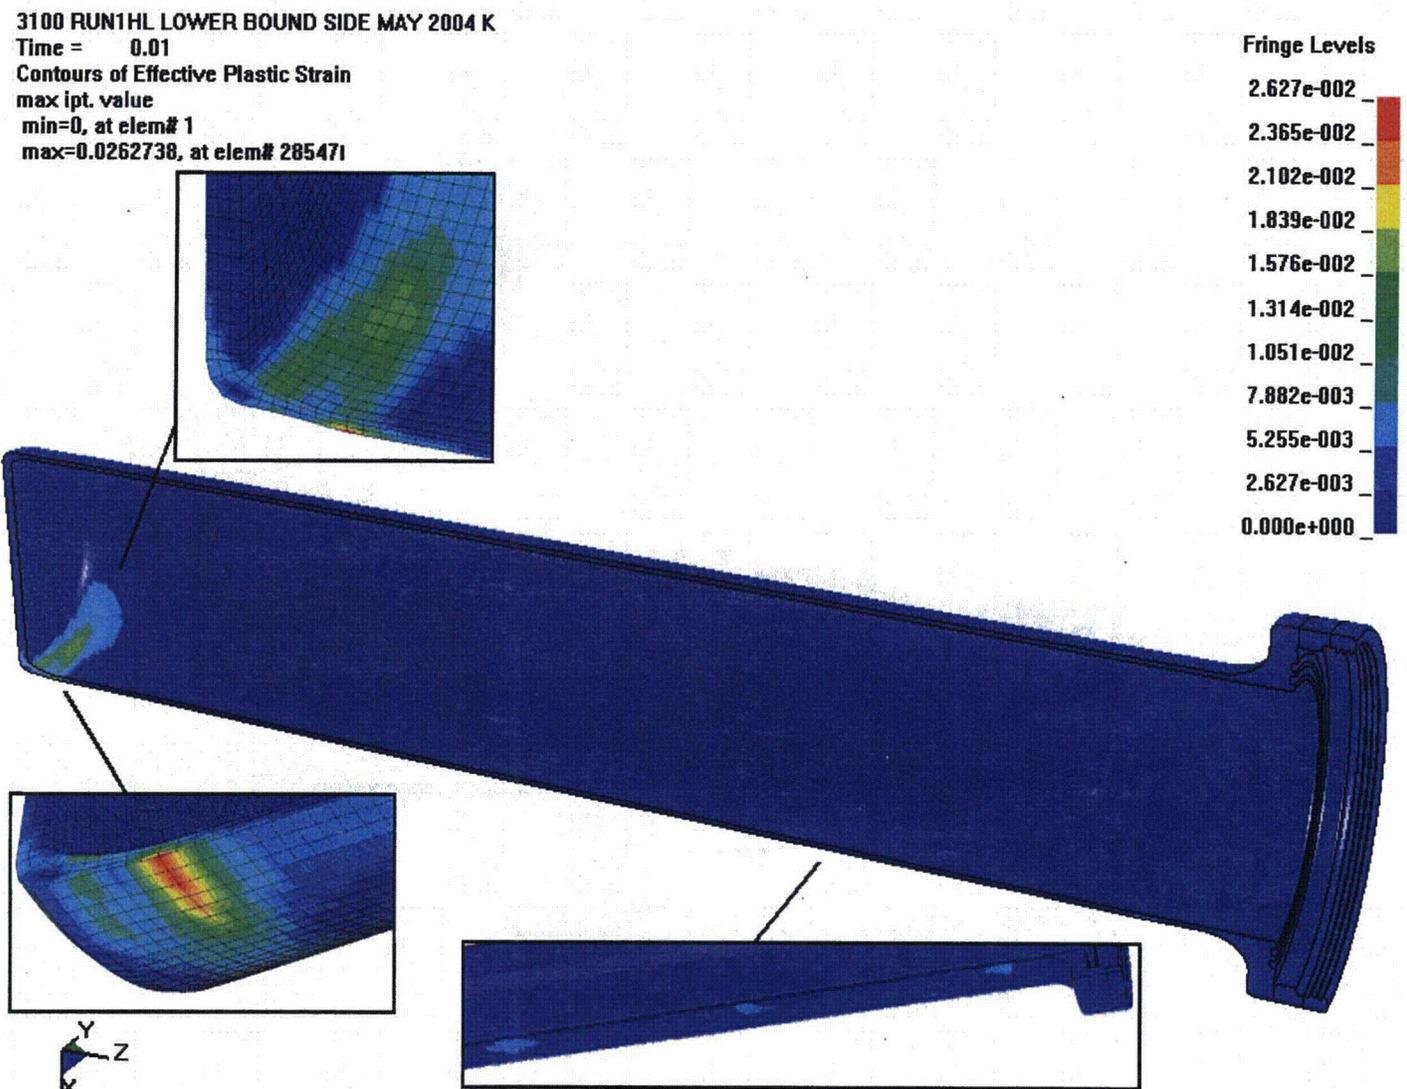
Figure 3.3.4 - Run1hl, 4-Foot Impact, Effective Plastic Strain in the CV Body

The CV body undergoes plastic deformation in the 4-foot impact. The effective plastic strain in the CV body is shown in Figure 3.3.4 to have a maximum of 0.0263 in/in. The elevated plastic strain levels are near the CV bottom head. The CV lid and nut ring remain elastic during the 4-foot impact. The plastic strain in other components for the 4-foot impact are given in Table 3.3.1.

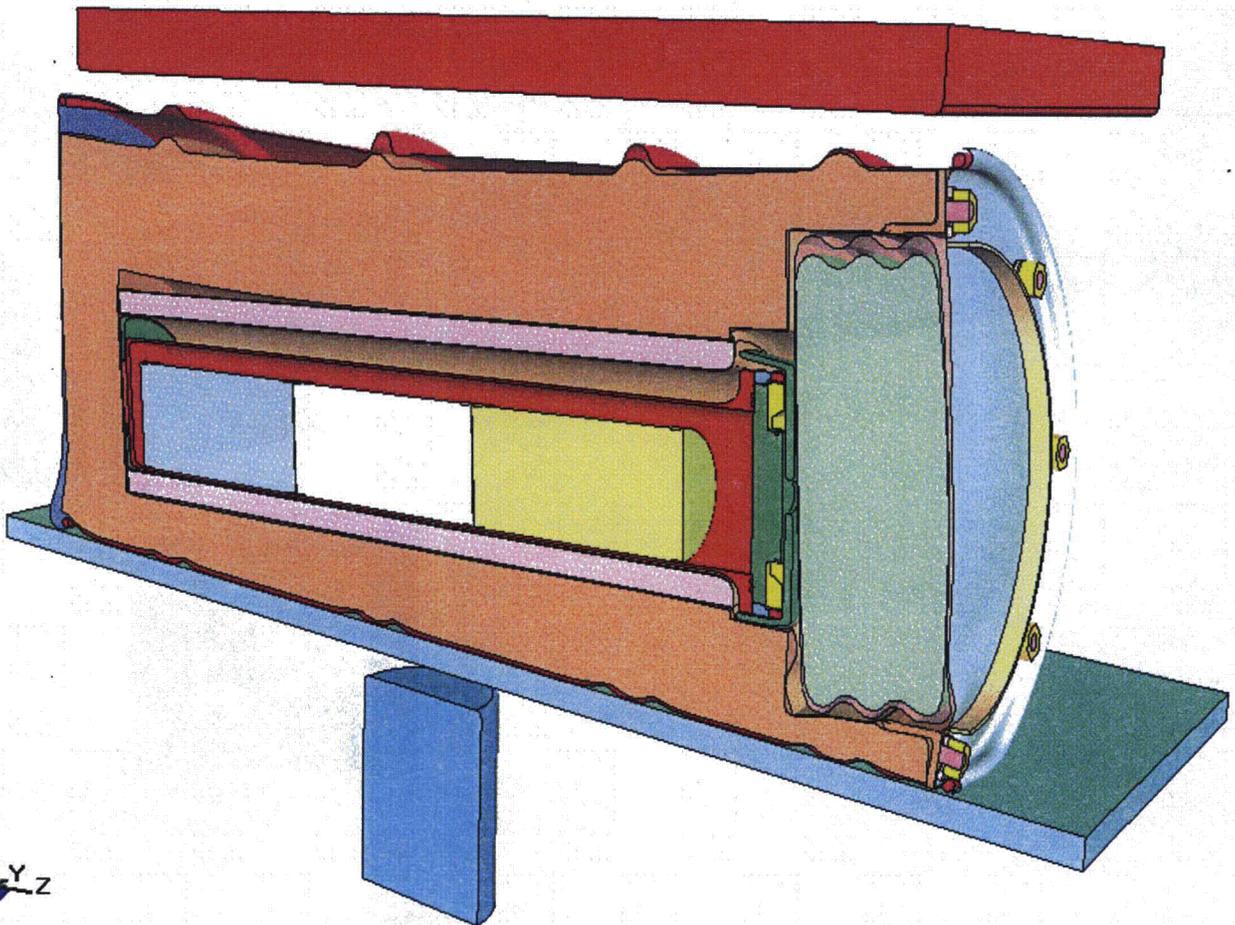
Figure 3.3.5 - Run1hl, 30-Foot Impact, Final Configuration

Figure 3.3.5 shows the final configuration for the run1hl 30-foot impact. Figures 3.3.6 and 3.3.7 show the configurations for the package extremes.

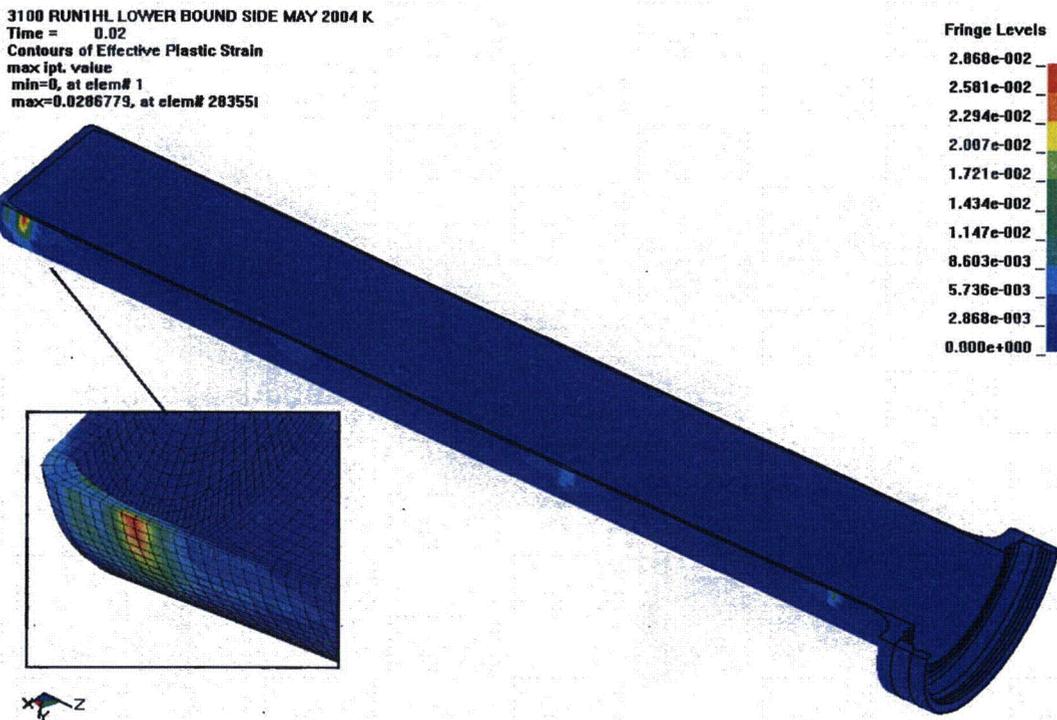
Figure 3.3.8 - Run1hl, 30-Foot Impact, Effective Plastic Strain in the CV

The maximum effective plastic strain due to the 30-foot impact in the CV body is 0.0287 in/in as shown in Figure 3.3.8. The maximum effective plastic strain in the drum lid

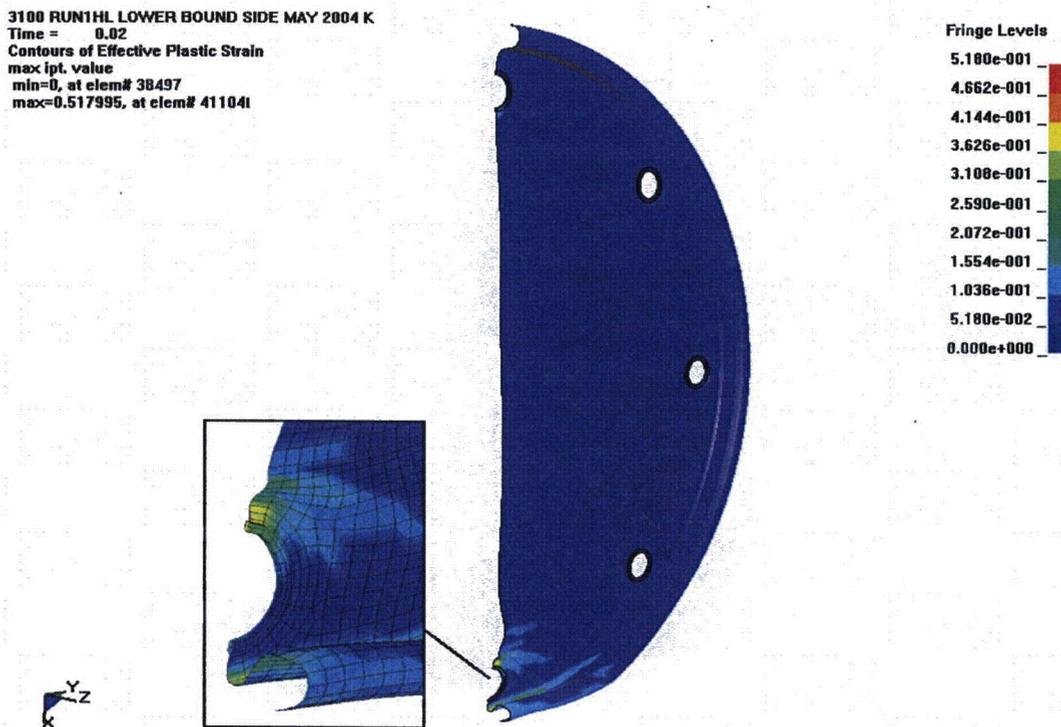
Figure 3.3.9 - Run1hl, 30-Foot Impact, Effective Plastic Strain in the Lid

is shown to be 0.5180 in/in in Figure 3.3.9. The maximum lid strain is a surface strain at the stud hole nearest the rigid surface (0°). The membrane effective plastic strain component is 0.4026 in/in in the localized region near the stud hole. Effective plastic strain levels in other components for the 30-foot impact are given in Table 3.3.2.

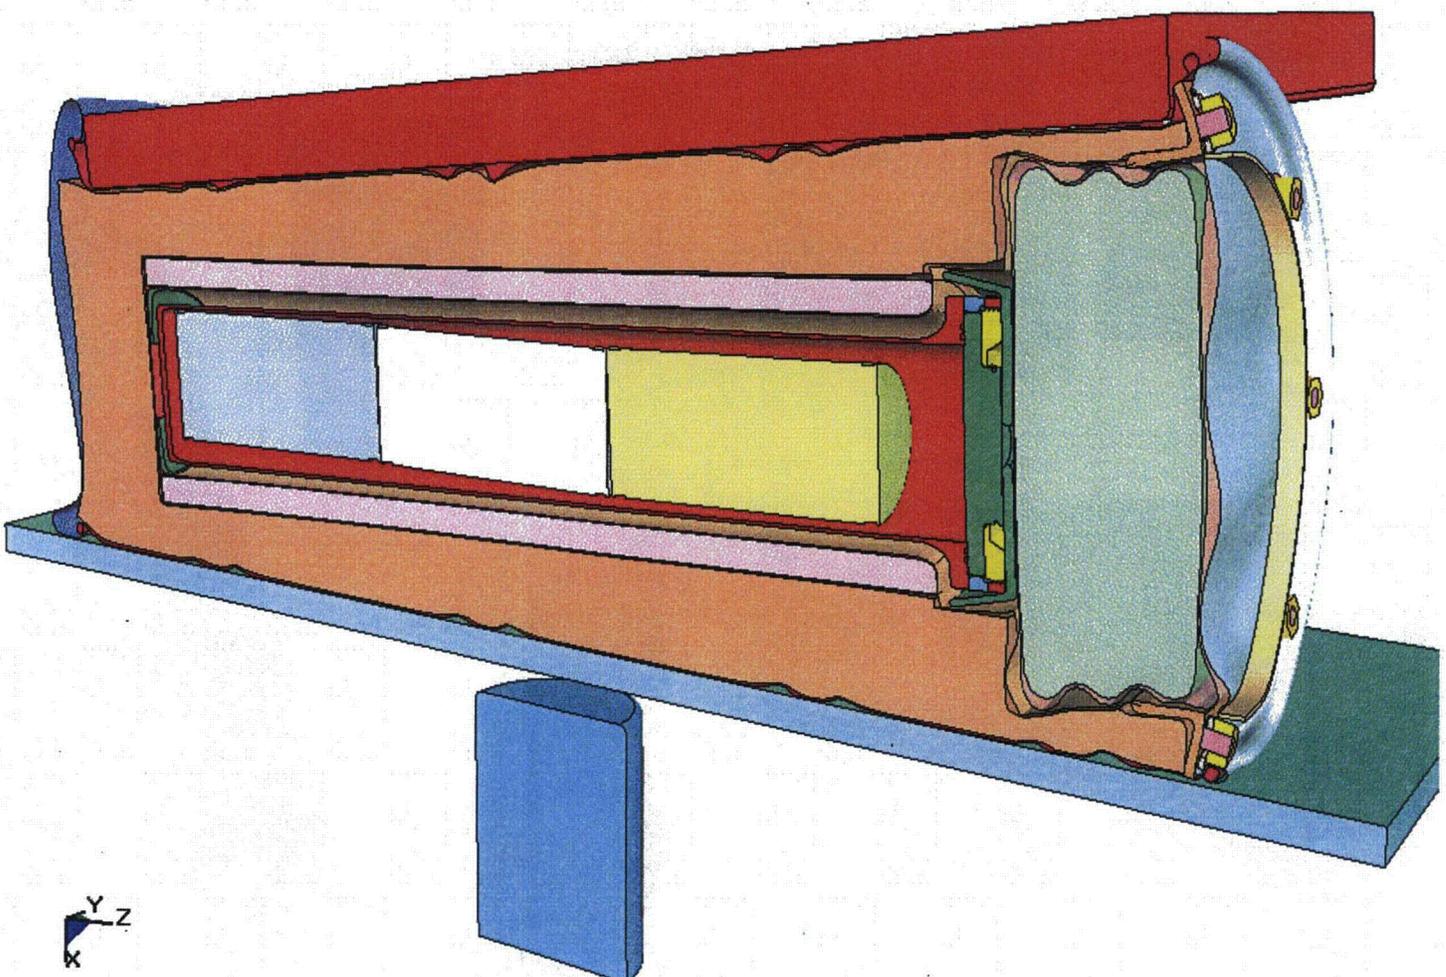
Figure 3.3.10 - Run1hl, Crush Impact, Final Configuration

The final configuration for the crush impact is shown in Figure 3.3.10. The configuration at the package extremes are shown in Figure 3.3.11. The maximum effective plastic strain in the CV body is 0.0287 in/in as shown in Figure 3.3.12. The maximum effective plastic strain in the drum for the crush impact is 0.5309 in/in (surface strain). The maximum in the drum occurs near the angle on the crush plate side of the drum as shown in Figure 3.3.13. The maximum membrane effective plastic strain at this location is 0.3616 in/in.

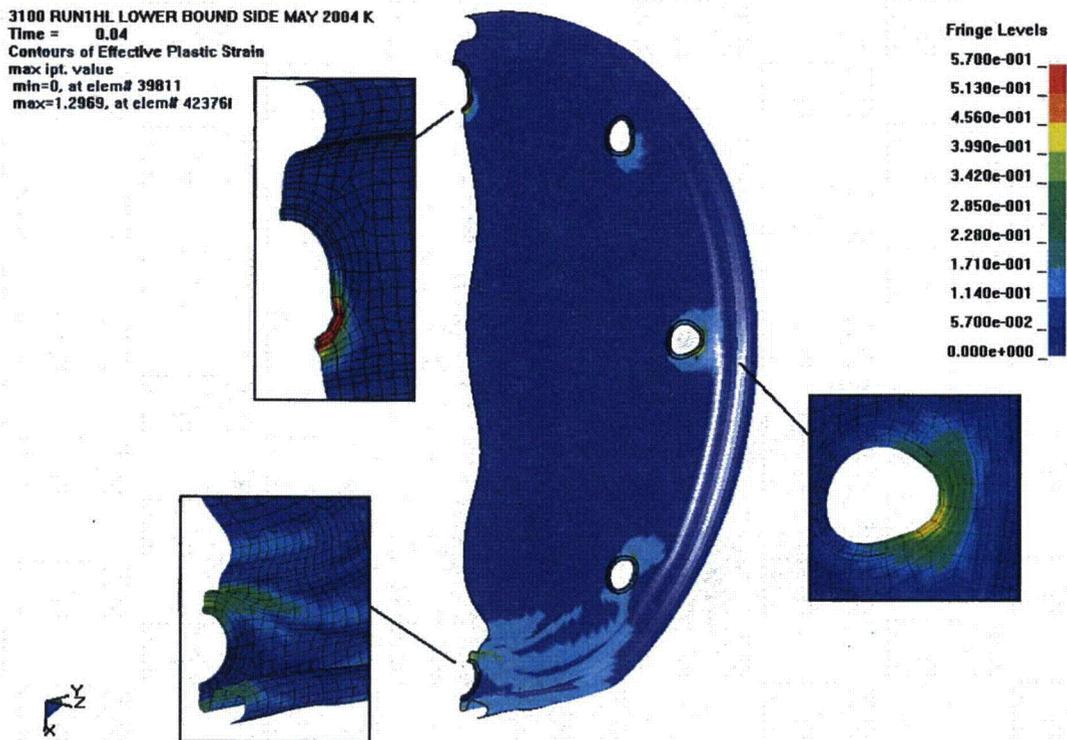
Figure 3.3.14 - Run1hl, Crush Impact, Effective Plastic Strain in the Lid

The maximum effective plastic strain in the lid is 1.2969 in/in (surface strain) and occurs just below the upper stud hole (hole nearest the crush plate, 180°) as shown in Figure 3.3.14. The maximum membrane effective plastic strain in this region of the lid is 0.8995 in/in. A time line investigation during the crush impact shows that the lid exceeds 0.57 in/in strain in bending at about 0.0228 seconds at the 180° stud hole. The crush impact started at about 0.0200 seconds, so the lid reaches failure level near the start of the crush impact. The membrane levels in the lid reach 0.57 in/in at about 0.0236 seconds.

The elevated effective plastic strain levels in the lid are localized in the region just inboard of the upper stud.

Considering the strain levels in the lid and the studs, some tearing in the lid at the 180° stud hole would be expected. But the tearing would be localized to the stud hole due to the extent of the strain patterns. Failure of the stud to restrain the lid due to this tearing is not expected. The lid stiffener would limit any tearing from the stud at 180° and the large washer would be expected to restrain the lid.

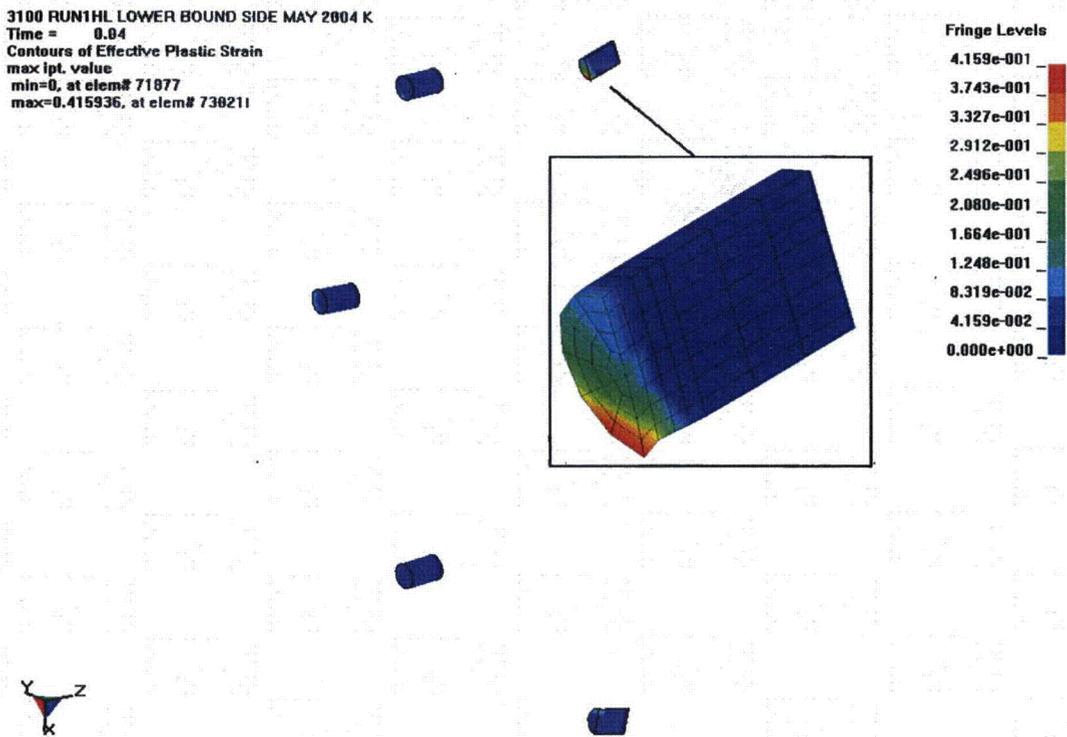
Figure 3.3.15 - Run1hl, Crush Impact, Effective Plastic Strain in the Studs

The effective plastic strain in the drum studs is 0.4159 in/in and occurs in the upper stud at the bearing of the lid onto the stud (180°). The elevated strains in the stud are localized on the inner surface. Effective plastic strain levels throughout the thickness of the stud are generally 0.25 in/in or less.

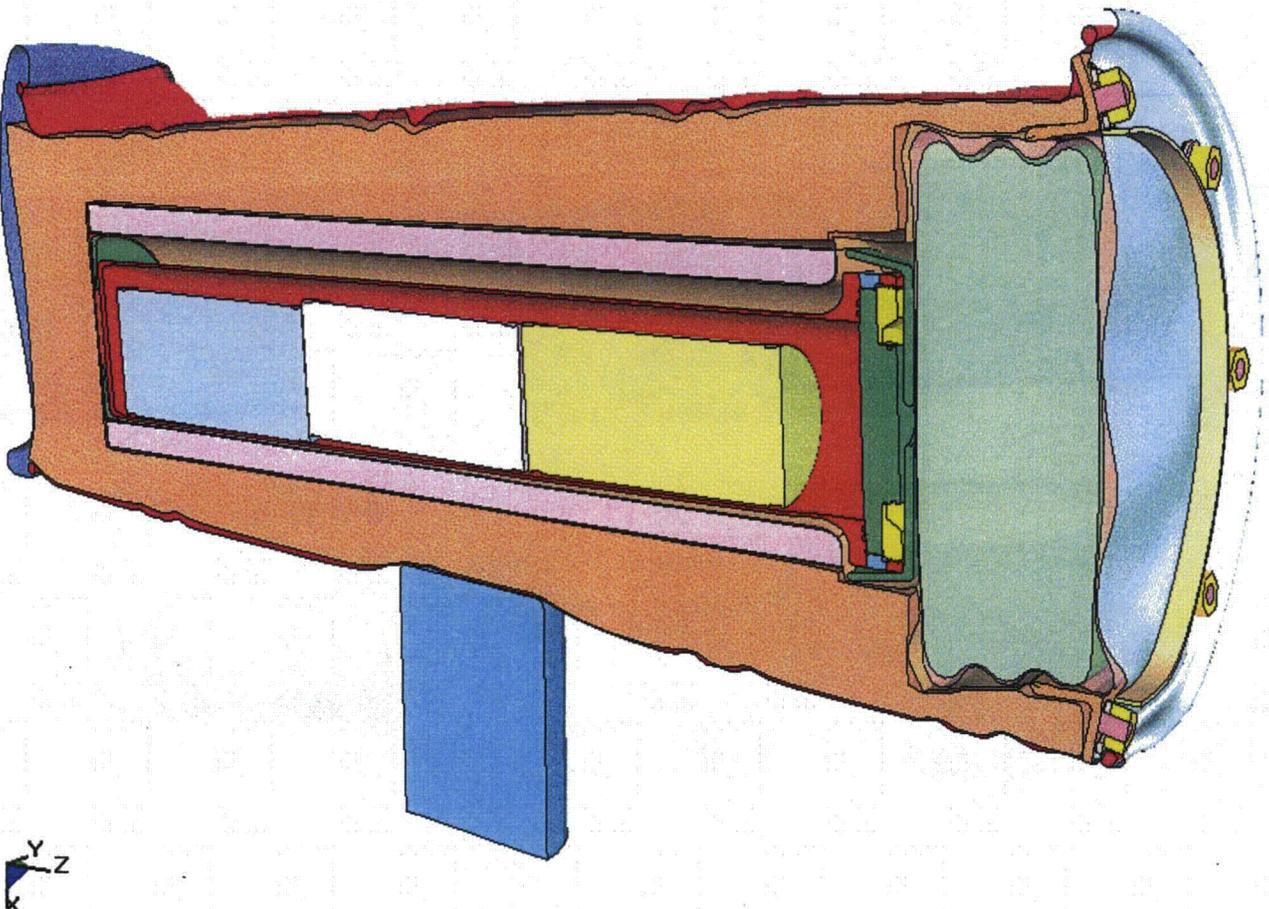
Figure 3.3.16 - Run1hl, Punch Impact, Final Configuration

The final configuration after the punch impact is shown in Figure 3.3.16. The effective plastic strain level in the CV body is shown in Figure 3.3.6. The maximum strain is 0.0299 in/in and is located near the bottom head. The effective plastic strain level in the drum after the punch impact remains at 0.5309 in/in as shown in Figure 3.3.18. The maximum effective plastic strain in the other package components for the punch impact are listed in Table 3.3.4.

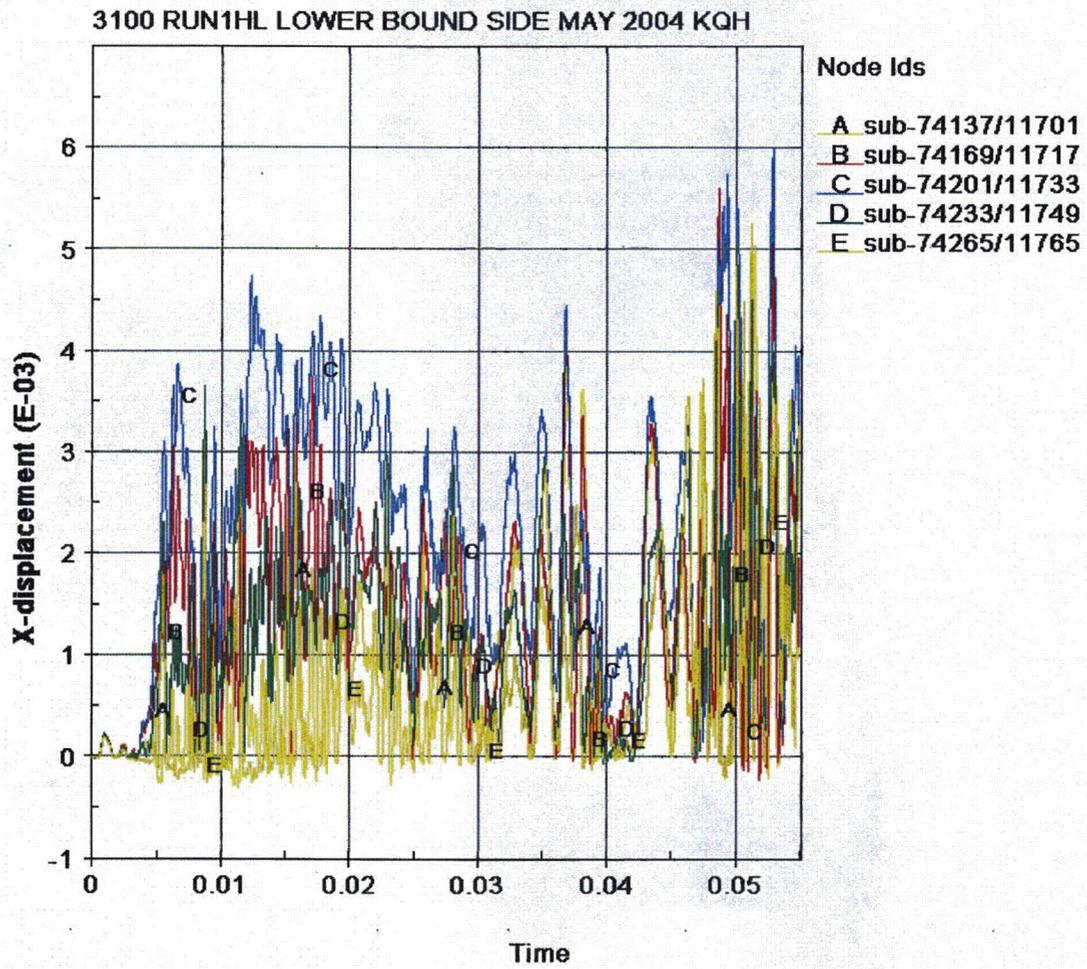
Figure 3.3.19 - Run1hl, CV Lid Separation Time History

Figure 3.3.19 shows the lid separation time history for all the impacts. The CV lid separation shows a maximum spike separation of about 0.006 inches occurs during the punch. The spike is a response to the rebounding impact of the CV/weights. An average value of .003 in or less is demonstrated in the response when the solution is stopped.

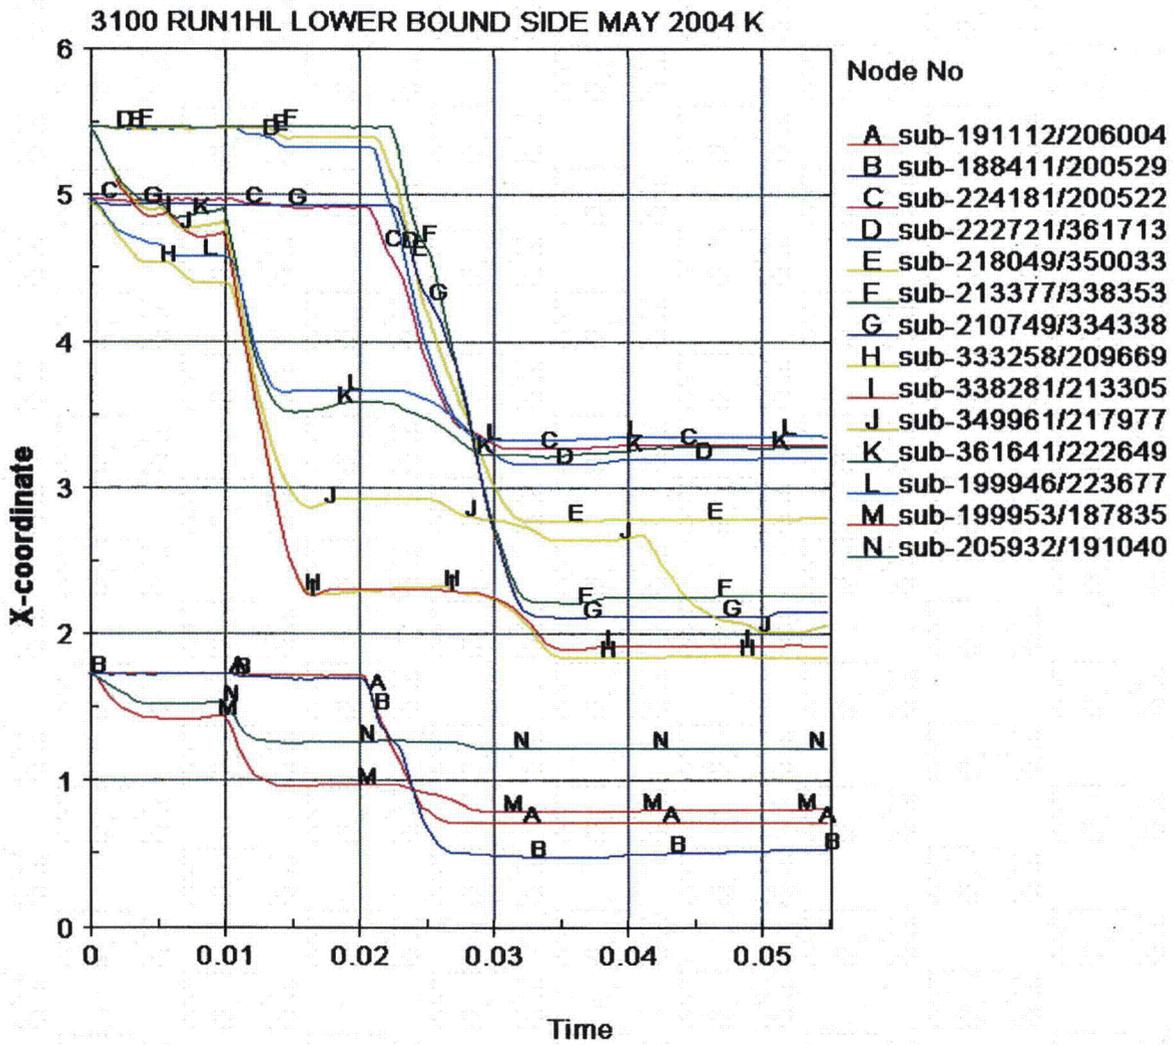
Figure 3.3.20- Run1hl, Kaolite Thickness Time History

Figure 3.3.20 shows the time history for the kaolite thicknesses. The nodal locations for nodes shown in Figure 3.3.20 are shown in Figure 3.1.32.
