3.2 Run1ga - Side

3.3 Run1hl - Side

3.4 Run1hh - Side

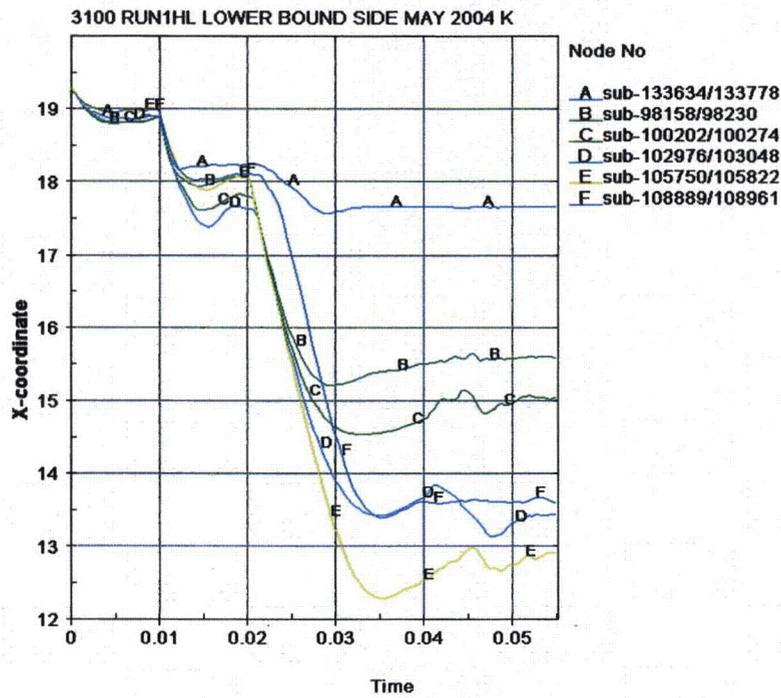
Figure 3.3.21 - Run1hl, Drum Dimension Time History in the X-Direction

Figure 3.3.21 shows the diameter changes in the drum in the model X direction. Figure 3.3.22 shows the radial changes in the Y direction (normal to the impact directions). The nodes are defined in Figure 3.1.34.

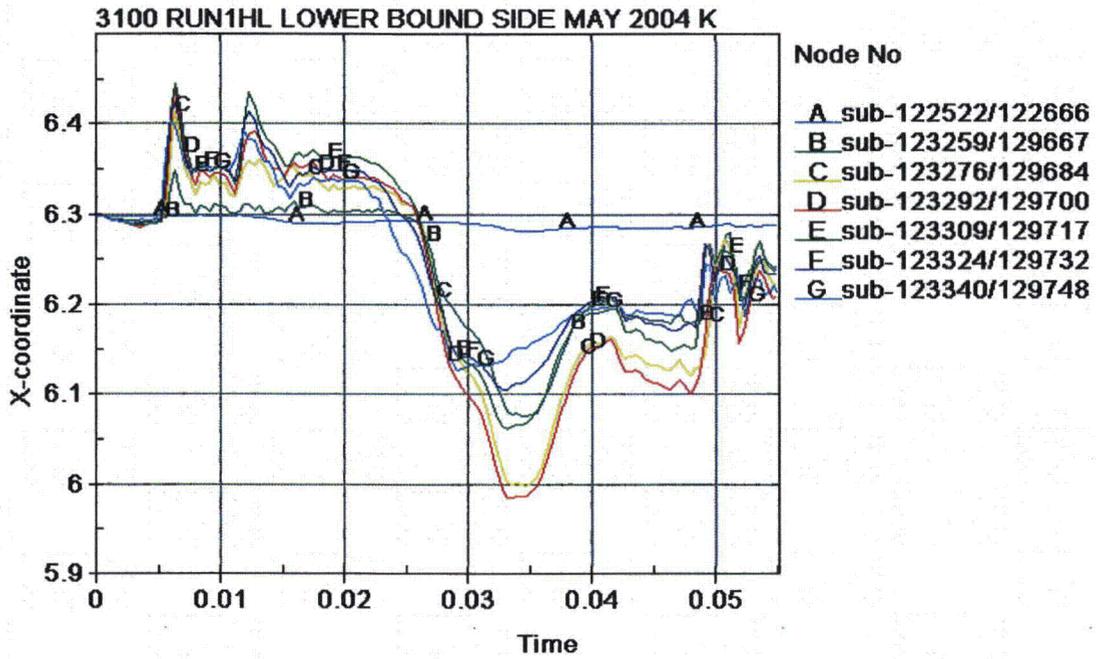
Figure 3.3.23 - Run1hl, Liner Diameter Time History

Figure 3.3.23 shows the liner diameter time history. The node pair locations are shown in Figure 3.1.37 and Table 3.1.3.

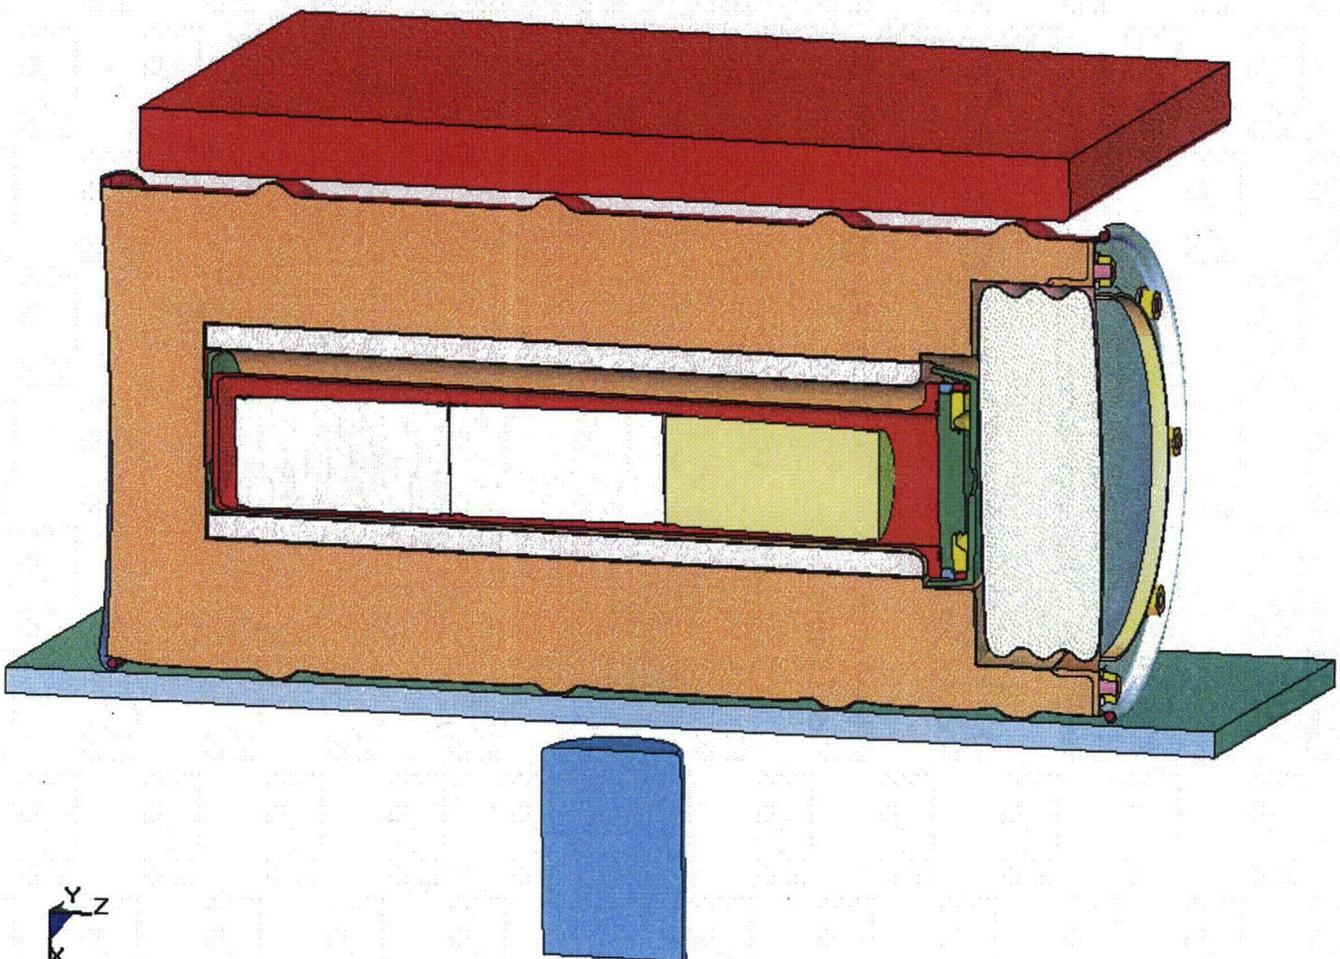
Figure 3.4.1 - Run1hh, 4-Foot Impact, Final Configuration

The final configuration for the 4-foot impact is shown in Figure 3.4.1. Figures 3.4.2 and 3.4.3 show the configuration at the corners of the shipping package. The effective plastic strain in the CV body for the 4-foot impact is shown in Figure 3.4.4. The maximum effective plastic strain is shown to be 0.0298 in/in near the bottom head. The effective plastic strain in other package components for the 4-foot impact are listed in Table 3.4.1.

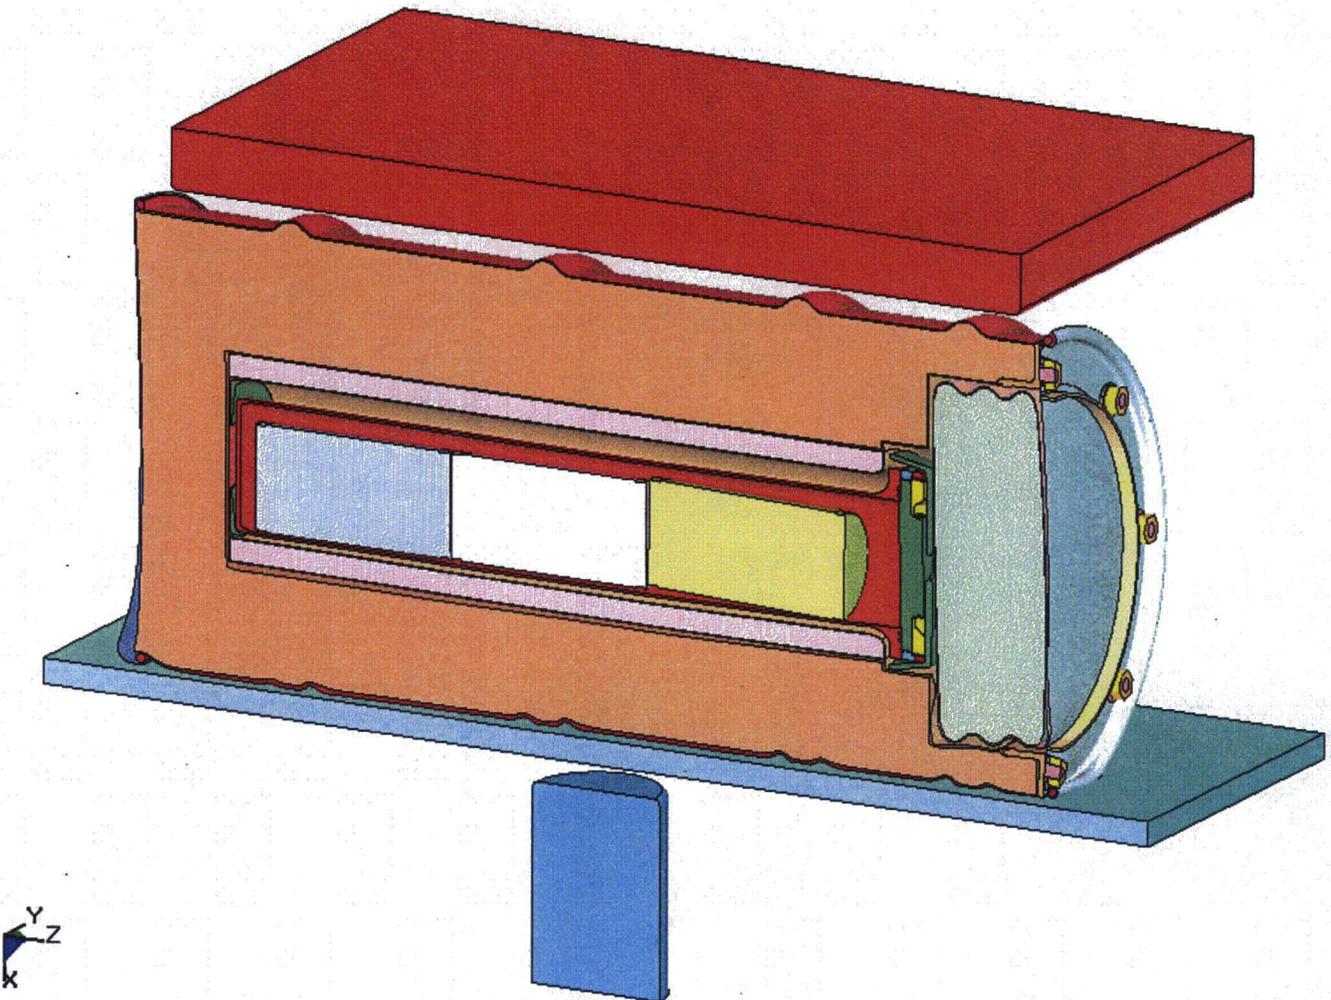
Figure 3.4.5 - Run1hh, 30-Foot Impact, Final Configuration

The final configuration for the 30-foot impact is shown in Figure 3.4.5. Figures 3.4.6 and 3.4.7 show the configuration at the corners of the package. The maximum effective plastic strain for the 30-foot impact in the CV Body is 0.0386 in/in near the bottom head. The maximum effective plastic strain in the drum lid is 0.4073 in/in near the rigid plane.

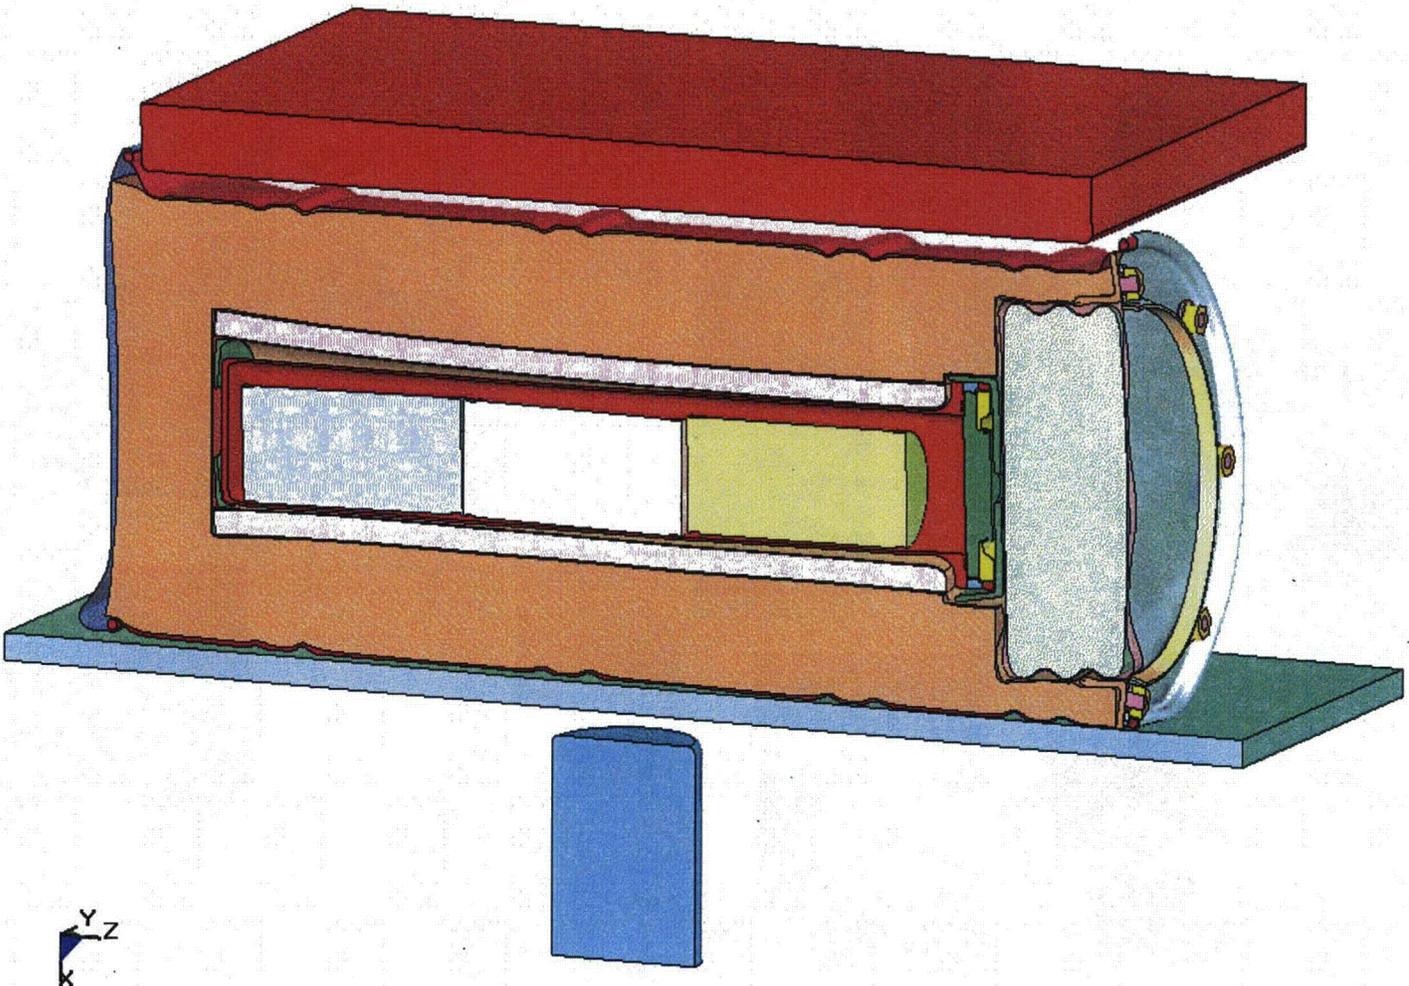
Figure 3.4.10 - Run1hh, Crush Impact, Final Configuration

The final configuration for the crush impact is shown in Figure 3.4.10. The configuration at the extremes of the package are shown in Figure 3.4.11. The maximum effective plastic strain for the crush impact in the CV body is 0.0462 in/in, on the crush plate side near the lid end of the top inner weight as shown in Figure 3.4.12. The maximum effective plastic strain in the drum is 0.2623 in/in near the angle and the rigid plane (Figure 3.4.13). The maximum effective plastic strain in the drum lid is 0.6411 in/in (surface strain), Figure 3.4.14. The maximum occurs at the lid hole for the stud closest to the crush plate (180°). The membrane effective plastic strain is 0.4922 in/in at this location. The effective plastic strain in the studs is 0.1753 in/in as shown in Figure 3.4.15. The effective plastic strain in other components are listed in Table 3.4.3 for the crush impact.

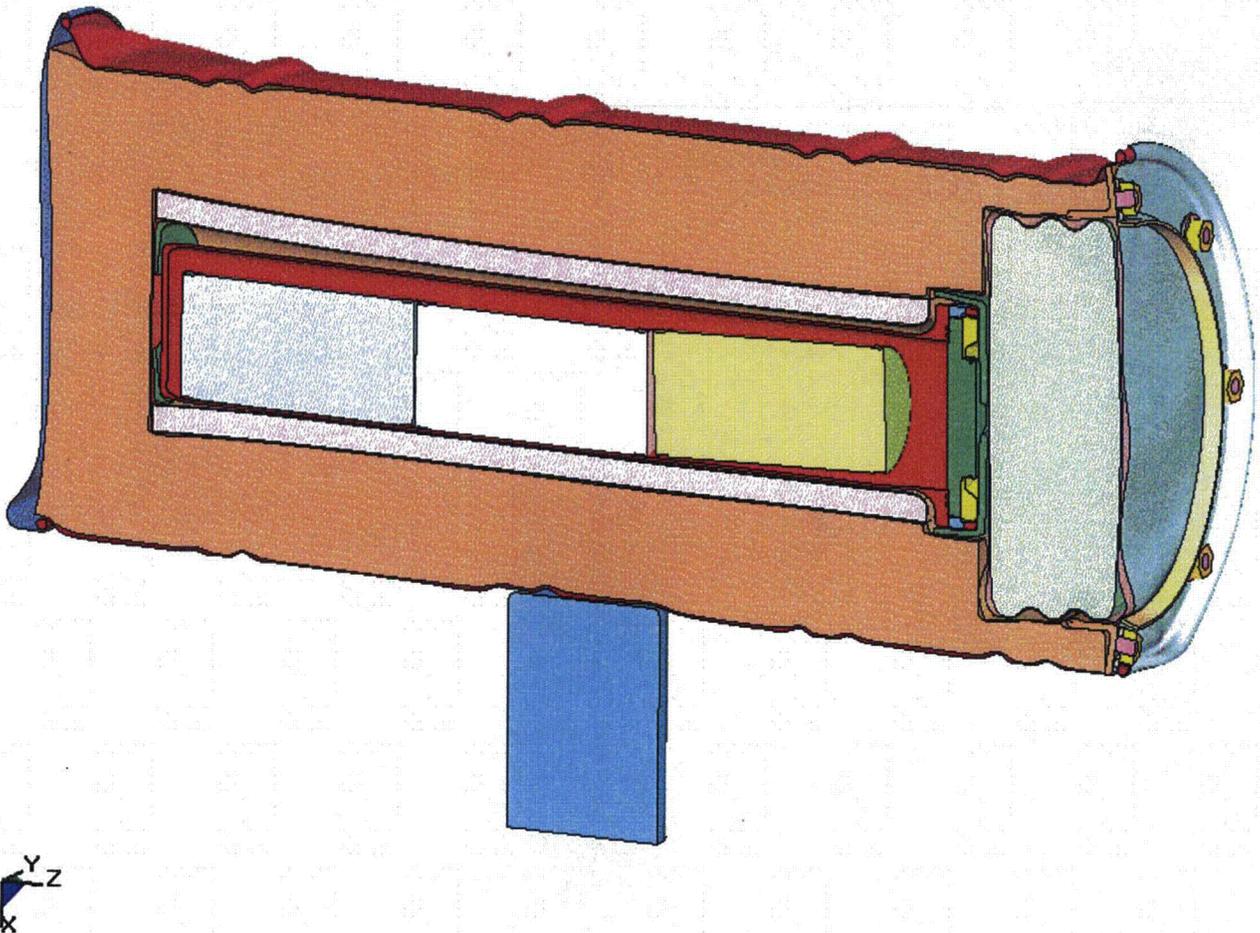
Figure 3.4.16 - Run1hh, Punch Impact, Final Configuration

The final configuration for the punch impact is shown in Figure 3.4.16. The maximum effective plastic strain in the CV body after the punch impact is shown to be 0.0599 in/in in Figure 3.4.17. The maximum effective plastic strain in the drum is 0.2623 in/in (surface strain) and is located near the angle at the rigid surface. The maximum effective plastic strain in elements local to the punch impact is 0.1382 in/in (surface strain) as shown in the insert in Figure 3.4.18. The maximum effective plastic strain for the lid and other package components at the end of the punch impact are listed in Table 3.4.4.

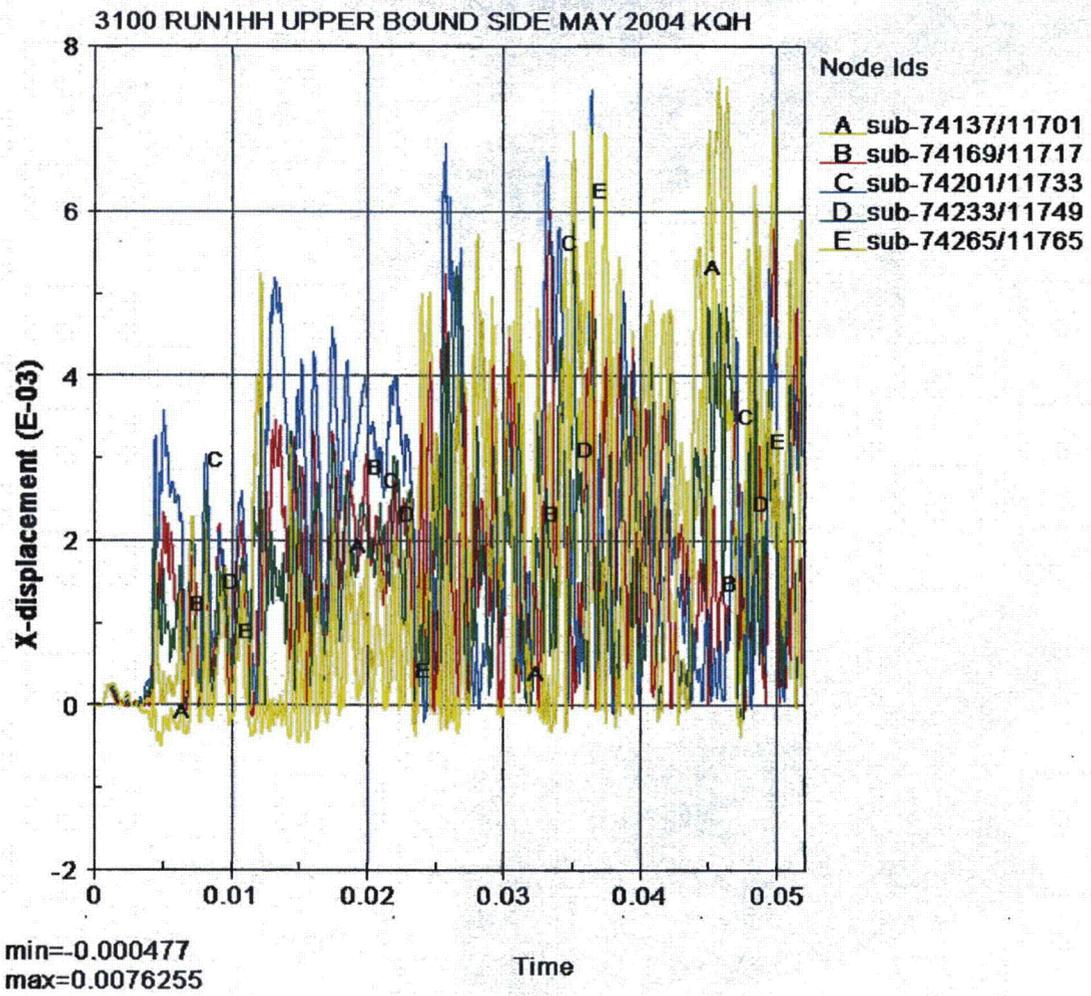
Figure 3.4.19 - Run1hh, CV Lid Separation Time History

Figure 3.4.19 shows the CV lid separation for all the impacts. A maximum spike for the lid separation of less than 0.008 inches is found. At the end of the impacts, the maximum separation is on the order of 0.006 in, with the response being oscillatory in nature. Average separation of 0.003 inches or less is shown to be expected after the successive impacts.

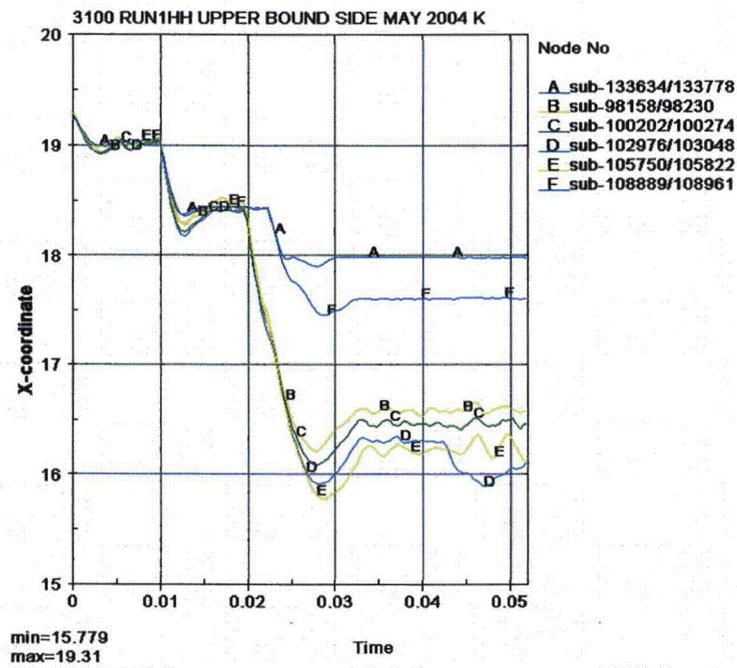
Figure 3.4.20 - Run1hh, Diameter of the Drum in the Direction of the Impacts

Figure 3.4.20 shows the drum diameter time history response to the impacts in the X direction (direction of the impacts). Figure 3.4.21 shows the Y direction radial response (normal to the impact direction). The drum nodes are defined in Figure 3.1.34.

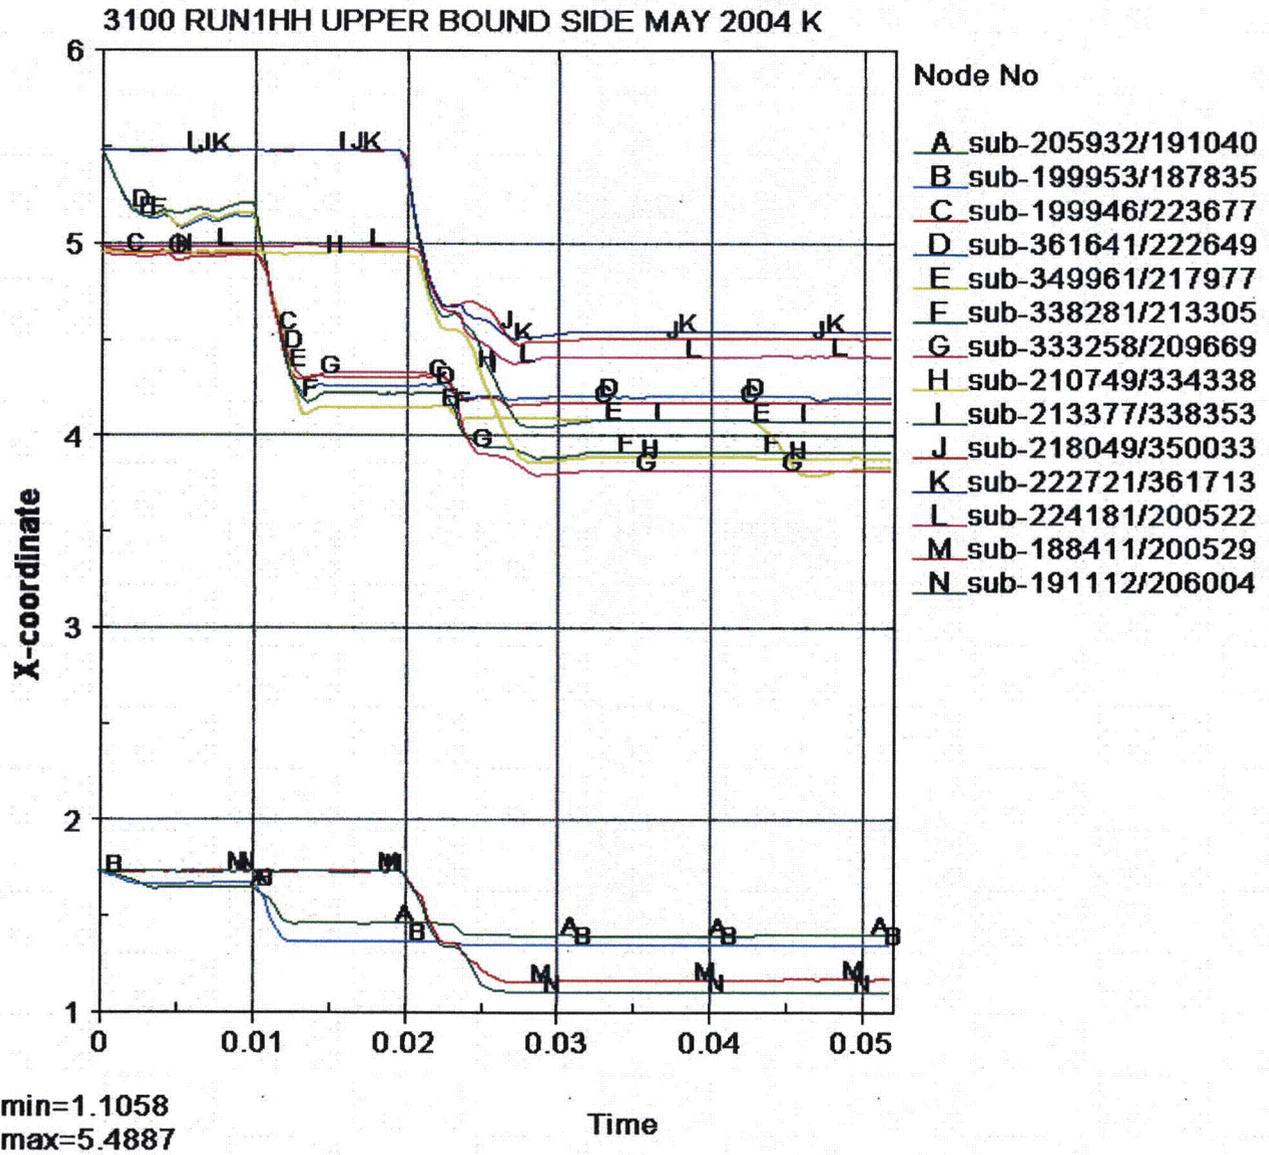
Figure 3.4.22 - Run1hh, Thickness Time History of the Drum Kaolite

The Figure 3.4.22 shows the kaolite thickness time history for the four impacts. Figure 3.1.32 shows the nodal locations.

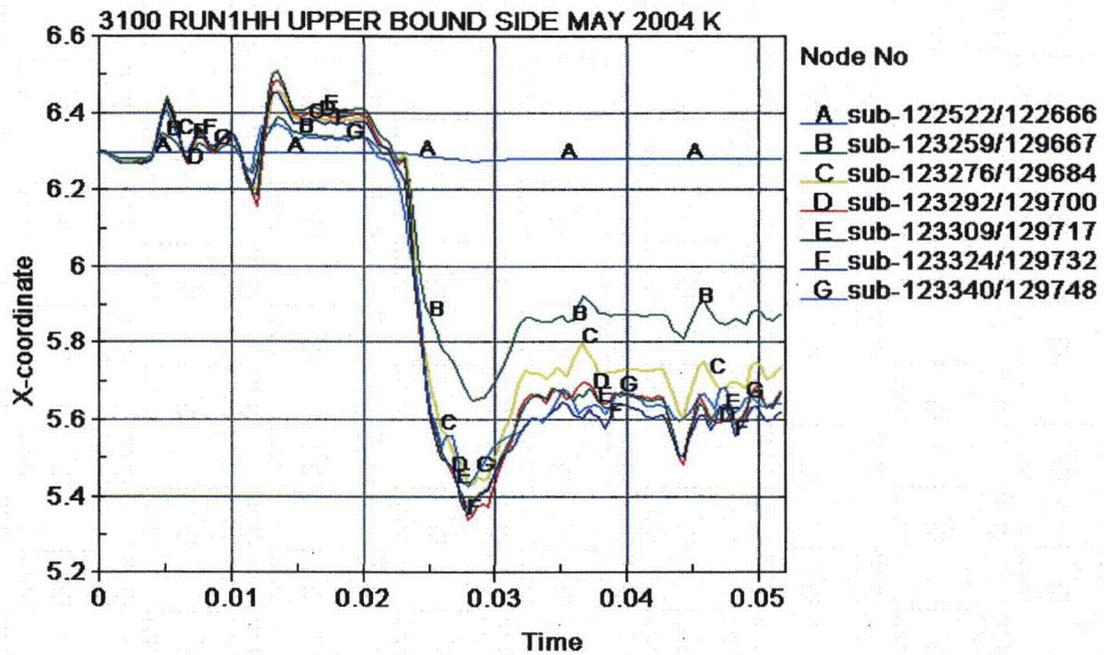
Figure 3.4.23 - Run1hh, Liner Diameter Time Histories

Figure 3.4.23 shows the liner diameter time history along its length. The nodal pairs are defined in Figure 3.1.37 and Table 3.1.3.
