### 3.1.4 Vibration Test

## 4 HAC TESTS

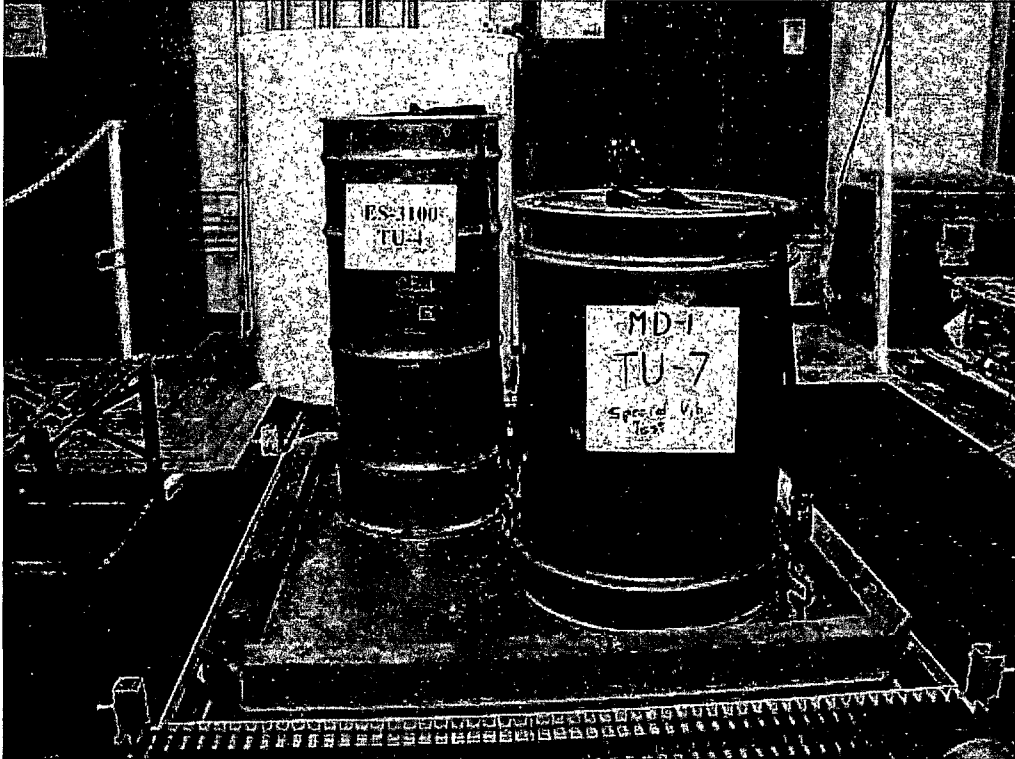
After having undergone the water spray test, free drop, penetration test, and the compression test, TU-4 was securely strapped to the vibration table with a nylon tie-down strap (as specified in the test plan) to begin the 4-hour test (Figure 3.5).

Figure 3.5 Test units staged for vibration testing

After the vibration test there was no apparent damage to the exterior of the package. The package was not opened to inspect the internal condition. However, upon later opening the package, there was an effect observed that was attributed to the vibration test. See Section 5.1, Drum Disassembly Observations.

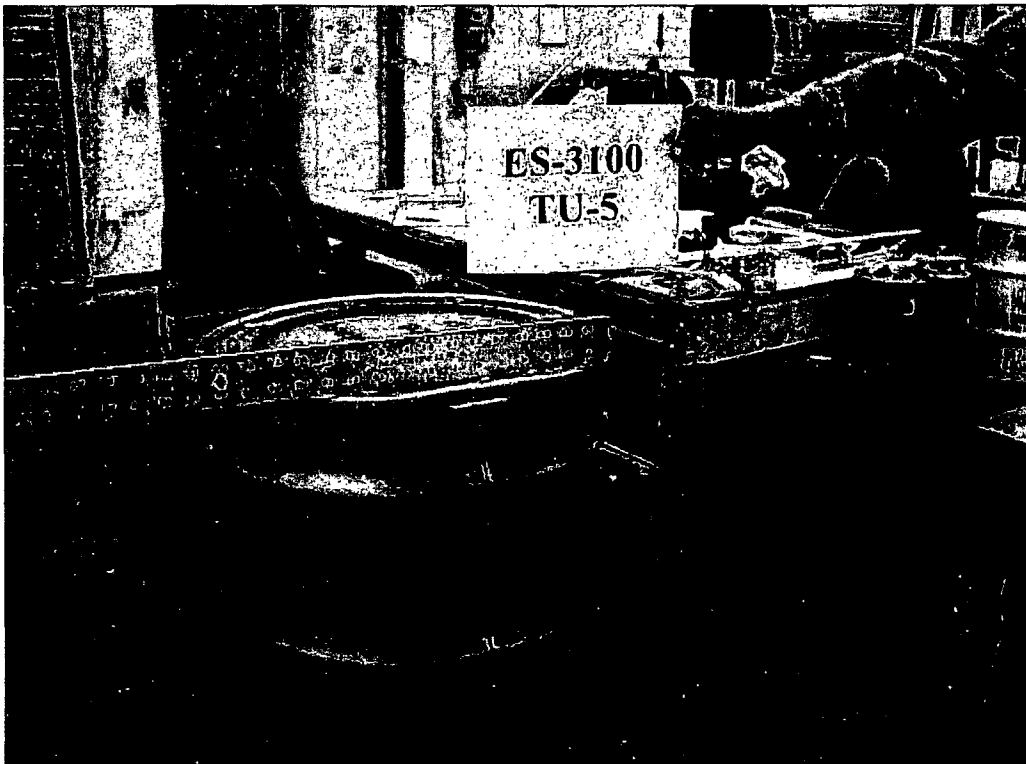
TU-5 deviated only 0.1° from the intended 12° angle to horizontal and was dropped on the 0° line of the package. The top false wire absorbed most of the impact and showed the most damage resulting from 1.2-m NCT drop. Figure 3.11 shows the extent of the flattening that occurred. It lost 0.5 in diameter along the 0° to 180° width and had a flat of 5-3/8 in. Also, the washer at about 270° was movable, though the nut remained more than finger tight. The diameters of the rolling hoops uniformly decreased by 1/8 in, and the diameter of the bottom false wire decreased by 1/4 in. The bottom false wire also had a flat of 5 in.

Figure 3.11 Flattening of top false wire of TU-5.

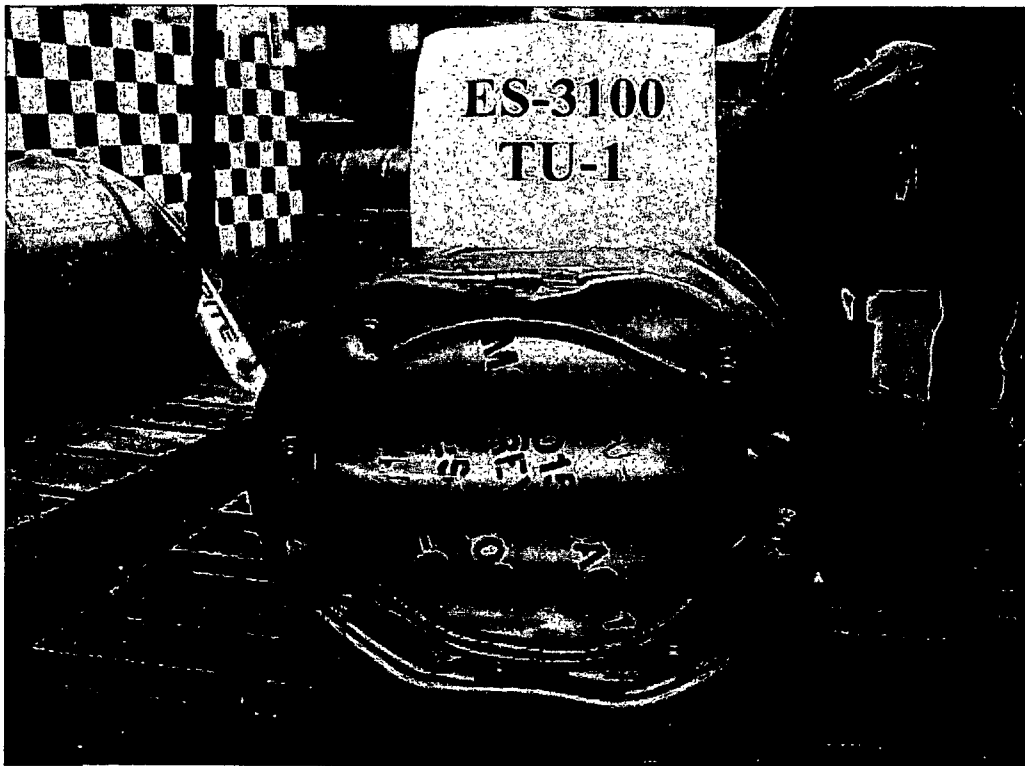
Test Units 1 through 5 were subjected to the dynamic crush test. This test consisted of placing the test units on the unyielding impact pad and dropping a  $1\text{ m} \times 1\text{ m}$  square 500 kg (1102 lb) steel plate onto the package from a 9-m (30-ft) drop height. Figure 4.7 shows the results of the dynamic crush test of TU-1.

Figure 4.7 Results of the dynamic crush test of TU-1.

TU-1 was set horizontally on the impact pad with the previously damaged 0° side down and the crush plate was centered over the approximate location of the CV flange, about 8 inches from the top of the package. The impact flattened the 180° side above the bottom hoop, generating a flat of 8-1/2 inches at the top false wire and 10-5/8 inches just above the bottom hoop. The impact also increased the flattening of the 0° side, generating a flat of 10 inches at the CG hoop to 9 inches at the top false wire. The diameter of the drum along the direction of impact was reduced by 2-7/8 inch at the top false wire and about 2-3/8 inch just above the bottom hoop. No nuts were loosened. See the datasheet in the Appendix H for more details. See Appendix A for photographs of damage.

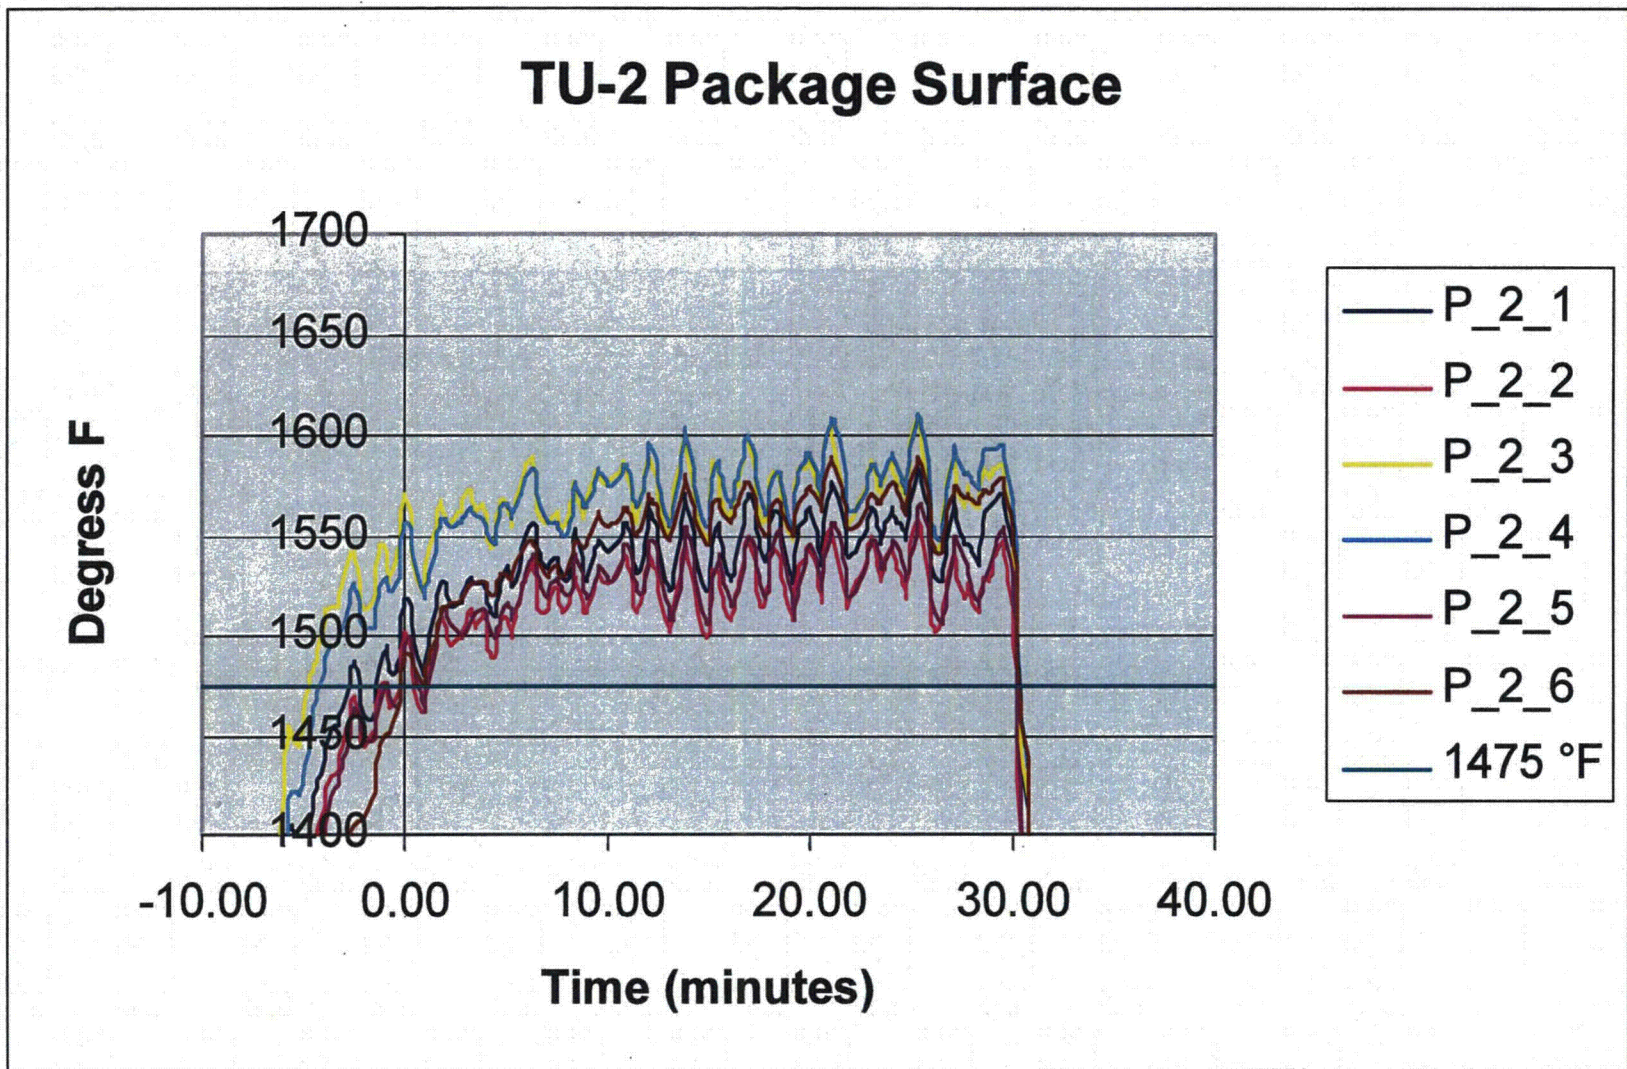
Figure 4.42 TU-2 Thermal test, Package thermocouples

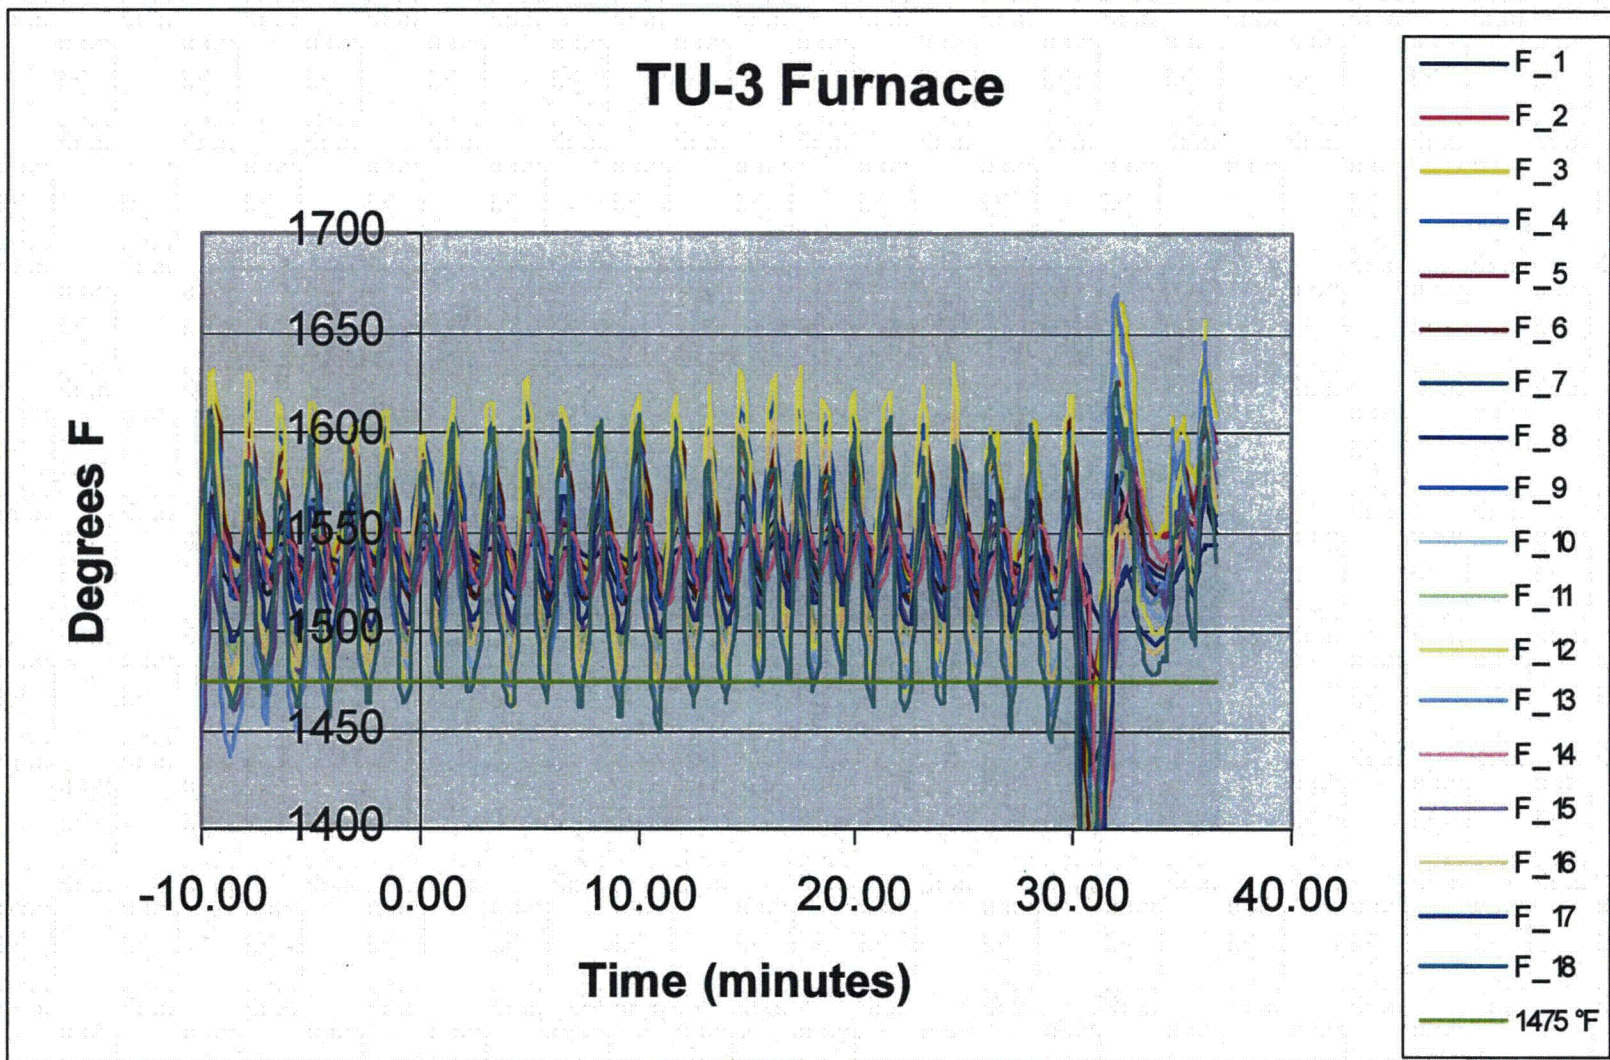
Figure 4.43 TU-3 Thermal test, Furnace thermocouples

TU-3 was preheated to above 100 °F for approximately 47 hours. After preheating, the test unit was removed from the preheat chamber and the 6 external thermocouples were installed. The unit was oriented horizontally, top to the right, with 0° down. The unit was loaded into the furnace and door closed in 59 seconds. The 30-minute test began 13 minutes after loading. Upon removal, smoke coming from the TID holes was noted. The unit was placed on a cooling stand. The package smoked lightly for about 35 minutes. All six burners were on for this test only.

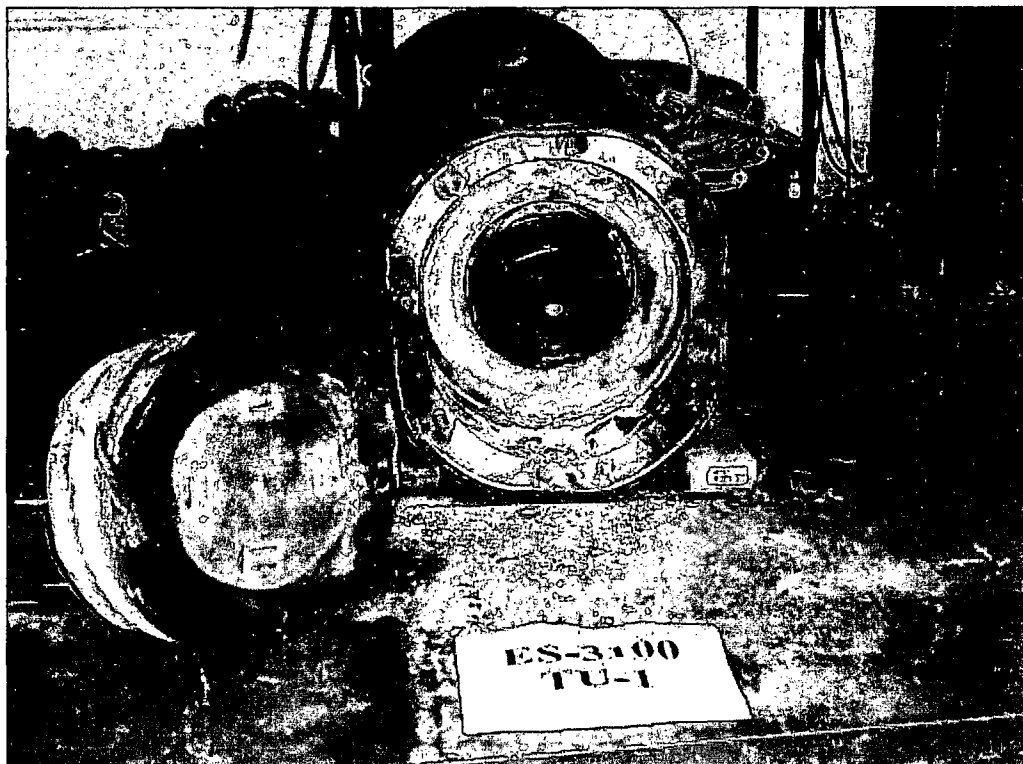
Figure 5.2 TU-1 with top plug removed

Figure 5.2 shows how the silicone cushion that fits between the top plug and inner liner had partially disintegrated, but the cushion at the top of the CV had remained intact. The gray char on the floor at the lip of the drum resulted from the dark gray silicone cushion turning whitish upon charring and depositing a residue. Another effect that was attributed to the charring of the silicone cushion was the presence of a few drops of purplish fluid. (See Figure 5.3) This was also seen in other units where the silicone cushion had burned and is likely a by-product of decomposition.

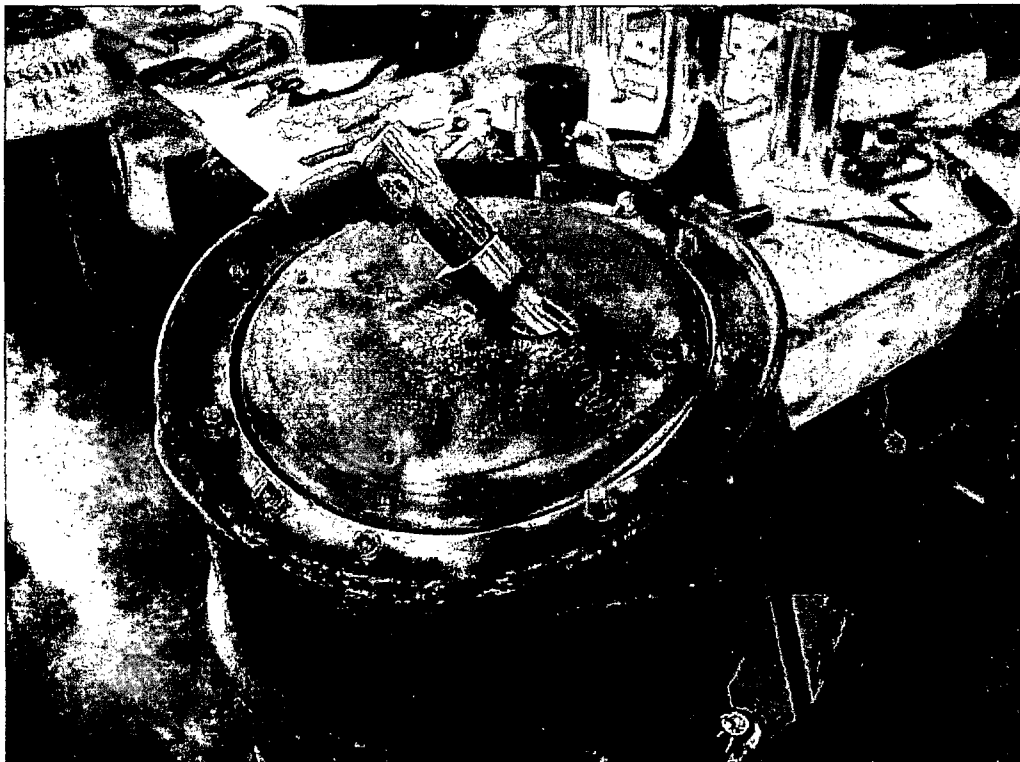
Figure 5.5 The lid of TU-3 being prepared for cutting

Having experienced a drop on the lid edge, CG over corner and the impact of the crush plate on its opposite corner, the drum of TU-3 could not stand upright because the bottom and top of it had been considerably deformed. The lid of TU-3 had to be pried off with considerable effort, and the top plug was extremely difficult to remove. In fact, it was necessary to cut the top plug with a pneumatic cutting shear and remove the exposed Kaolite so that the top plug shell could be collapsed enough to allow it to be removed from the drum (Figure 5.5). After a section of the top of the plug had been removed, the Kaolite was scooped out and the plug was then cut, folded away from the pinch-point of the drum, and removed with a crowbar. The Kaolite was retained in a plastic bag for weighing or material balance. Figure 5.6 shows a view of the top plug after removal. After the top plug was removed, the CV was easily removed.

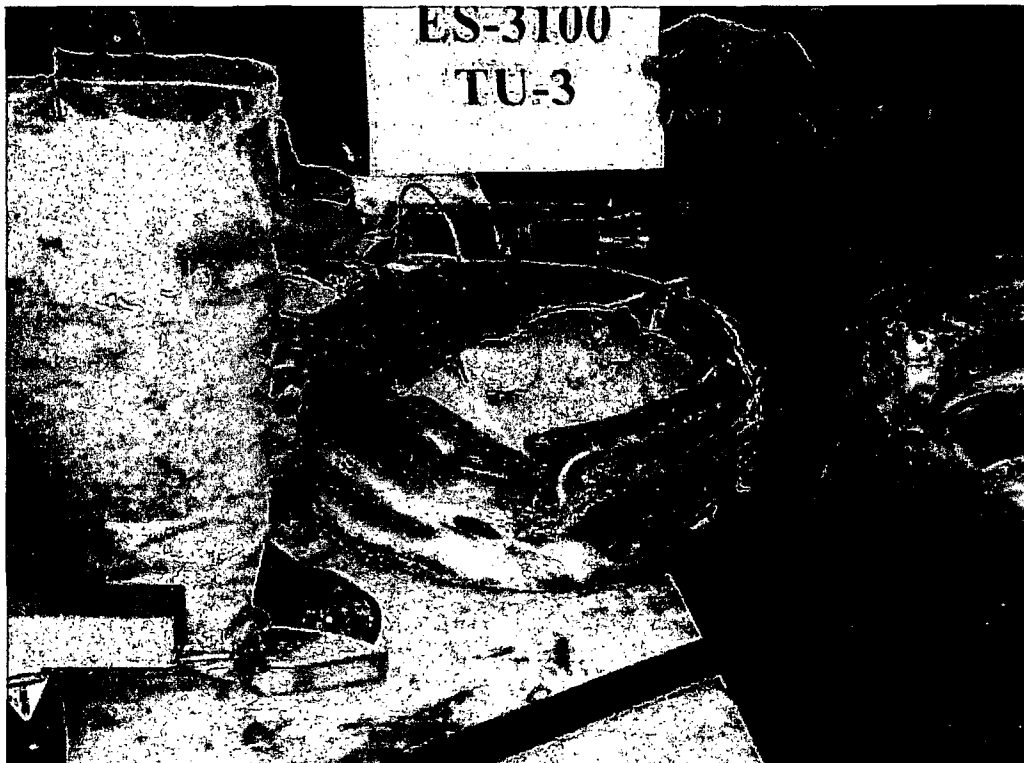
Figure 5.6 Top plug and kaolite from TU-3

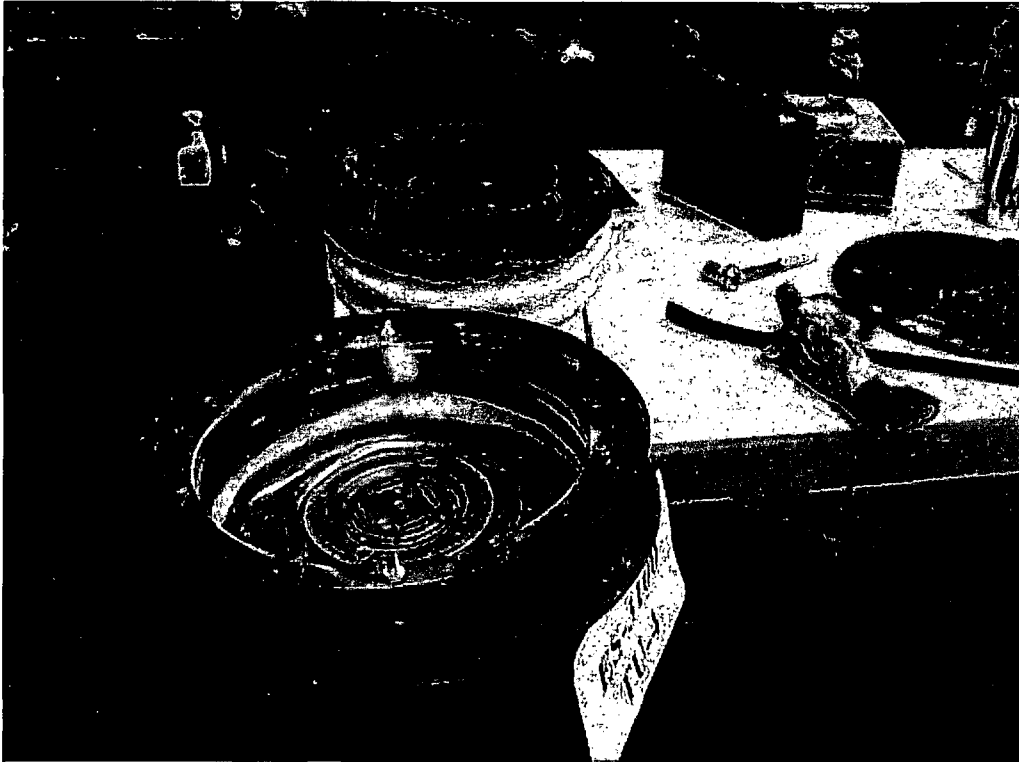
TU-4 had experienced both a 4 ft and a 30-ft drop onto its drum head and the crush plate had been dropped on its bottom. Thus, most of the apparent damage was to the lid area. The lid and top plug were removed with crowbars. The uppermost vertical section of the inner liner was protruding upward. Figure 5.7 shows how the uppermost vertical section of the inner liner protrudes upward. Figure 5.8 is a top view of this phenomenon.

**Figure 5.7 Convex appearance of inner liner of TU-4 drum**

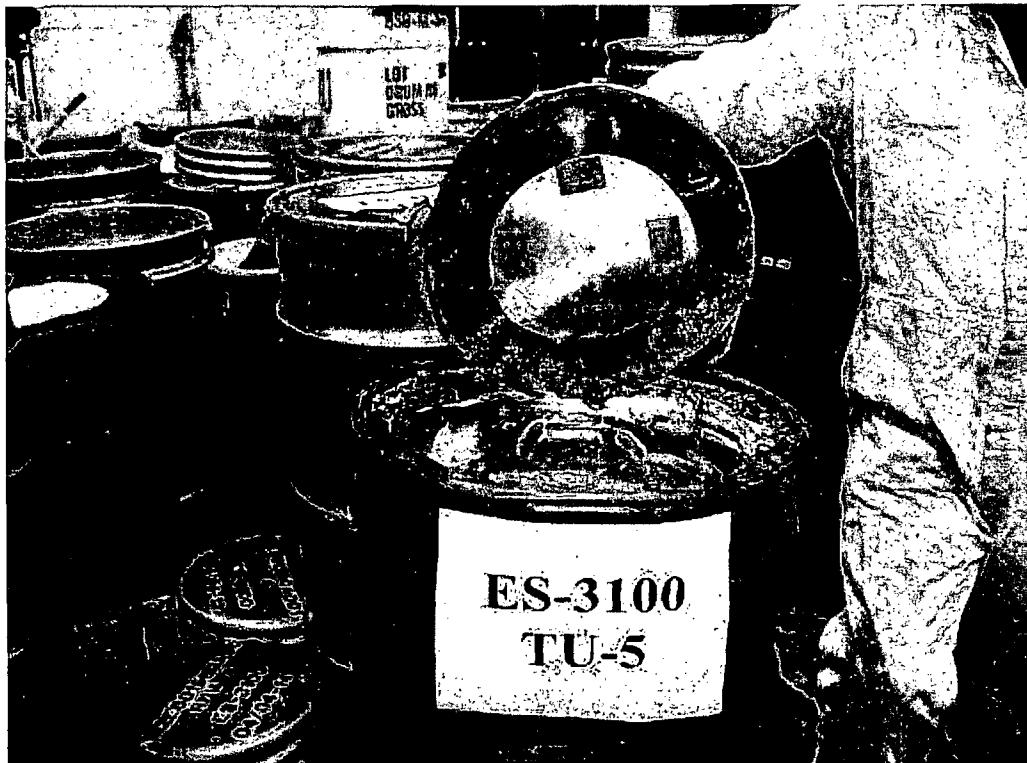
TU-5 was in relatively good shape after the tests and was easily disassembled. Most of the silicone cushion underneath the top plug withstood the thermal test. So not much char was present but the silicone itself was goeey and sticky. Figure 5.10 gives an indication of the degraded state of the silicone cushion.

Figure 5.10 Deterioration of TU-5's silicone cushion

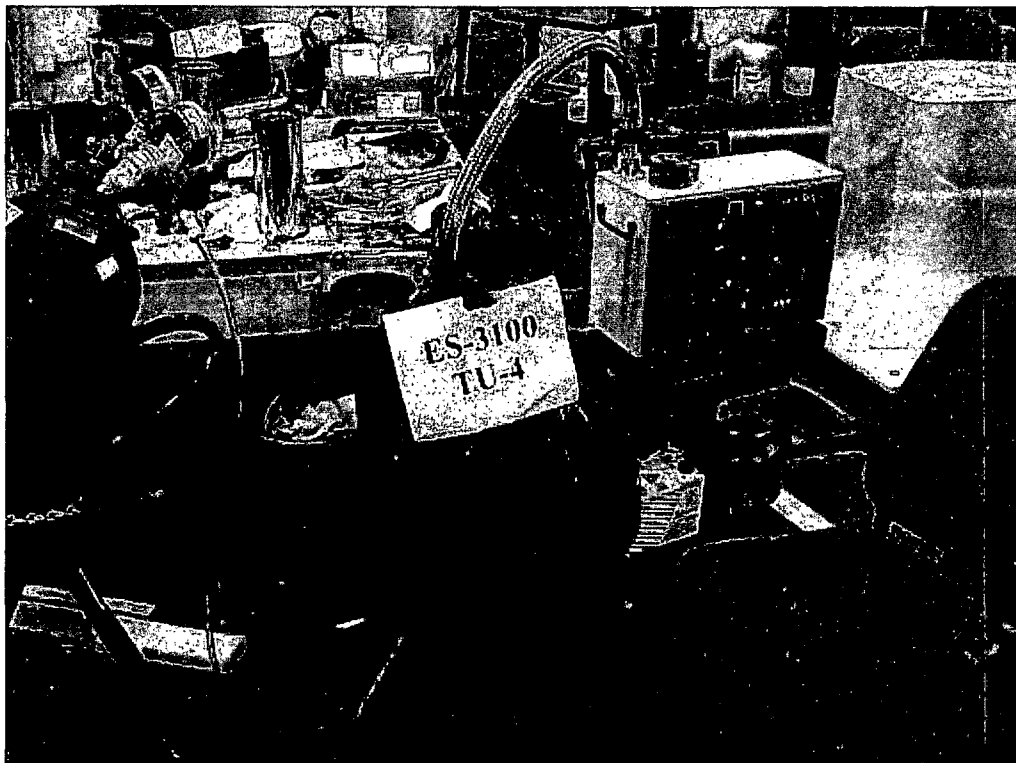
The main body of the each CV was leak checked to a sensitivity of  $1 \times 10^{-7}$  cc/sec using the Varian Model 959 helium leak test system and was performed to the TTG Procedure TTG-PRF-02, Rev. 0, dated 1-30-04. Each CV was prepared for the test by drilling a hole in the CV lid and tapping for a 1/4-inch NPT tapered pipe thread. A K-flange adapter was screwed into the hole with fast setting epoxy on the threads to seal them. After the epoxy hardened, the mass spectrometer helium leak tester was connected to the adapter. The vacuum pump was then engaged and the volume of the CV was evacuated to < 100 milli Torr. The CV was enclosed in a plastic bag and evacuated with a shop vacuum to reduce the ambient air in the bag. A constant flow of helium gas was introduced into the bag to ensure that the CV would remain bathed in helium during the test. The helium atmosphere was maintained for at least 20 minutes. Figure 5.11 shows one of the test units being subjected to the full containment boundary leak test. Complete data from these tests are given on Appendices H – L. Photos of the various leak tests are shown in Appendices A – E.

**Figure 5.11 TU-4 undergoing the containment boundary helium leak test**

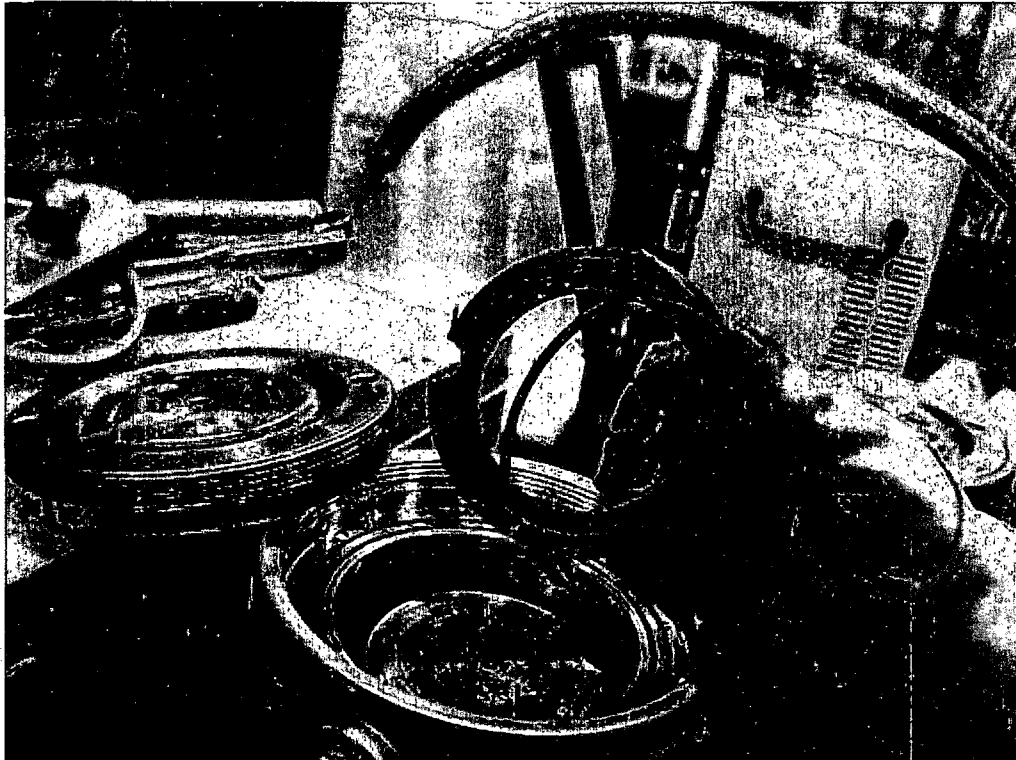
The surrogate payloads of TU-3 displayed more rust than most of the other units. Also, the silicone pads on top of the metallic payloads were beginning to unravel and fray. In Figure 5.22, note particularly how the cushion of the top load (further left in the picture) had stripped. On the other hand, the Borobond4 spacers were in excellent condition. Figure 5.23 is an illustration of how the temperature labels were abraded and marred by the movement of the load inside the CV.

**Figure 5.19 Disintegration of spacer cushion of surrogate load**

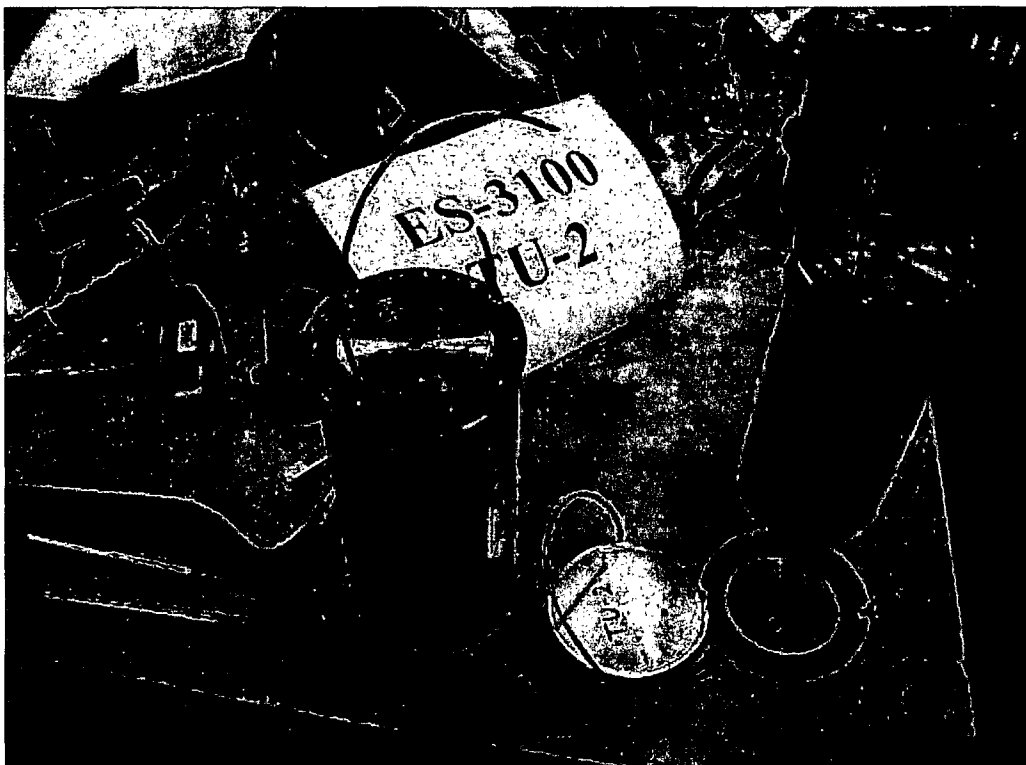
Figure 5.21 Broken cable lanyard of TU-2

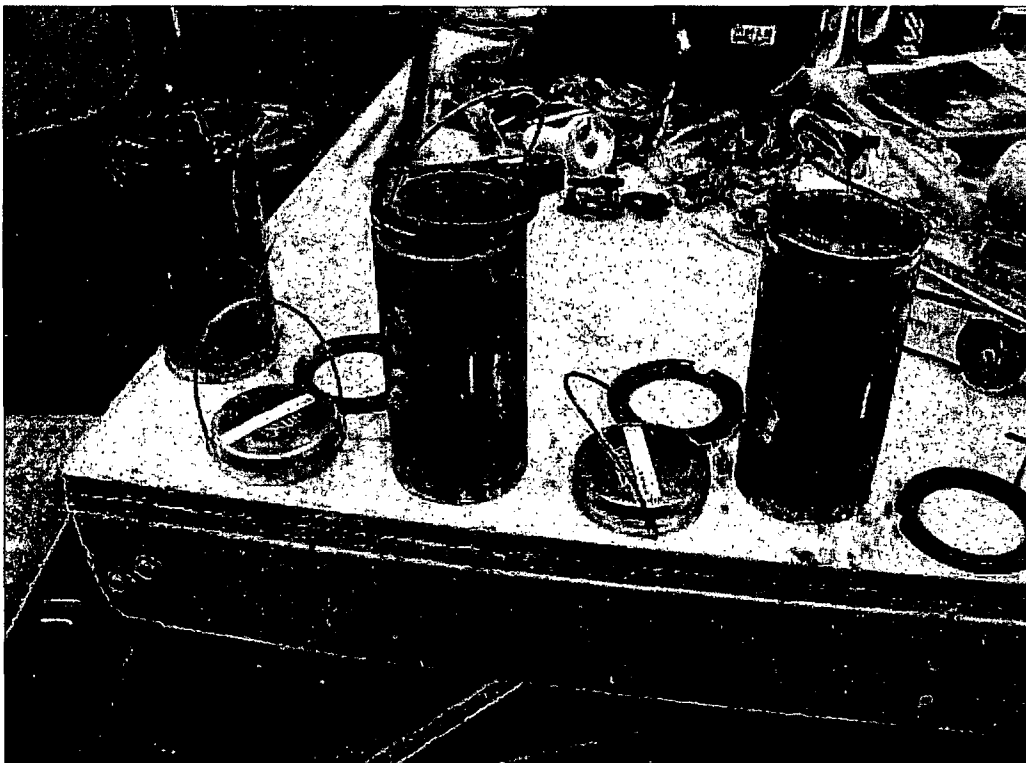
Figure 5.22 Surrogate payloads of TU-3

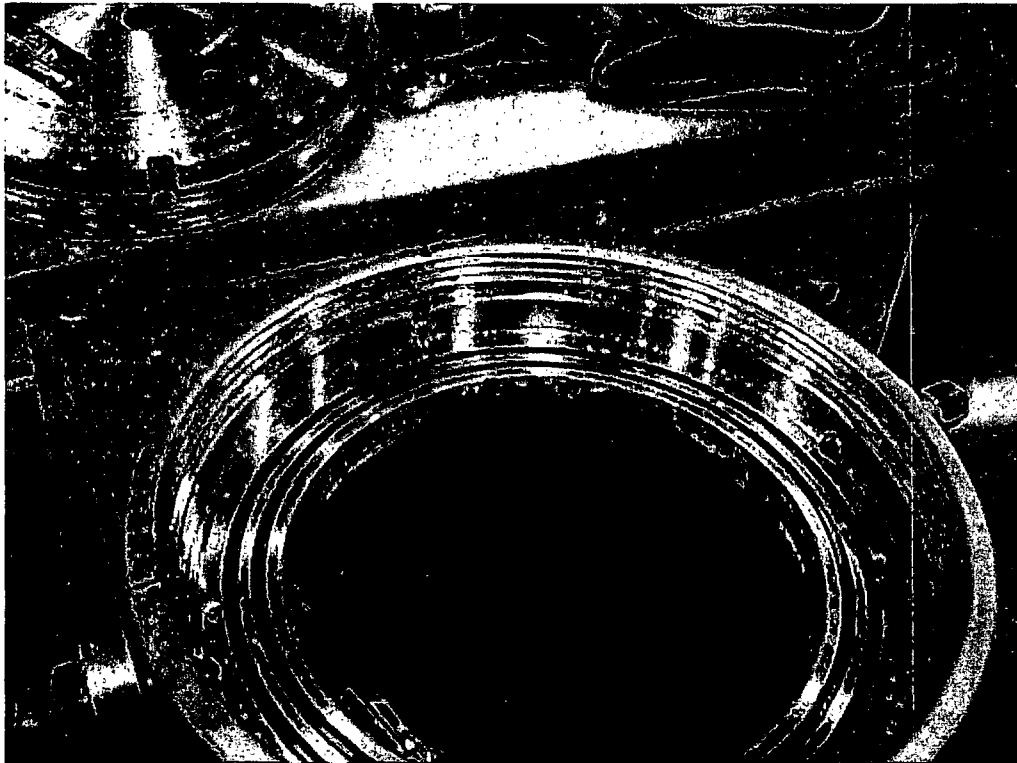
**Figure 5.23 Blemishing of temperature labels on flange of CV**

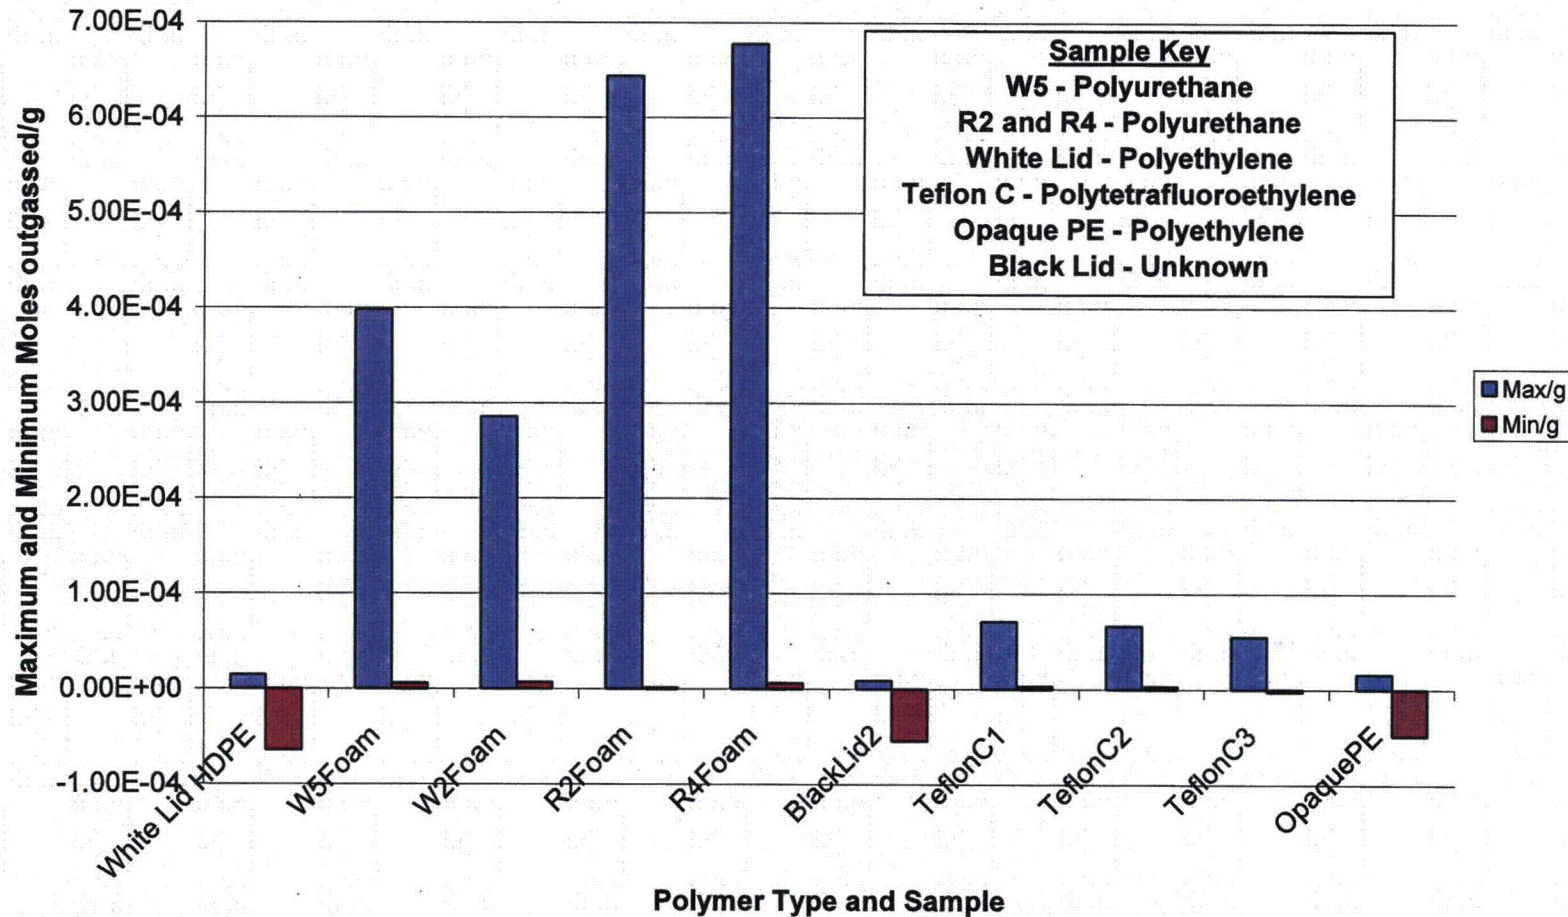
Fig. 14. Relative outgassing by polymer types examined.
