Rancho Seco  
Final Status Survey Summary Report  
March 24, 2008  
Service Water Piping System  
Survey Unit F8990471

## FINAL STATUS SURVEY SUMMARY REPORT

F8990471, Service Water Piping System

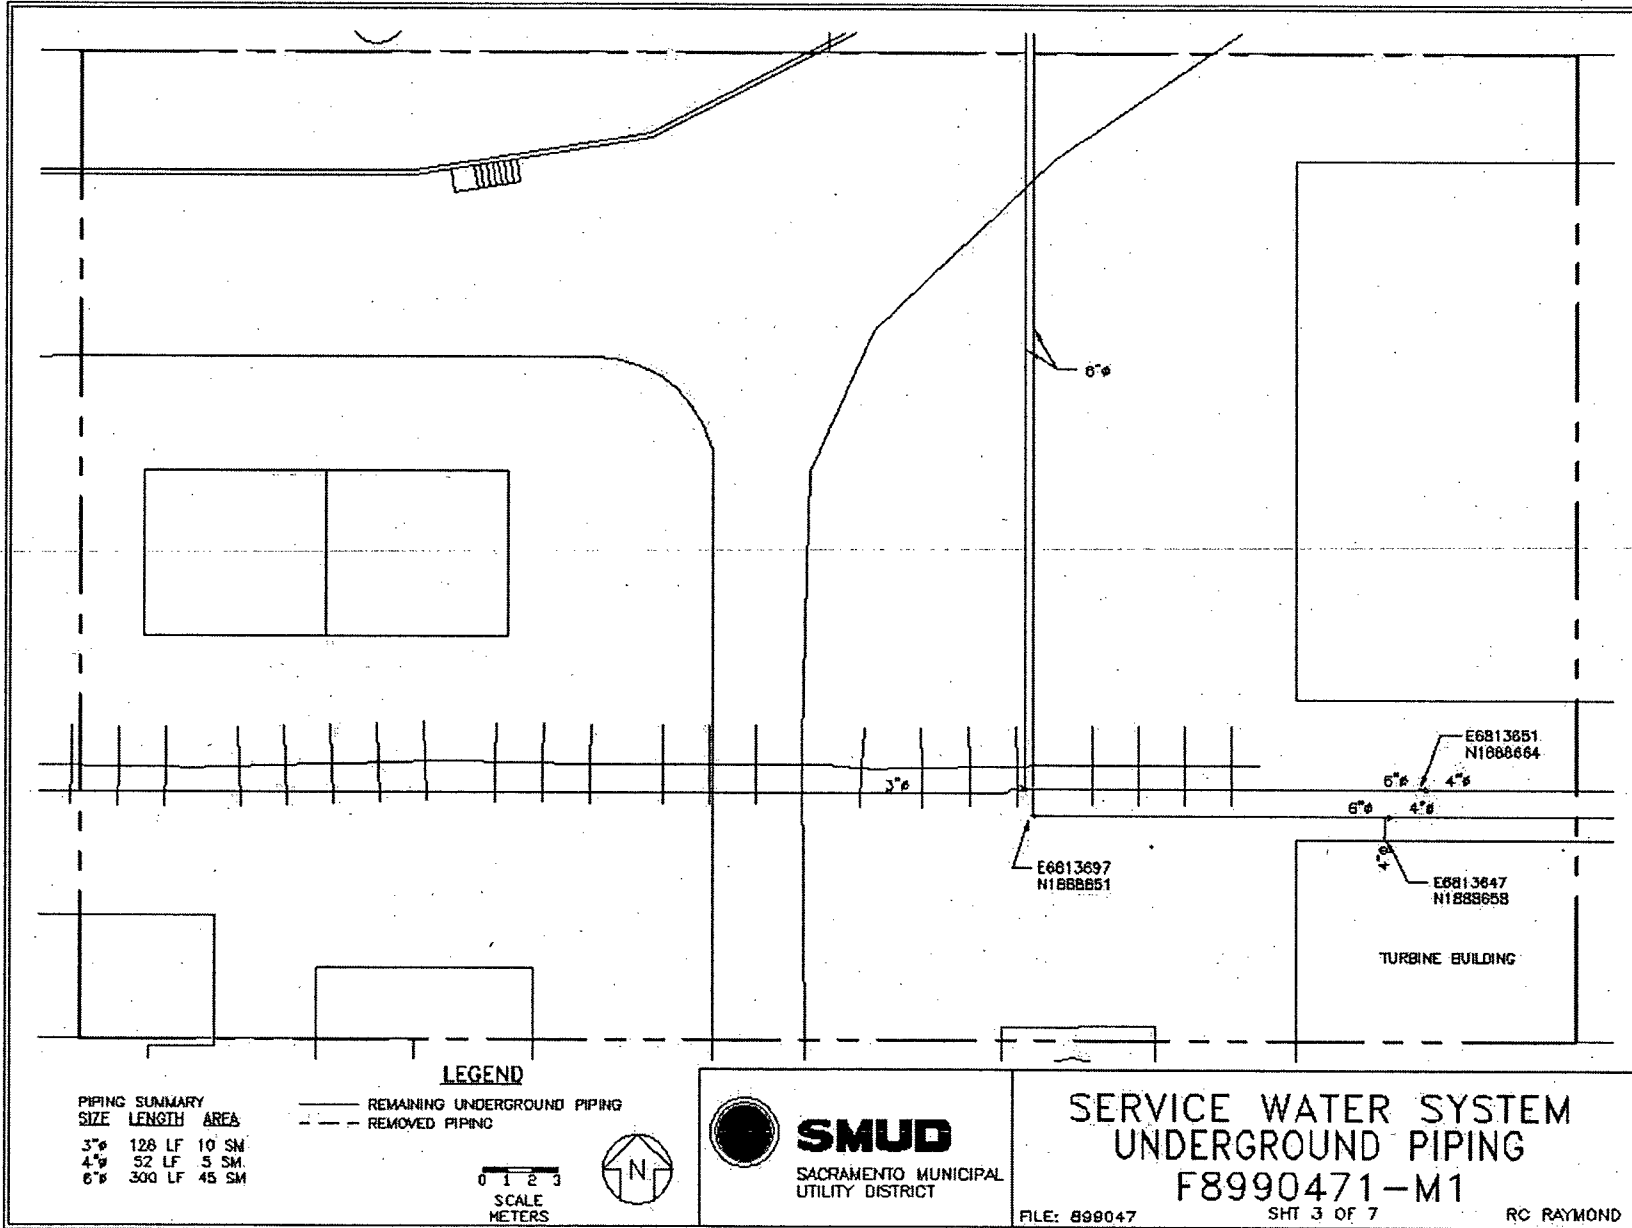
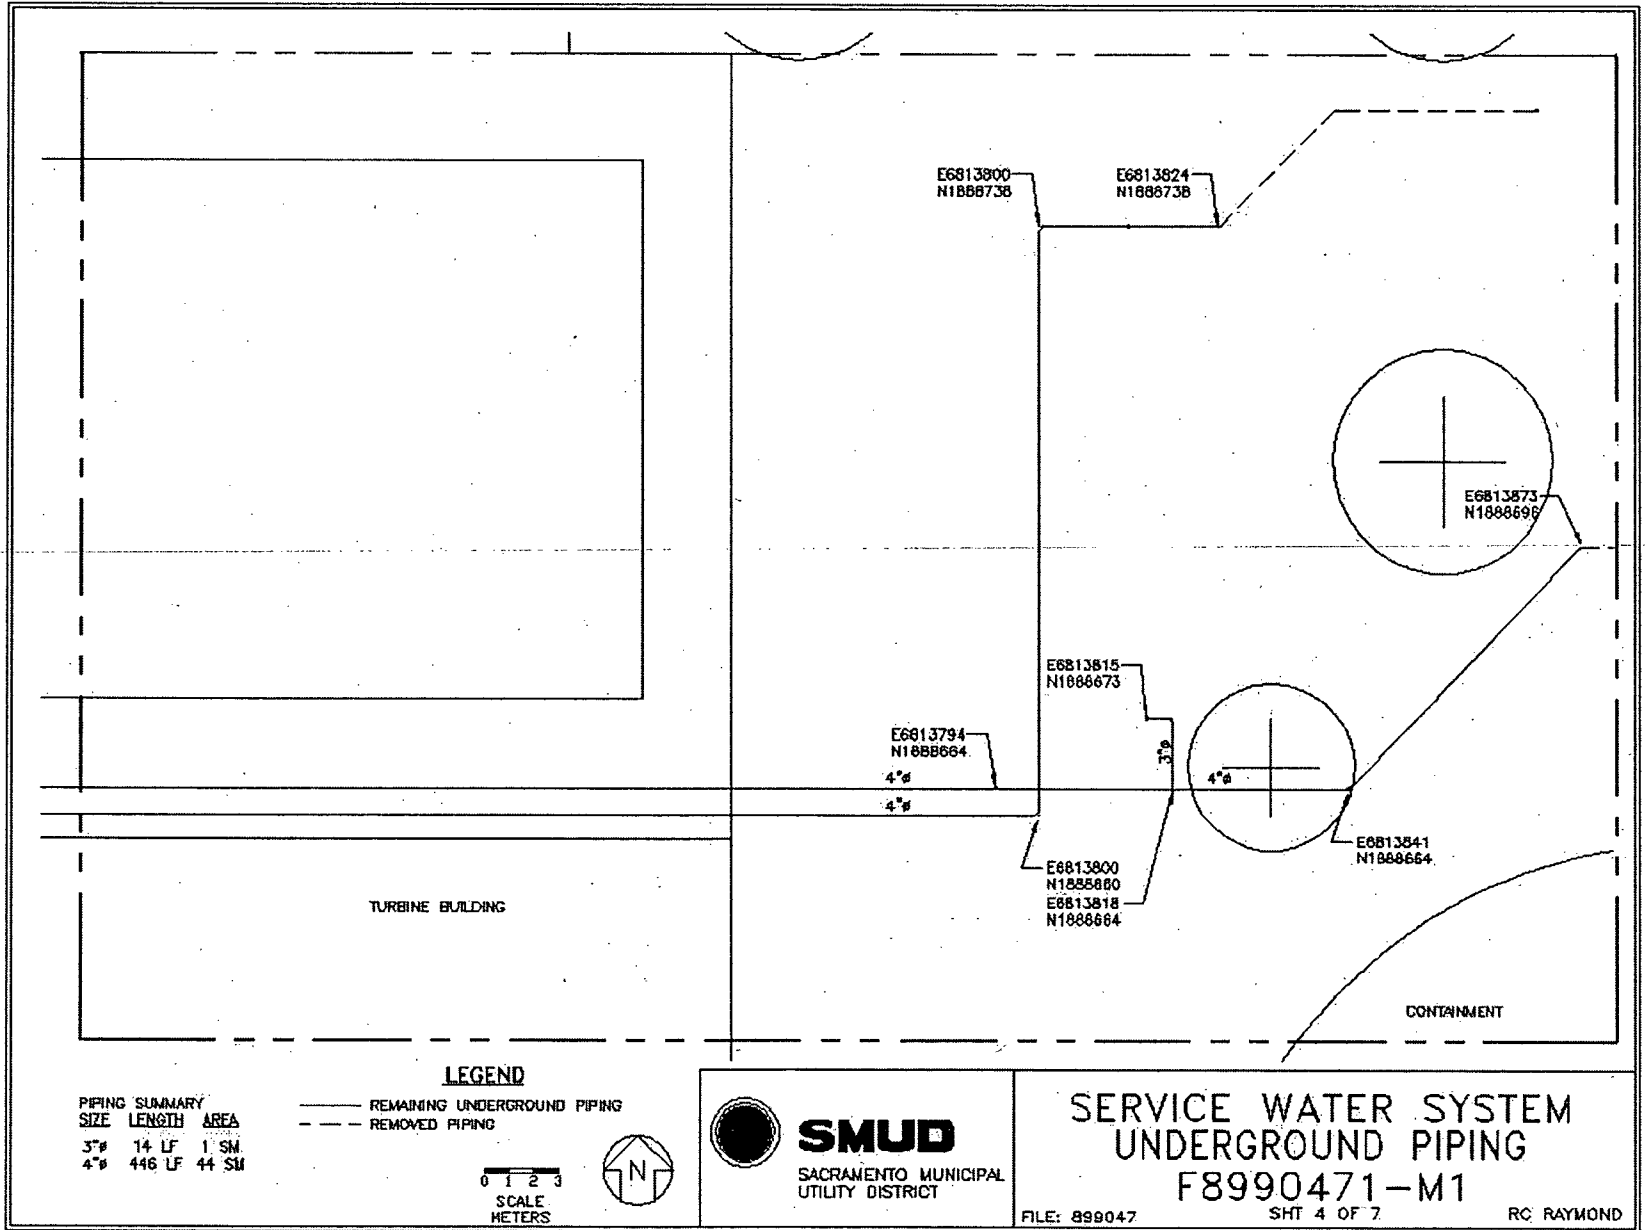
SHT 4 OF 7

SIZE	LENGTH	AREA
3"	14 LF	1 SM
4"	446 LF	44 SM

**SERVICE WATER SYSTEM  
 UNDERGROUND PIPING  
 F8990471-M1**

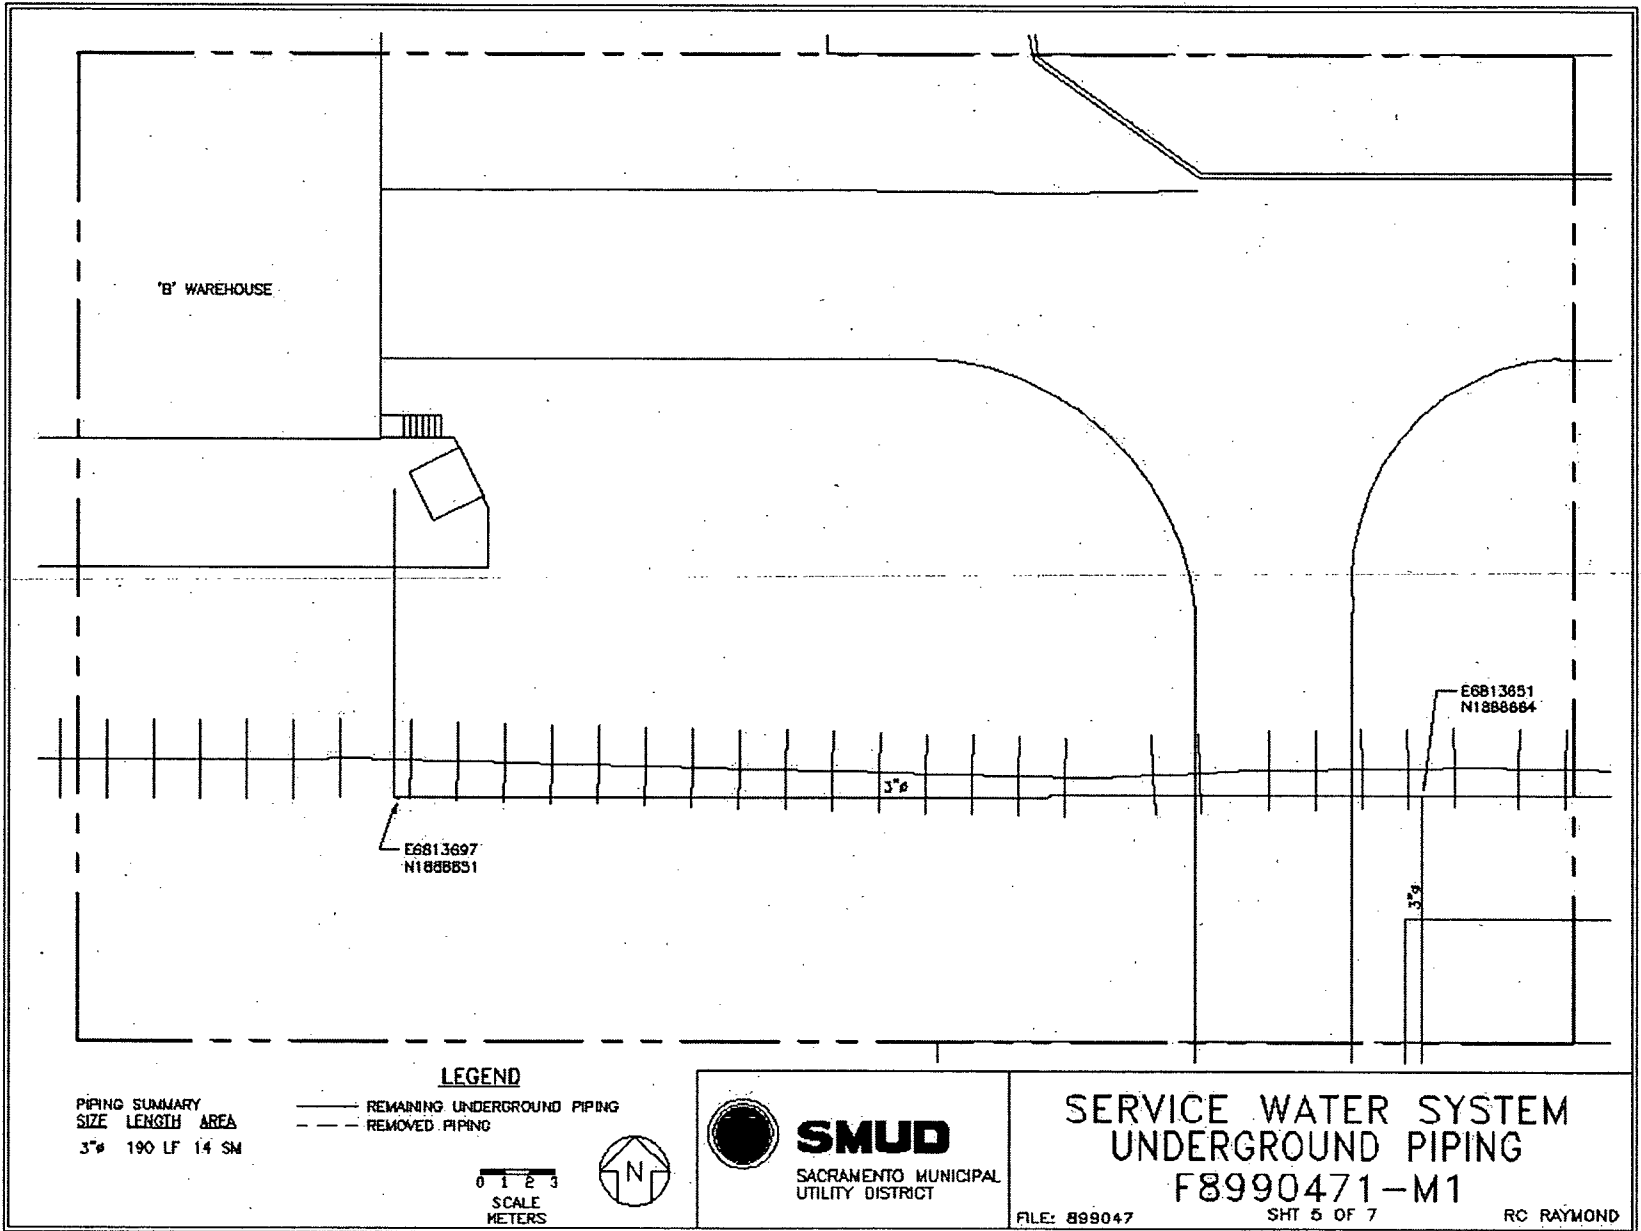
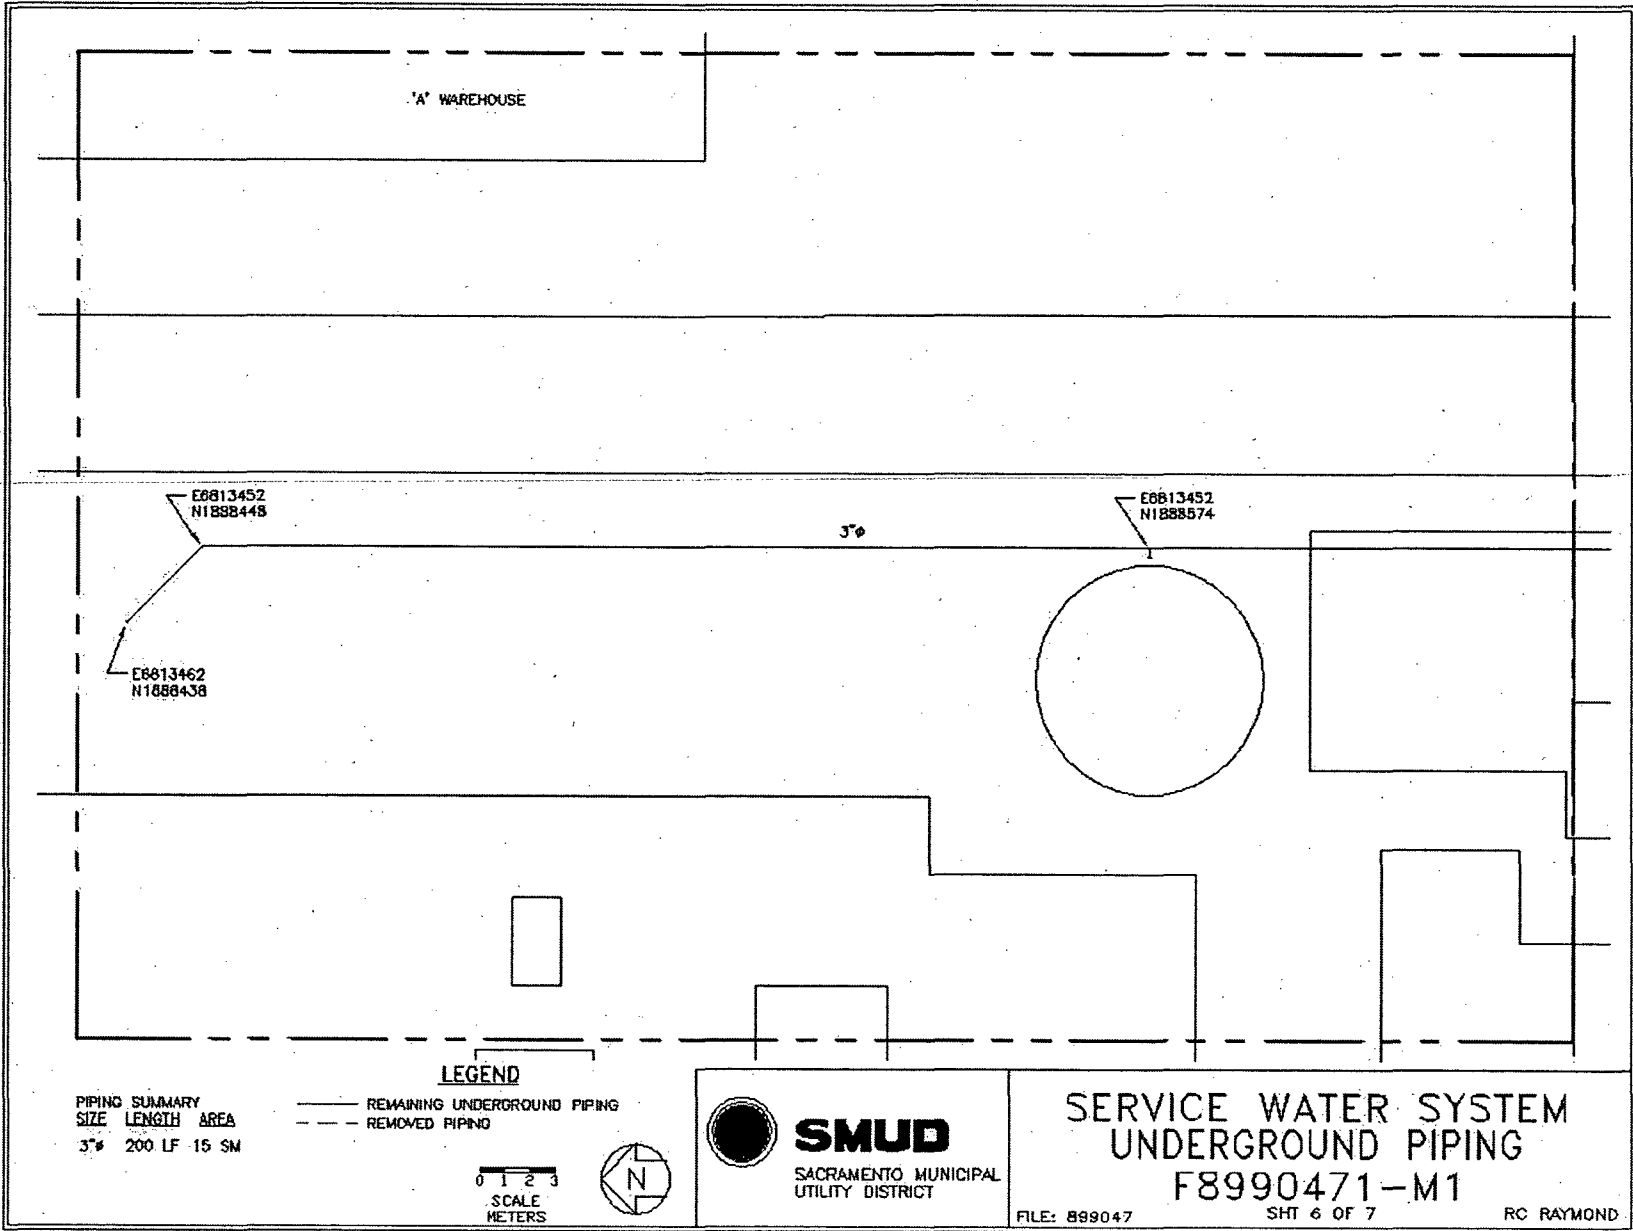
SIZE	LENGTH	AREA
3"	200 LF	15 SM

**SERVICE WATER SYSTEM  
UNDERGROUND PIPING**  
F8990471-M1
