**BATHYMETRY AND VOLUME STORAGE OF A PORTION OF LAKE GRANBURY,
HOOD COUNTY, TEXAS**

Prepared by

**Stephen K. Boss, Ph.D., P.G.
Department of Geosciences
113 Ozark Hall
University of Arkansas
Fayetteville, AR 72701**

11 July 2007

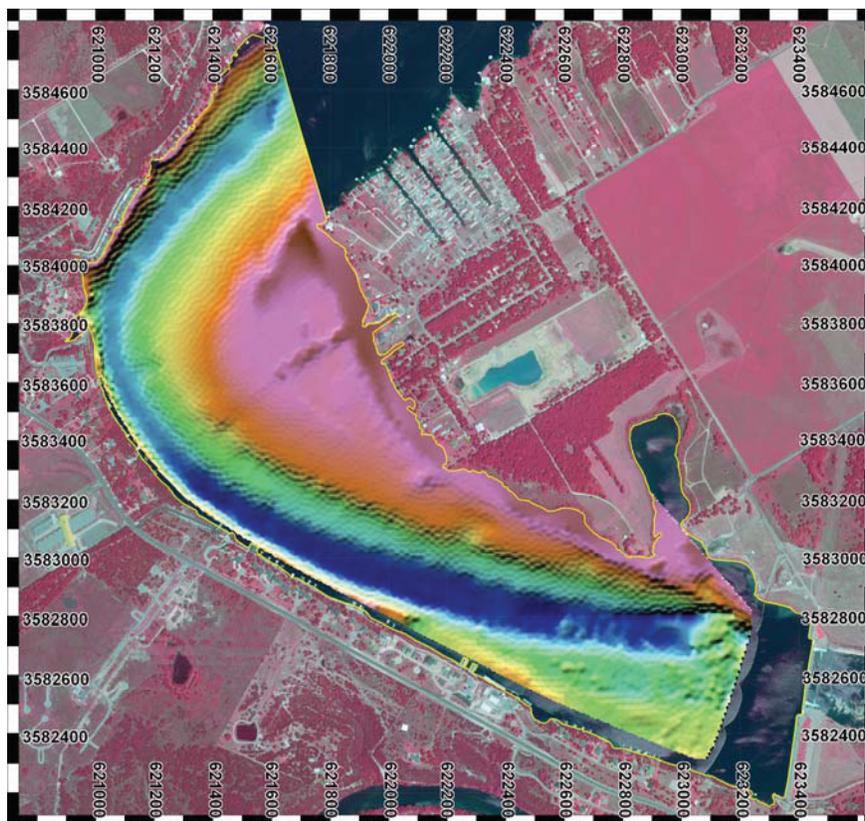
Color shaded relief map of Lake Granbury, Hood County, Texas

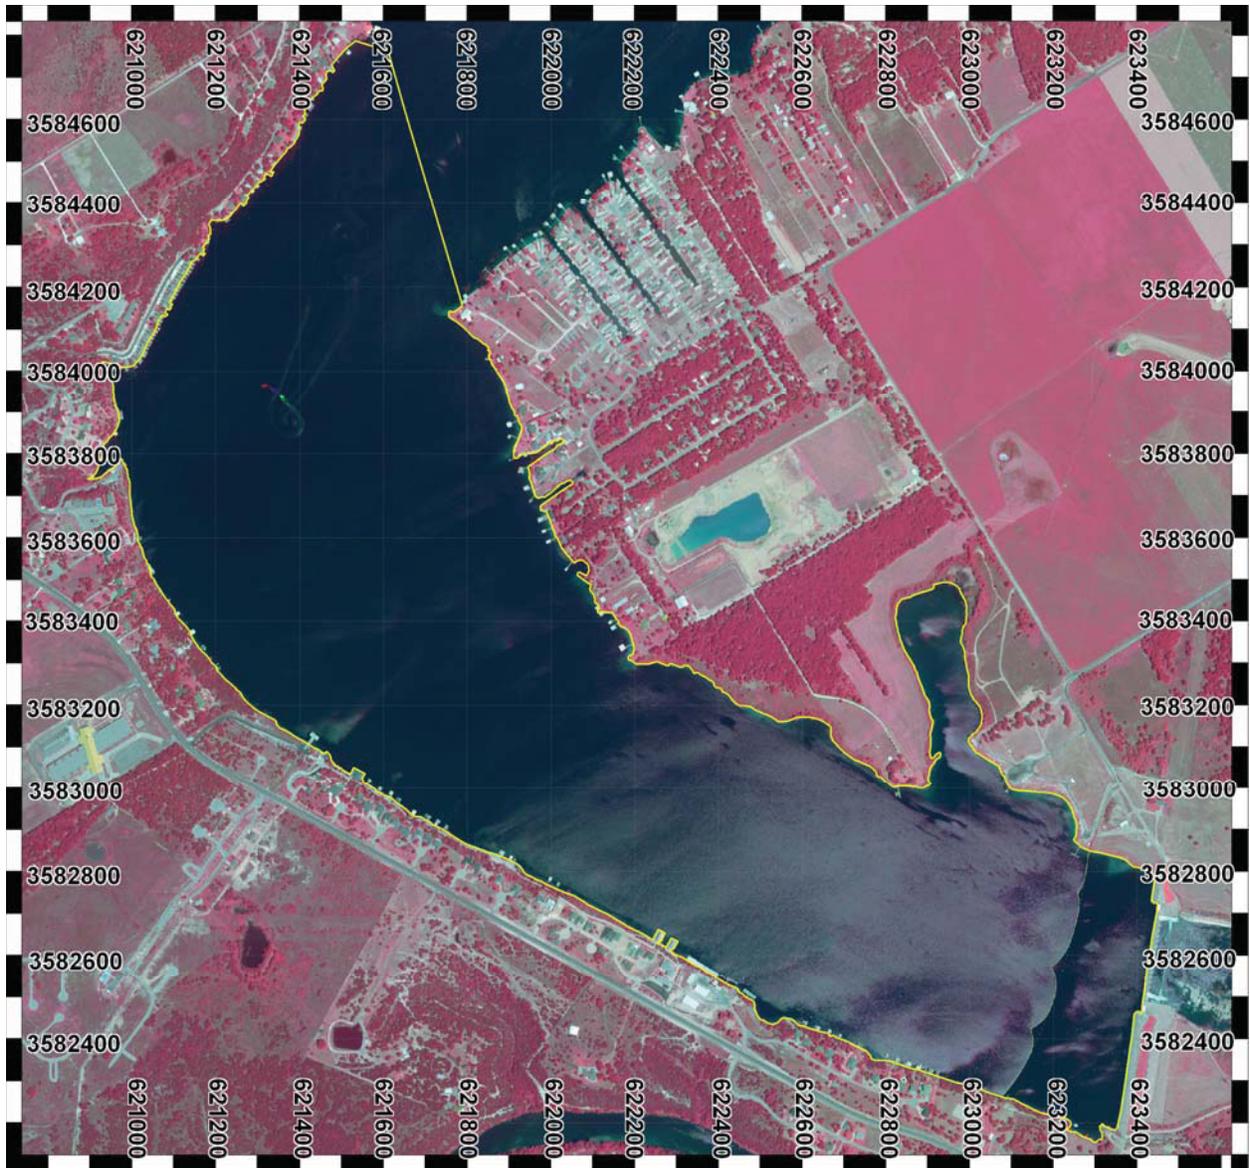
Fig. 1. Aerial photograph of lower Lake Granbury, Hood County, Texas. The yellow border along the lake represents the area mapped for this study. Aerial photography obtained from Texas Natural Resources Information System (<http://www.tnris.state.tx.us/>); Color IR image acquired as part of National Agriculture Imagery Program (NAIP), 2004. De Cordova Bend Dam is located at the southeast corner of the image. The floating safety boom upstream of the dam is clearly visible in this image. Grid on image border is 100m; grid numbers on image are UTM coordinates, 200m spacing. North at top of image.

In April 2007, Enercon Services, Inc. conducted bathymetric mapping over 507 acres of lower Lake Granbury (Fig 1). The mapped area extended from the floating safety boom near the De Cordova Bend Dam upstream approximately 1.9 miles to an area locally referred to as Walters Bend (U.S.G.S 7.5-minute Acton, TX quadrangle map), the location of the TXU electric power generating facility. Enercon Services, Inc. contracted with Dr. Stephen K. Boss, University of Arkansas to process bathymetric data, develop detailed bathymetric maps of the mapped areas of Lake Granbury, and estimate area-elevation-volume relationships within the mapped area. The following report documents analytical methods and results obtained from this mapping project.

Contour lines (Fig. 5) were converted to polygons bounding upper and lower 1-ft contours (for example, contours depicting -10 foot and -11 foot depths were joined to create a polygon bounding the -10 to -11 foot region of lower Lake Granbury). The area (in acres) of each polygon was derived from the GIS, and all contour-bound areas were summed to determine a total area mapped for each water body. Note that in all areas included in this study, the mapped area (507 acres) was slightly less than the total surface area (577 acres) of the impoundment because very shallow water in some upstream arms and nearshore areas limited navigability and excluded the area between the De Cordova Bend dam and the floating safety boom (Figs. 1,3).

Bathymetry for areas shallower than the operable depths of the echo sounding system were interpolated from the last recorded data point to zero-depth at the shore. For purposes of mapping these areas, the shore was taken as the boundary of the digitized polygon of the water body (yellow bounding line on Figs. 1, 3-5).

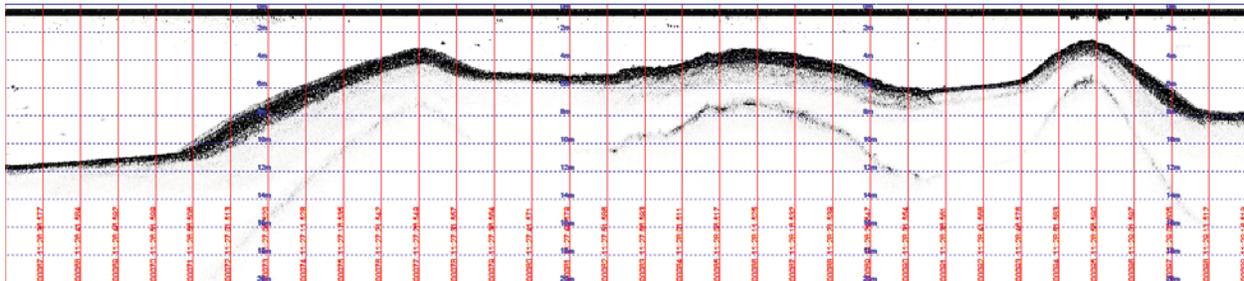
Fig. 2. Example of echo sounder profile from Granbury Lake project area. Heavy dark like with irregular relief represents echo from lake bottom. Vertical scale on image is 66 ft (20 m). Horizontal width of image is approximately 1,083 ft (330 m).

All bathymetric data were acquired using a Knudsen Engineering, Ltd. Model KEL B/P 320 echo sounding system. The Model 320 B/P echo sounder transmits acoustic energy with two distinct frequencies, 200 kHz and 28 kHz (Anonymous, 1998). The 200 kHz (high frequency) band had sufficient energy to penetrate the water column but reflected from the water/sediment interface (Fig. 2). Data from this frequency were used to generate maps depicting present-day bathymetry of the reservoir within the study area. The theoretical vertical resolution of the 200 kHz pulse (i.e. one-quarter λ ; Sherrif, 1985) is 1.85 mm, though in practice vertical resolution is typically only 1 – 2 cm because theoretical ideal conditions are not achievable in the field.

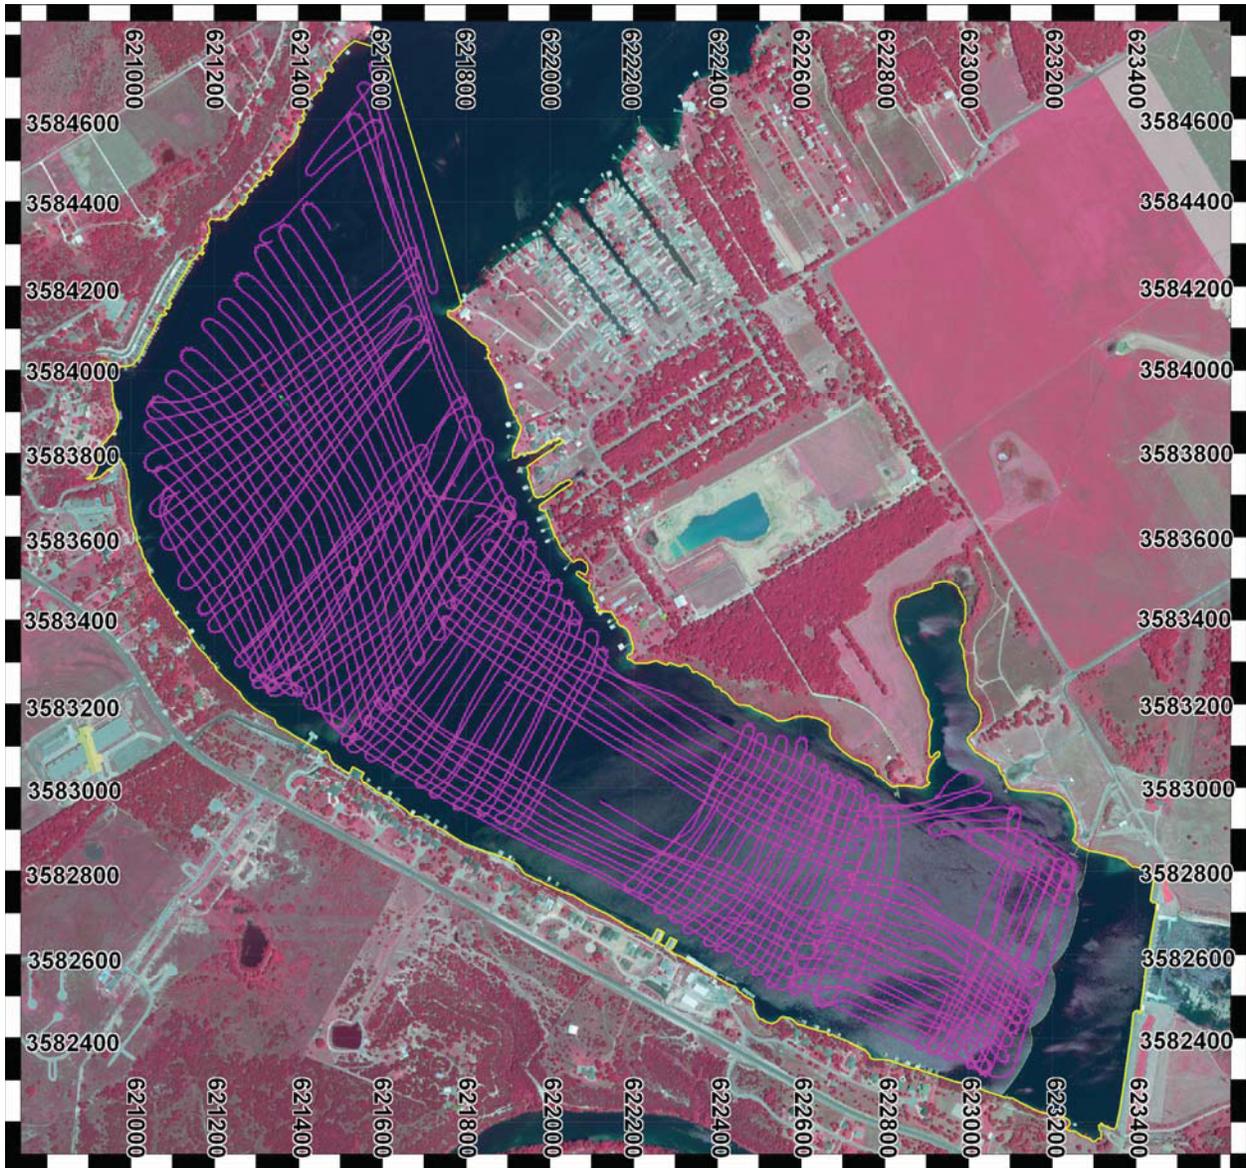
Fig. 3. Map showing distribution of dual frequency echo sounder tracklines (magenta lines) on lower Lake Granbury acquired 3 – 12 April 2007. Note several data gaps resulting from both poor data and corrupted echo sounder files. These data gaps were filled using digital terrain data obtained from USGS 30-m digital elevation model of Acton, TX 7.5 minute quadrangle (see description below). Also note limits of mapped area corresponding to area enclosed by yellow border. Map grid and orientation same as for Fig. 1.

Echo sounder mapping of lower Lake Granbury was conducted 3 – 12 April 2007. The Knudsen 320 B/P echo sounder system was mounted on the survey vessel which was then steered in an overlapping grid pattern to ensure maximum areal coverage while minimizing acquisition time at the site (Fig. 3). For all mapped areas, echo sounder operations were limited to water depths greater than approximately 5 ft. A total of 74.3 trackline miles were acquired over 507 acres of lower Lake Granbury during the field interval of this study.

The total area of the mapped portion of lower Lake Granbury was determined by digitizing a polygon of the water body limits observable on digital orthophoto quarter quadrangles (DOQQ) of each site. The dates of the DOQQs were 2004 (Texas Natural Resources Information System, 2007; <http://www.tnris.state.tx.us/>) and it was assumed the water level observed on each DOQQ was representative or typical for this reservoir. Comparison of the derived digital boundaries to mapped echo data suggests this assumption is valid. The total area (acres) of the polygon bounding the mapped area was determined from the GIS software to be 577.0 acres. The total area covered by survey tracklines (magenta lines on Fig. 3) was 507.0 acres

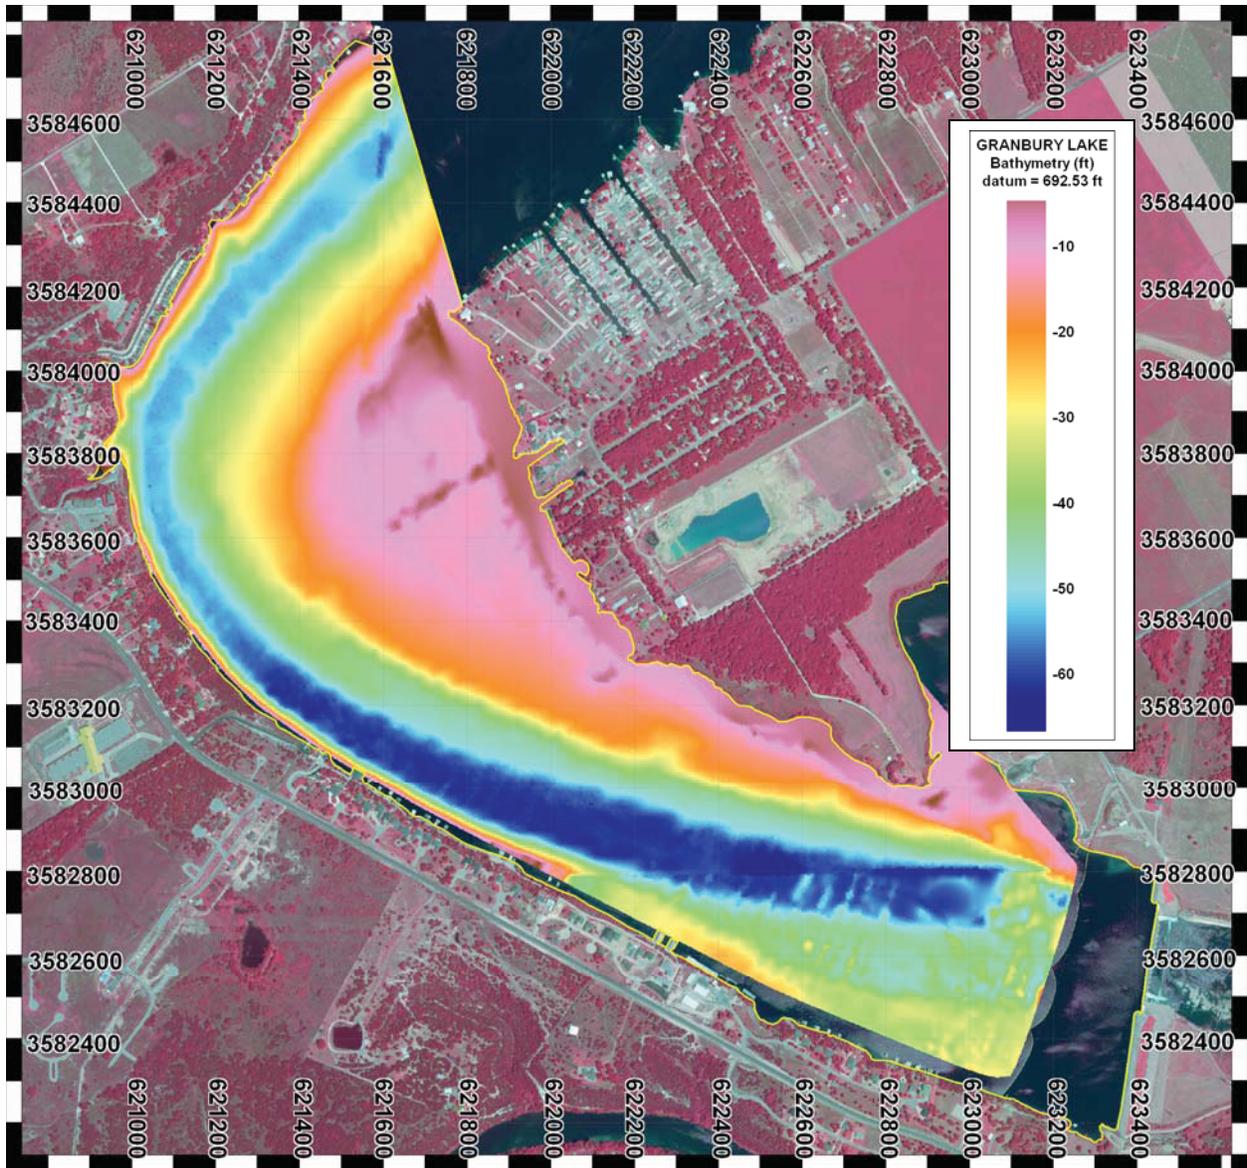
Fig. 4. Colored relief map of lower Lake Granbury derived from merged echo sounder and DEM data.

The resulting final terrain model was derived from 508,408 individual soundings within the mapped area. The final terrain model was color-coded by elevation and “illuminated” to create a shaded relief image (Fig. 4). Gridded bathymetric data were then contoured with a 1-foot contour interval using the automated contouring function of the GIS software (Fig. 5). No adjustments to derived contours were made.

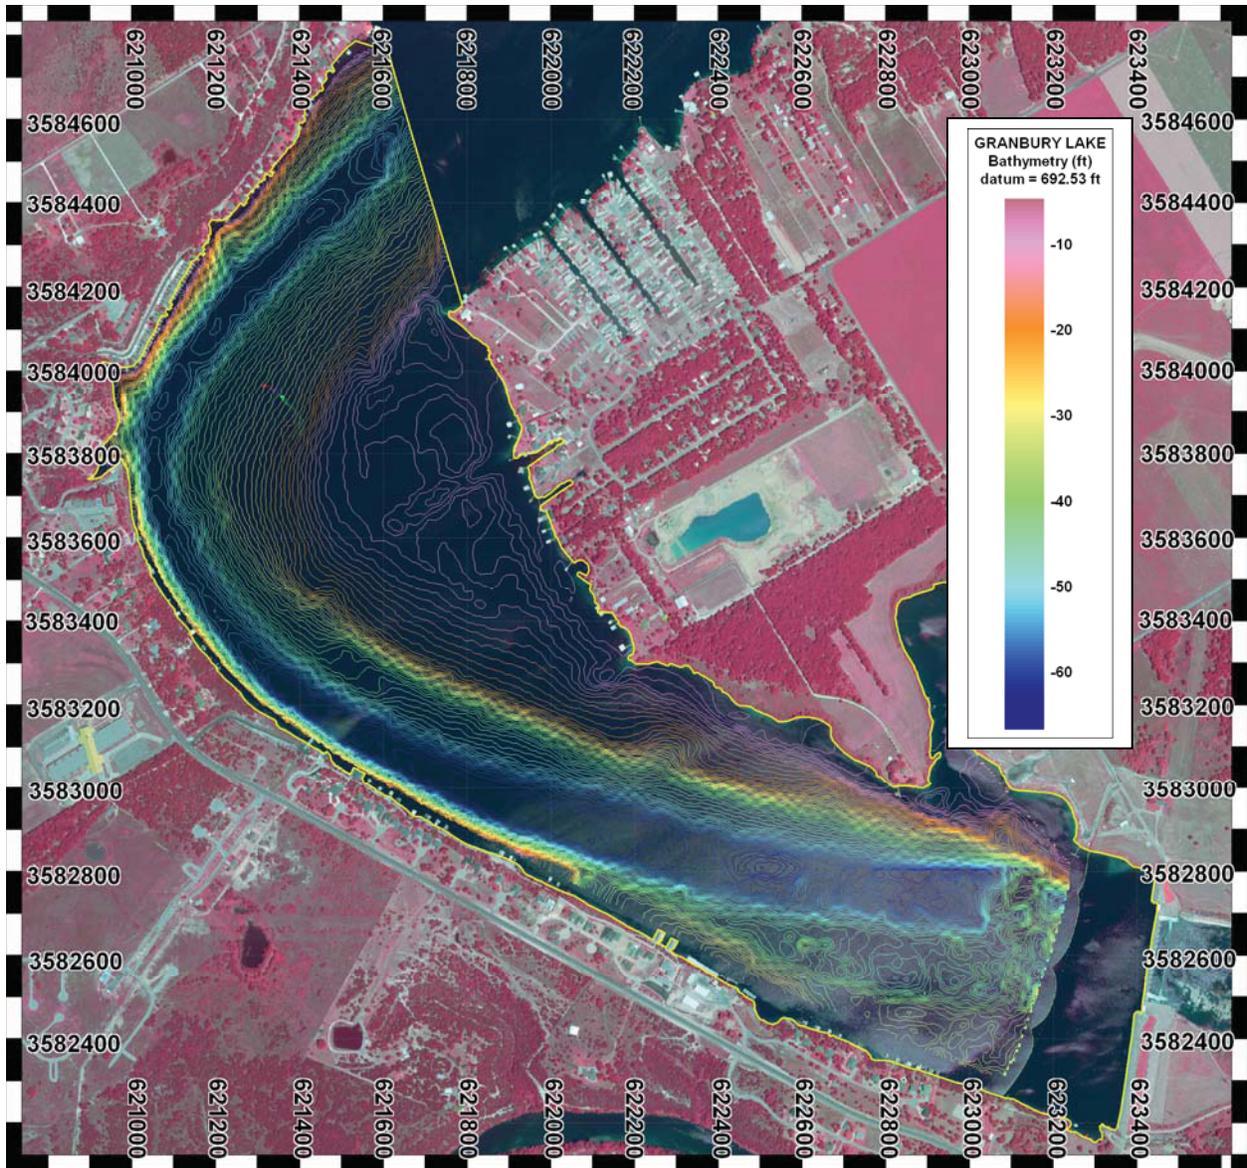
Fig. 5. Contour map of lower Lake Granbury derived from gridded bathymetric data displayed in Fig. 4. Contour interval = 1 ft.

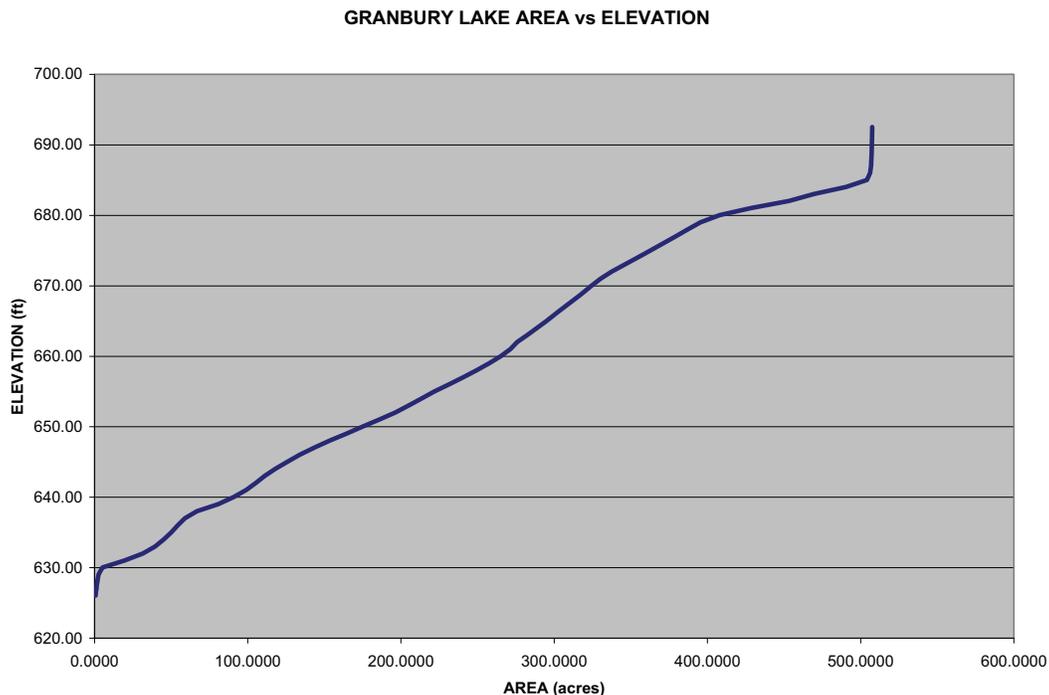
Fig. 6. Plot of surface area versus elevation derived from bathymetric data for lower Lake Granbury.

In addition to estimating maximum volume storage using the methods above, volume estimates for varying reservoir levels (elevations) and areas were derived by ‘stripping’ from the elevation measured on the days of data acquisition to the maximum observed depth at each site. Curves depicting impoundment area versus elevation (Fig. 6), area versus volume (Fig. 7), and elevation versus volume (Fig. 8) were prepared and are included below.

The total volume storage within the mapped area was determined from summation of areas between 1-ft contours to be 16,182 acre-feet for lake level of 692.53 ft above mean sea-level. The relation of surface area, elevation, and volume of lower Lake Granbury are presented in Figs. 6-8 above. These curves display forms typical of impoundments along rivers in that they show relatively simple correlations among the parameters area, elevation, and volume.

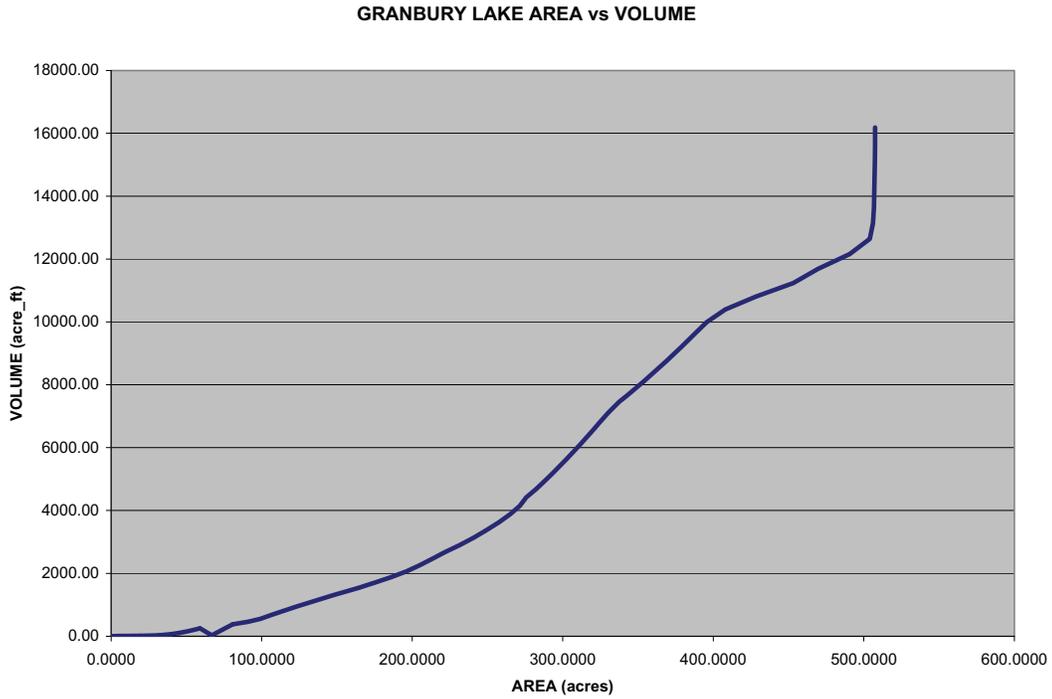
Fig. 7. Plot of surface area versus volume derived from bathymetric data for lower Lake Granbury.

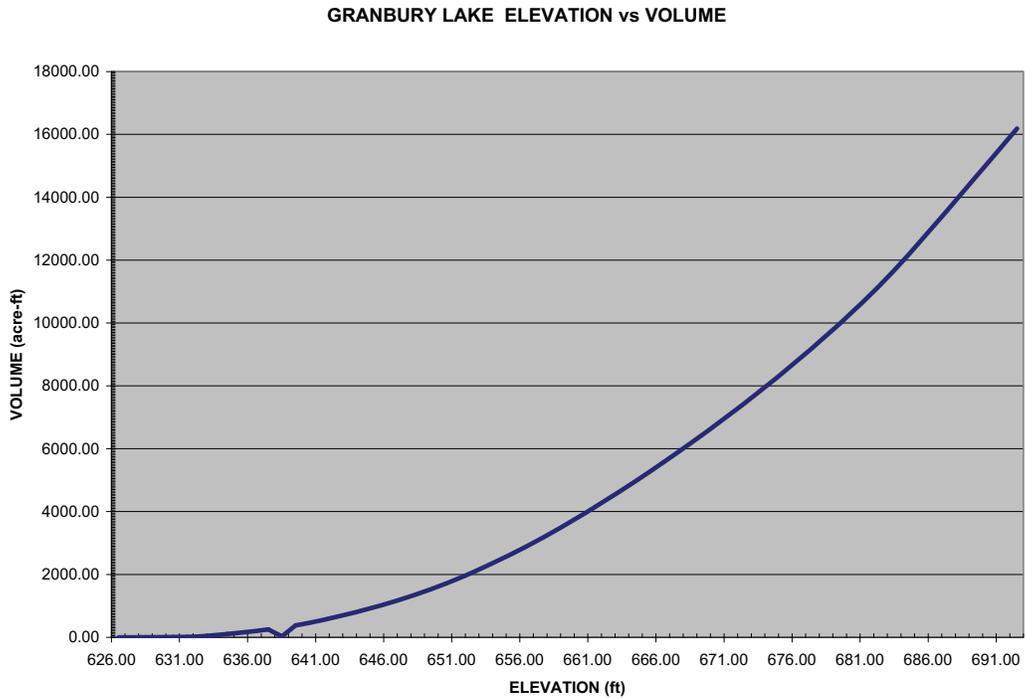
Fig. 8. Plot of elevation versus volume derived from bathymetric data for lower Lake Granbury.

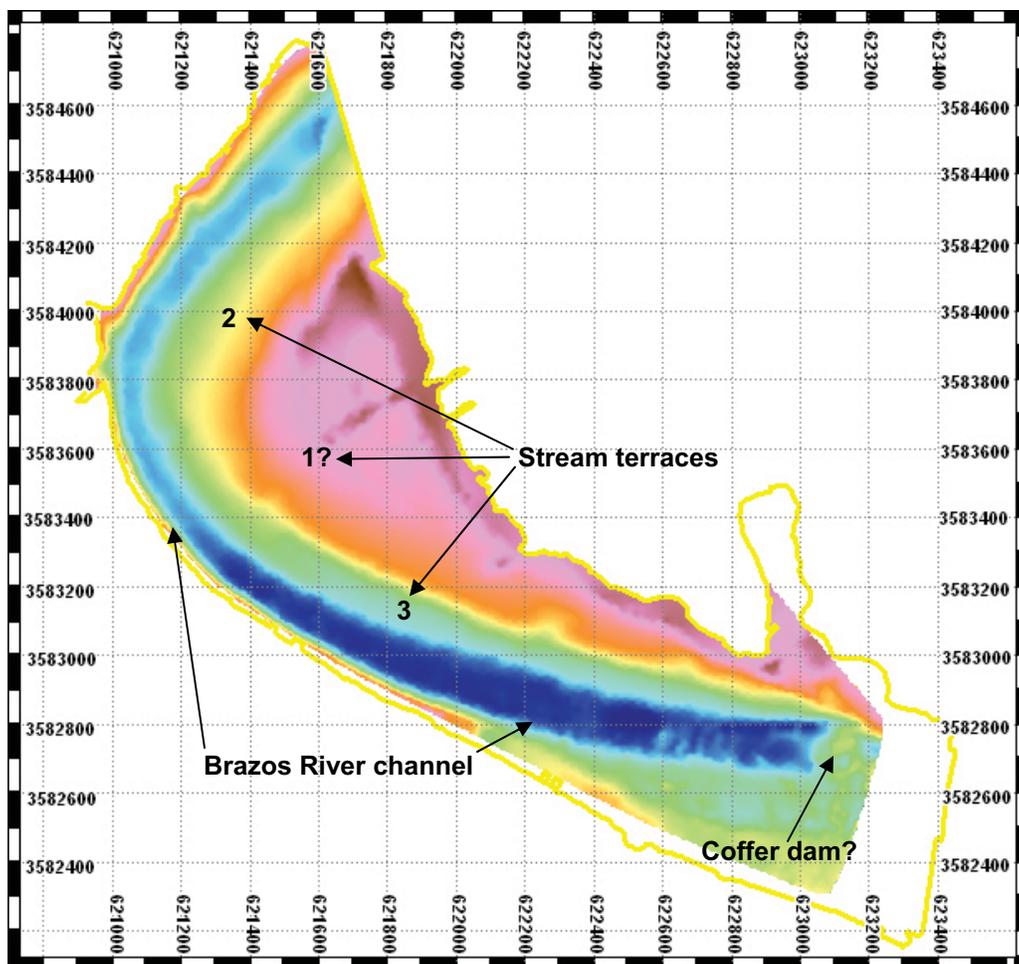
Fig. 9. Bathymetry of the Lake Granbury project area derived from echo sounder profiles and data merged from USGS 30-m digital elevation model of Acton, Texas 7.5-minute quadrangle. Note of this map the main channel of the Brazos River is plainly evident, as are several well-developed stream terraces. The bathymetric anomaly labeled “Coffer dam?” is of unknown origin. This structure abruptly truncates the river channel and may be the remnant of a coffer dam built to divert stream flow during construction of De Cordova Bend dam. Alternatively, this feature could be the remnant of a lock and dam system that was constructed along the Brazos River during the early 20th Century.

Overall, the bathymetry of lower Lake Granbury is rather simple, being formed from a broad meander of the Brazos River. Within the mapped area, bathymetry ranged from 0 – 67 ft with an average depth of 32.3 ft (standard deviation 17.2). A colored relief map (Fig. 9) shows the very distinctive former main channel of the Brazos River meander composing the lower reservoir to the dam site. In the northwest portion of the mapped area, a point bar is evident where gently sloping bathymetry eventually merges with the land surface. Along the inside bend of the main channel, a very well developed stream terrace is evident immediately adjacent to the former river channel. Upslope on the point bar itself, there appear to be two and possibly three additional stream terraces reflecting adjustment of the former free-flowing Brazos River to base-level changes.

The only unusual aspect of bathymetry in the mapped area is located near the southeast corner of the map. Here, the main channel of the Brazos River is abruptly truncated by a structure of unknown origin. Beyond the mapped area, the river channel appears to re-emerge, and is evident on the USGS DEM. The origin of this structure is not known. It is possible that it represents remains of a coffer dam that may have been constructed to divert the river during construction of the De Cordova Bend Dam in the 1960's or it could be the remnant of an early 20th Century lock and dam that was part of a proposed network to promote river commerce along the Brazos water course.
