General
Engineering
Guideline

ATTACHMENT D General Visual Examination Checklist

IP2-GEG-3113
Rev. 1
Rev. Date: 03-10-2000

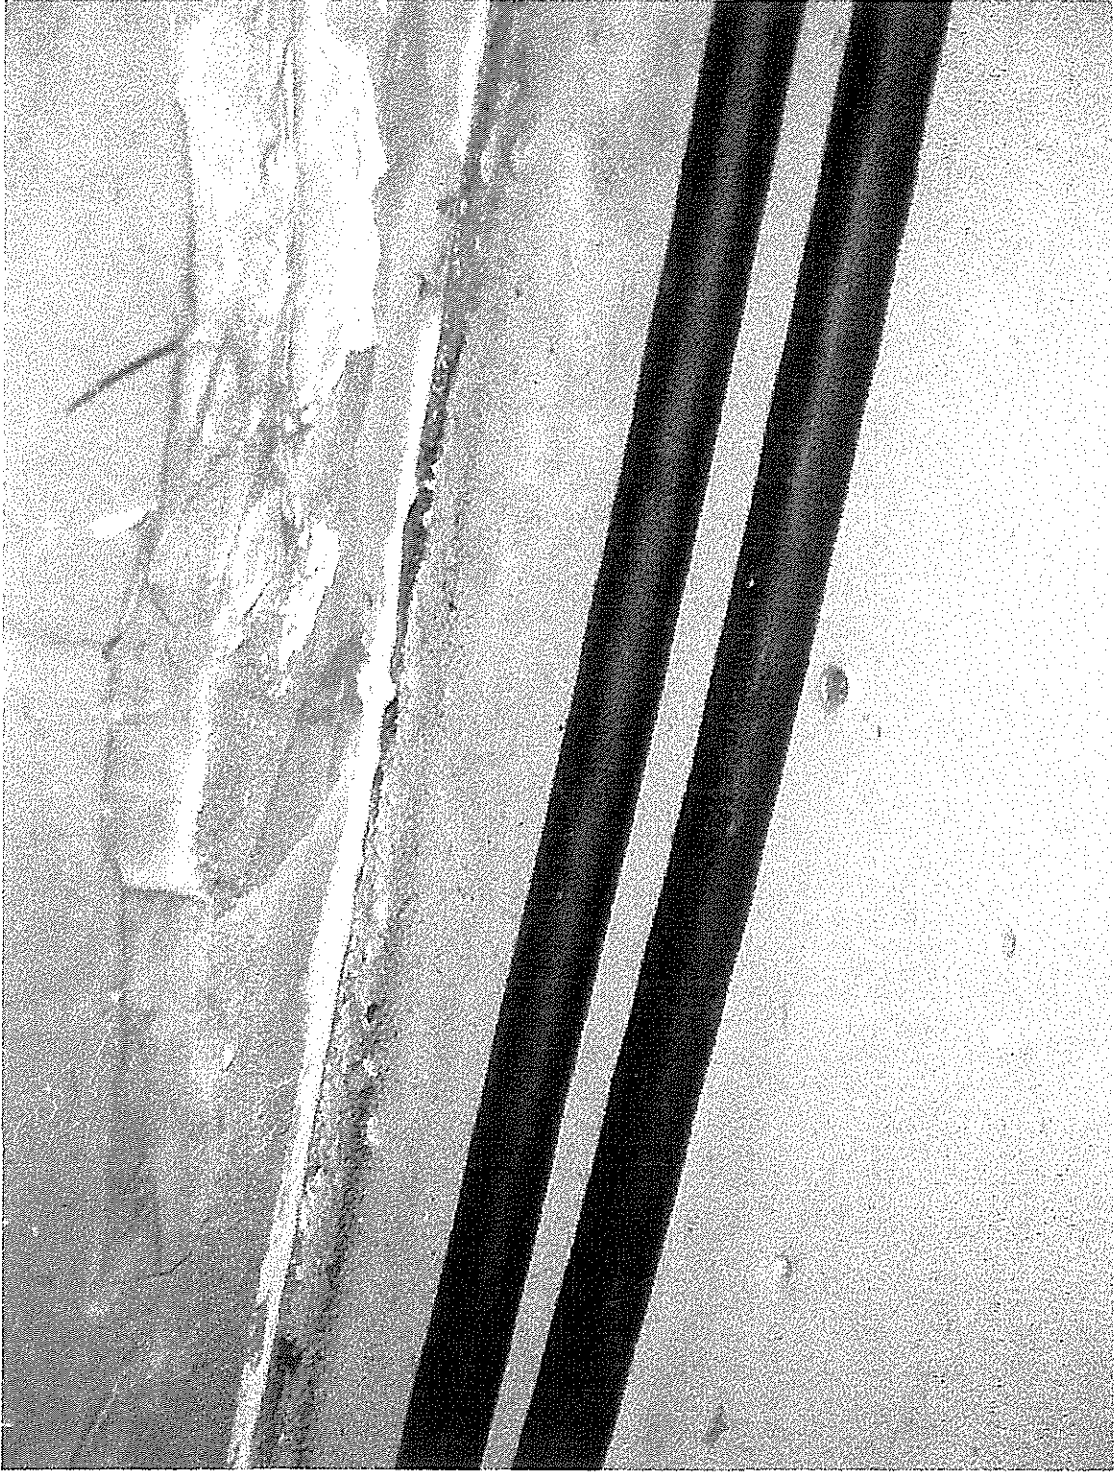
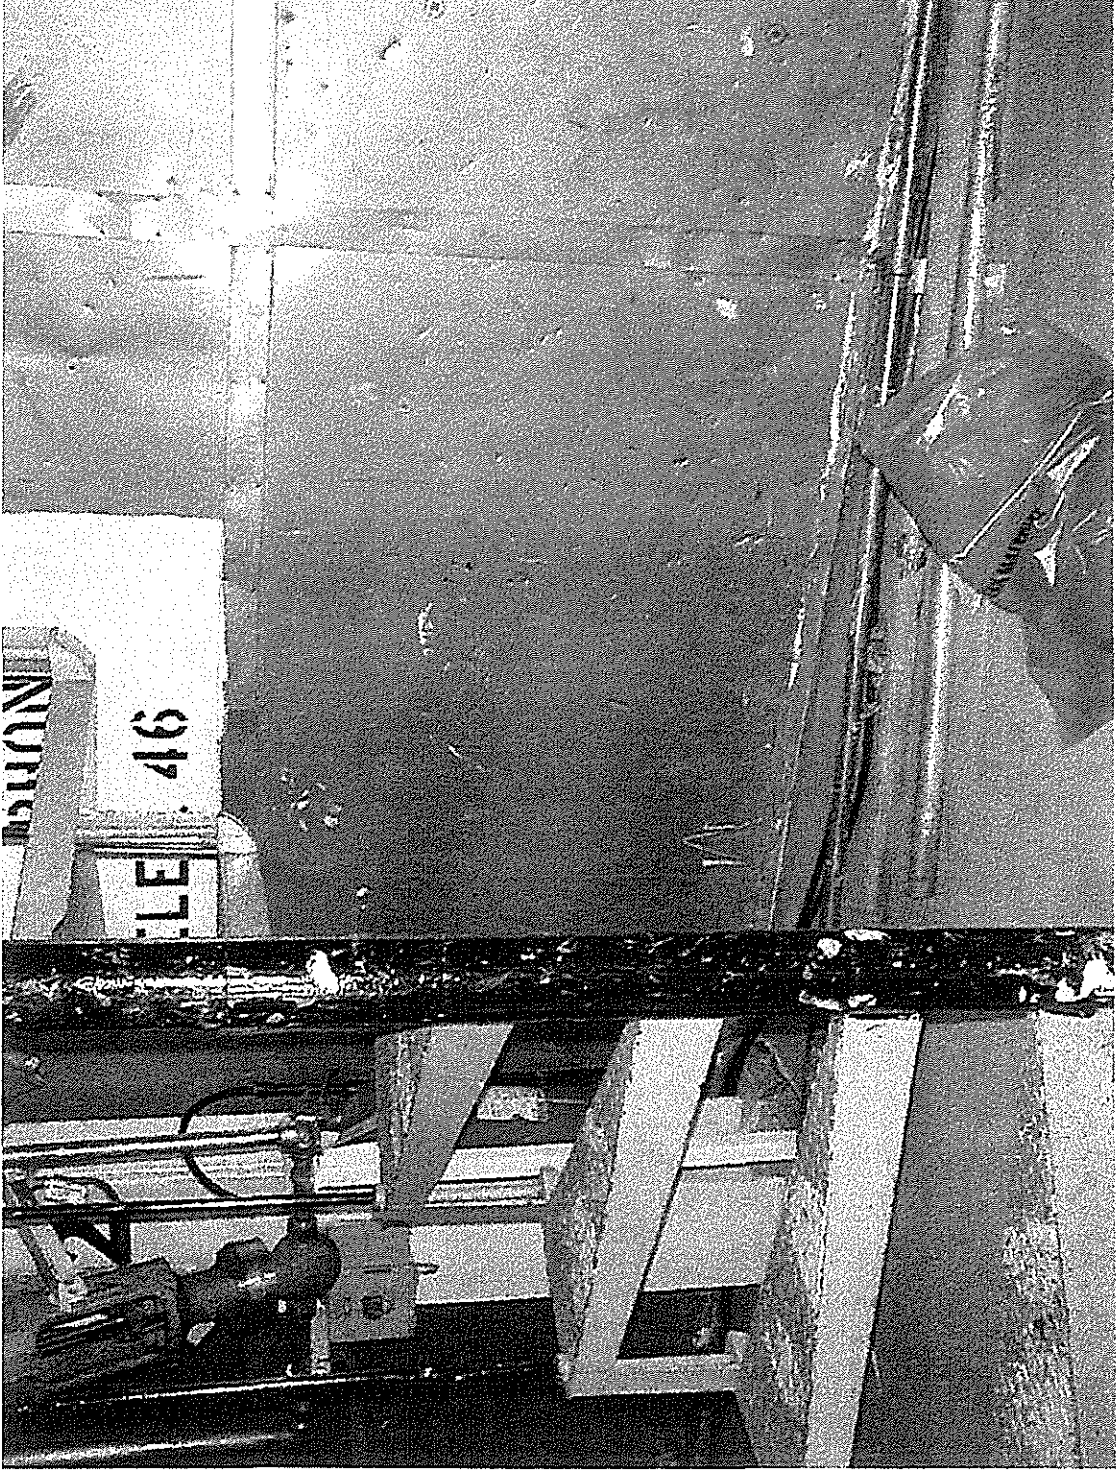
Item No.	Description	Photo
01	Sealant is missing from Column 1-4. See Drawing IWE-DET-001 and ConEd Drawing DMD 322097 Det. 1.	00030801.jpg and 00030804.jpg
02	Metal corrosion is noted below concrete in a 2 foot circumferential area between Column 3-4.	00030905.jpg 00031403.jpg

Item No.	Discussion	Acceptable	Additional Eval. Req'd.
01, 02	The corrosion of the liner at the slab interface requires engineering evaluation to determine its significance relative to Containment integrity. Subsequent investigations have revealed that this condition potentially exists throughout the entire circumference of the containment. The liner corrosion and the moisture barrier have been addressed via CRS 200001209.		✓

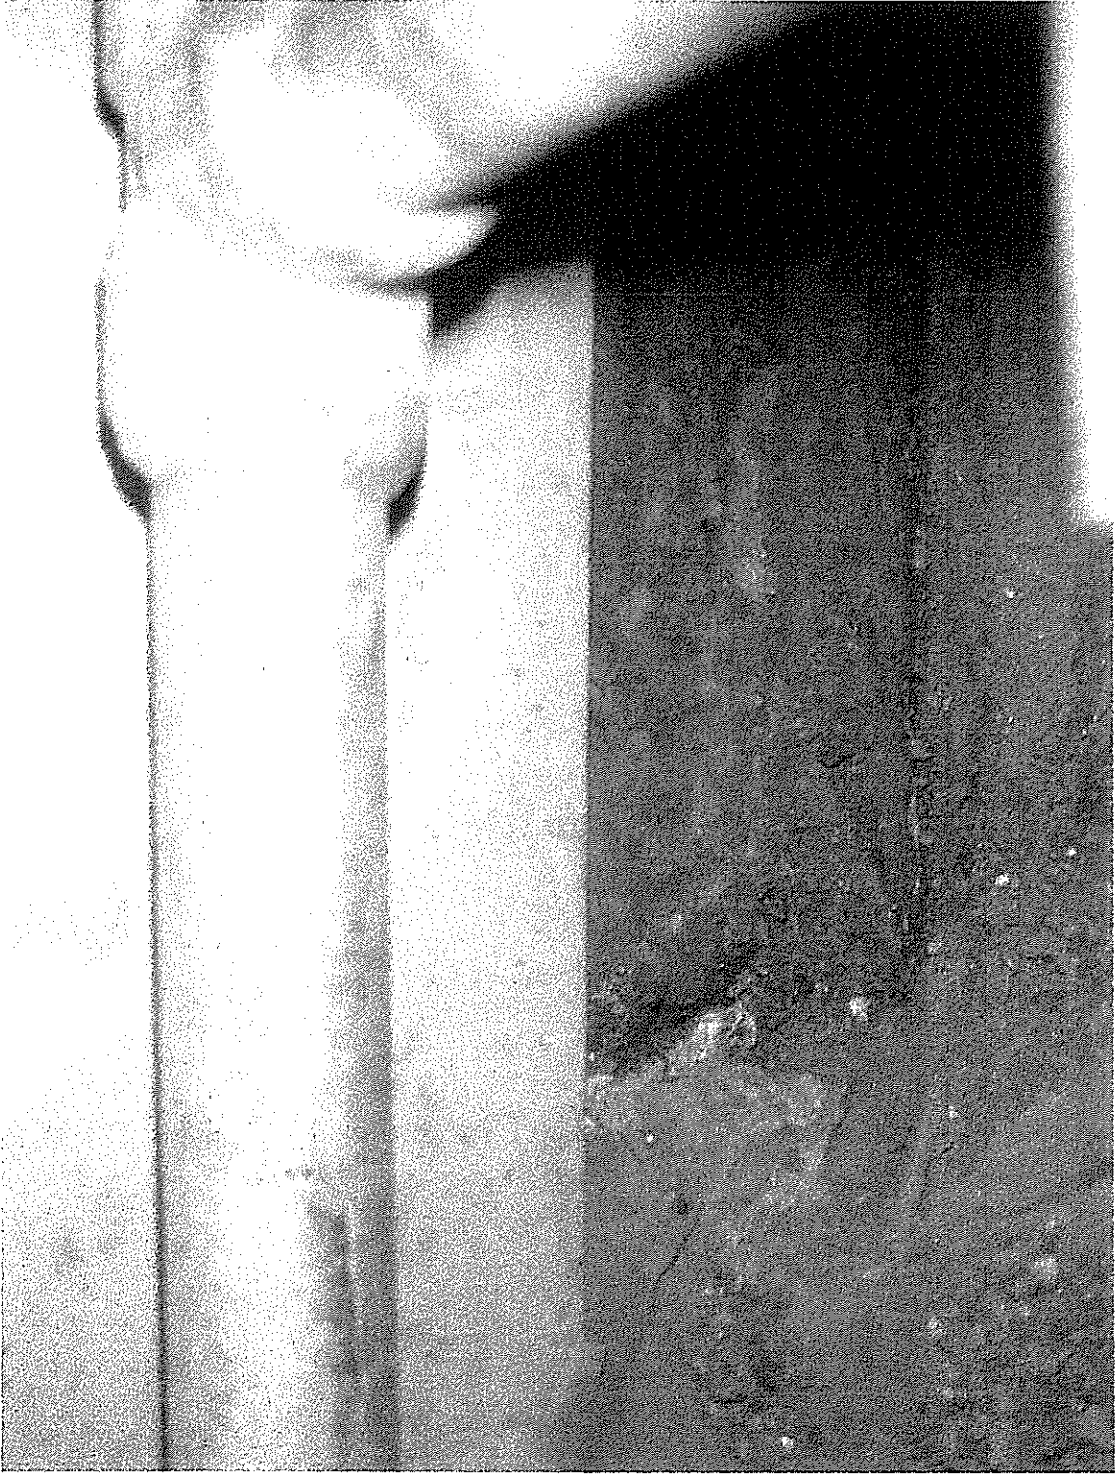
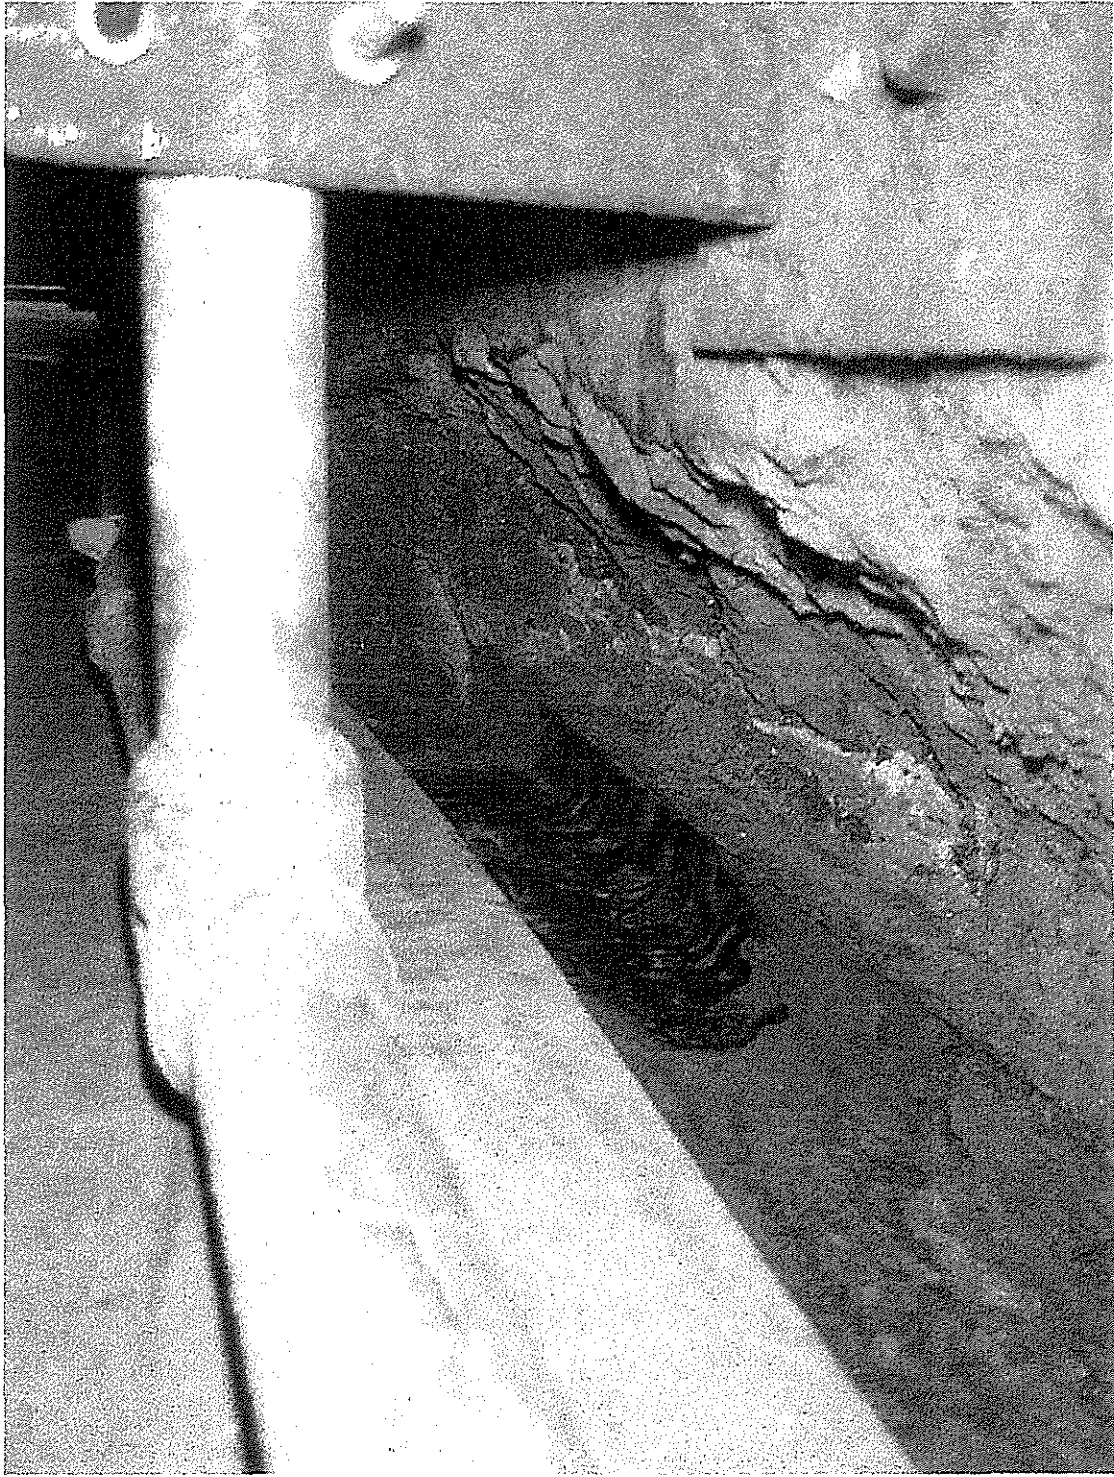
Item No.	Description	Photo
01	Area at moisture barrier caulking sealant is missing from Column 4-5. See Drawing IWE-DET-001 and ConEd drawing DMD 322097 Det. 1. Supplemental examinations will be performed to determine the extent of potential liner degradation.	00031601.jpg and 00031604.jpg

Item No.	Discussion	Acceptable	Additional Eval. Req'd.
01	The corrosion of the liner at the slab interface requires engineering evaluation to determine its significance relative to Containment integrity. Subsequent investigations have revealed that this condition potentially exists throughout the entire circumference of the containment. The liner corrosion and the moisture barrier have been addressed via CRS 200001209.		✓

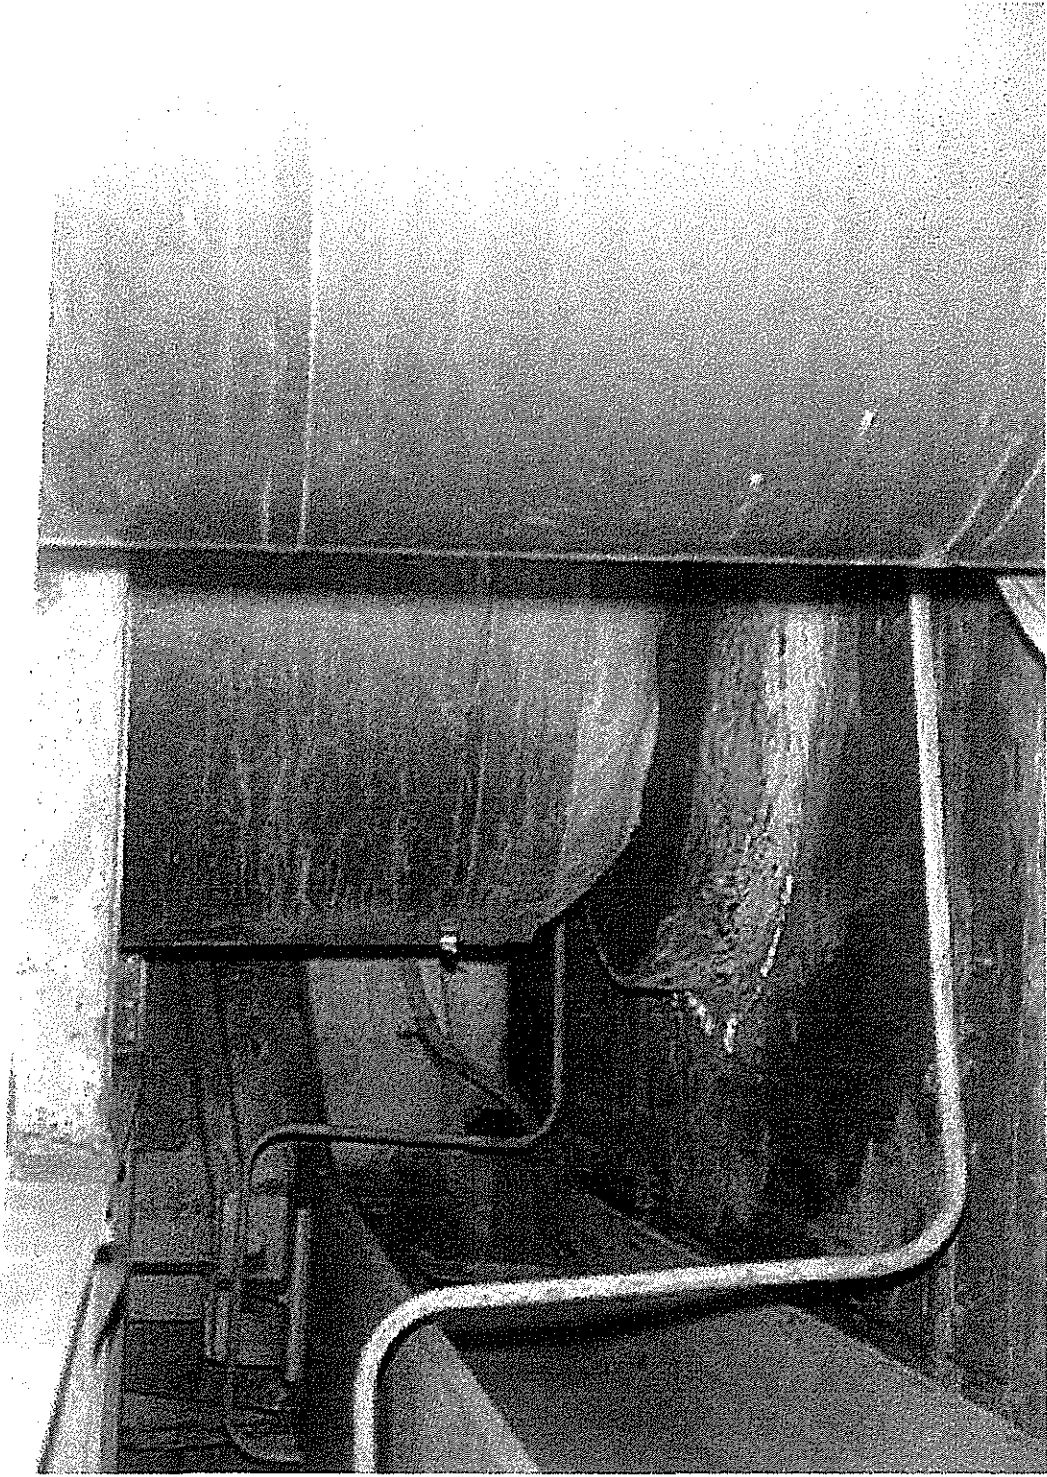
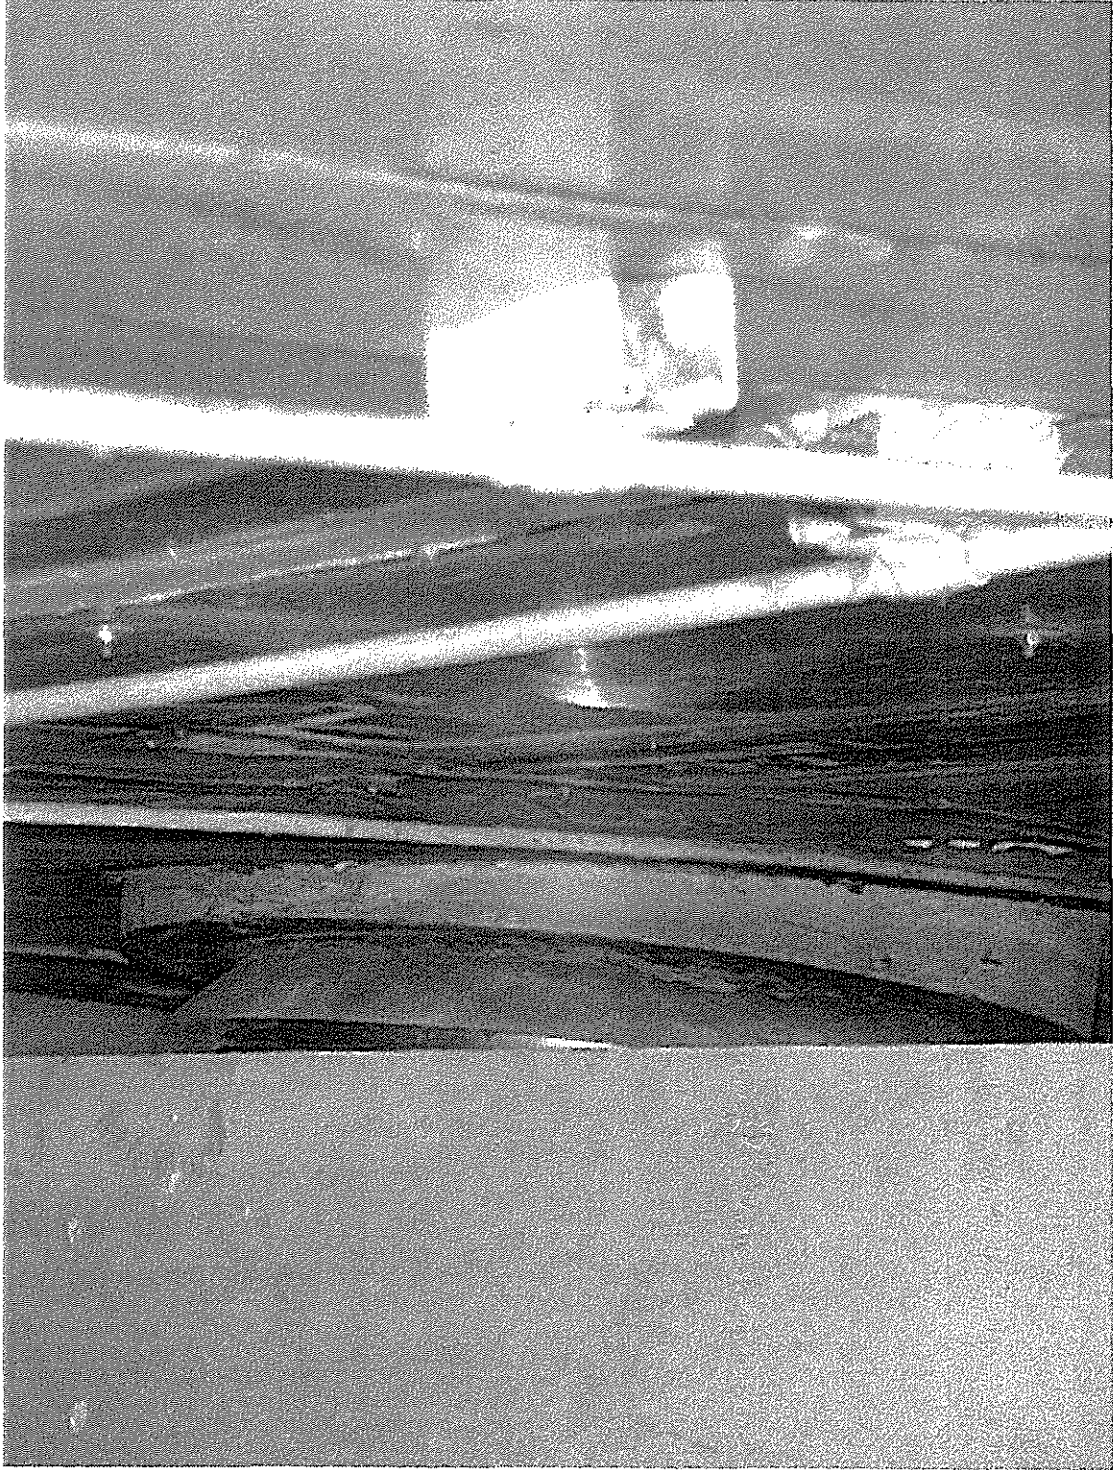
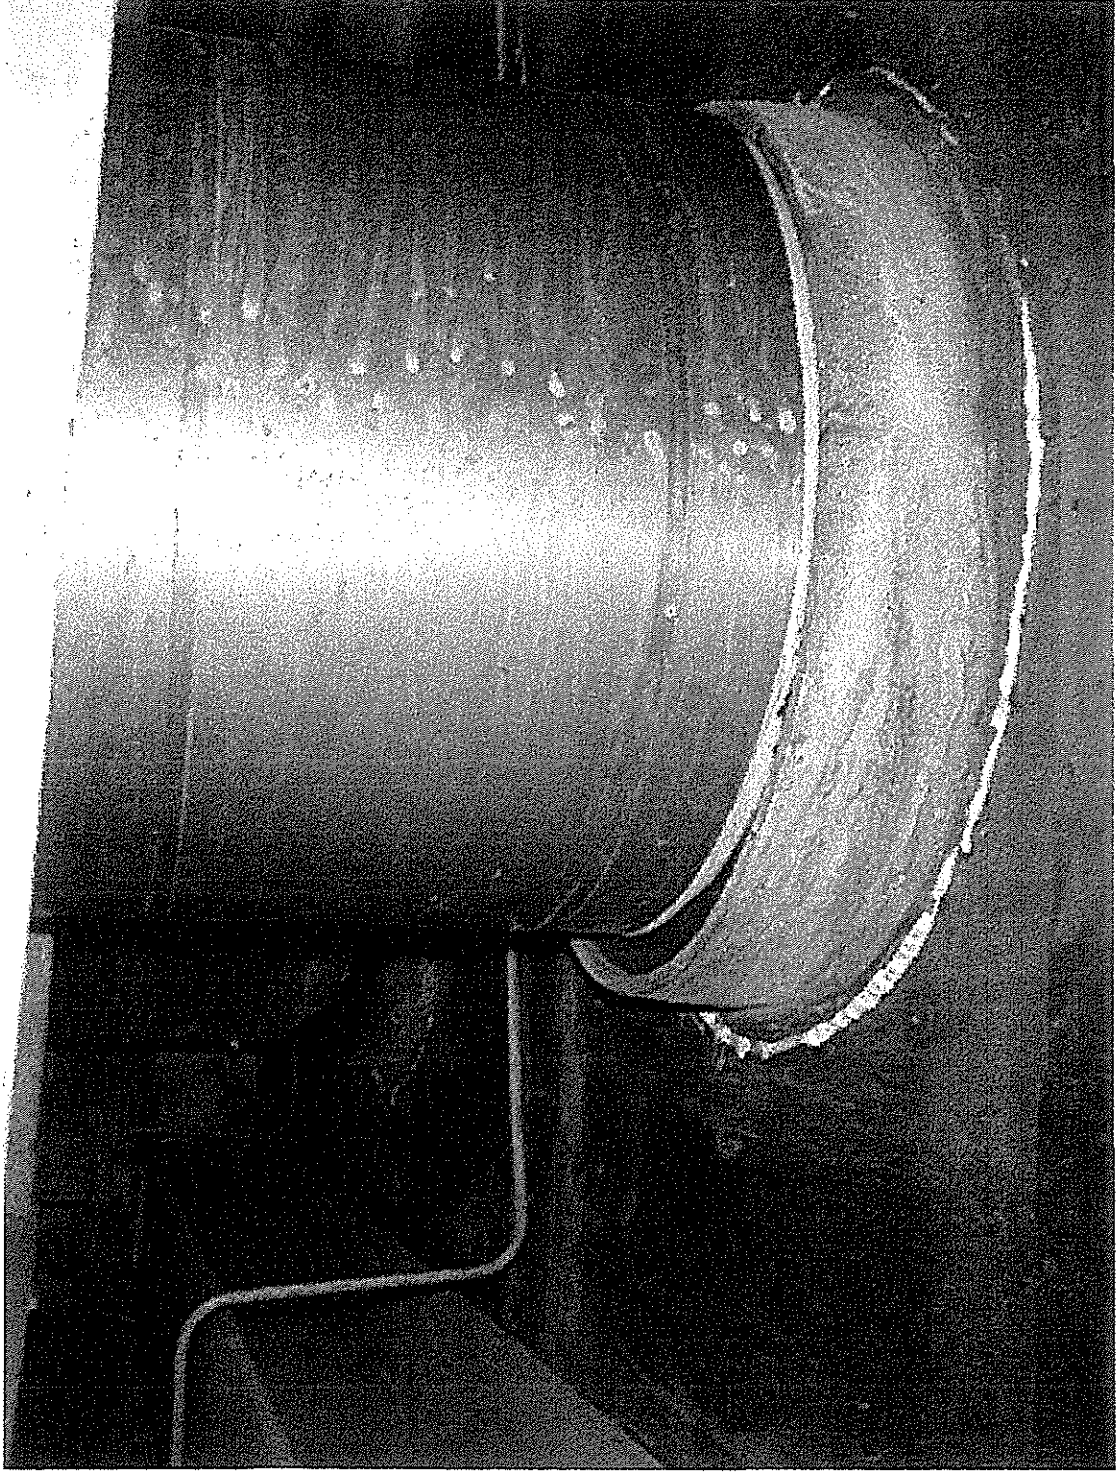
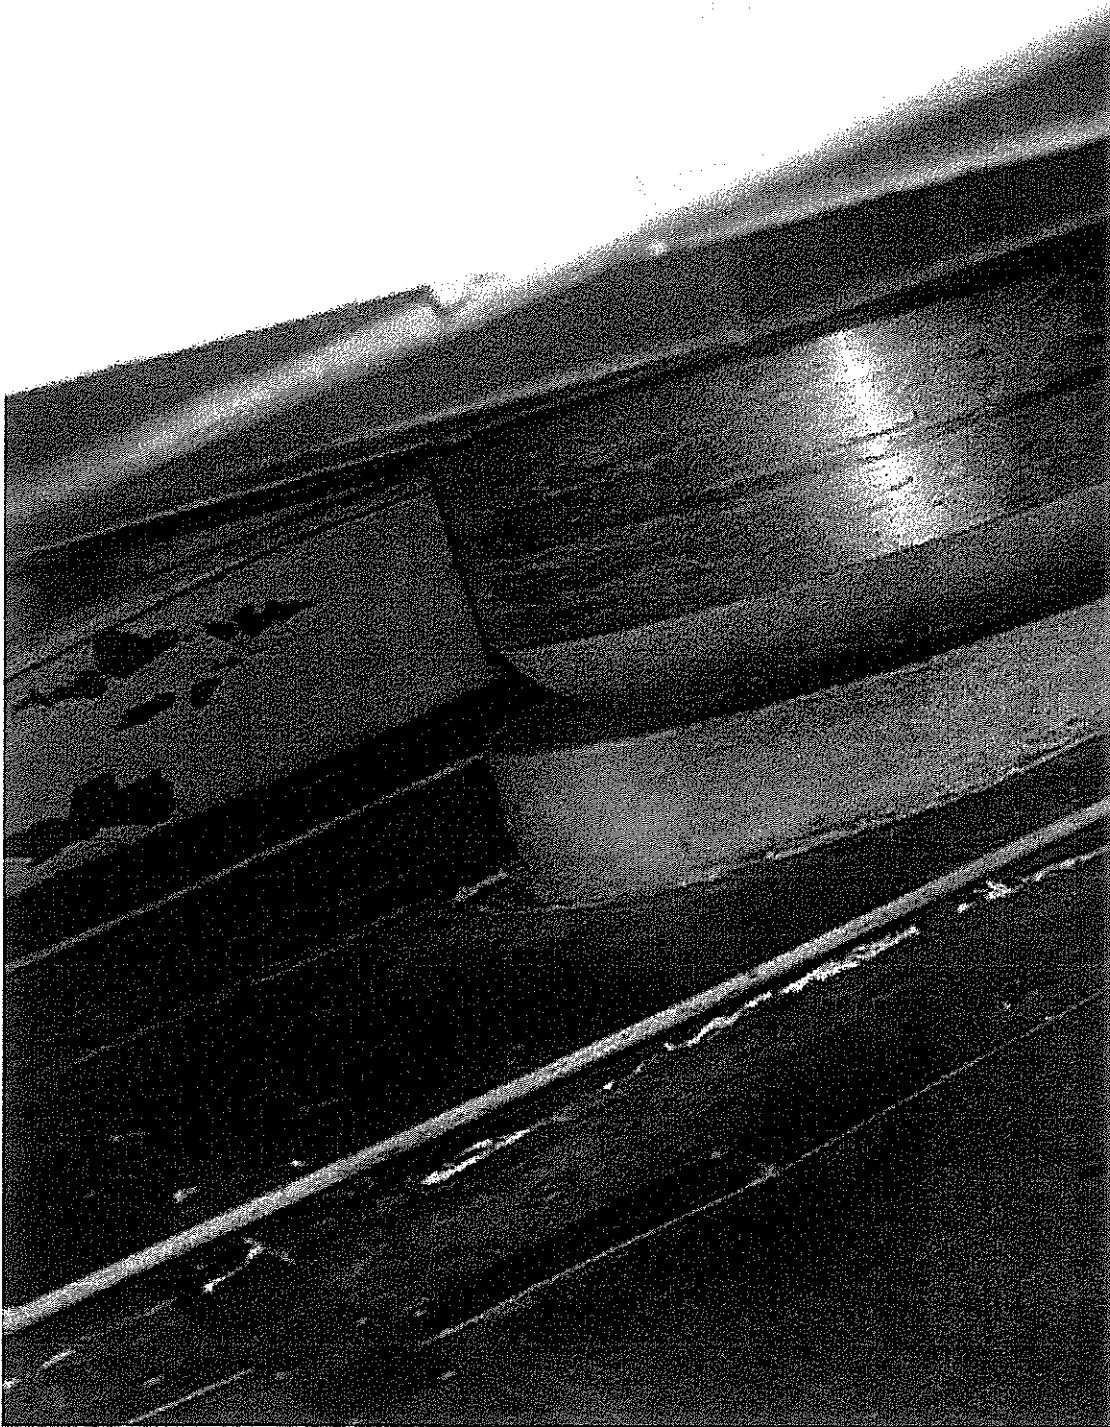
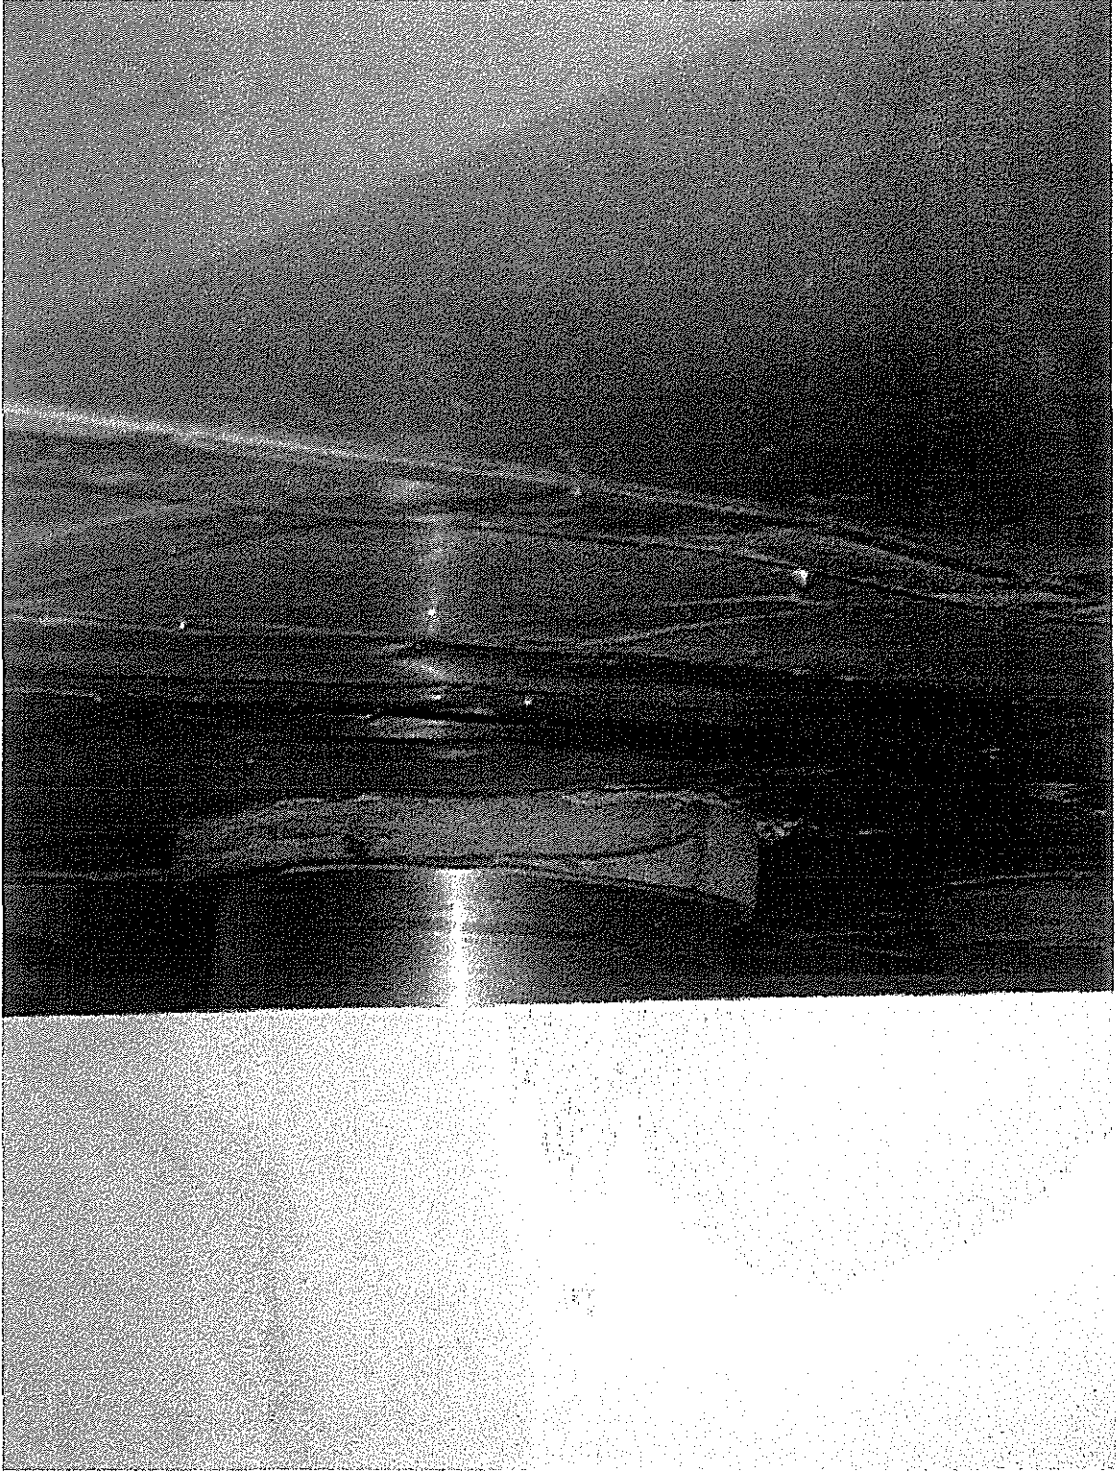
Item No.	Description	Photo
01	Mechanical penetration nos. MP-C, MP-D, MP-G and MP-H showed surface rusting on the head plates. Penetrations are for main steam and feedwater piping with service that will not promote an active corrosive environment. Rust staining around the mechanical penetrations is classified as ASTM D610, Grade 1 -2 that is between 1/3 and 1/2 of the head plate circumference is rusting.	00031706.jpg, 00031707.jpg, 00031708.jpg, 00031709.jpg and 00031710.jpg

Item No.	Discussion	Acceptable	Additional Eval. Req'd.
01	<p>The corrosion on the 2-1/2" thick penetration head plates has resulted from high temperatures, which have burned off the coating and allowed corrosion of the plate. (MP-C and MP-D are for Main Steam lines with process temperatures of 556°F. MP-G and MP-H are for Feedwater lines with process temperatures of 427°F.) The corrosion is powdery in form and does not exhibit flaking or pitting which would indicate a more severe condition. During plant operation the piping temperatures will be sufficiently high as to preclude moisture from the head plates and thus the plates will only be subject to corrosion during plant outages. These times are sufficiently short and the corrosion rates sufficiently low as to not result in significant loss of material (i.e., well less than 10% as discussed in IWE-3512.3) Corrosion on the penetration sleeves is general surface corrosion that has not resulted in any significant loss of material. Examination at the next regular inspection period is sufficient to monitor these conditions.</p>	✓

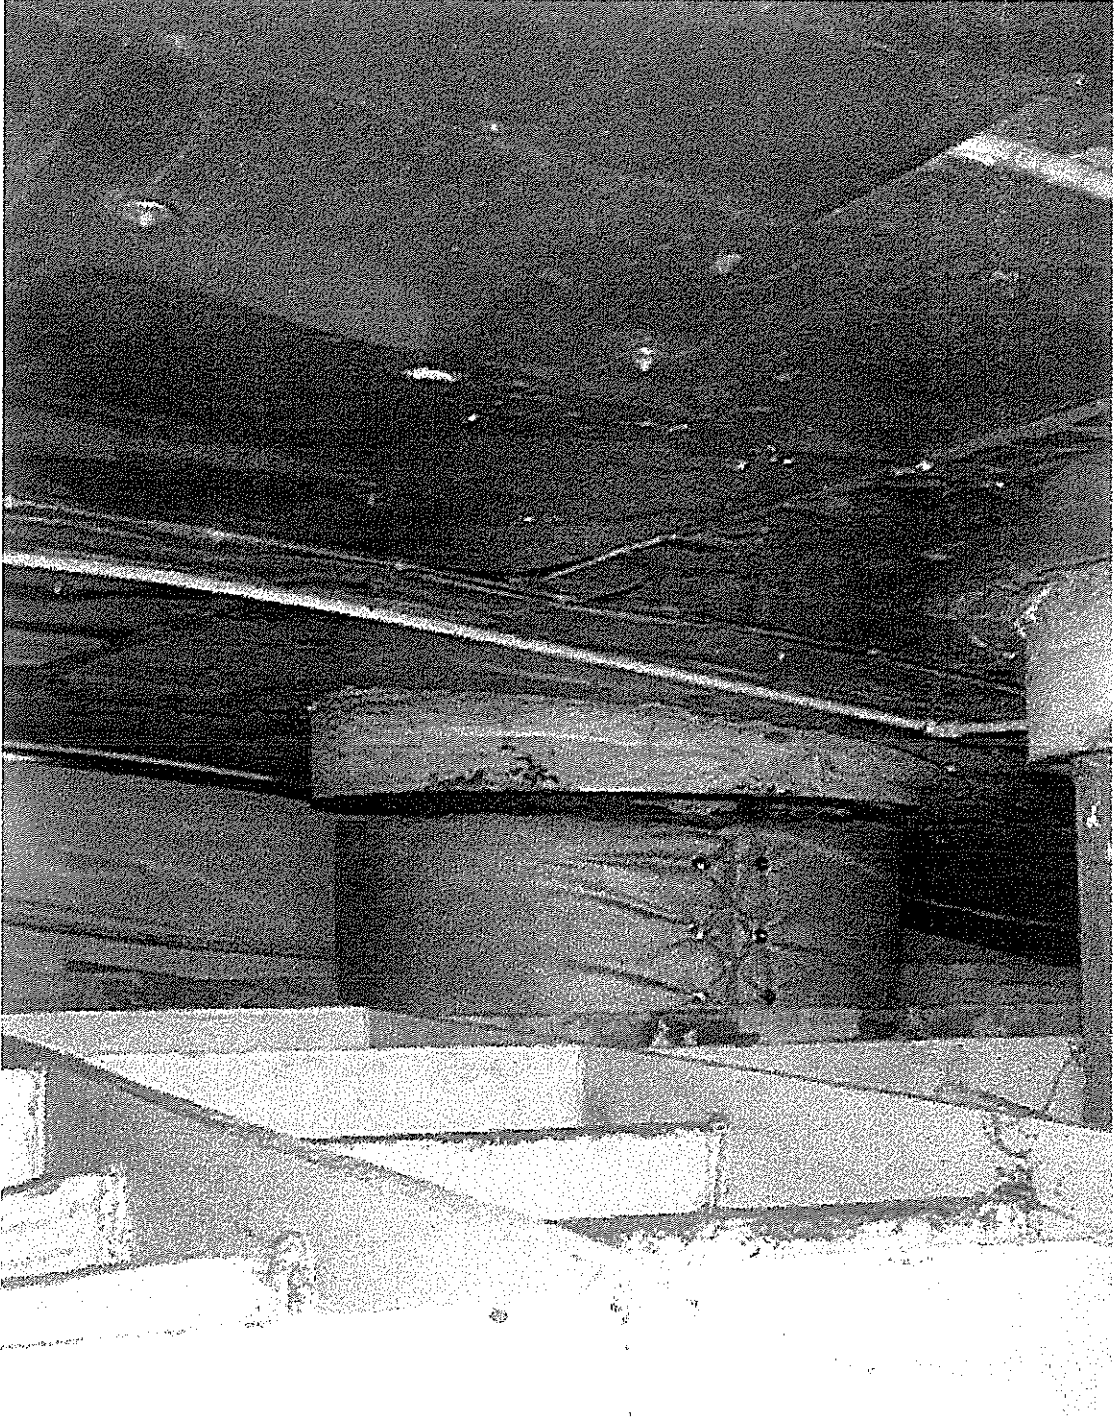
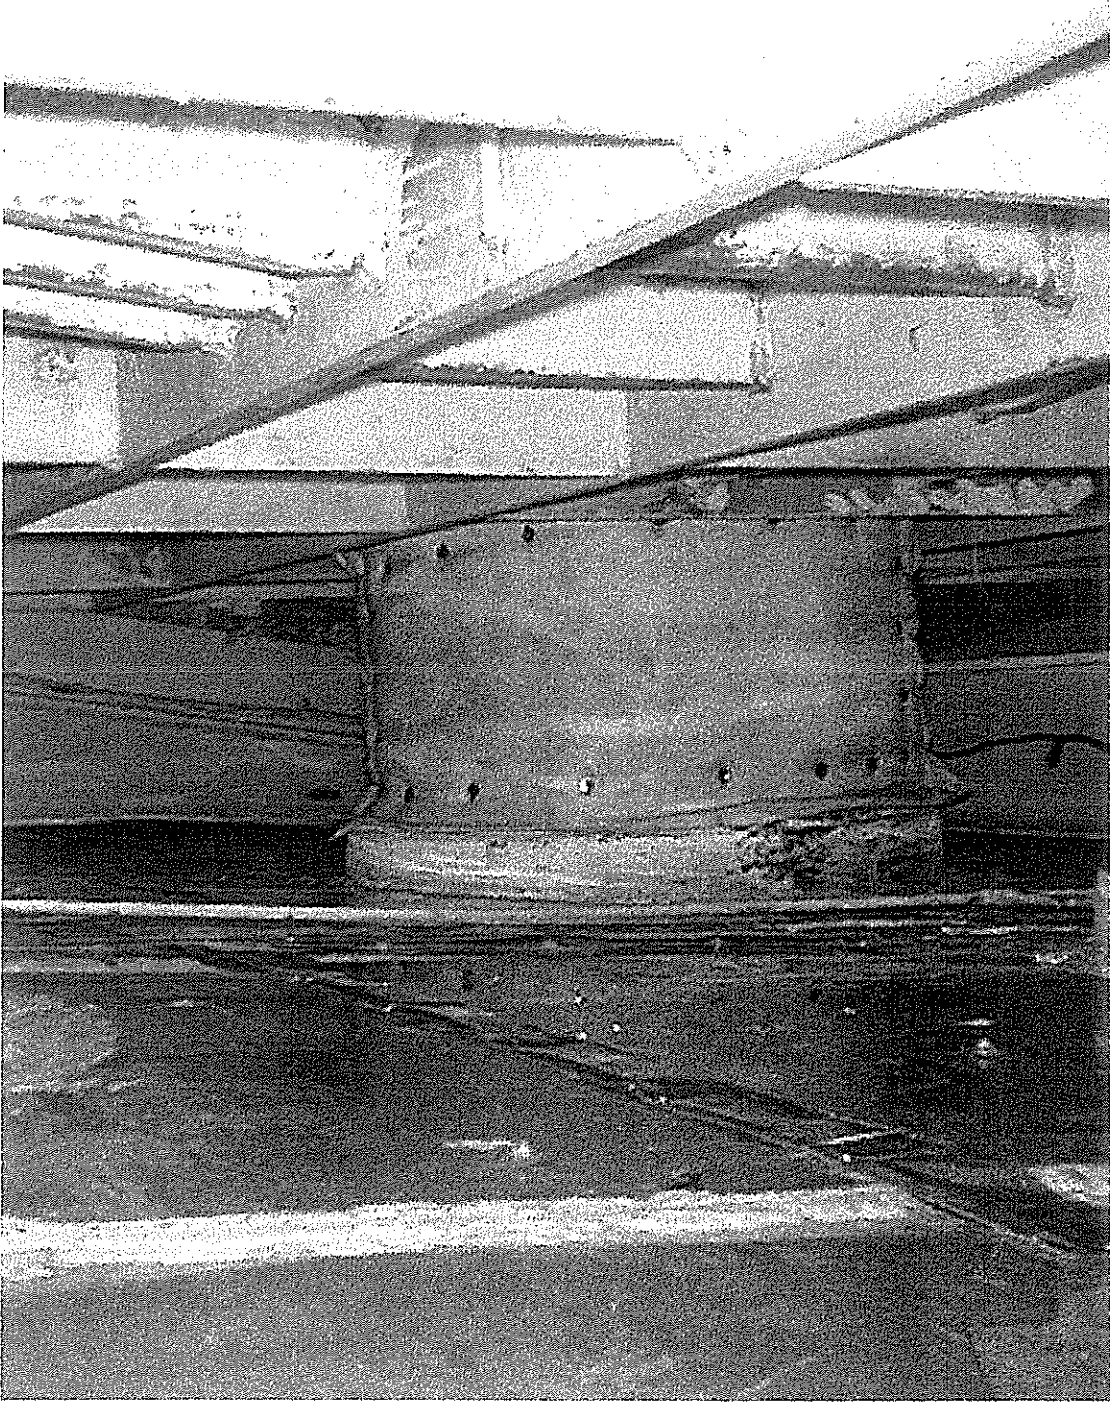
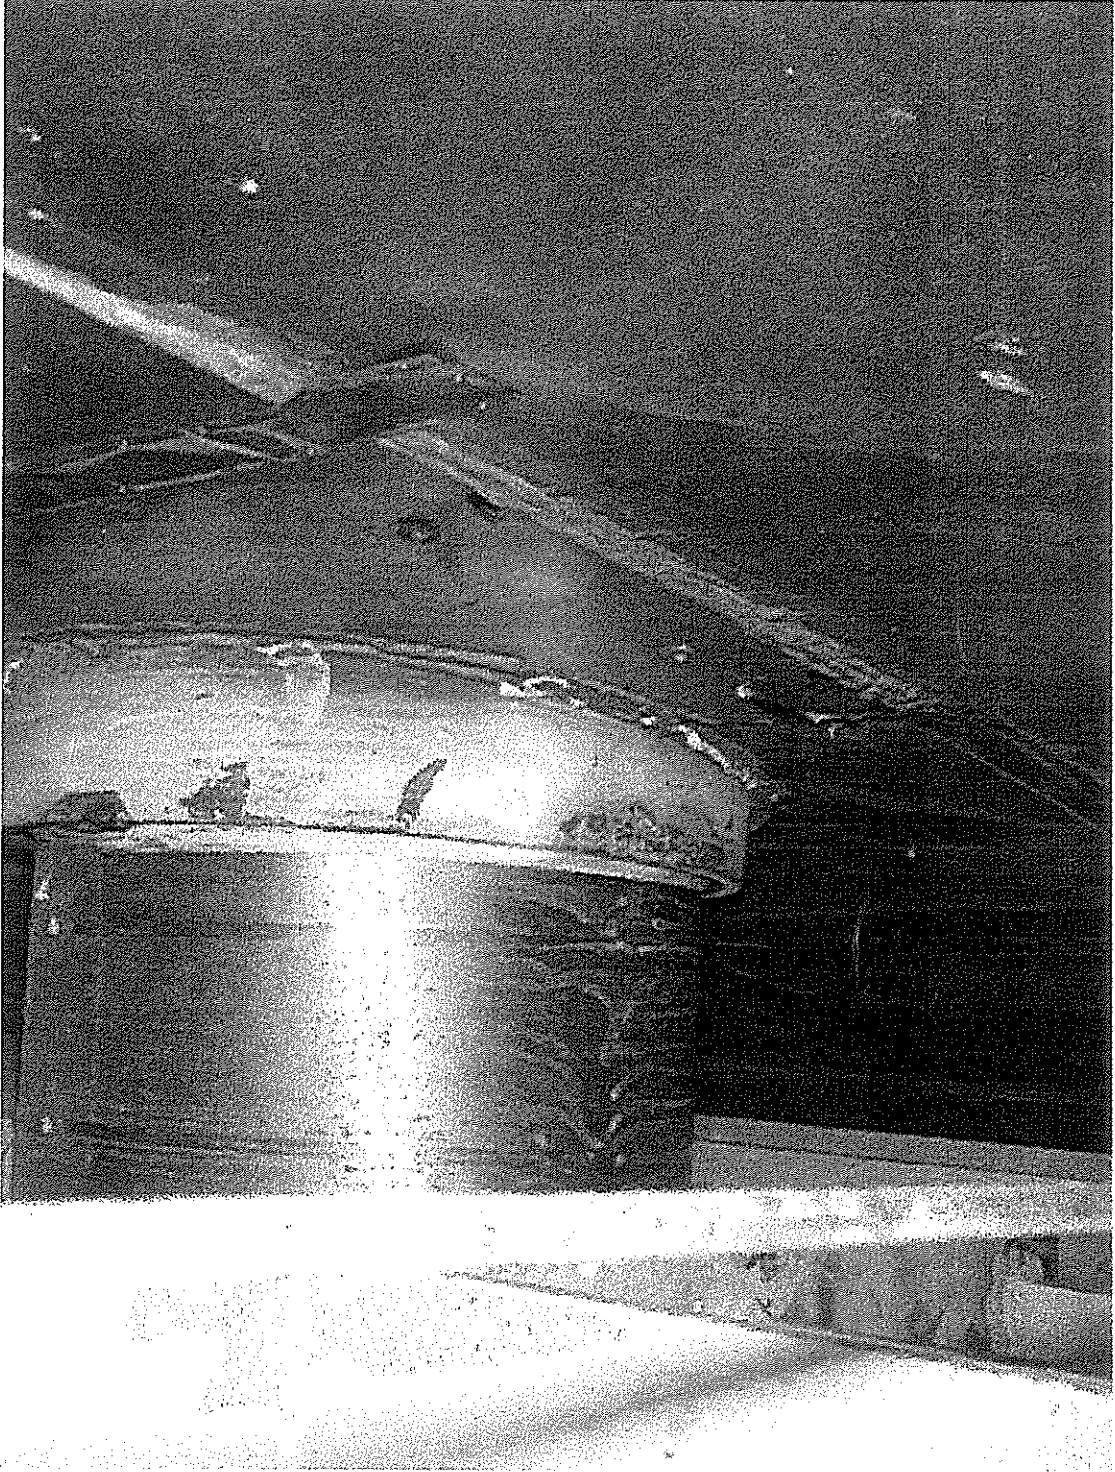
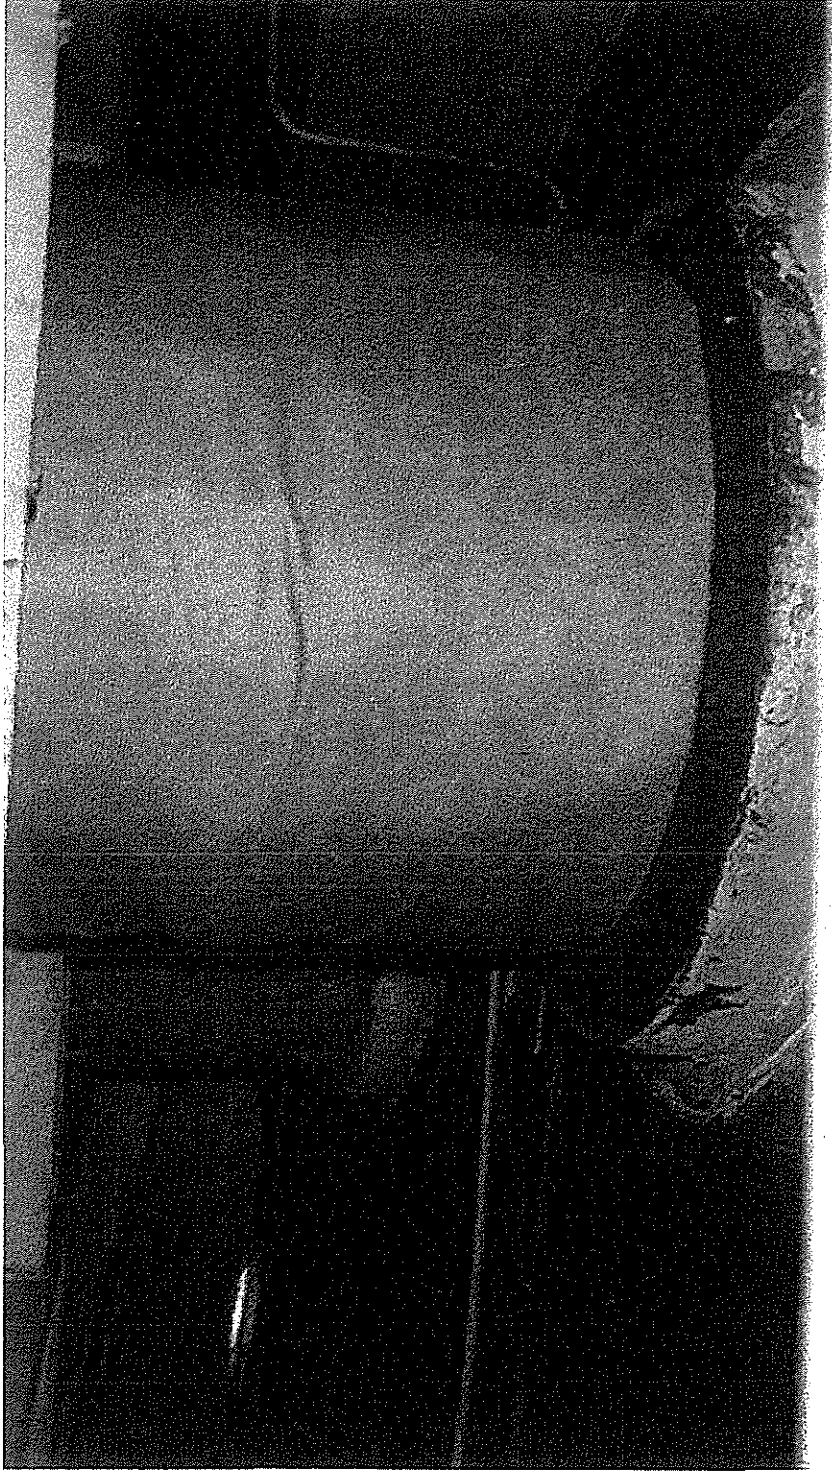
Item No.	Description	Photo
01	Mechanical penetration nos. MP-A, MP-B, MP-E and MP-F showed surface rusting on the end plates. Penetrations are for main steam and feedwater hot piping in which service will not promote an active corrosive environment. Rust staining is classified as ASTM D610, Grade 1-2 (between 1/3 and 1/2 of of end plate is rusted).	00031512.jpg - 00031515.jpg
02	Electrical penetration nos. EP-H11, EP-H12, EP-H13, EP-H14, EP-H15, EP-H16, EP-H17, EP-H18, EP-H58, EP-H59 showed loose surface rusting on the construction primer coat around the weld ring -to-flange areas. Rust staining is classified as ASTM D610, Grade 1-2 (between 1/3 and 1/2 of weld ring-to-flange circumference is rusted).	00031407.jpg - 00031417.jpg
