General
Engineering
Guideline

ATTACHMENT D General Visual Examination Checklist

IP2-GEG-3113
Rev. 1
Rev. Date: 03-10-2000

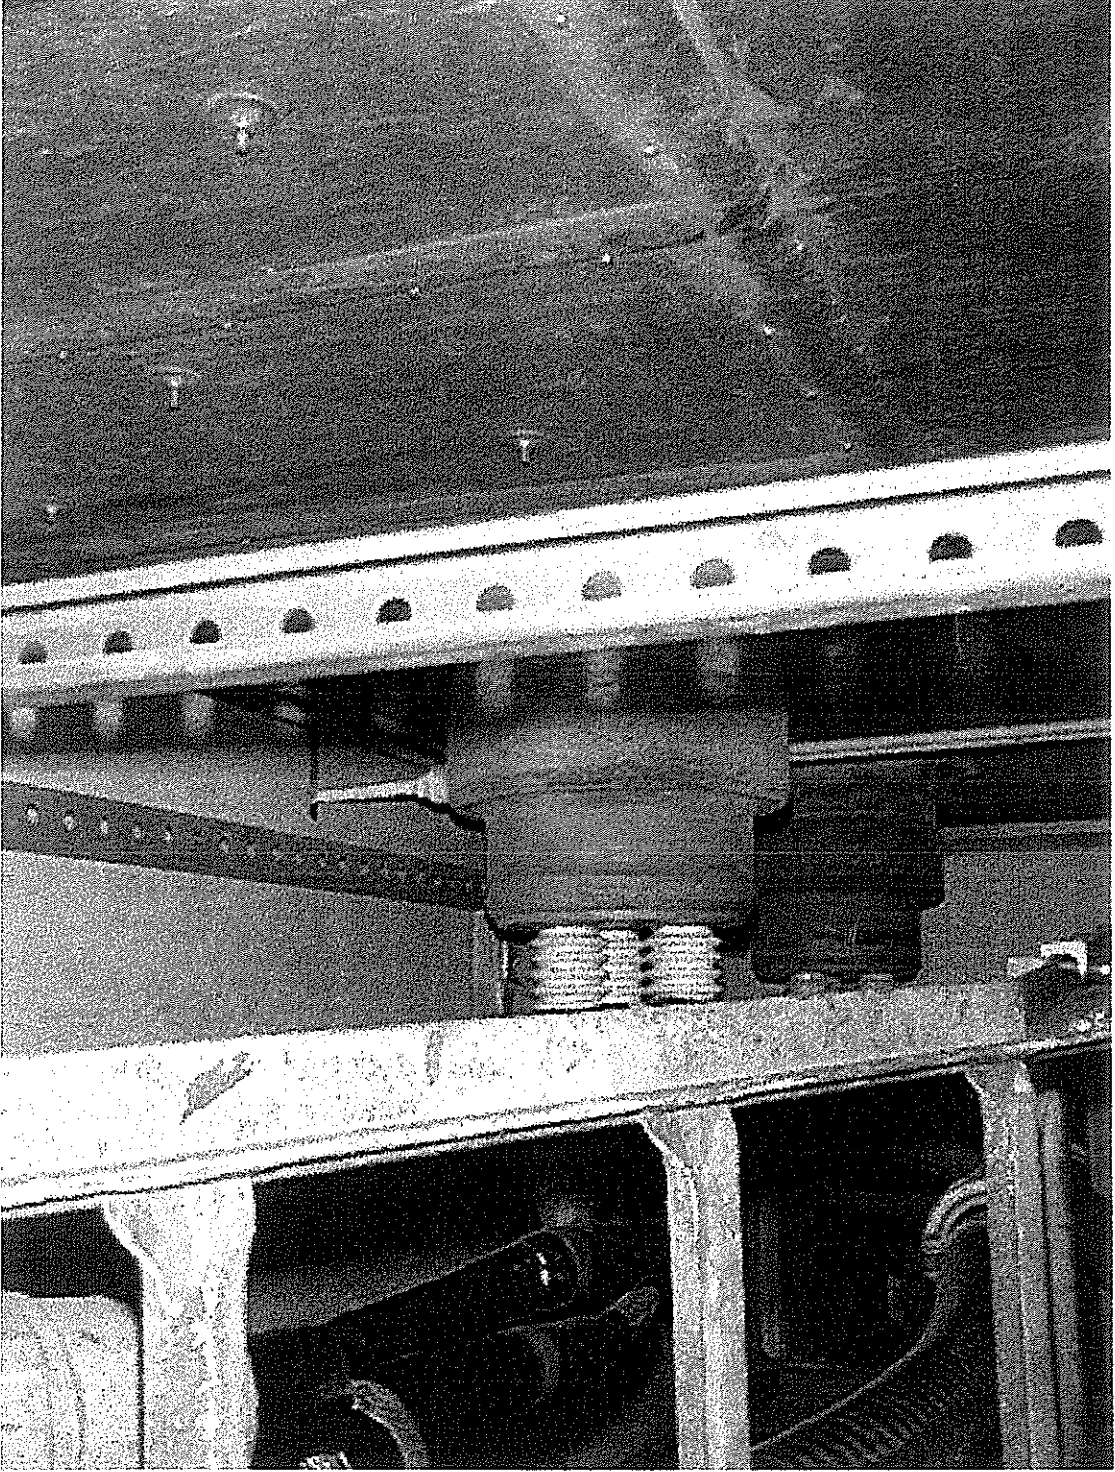
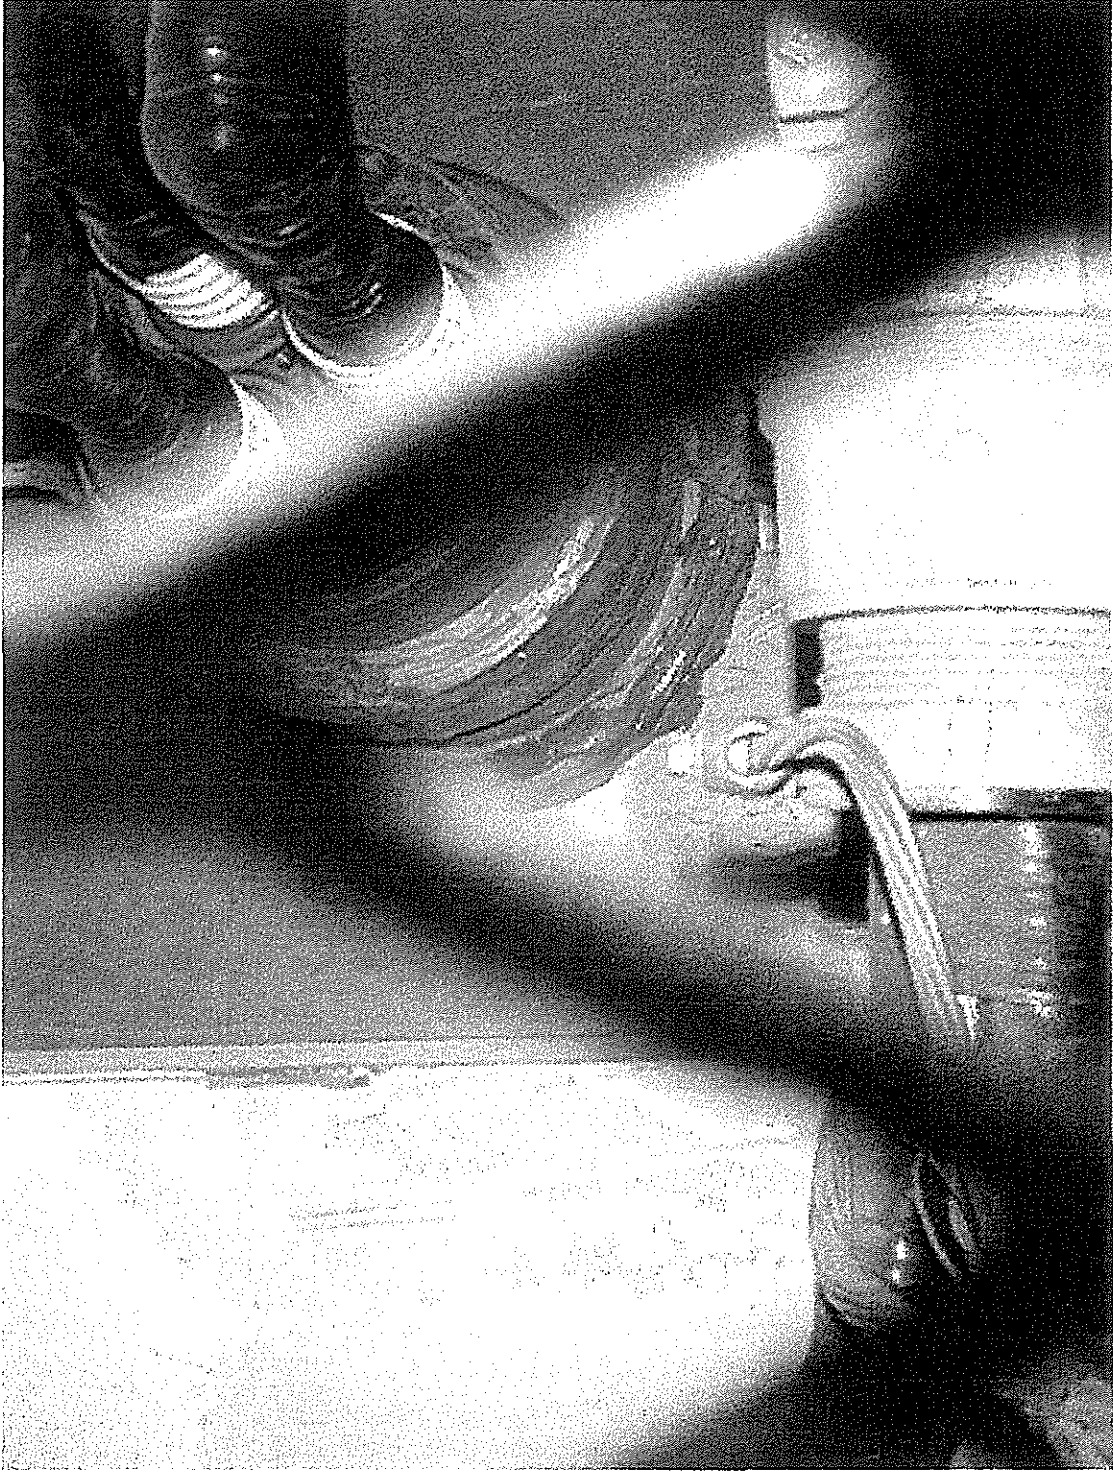
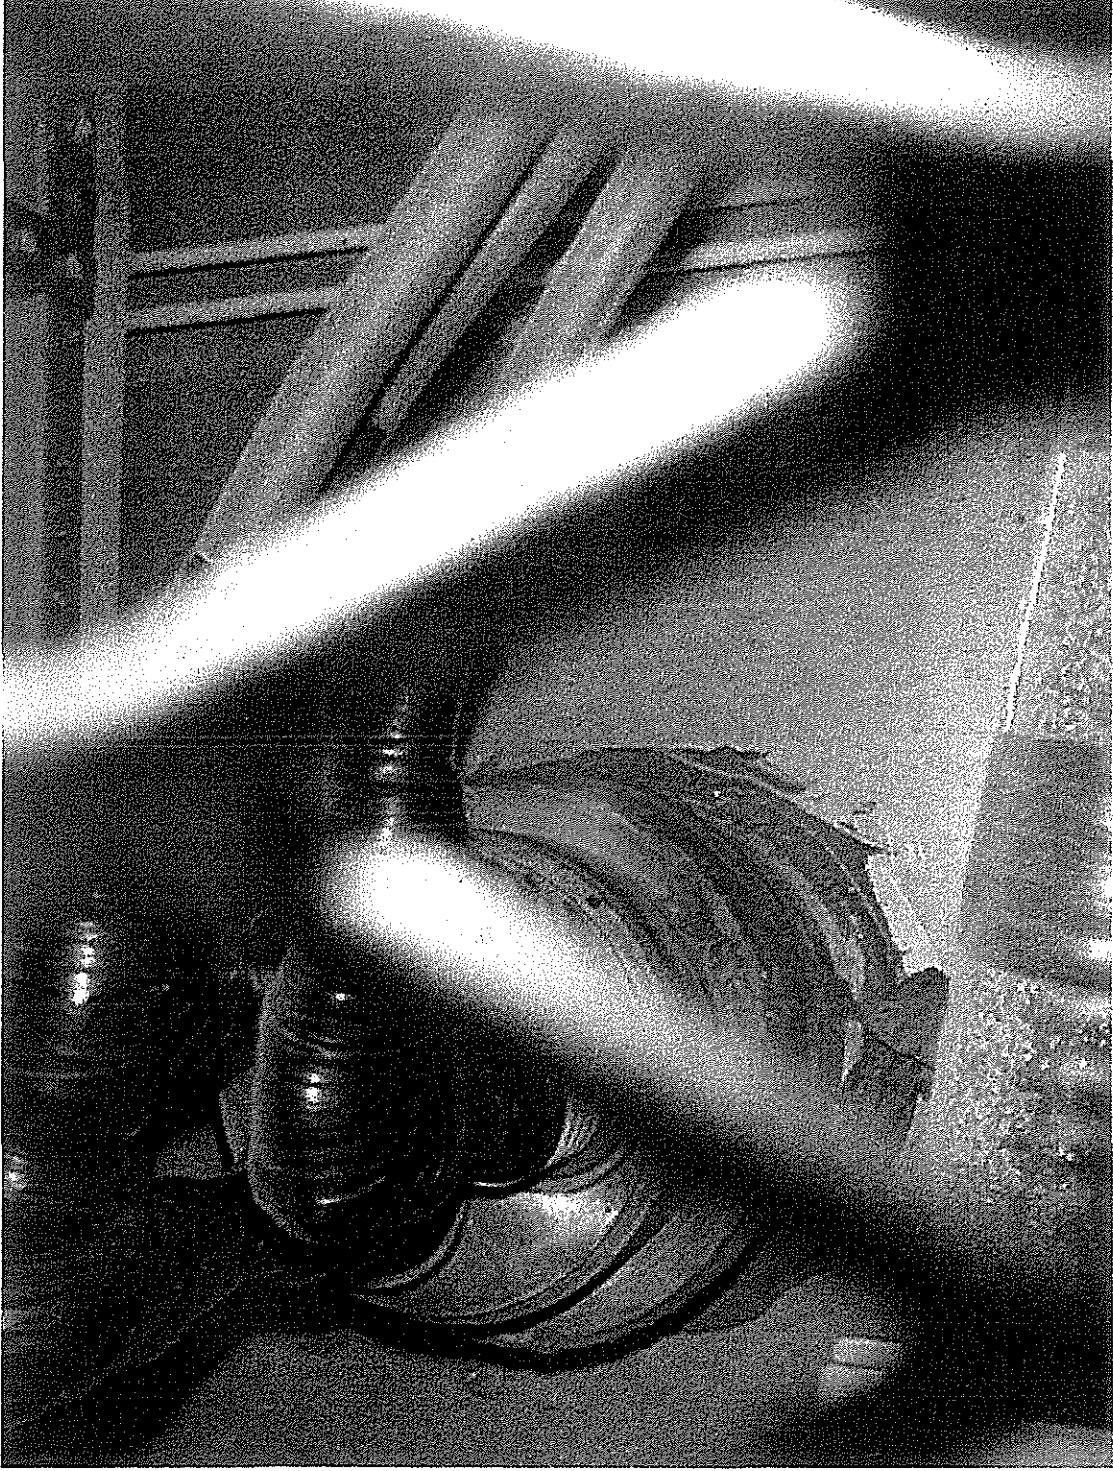
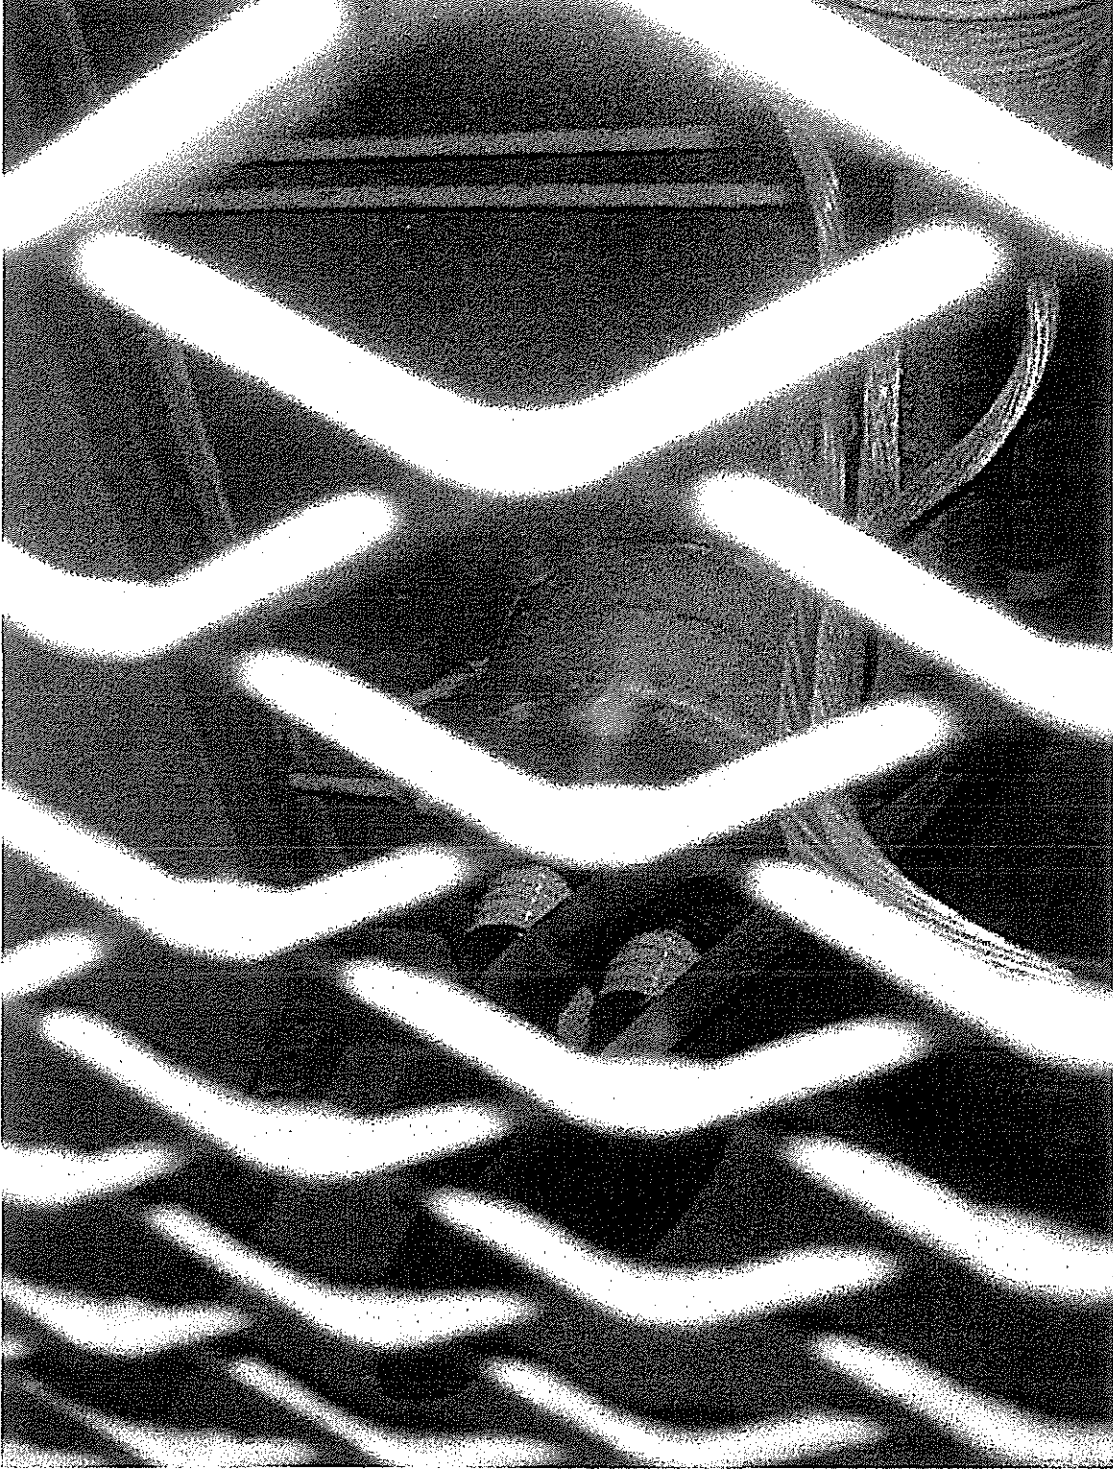
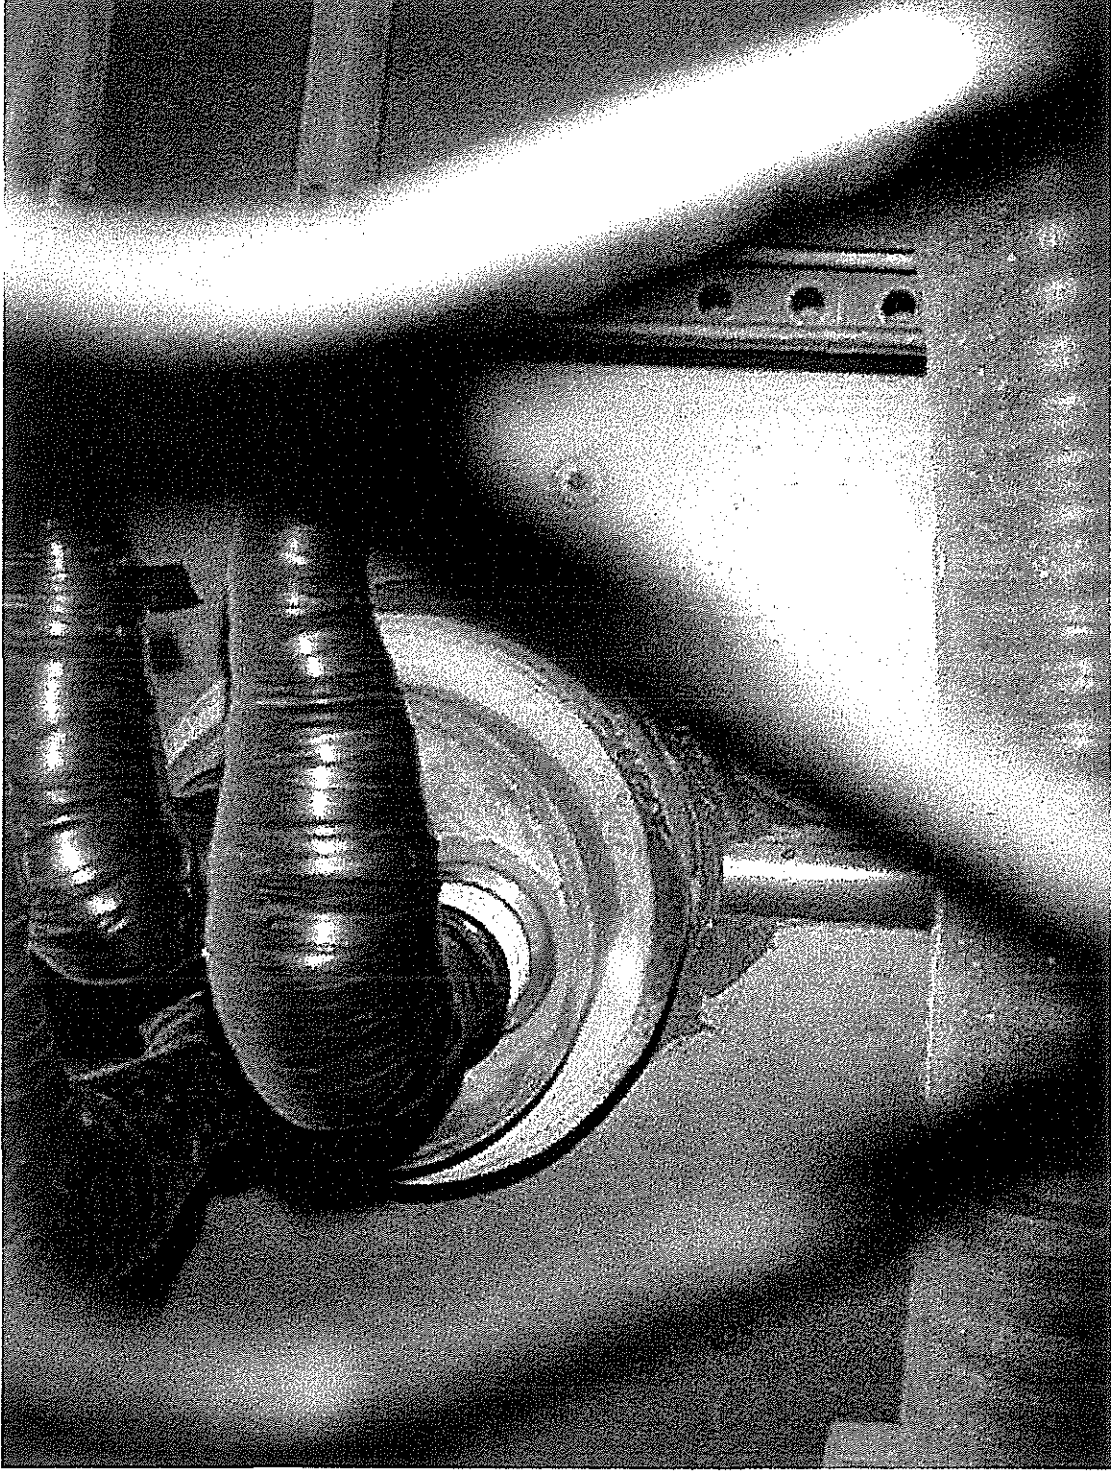
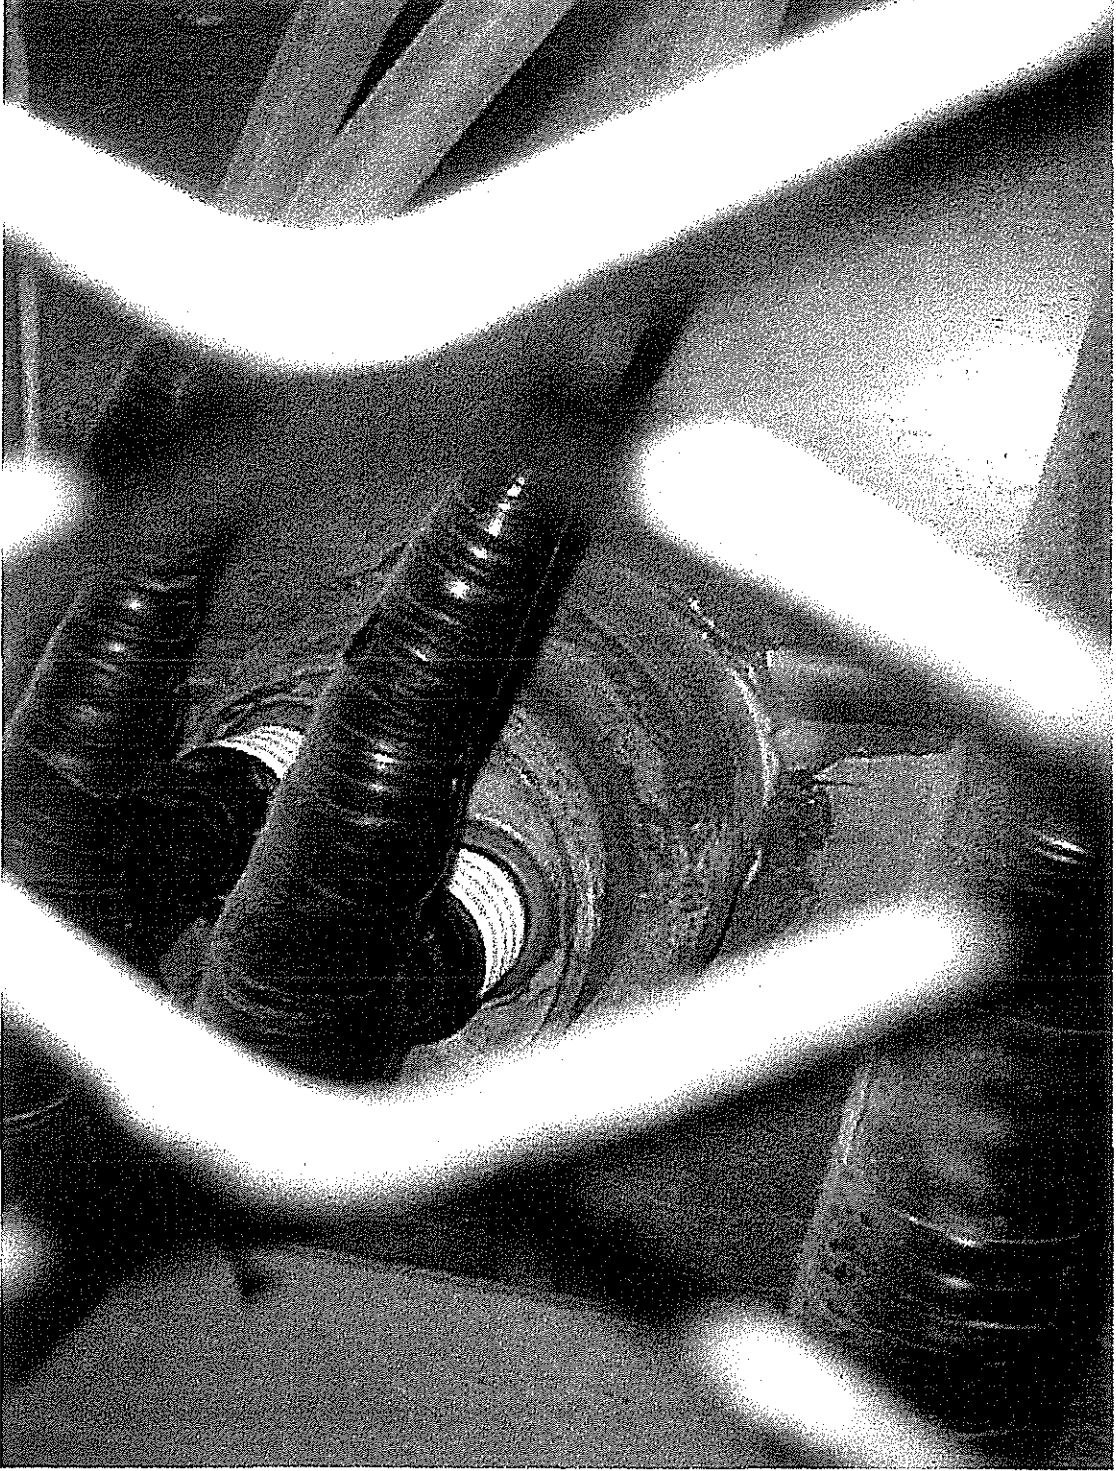
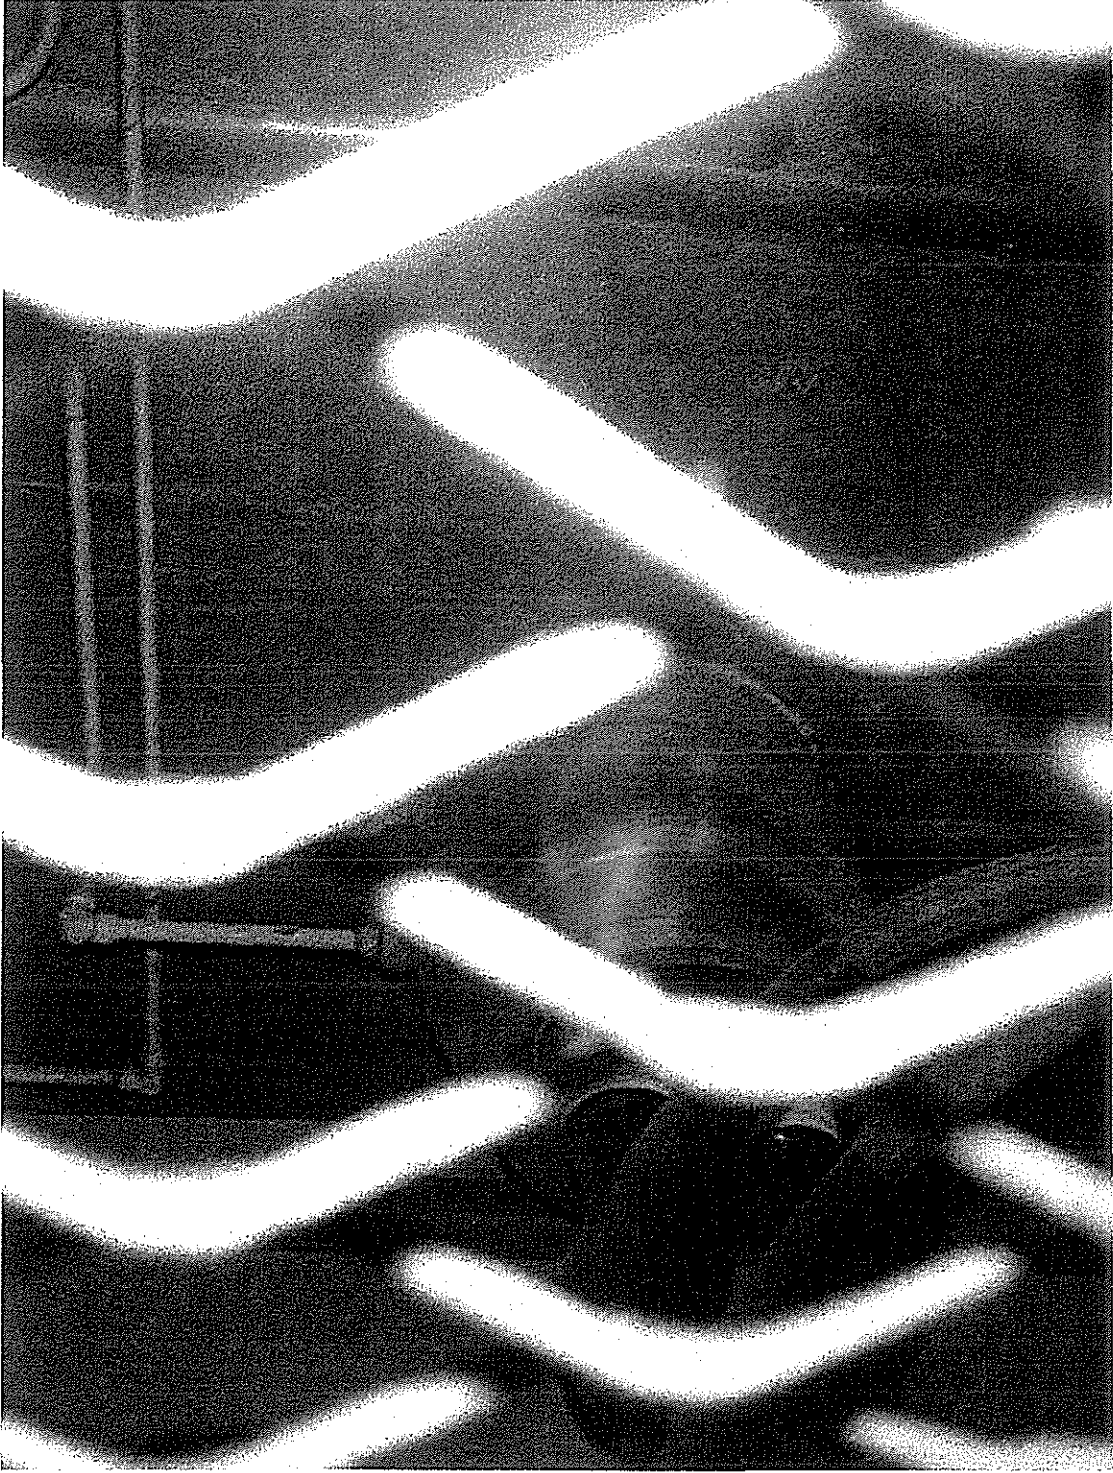
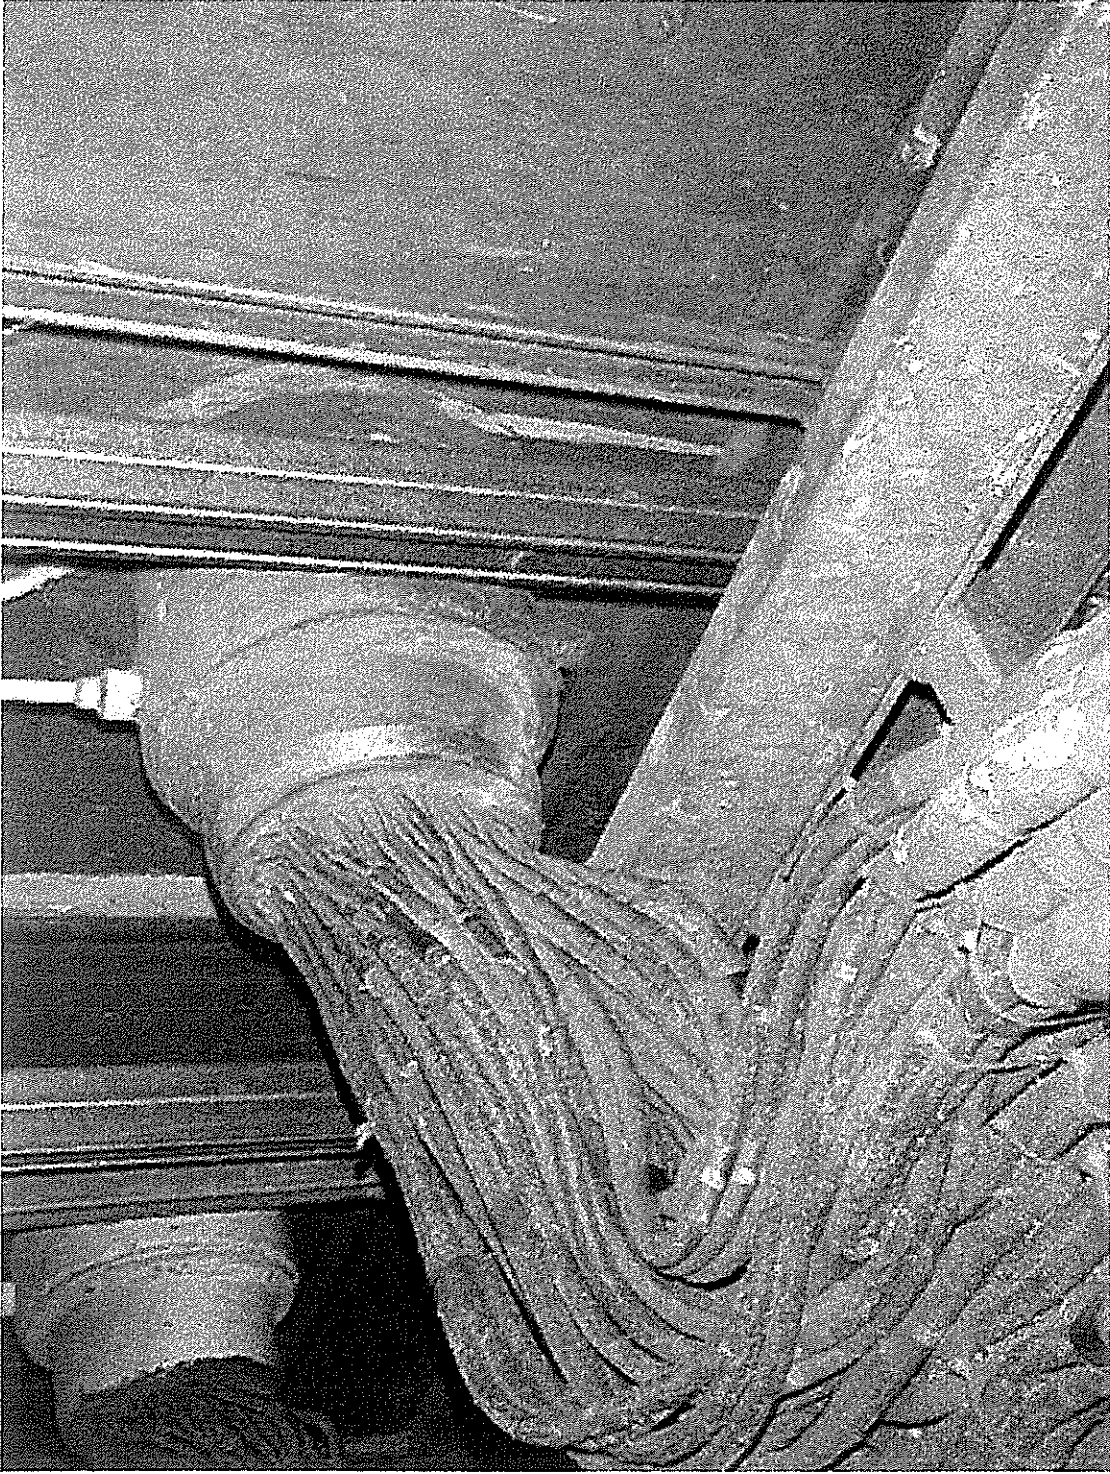
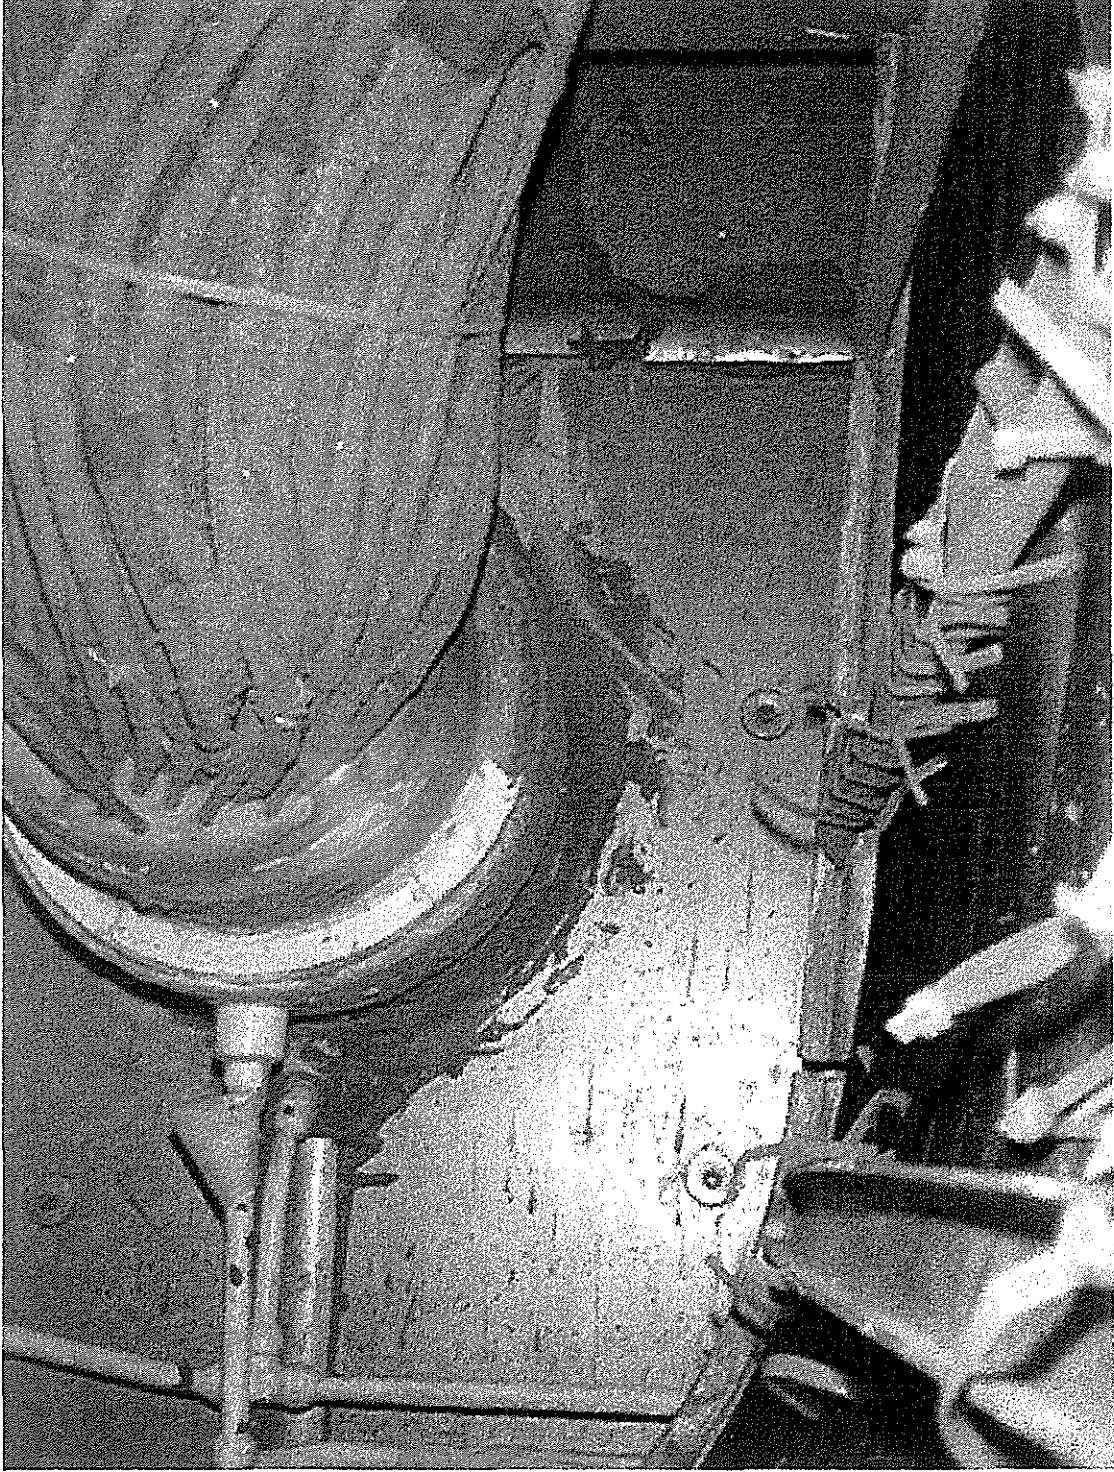
Item No.	Description	Photo
01	Mechanical penetration nos. MP-A, MP-B, MP-E and MP-F showed surface rusting on the end plates. Penetrations are for main steam and feedwater hot piping in which service will not promote an active corrosive environment. Rust staining is classified as ASTM D610, Grade 1-2 (between 1/3 and 1/2 of of end plate is rusted).	00031512.jpg - 00031515.jpg
02	Electrical penetration nos. EP-H11, EP-H12, EP-H13, EP-H14, EP-H15, EP-H16, EP-H17, EP-H18, EP-H58, EP-H59 showed loose surface rusting on the construction primer coat around the weld ring -to-flange areas. Rust staining is classified as ASTM D610, Grade 1-2 (between 1/3 and 1/2 of weld ring-to-flange circumference is rusted).	00031407.jpg - 00031417.jpg
