FORM VT-3C
CONTAINMENT INSERVICE INSPECTION
RECORD OF VT-3C EXAMINATION

STATION/UNIT: Indian Point 2 COMPONENT NO.: VCC-21
 ZONE NUMBER: IWL-108-004 DRAWING NO.: 320855
 EQUIPMENT USED: Celestron Giant 20x80 Binoculars (Ser. No. 990176)

Work Order No. NP-99-11274

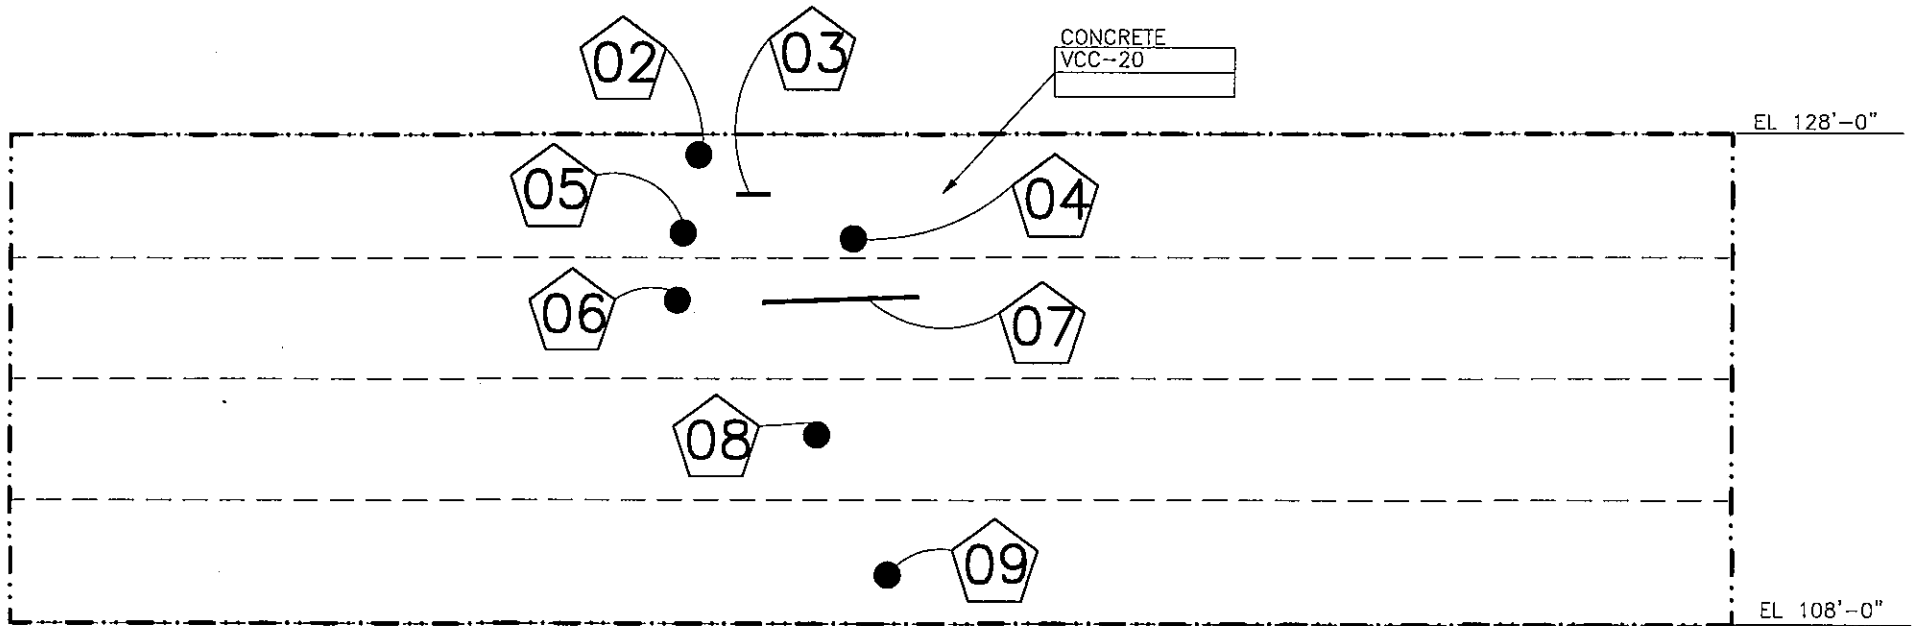
CONCRETE INSPECTION ZONE IWL-108-003
 (EXTERIOR DEVELOPED VIEW, LOOKING FROM OUTSIDE)

-DENOTES COMMENT NUMBER ON INSPECTION FORM.

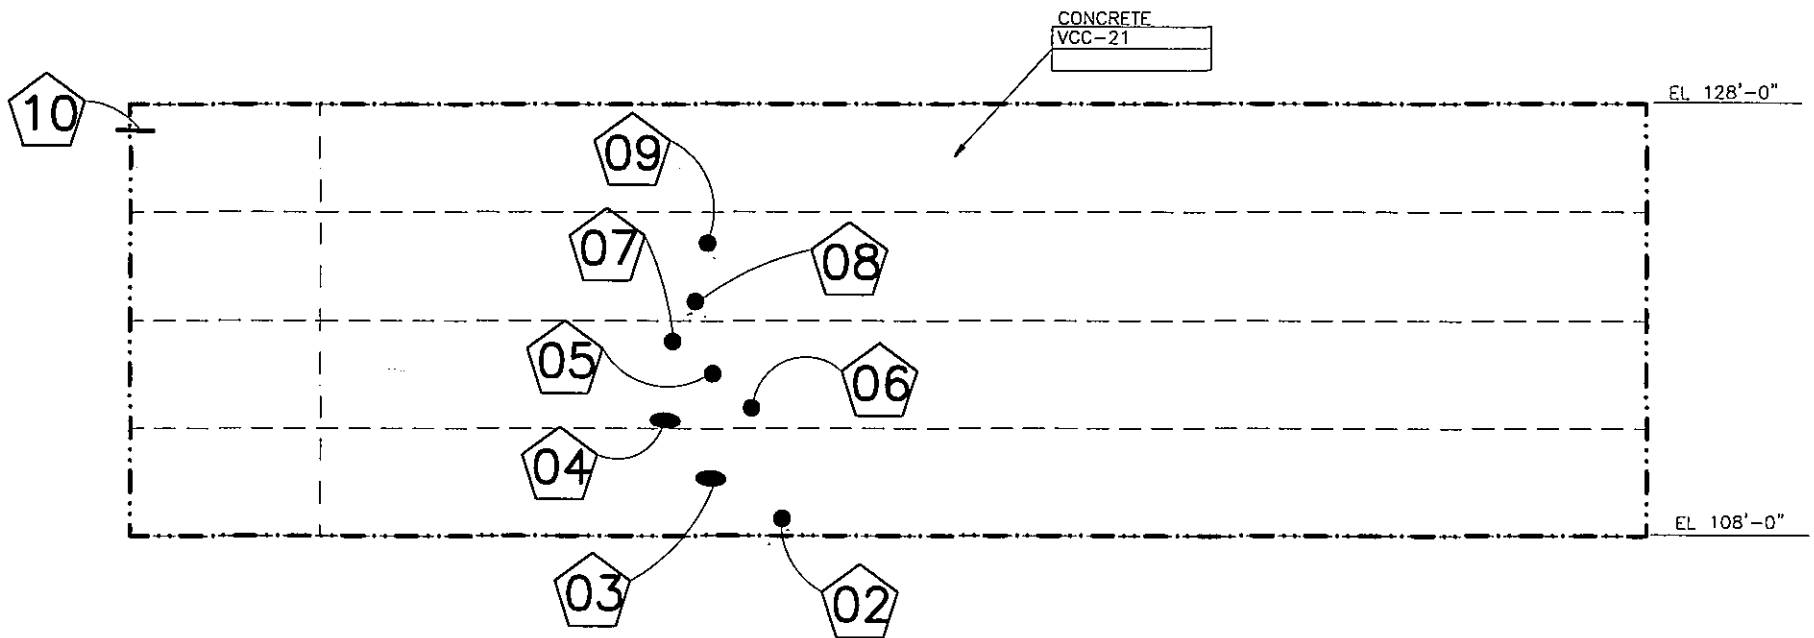
CONCRETE INSPECTION ZONE IWL-108-004
 (EXTERIOR DEVELOPED VIEW, LOOKING FROM OUTSIDE)

XX -DENOTES COMMENT NUMBER ON INSPECTION FORM.

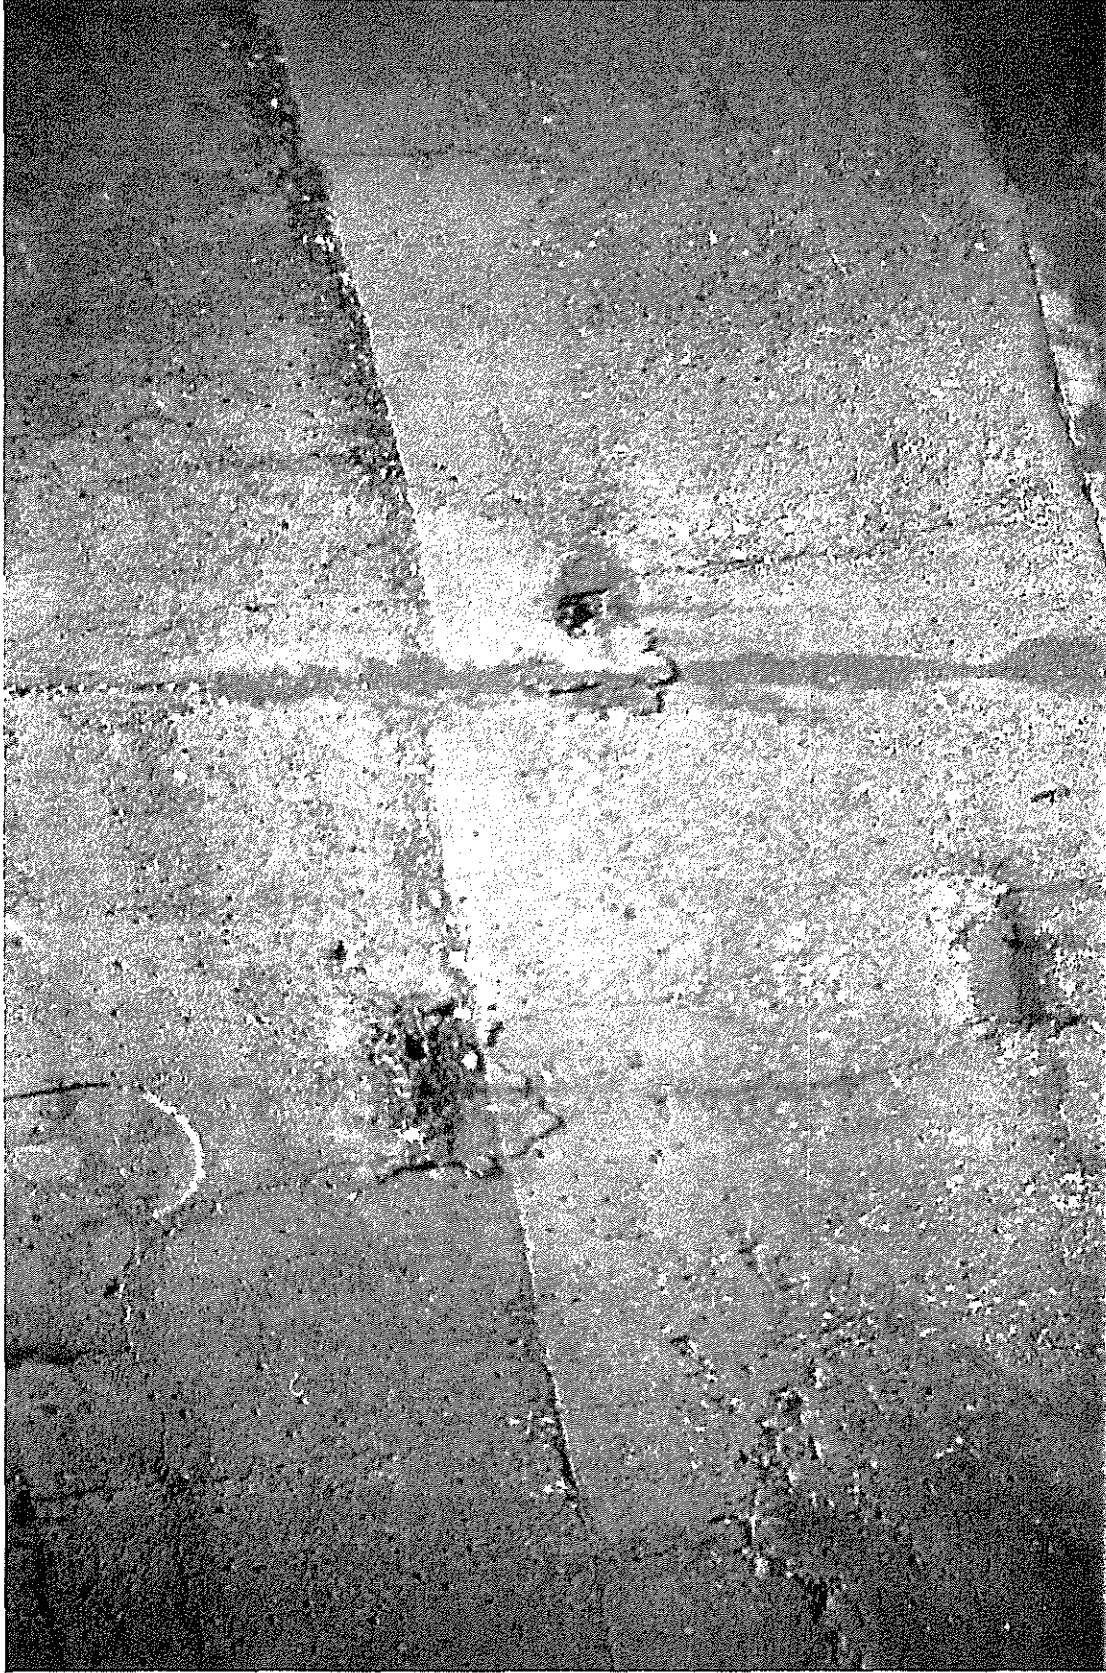
00052618.jpg

| No. | Comment | Initials |
|---|--|---|
| 2 | 1 1/2" rebar exposed due to spall. See photo 00052618 | RN |
| 3 | Concrete spall, 8" concrete about to popout. See photo 00052618 | RN |

Comments: The surface texture (comment #1) resulted from original construction and does not reflect degradation. Engineering evaluation is needed for all of the other observed conditions.

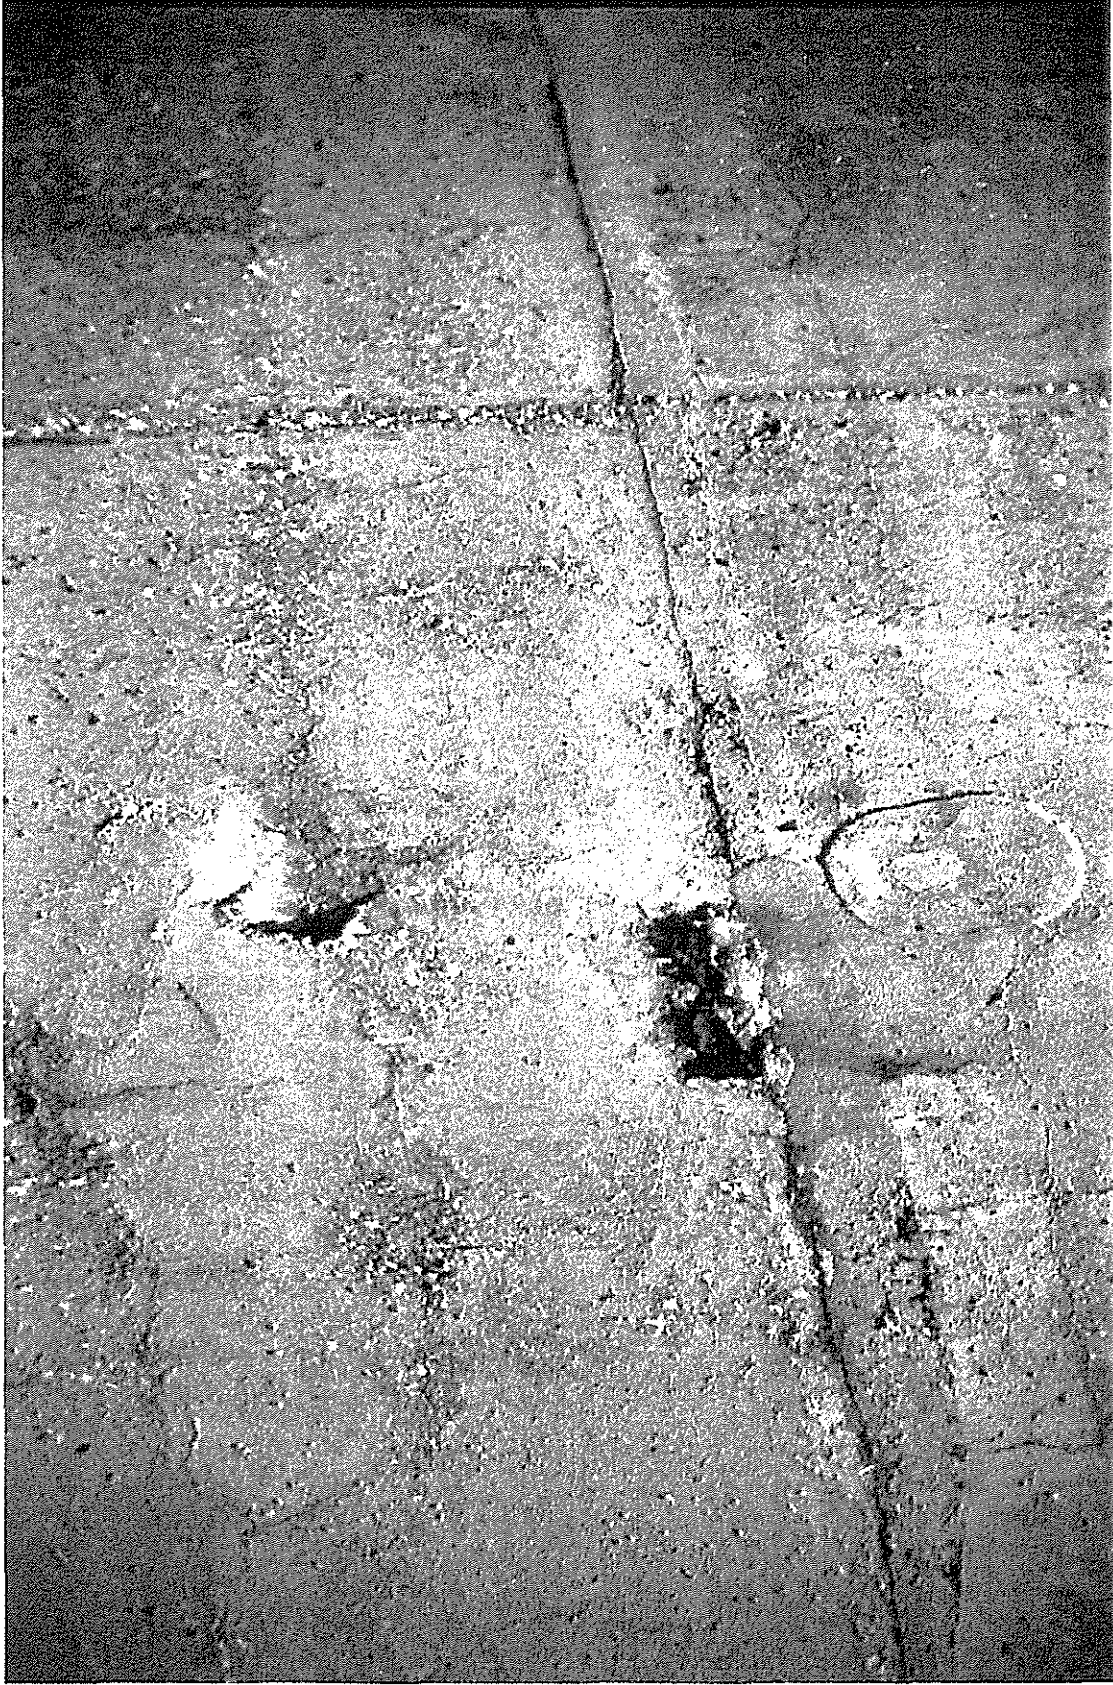
00052619.jpg

| No. | Comment | Initials |
|---|--|---|
| 4 | 10"x4" concrete spall exposing rebar over 8" length. See photo 00052619 | RN |

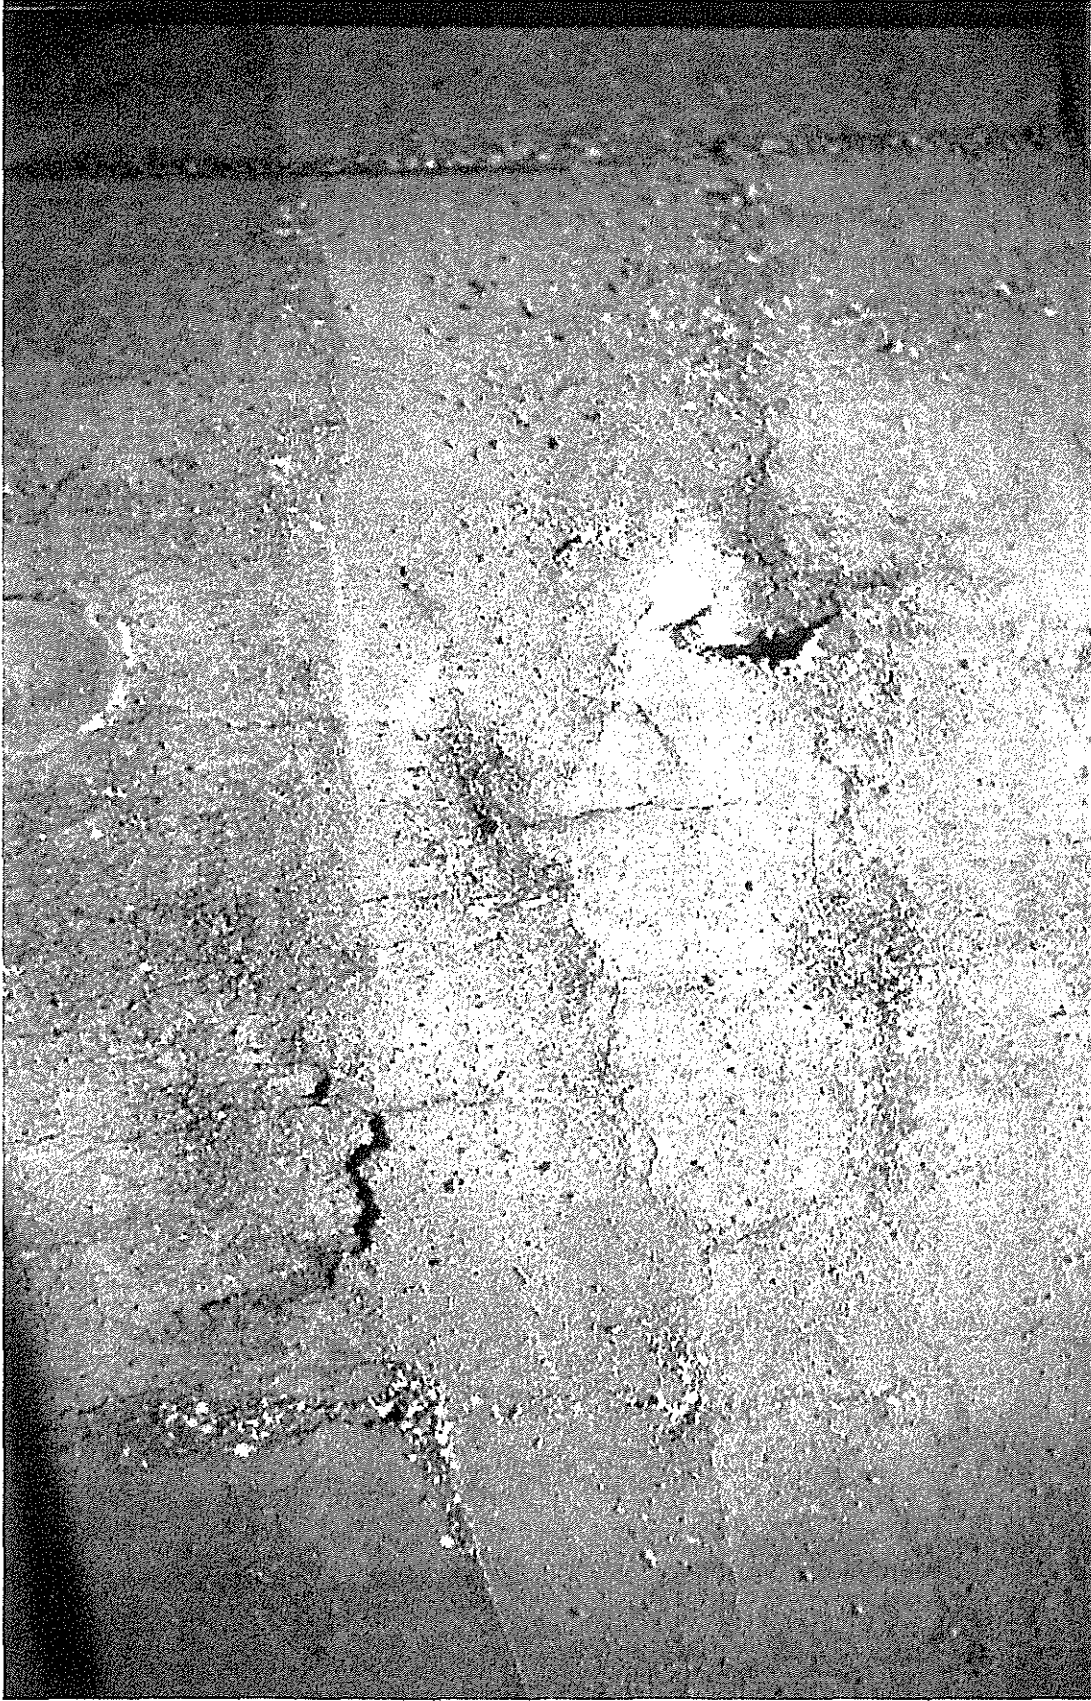
00052621.jpg

| No. | Comment | Initials |
|---|--|---|
| 5 | 2" concrete spall. See photo 00052621 | RN |
| 6 | 6" concrete about to spall. See photo 00052621 | RN |
| 7 | same as item 6. See photo 00052621 | RN |

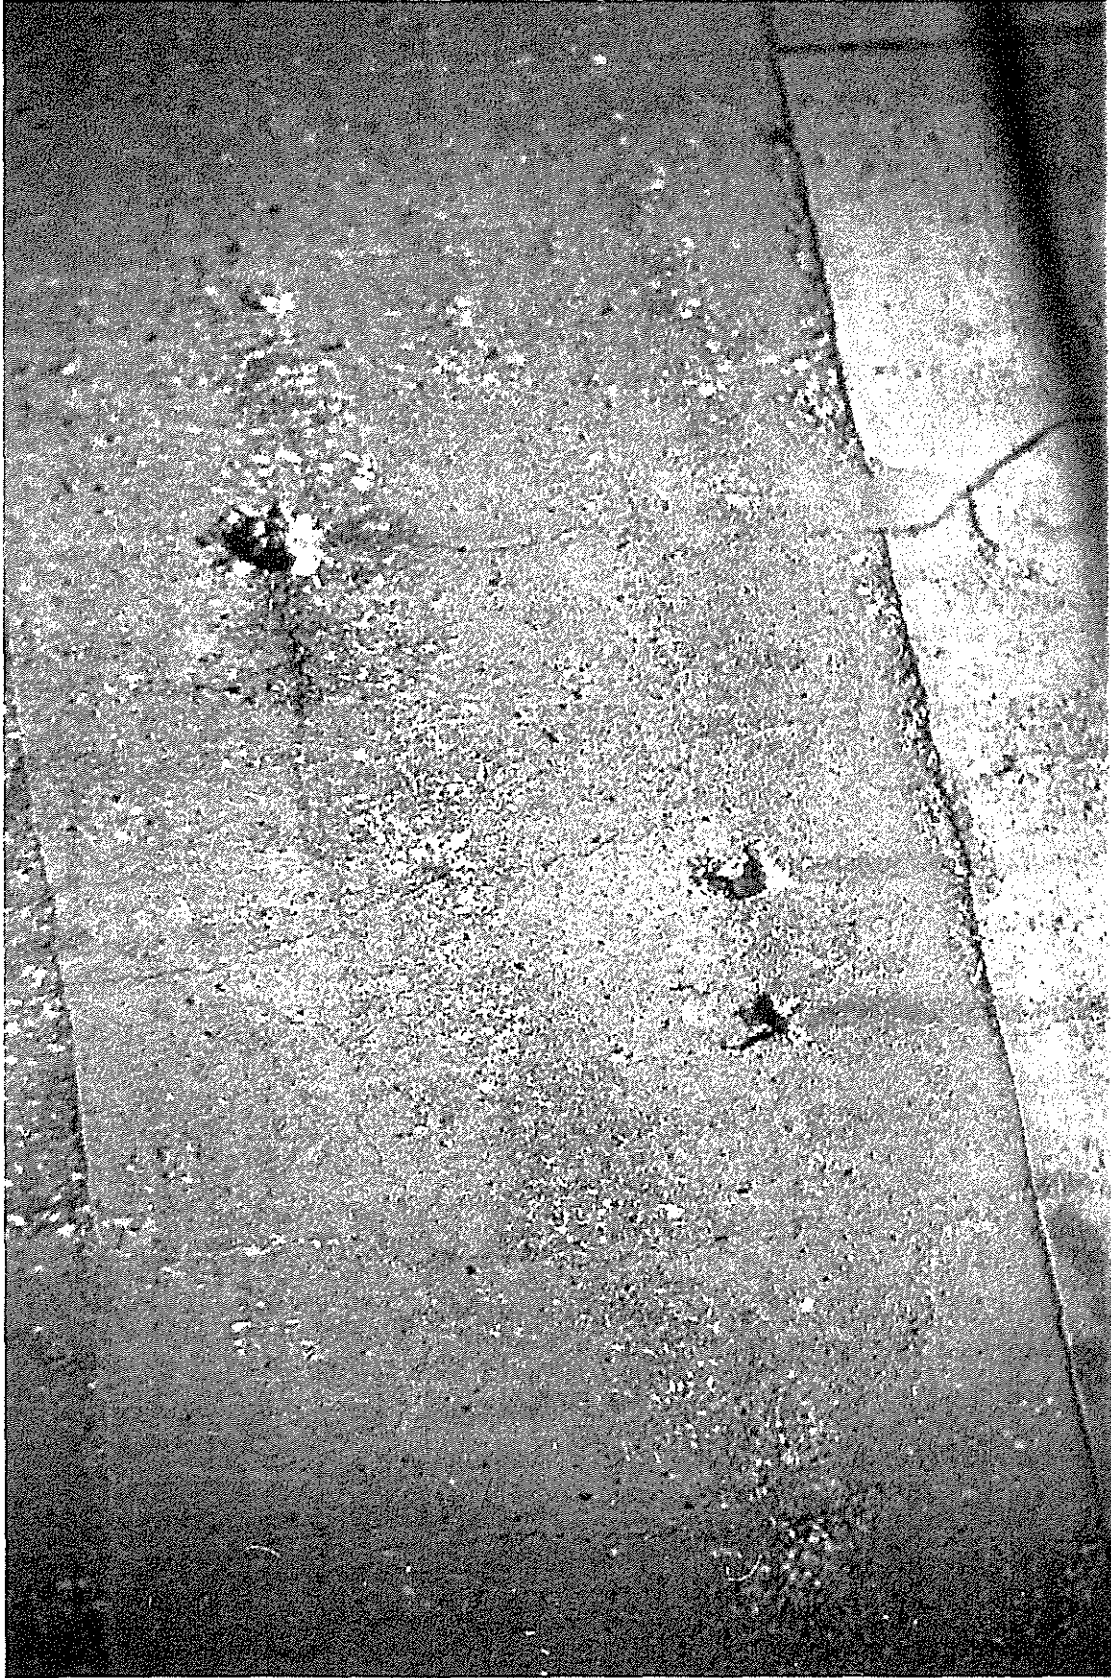
00052622.jpg

| No. | Comment | Initials |
|---|--|---|
| 8 | rebar (rusty) exposed at 2 locations spaced 9". See photo 00052622 | RN |
| 9 | 2" hole exposing rebar. See photo 00052622 | RN |

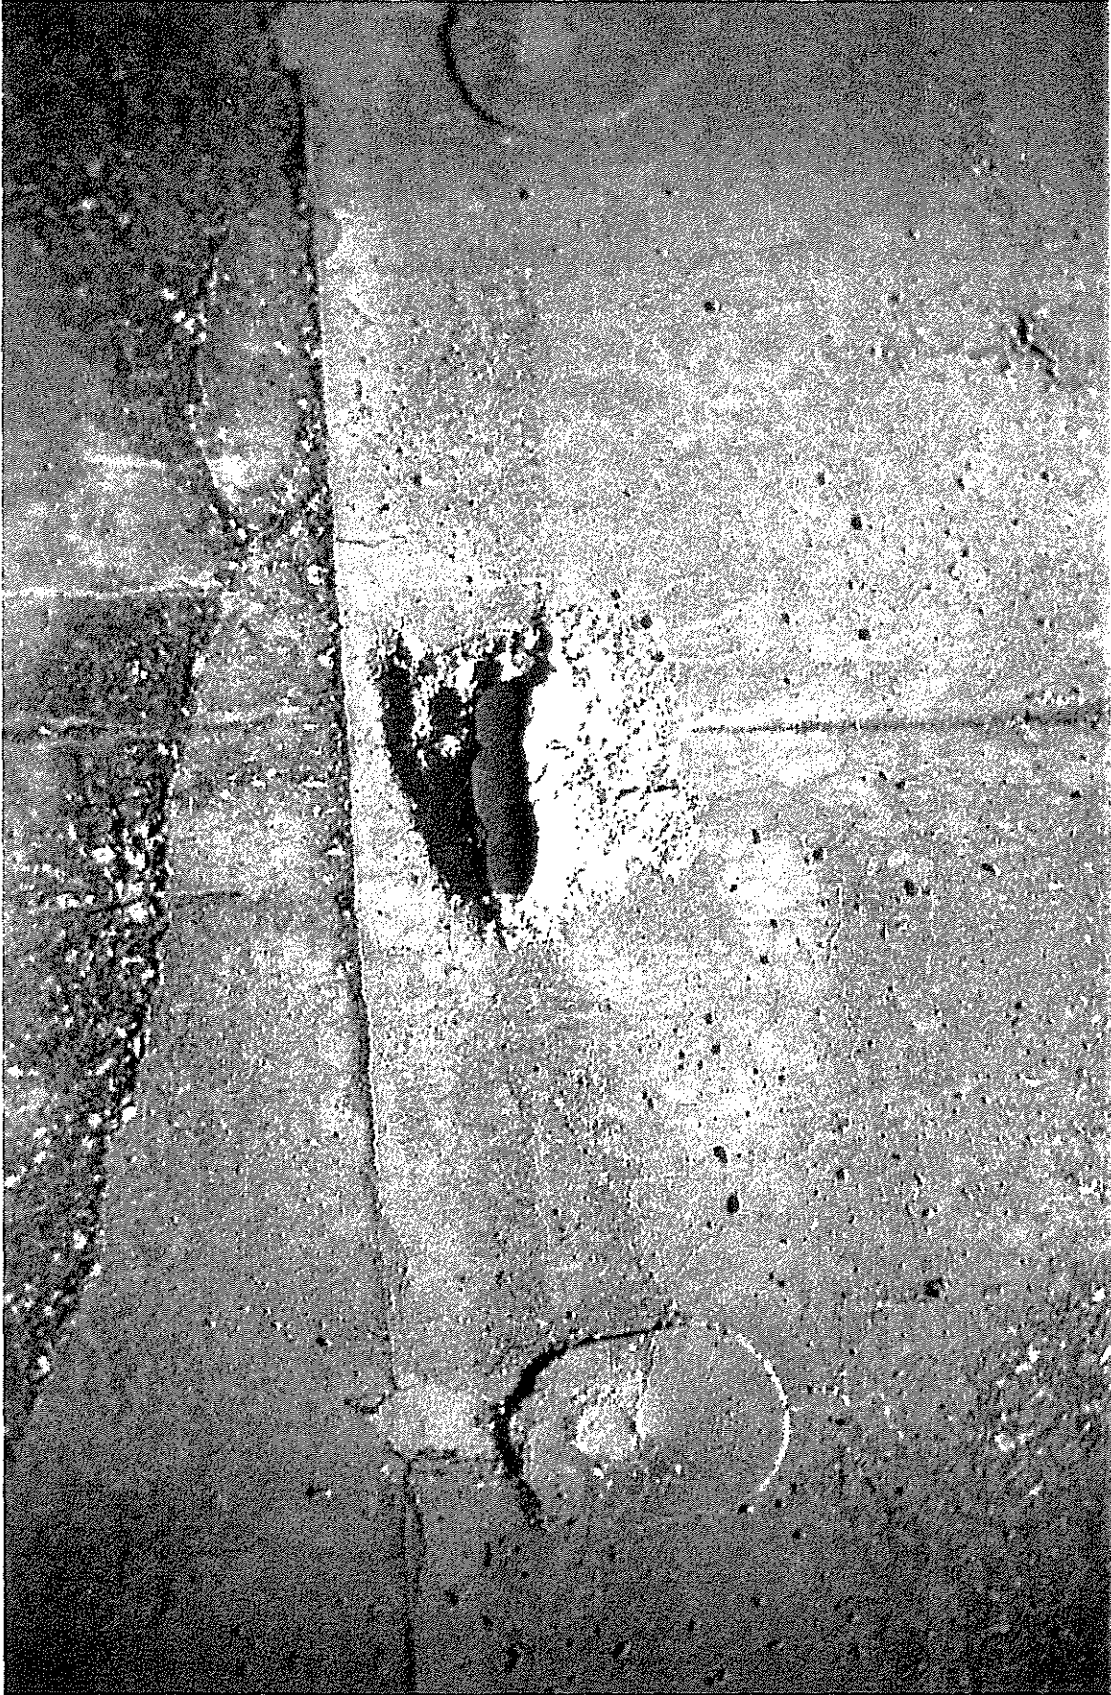
00052623.jpg

| No. | Comment | Initials |
|---|--|---|
| 10 | 1/2" cover concrete spalled off over 10" square exposing 9" length of cadweld sleeve. See photo 00052623 | RN |

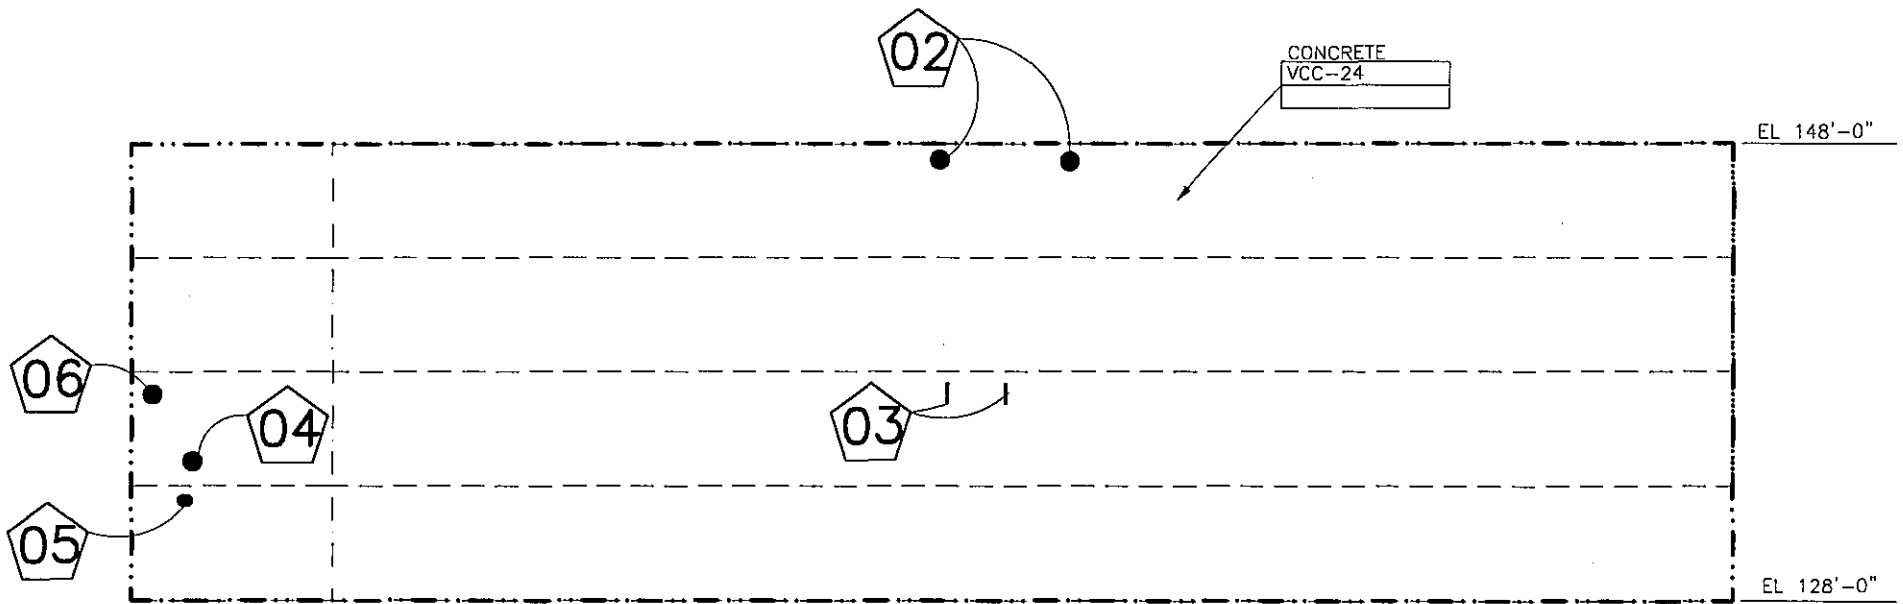
CONCRETE INSPECTION ZONE IWL-128-001
(EXTERIOR DEVELOPED VIEW, LOOKING FROM OUTSIDE)

-DENOTES COMMENT NUMBER ON INSPECTION FORM.

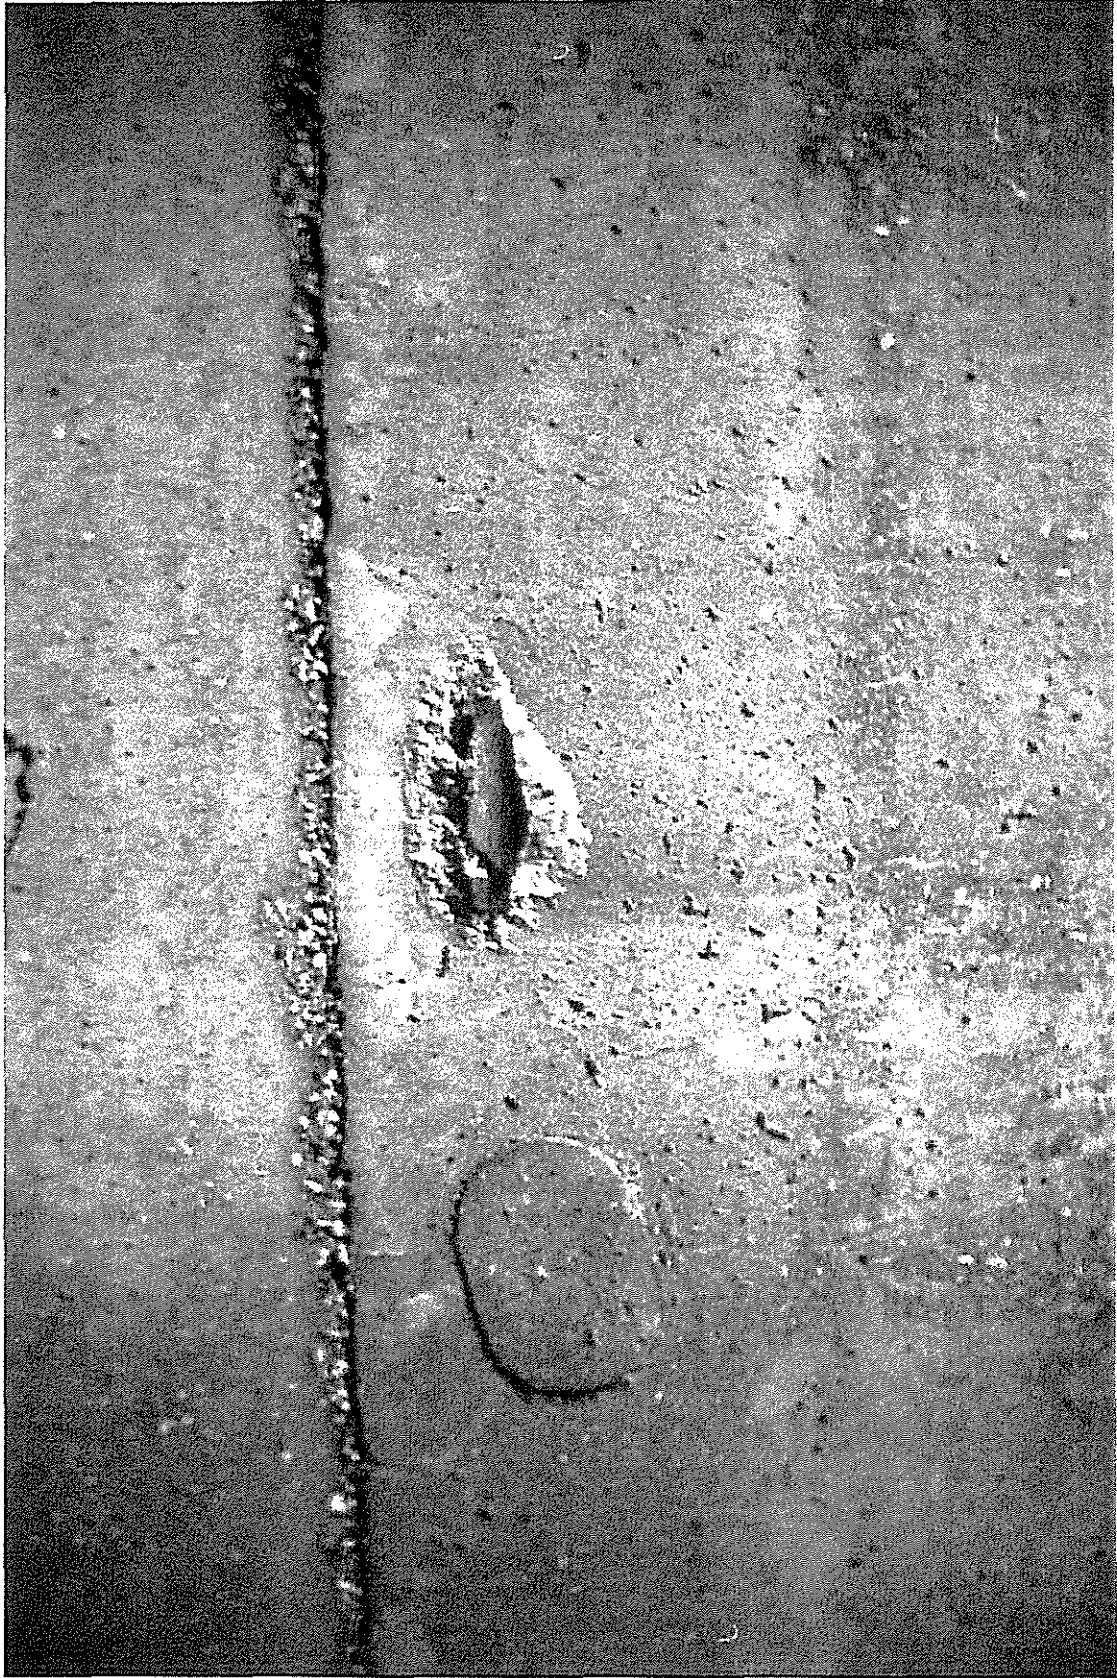
00052601.jpg

| No. | Comment | Initials |
|---|--|---|
| 5 | Rust stain on concrete below, from exposed cadweld sleeve with rust over 6" length. Inadequate concrete (about 1/2") cover. See photo 00052601. | RW |

Comments: The leaching is not significant. The surface texture resulted from original construction and does not reflect degradation of the containment. Engineering evaluation is needed for the spalling/corrosion associated with the reinforcing steel (comment nos. 4, 5 & 6).

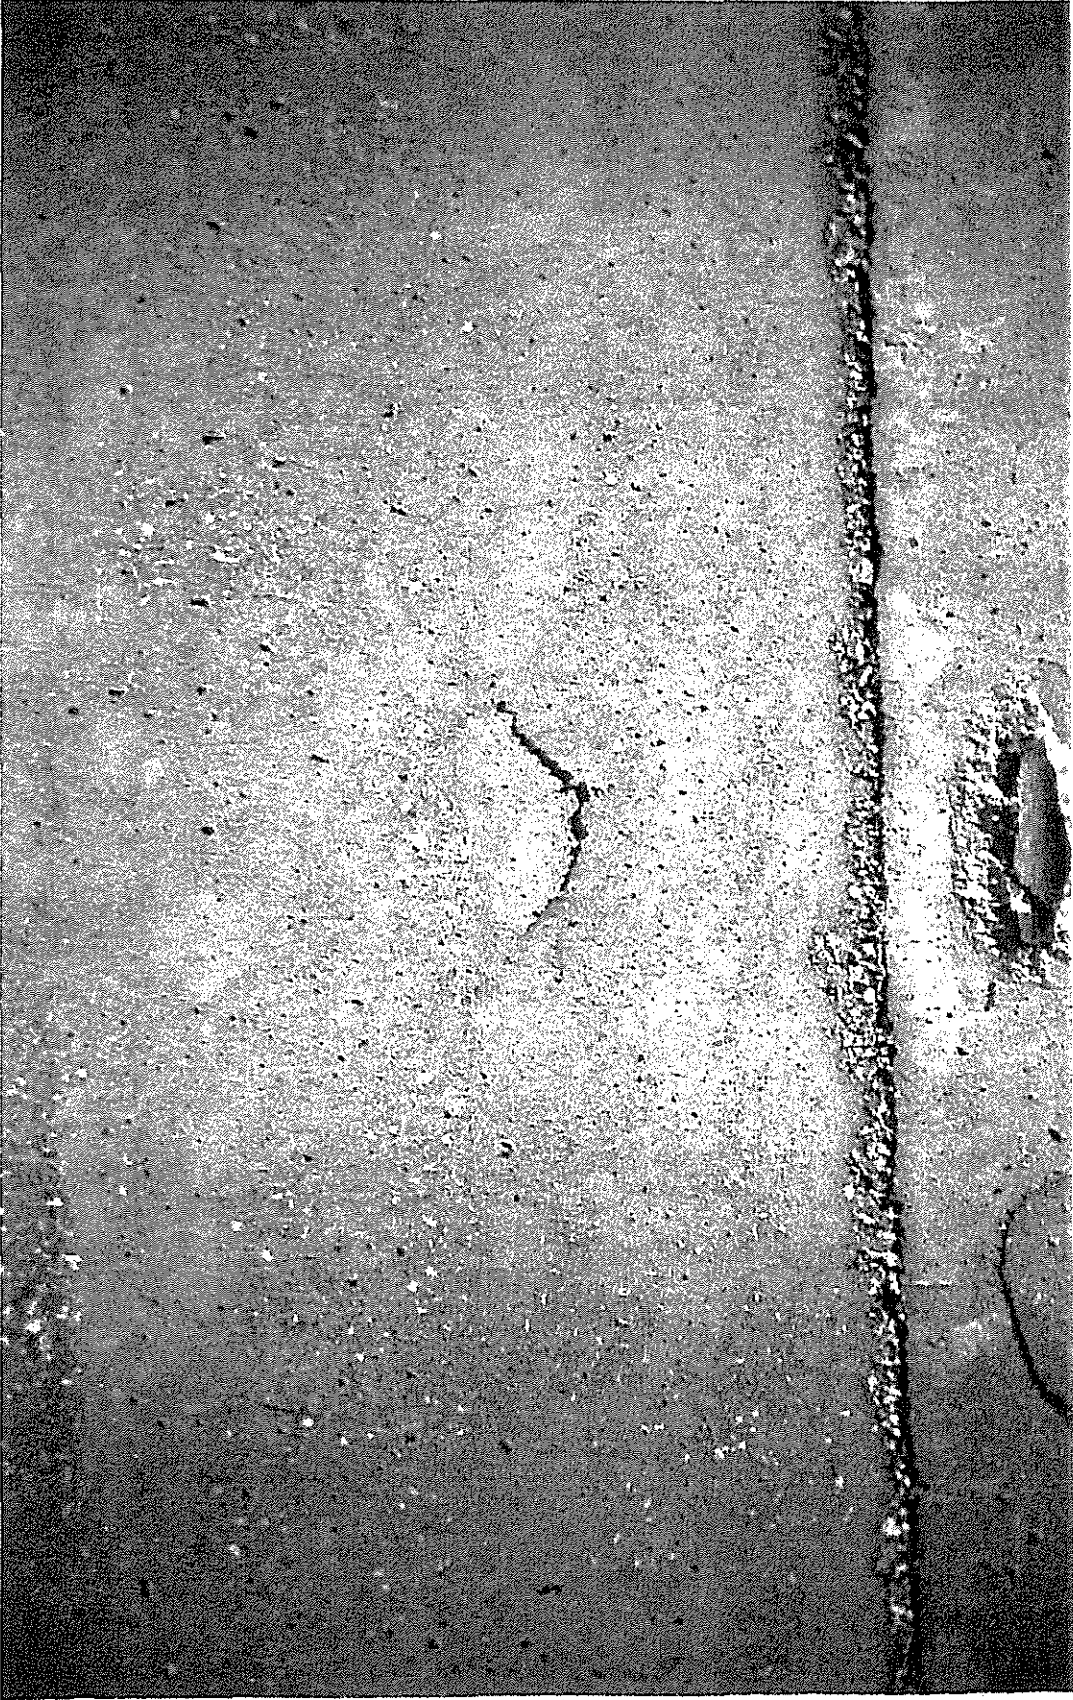
00052602.jpg

| No. | Comment | Initials |
|---|--|---|
| 4 | 6" of mortar about to spall. See photo 00052602 | RW |

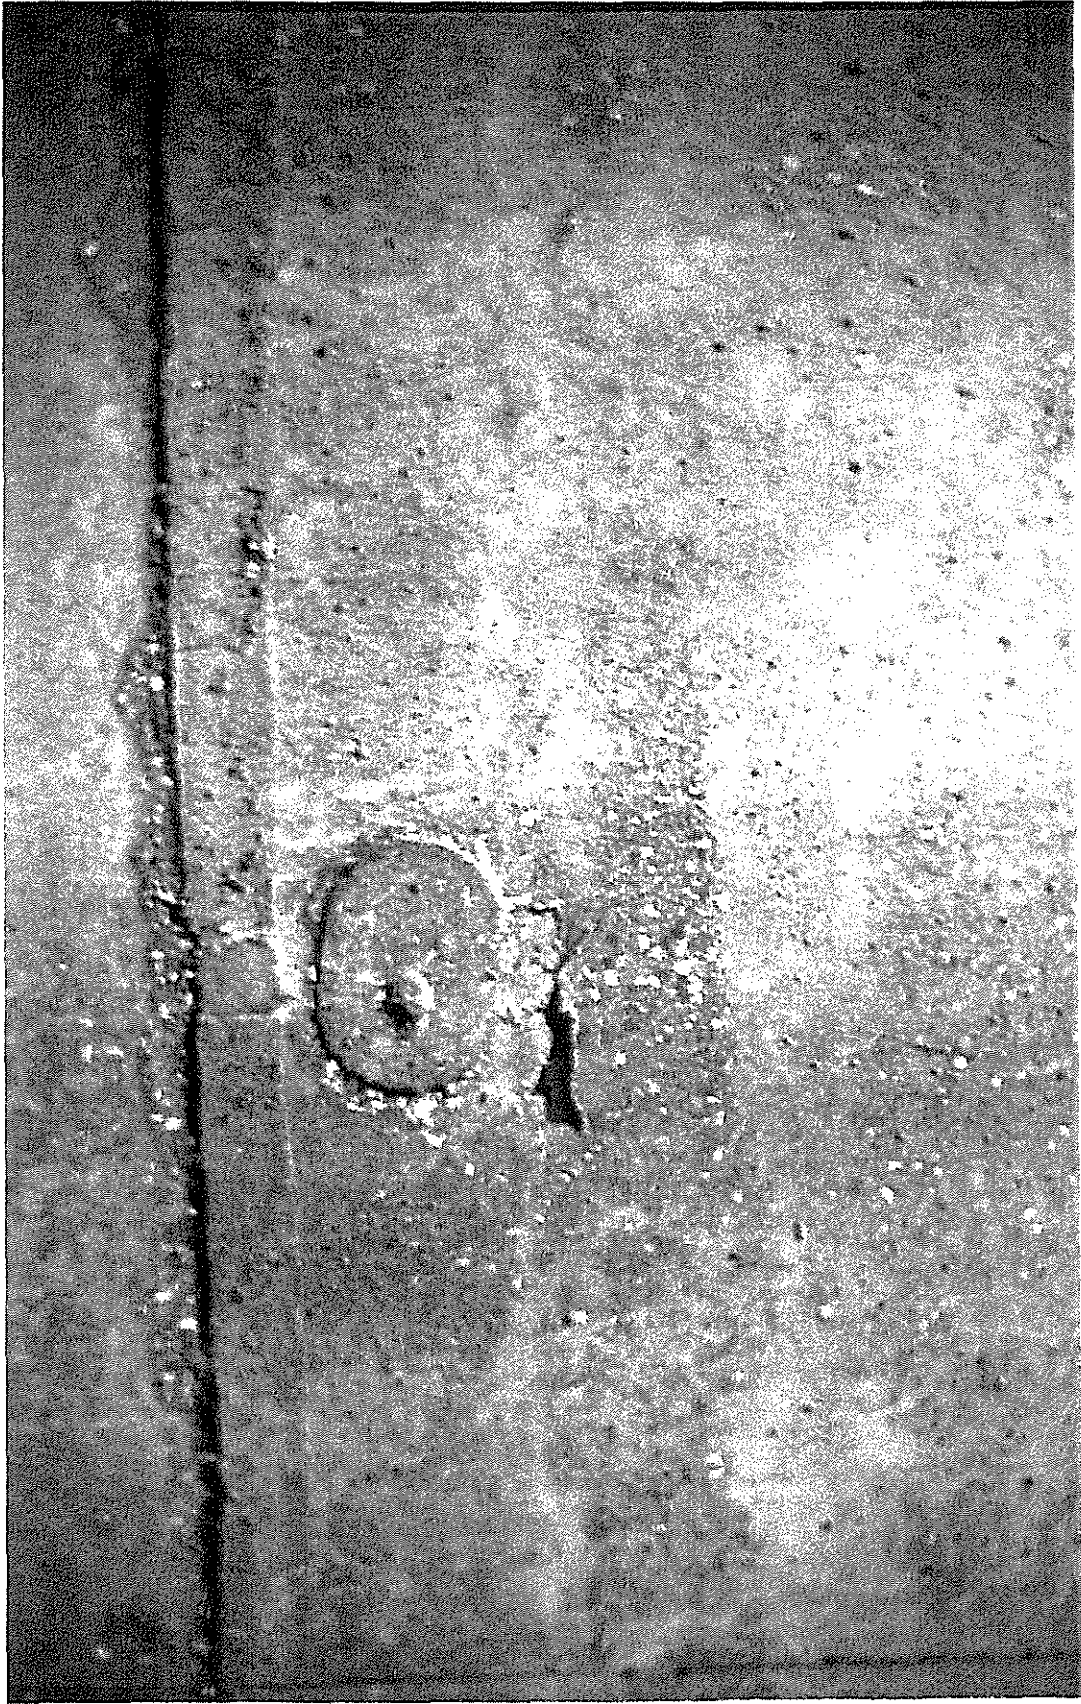
00052603.jpg

| No. | Comment | Initials |
|---|--|---|
| 6 | 1" deep hole created in concrete cover by inadequate consolidation during pouring exposing 2" of reinforcing steel. See photo 00052603 | RW |

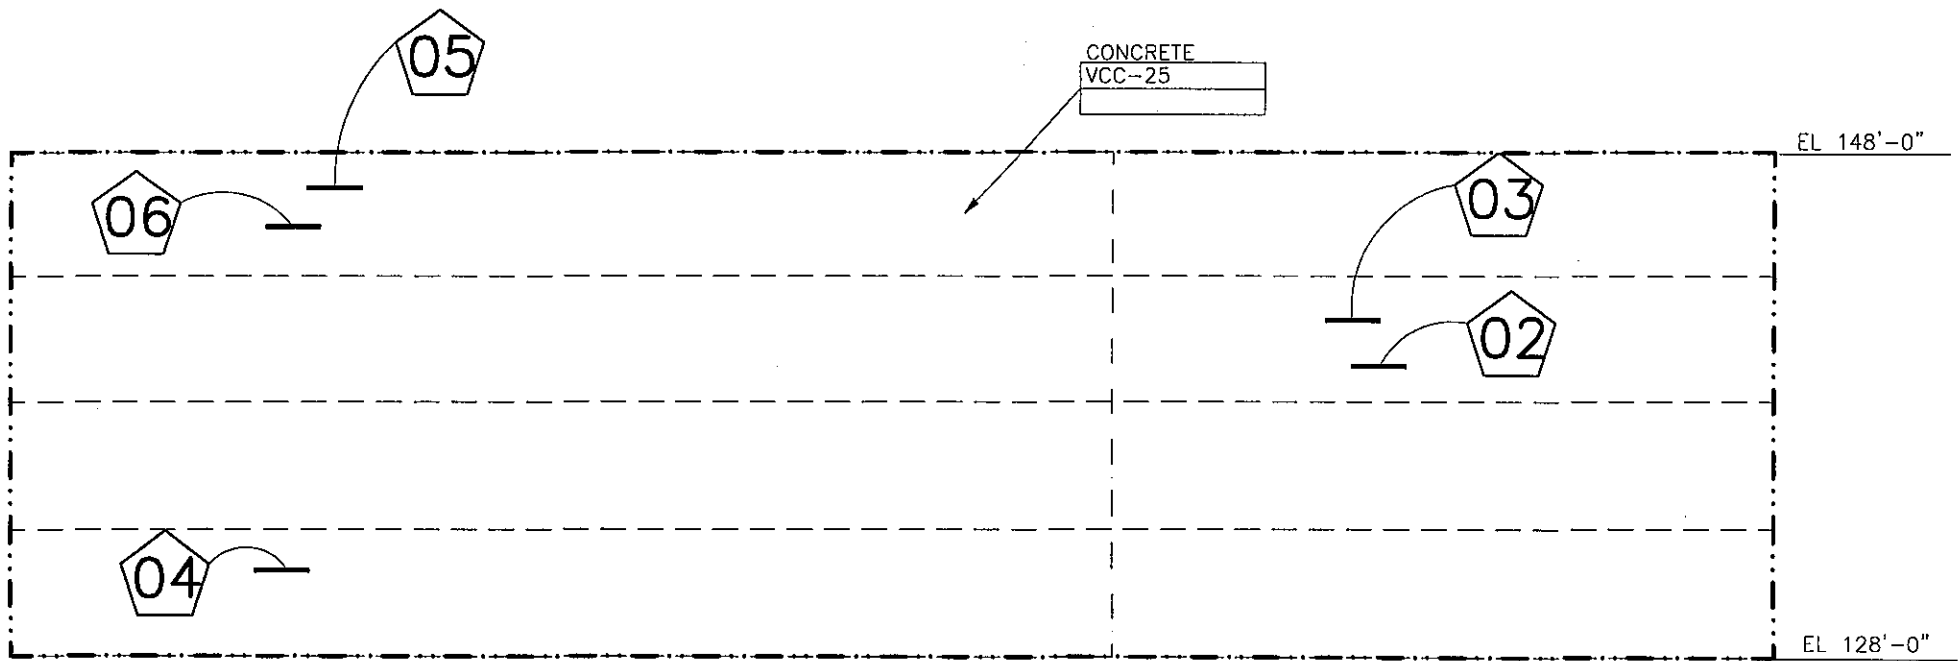
CONCRETE INSPECTION ZONE IWL-128-002
 (EXTERIOR DEVELOPED VIEW, LOOKING FROM OUTSIDE)

XX —DENOTES COMMENT NUMBER ON INSPECTION FORM.

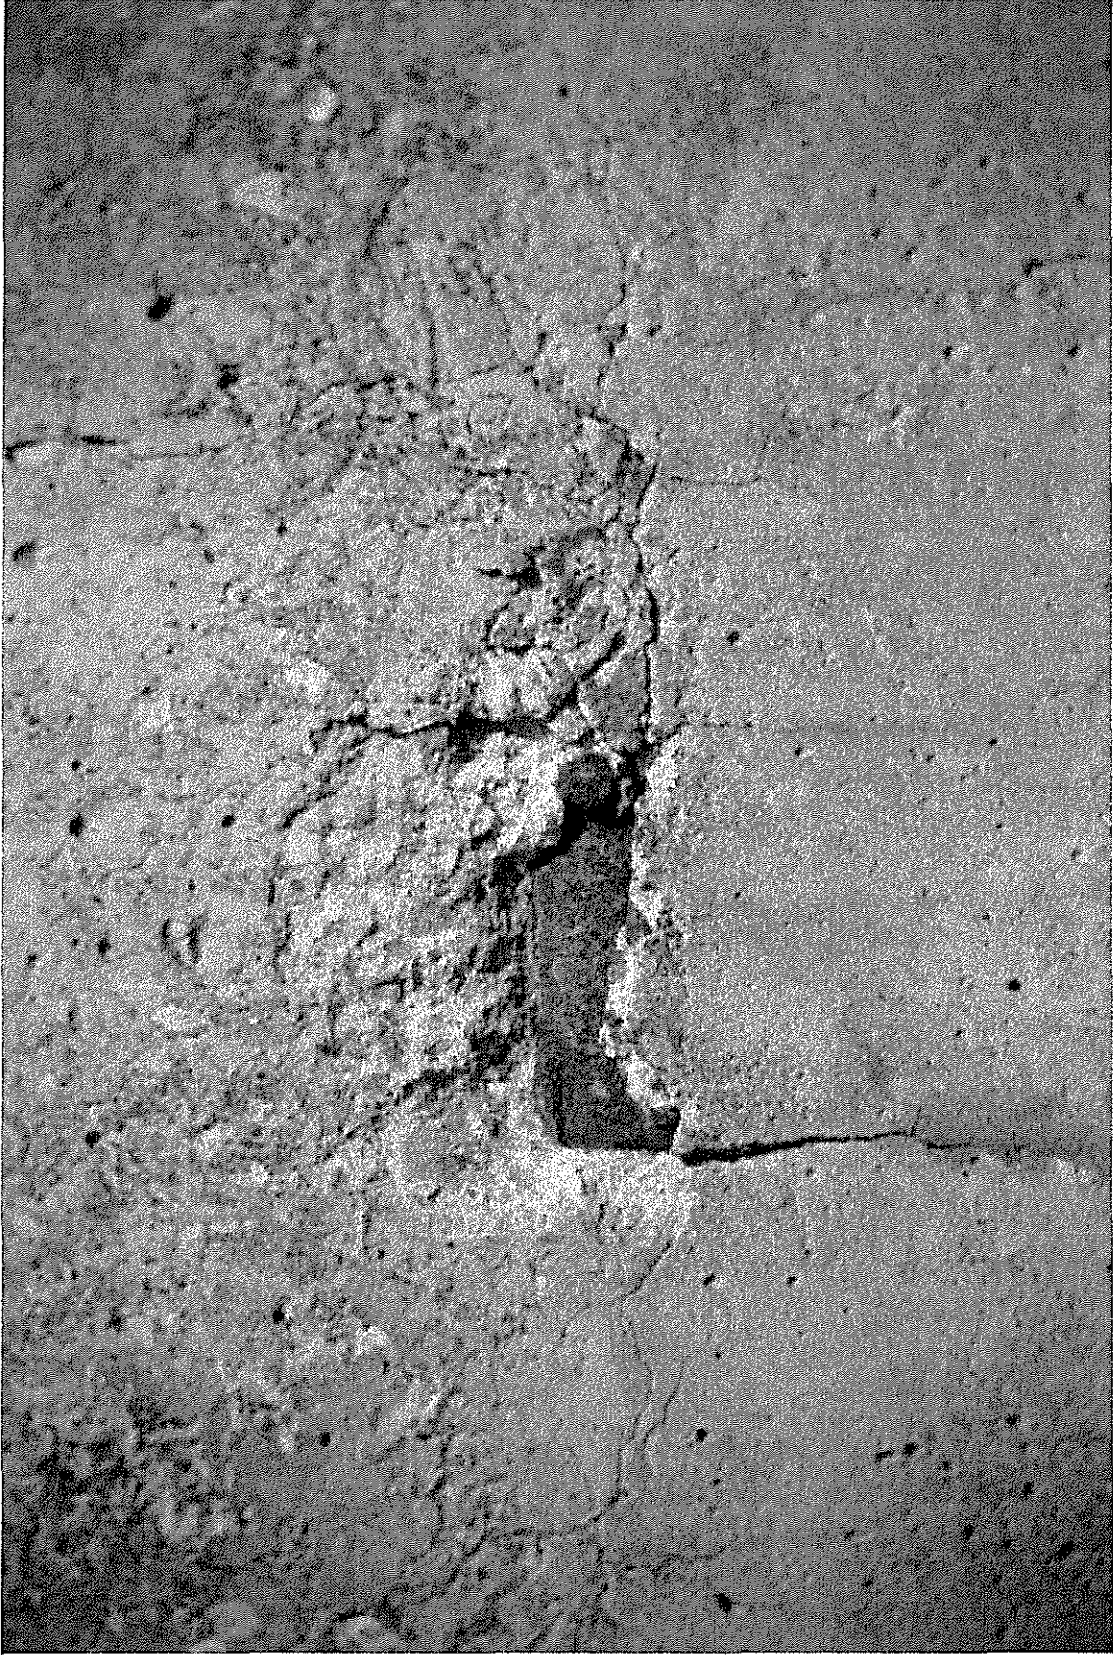
00053136.jpg

| No. | Comment | Initials |
|---|--|---|
| 2 | Cadweld exposed & corroded due to loss of concrete cover. See photos 00053136 and 00053139 | CAS |

Comments: The surface texture (comment #1) resulted from original construction and does not reflect degradation of the containment. Engineering evaluation is needed for the spalling/exposed reinforcing steel (comments #2-#6).
