FORM VT-3C
CONTAINMENT INSERVICE INSPECTION
RECORD OF VT-3C EXAMINATION

STATION/UNIT: Indian Point 2 COMPONENT NO.: VCC-21
 ZONE NUMBER: IWL-108-004 DRAWING NO.: 320855
 EQUIPMENT USED: Celestron Giant 20x80 Binoculars (Ser. No. 990176)

Work Order No. NP-99-11274

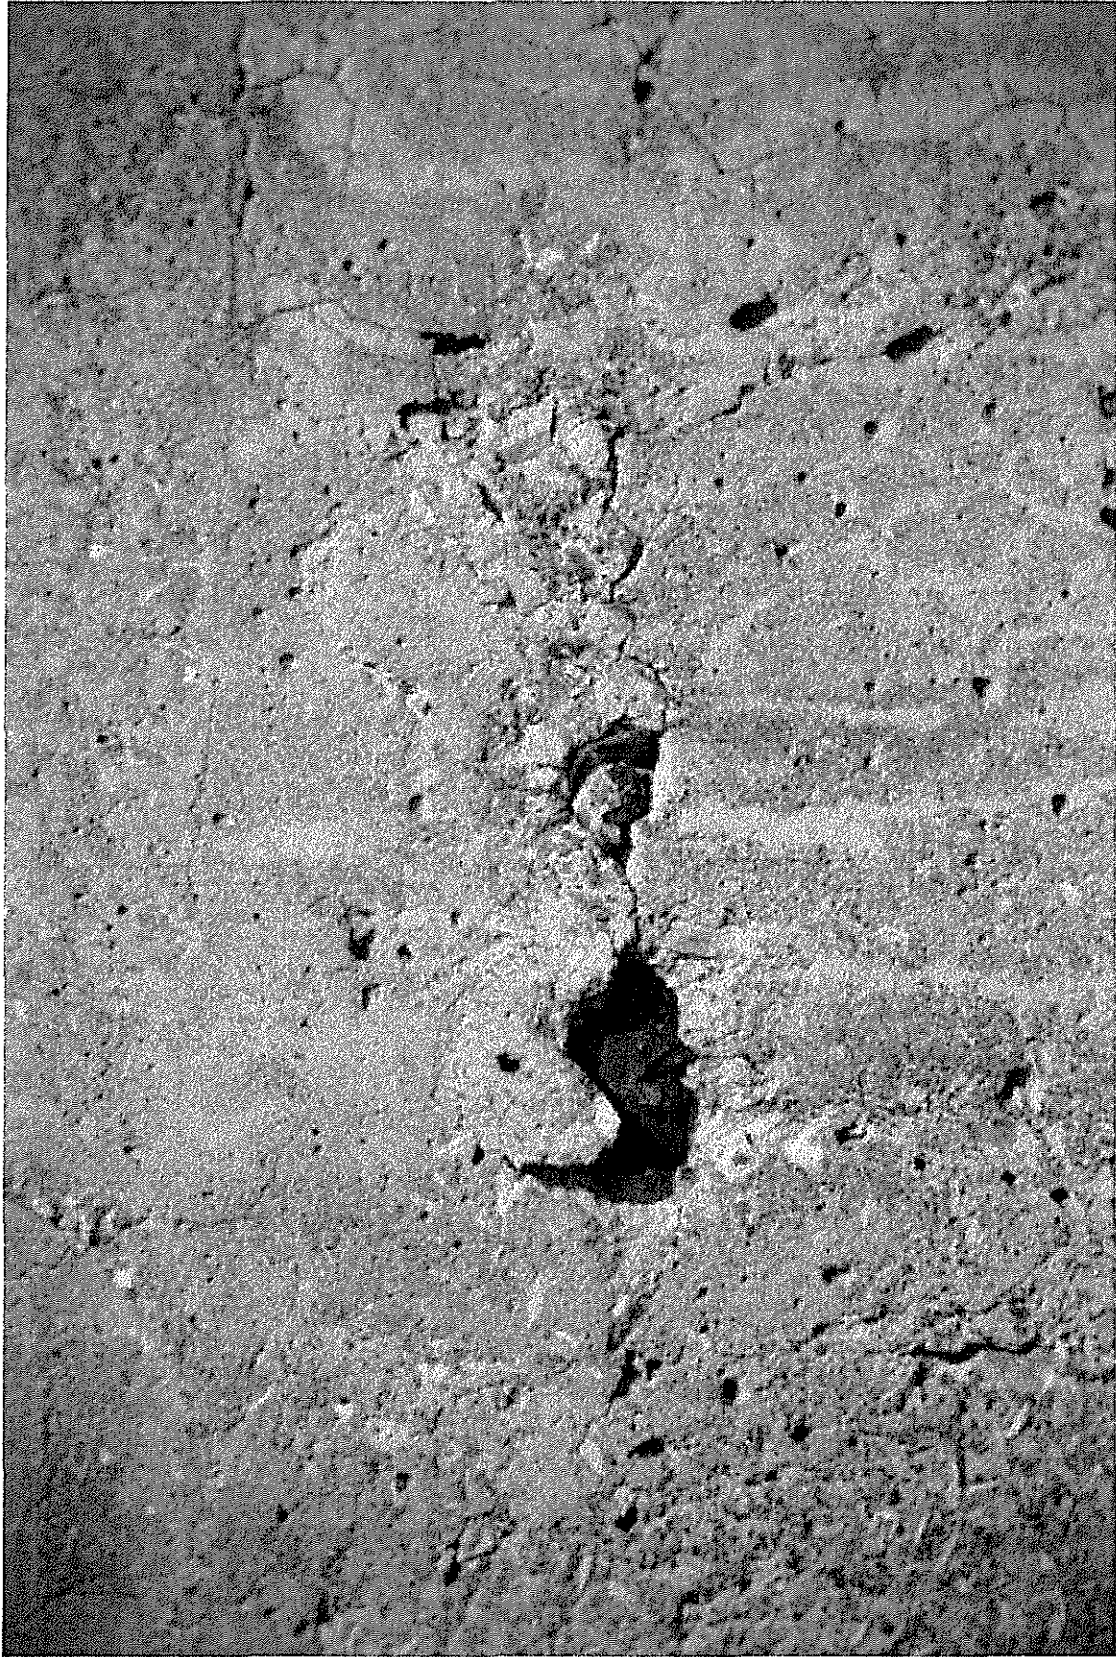
00053137.jpg

| No. | Comment | Initials |
|---|--|---|
| 3 | Cadweld exposed & corroded due to loss of concrete cover. See photo 00053137 00053139 | CAS |

Comments: The surface texture (comment #1) resulted from original construction and does not reflect degradation of the containment. Engineering evaluation is needed for the spalling/exposed reinforcing steel (comments #2-#6).

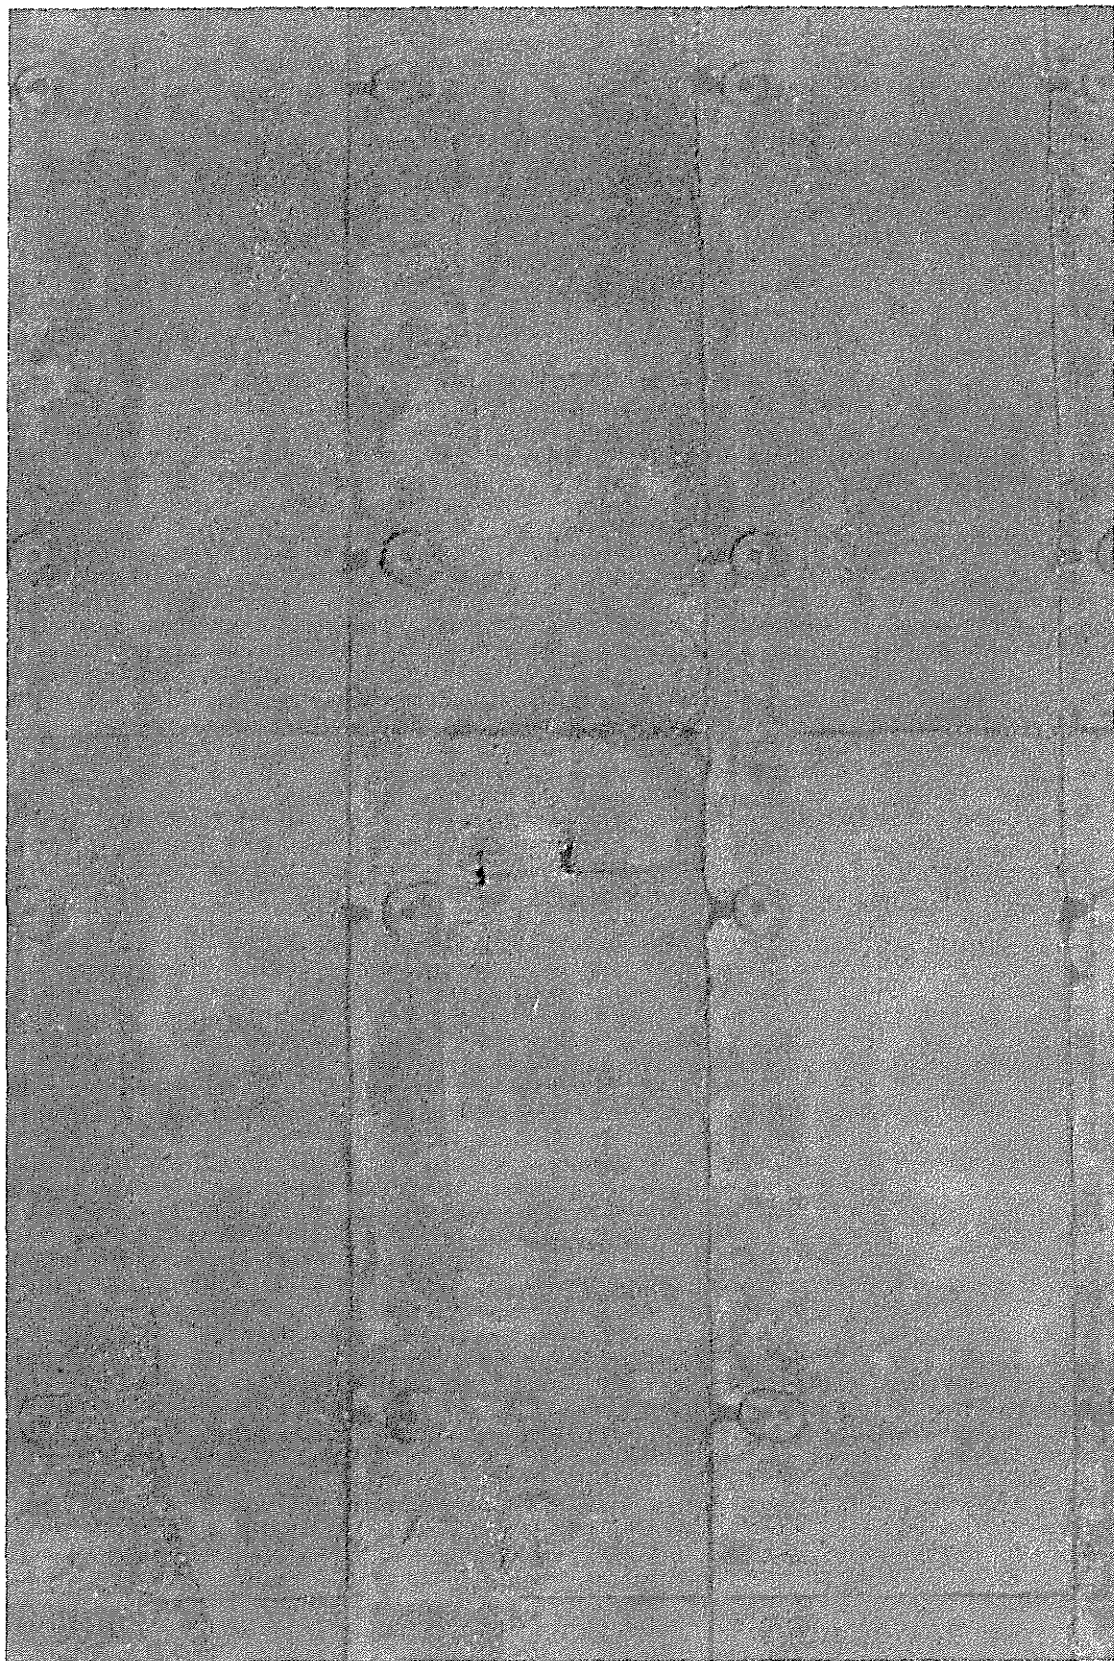
00053139.jpg

| No. | Comment | Initials |
|---|--|---|
| 2 | Cadweld exposed & corroded due to loss of concrete cover. See photos 00053136 and 00053139 | CAS |

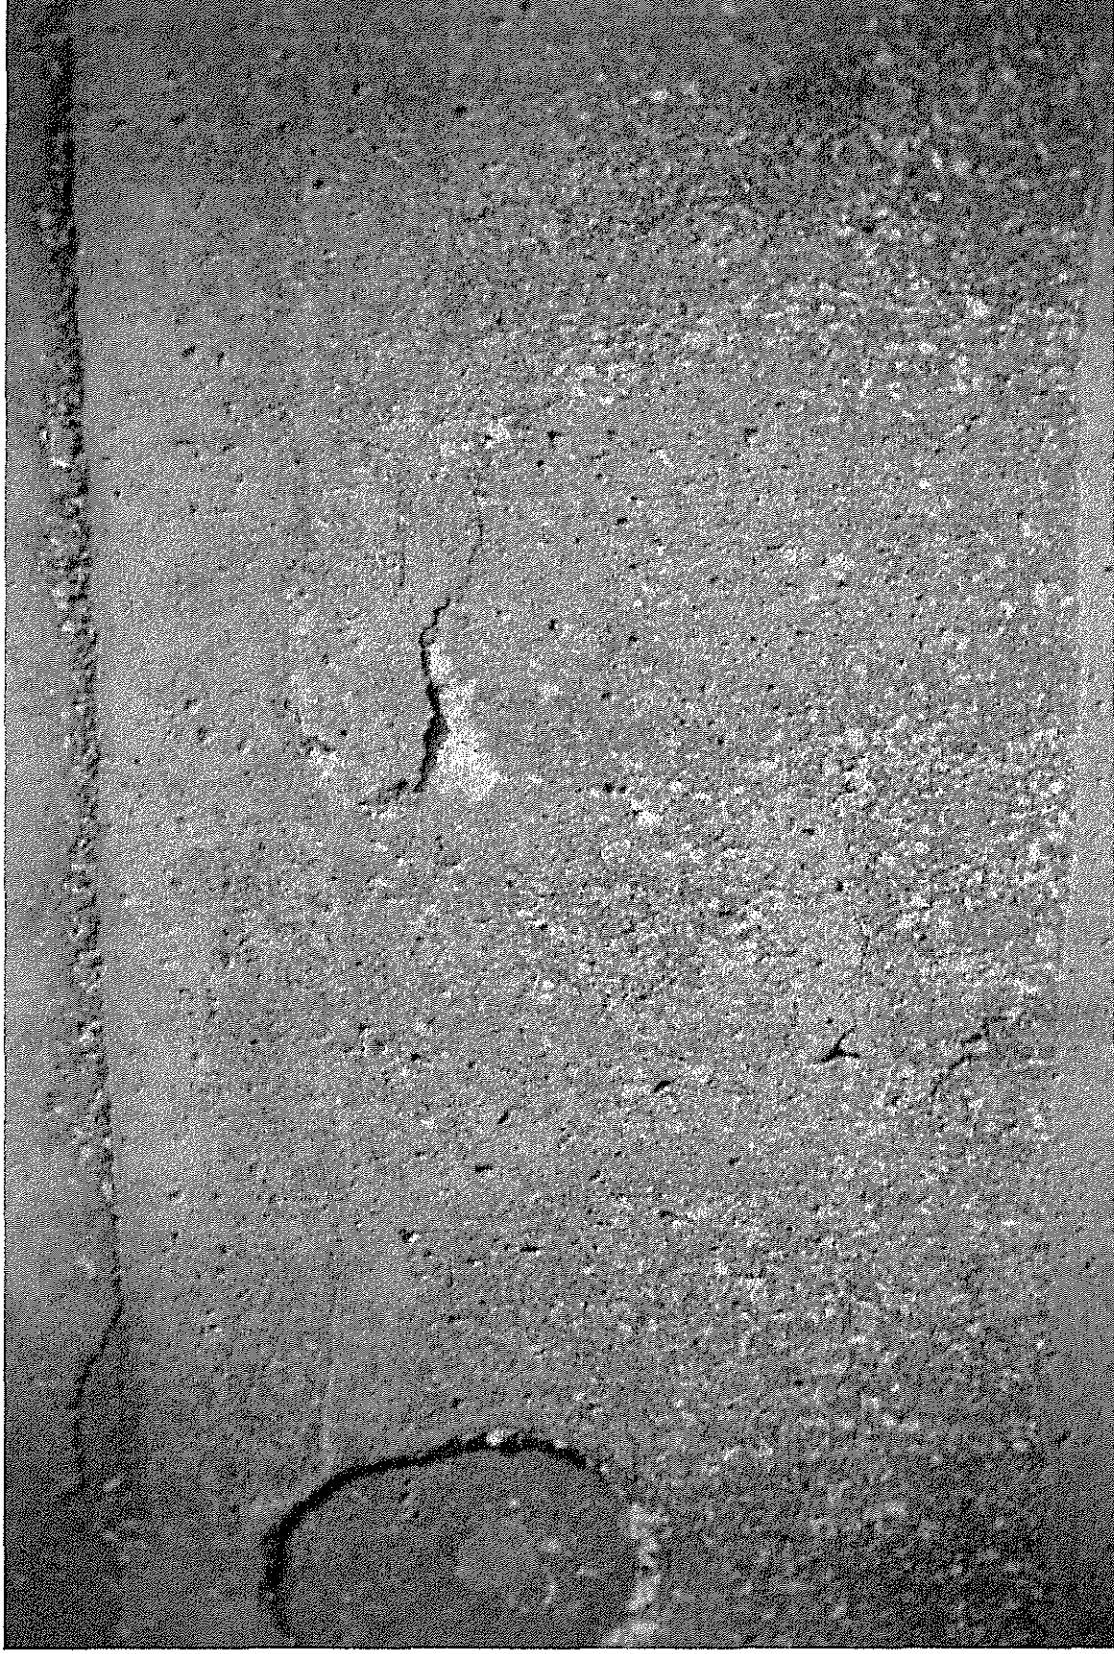
00053150.jpg

| No. | Comment | Initials |
|---|--|---|
| 5 | A small area of concrete has cracked and is likely to spall off. By comparison to other similar areas it is believed to be a cadweld or reinforcing steel which is corroded due to insufficient concrete cover. See photo 00053150 | CAS |
| 6 | The concrete has cracked & bulged in a small area that is likely to spall off. By comparison to other similar areas it is believed to be a cadweld or reinforcing steel which is corroded due to insufficient concrete cover. See photo 00053150 | CAS |

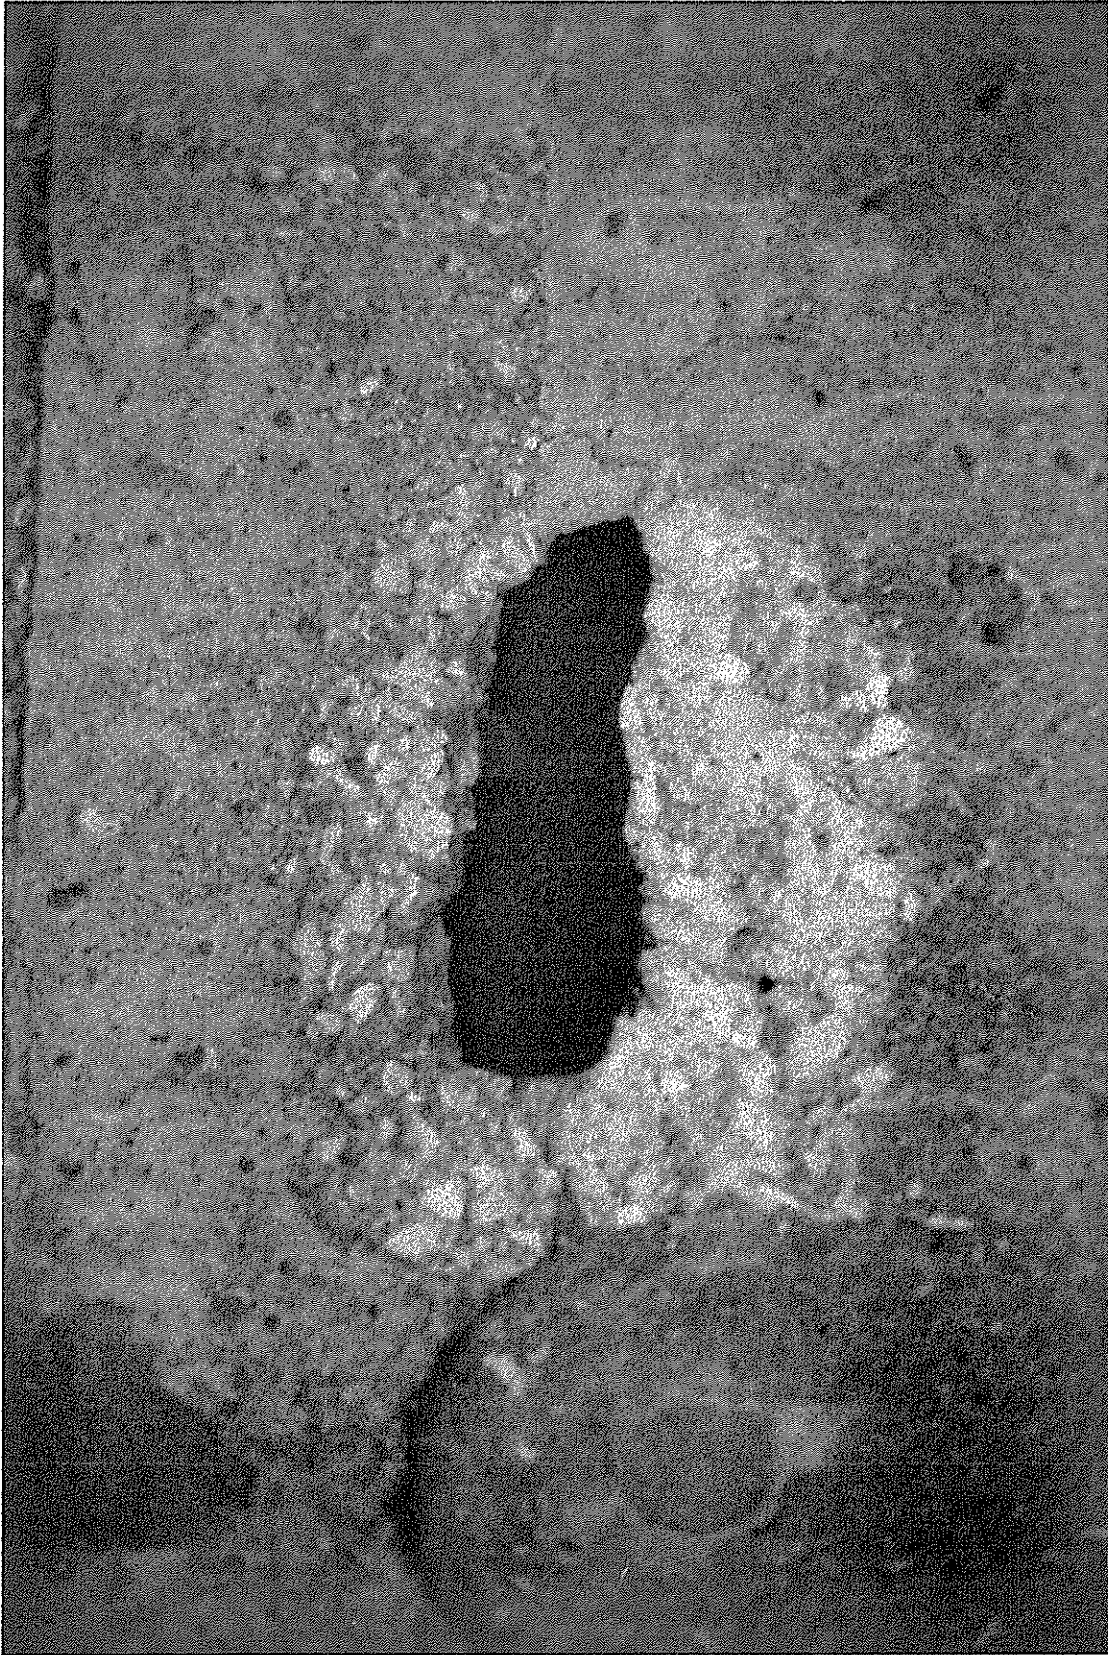
00060119.jpg

| No. | Comment | Initials |
|---|--|---|
| 4 | Cadweld exposed & corroded due to loss of concrete cover. See photo 00060119 | CAS |
