**FORM VT-3C**  
 CONTAINMENT INSERVICE INSPECTION  
 RECORD OF VT-3C EXAMINATION

STATION/UNIT: Indian Point 2 COMPONENT NO.: VCC-05  
 ZONE NUMBER: IWL-043-002 DRAWING NO.: 320842  
 EQUIPMENT USED: Mag-Lite flashlight (see note 4)

Work Order No. NP-99-11274

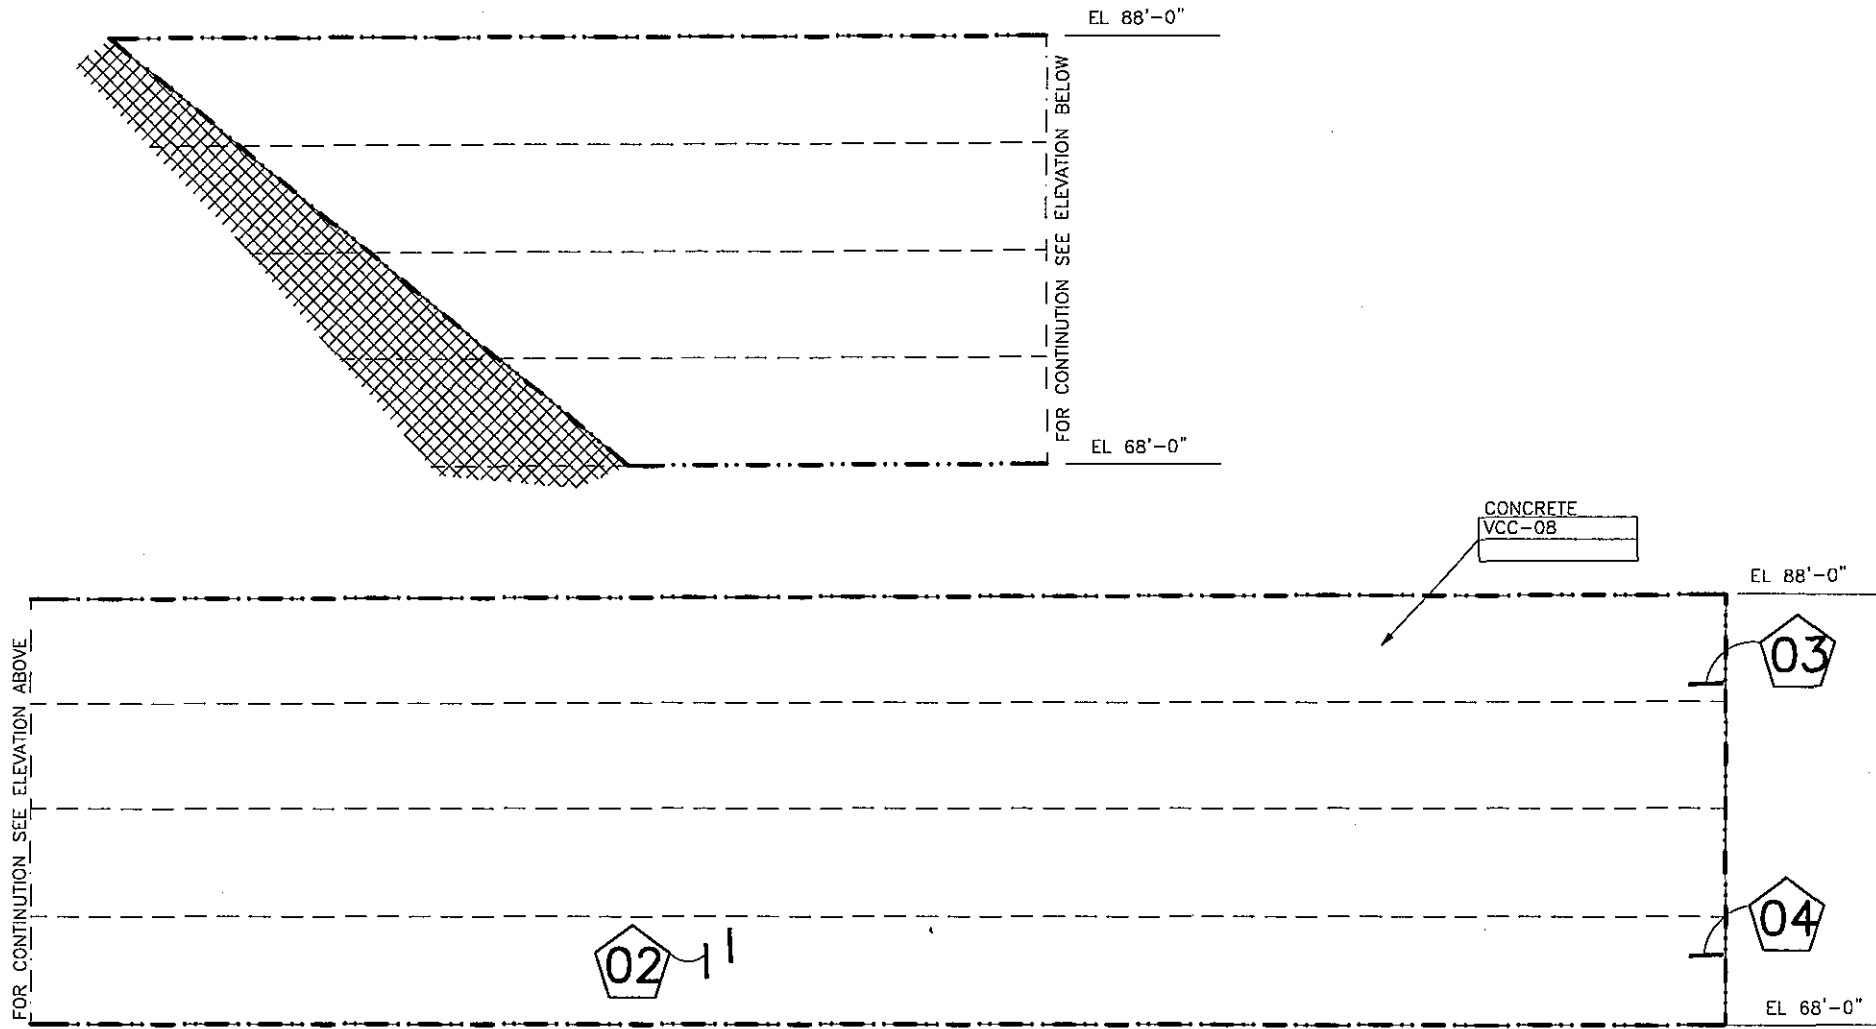
**CONCRETE INSPECTION ZONE IWL-068-001**  
 (EXTERIOR DEVELOPED VIEW, LOOKING FROM OUTSIDE)

No.	Comment	Initials
1	Non-uniformity of surface color and texture observed at various locations in the zone. The condition does not indicate significant material deterioration of the concrete.	RW
2	2' long white deposits (2), 2' apart	RW
3	Rust stain from surface attachment plate	RW
4	Rust stain from surface attachment plate	RW

Comments: The indications observed are not significant relative to containment integrity.

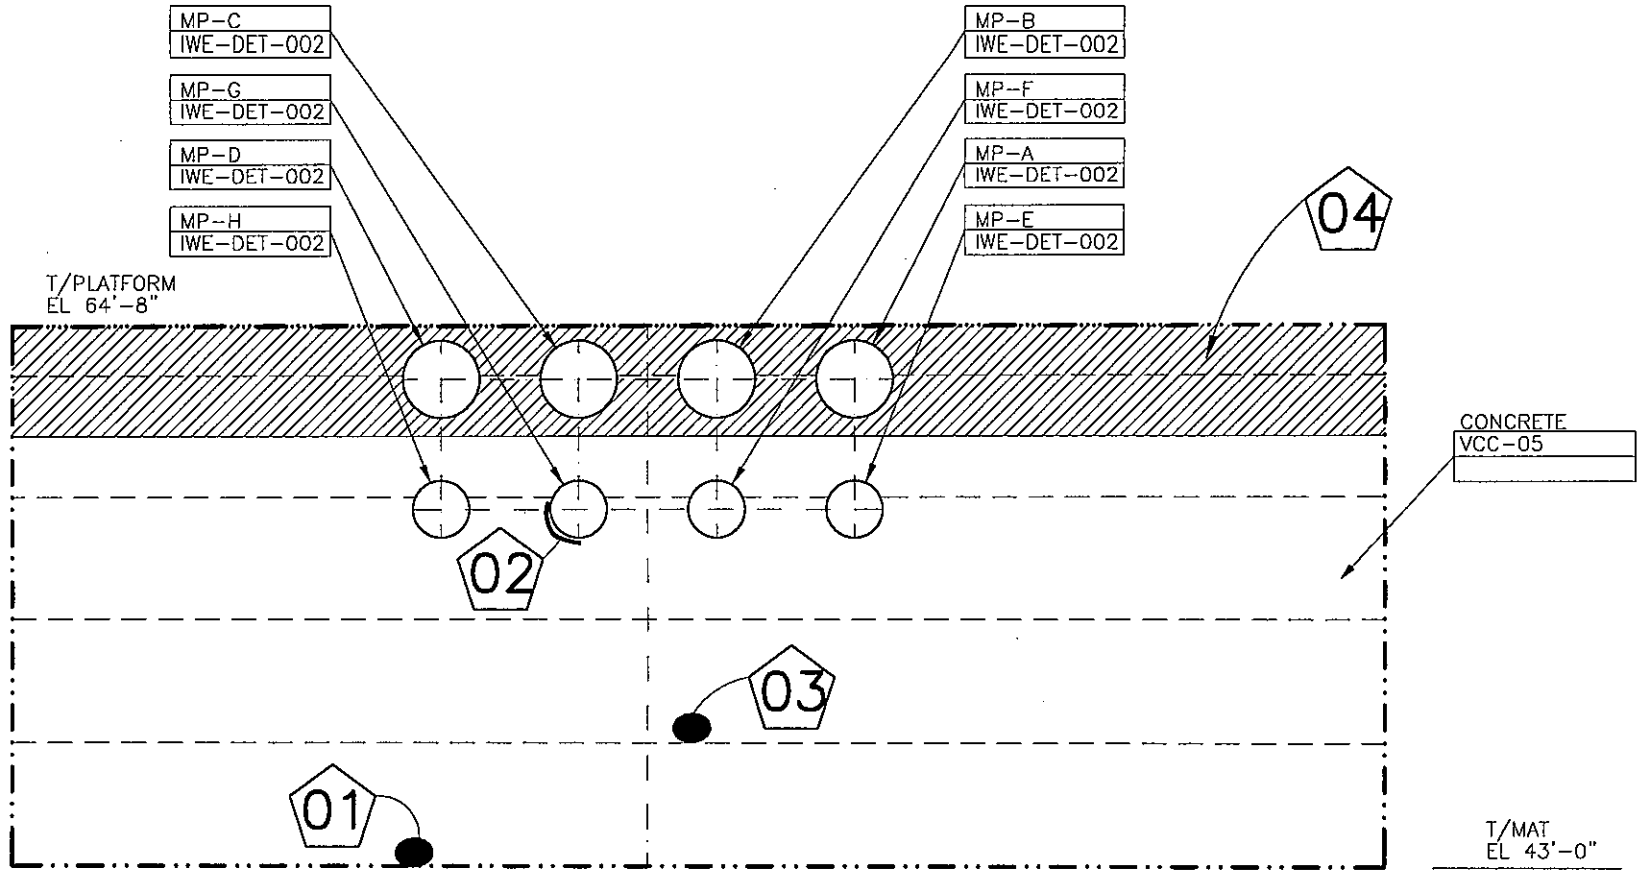
**CONCRETE INSPECTION ZONE IWL-043-002**  
 (EXTERIOR DEVELOPED VIEW, LOOKING FROM OUTSIDE)

No.	Comment	Initials
1	A spalled area approximately 10" long was found at the floor line directly below penetration MP-H. This area appears to have some unconsolidated concrete ("honeycomb") from the original placement of the concrete. See Photo 00060131	CAS
2	A crack with apparent delamination was found around the lower left edge of penetration MP-G. See Photo 00060132	CAS
3	A delamination was found at approx. El. 49' directly below penetration MP-F. The area was estimated to be 18" wide by 12" high by sounding the concrete (tapping the surface with a metal object). See Photos 00060133 and 00060134.	CAS
4	This area was examined from the floor level at El. 43'. The examination distances were a maximum of 20 feet. While this distance exceeds the limits for direct visual examination, it was too short for use of the binoculars due to their minimum focal length. Lighting levels using the flashlight exceeded the 50 foot-candle requirement. The upper 5 feet of this zone were not visible for inspection by direct line of sight due to piping and structural steel obstructions.	CAS

5	There are a number of areas within this zone where the coating is flaking and peeling. There is no evidence that this is due to degradation of the concrete substrate. It is a coatings related issue and not containment degradation.	CAS

Comments : The areas with coating deterioration (comment #5) do not exhibit any degradation of the concrete substrate and therefore are not significant relative to containment integrity. The spalling and cracking (comments #1, 2, 3) require evaluation.

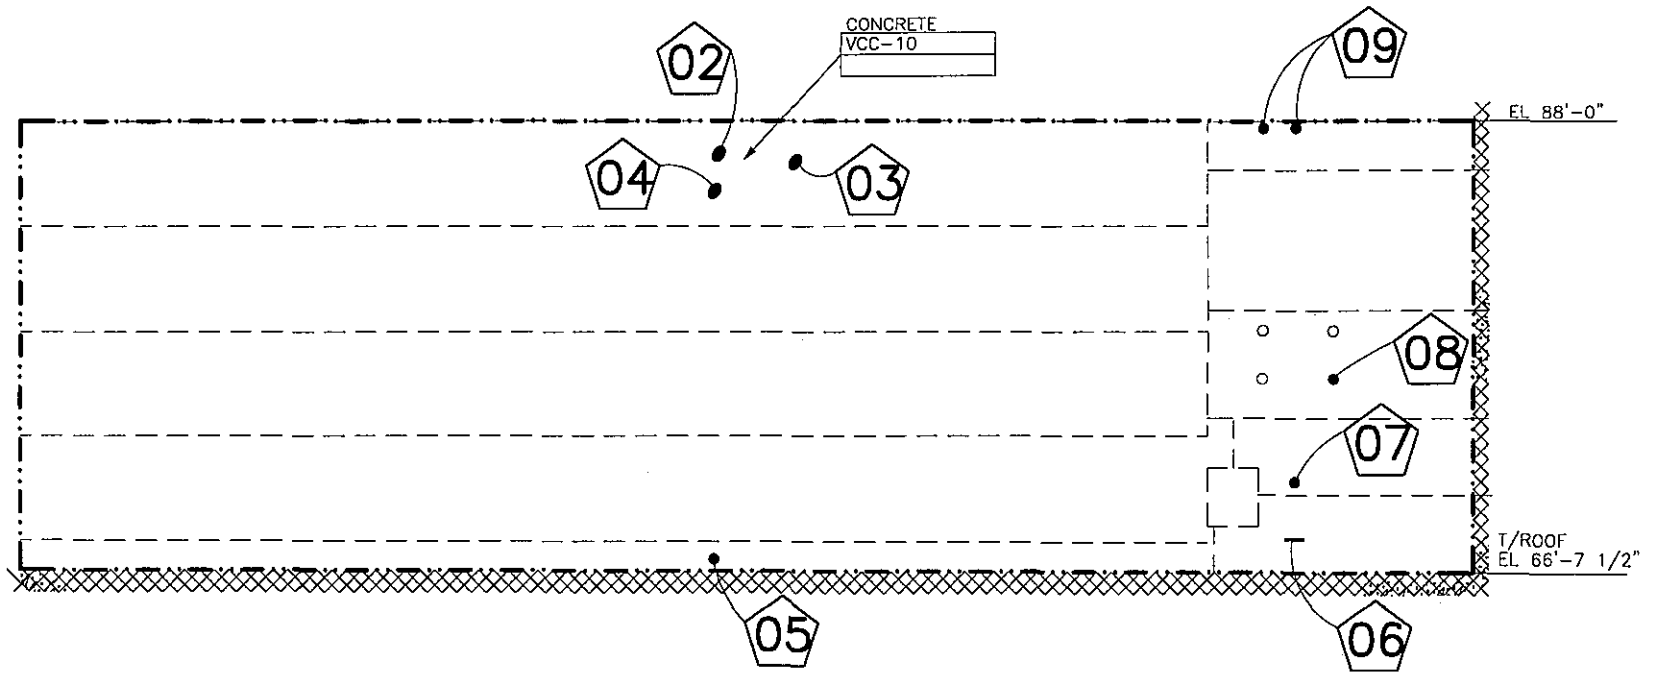
**CONCRETE INSPECTION ZONE IWL-068-003**  
 (EXTERIOR DEVELOPED VIEW, LOOKING FROM OUTSIDE)

No.	Comment	Initials
1	Non-uniformity of surface color and texture observed at various locations in the zone. The condition does not indicate significant material deterioration of the concrete.	CAS
2	Small rust spot visible on concrete surface. It could be tie wire or other misc. steel but does not appear to be rebar. See photo 00053120	CAS
3	Small rust spot visible on concrete surface. It could be tie wire or other misc. steel but does not appear to be rebar. See photo 00053121	CAS
4	Small rust spot visible on concrete surface. It could be tie wire or other misc. steel but does not appear to be rebar. See photo 00053122	CAS
5	Small rust spot visible on concrete surface. It could be tie wire or other misc. steel but does not appear to be rebar. See photo 00053123	CAS
6	Exposed cadweld with some rusting. See photo 00053124	CAS
7	Small rust spot visible on concrete surface. It could be tie wire or other misc. steel but does not appear to be rebar. See photo 00053125	CAS

8	Form tie hole which was not filled. This is not significant relative to containment structural integrity.	CAS
9	Two small rust spots visible on concrete surface. It could be nails, form ties or other misc. steel but does not appear to be rebar. See photo 00053126	CAS

Comments : The exposed cadweld (comment #6) requires evaluation. The other observed conditions are not significant relative to containment integrity.

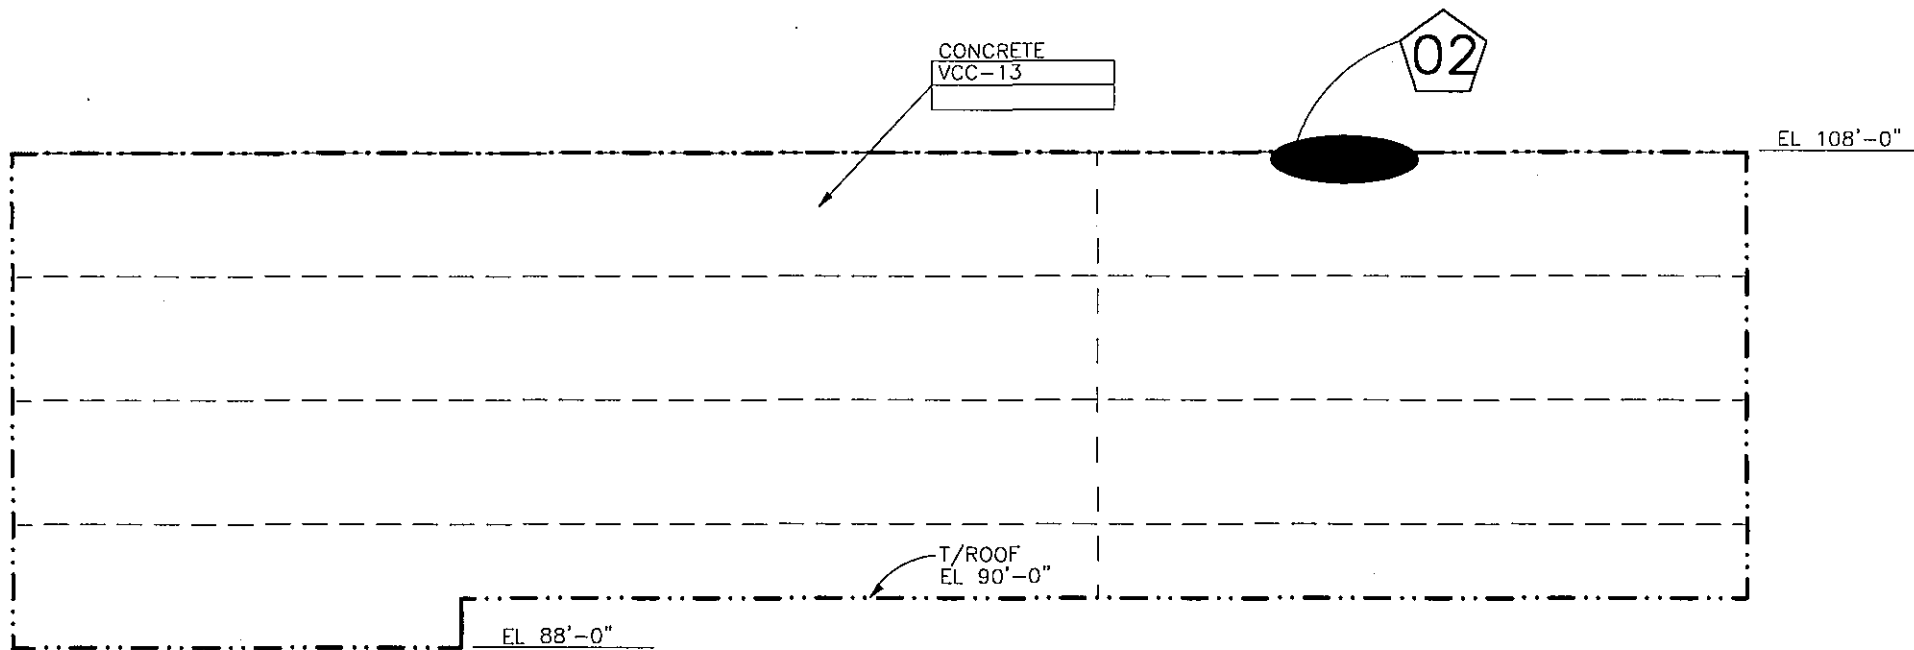
**CONCRETE INSPECTION ZONE IWL-088-002**  
 (EXTERIOR DEVELOPED VIEW, LOOKING FROM OUTSIDE)

No.	Comment	Initials
1	Non-uniformity of surface color and texture observed at various locations in the zone. The condition does not indicate significant material deterioration of the concrete.	CAS
2	An area approximately 4' long by 1' high near the top of the zone & in line with the southern most relief valve silencer has aggregate exposed due to loss of surface paste. See photo 00053135	CAS

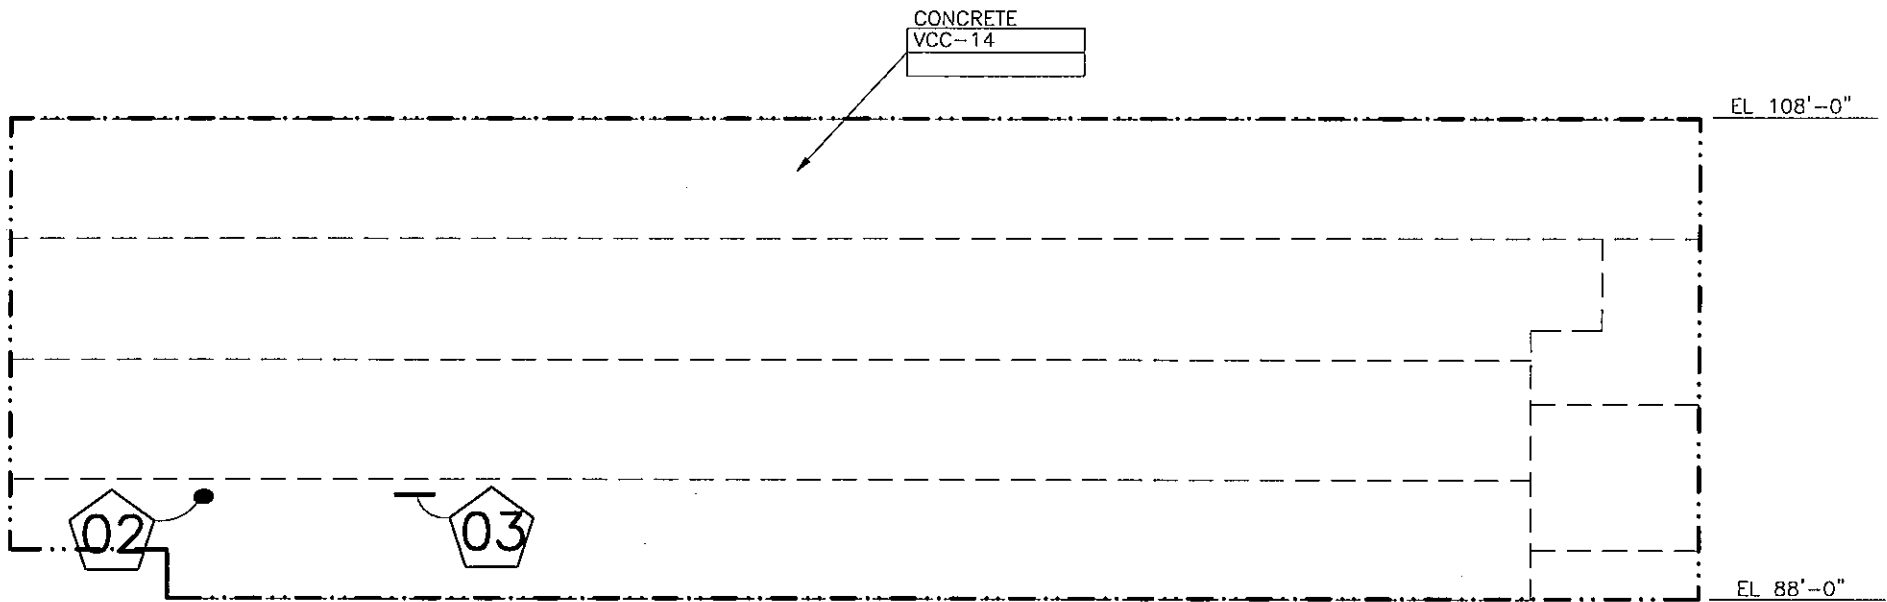
**CONCRETE INSPECTION ZONE IWL-088-003**  
(EXTERIOR DEVELOPED VIEW, LOOKING FROM OUTSIDE)

No.	Comment	Initials
1	Non-uniformity of surface color and texture observed at various locations in the zone. The condition does not indicate significant material deterioration of the concrete.	CAS
2	A small section of reinforcing steel is exposed and is corroded. Based on its size and orientation it does not appear to be main reinforcing steel but could be a shear bar. See photo 00053130	CAS
3	A small section of reinforcing steel is exposed and is corroded. Based on its size and orientation it does not appear to be main reinforcing steel but could be a shear bar. See photo 00053131	CAS

Comments : The exposed bars require further evaluation. The condition described in comment #1 originated from original construction and does not reflect degradation.

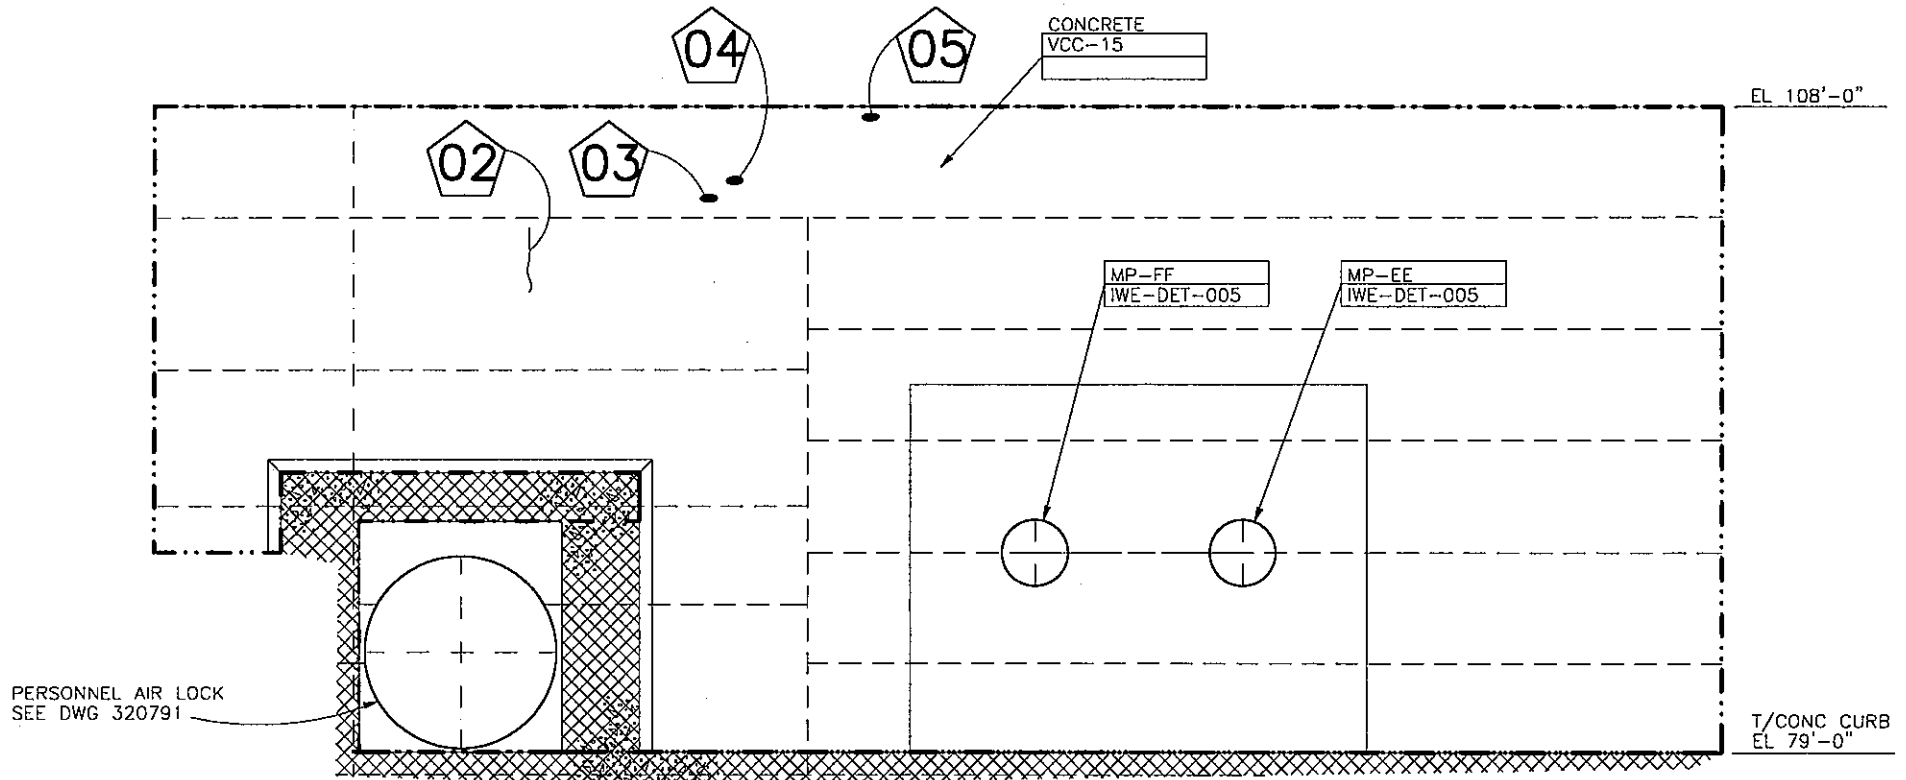
**CONCRETE INSPECTION ZONE IWL-088-004**  
 (EXTERIOR DEVELOPED VIEW, LOOKING FROM OUTSIDE)

No.	Comment	Initials
1	Non-uniformity of surface color and texture observed at various locations in the zone. The condition does not indicate significant material deterioration of the concrete.	RW
2	2' long white deposit from top of construction opening closure grout. See photo 00052616	RW
3	Concrete spall about 8" square area about to popout. See photo 00052613	RW
4	Rebar exposure accompanied by 4" concrete spall. See photo 00052613	RW
5	10"x4" concrete spall exposing 8" length of cadweld sleeve. Only 1/2" concrete cover in this area. See photo 00052615	RW

Comments: Engineering evaluation IS required for the conditions noted in comments #3 #4 & #5. The other conditions are not significant relative to containment integrity.

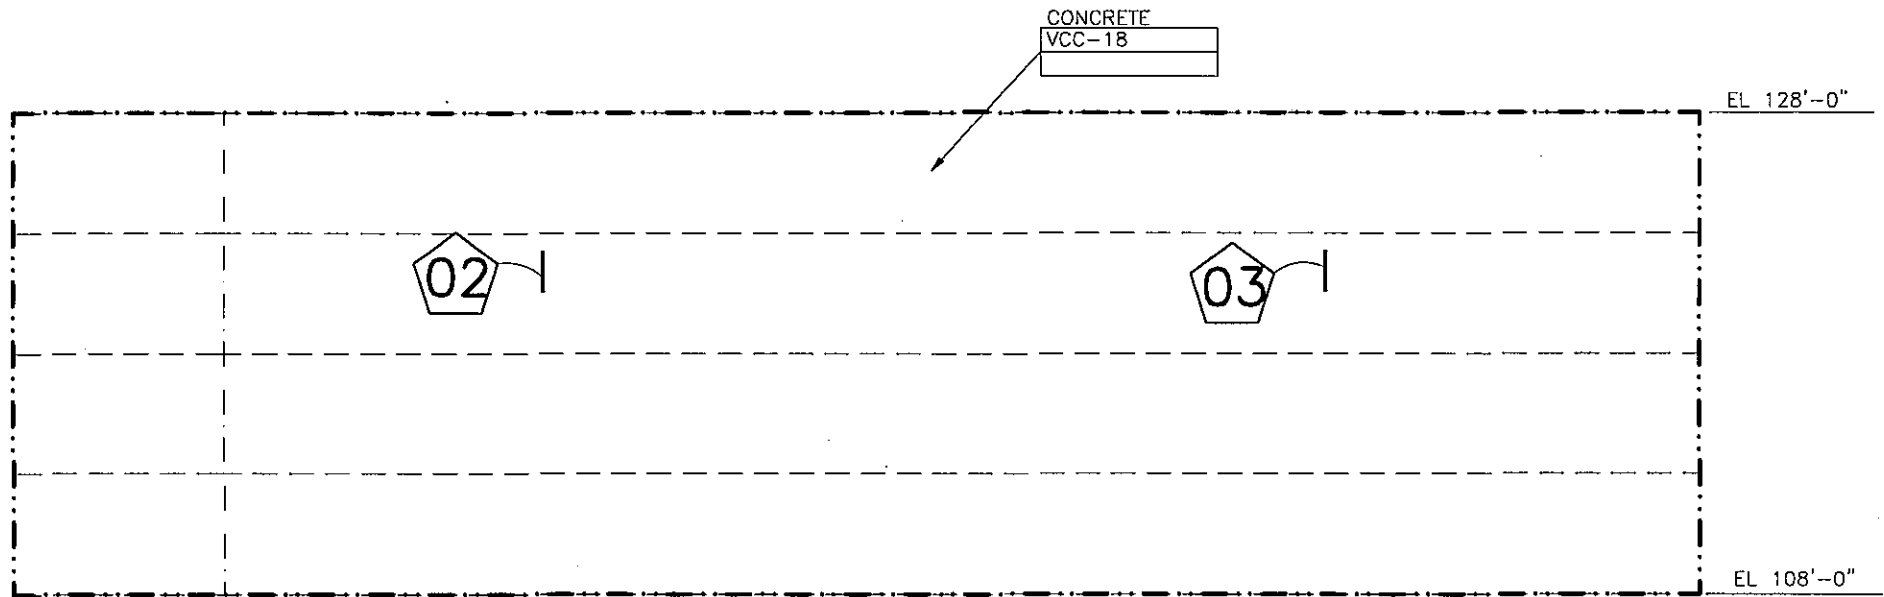
**CONCRETE INSPECTION ZONE IWL-108-001**  
(EXTERIOR DEVELOPED VIEW, LOOKING FROM OUTSIDE)

No.	Comment	Initials
1	Non-uniformity of surface color and texture observed at various locations in the zone. The condition does not indicate significant material deterioration of the concrete.	RN
2	18" long leaching from the construction joint down to the form tie hole mortar patch	RN
3	leaching about the same length as in item 2	RN

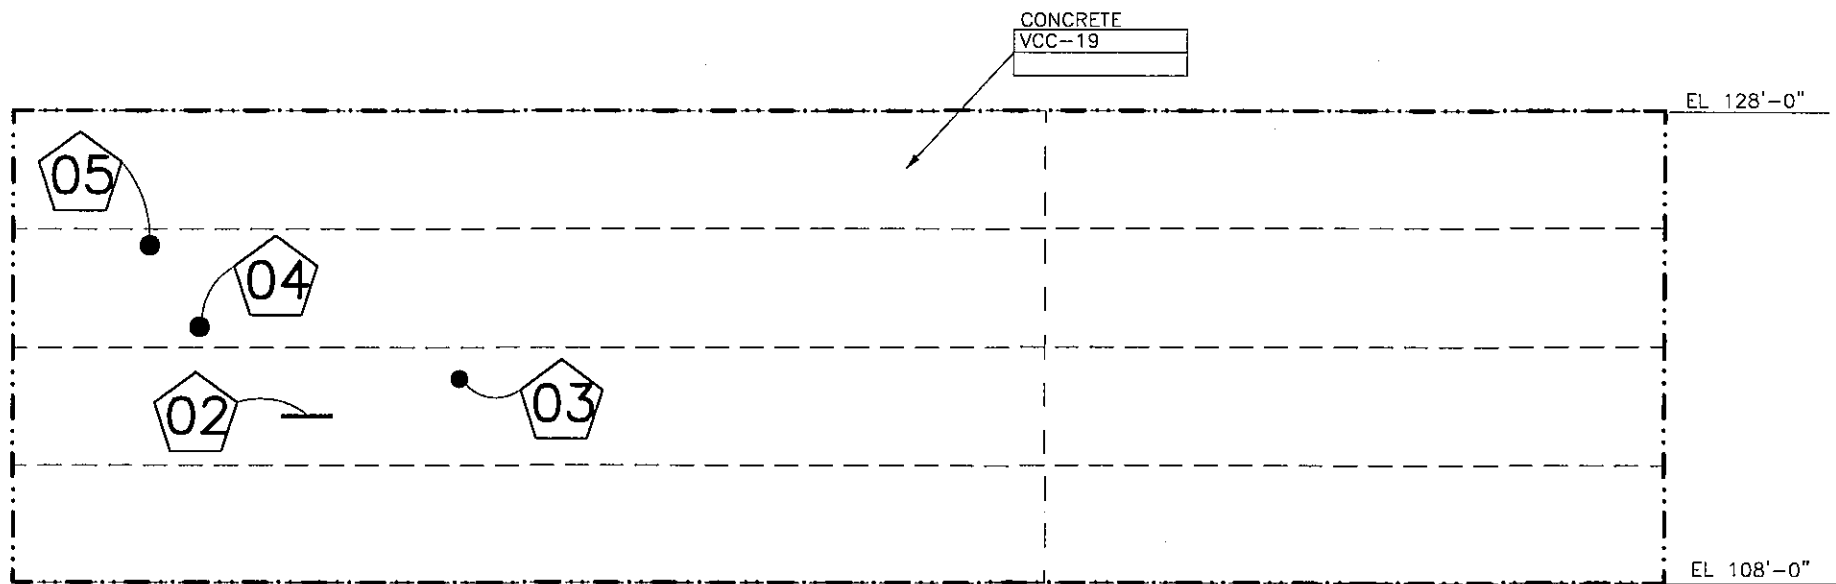
**CONCRETE INSPECTION ZONE IWL-108-002**  
 (EXTERIOR DEVELOPED VIEW, LOOKING FROM OUTSIDE)

No.	Comment	Initials
1	Non-uniformity of surface color and texture observed at various locations in the zone. The condition does not indicate significant material deterioration of the concrete.	CAS
2	Exposed cadweld (approx. 9" long) with corrosion apparently due to inadequate cover. See photo 00060116	CAS
3	A small spot of corrosion appears on the concrete surface. It is not apparent whether this is reinforcing steel, a cadweld or miscellaneous steel. See photo 00060117.	CAS
4	A small spot of corrosion appears on the concrete surface. It is not apparent whether this is reinforcing steel, a cadweld or miscellaneous steel. See photo 00060118	CAS
5	Leaching is evident approximately 18" long extending downward from the construction joint.	CAS

Comments: Engineering evaluation is required for the exposed reinforcing steel (comment #2, #3 & #4). The leaching (comment #5) is not significant. The surface texture (comment #1) results from original construction and does not reflect degradation.
