**FORM VT-3C**  
 CONTAINMENT INSERVICE INSPECTION  
 RECORD OF VT-3C EXAMINATION

STATION/UNIT: Indian Point 2 COMPONENT NO.: VCC-35  
 ZONE NUMBER: IWL-148-006 DRAWING NO.: 320869  
 EQUIPMENT USED: Celestron Giant 20x80 Binoculars (Ser. No. 990176)

**CONCRETE INSPECTION ZONE IWL-148-006**  
 (EXTERIOR DEVELOPED VIEW, LOOKING FROM OUTSIDE)

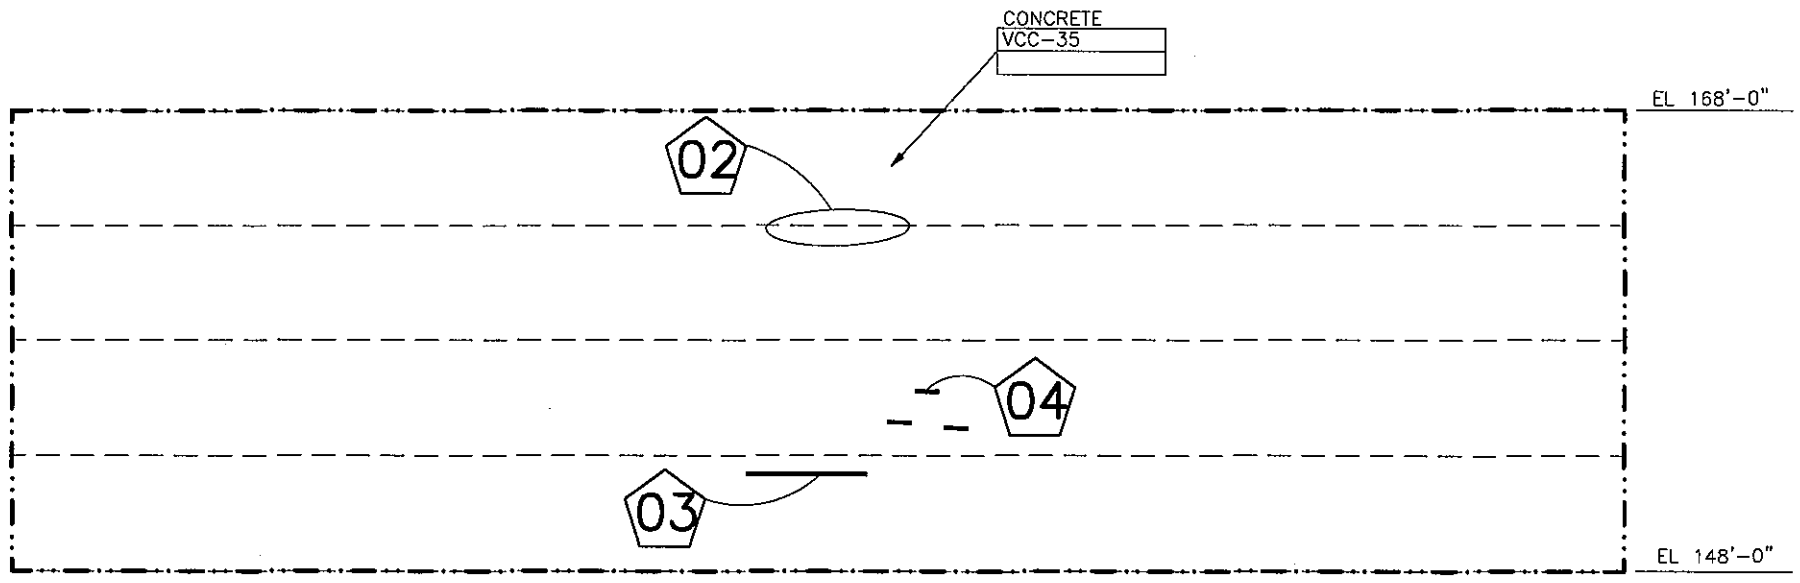
No.	Comment	Initials
1	Non-uniformity of surface color and texture observed at various locations in the zone. The condition does not indicate significant material deterioration of the concrete.	RW
2	White desposit from concrete cover patch over exposed rebar at construction joint 6" long. See photos 00052606 and 00052607	RW
3	Cadweld exposure from 9" long concrete spalling. See photo 00052609	RW
4	Rebar exposure at 3 spots, 1" to 3" long due to 1/2" cover concrete spall. See photo 00052608	RW

Comments: The surface texture (comment #1) resulted from original construction and does not reflect degradation of the containment. The leaching (comment #2) is not significant. Engineer evaluation is needed for the reinforcing steel (comments #3 & #4).

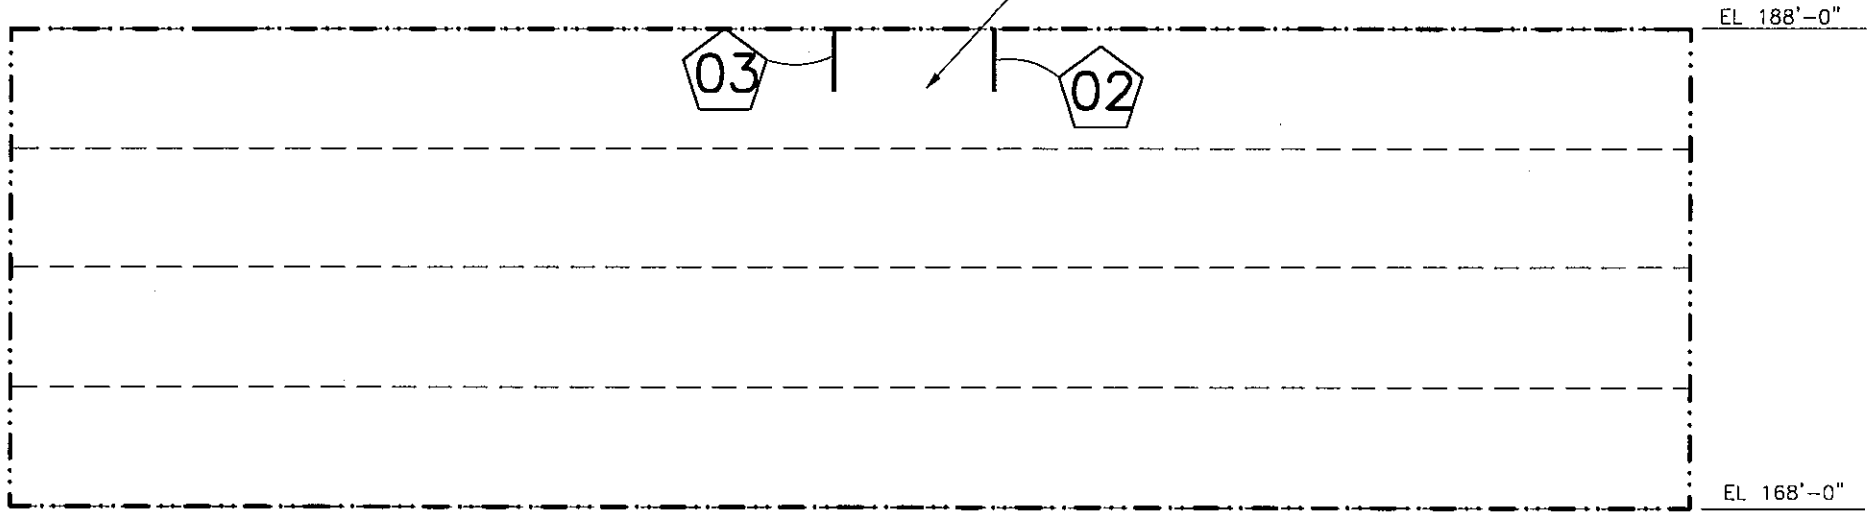
**CONCRETE INSPECTION ZONE IWL-168-001**  
(EXTERIOR DEVELOPED VIEW, LOOKING FROM OUTSIDE)

No.	Comment	Initials
1	Non-uniformity of surface color and texture observed at various locations in the zone. The condition does not indicate significant material deterioration of the concrete.	RW
2	minor leaching from dome spring line construction joint	RW
3	2' long leaching from dome spring line construction joint	RW

Comments: The surface texture (comment #1) resulted from original construction and does not reflect degradation of the containment. The leaching (comment #2) is not structurally significant.

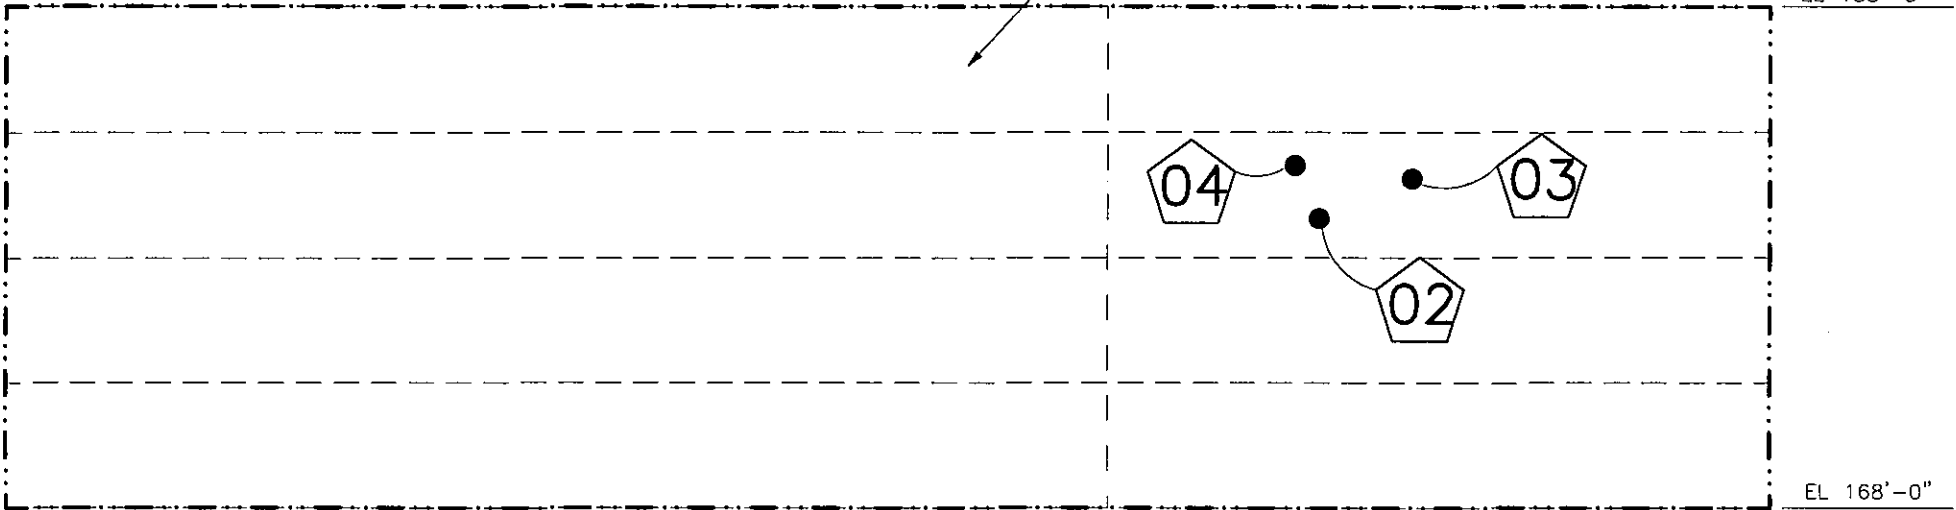
**CONCRETE INSPECTION ZONE IWL-168-002**  
(EXTERIOR DEVELOPED VIEW, LOOKING FROM OUTSIDE)

No.	Comment	Initials
1	Non-uniformity of surface color and texture observed at various locations in the zone. The condition does not indicate significant material deterioration of the concrete.	CAS
2	A small spot of steel is exposed and corroded. It is not known whether this is reinforcing steel. See photo 00053142	CAS
3	A small spot of steel is exposed and corroded. It is not known whether this is reinforcing steel. See photo 00053143	CAS
4	The concrete has cracked & bulged in a small area that is likely to spall off. By comparison to other similar areas it is believed to be a cadweld or reinforcing steel which is corroded due to insufficient concrete cover. See photo 00053144	CAS

Comments: The surface texture (comment #1) resulted from original construction and does not reflect degradation of the containment. Engineering evaluation is needed for the rebar issues (comments #2, #3 & #4).

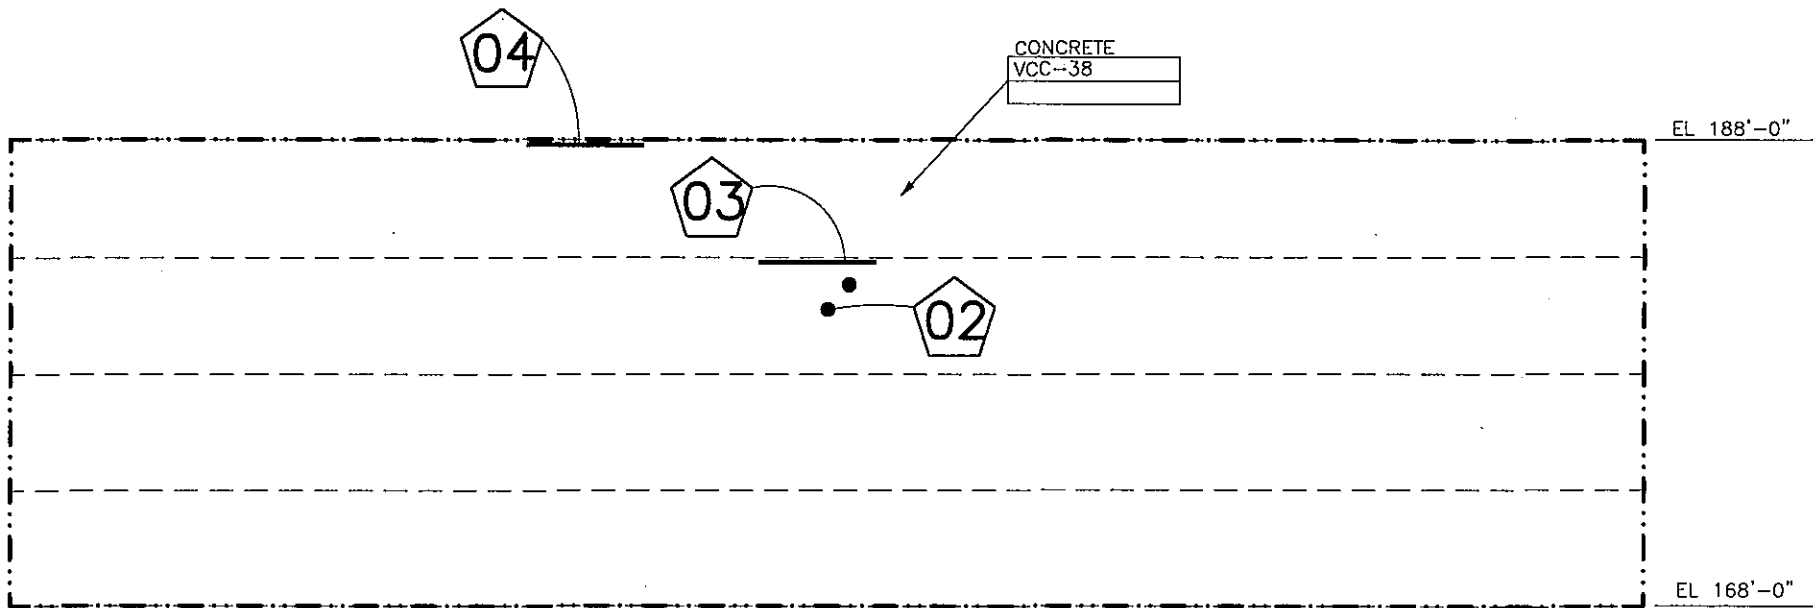
**CONCRETE INSPECTION ZONE IWL-168-003**  
 (EXTERIOR DEVELOPED VIEW, LOOKING FROM OUTSIDE)

No.	Comment	Initials
1	Non-uniformity of surface color and texture observed at various locations in the zone. The condition does not indicate significant material deterioration of the concrete.	RW
2	2 voids exposing 1" corroded steel. See photo 00053103	RW
3	9"x3" concrete spall exposing cadweld sleeve and insufficient concrete cover. See photo 00053102	RW
4	9"x3" concrete spall exposing cadweld sleeve and insufficient concrete cover. See photo 00053101	RW

Comments: The surface texture (comment #1) resulted from original construction and does not reflect degradation of the Containment. Engineering evaluation is needed for the exposed/corroded reinforcing steel rodwelds.

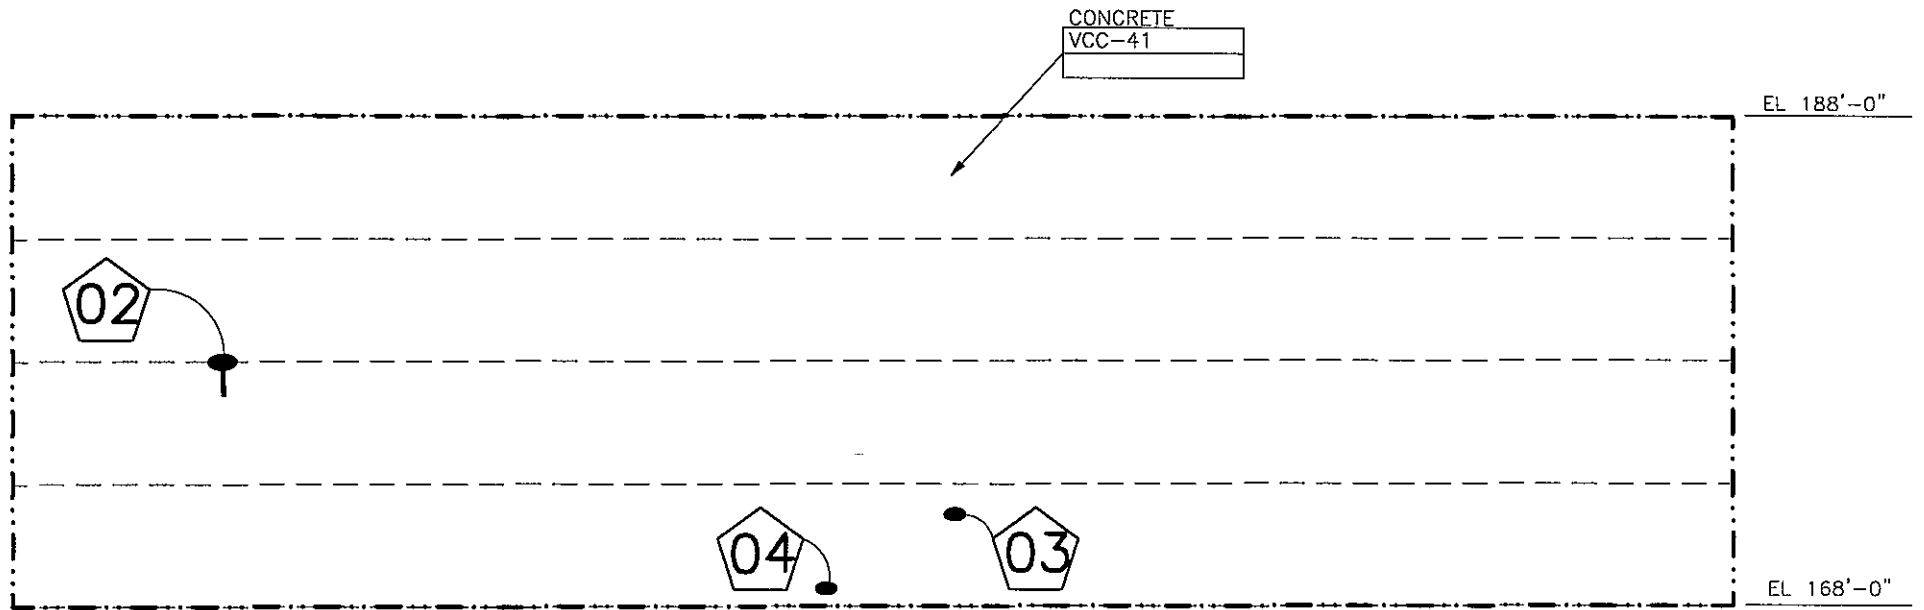
**CONCRETE INSPECTION ZONE IWL-168-006**  
 (EXTERIOR DEVELOPED VIEW, LOOKING FROM OUTSIDE)

No.	Comment	Initials
1	Non-uniformity of surface color and texture observed at various locations in the zone. The condition does not indicate significant material deterioration of the concrete.	RN
2	12" long Efflorescence (white deposit) from 3" radius chipped concrete (spall). See photo 00060101	RN
3	10" long cadweld sleeve exposed due to spalling of (1/2") cover concrete. See photos 00052604 and 00052605	RN
4	10" long cadweld sleeve exposed due to spalling of (1/2") cover concrete. See photos 00052604 and 00052605	RN

Comments: The surface texture (comment #1) resulted from original construction and does not reflect degradation of the containment. The leaching (comment #2) is not structurally significant. Engineering evaluation is needed for the exposed reinforcing steel (comments #3/#4).

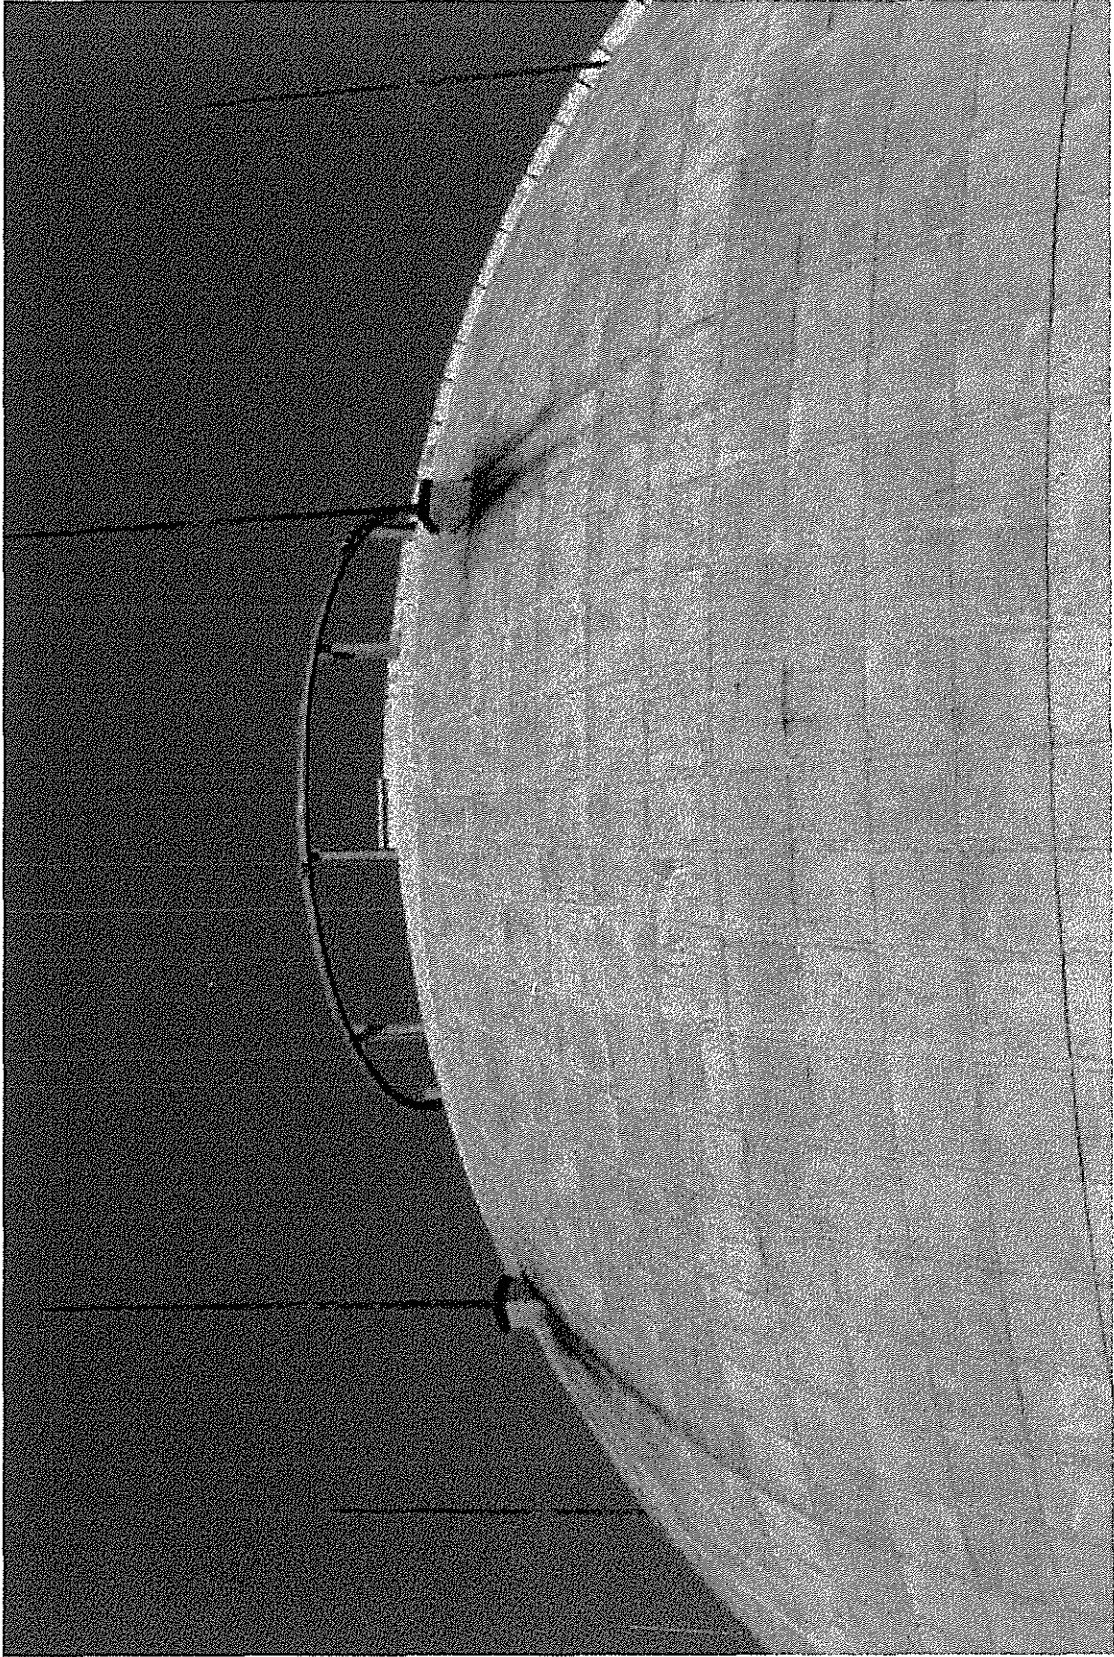
00053129.jpg

No.	Comment	Initials
1	Large rust stains are evident on the surface of the dome at and below the concrete pier which supports the lightning rod. The rust is obviously dripping down from the lightning rod base support plate. No cracking is evident in the area so rebar corrosion is not suspected. See photo 00053129	RW

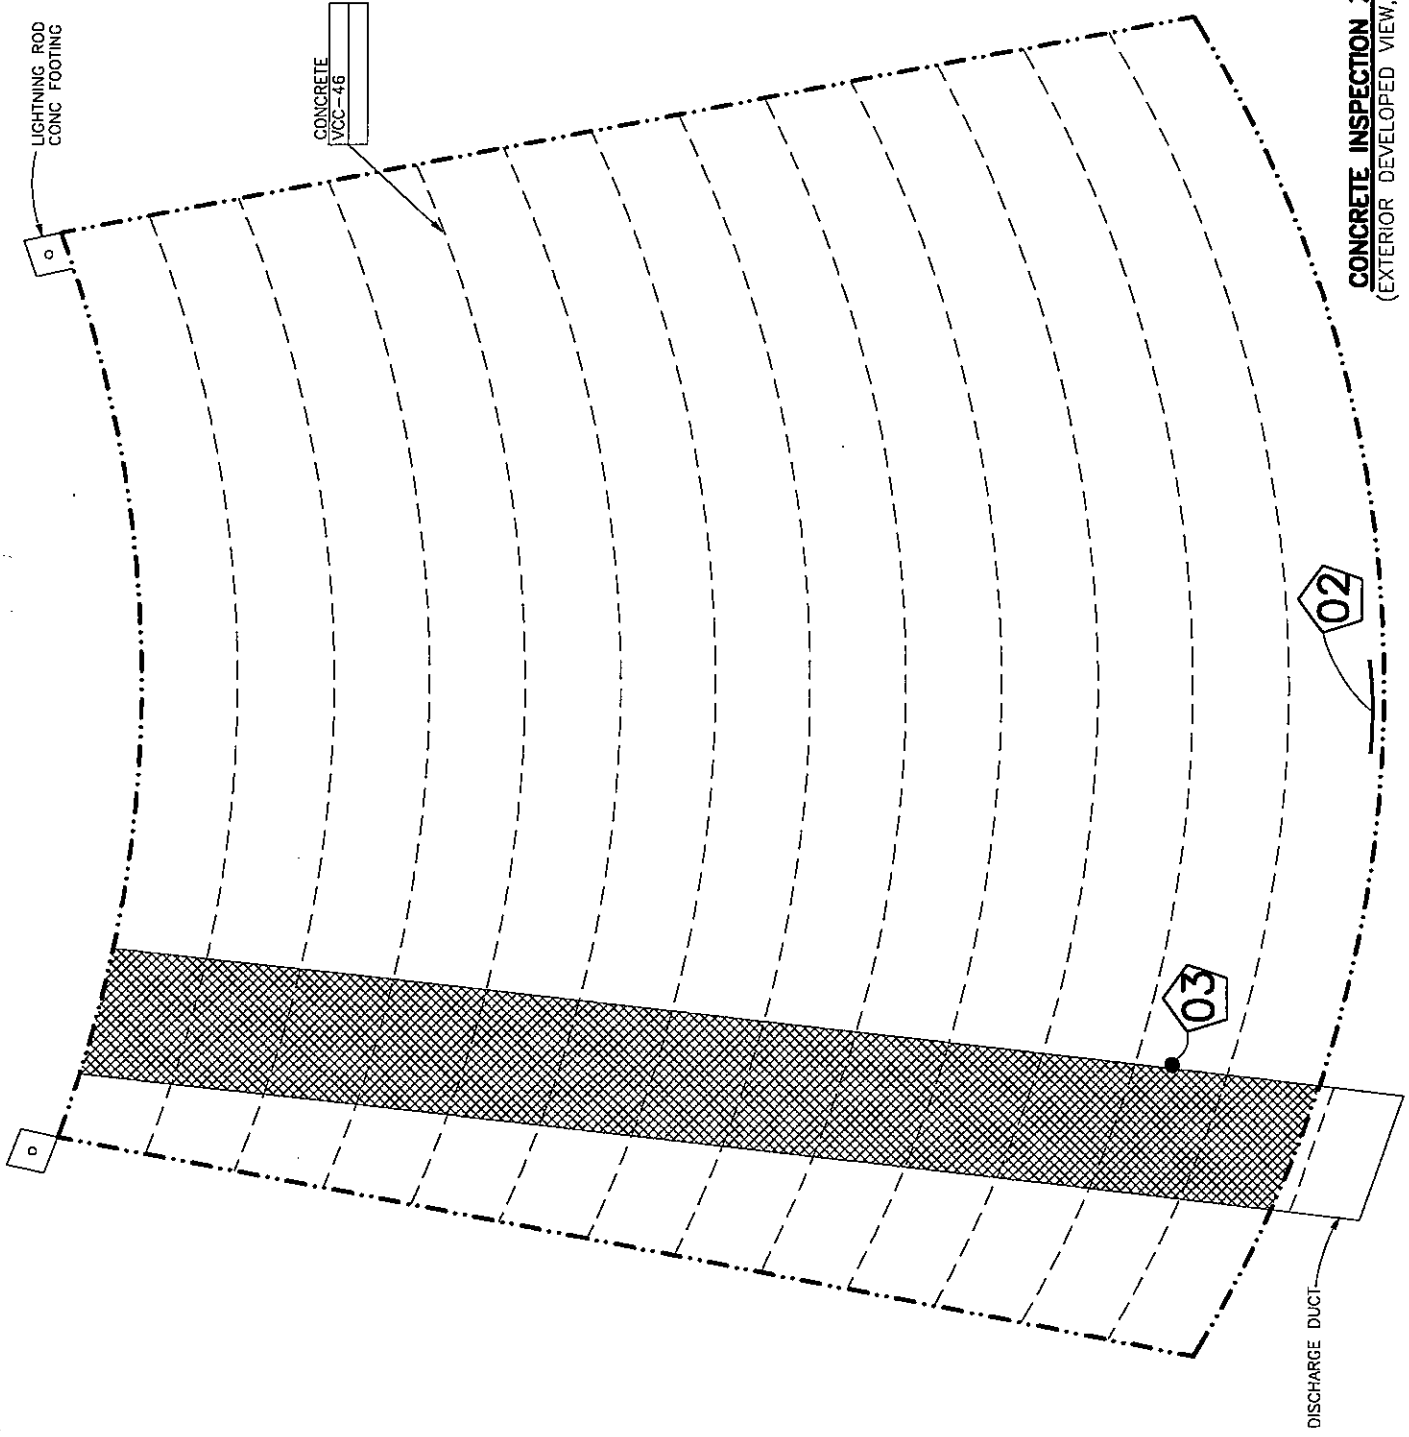
**CONCRETE INSPECTION ZONE IML-DOME-005**  
 (EXTERIOR DEVELOPED VIEW, LOOKING FROM OUTSIDE)

No.	Comment	Initials
1	Large rust stains are evident on the surface of the dome at and below the concrete pier which supports the lightning rod. The rust is obviously dripping down from the lightning rod base support plate. No cracking is evident in the area so rebar corrosion is not suspected. Corrosion staining is also evident at surface attachments for the discharge duct due to rusting of the attachment plates. See photo 00060104	RW
2	4' long horizontal crack and about 20 to 30 mils in width, 15" above the dome spring line. See photo 00060103	RN
3	3" diameter void (shallow hole) under the duct edge. See photo 00060106	RN

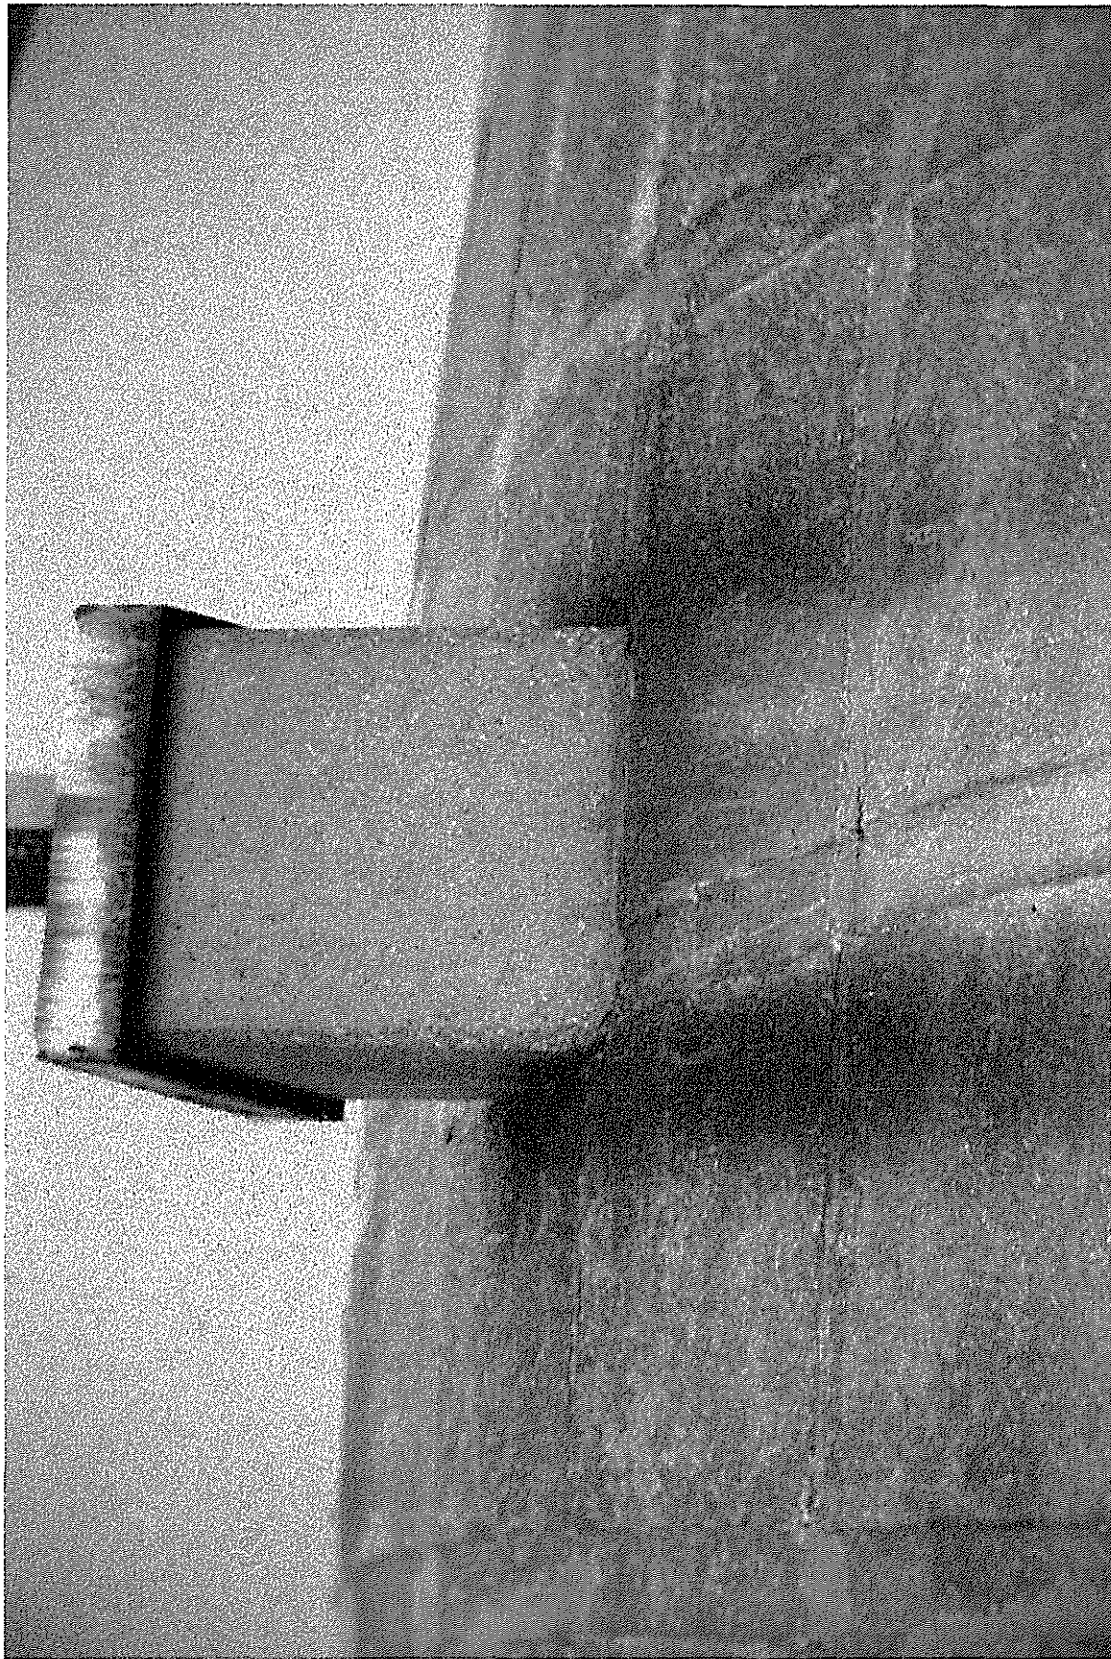
00060105.jpg

No.	Comment	Initials
1	Large rust stains are evident on the surface of the dome at and below the concrete pier which supports the lightning rod. The rust is obviously dripping down from the lightning rod base support plate. No cracking is evident in the area so rebar corrosion is not suspected. See photo 00060105	RN

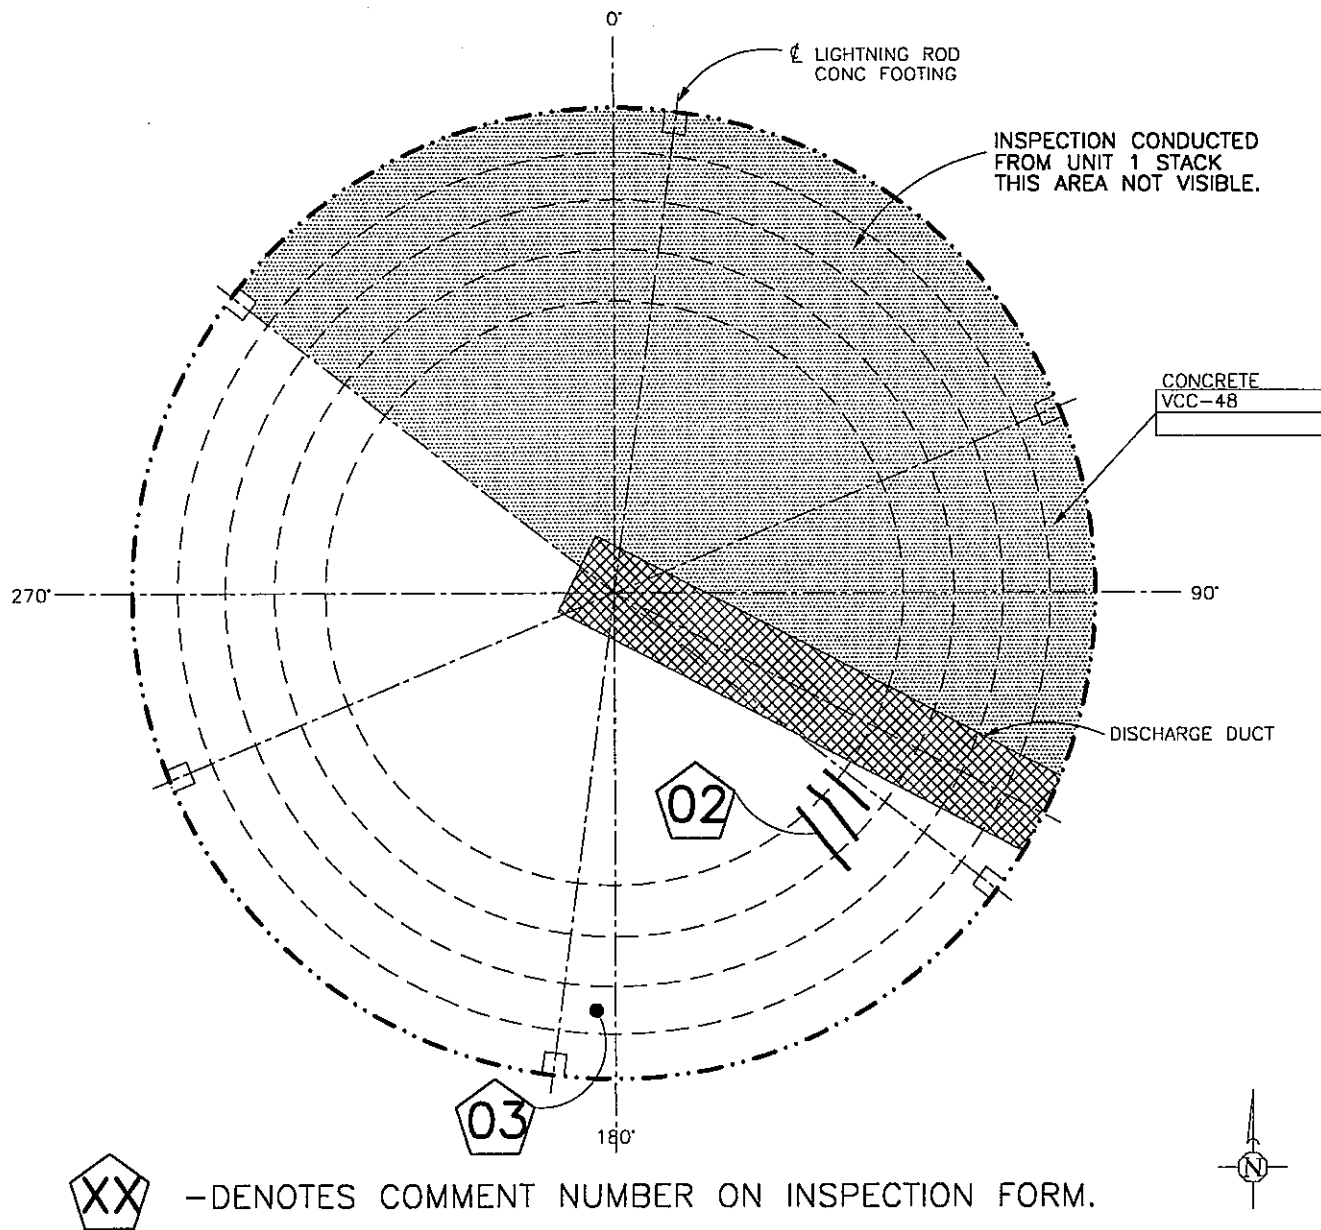
**CONCRETE INSPECTION ZONE IWL-DOME-007**  
 (EXTERIOR DEVELOPED VIEW, LOOKING FROM OUTSIDE)

No.	Comment	Initials
1	Large rust stains are evident on the surface of the dome at and below the concrete piers which supports the lightning rods. The rust is obviously dripping down from the lightning rod base support plate. No cracking is evident in the area so rebar corrosion is not suspected. Corrosion staining is also evident at surface attachments for the discharge duct due to rusting of the attachment plates. See photo 00053145	CAS
2	Three (3) rust streaks (6' to 8' long) are present in the upper part of the dome at approximate Azimuth 135. There is no obvious source of these streaks but there is no concrete cracking or other signs to indicate that the corrosion originates from reinforcing steel.	CAS
3	A shallow spall approximately 18" in diameter is present approximately at Azimuth 180 just above and to the east of the lightning rod foundation.	CAS

Comments: Engineering evaluation is needed to evaluate the significance of the spalled area (comment #3).
