**FORM VT-3C**  
**CONTAINMENT INSERVICE INSPECTION**  
**RECORD OF VT-3C EXAMINATION**

STATION/UNIT: Indian Point 2 COMPONENT NO.: VCC-26  
 ZONE NUMBER: IWL-128-003 DRAWING NO.: 320860  
 EQUIPMENT USED: Celestron Giant 20x80 Binoculars (Ser. No. 990176)

Work Order No. NP-99-11274

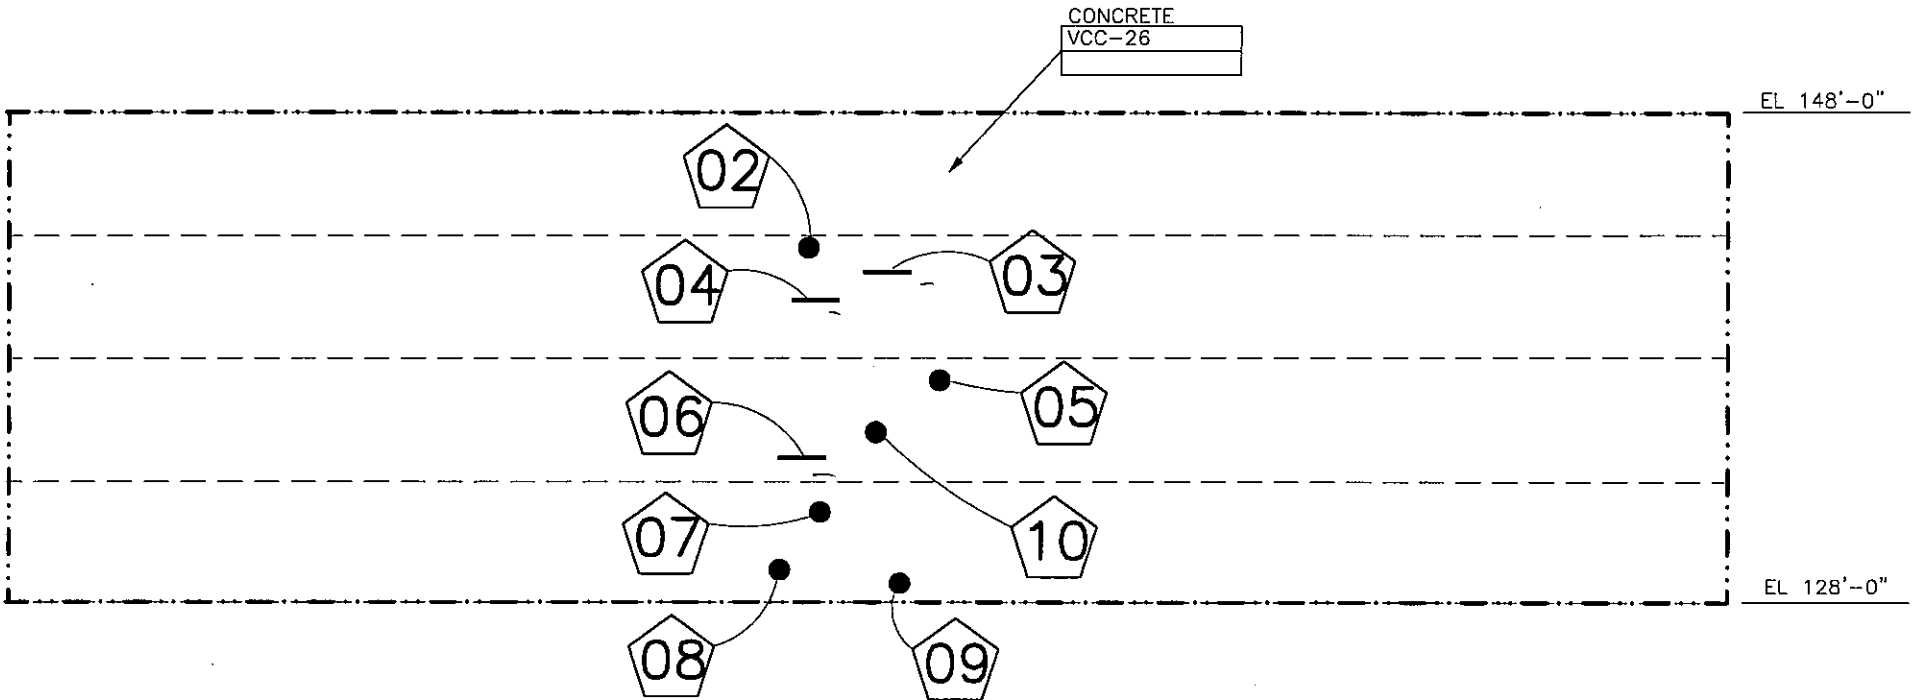
**CONCRETE INSPECTION ZONE IWL-128-003**  
 (EXTERIOR DEVELOPED VIEW, LOOKING FROM OUTSIDE)

No.	Comment	Initials
1	Non-uniformity of surface color and texture observed at various locations in the zone. The condition does not indicate significant material deterioration of the concrete.	RN
2	Delamination of concrete cover over 2" length. See photo 00053105	RN
3	10"x4" concrete spall exposing cadweld sleeve. See photo 00053106 and 00053107	RN
4	2 closely spaced spalls about 8" in diameter about to pop out exposing steel. See photo 00053108	RN
5	leaching in the form tie hole patch area	RN
6	4"x2" opening in concrete exposing cadweld sleeve. See photo 00053110	RN
7	1" dia void in concrete exposing rebar. See photo 00053111	RN
8	concrete cover about to spall in a 6"square surface. See photo 00053112	RN
9	concrete cover about to spall in a 6"square surface	RN
10	concrete cover about to spall in a 6"square surface. See photo 00053109	RN

Comments: The leaching (comment #5) is not significant. The surface texture (comment #1) resulted from original construction and does not reflect degradation of the containment. Engineering evaluation is needed for all of the other comments, which relate to rebar corrosion.

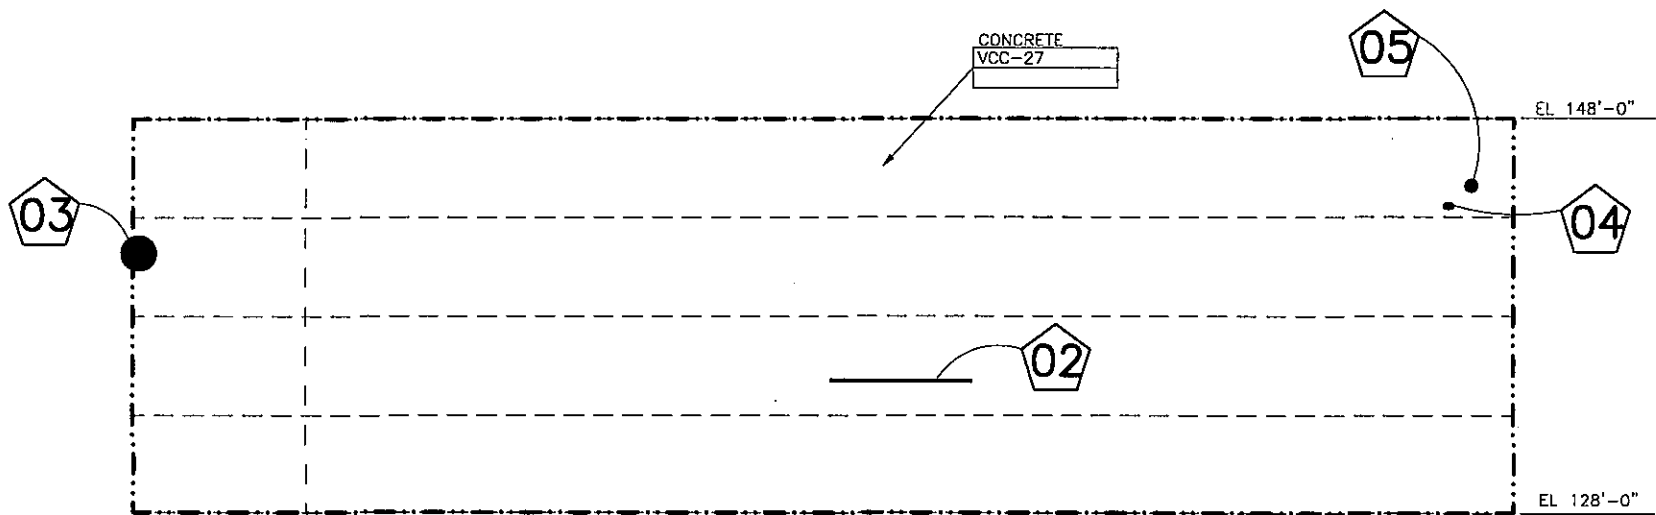
**CONCRETE INSPECTION ZONE IWL-128-004**  
 (EXTERIOR DEVELOPED VIEW, LOOKING FROM OUTSIDE)

No.	Comment	Initials
1	Non-uniformity of surface color and texture observed at various locations in the zone. The condition does not indicate significant material deterioration of the concrete.	RN
2	Loss of mortar 1/4" deep over an area 2' x 6". See photo 00052624	RN
3	2" rebar steel exposure due to cover concrete spalling. See photo 00052625	RN
4	Exposed and corroded rebar. See photo 00060120	RN
5	The concrete has cracked & bulged in a small area that is likely to spall off. By comparison to other similar areas it is believed to be a cadweld or reinforcing steel which is corroded due to insufficient concrete cover. See photo 00060120	RN

Comments: The surface conditions (comments #1 & #2) resulted from original construction and do not reflect degradation of the containment. The other conditions (comments #3, #4 & #5) involve rebar corrosion and require engineering evaluation.

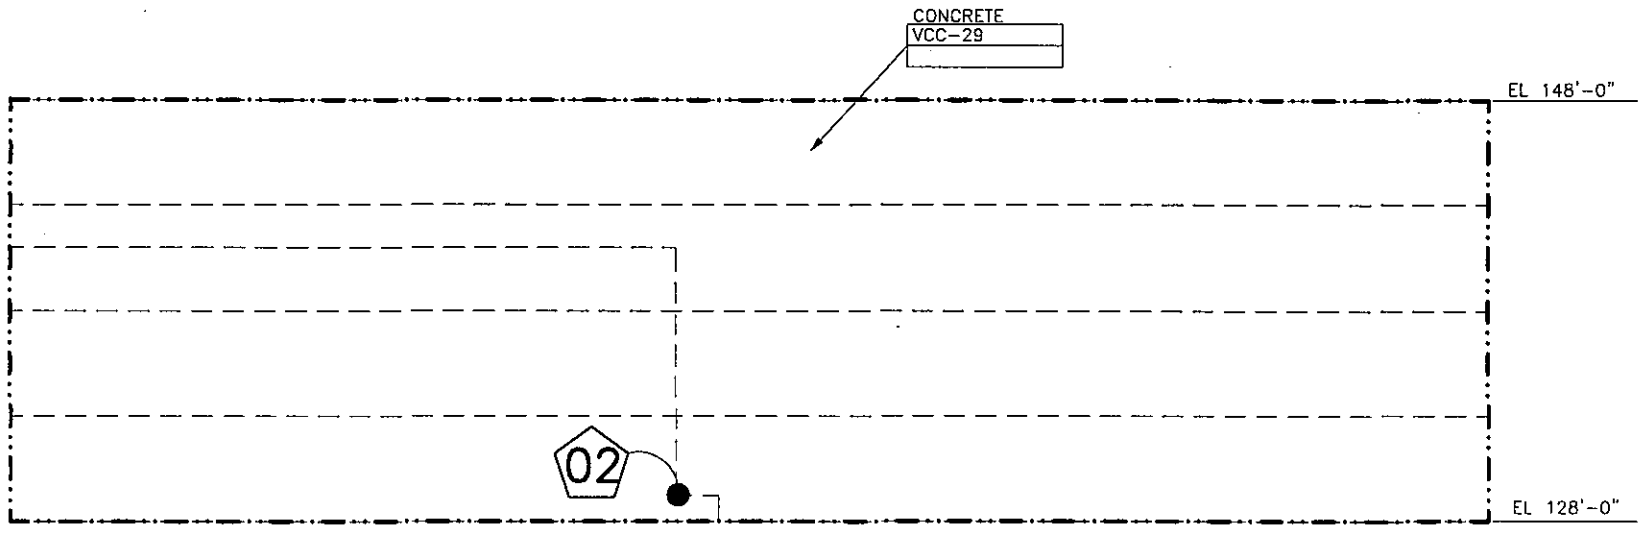
**CONCRETE INSPECTION ZONE IWL-128-006**  
(EXTERIOR DEVELOPED VIEW, LOOKING FROM OUTSIDE)

No.	Comment	Initials
1	Non-uniformity of surface color and texture observed at various locations in the zone. The condition does not indicate significant material deterioration of the concrete.	RF
2	White deposit (Efflorescence) from a 6" square area of concrete cover patch. See photo 00052610	DN

Comments: The leaching is not significant. The surface texture resulted from original construction and does not reflect degradation of the containment.

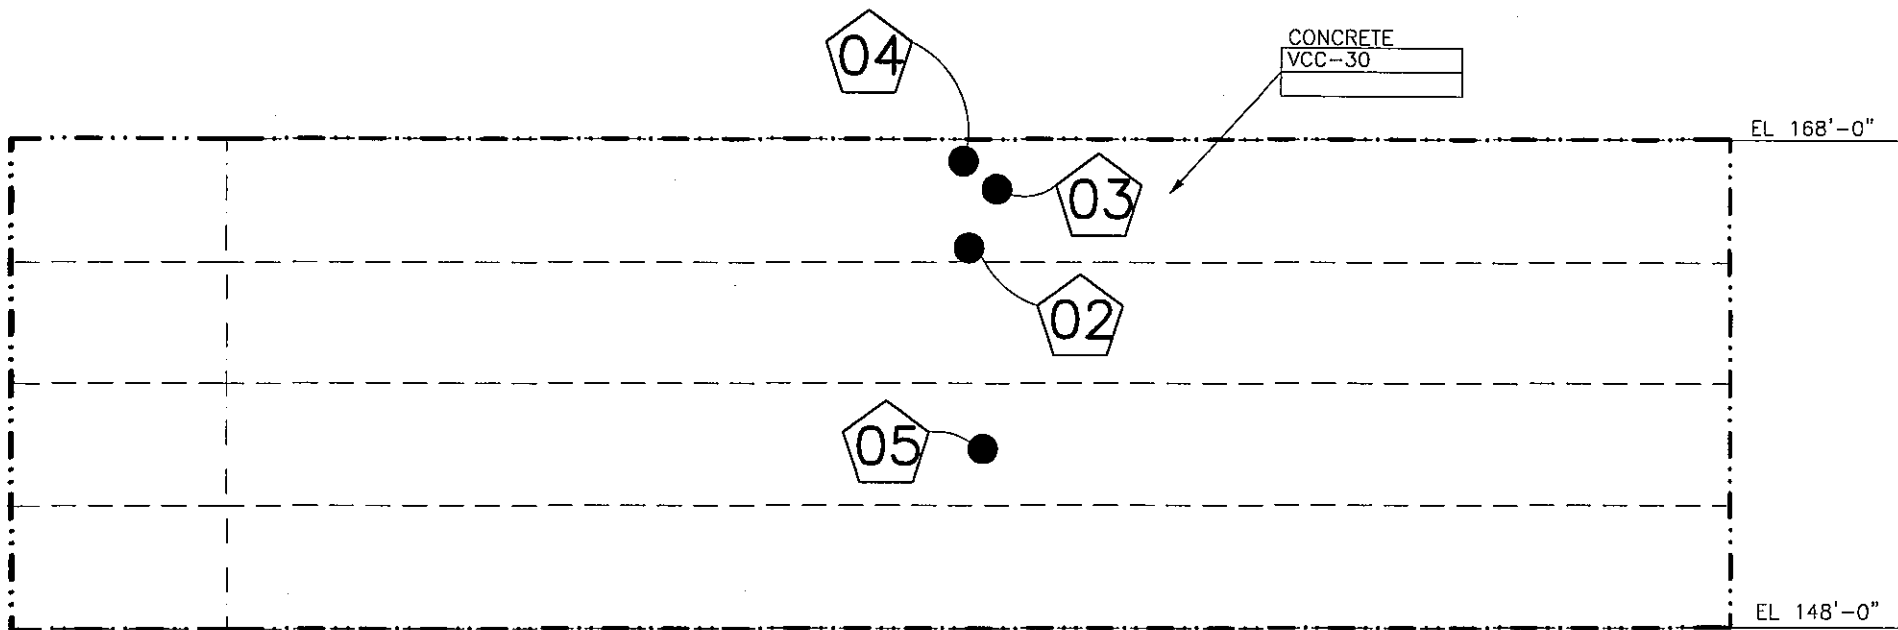
**CONCRETE INSPECTION ZONE IWL-148-001**  
 (EXTERIOR DEVELOPED VIEW, LOOKING FROM OUTSIDE)

No.	Comment	Initials
1	Non-uniformity of surface color and texture observed at various locations in the zone. The condition does not indicate significant material deterioration of the concrete.	CAS
2	Cadweld exposed & corroded due to loss of concrete cover. See photo 00053146	CAS
3	Cadweld exposed & corroded due to loss of concrete cover. See photo 00053147	CAS
4	Cadweld exposed & corroded due to loss of concrete cover. See photo 00053147	CAS
5	The concrete has cracked & bulged in a small area that is likely to spall off. By comparison to other similar areas it is believed to be a cadweld or reinforcing steel which is corroded due to insufficient concrete cover. See photo 00053148	CAS

Comments: The surface texture (comment #1) resulted from original construction and does not reflect degradation of the Containment. The other conditions (comments #2 - #5) involve corroded reinforcing steel and require engineering evaluation.

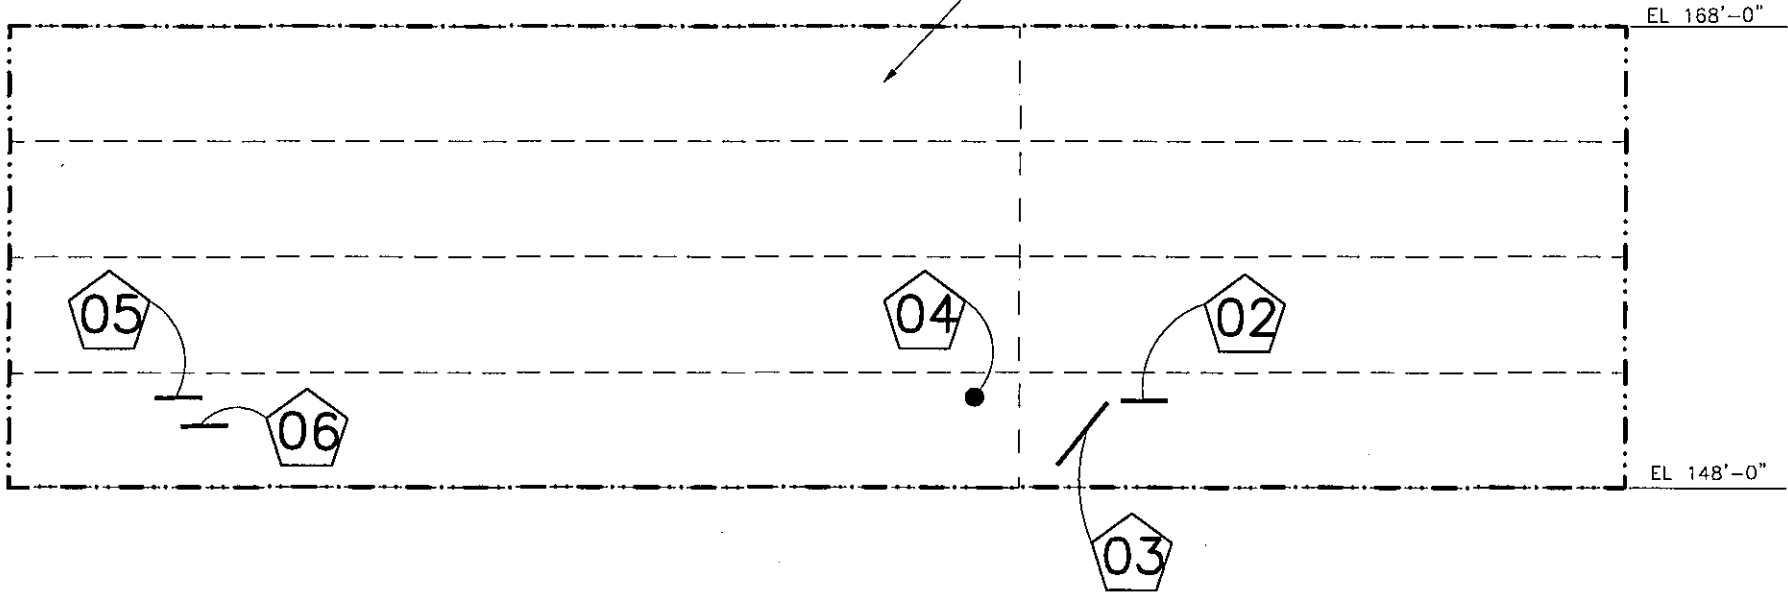
**CONCRETE INSPECTION ZONE IWL-148-002**  
(EXTERIOR DEVELOPED VIEW, LOOKING FROM OUTSIDE)

No.	Comment	Initials
1	Non-uniformity of surface color and texture observed at various locations in the zone. The condition does not indicate significant material deterioration of the concrete.	CAS
2	Exposed steel is corroded and appears to be rebar. See photo 00053138	CAS
3	A piece of steel, not reinforcing steel, is exposed at the concrete surface on a diagonal line approximately 3' long. See photo 00053140	CAS
4	A small spot of steel is exposed and corroded. It does not appear to be reinforcing steel. See photo 00053141	CAS
5	Cadweld exposed & corroded due to loss of concrete cover. See photo 00053149	CAS
6	Cadweld exposed & corroded due to loss of concrete cover. See photo 00053149	CAS

Comments: The surface texture (comment #1) resulted from original construction and does not reflect degradation of the containment. The exposed & corroded reinforcing steel (comments #2 - #6) require engineering evaluation.

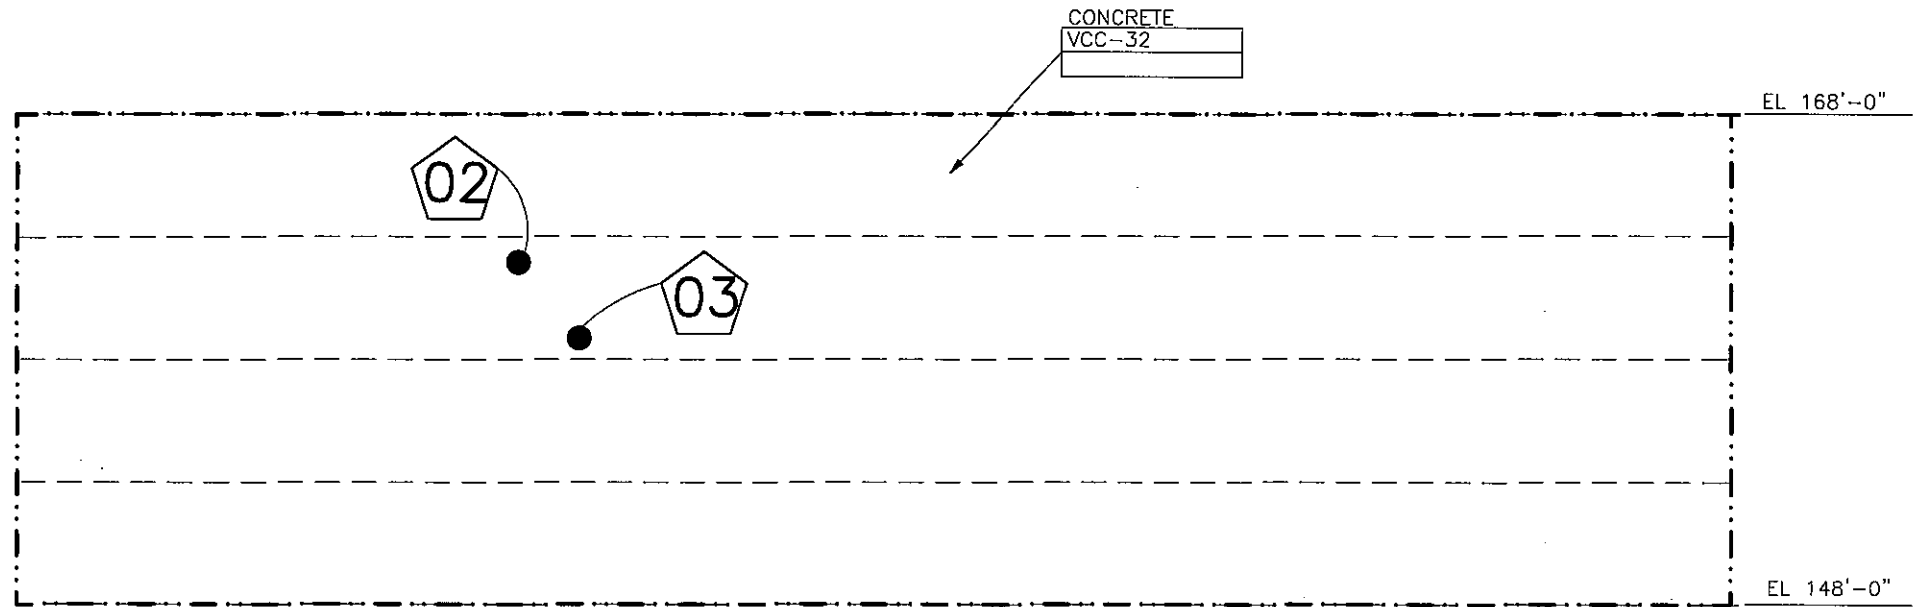
**CONCRETE INSPECTION ZONE IWL-148-003**  
 (EXTERIOR DEVELOPED VIEW, LOOKING FROM OUTSIDE)

No.	Comment	Initials
1	Non-uniformity of surface color and texture observed at various locations in the zone. The condition does not indicate significant material deterioration of the concrete.	CAS
2	A small spot of steel is exposed and corroded. It is not immediately apparent whether it is reinforcing steel but it is similar in appearance to cadwelds exposed in other areas. See photo 00053133	CAS
3	A small spot of steel is exposed and corroded. It is not immediately apparent whether it is reinforcing steel but it is similar in appearance to cadwelds exposed in other areas. See photo 00053134	CAS

Comments: The surface texture (comment #1) resulted from original construction and does not reflect degradation of the Containment. Engineering evaluation is needed for the rust staining that is potentially from corroded rod welds.

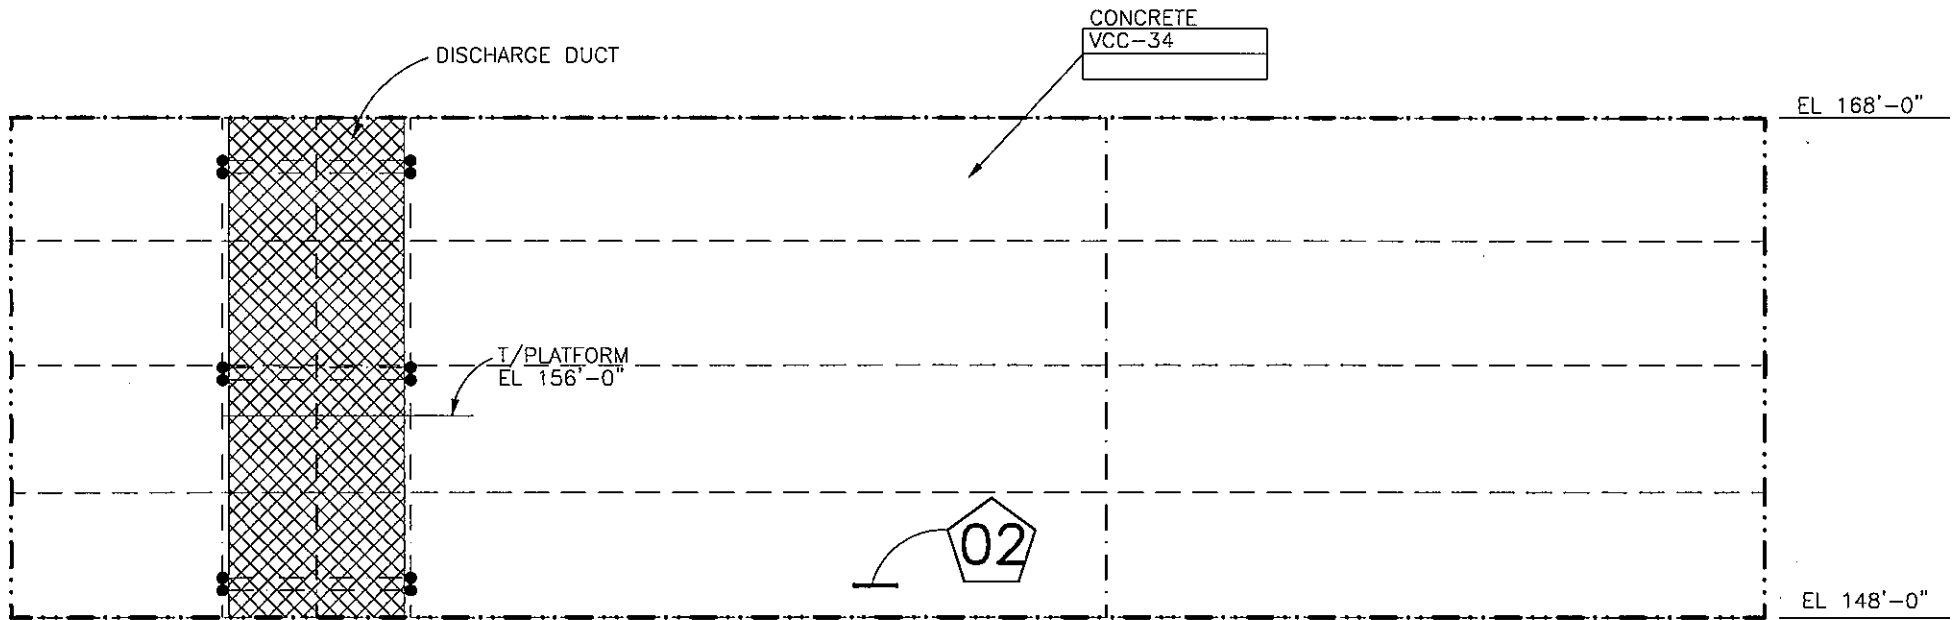
**CONCRETE INSPECTION ZONE IWL-148-005**  
 (EXTERIOR DEVELOPED VIEW, LOOKING FROM OUTSIDE)

No.	Comment	Initials
1	Non-uniformity of surface color and texture observed at various locations in the zone. The condition does not indicate significant material deterioration of the concrete.	CAS
2	Rebar exposed and corroded. See photo 00060102	CAS

Comments: The surface texture (comment #1) resulted from original construction and does not reflect degradation of the containment. Engineering evaluation is need for the exposed/corroded reinforcing steel.
