Attachment 7.2
CONTAINMENT INSERVICE INSPECTION
RECORD OF VT-3 / GENERAL VISUAL EXAMINATION

IPEC Unit: 2 Interval Period: 1st/2nd Inspection Inspection Report No.: IP2-O5-IWL-001

Component No.: VCC - 09 Zone No: 002 Drawing No.: _____

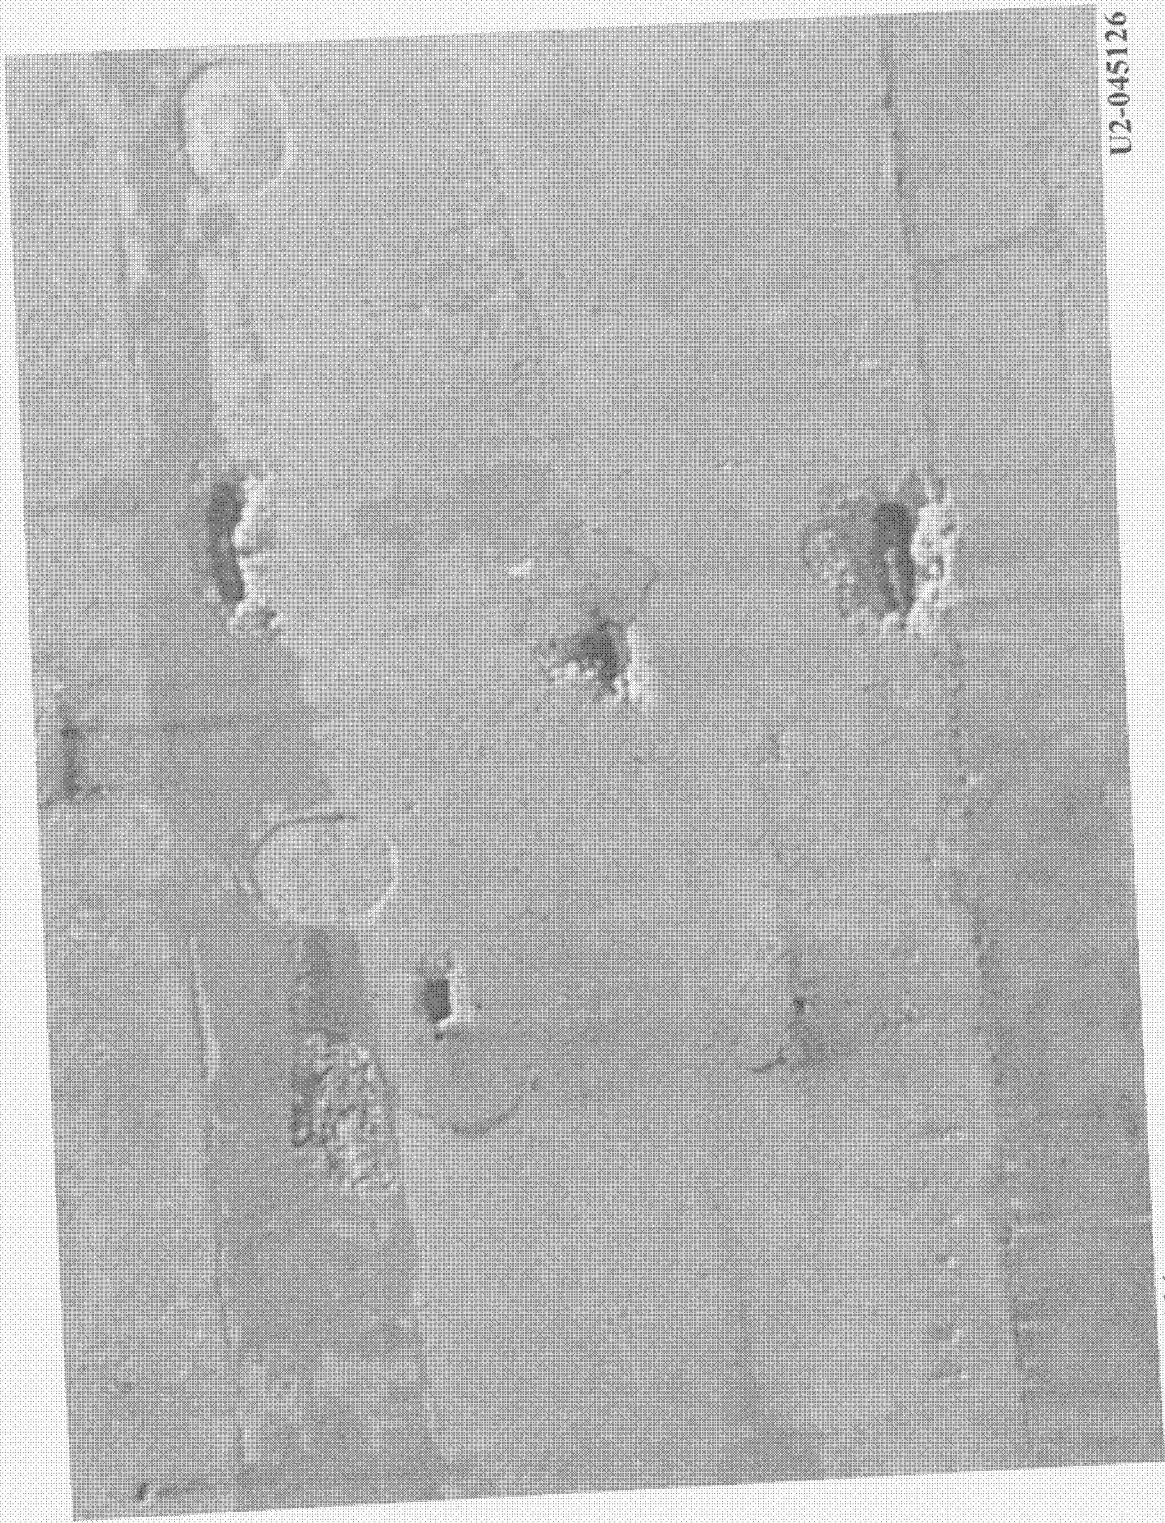
No.	Comment	Initials
1	General pattern cracking and discoloration over concrete surface.	<i>WJF</i>
2	Popout, approx. 3" long, exposing rebar with rust at El. 105.	<i>WJF</i>
3	2' long white deposit from top of construction opening closure grout. This area has remained unchanged since previous inspection.	<i>WJF</i>
4	Concrete spall about 8" square area about to popout. Since previous inspection, roughly a 4" square popout has occurred exposing rebar at El. 104. See photo U2-045126	<i>WJF</i>
5	Rebar exposure with rust and staining, accompanied by 4" concrete spall with some additional spalling since previous inspection at El. 105. See photo U2-045126	<i>WJF</i>
6	Popouts are visual at El. 104 and El. 106, each having rust streaks approximately 10" long.	<i>WJF</i>
7	10"x4" concrete spall exposing 8" length of cadweld sleeve. Only 1/2" concrete cover in this area. Since previous inspection, minor additional spalling has occurred, along with rust streaks and staining. See photo U2-045126	<i>WJF</i>
