IWL VISUAL CONTAINMENT INSPECTION Indian Point Unit No. 2

### FORM VT – 3C CONTAINMENT INSERVICE INSPECTION RECORD OF VT – 3 /GENERAL VISUAL EXAMINATION

STATION/UNIT: IPEC / Indian Point No. 2 COMPONENT NO. : VCC – 34

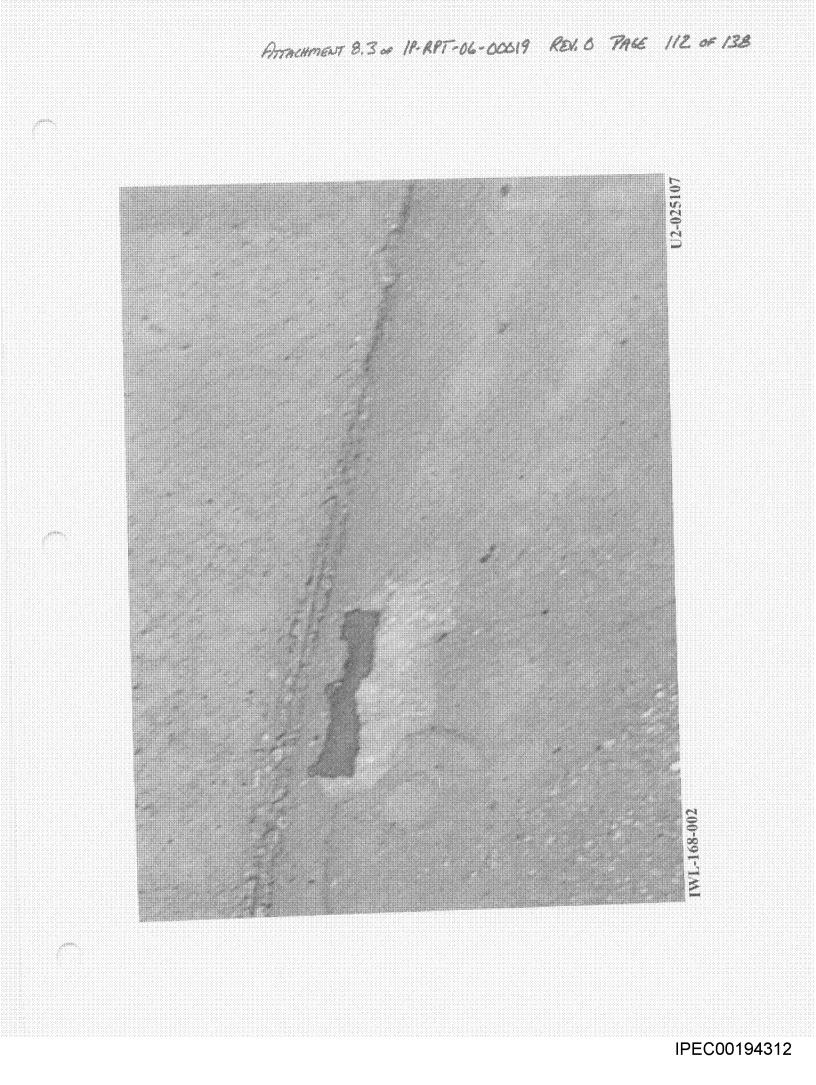
No.	Comment	Initials
1	A small spot of steel is exposed and corroded with staining. It is not known whether this is reinforcing steel. This area has remained unchanged since previous inspection.	Mp
2	A small spot of steel is exposed and corroded with staining. It is not known whether this is reinforcing steel. This area has remained unchanged since previous inspection.	May
3	The concrete has cracked & bulged in a small area that is likely to spall off. By comparison to other similar areas it is believed to be a cadweld or reinforcing steel which is corroded due to insufficient concrete cover. This area has remained unchanged since previous inspection.	Met
4	Patch of shallow popouts just below El. 188.	hef
5	A popout exposing a cadweld with rust and staining (approx. 8" long) is visible. See photo U2-025107	lig
6	Leaching has occurred 6" long.	Nief
7	A joint spall and some pitting/abrasion is visible at El. 173.	hig

8	Area of light abrasion approximately 4' long was spotted between El. 168 and El. 178	mof
9	General pattern cracking, bugholes, and leaching between El. 168 and El. 178.	Mal
		Ũ
		<u> </u>

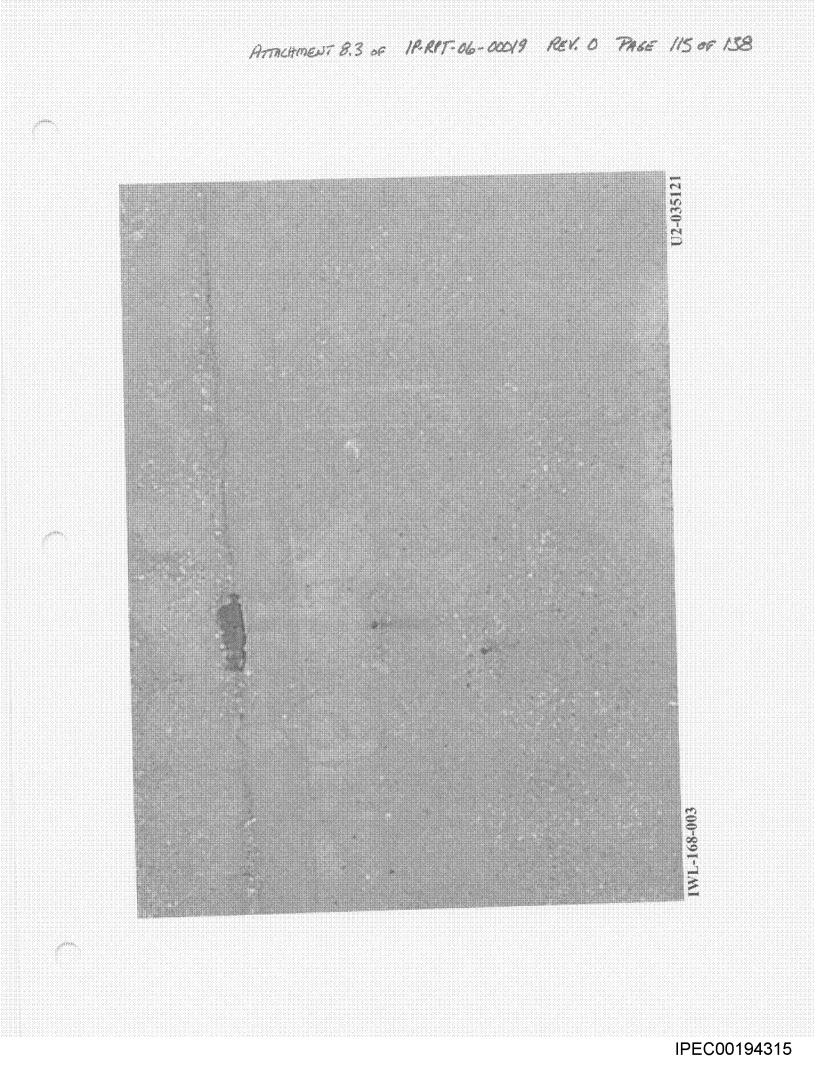
No.	Comment	Initials
1	General joint cracking, minor leaching, and pattern cracking between El. 168 and El. 173.	Inof
2	Bugholes with visible rust at El. 174 approximately 10 feet from left boundary.	ing
3	General joint cracking, bugholes, and spalls between El. 173 and El. 178.	Inf
4	General pattern cracking, minor joint cracking, and light spalling between El. 178 and El. 183.	Inf
5	9"x3" concrete spall exposing cadweld sleeve with staining due to insufficient concrete cover. This spall remains unchanged since previous inspection.	Met
6	2 voids exposing 1" corroded steel with staining remain unchanged since previous inspection. See photo U2-035121	uof
7	9"x3" concrete spall exposing cadweld sleeve with staining due to insufficient concrete cover has had additional spalling since previous inspection. See photo U2-035121	inf
8	Joint crack with spalling is visible just below El. 188.	uof
		0

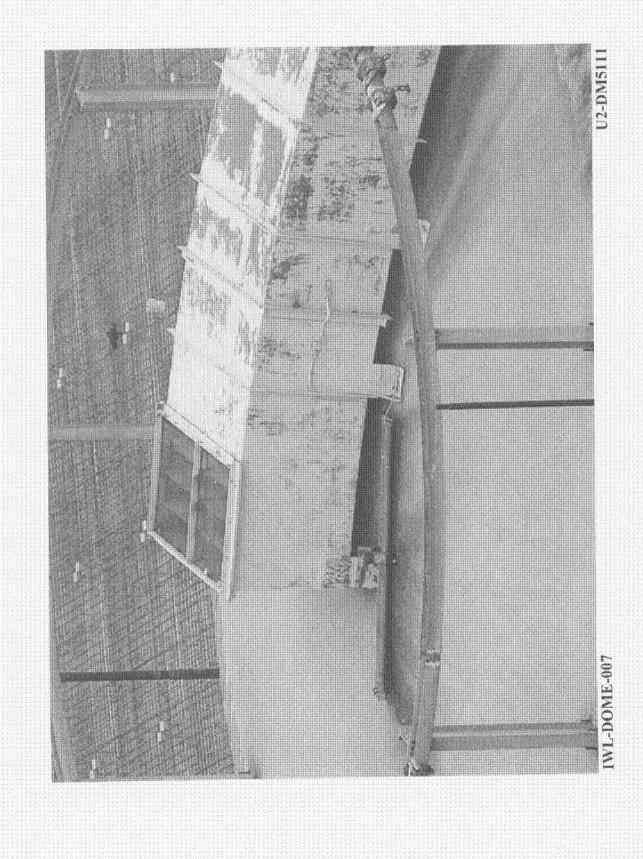
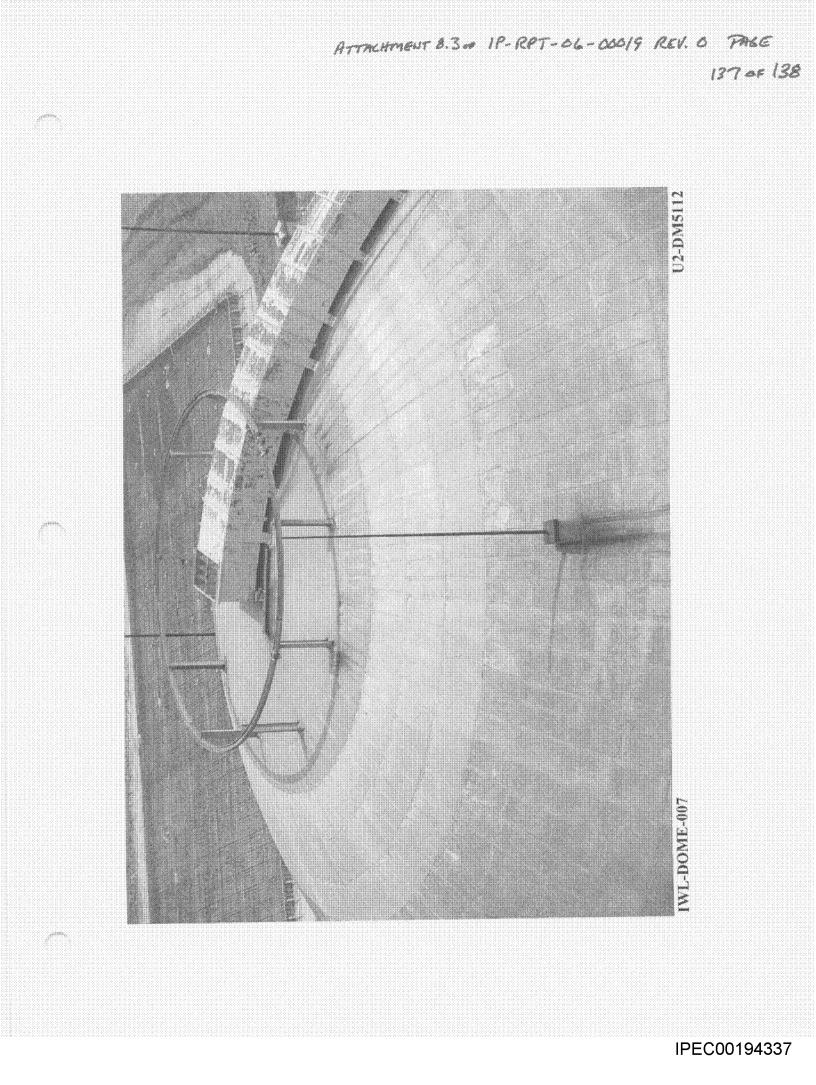
No.	Comment	Initials
1	Large rust stains are evident on the surface of the dome due to lightning rod rusting at all six locations. Also, visible surface rust appears clearly from exhaust duct steel. See photos U2-DM5111 and U2-DM5112	nof
2	Cracking exists at three elevations creating a full circle around the dome.	Mp
3	Visible void roughly 2" x 2".	ng
4	General leaching, pattern cracking, bugholes, and surface discoloration. See photo U2-DM5114	nof
5	Unidentified piece of concrete (approx. 4"x8") found on dome.	Net
		$\mathcal{O}$
si In
