IP3 ASME Section XI, IWL  
 Concrete Containment Inspection  
 for 2005

IP-RPT-06-00013 Revision 0  
 Attachment 8.2 Page 30 of 124

**Attachment 7.2 of ENN-EP-S-003, Rev. 0**  
**CONTAINMENT INSERVICE INSPECTION**  
**RECORD OF VT-3 / GENERAL VISUAL EXAMINATION**

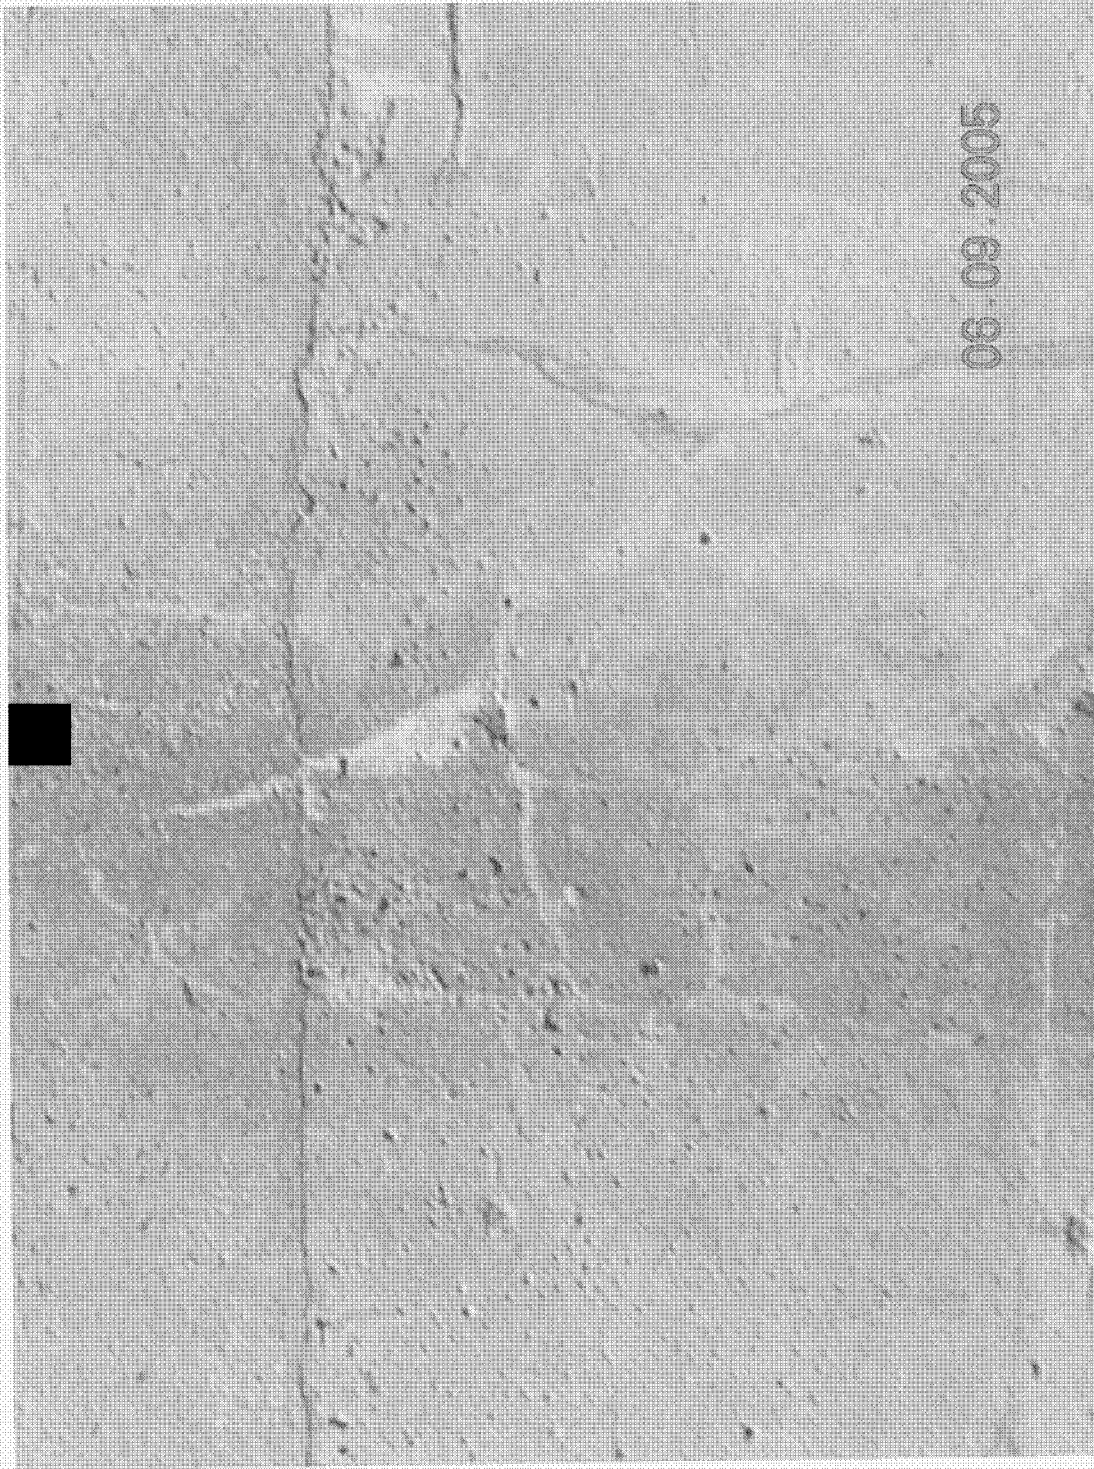
No.	Comment	Initials
1	Area of light scaling, approximately 5'x5', between El. 83 and El. 88.	PMB
2	General bugholes, rust staining, pattern cracking, discoloration, and leaching are visible between El. 83 and El. 88. See photo U3-066092	PMB
3	Accessible areas in this component ranged from El. 83 to El. 88.	PMB
4	Void with exposed rebar tip, rusting, and staining. See photos U3-066093 and U3-066094	PMB
