IP-RPT-09-00069

IP3 ASME Section XI, IWL Concrete Containment Inspection for 2009

**CONTAINMENT INSERVICE INSPECTION RECORD OF VT-3/GENERAL VISUAL EXAMINATION**

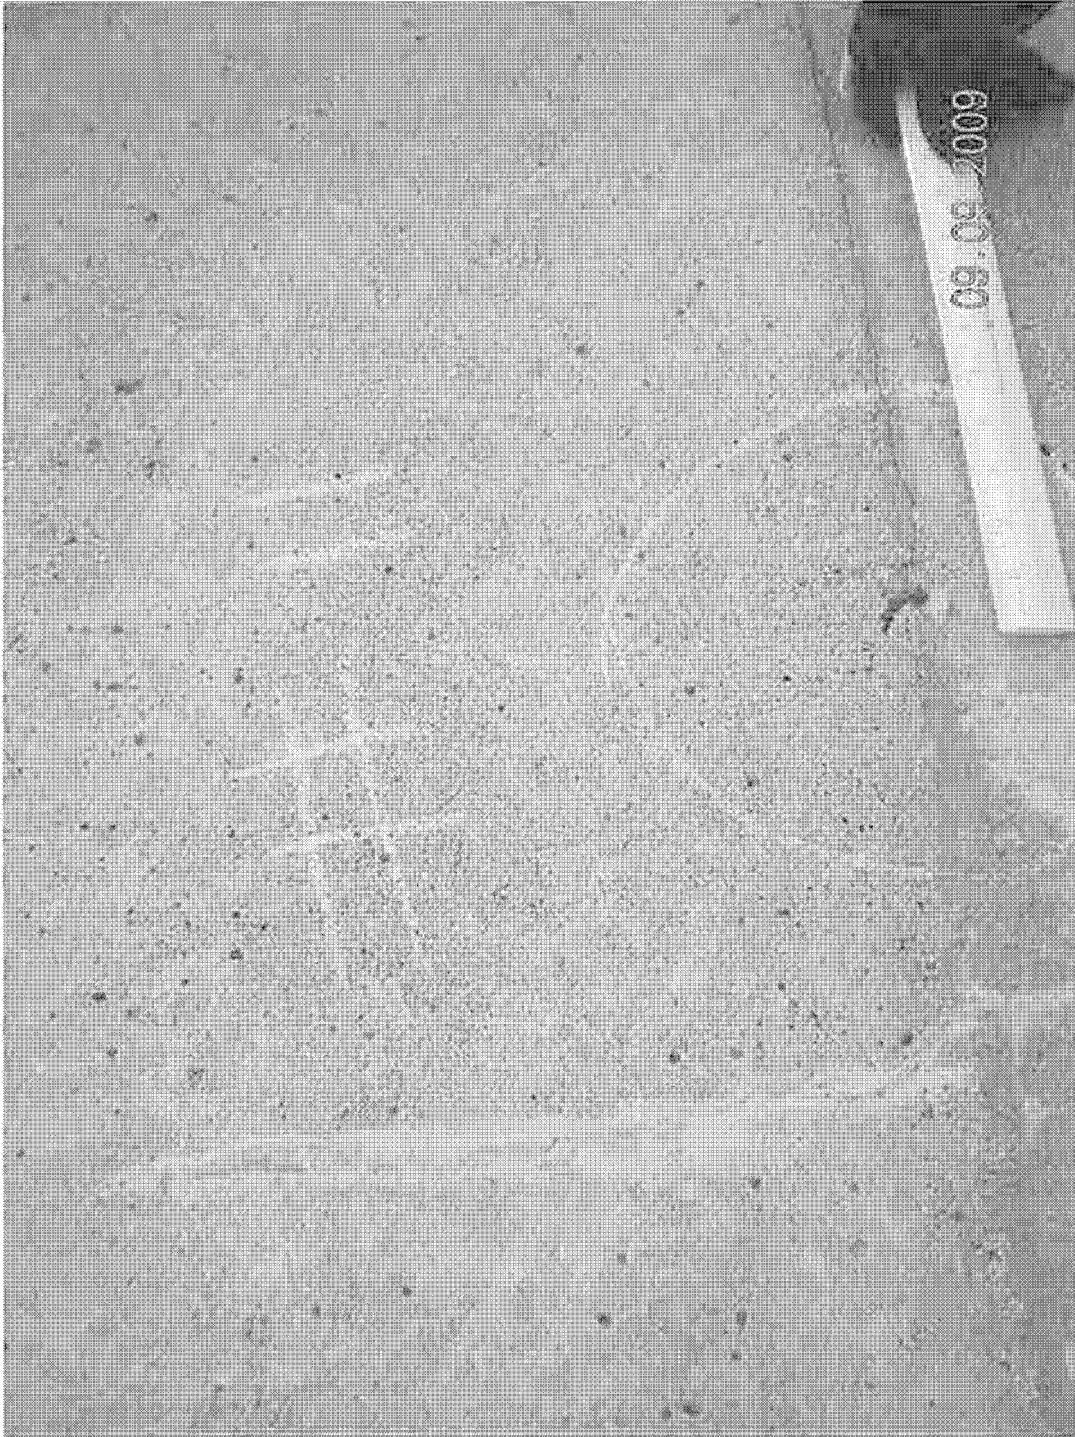
U3-029094

No.	Comment	Initials
1	Numerous bugholes, leaching and vertical cracking – all minor and previously identified.	PMB
2	Joint spalling, approximately 4" long by 1/2" wide, at El. 138 (previously identified with no changes).	PMB
3	Diagonal spalls, all less than 3" long by 1/2" wide, between El. 133 and El. 138 (previously identified with no changes).	PMB
4	3" x 1" x 1/2" deep spall / pop out at El. 143. This was previously identified and remains unchanged with NO exposed metal, rusting, or leaching.	PMB
5	Reddish discoloration in both zones 2 and 3 over an area of roughly 20' x 90'.	PMB
6	Approximately 5' of rough joint with minor separation at El. 148. There is no exposed rebar, rust staining, or leaching at this location.	PMB
7	Exposed steel, approx. 1/2" diameter, with minimal rust and staining at El. 138'. The area was cleaned and prime coated. See photo U3-029094.	PMB
