Corrosion of Titanium Grades 7 and 29 Under Dripping of Seepage Water

Xihua (Shē-wǎ) He
Center for Nuclear Waste Regulatory Analyses
Southwest Research Institute®
San Antonio, Texas

NACE 2012
Salt Lake City, Utah

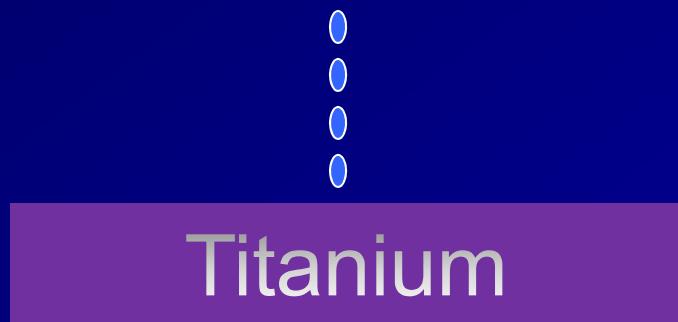
- Dripping tests were conducted to understand how the results may differ from tests conducted in the literature, which were performed under immersion conditions

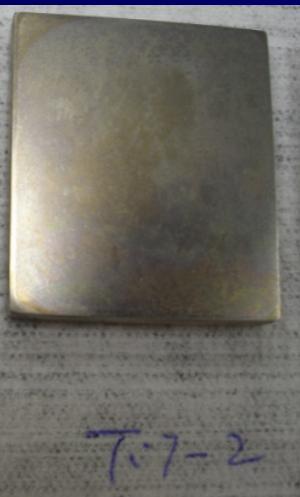
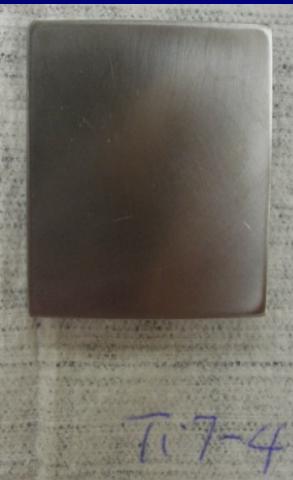
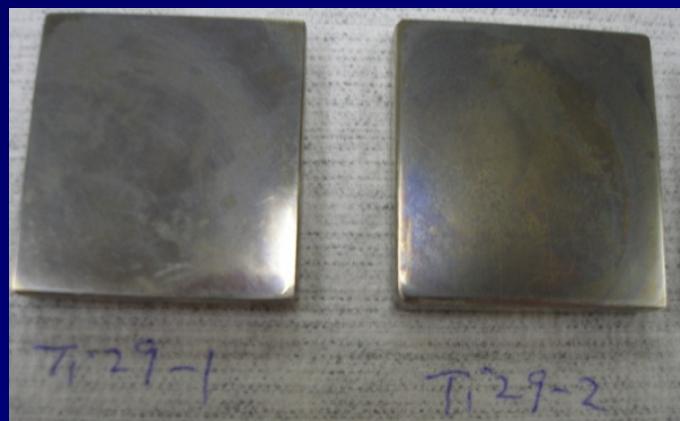
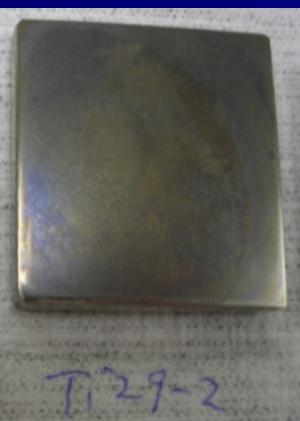
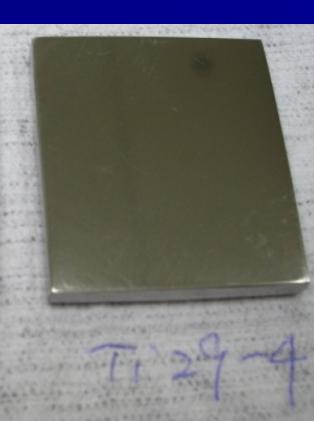
Optical Photos After 1st HCl Solution Cleaning

Note: The dimensions of the specimens are about 4 cm × 4 cm × 0.6 cm

- White deposits dissolved, but thick oxide still remained
- Weight analysis showed weight gain

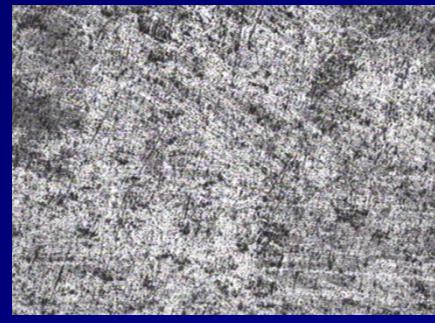
Optical Photos under Higher Magnification of 3rd HCl Cleaned Specimens

- More general corrosion at the front side subjected to dripping as evidenced by a smoother surface, compared to more evident polishing scratches at the back side

- The first batch of tests at 80 °C and 85% relative humidity for 181 days showed that
 - The corrosion rates of the specimens subjected to dripping ranged from 29–50 nm/yr, close to the upper bound of that reported in the literature under immersion condition
 - No statistically significant difference in corrosion rate and no differences in corrosion features observed between Titanium Grades 7 and 29
 - The front side, which was subjected to direct dripping, corroded more than the back side, which was not subjected to direct dripping

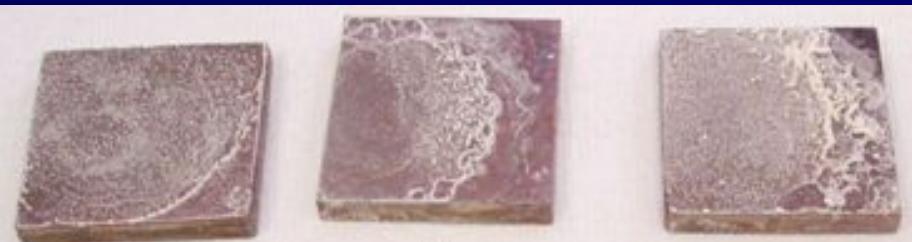
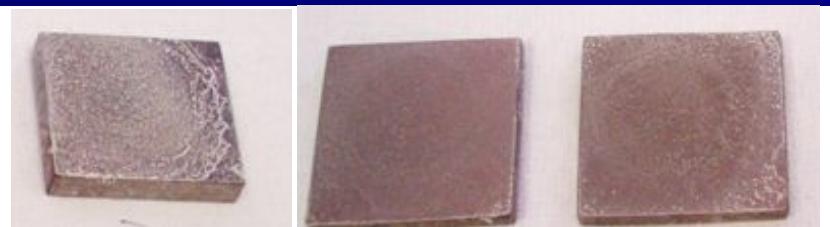
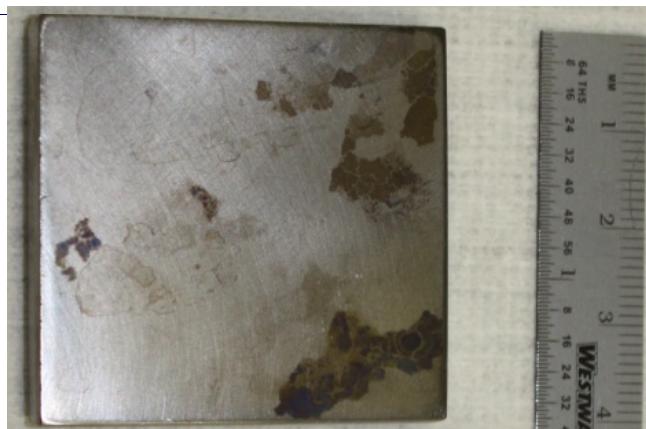
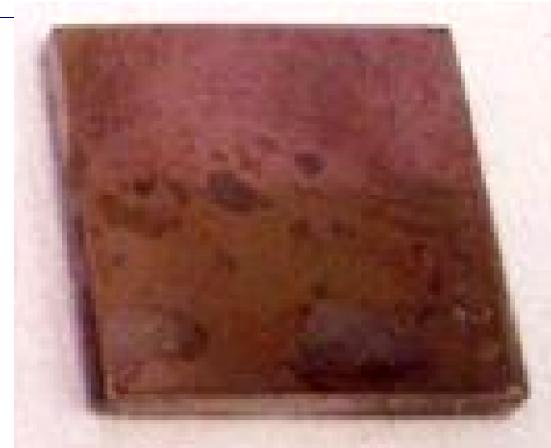
Second Batch of Posttest (a) Titanium Grade 7 and (b) Titanium Grade 29 Specimens at Temperature of 95 °C [203 °F] and Relative Humidity of 75 Percent

- Corrosion rates were higher than what was measured from the first batch of tests at 80 °C and 85% relative humidity
- Higher corrosion rates without dripping could suggest that dry oxidation without deposits from dripping water covering the surface could lead to higher corrosion rates

- The second batch of tests at 95 °C and 75% relative humidity for 64 days showed that the corrosion rates for Titanium Grades 7 and 29 under dripping were 130–370 nm/yr and 270–520 nm/yr, respectively
- No localized corrosion was observed on either material from the two batches of tests
