# Historical Site Assessment

## Buffalo Materials Research Center

**Revision 1**  
**May 31, 2011**

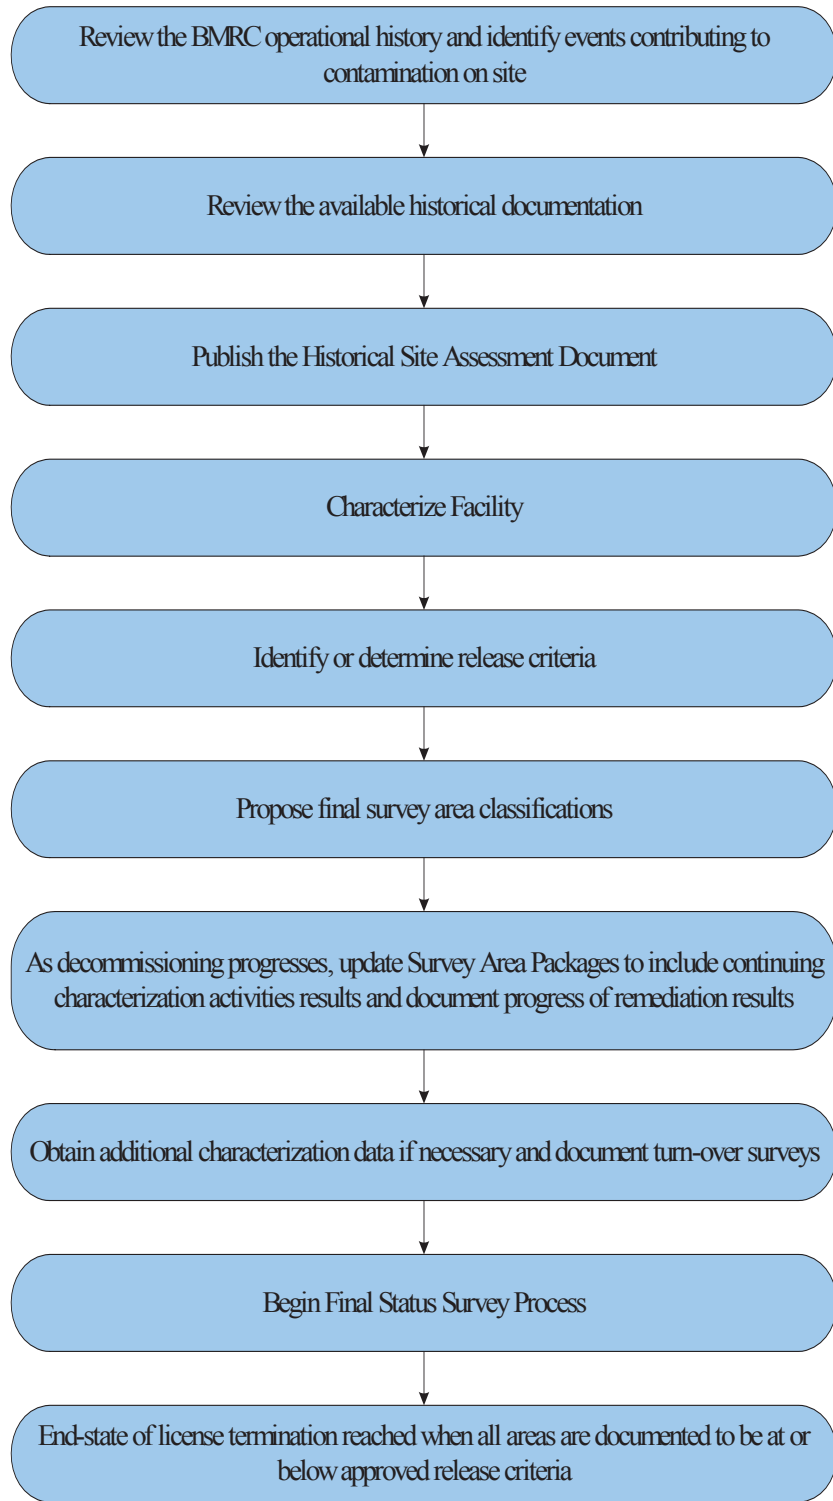
PROCESS FOR THE BMRC MARSSIM TERMINATION PROCESS

The general process for integrating the HSA with continuing characterization, Derived Concentration Guideline Level (DCGL) Development, and the FSS is shown in the flowchart on the following page. All processes, i.e., characterization, free release of items, and FSS, will be conducted using plans and procedures approved by the University.

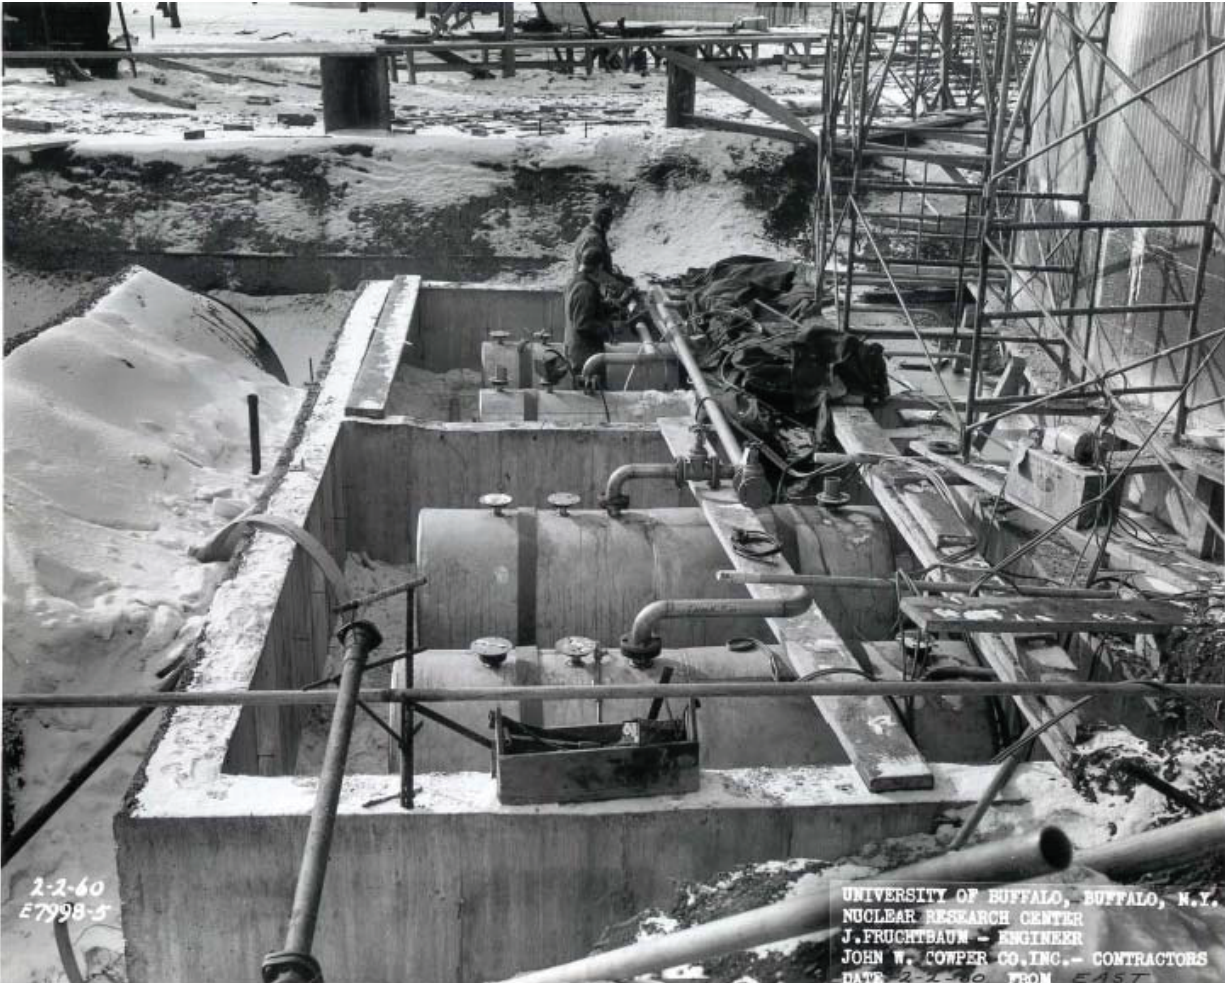
**Construction Photos from 1959 of the Tank Farm following installation of the 10K waste tank.**
