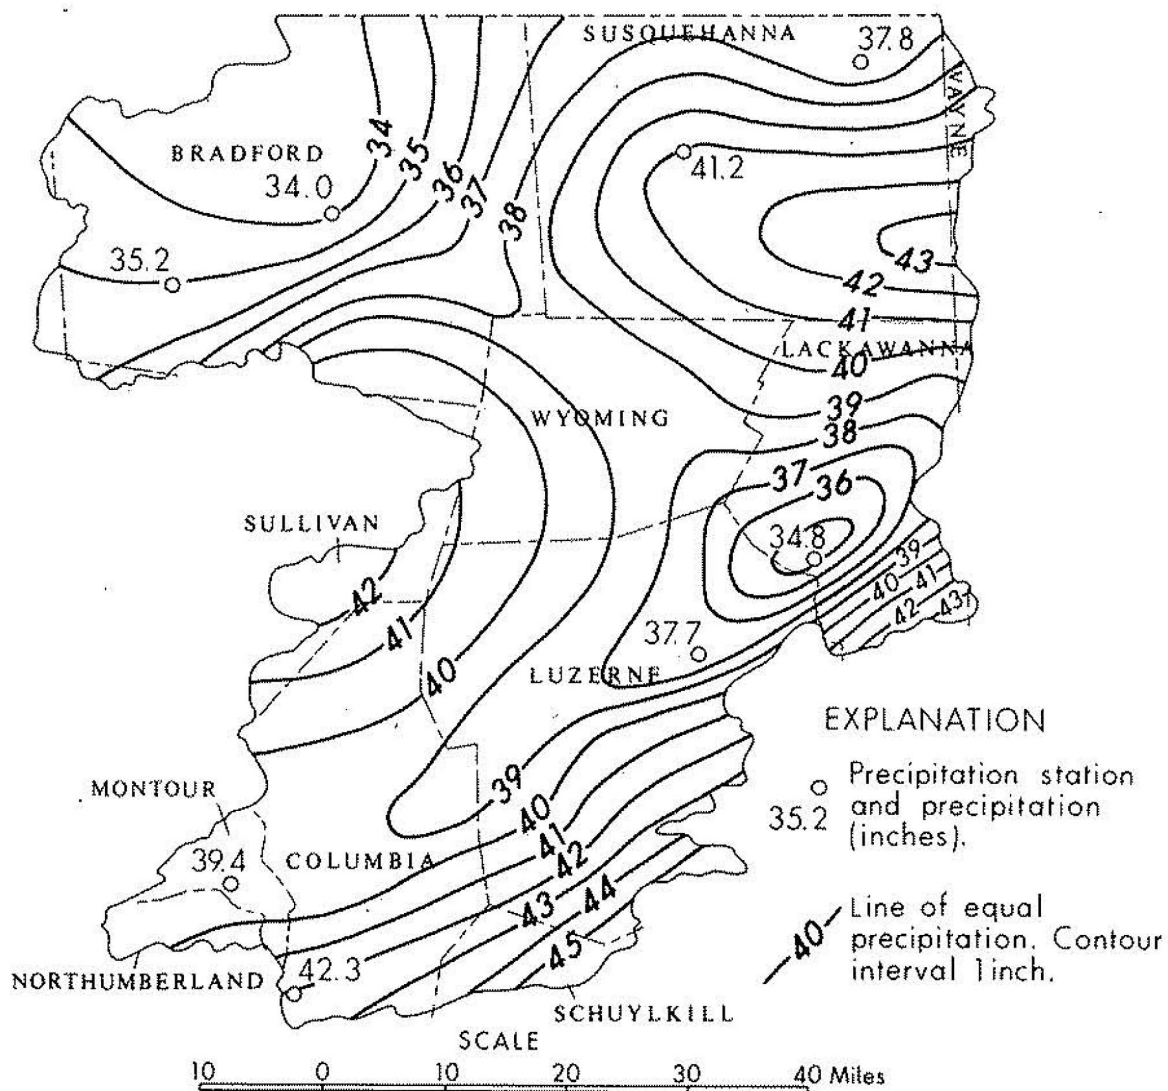
Figure 2.3-26— Average Annual Precipitation in the North Branch of the Susquehanna River Basin in Pennsylvania, 1941 - 1970

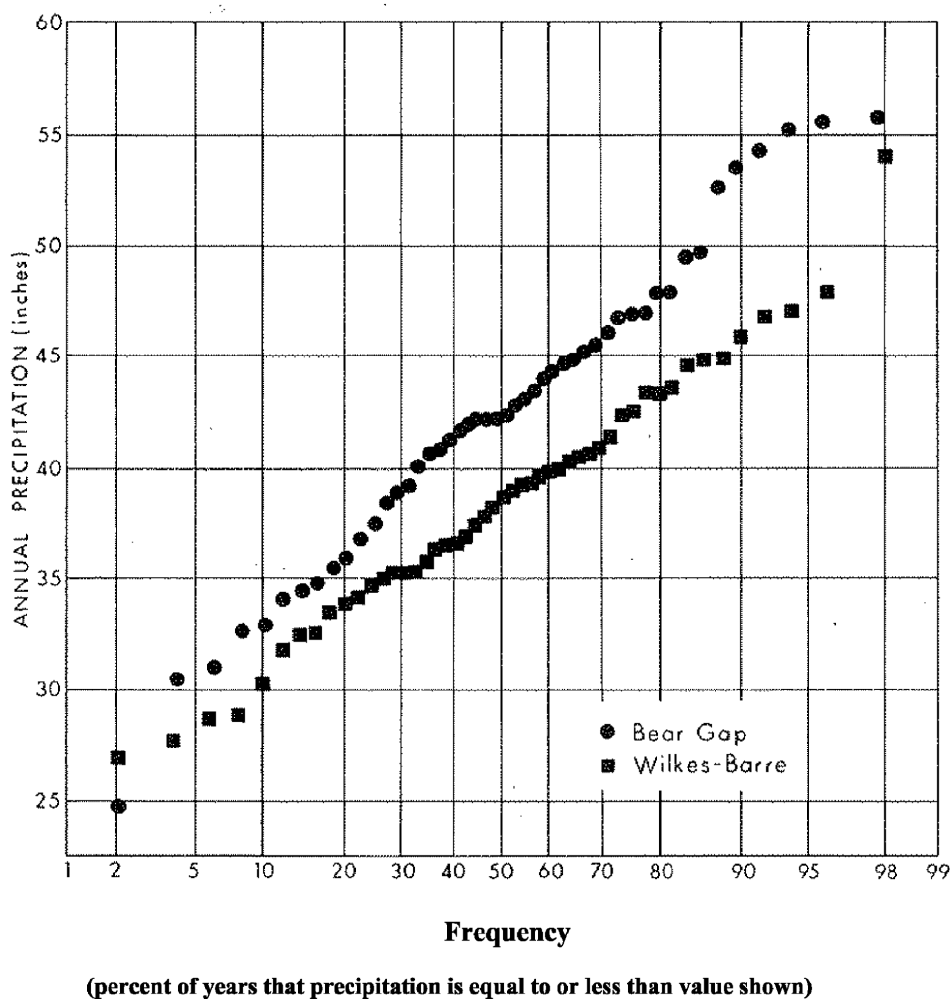
Figure 2.3-27— Percent Frequency Distribution of Annual Precipitation in the Southern Part of the North Branch Susquehanna River Basin, 1931 - 1980

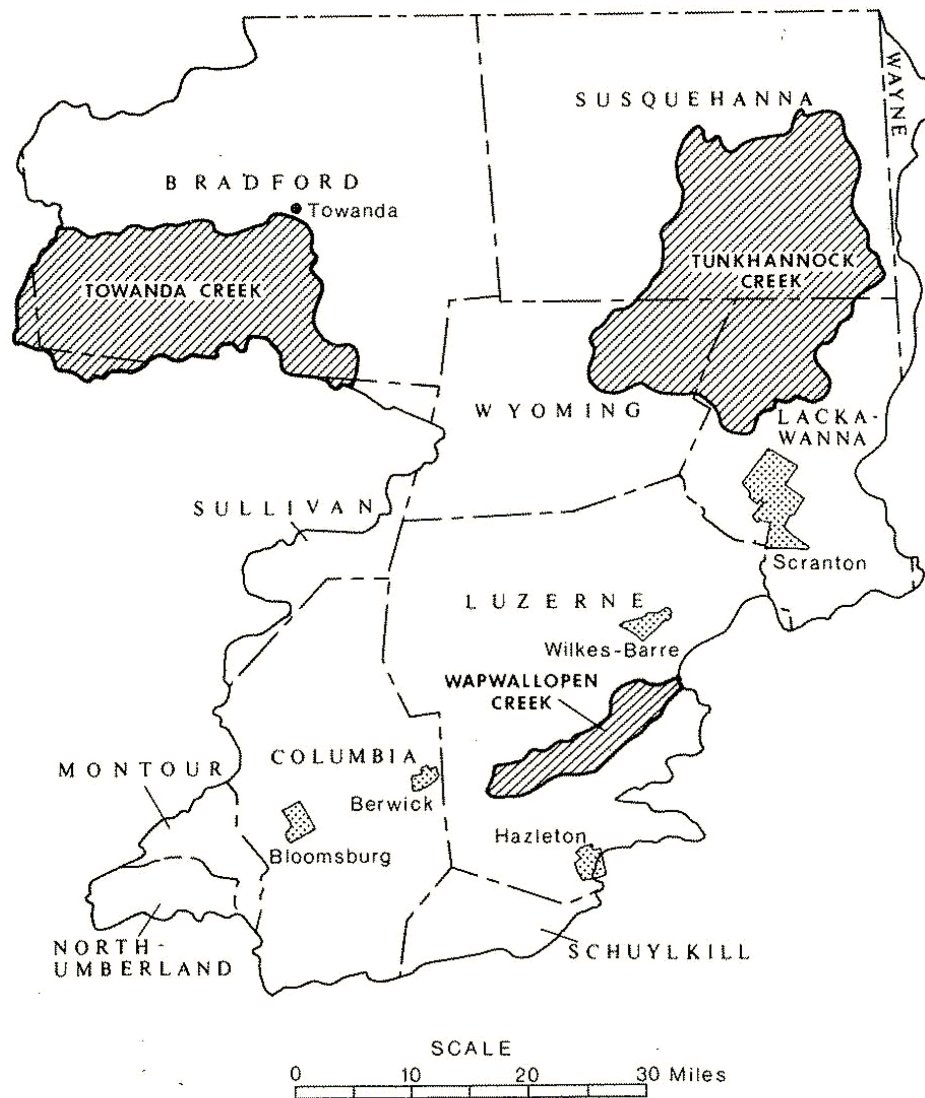
Figure 2.3-28— Locations of Drainage Basins Where Long-Term Water Budget Analyses Have Been Performed

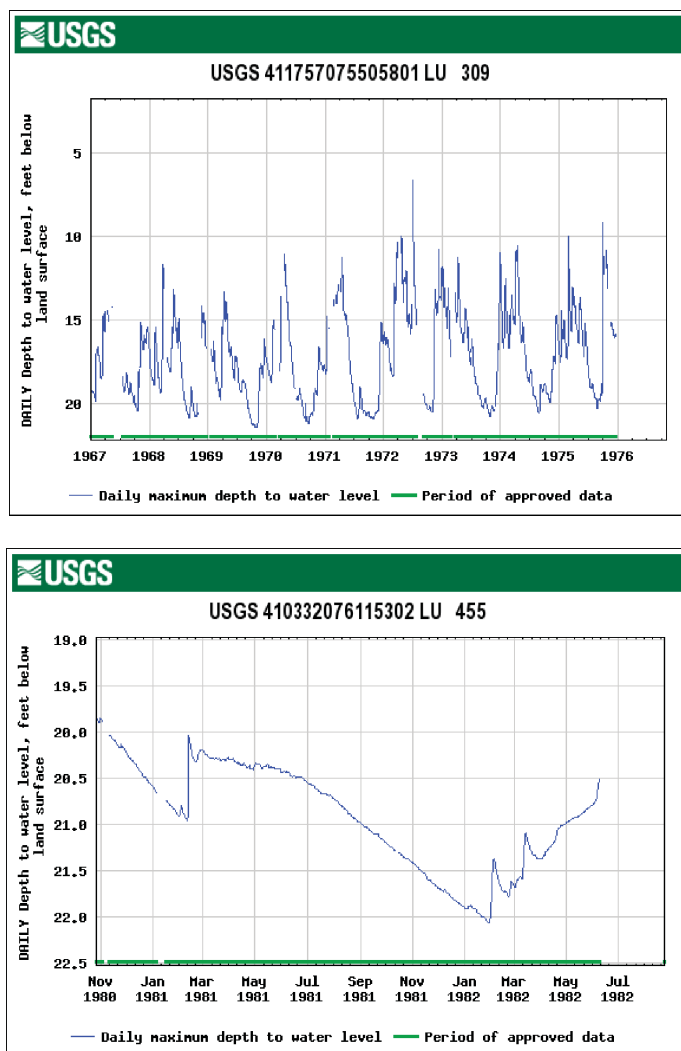
Figure 2.3-29— Hydrographs of Two USGS Monitoring Wells in Luzerne County Screened in Glacial Outwash

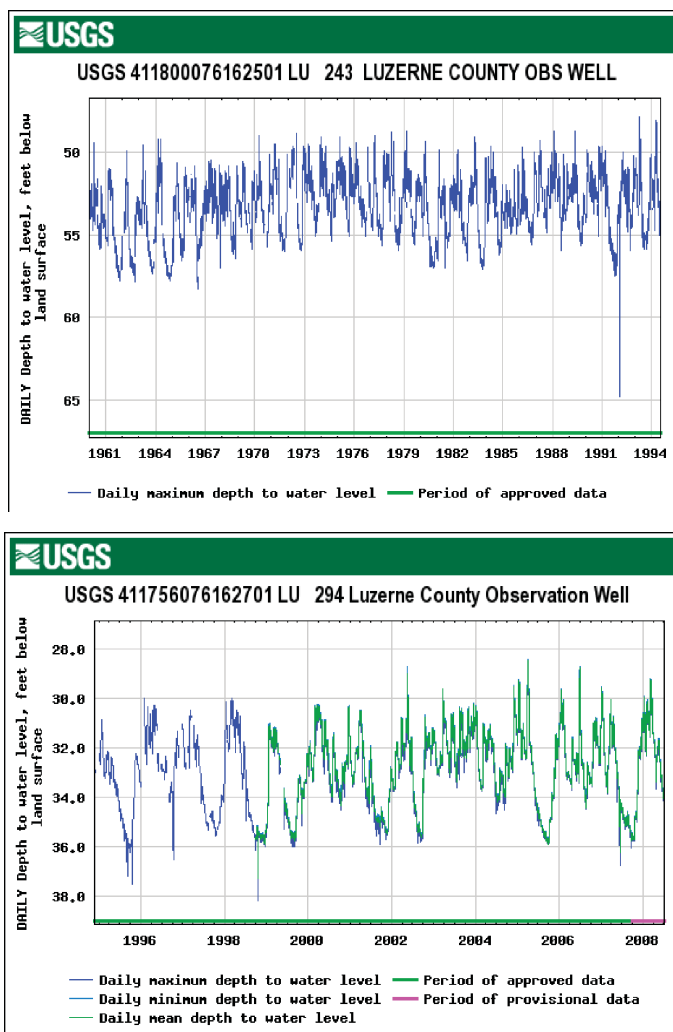
Figure 2.3-30— Hydrographs of Two USGS Monitoring Wells in Luzerne County Screened in the Catskill Formation

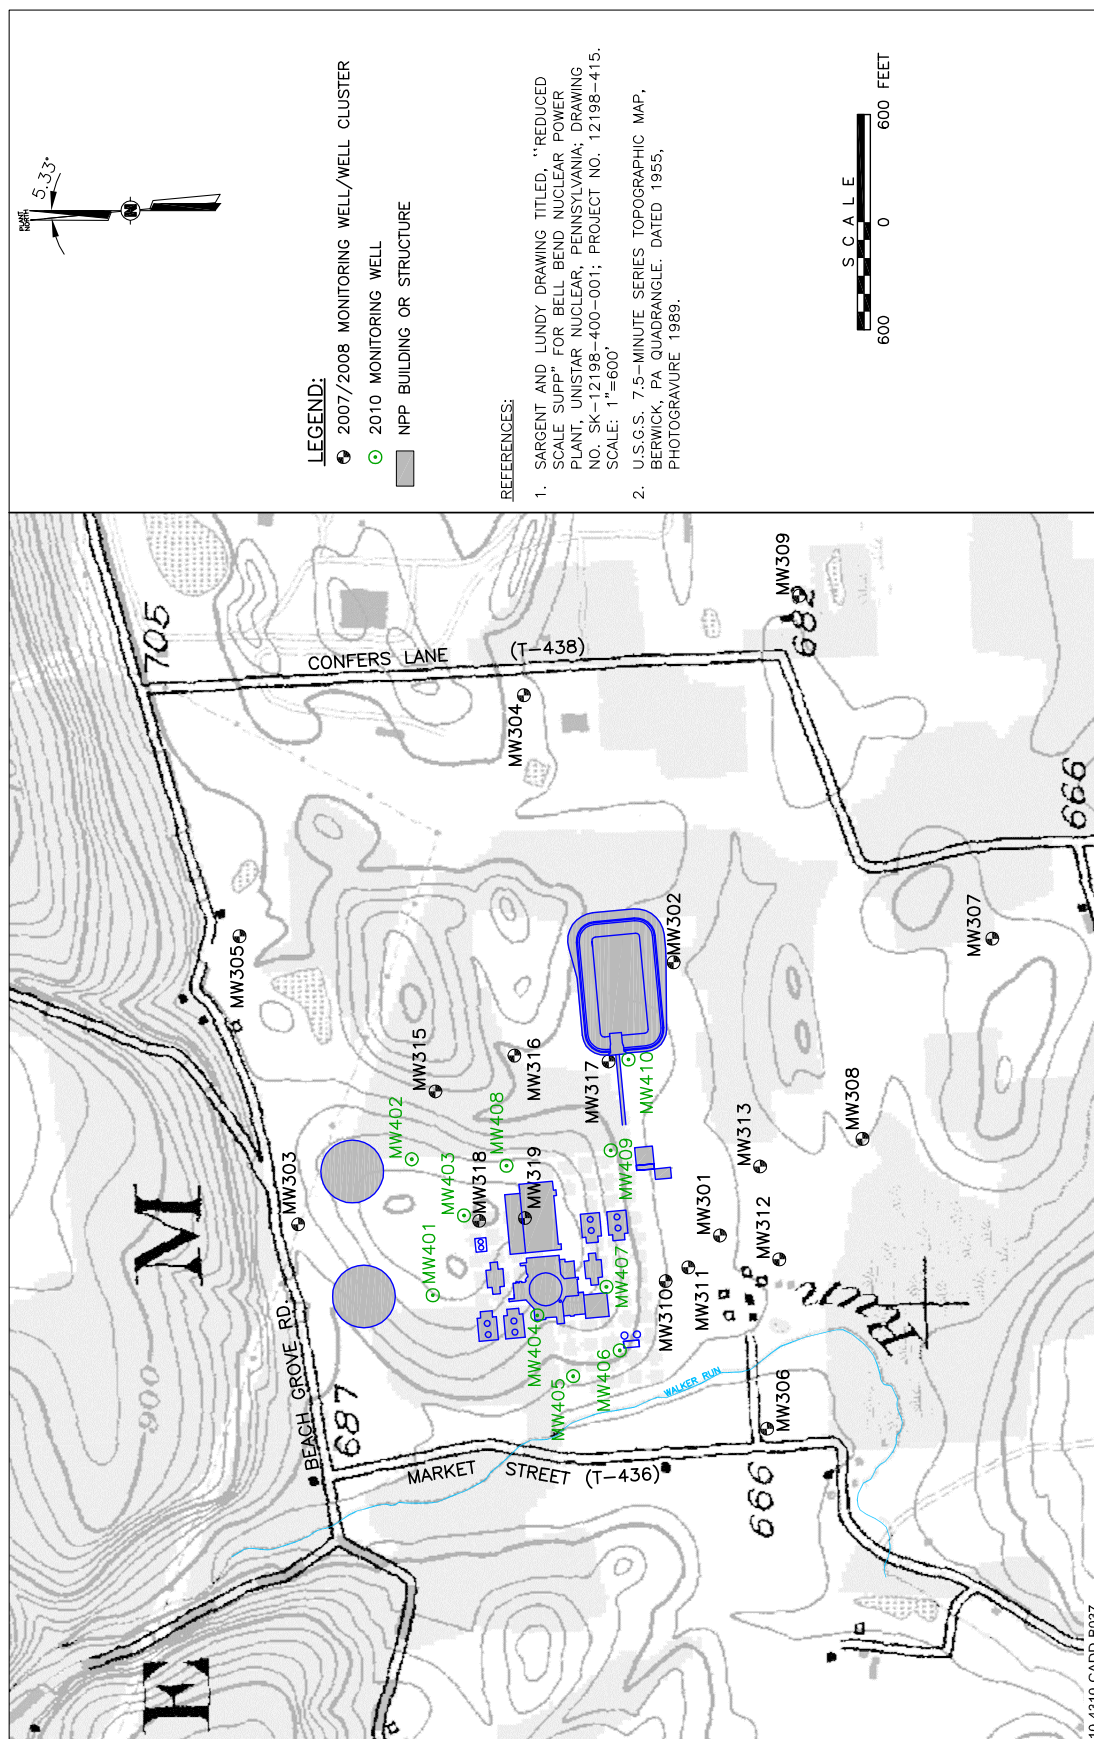
Figure 2.3-31 — Locations of Groundwater Monitoring Wells

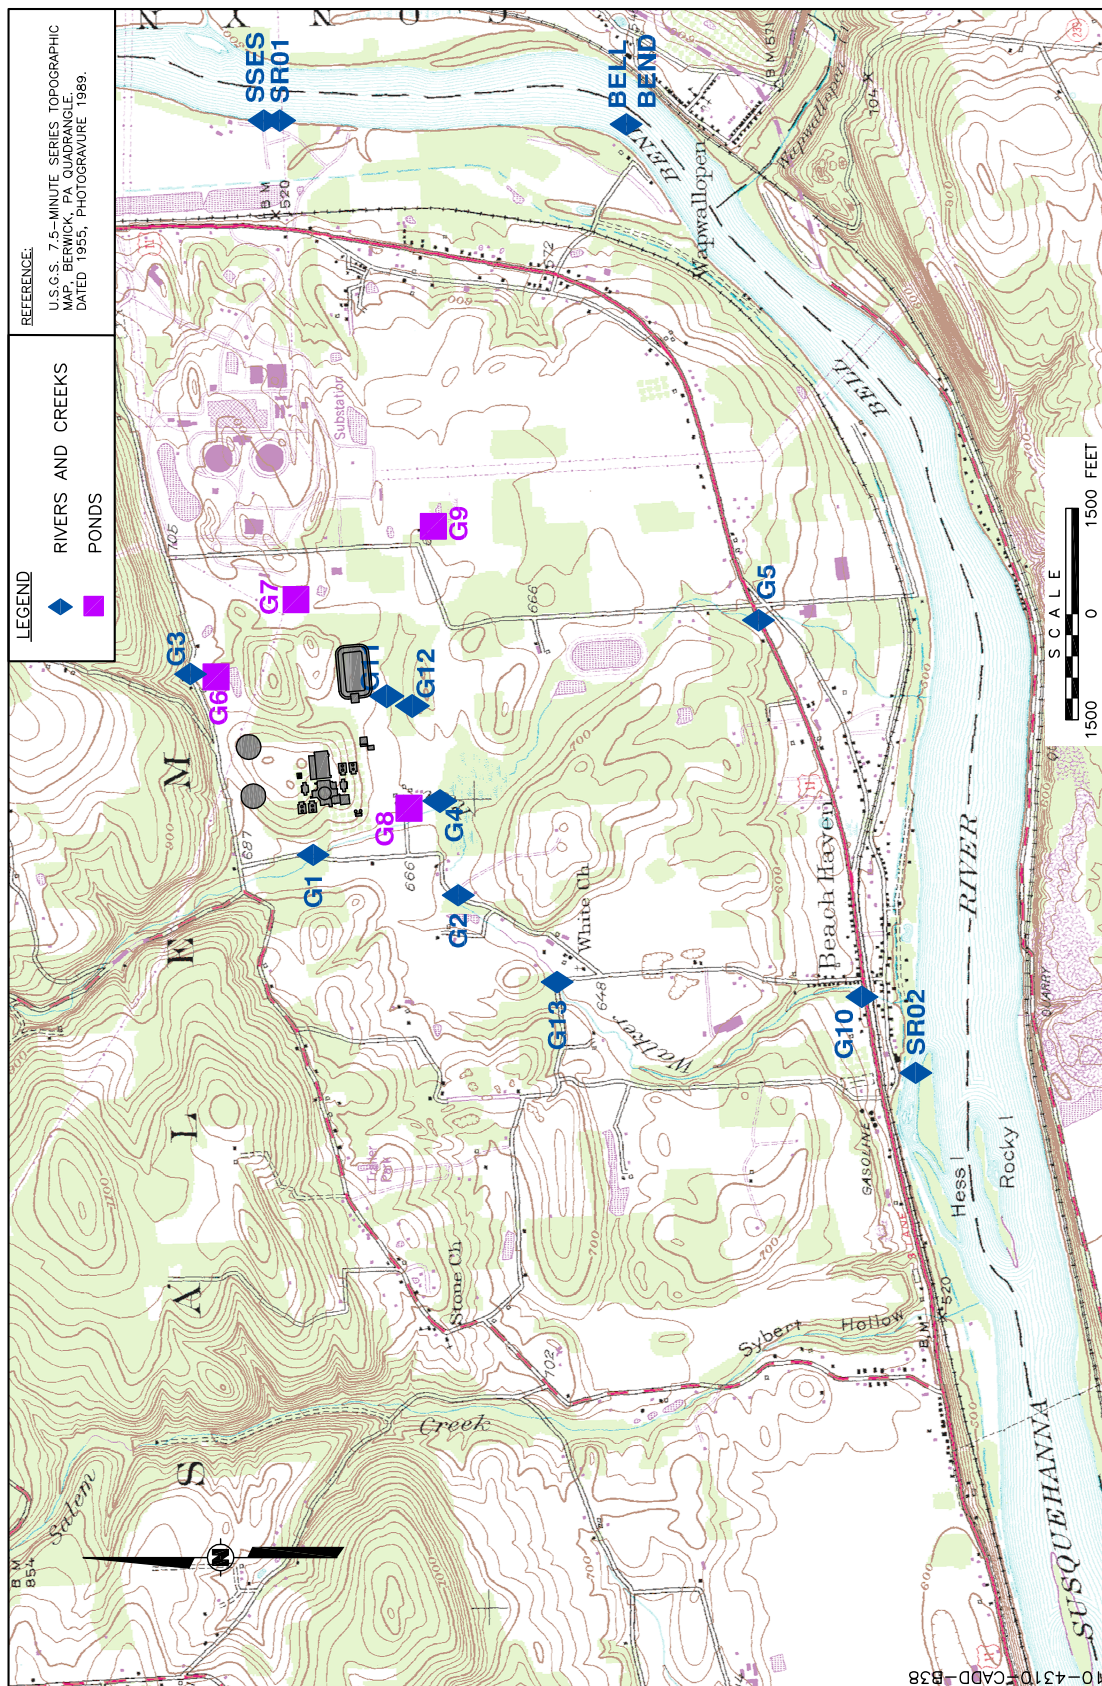
Figure 2.3-32— Locations of BBNPP Surface Water Monitoring Stations

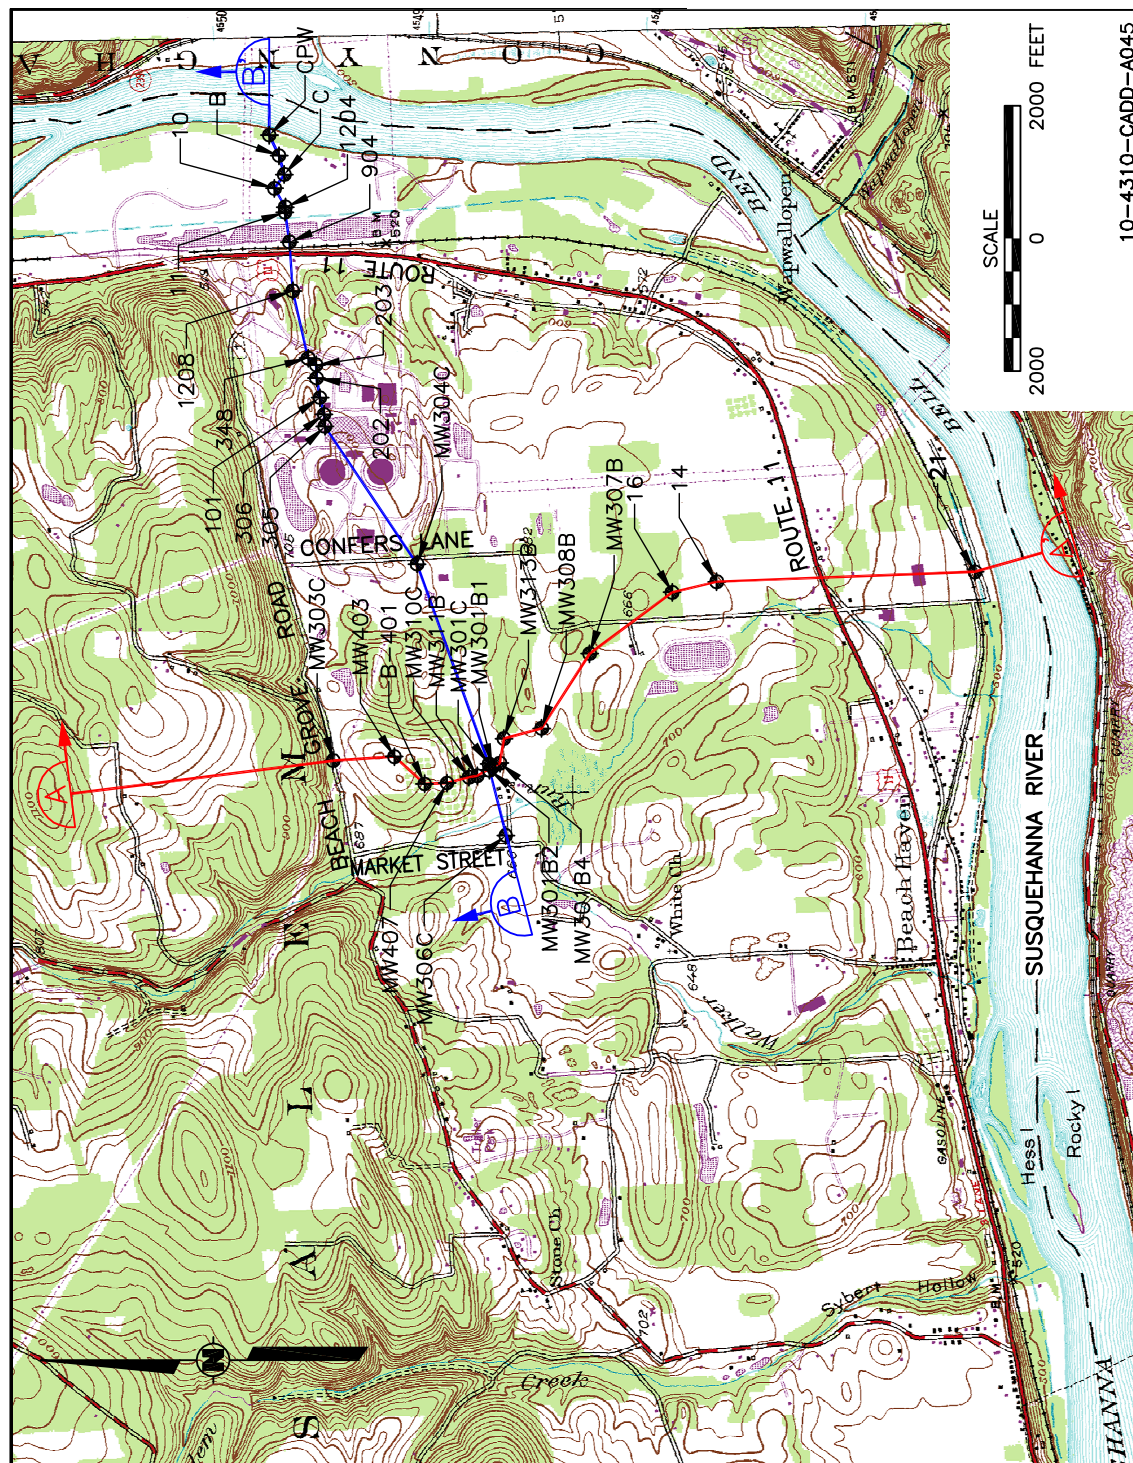
Figure 2.3-33— Locations of Hydrogeological Cross Sections

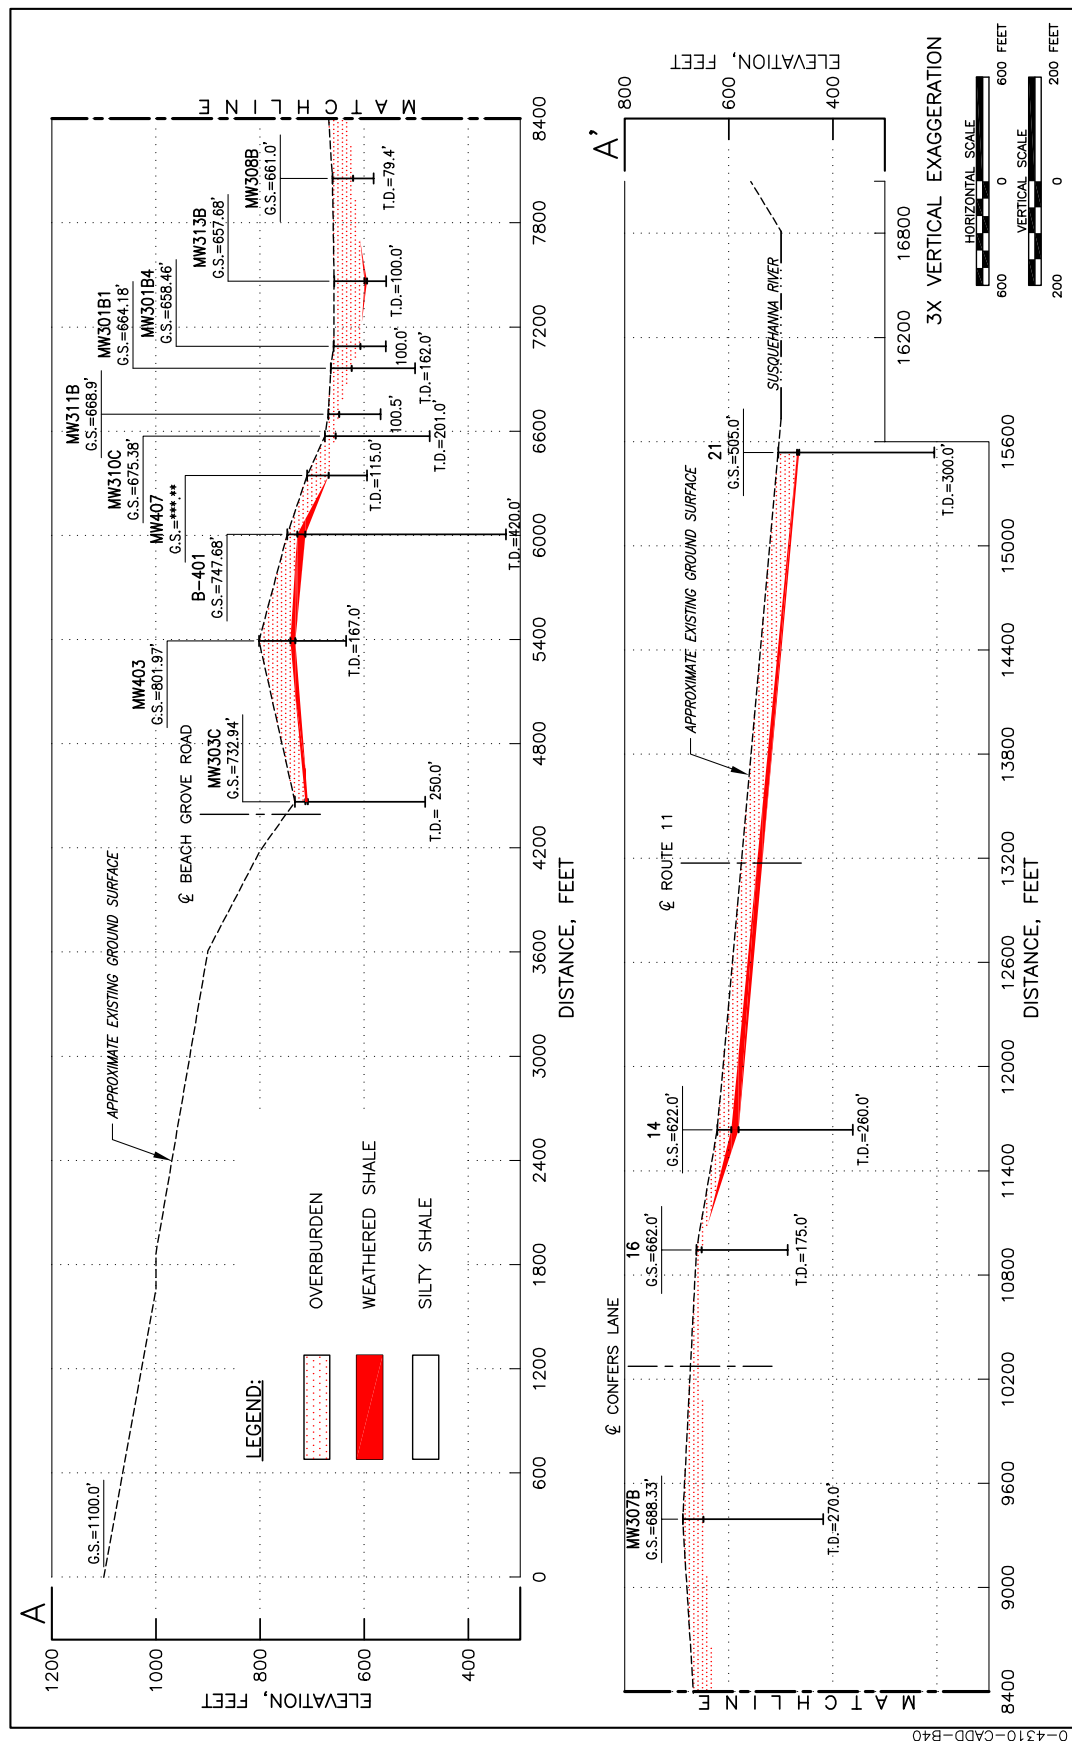
Figure 2.3-34—Hydrogeological Cross Section A-A'

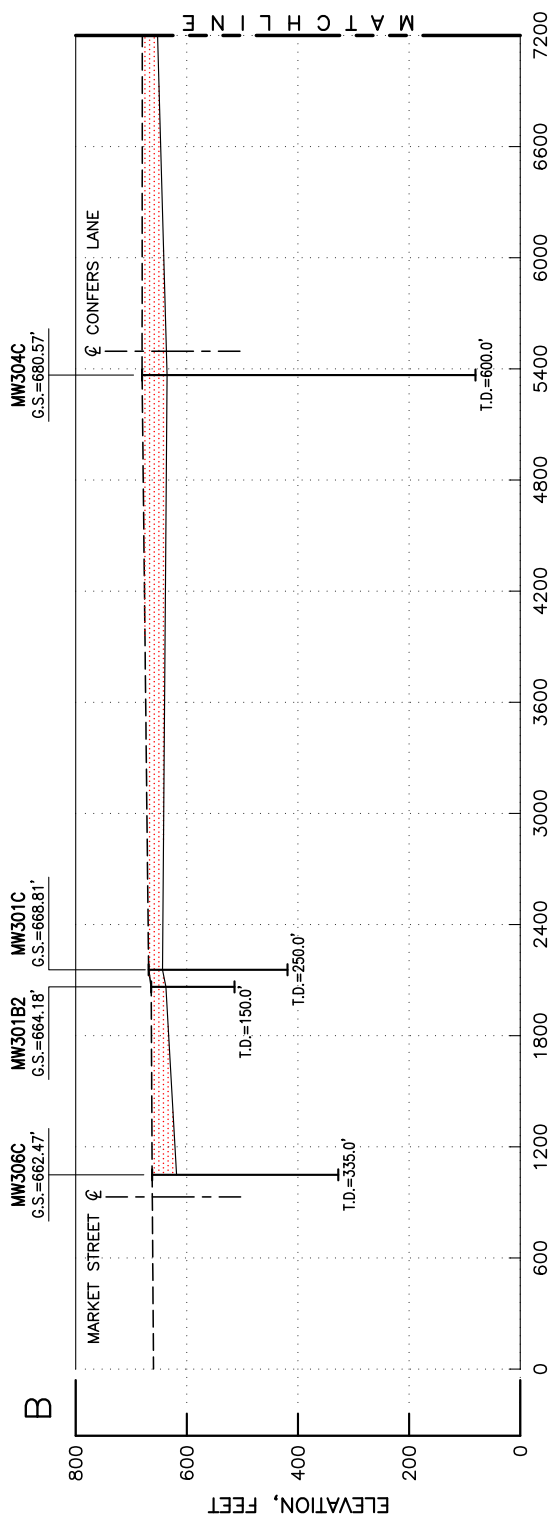
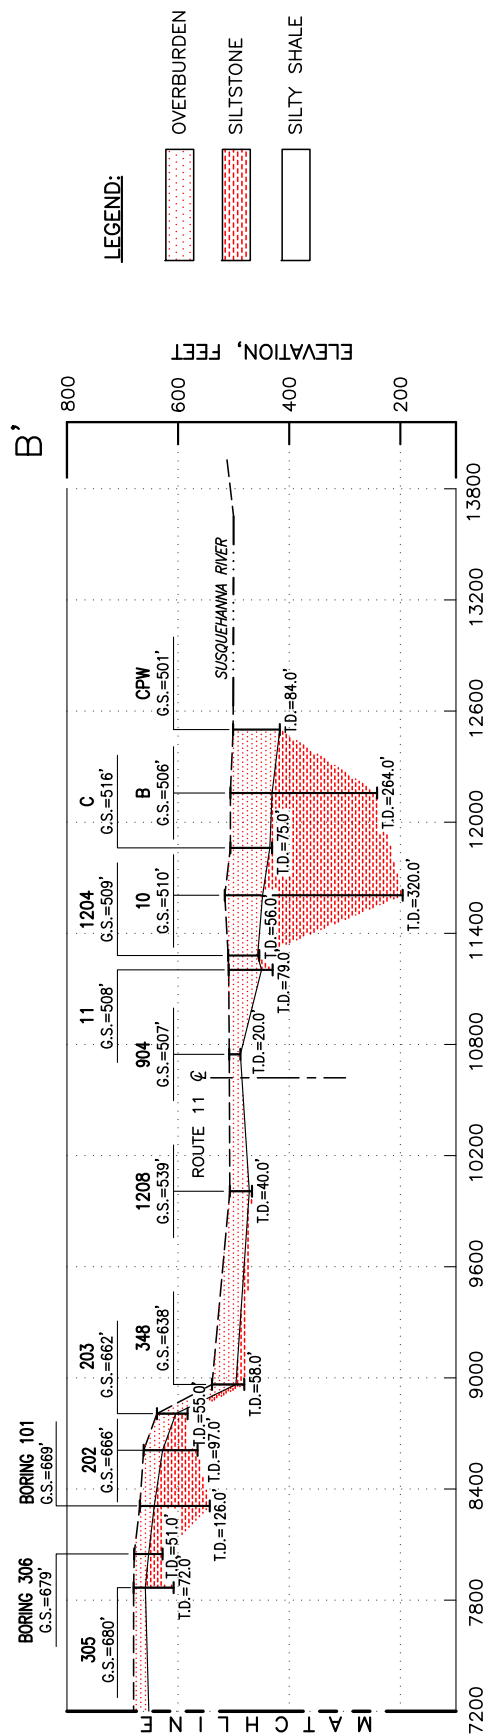
Figure 2.3-35— Hydrogeological Cross Section B-B'
