ANP-10320NP
Revision 0

Summary Report on Postirradiation Examinations of MOX Fuel

AREVA NP Inc.

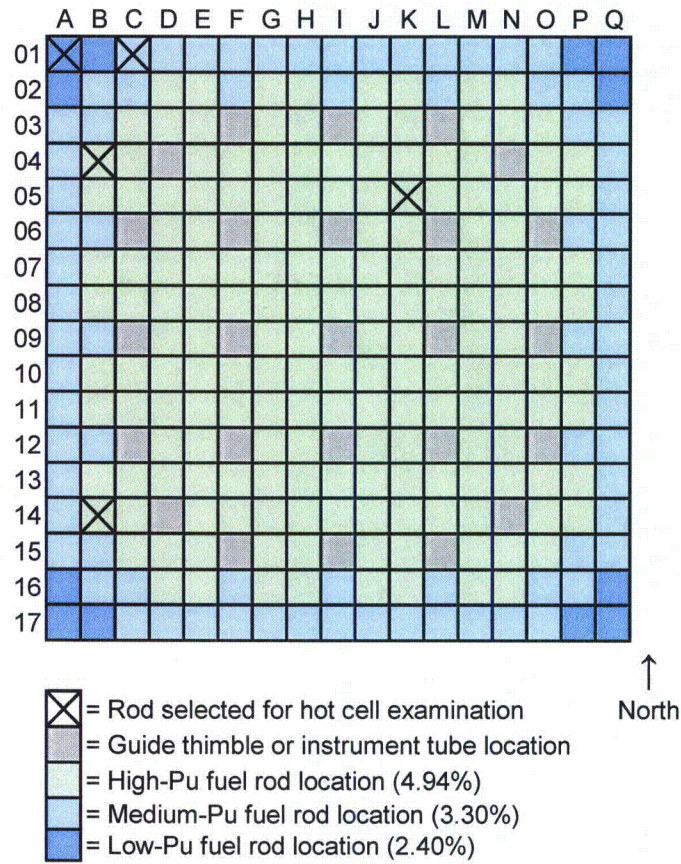
Figure 1-2—Locations of Rods Selected for Hot Cell Examination

At least four rods will be selected for hot cell examination. Rod selection will reflect the following considerations: (1) High-burnup rods are generally preferable. (2) The rods should be chosen from more than one assembly. (3) The rods should represent all three zones of plutonium content. (4) The rods should be chosen from various types of locations (e.g., corner, interior).
