**ACI 546R-04**

# Concrete Repair Guide

Reported by ACI Committee 546

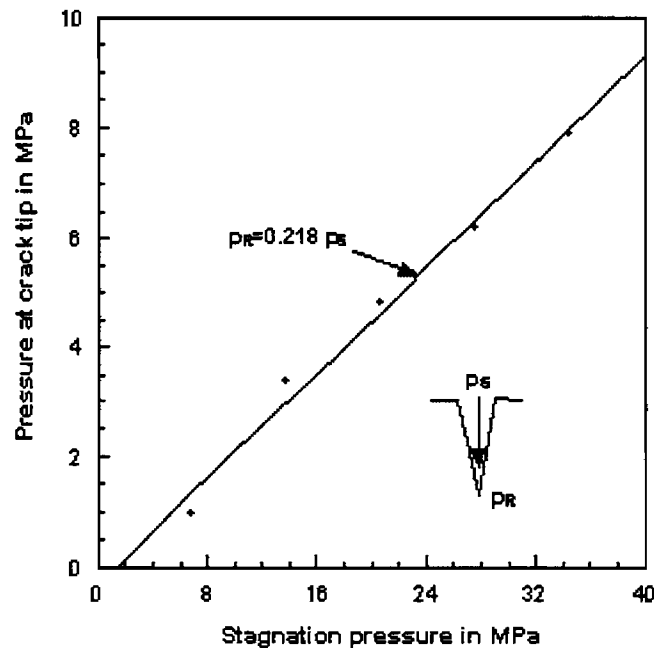
Figure 2.9 Water flow into a crack (Mazurkiewicz et al., 1986)

The constant was found to be  $C_1=0.22$  which corresponded closely to values estimated by Momber and Kovacevic (1995) who found  $0.19 < C_1 < 0.21$  based on an LEFM-model. Lin et al. (1996) used a finite element code to investigate the influence of the water jet velocity on principal stresses as well as stress intensity at the crack tip. Some of their results are shown in Fig. 2.10. The calculated points (filled circles) can be approximated by a square-root relationships which verifies Eq. (2.25). The open circles in Fig. 2.10 are experimental points estimated by Witzel (1998) on rocks. However, the calculated points in Fig. 2.10 can be approximated by an almost linear function in the range of low jet velocities up to 300 m/s. A

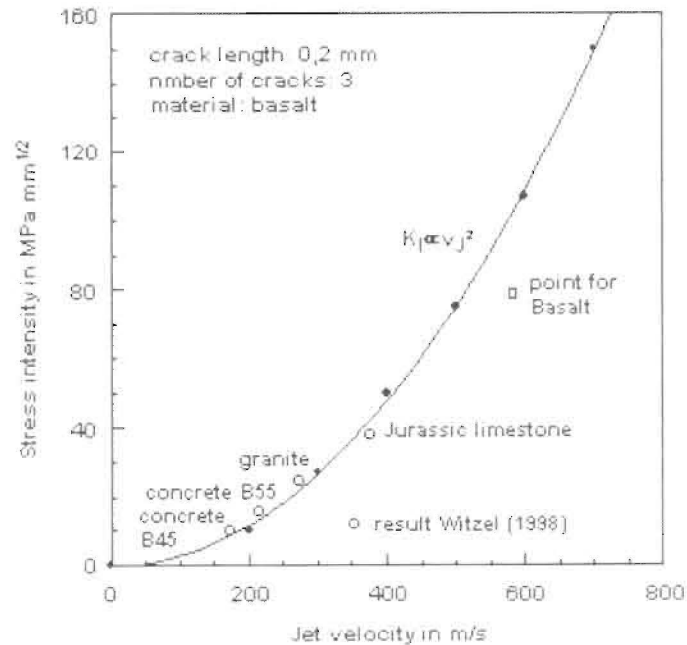
Figure 2.10 Relationship between jet velocity and stress intensity (Lin et al., 1996)

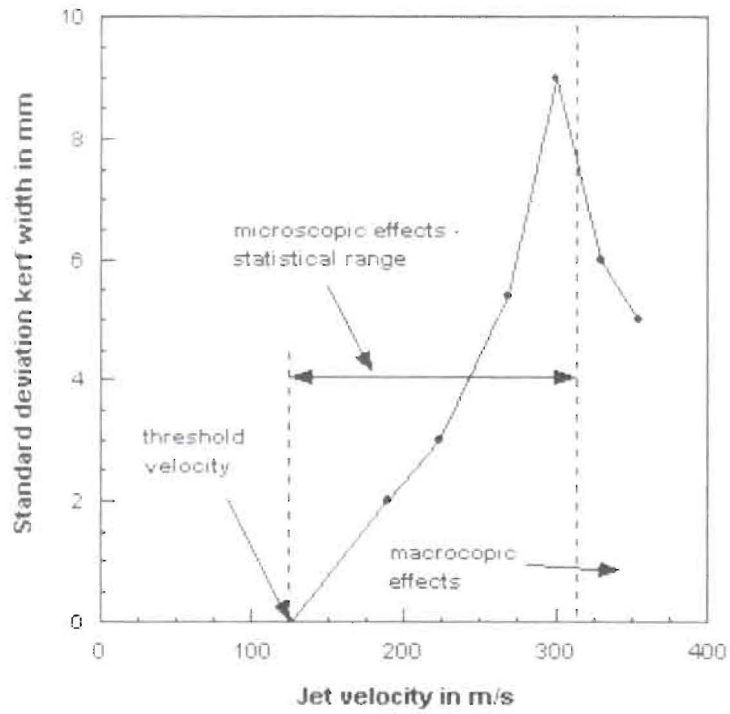
Figure 2.14 *Effect of jet velocity on kerf width variation in concrete (Momber and Kovacevic, 1995)*

tensile strength, whereas the transition exposure time followed a more complex relationship (Sugawara et al., 1998). Momber and Kovacevic (1995) have investigated the influence of jet velocity on the fracture statistics of concrete surfaces. The results illustrated in Fig. 2.14 show that the standard deviation of the kerf width started to drop at a certain jet velocity (at about 300 m/s). If this velocity was exceeded the failure process was more homogeneous. Effects due to the microstructure (e.g. microcrack distribution) were eliminated, and a macroscopic material property, let's say tensile strength, determined the material response. The average kerf width was always larger for a plain matrix material (cement matrix) than for a composite (mortar or concrete) due to the rather unrestrained fracture propagation in the matrix. This is illustrated in Fig. 2.15 showing the very smooth fracture face in a cement matrix. It may, however, be noted that the roughness of the surface increased as the fracture propagated (from top to bottom). Such effects are known from other brittle material as well (Hull, 1999; Schönert, 1972) and is considered to be a result of crack acceleration. If two concrete materials were compared, a water jet formed wider kerfs in the material with the coarser aggregates (Momber, 1998b; Werner, 1991a).

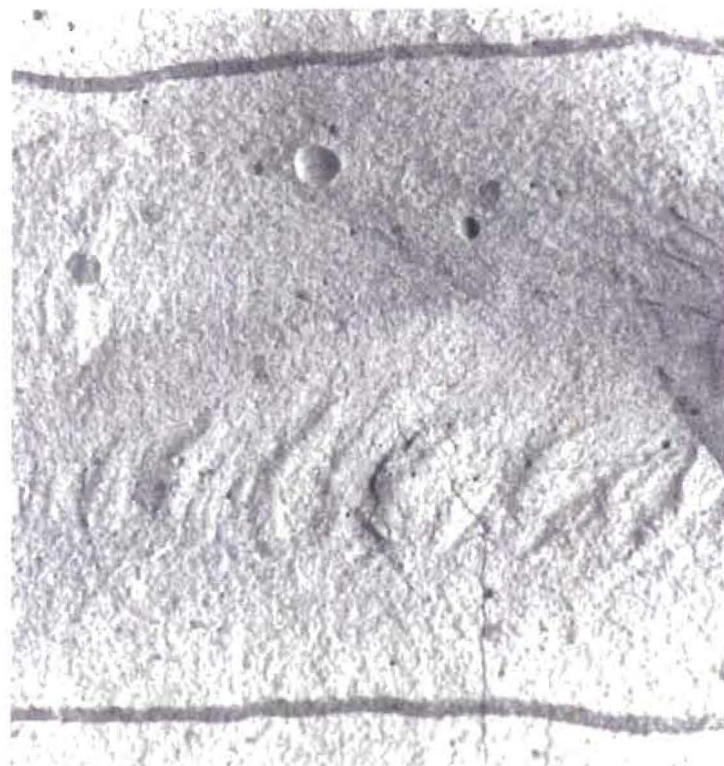
Figure 2.15 *Fracture surface of a cement sample cut with a high-speed water jet (Momber and Kovacevic, 1994)*

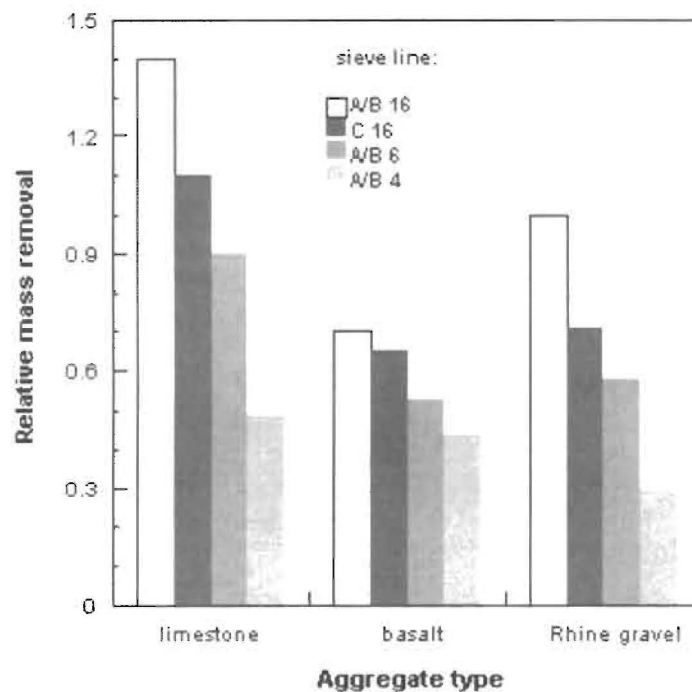
Figure 2.37 Effect of aggregate type on removal rate (Werner, 1991a)

line on the relative removal rate. Notably effects can be noted. The difference between maximum and minimum removal rate is about 470%. Removal rate is maximum for a limestone-based concrete under all circumstances, followed by the gravel-based concrete. The basalt-based concrete has the highest hydrodemolition resistance. It also seems that the effects of aggregate sort become more important for the coarser mixtures. The corresponding eroded surfaces are rather even and characterised by always broken aggregates in case of limestone, whereas they are very uneven and characterised by mainly (but not exclusively) broken aggregates in case of basalt. In case of river gravel the amount of broken aggregate was less than 30% (Werner, 1991a). Numerous aspects cause the different behaviours of the materials, among them morphology and surface energy of the aggregates and the compositions and properties of the aggregate-matrix interfaces.

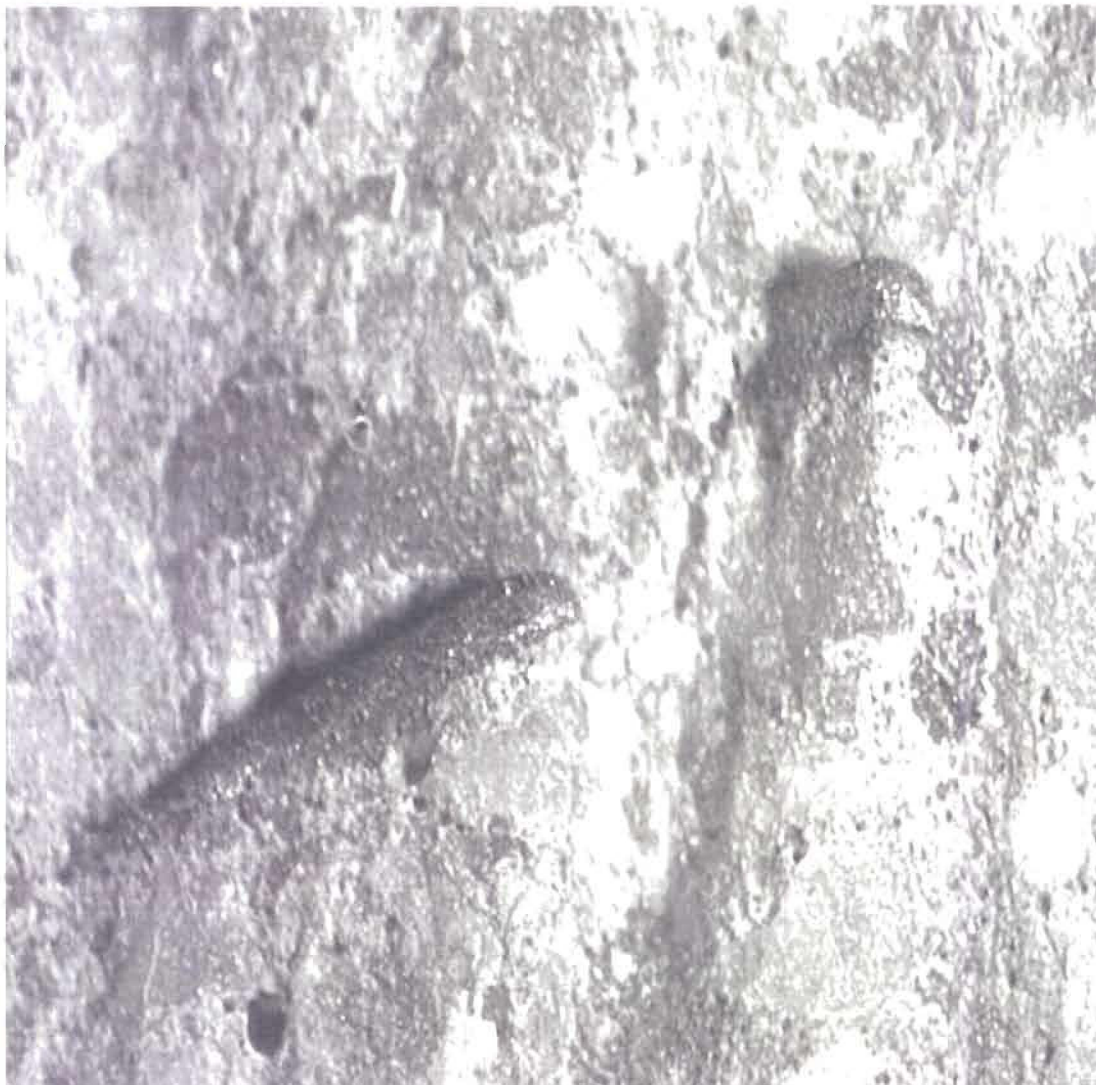
*Figure 2.41 Shadow zones, formed behind reinforcement fibres during water jet erosion (Hu et al., 2004)*

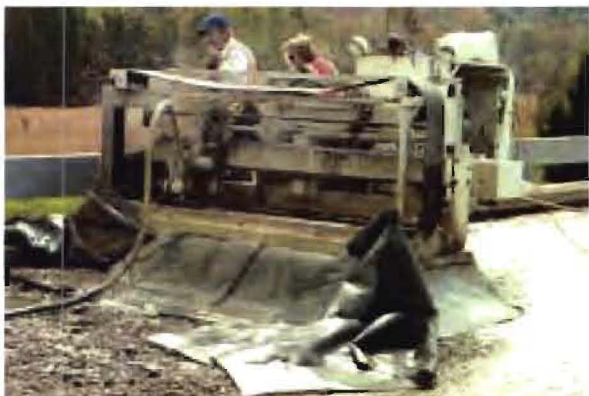
Figure 1: Hydro machine in action. (Note the rubble in front, compared to the milled deck behind.)

the hydroblast machine over the whole bridge, 5,800 square feet, or \$ 2.06/sf. This price included vacuuming up the debris and dumped on site. MoDOT maintenance forces were used to haul the rubble away. MoDOT also had to set up straw bail dams to catch the solids in the water before it was allowed to enter the roadway ditch. The effluent was checked by MoDOT to supply information on turbidity to the Missouri Department of Natural Resources to make sure it passed clean water standards.

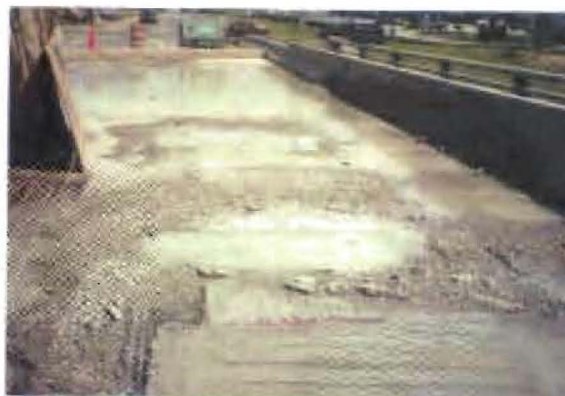
Figure 2: Note the straw bails covered with burlap at the end of the bridge to filter waste water.

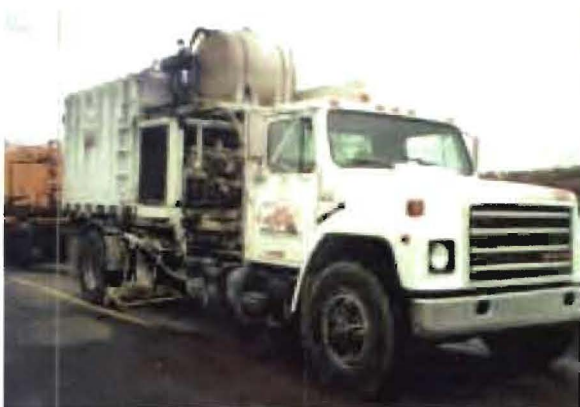
Figure 3: Heavy, self contained vacuum truck . Note: vacuum nozzle located in front of the rear wheel works very well to pick up debris.

The biggest concern from this first project was about the vacuum truck backing onto the rebar mat and bending it down where concrete was removed below the top mat. The heavy truck (Figure 3) worked all right here. However, if a lot of reinforcing steel is showing, plywood would need to be placed under the truck tires to distribute the load better. Alternately, a hand guided vacuum, or one with a boom (Figure 4), which didn't have to travel over the rebar could be substituted for the truck.

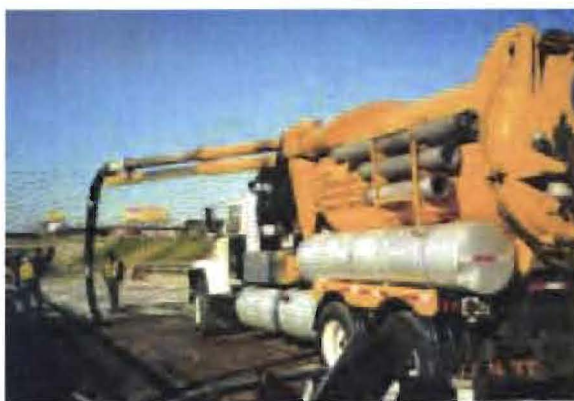
Figure 4: Vacuum truck with hose on boom; can stay off rebar mat but is slower picking up debris.

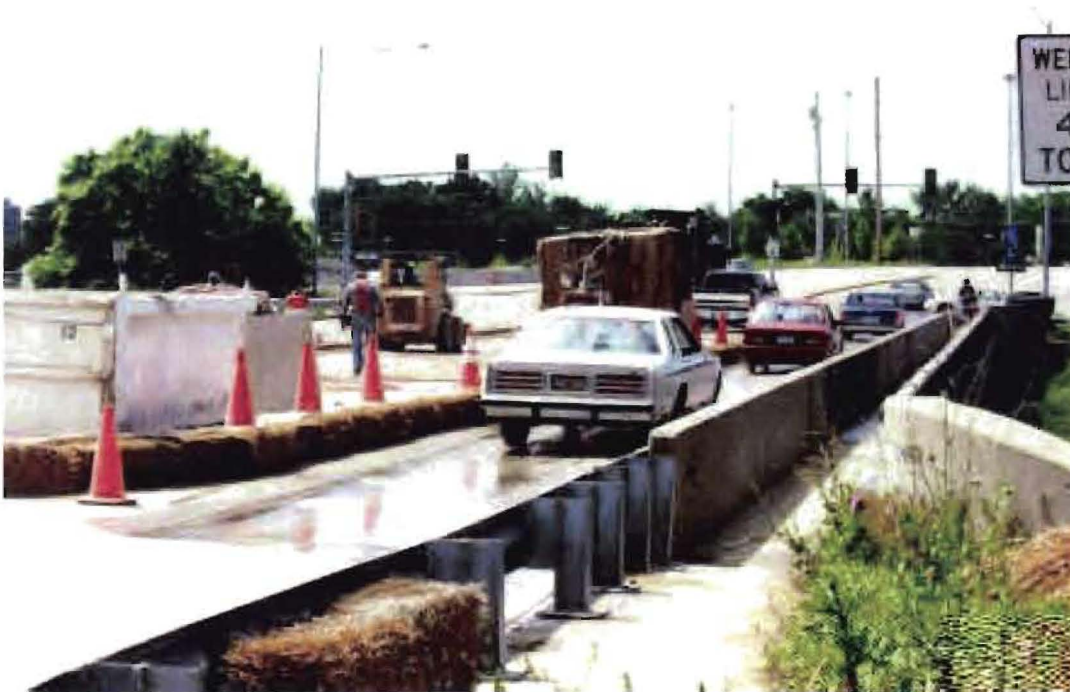
Figure 5: Shows traffic control and containment of blast water while hydroblasting for patches in two center lanes of a four lane bridge.

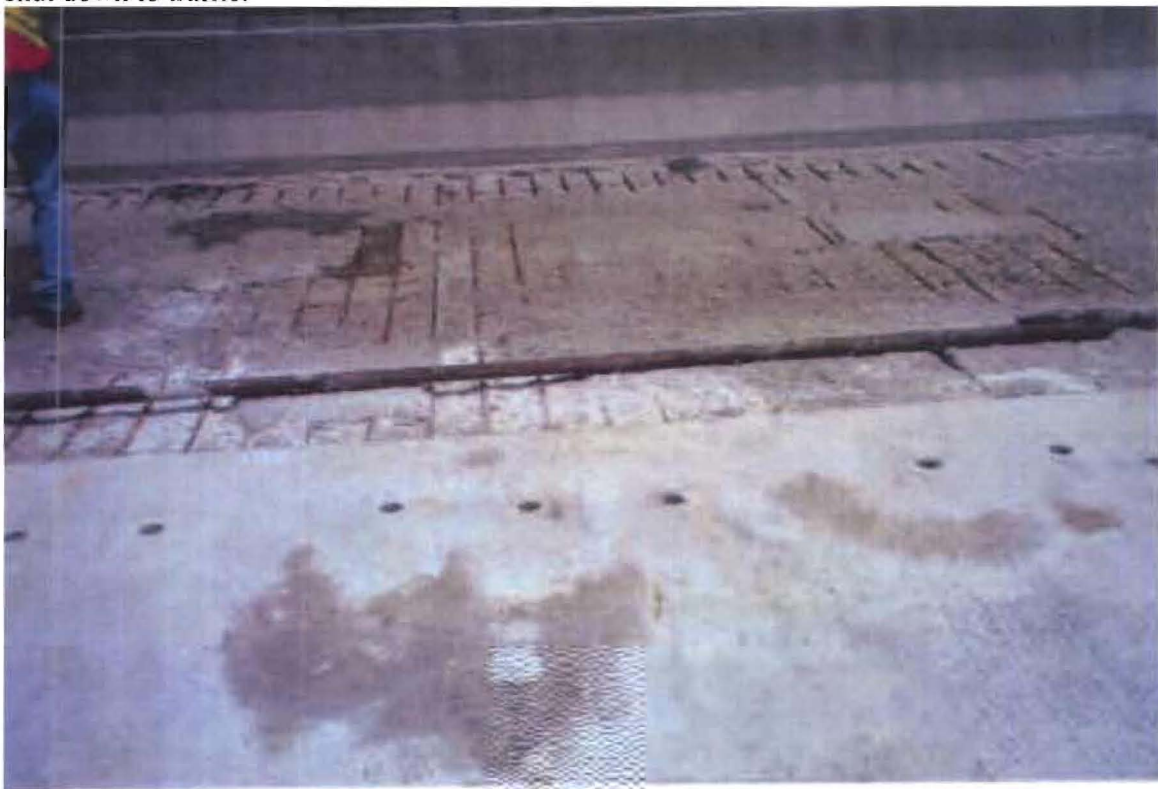
Figure 6: Finished hydrodemolition of half (background) of Bridge A0174 E. In the foreground, new latex modified concrete overlay. Note: 2" core holes in the overlay are where pull-off tests for direct tension were taken.

Because of staged construction, this project required two mobilizations of the hydrodemolition equipment. The westbound bridge was closed to traffic in 1998. The whole deck of the westbound structure, 7,100 sf., was completed. The hydrodemolition contractor returned in early 1999 to do the 7,100 sf. of the eastbound bridge (Figure 6). Even though two trips were required, it is believed the bid was lower than expected due to being able to hydroblast a fairly large amount of surface each trip. Also, no traffic control was needed since the bridges were shut down to traffic.

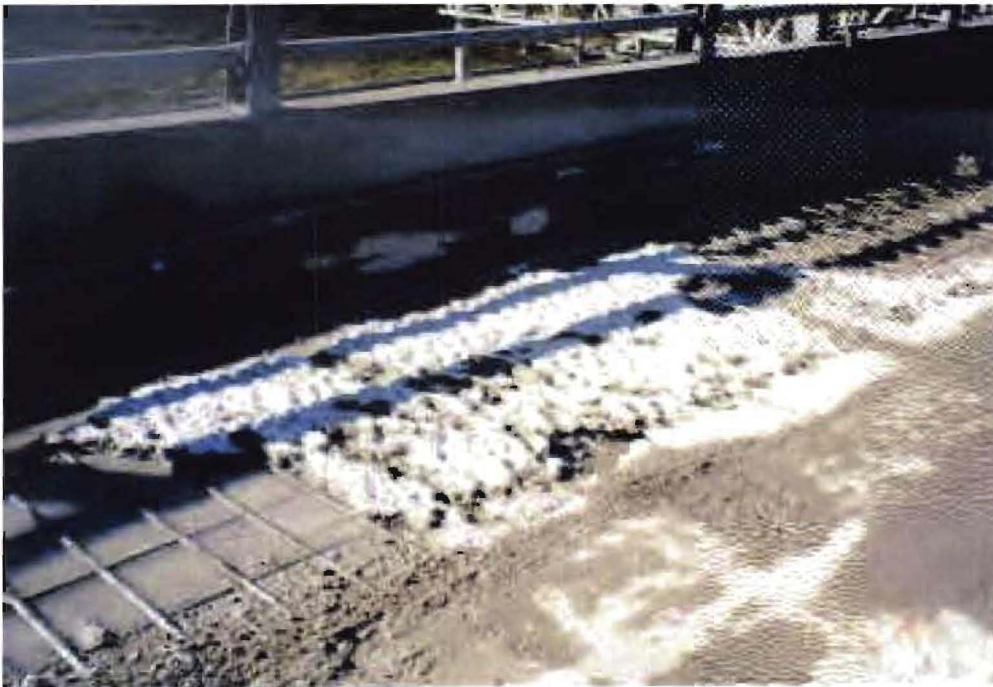
Figure 7: Poor concrete and a thin 6 1/2" upper deck made it necessary to do hydrodemolition at 13,000 psi . This is after the first pass (Note how clean the re-steel is in the foreground on the left). A second pass with the hydro-blaster was necessary to remove the island of unsound concrete left over the rebar in the center of the photo.

Bridge A-185R Ramp on Route I-70, St. Louis City was shut down due to construction in the area. MoDOT maintenance forces took this opportunity to again use hydrodemolition work to repair this bridge deck. A maintenance contract was let for hydrodemolition. The cost was \$29.09/sy (\$ 3.23/sf) which compared well with the only construction project MoDOT had let with hydrodemolition, discussed above, which bid at \$ 31.50/sy (\$ 3.50/sf ). Poor concrete and a thin 6 1/2" upper deck on this type box girder bridge made it necessary to make two passes with the hydrodemolition machine set at 13,000 psi. (see Figure 7) One pass at the normal setting of 17,000 – 18,000 psi would have blown through the poor quality concrete. Hydrodemolition makes it easier to regulate than conventional methods with regards to how much concrete is removed when it's necessary to patch and keep open a badly deteriorated deck.

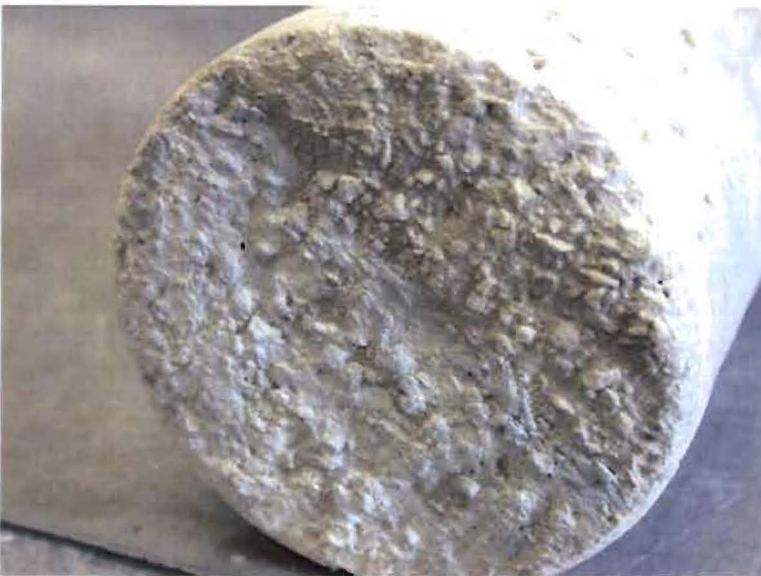
*Figure 2. Exposed end of Core F2, showing sand particles elevated slightly in relief above the coating. The gray and tan portions of the surface are readily apparent.*

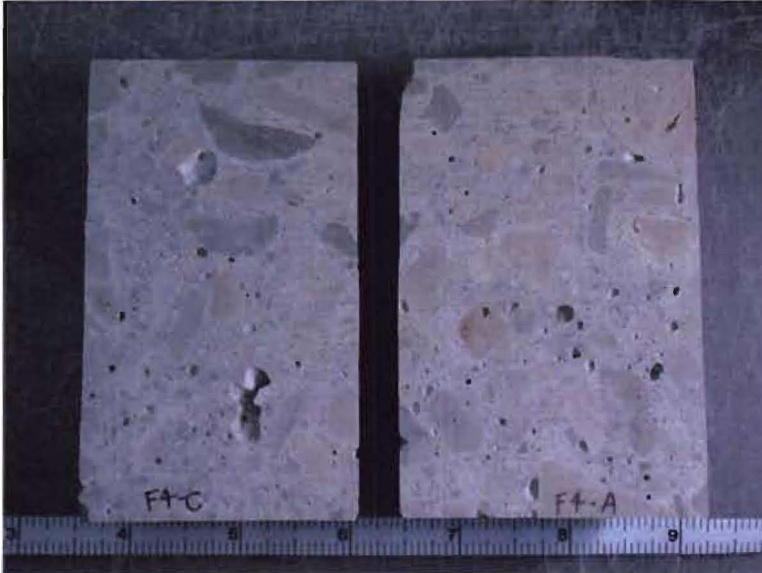
Figure 5. Lapped cross-sections of Core F4 that were analyzed by point-count analysis. The bottom approximate half of the concrete shows significant amounts of entrapped voids, including one larger unconsolidated void in the specimen on the left, while the upper halves show less air voids.

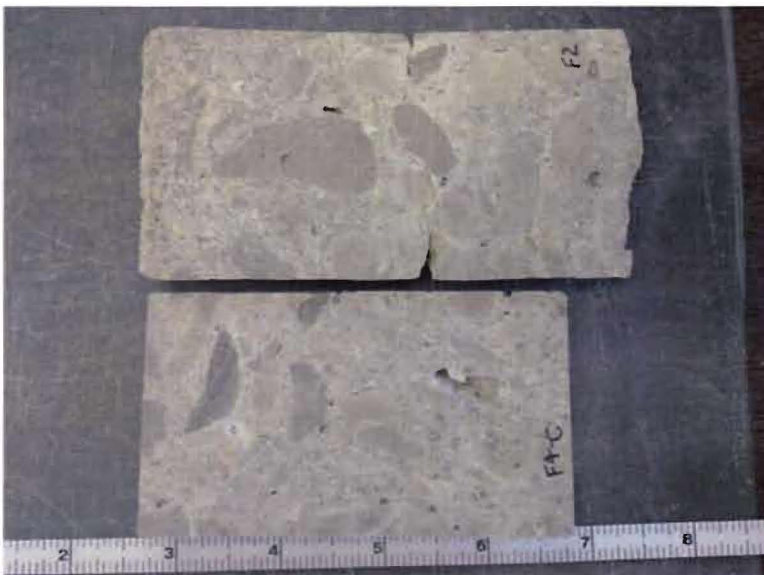
Figure 9. Lapped cross-sections of Cores F2 (top) and F4. Slight differences in paste color are evident. Core F2, on top, exhibits overall more gray and light-colored paste, while Core F4 exhibits more uniformly-colored tan paste.

Brief visual comparison of the cores showed that the concretes appear to be similar, although Core F2 appears to have overall gray paste with some variation in color and Core F4 has more uniform, light tan paste, as shown in Figure 1.

Core F4 was briefly examined petrographically as part of the point-count analysis and also for general comparison with Core F2. Figure 9 is a photograph of the lapped cross-sections of Cores F2 and F4 for comparative purposes. A full-depth, tight, meandering microcrack extends the full thickness of Core F4. The crack goes through a few aggregate particles in its path, indicating that it most likely did not occur early in the life of the concrete. Air voids in Core F4 contain secondary deposits linings in the same abundance and pattern as those of Core F2. Variability of the water-cement ratio and air-void system are evident in Core F4, although the variations do not appear to be as common as in Core F2. Additional petrographic examination of Core F4 would be necessary to determine its water-cement ratio and other properties more closely.

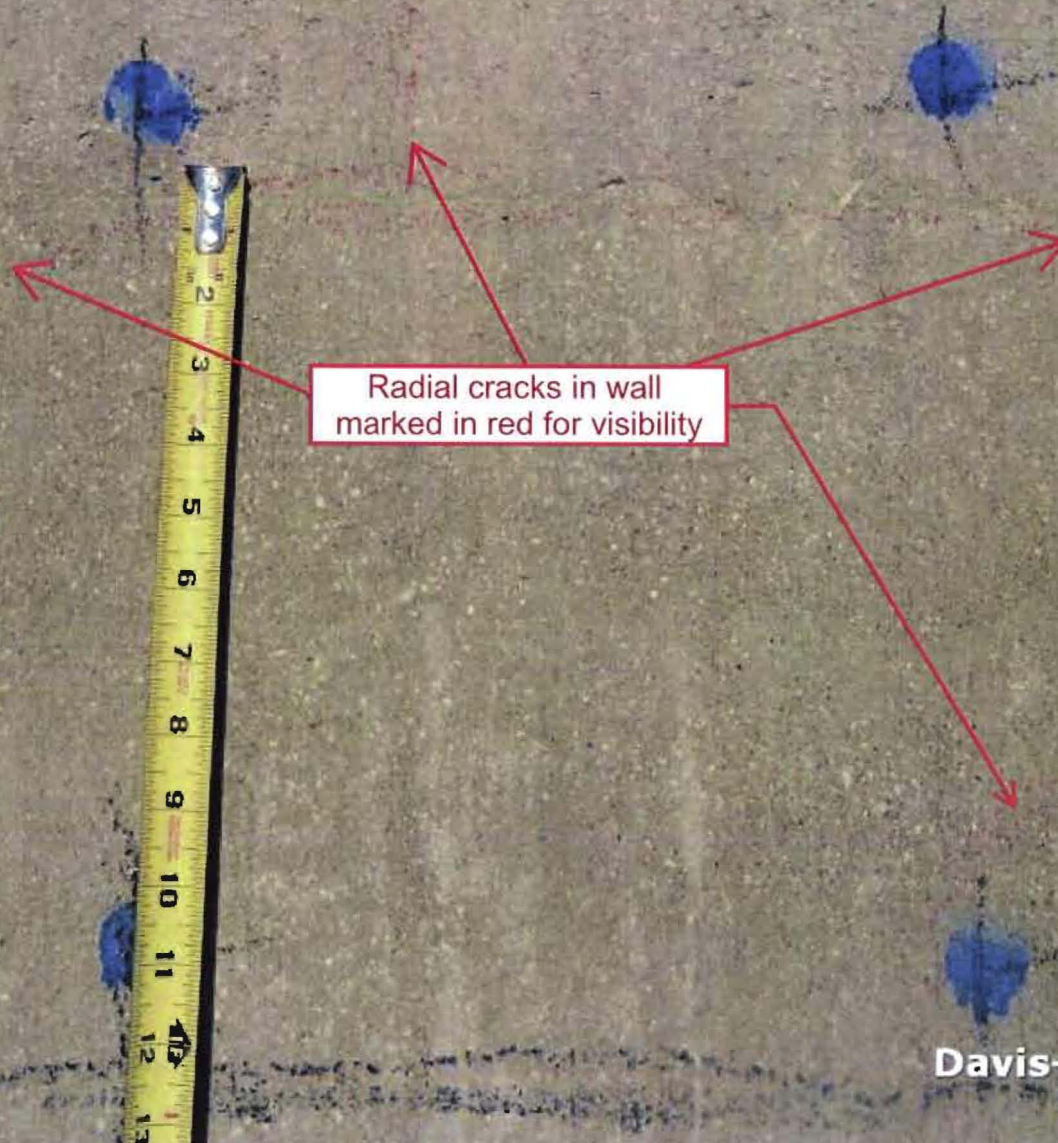
Radial cracks in wall  
marked in red for visibility

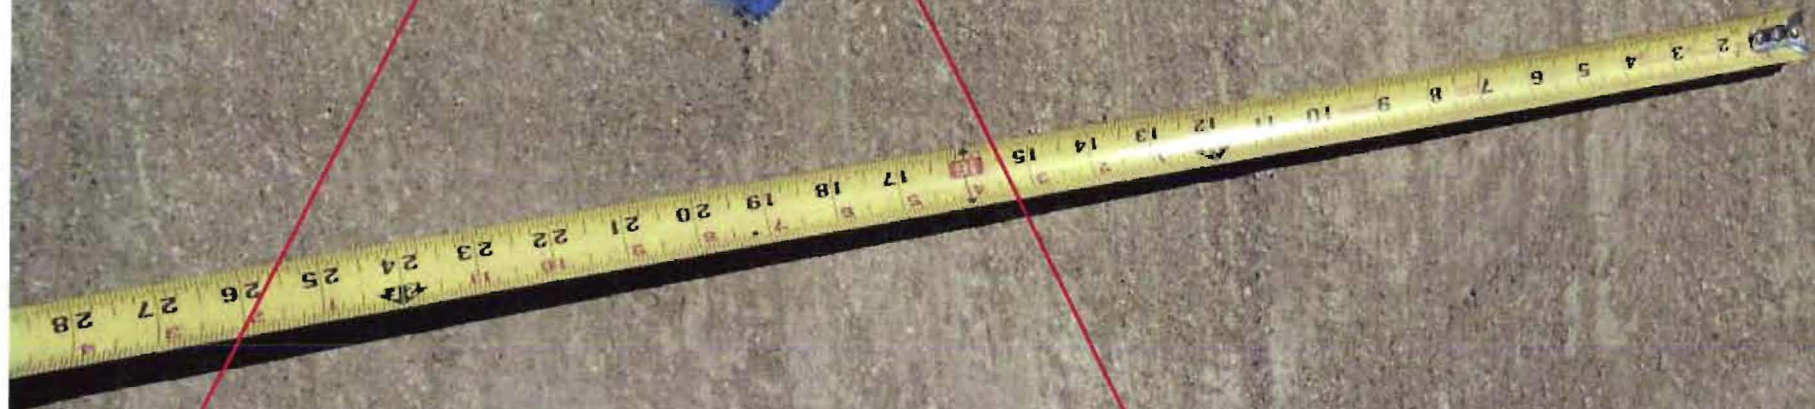
Radial cracks in wall  
marked in red for visibility
