Subject: Laminar Cracking of the Davis-Besse Shield Building – Concrete Sample Testing for Debonding

Exhibit 72: Water and Moisture Transfer into Concrete

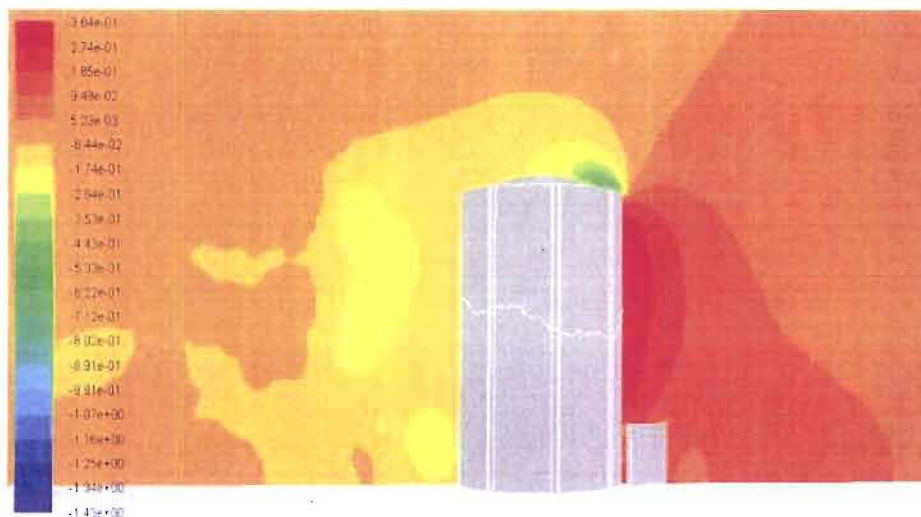
The stagnation pressure region has shifted up towards the top of the containment tower (Figure 25). This is a result of the Auxiliary building being partially in front of containment tower. The flow on the aft side of the tower is unsteady and turbulent (Figure 26). The addition of the Auxiliary building has caused the flow to rise due to the pressure increase just before the shield building. This results in a higher pressure region at the midpoint causing a larger overturning moment. The two figures below show pressure and velocity contours at 105mph during winter conditions.

**FIGURE 25: CROSS-SECTION OF 105MPH SW PRESSURE CONTOURS (Psi)**

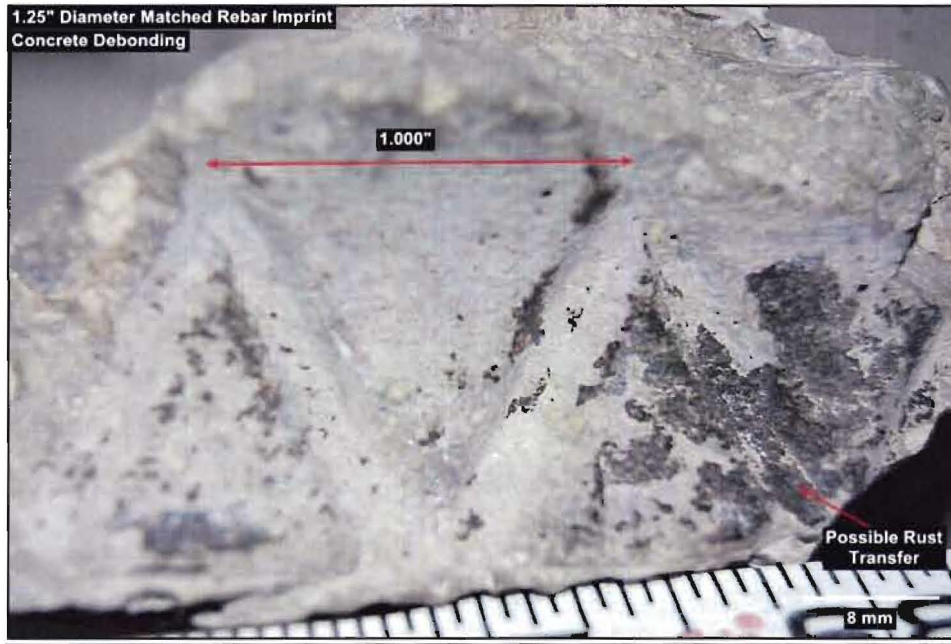
The following plant photo shows the imprint of rebar onto concrete. The photo documents the measured distance between the crests as 1.0 inches. In addition, it also points out possible rust transfer. To confirm that the imprint originated from concrete/rebar interaction, Figure A2 is a confirmatory photo of a 1.25 inch diameter rebar that shows the same pattern as the imprint. The figure also illustrates the 1.0 inch crest to crest measurement.

Figure A 1: Shield Building Concrete Sample Illustrating Rebar Imprint

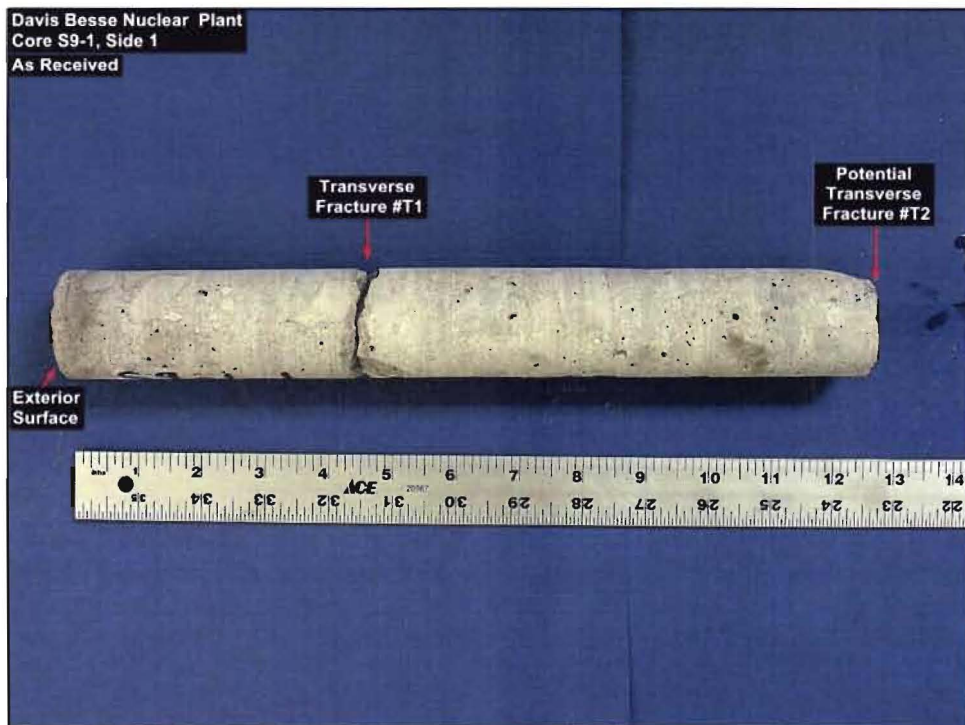
Figure A 2: Example of *As Received* Core Sample with Transverse Crack (Sample # S9-1)
