**Long-Term Surveillance Plan  
for the  
DOE Bluewater (UMTRCA Title II) Disposal Site  
Near Grants, New Mexico**

July 1997

Prepared for  
U.S. Department of Energy  
Grand Junction Office  
Grand Junction, Colorado

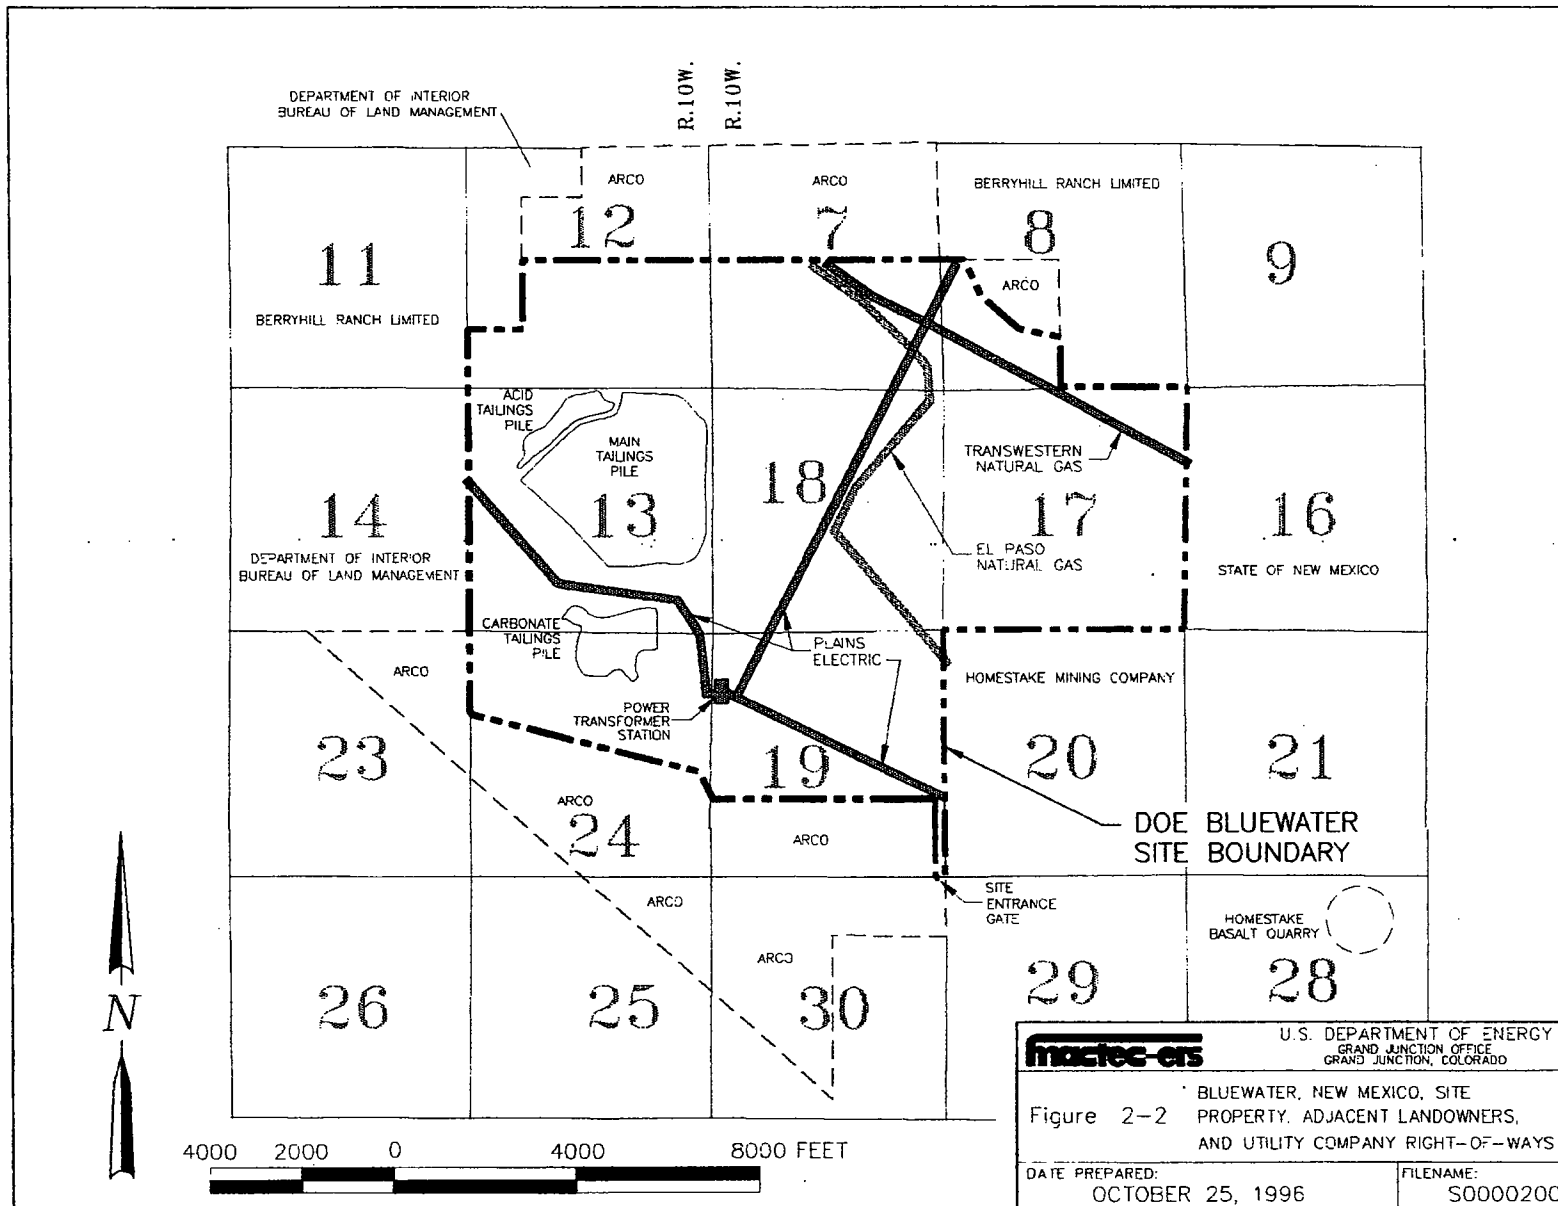
Figure 2-2. Bluewater, New Mexico, Site Property, Adjacent Landowners, and Utility Company Right-of-Ways

Several utility company right-of-ways pass across the site property (Figure 2-2). The legal description of each utility company right-of-way across the property is given in Appendix C. These right-of-way corridors are delineated by stock fence where they pass across the site property. Where each right-of-way intersects the site property fence, a vehicle access gate has been constructed in the site property fence. These gates are locked and a key to each lock is kept by the appropriate utility company. Where access roads inside the site property intersect a utility company right-of-way, two vehicle access gates have been constructed to allow travel across the right-of-ways. Gates at these crossings are locked and have the same key as the entrance gate. The Plains Electric Generation and Transmission Cooperative, Inc., in addition to its power line right-of-way, also has a tract 330 by 660 ft (100 by 200 m) that contains a power transformer station along its right-of-way in the south part of the site. The legal description of this tract is given in Appendix C. A chain-link fence about 7 ft (2.2 m) high has been constructed on the boundary of the power transformer station property tract.

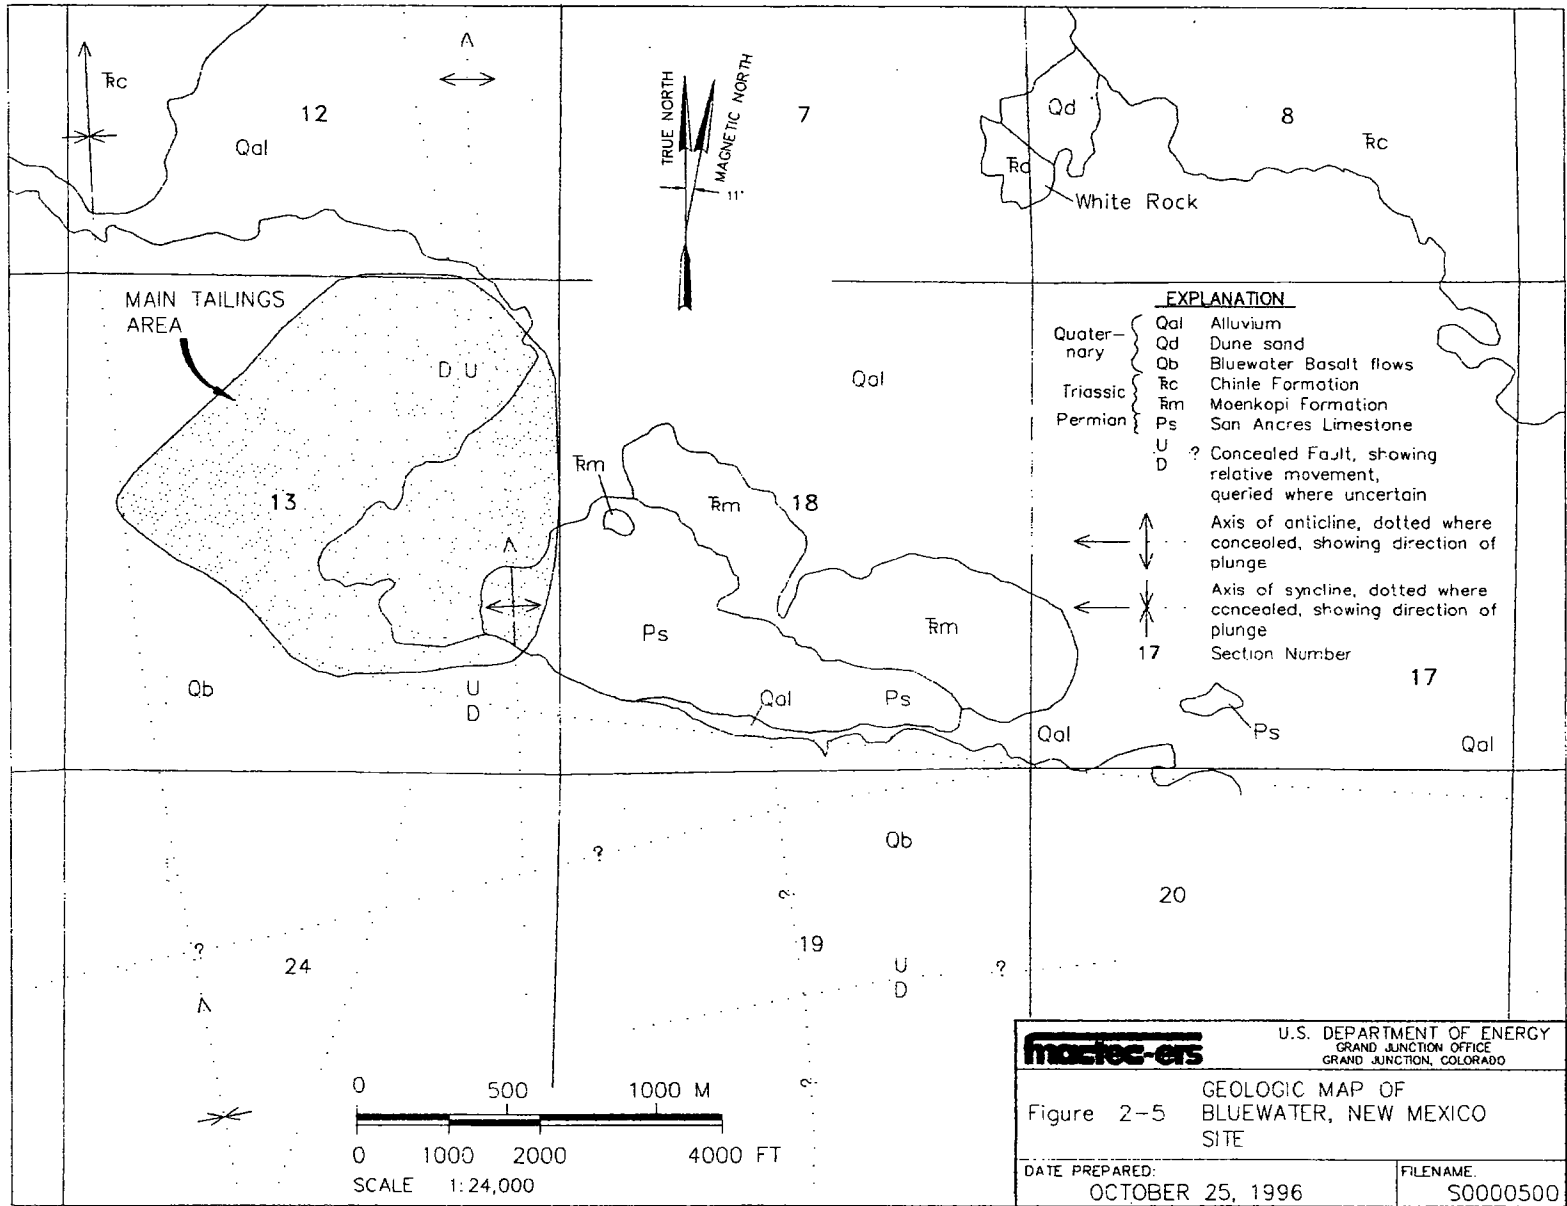
Figure 2-5. Geologic Map of Bluewater, New Mexico, Site

Geology of the Bluewater site is shown in Figure 2-5, which has been compiled and modified from the *Geologic Map of the Bluewater Quadrangle, Valencia and McKinley Counties, New Mexico* (Thaden and Ostling 1967) and from the geologic map, Plate 1, in *Geology and Ground-Water Resources of the Grants-Bluewater Area, Valencia County, New Mexico* (Gordon 1961). The following discussion of

geologic conditions at the site is summarized mainly from the section on "Geology and Geoseismicity" in Volume II of *Licensing Documentation* prepared by Dames and Moore (ARCO 1981).

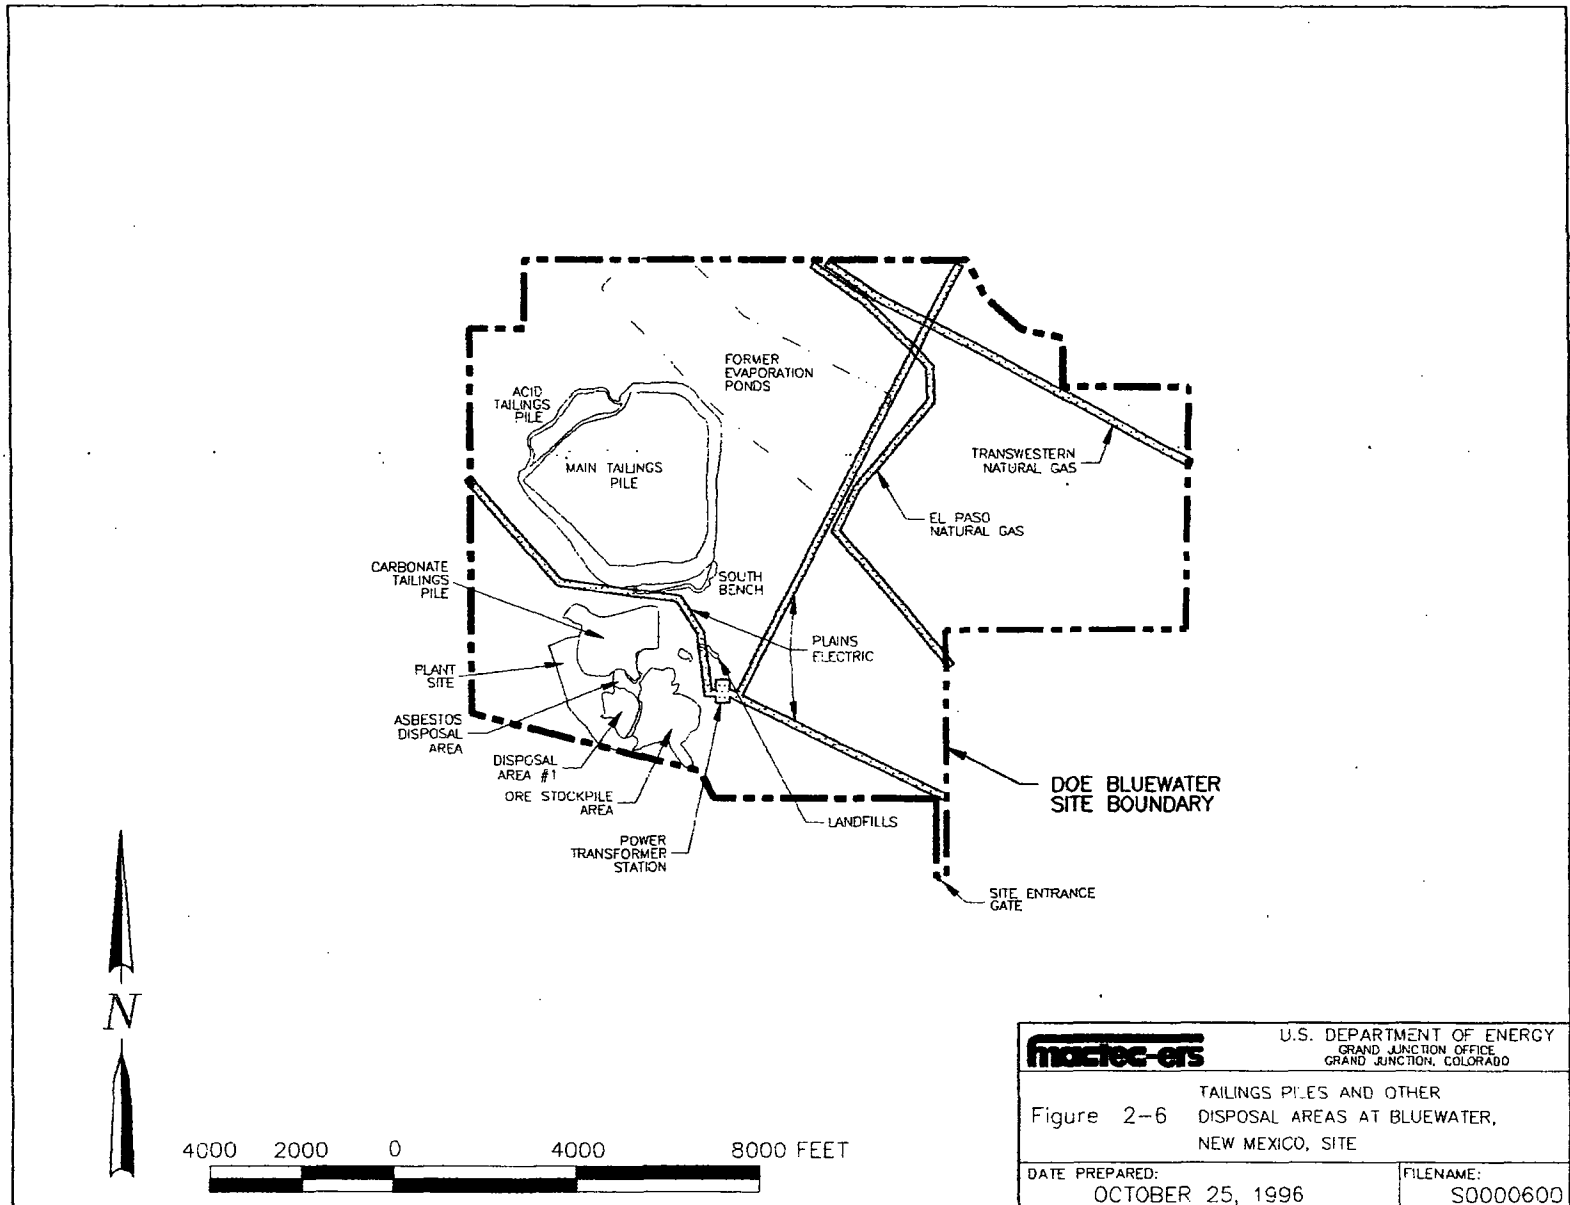
Figure 2-6. Tailings Piles and Other Disposal Areas at Bluewater, New Mexico, Site

The other disposal areas are shown in Figure 2-6, and more detailed maps of these areas are in the Completion Report (ARCO 1996a). The plant site area surface was smoothed to cover foundations and fill sumps, covered by an average thickness of 15 in. (38 cm) of compacted engineered fill, and overlain by 8 in. (20 cm) of topsoil, which was seeded with native grasses.

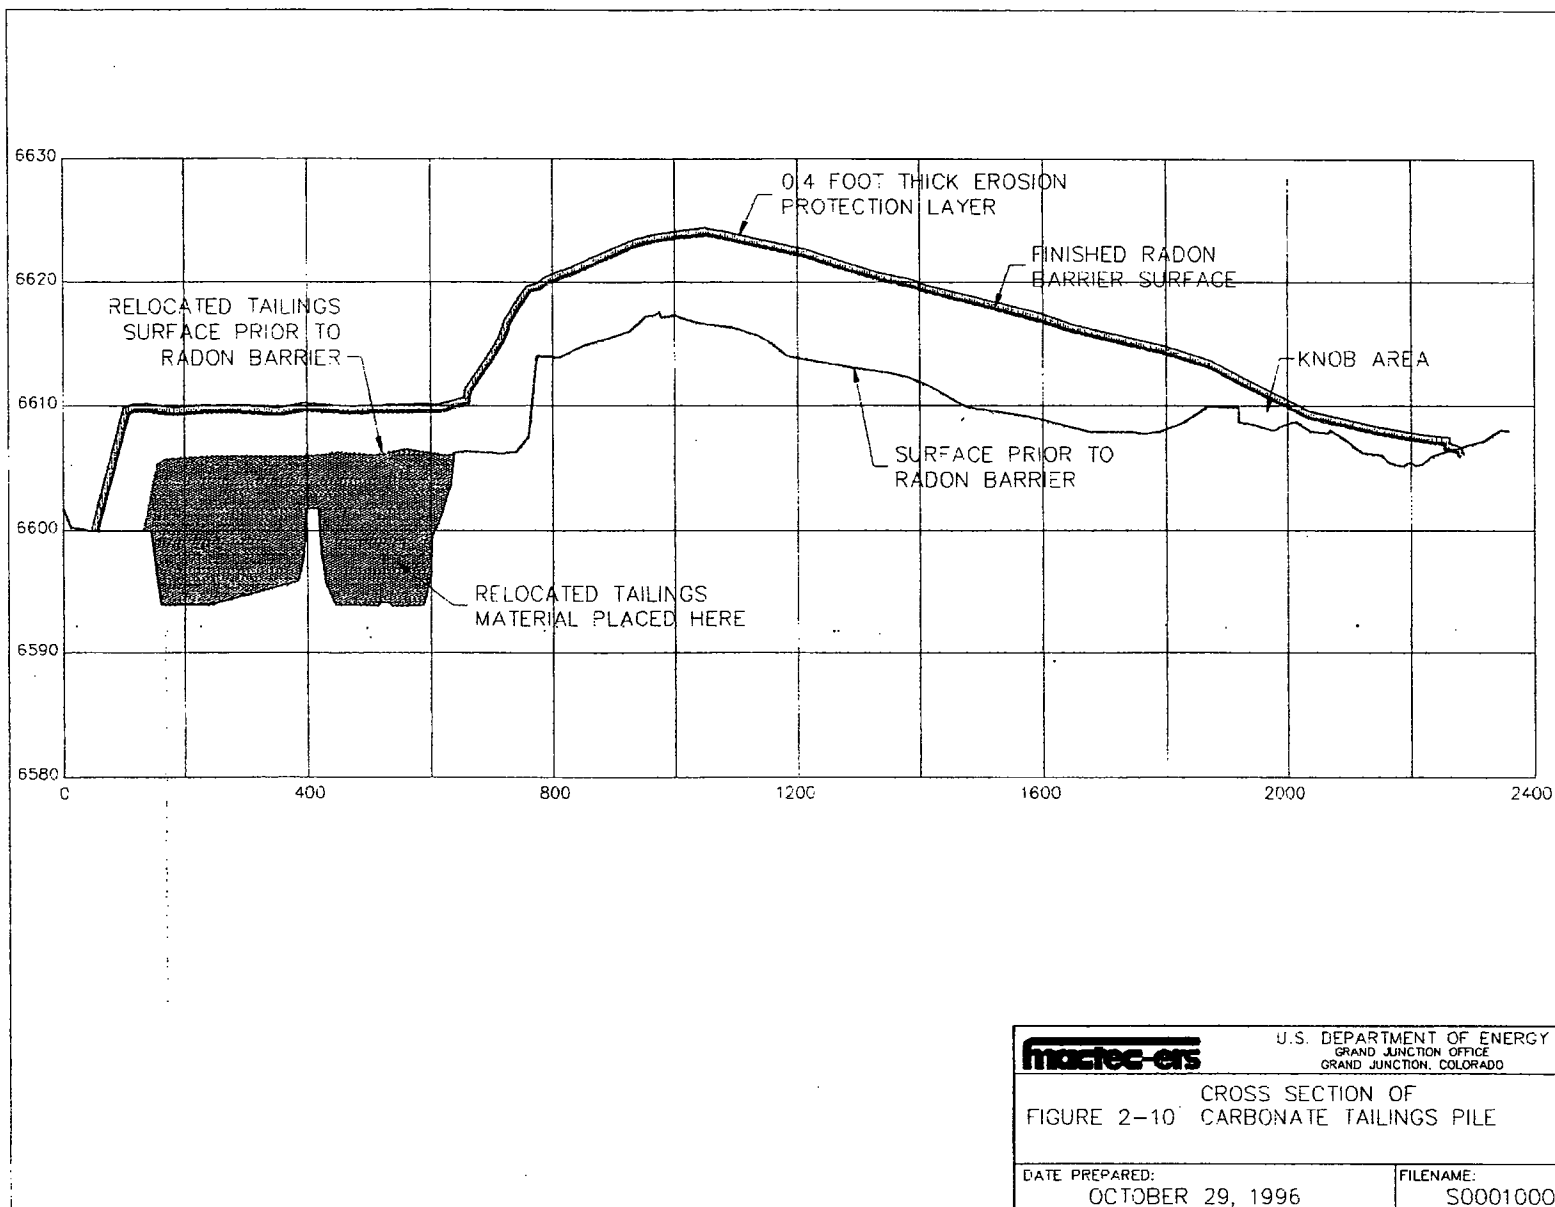
Figure 2-13. Cross Section of Carbonate Tailings Pile

The carbonate tailings pile contains tailings generated from the carbonate leach process that were deposited just northeast of the plant site from 1953 to late 1955. The carbonate pile shown in Figure 2-9 includes disposal areas no. 2 and no. 3, both of which were used for disposal of mill building debris, evaporation pond liner, and other rubble. Disposal area no. 2 is in the south part of the carbonate pile and disposal area no. 3 is in the southwest part of the pile. A typical cross section through the carbonate pile is shown in Figure 2-10.

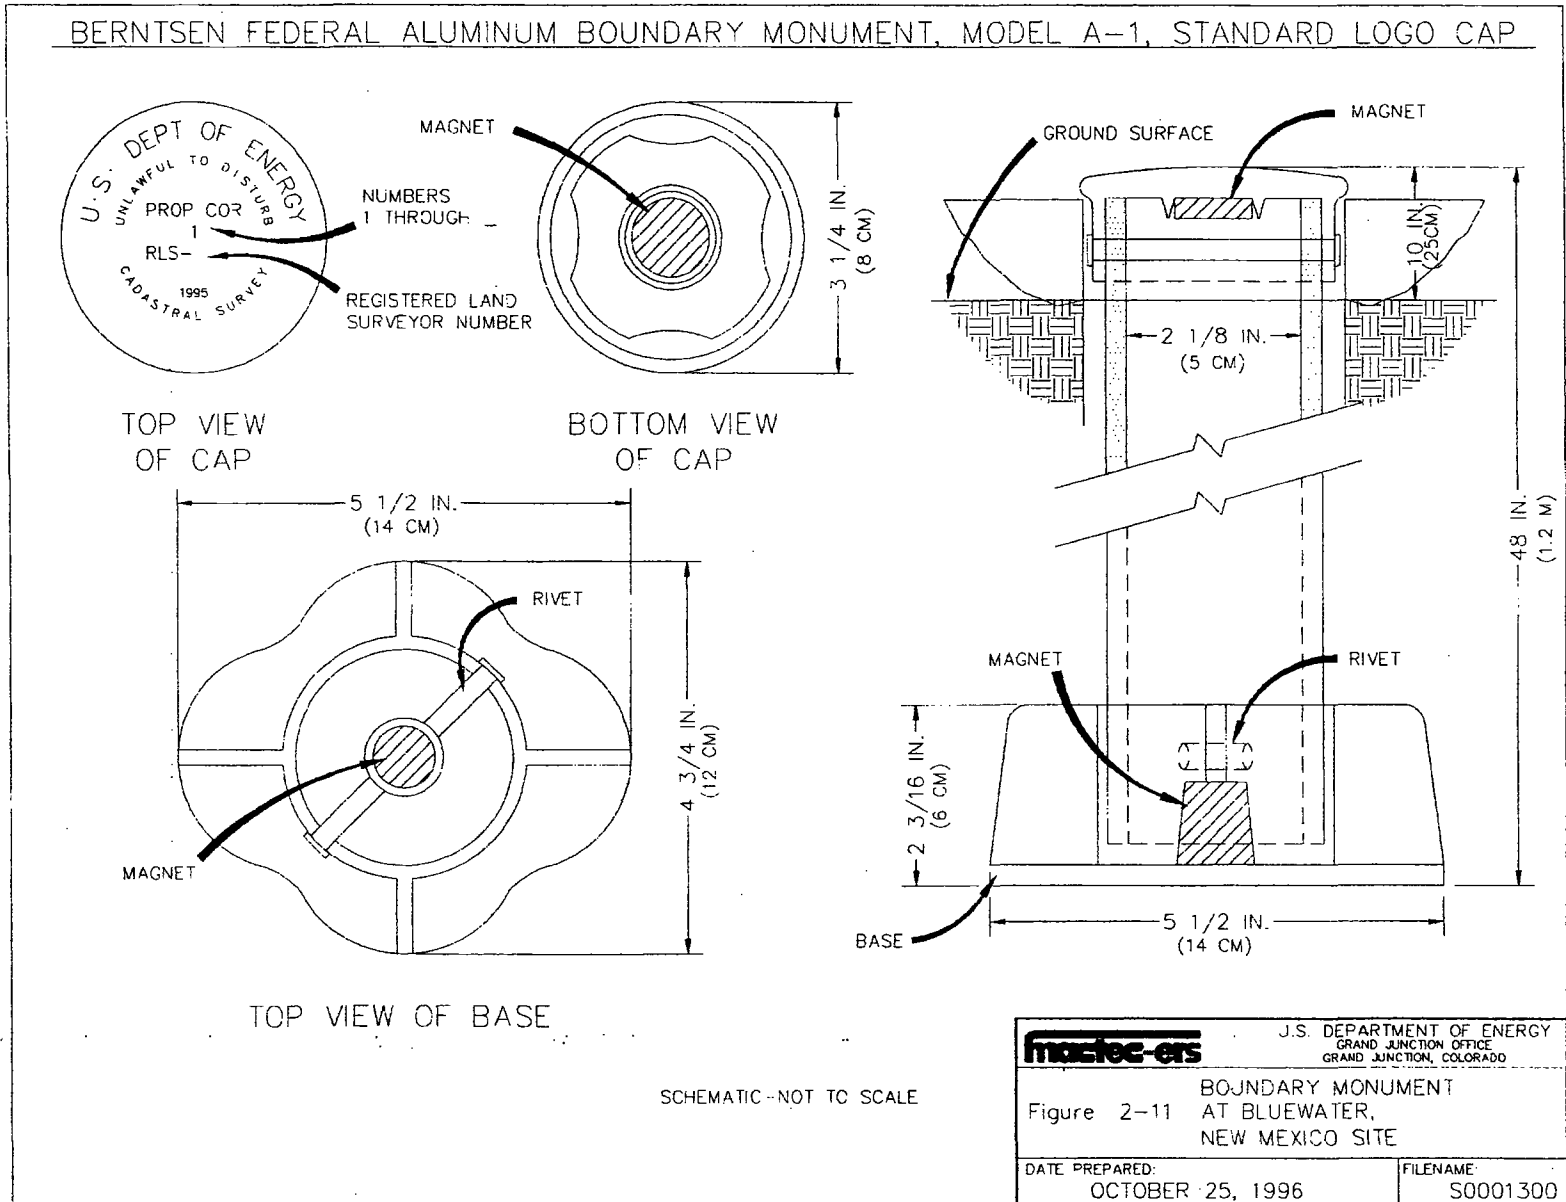
Figure 2-11. Boundary Monument at Bluewater, New Mexico, Site

Bernsten Federal aluminum survey monuments, Model A-1, were used for the 24 boundary monuments (Figure 2-11). Ceramic magnets are epoxied into the cap and base of each monument and are vertically oriented so that the monument can easily be found if it becomes buried. The monuments are set with the base 38 in. (97 cm) below ground surface and 10 in. (25 cm) above ground surface (Figure 2-11).

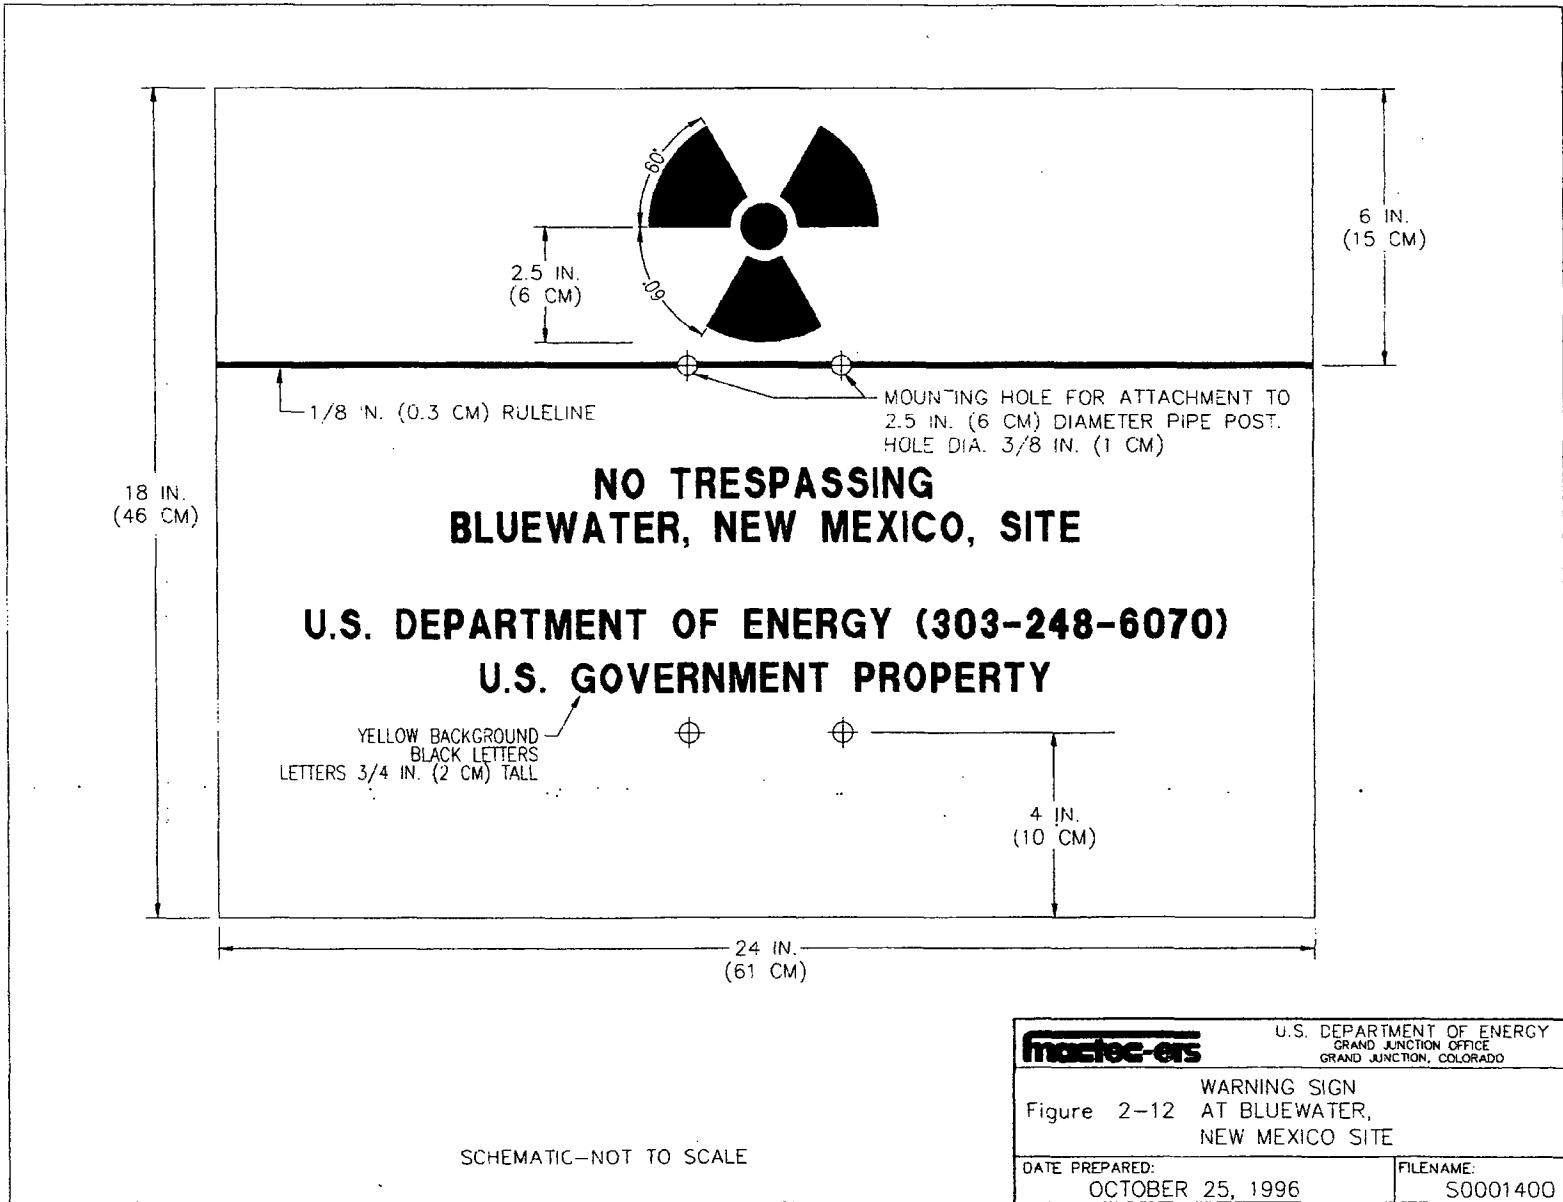
Figure 2-12. Warning Sign at Bluewater, New Mexico, Site.

Warning signs are posted at various places around the site property: at the entrance gate, other vehicle access gates, and around the tailings piles and other disposal areas. These warning signs inform the public of the name, function, and ownership of the site (Section 2.6). The signs are attached at a height of about 5 ft (1.5 m) above ground to 2.5-inch (in.) (5.5 centimeters [cm]) diameter pipe (posts) set in concrete. Sign posts are placed approximately 5 ft (1.5 m) inside the fence when set along the site perimeter. Warning signs are similarly placed on posts around the main tailings area, the carbonate tailings area, and other disposal areas. These signs are placed no more than 500 ft (152 m) apart and about 100 ft (31 m)

from the edge of each radioactive material disposal area. These warning signs provide sufficient warning to persons approaching the areas of buried radioactive material. Human intrusion and vandalism are expected to be minor because of the remoteness of the site, sparse population of the area, and land use (mainly cattle grazing) of surrounding land. Additional security is considered unnecessary.

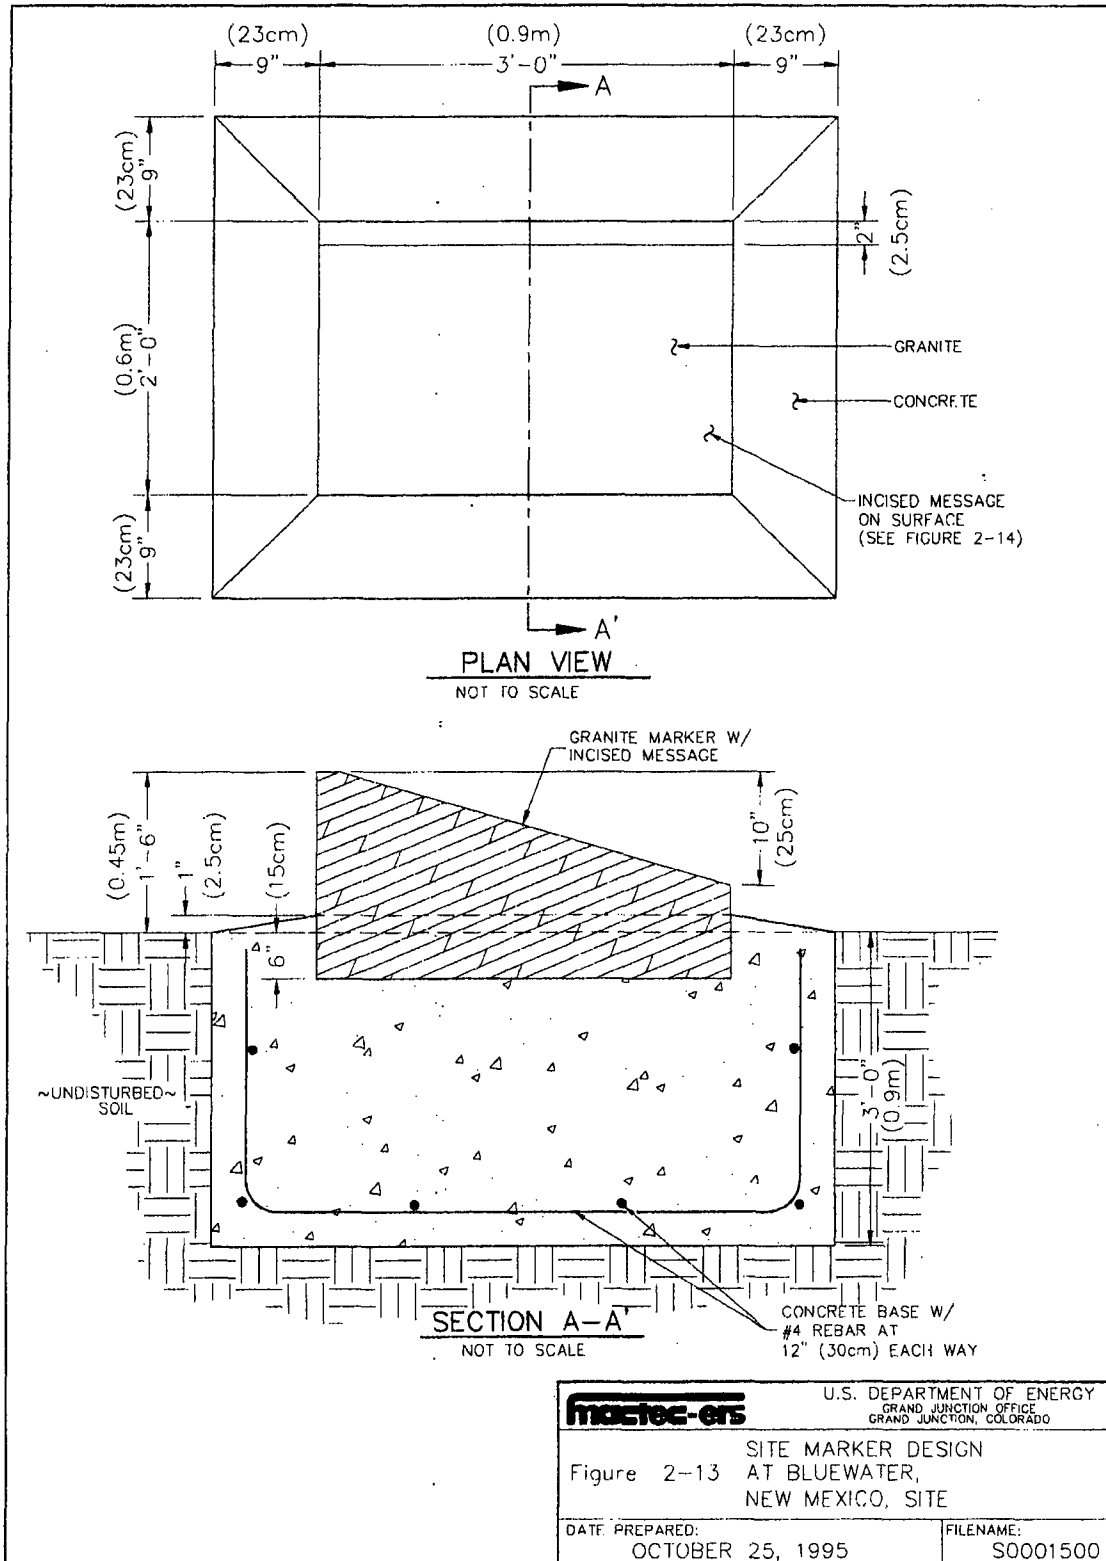
Figure 2-13. Site Marker Design at Bluewater, New Mexico, Site

One unpolished granite site marker with the dimensions shown in Figure 2-13 has been installed at the Bluewater site. Site marker SMK-1 is set on the ground surface in the level area between the main tailings pile and the carbonate tailings pile (Plate 1).

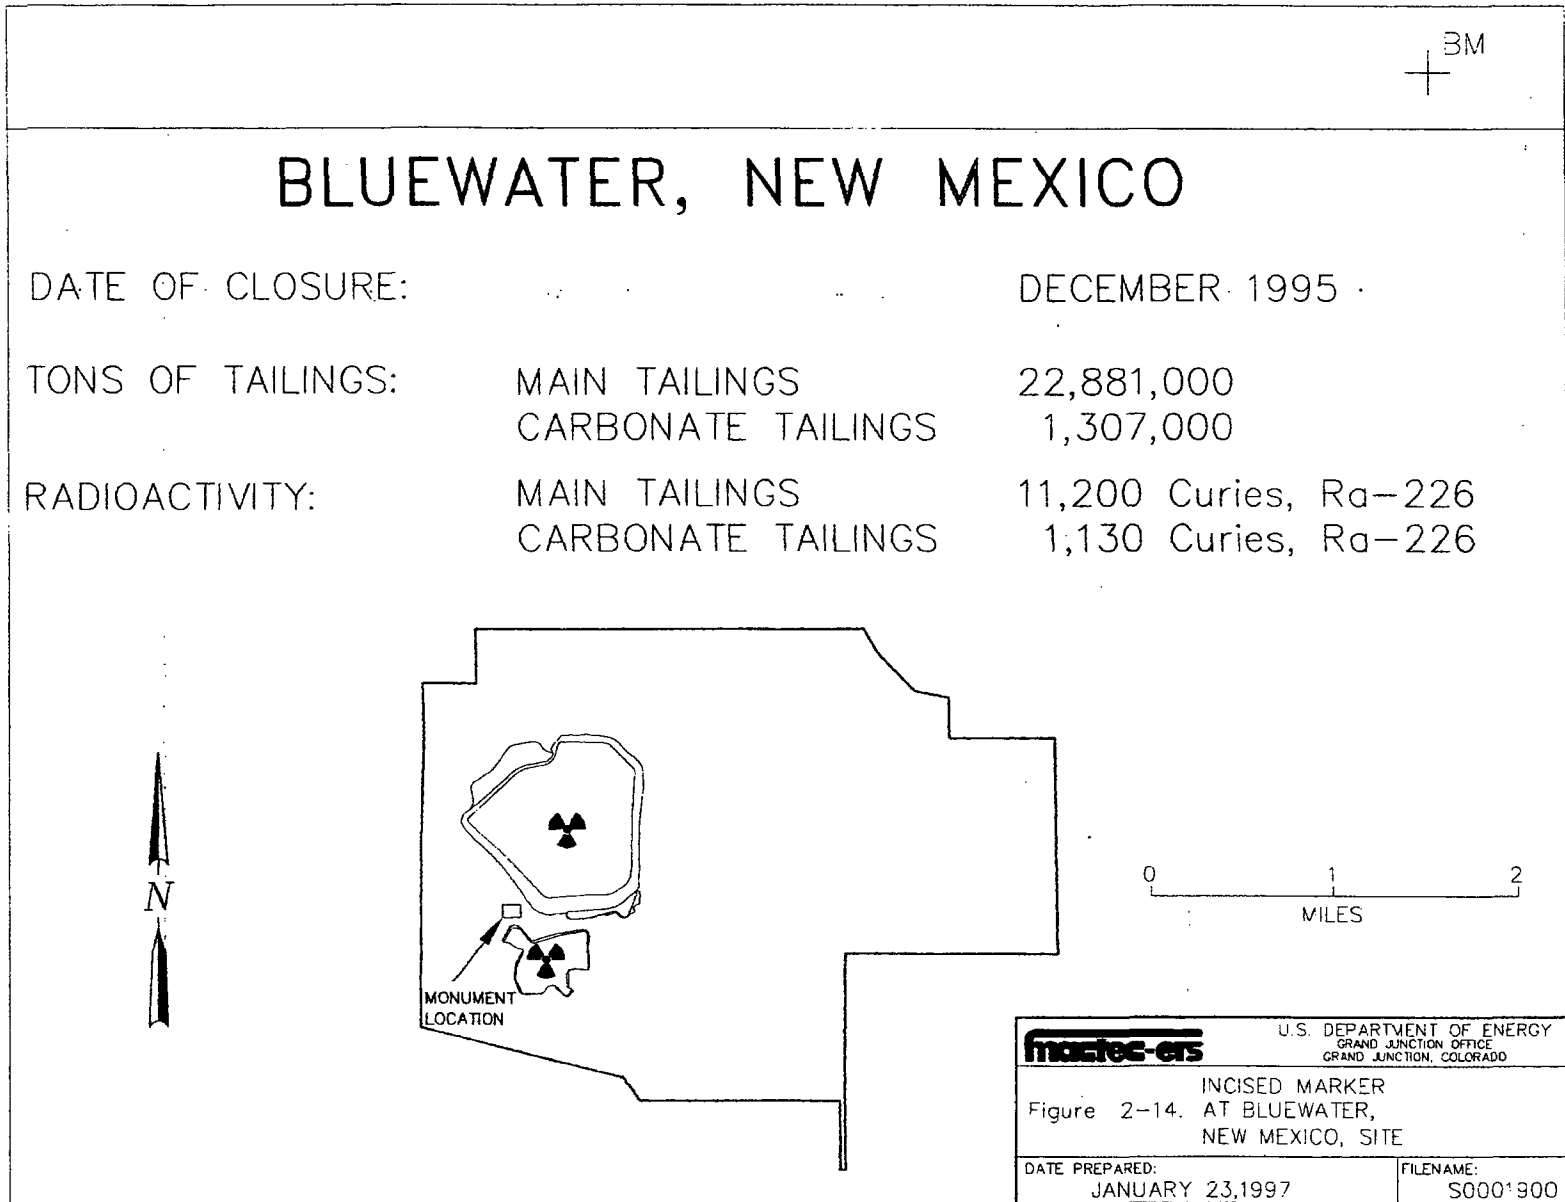
Figure 2-14. Incised Marker at Bluewater, New Mexico, Site

The inscription on the site marker identifies the general locations of the tailings piles within the site property, the date of closure, the tonnage of tailings, and the curies of radioactivity of radium-226. The international symbol for radiation is also inscribed in the marker at the position of each tailings disposal area (Figure 2-14).

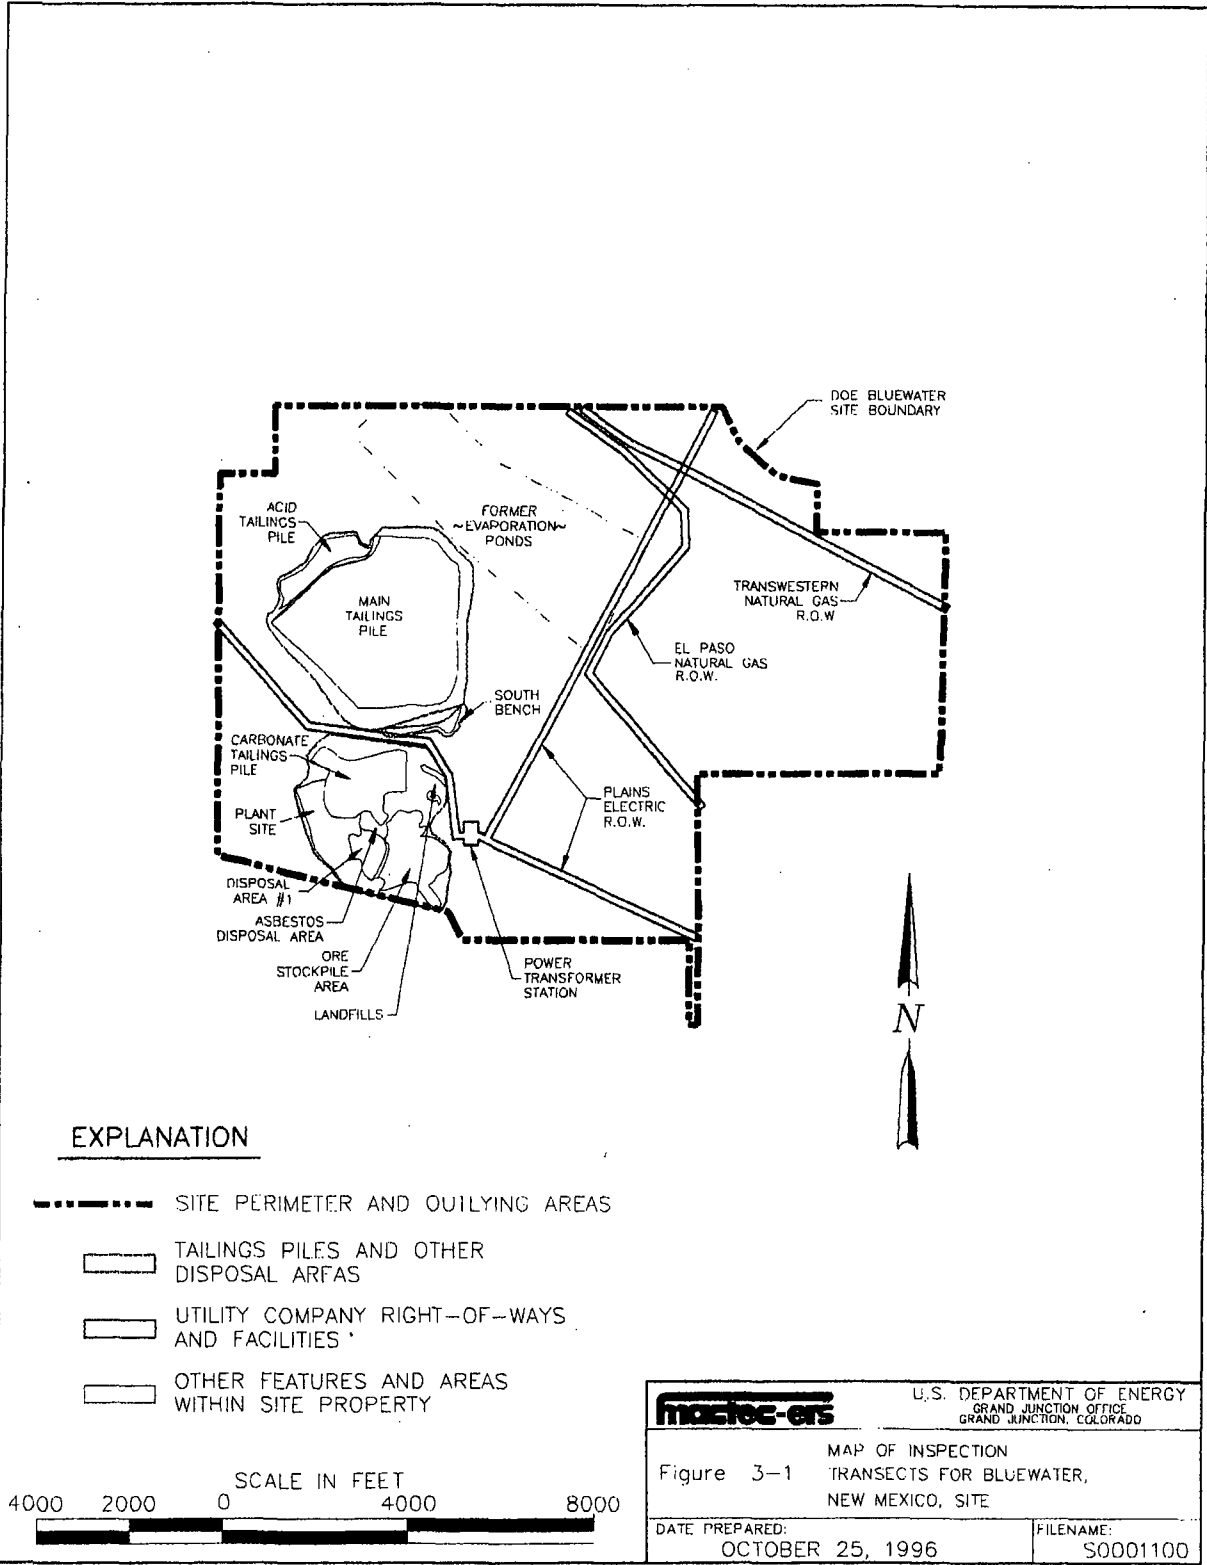
Figure 3-1. Map of Inspection Transects for Bluewater, New Mexico, Site

The area within each transect will be generally inspected for evidence of slumping, settlement, wind or water erosion, and human, plant, or animal intrusion. The condition of disposal area cover and riprap and the health and success of revegetation efforts will be evaluated. Within each transect, the condition of specific site-surveillance features (Section 2.6), such as the site marker, warning signs, monitor wells, and boundary monuments, will be individually inspected for change, deterioration, and other effects such as vandalism. The entire perimeter fence will be inspected for integrity and deterioration.
