## SONGS Unit 2 Return to Service Report

#### **MHI Document L5-04GA564 Tube Wear of Unit-3 RSG Technical Evaluation Report**

**Tube wear of Unit-3 RSG – Technical Evaluation Report**

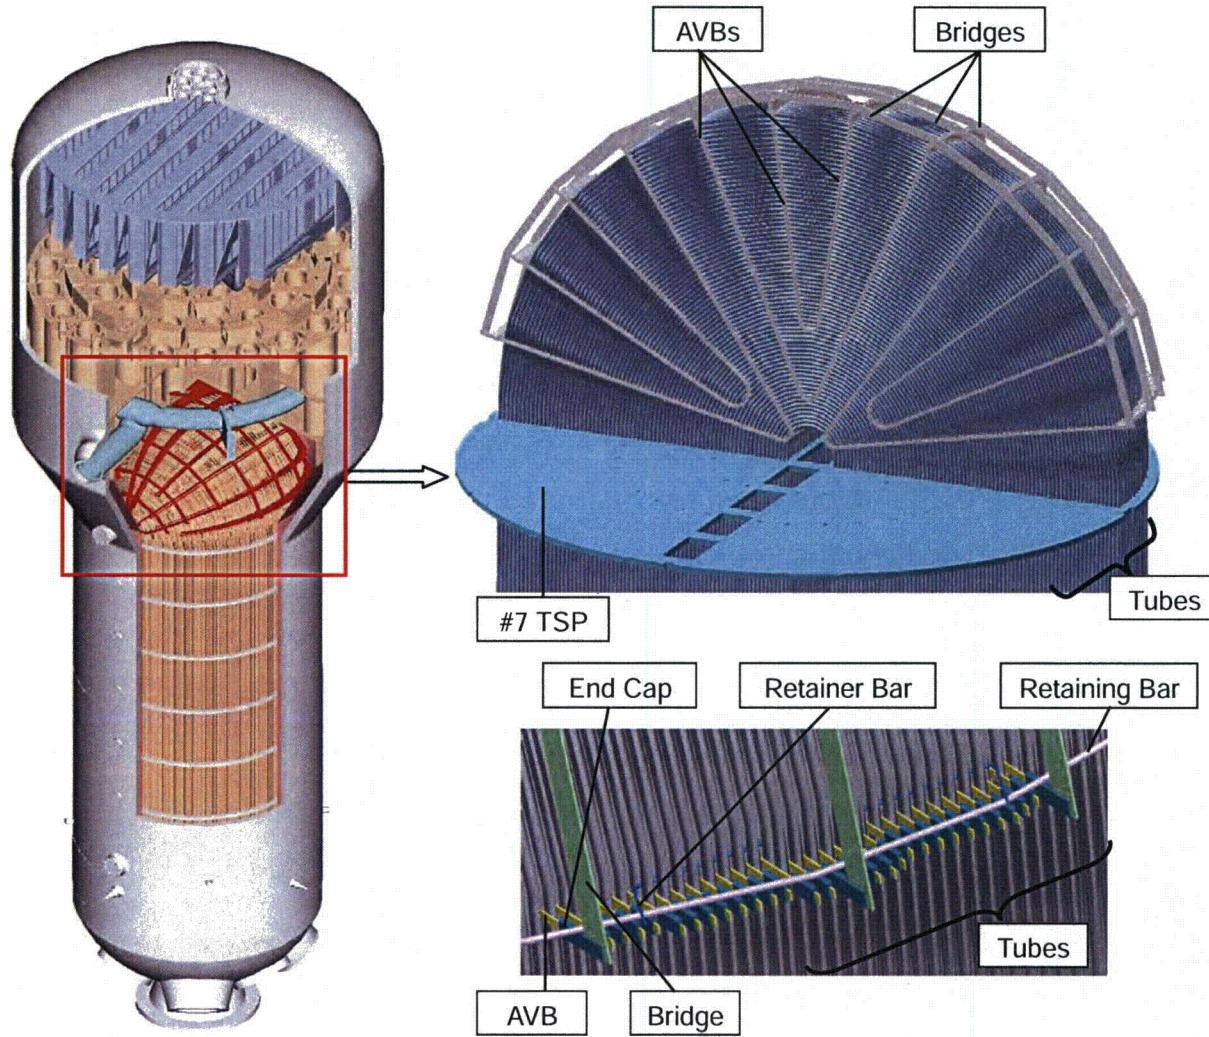
The tube bundle and AVB structure configuration and components (AVBs, retaining bars, bridges and retainer bars) are shown in Fig.2-1. MHI investigated field experience with U-bend tube degradation using INPO, NRC and NPE data bases, and concluded that tube wear in the operating U-tube SGs was mostly being caused by out-of-plane tube motion. Consistent with this and Reference 7, only out-of-plane vibration of the SG U-tubes was evaluated because tube U-bend natural frequency in the out-of-plane direction is lower than natural frequency in the in-plane direction and out-of-plane vibration is more likely to occur than in-plane vibration. No SG problems stemming from in-plane tube motion were identified by MHI and thus MHI concluded that the design and fabrication processes described above were sufficient for minimizing tube wear in the SONGS RSGs.

Fig.2-1 Tube Bundle and AVB Structure Configuration

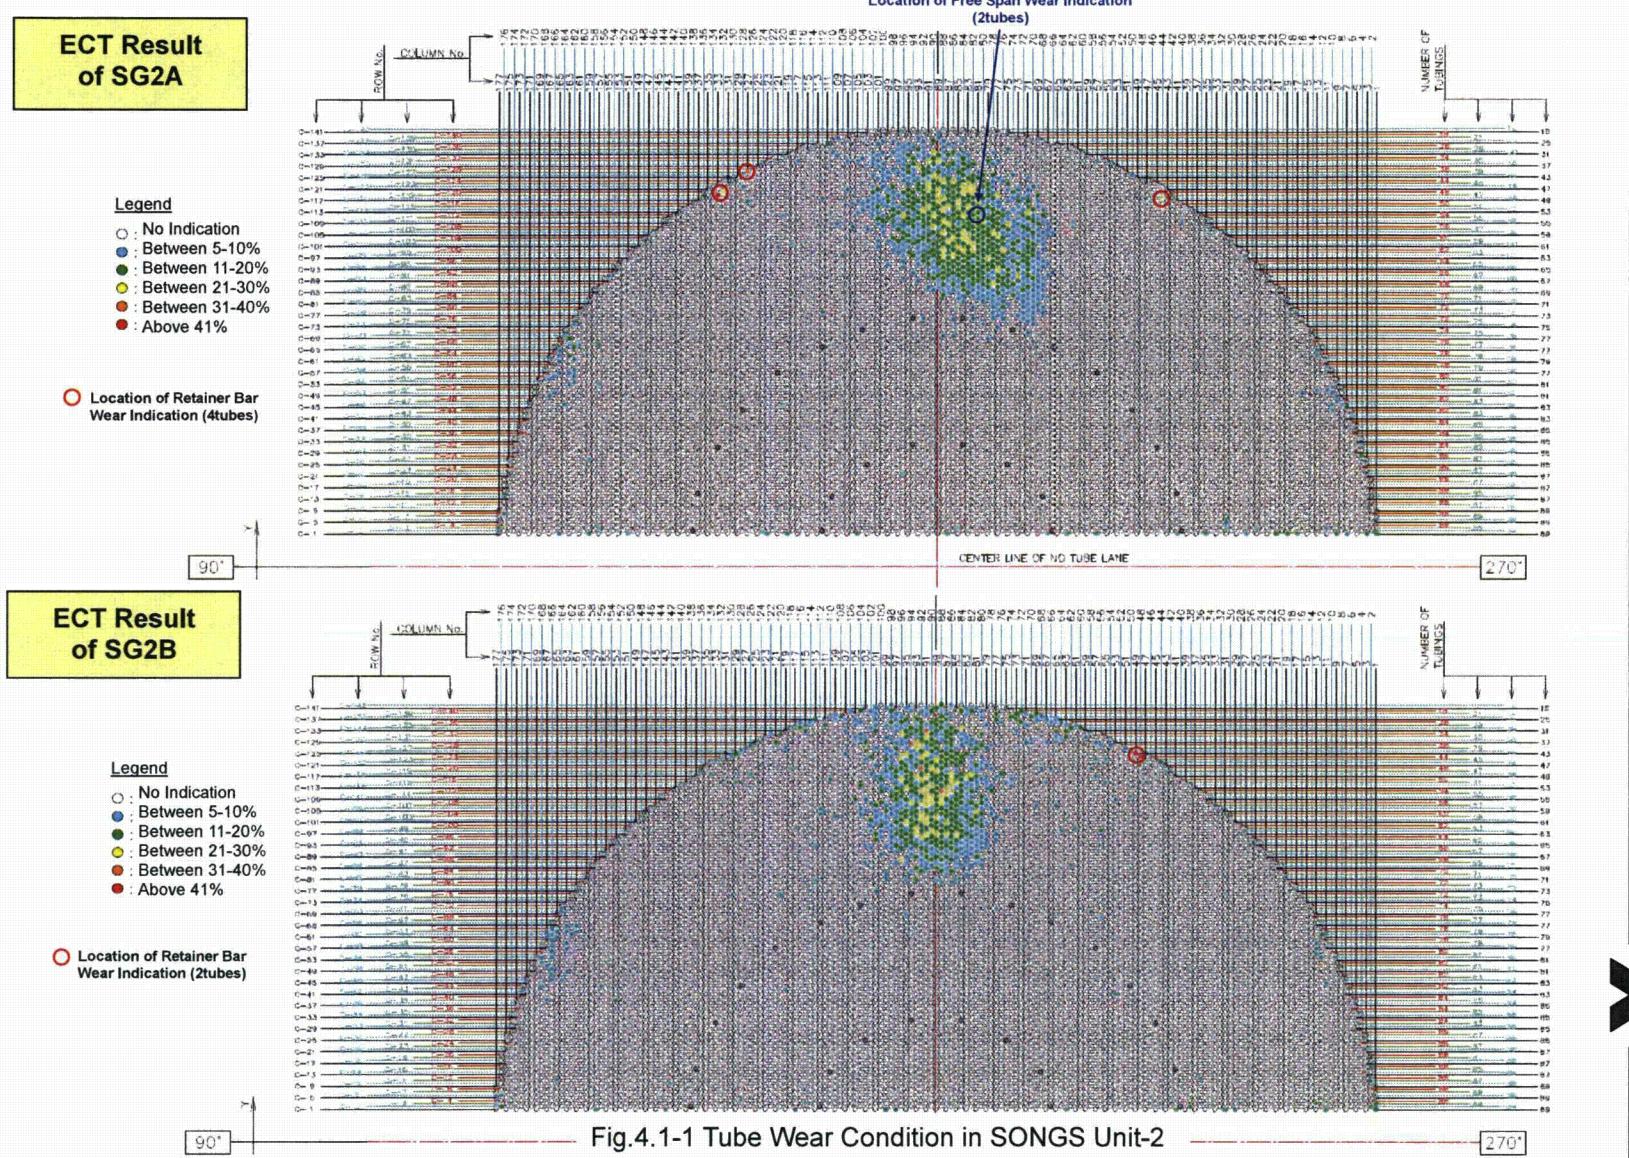
Wear indications obtained from ECT inspection are shown in Fig.4.1-1 and 4.1-2.

Fig.4.1-1 Tube Wear Condition in SONGS Unit-2

The tubes in Unit 2 have experienced wear at 4 locations, i.e. wear in the free span area, wear at the AVB bars, wear at the TSPs and wear at retainer bars, as well as wear due to a foreign object. Table 4.1.2-1 shows the number of tubes that have shown wear at these four different locations as well as foreign object wear and is provided by SCE (Reference 9 and 11).

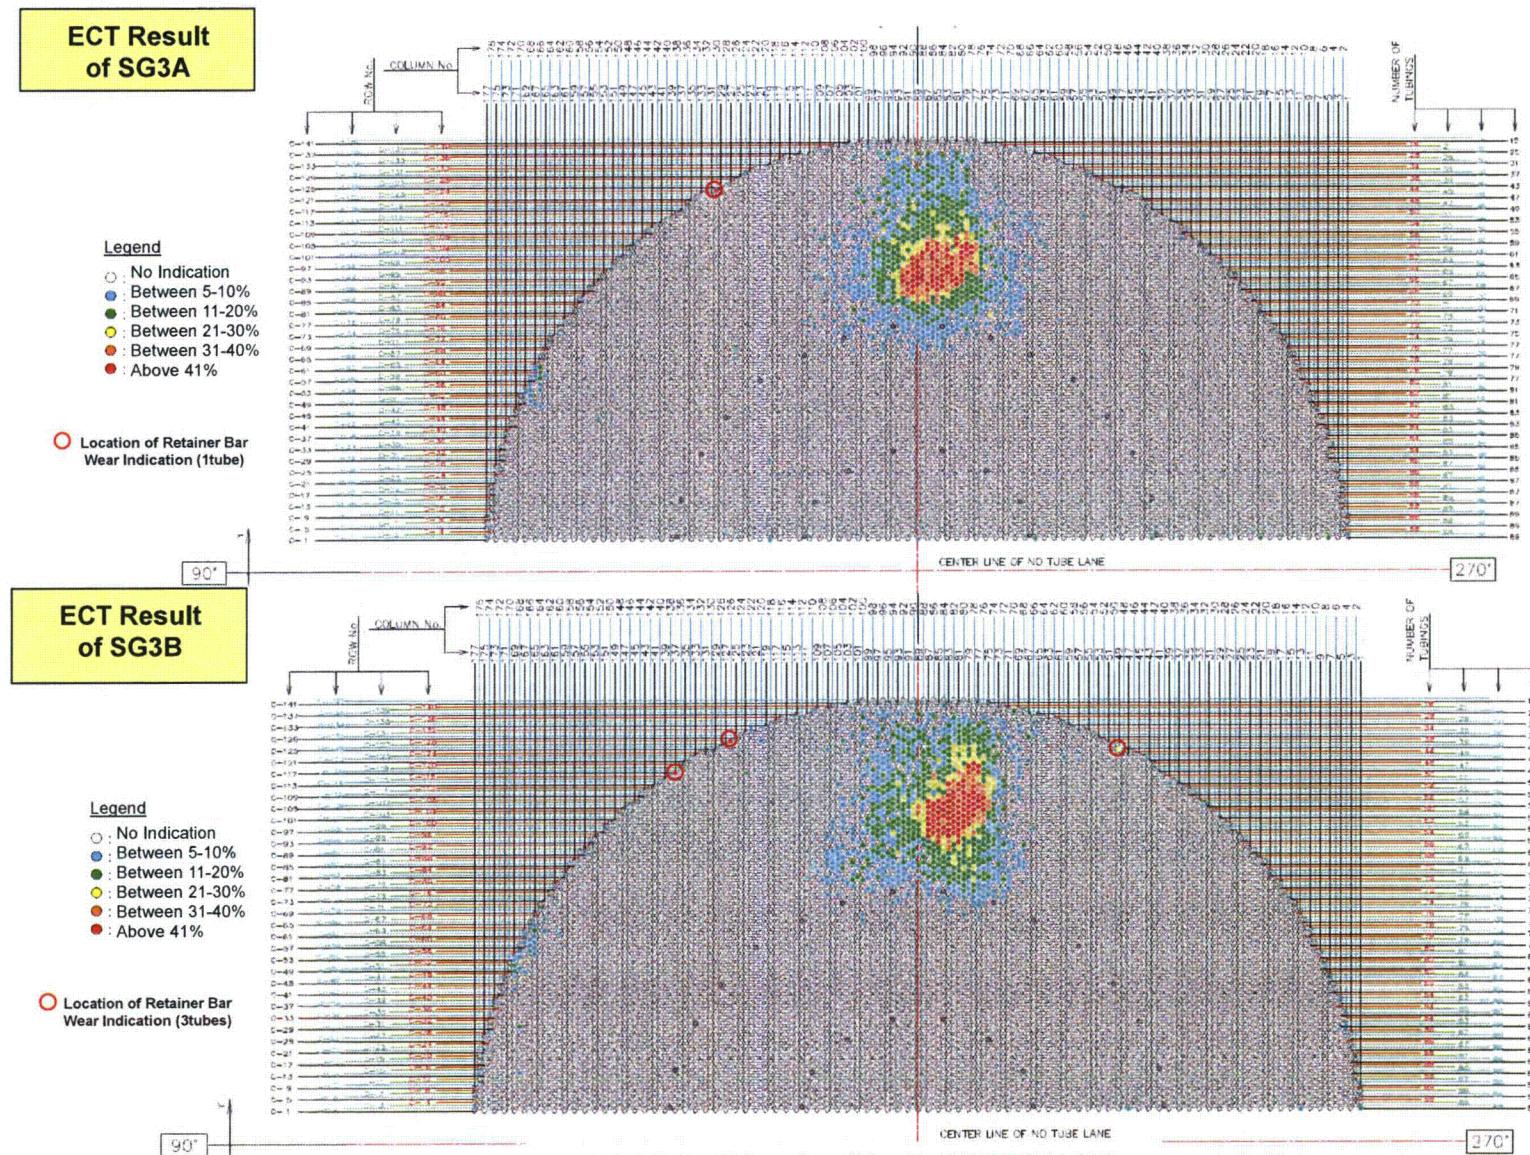
Fig.4.1-2 Tube Wear Condition in SONGS Unit-3

The tubes in Unit 3 have experienced wear at 4 locations, i.e. wear in the free span area, wear at the AVB bars, wear at the TSPs and wear at retainer bars. Table 4.1.3-1 shows the number of tubes that have shown wear at these four different locations and is provided by SCE (Reference 9 and 11).

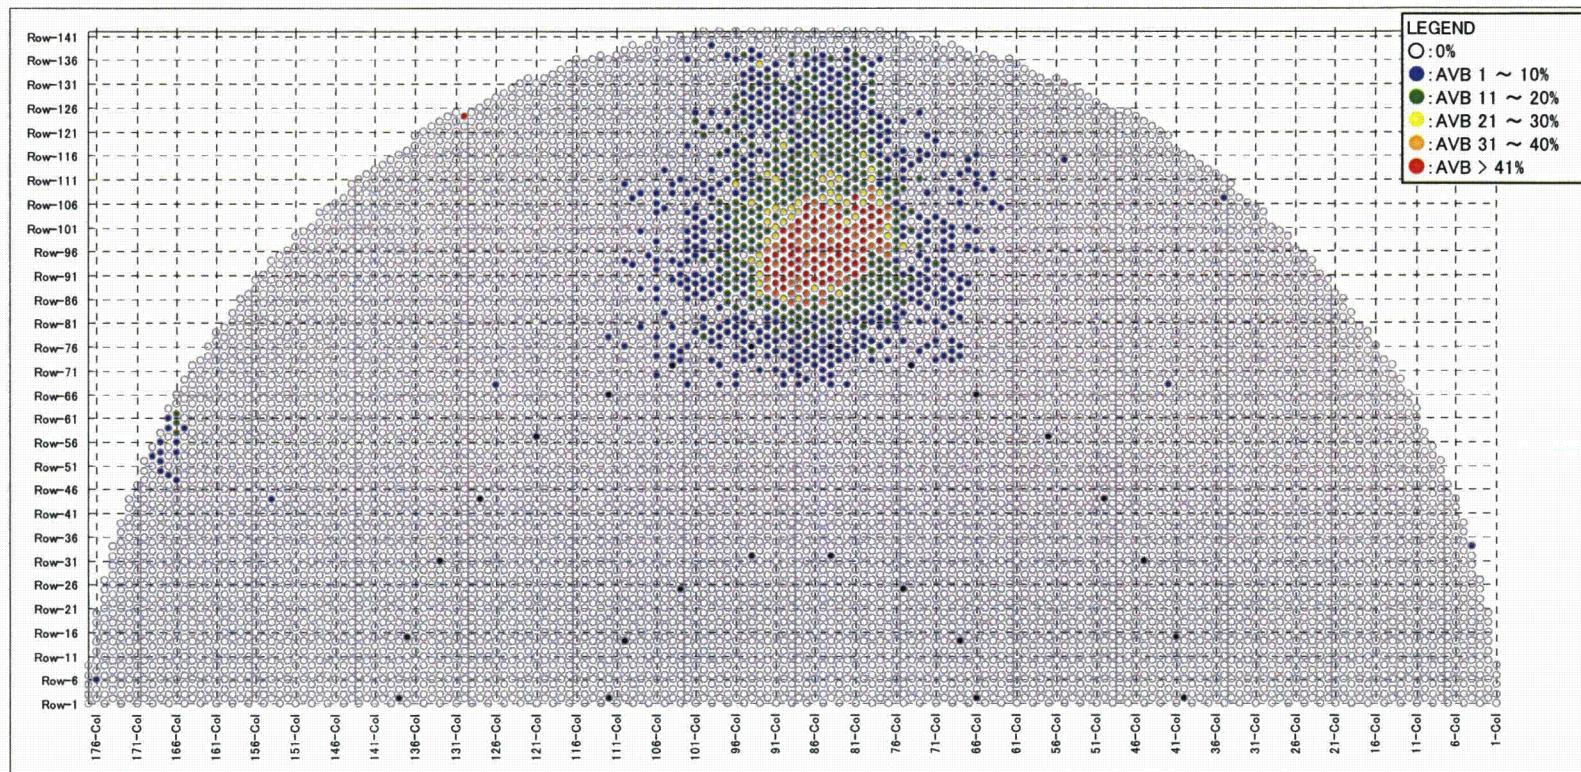
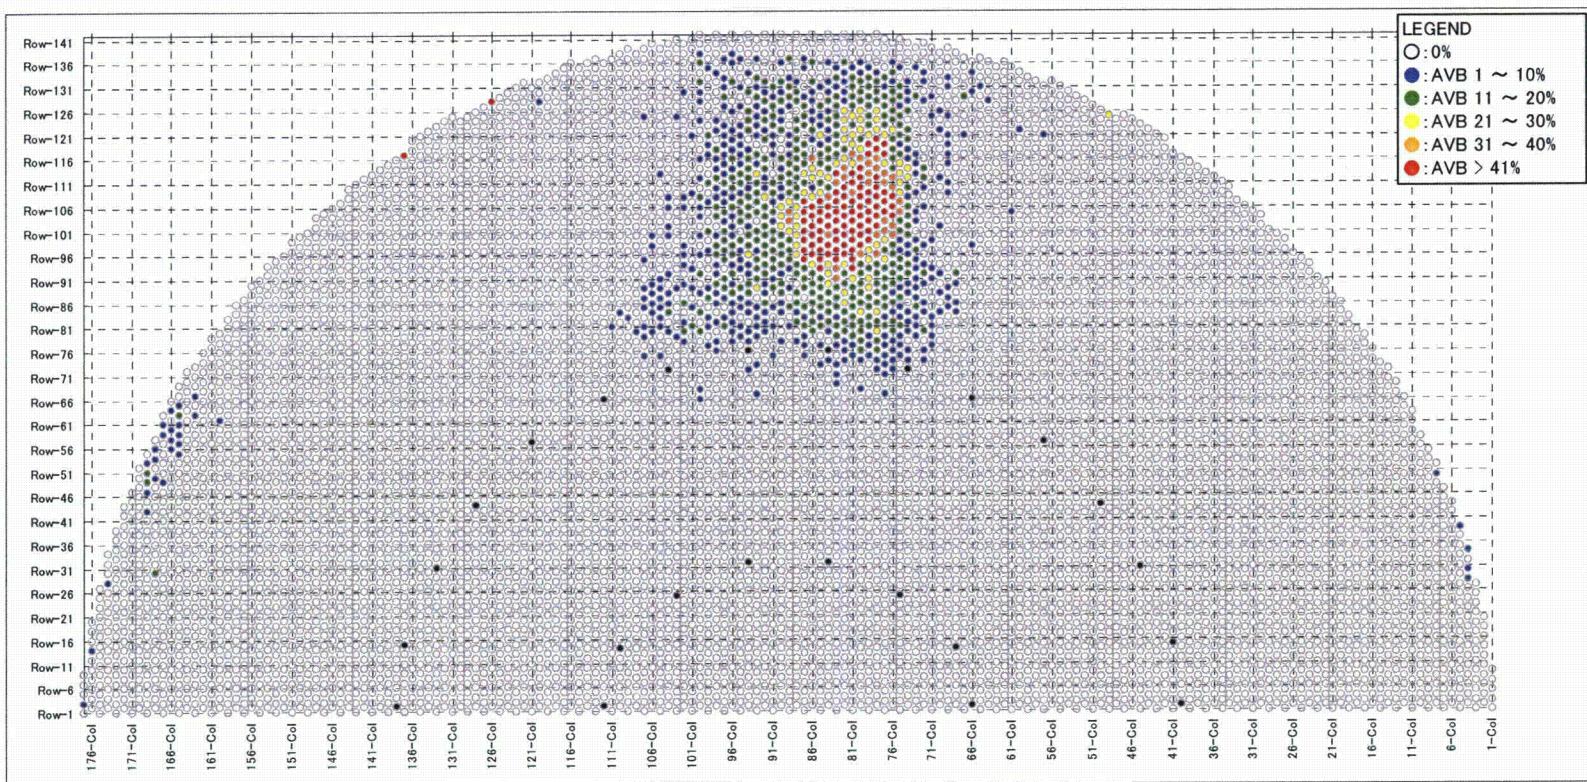
Wear at the tube-to-AVB intersections only with no wear indications in the tube free-span sections. Some of these tubes have wear indications at the TSPs as well. In this case, it is considered that mainly the U-bend section of the tube was vibrating. These tubes are shown in Fig.4.1.1-2.

Wear at the AVB structure retainer bars in the tube U-bend section. These tubes have no wear indications in the free span, at AVBs or at TSPs. In this case, it is considered that the retainer bar itself was vibrating and the tube was not vibrating. These tubes are shown in Fig.4.1.1-2 and in Appendix-1.

Fig 4.1.1-2(1/2) Tubes with wear indications at AVBs and at retainer bars

Fig 4.1.1-2(2/2) Tubes with wear indications at AVBs and at retainer bars

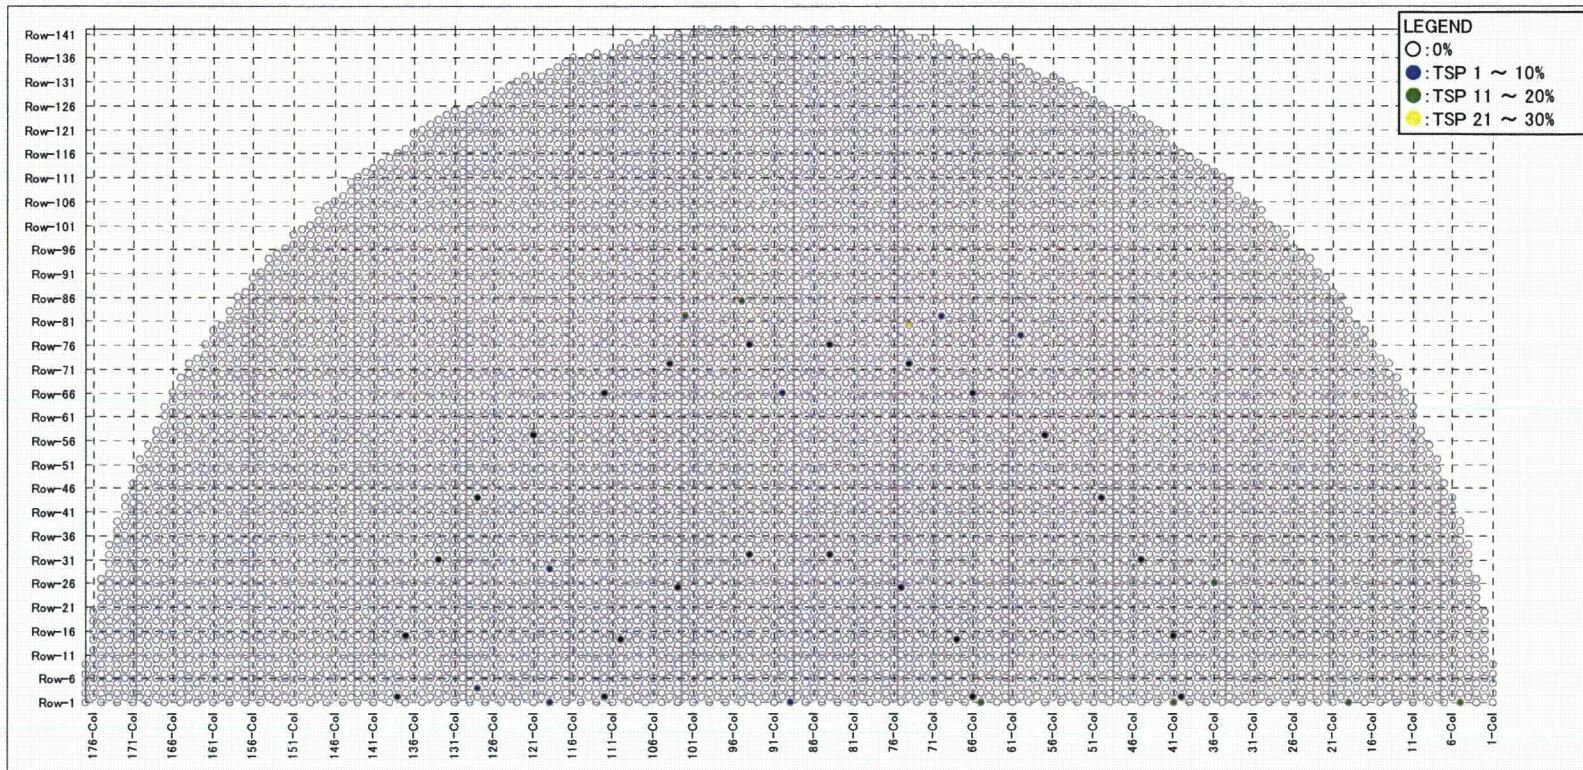
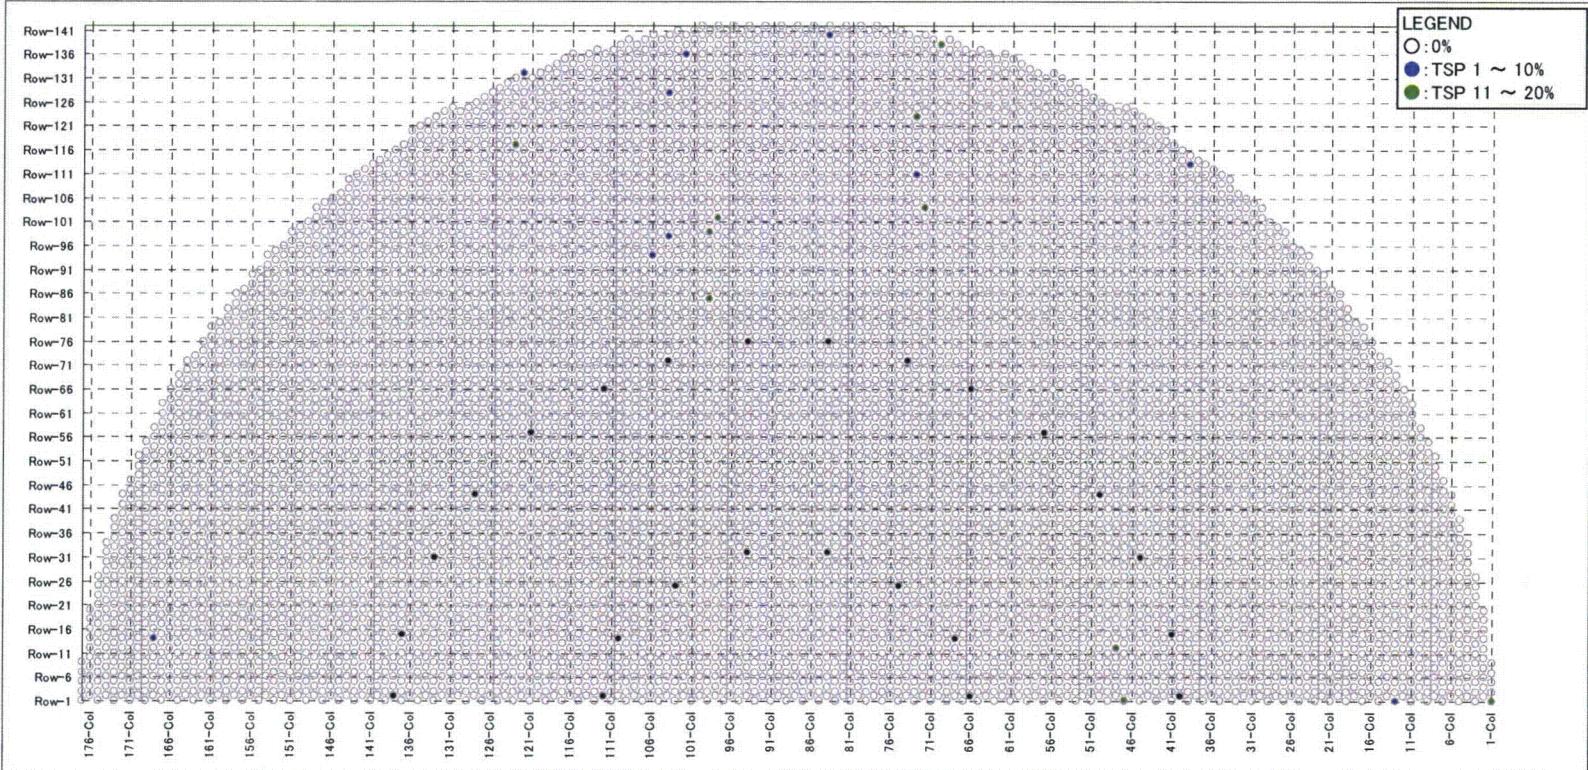
Wear at the tube-to-TSP intersections only in the straight section of the tubes. In this case, it is considered that only the straight section of the tube was vibrating. The tubes with wear at TSPs without wear in the U-bend section are shown in Fig. 4.1.1-3; the tubes with wear at TSPs and with wear in the U-bend section are shown in Fig. 4.1.1-4).

Fig 4.1.1-3(1/2) Tubes with wear indications at TSPs only

Fig 4.1.1-3(2/2) Tubes with wear indications at TSPs only

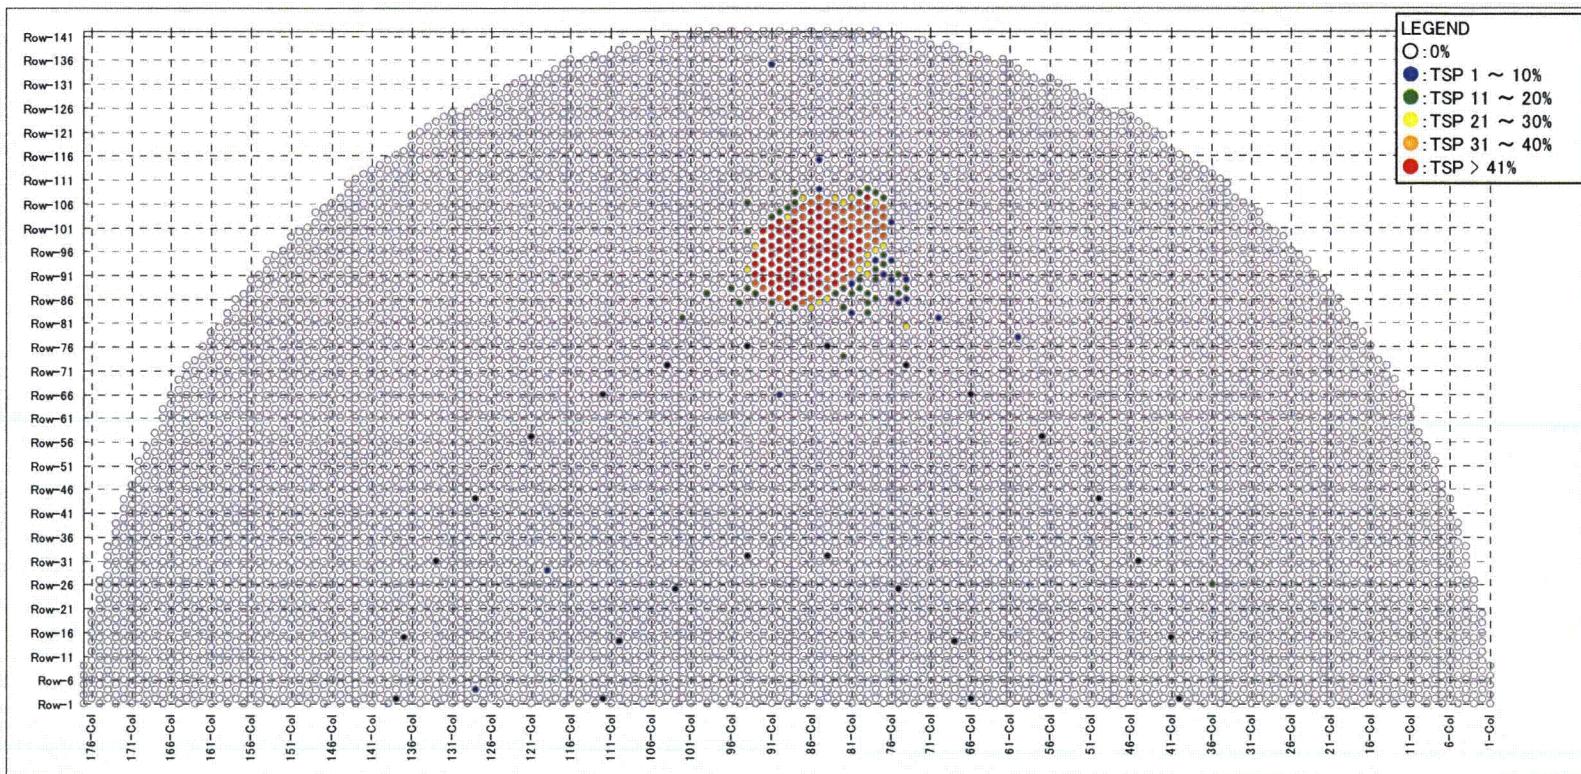
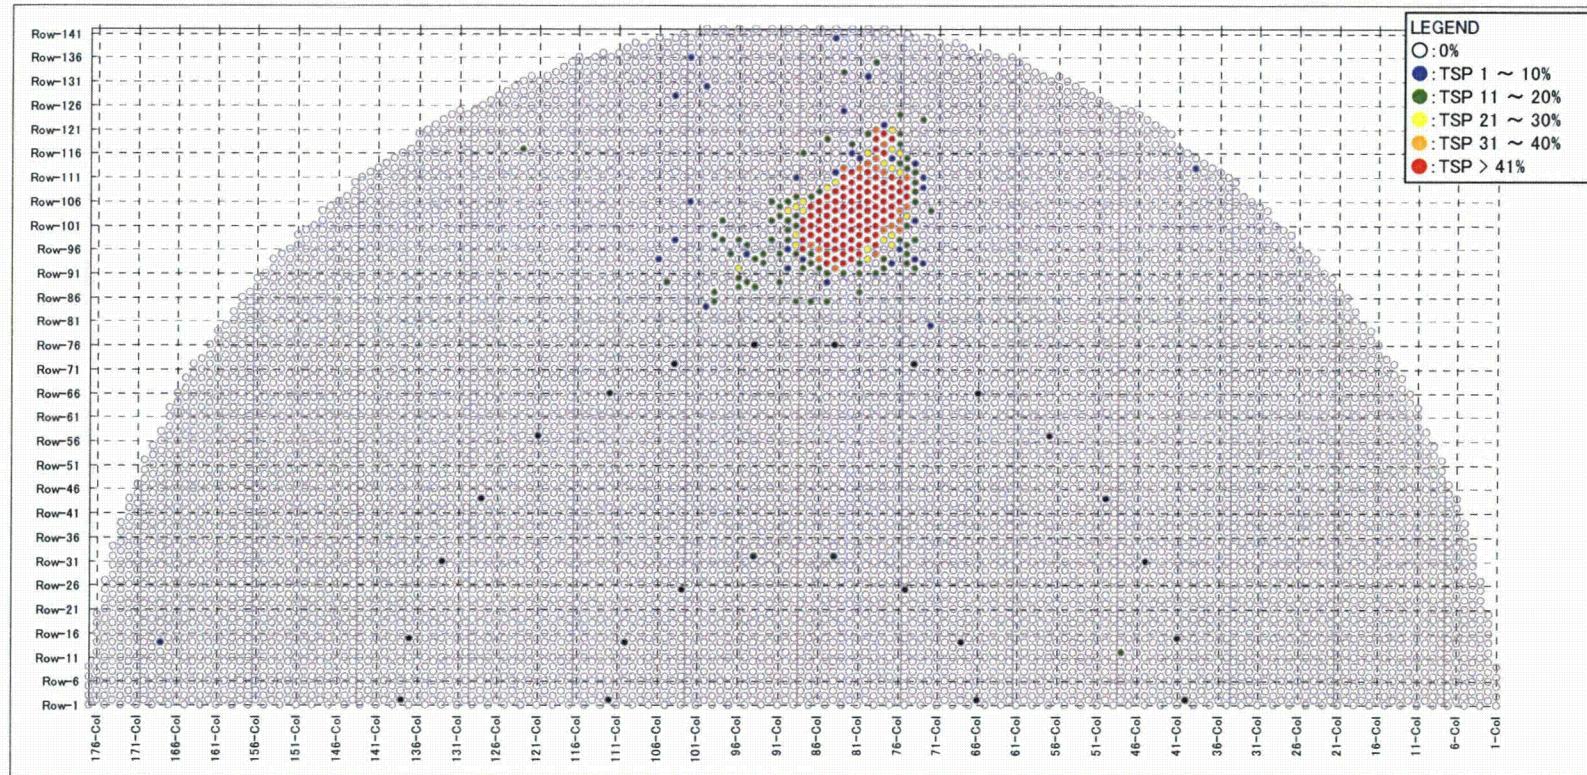
Fig 4.1.1-4(1/2) Tubes with wear indications at TSPs and TTW indications

Fig 4.1.1-4(2/2) Tubes with wear indications at TSPs and TTW indications

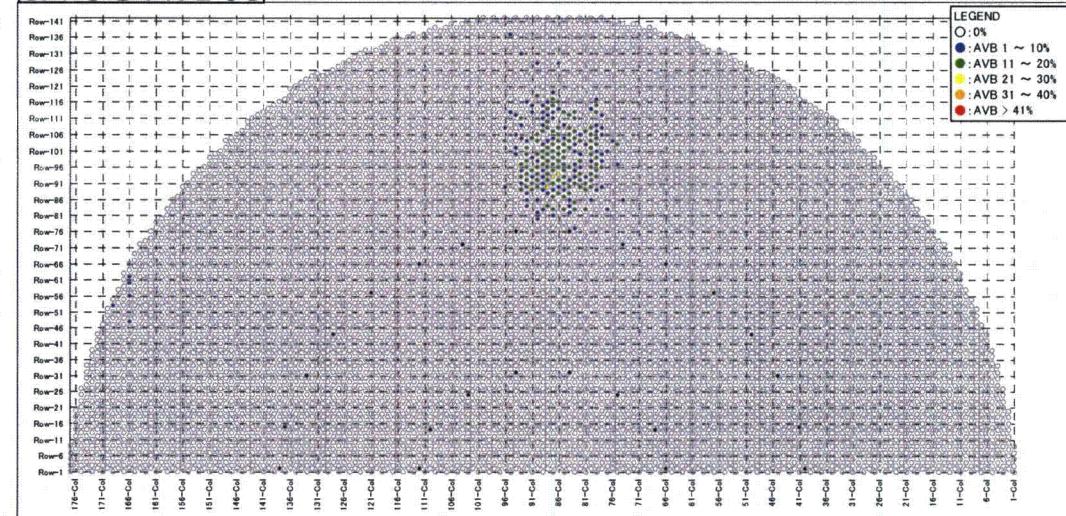
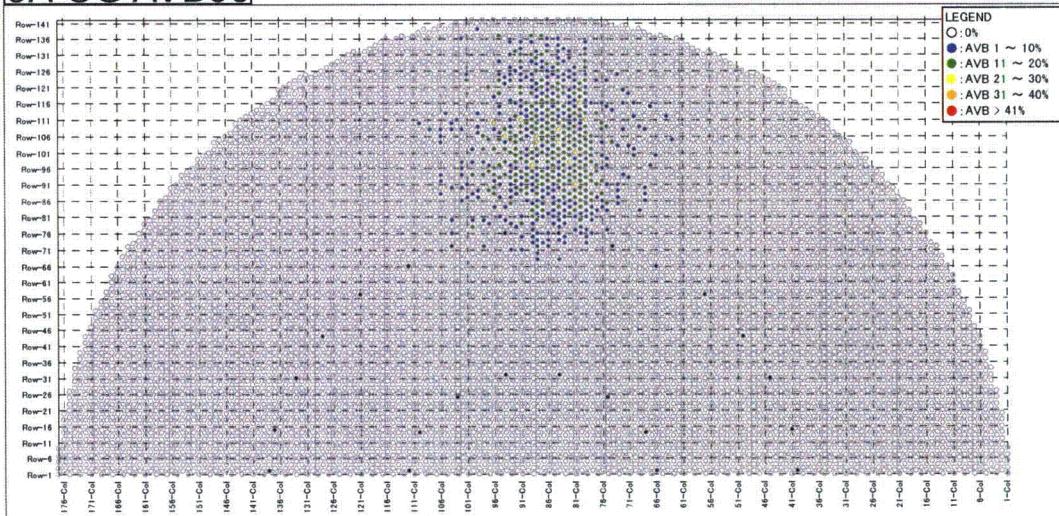
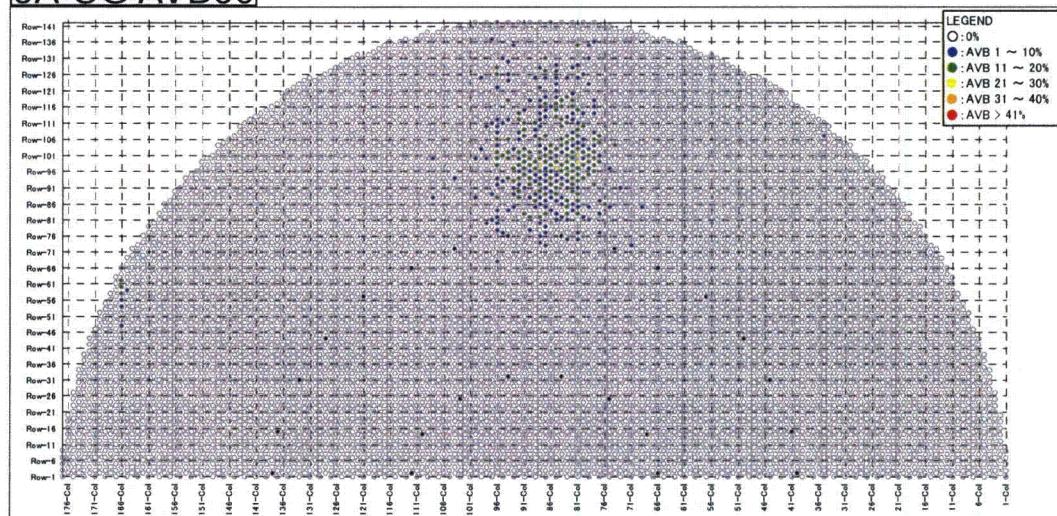
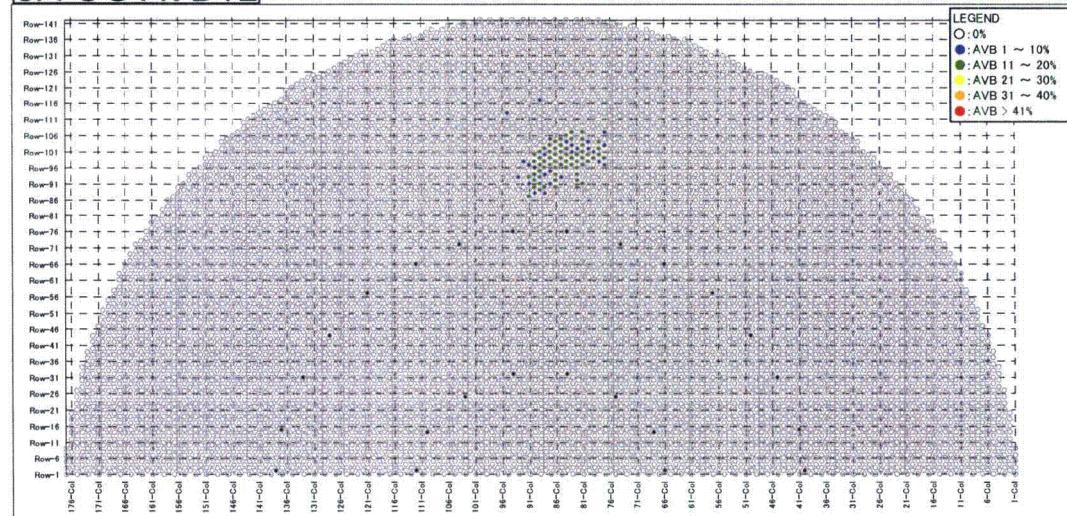
Fig 4.1.1-5 (1/4) Tubes with wear indication (at AVBs)

Fig 4.1.1-5 (2/4) Tubes with wear indication (at AVBs)

Fig 4.1.1-5 (3/4) Tubes with wear indication (at AVBs)

Fig 4.1.1-5 (4/4) Tubes with wear indication (at AVBs)

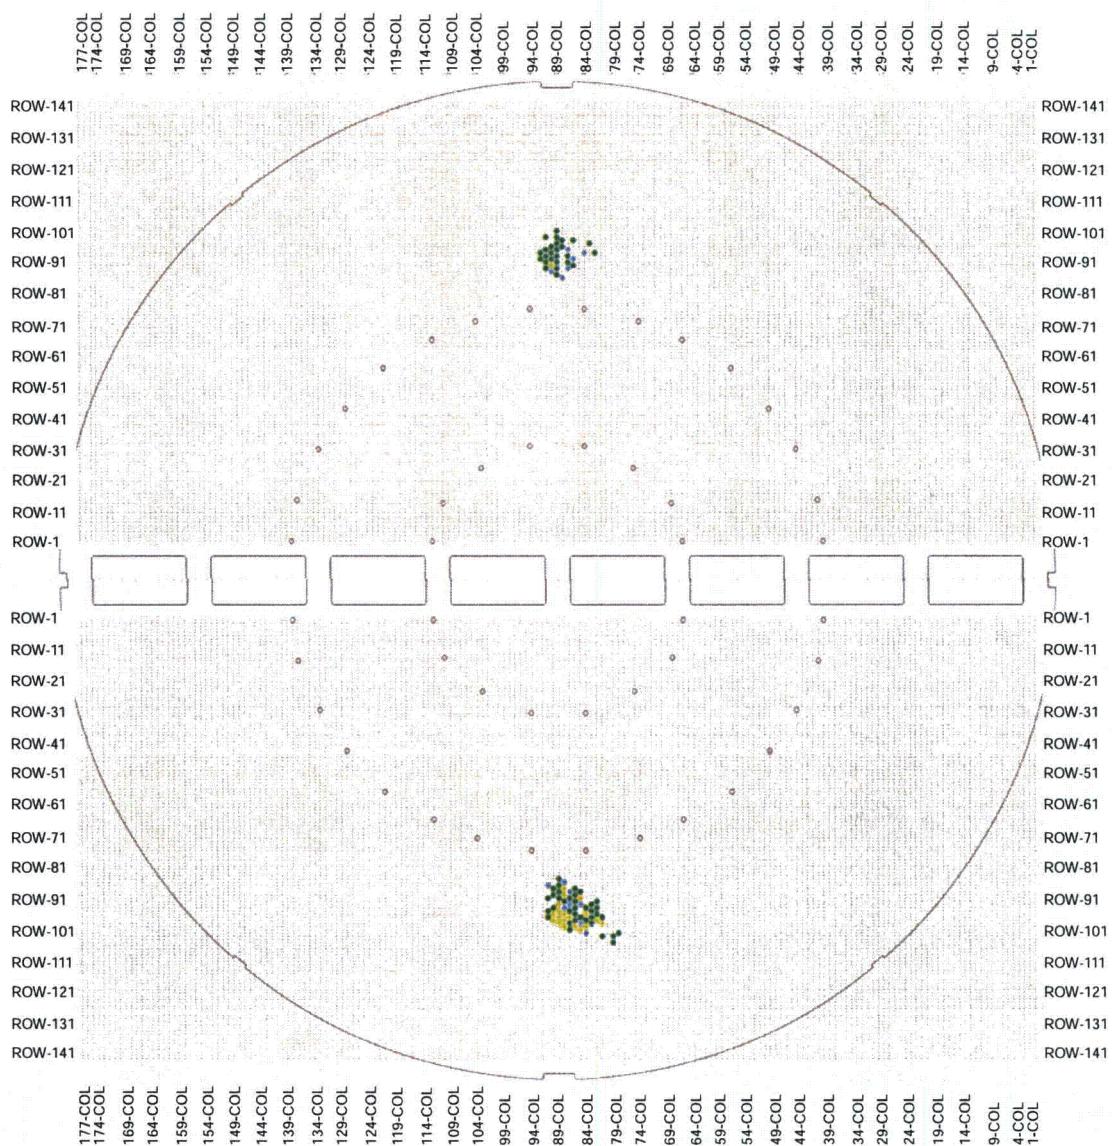
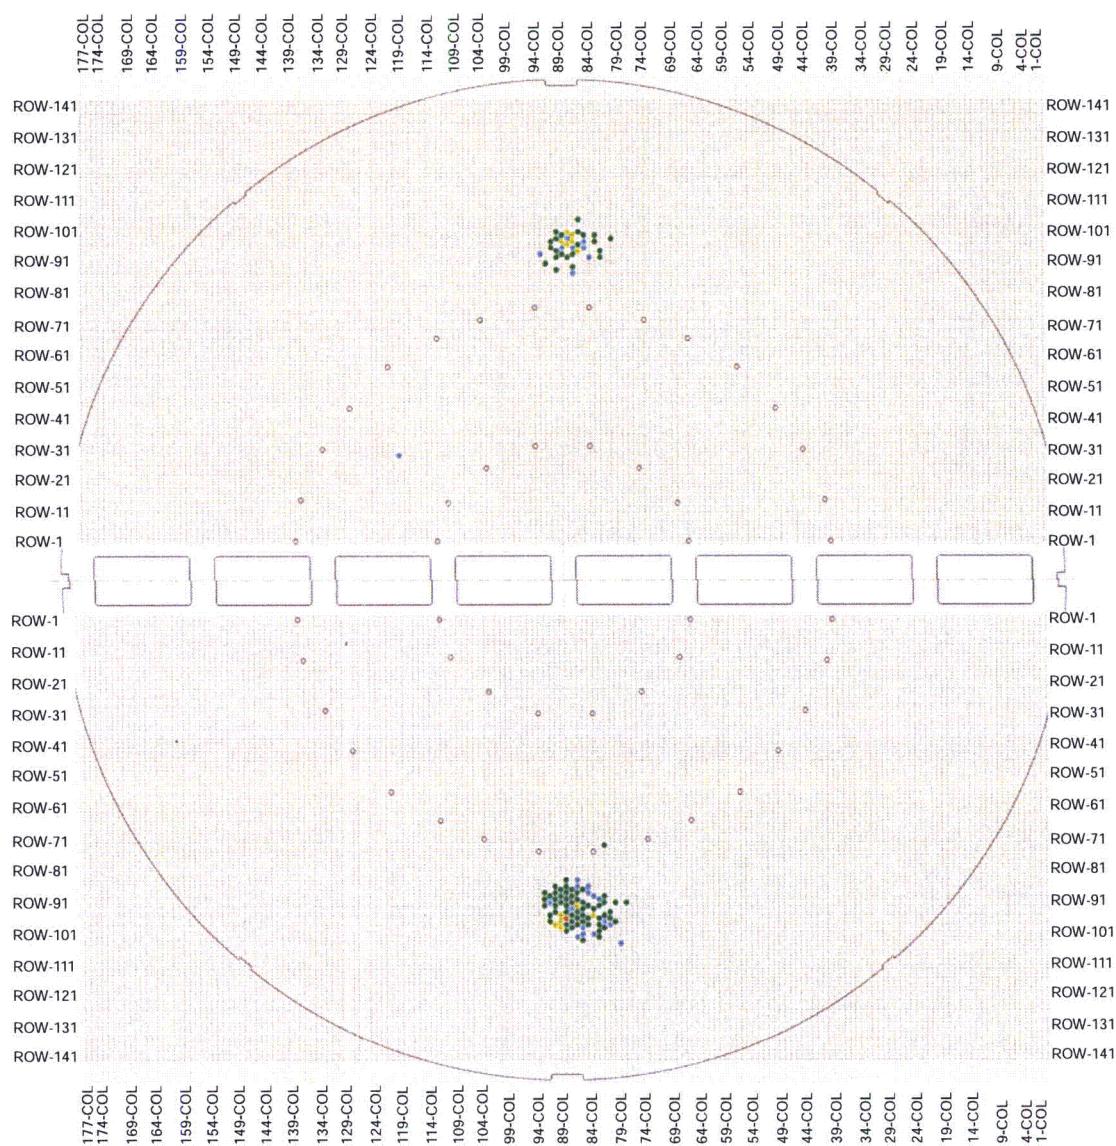
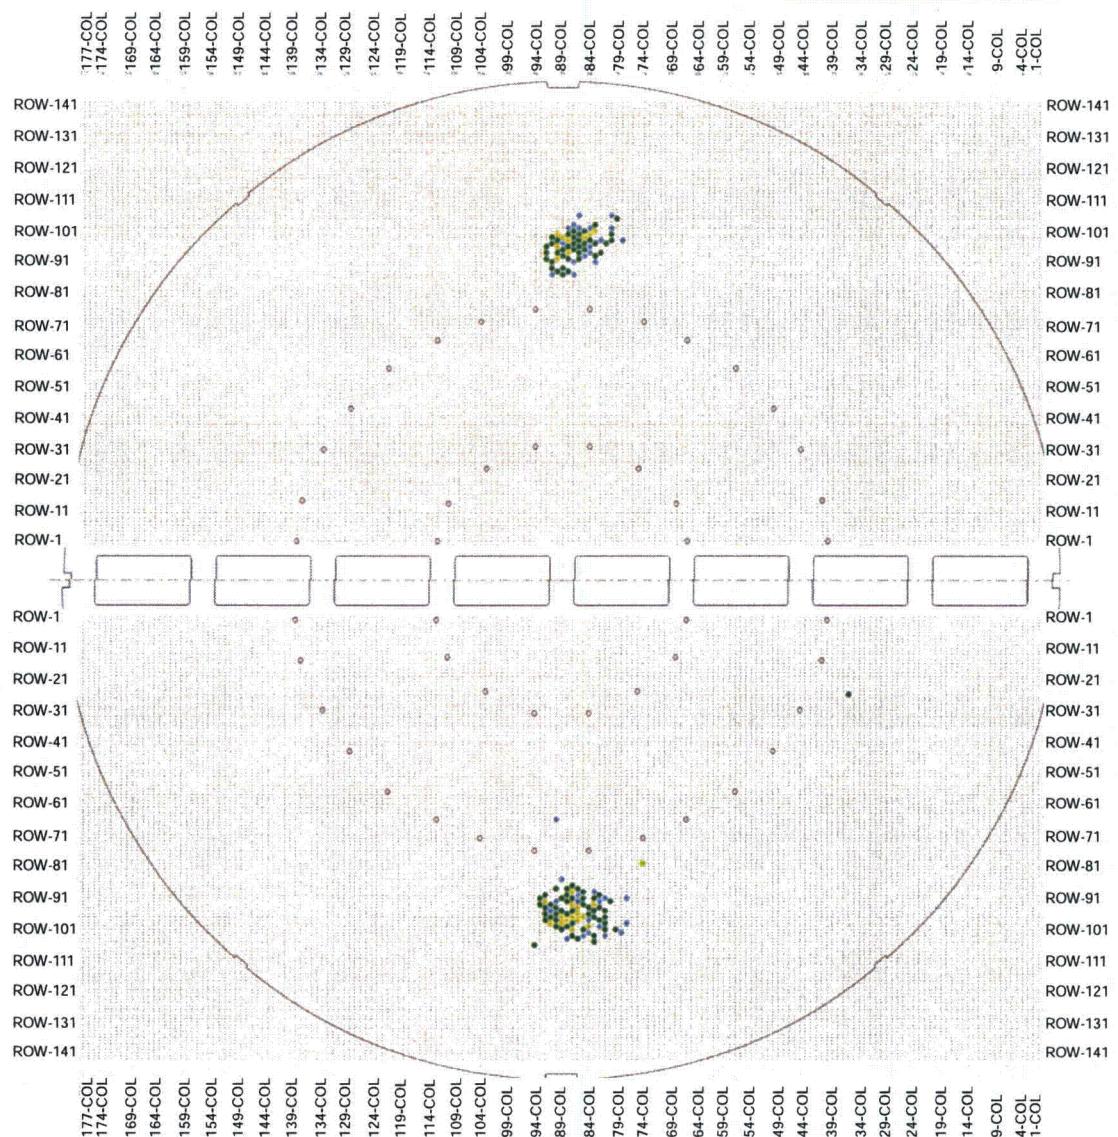
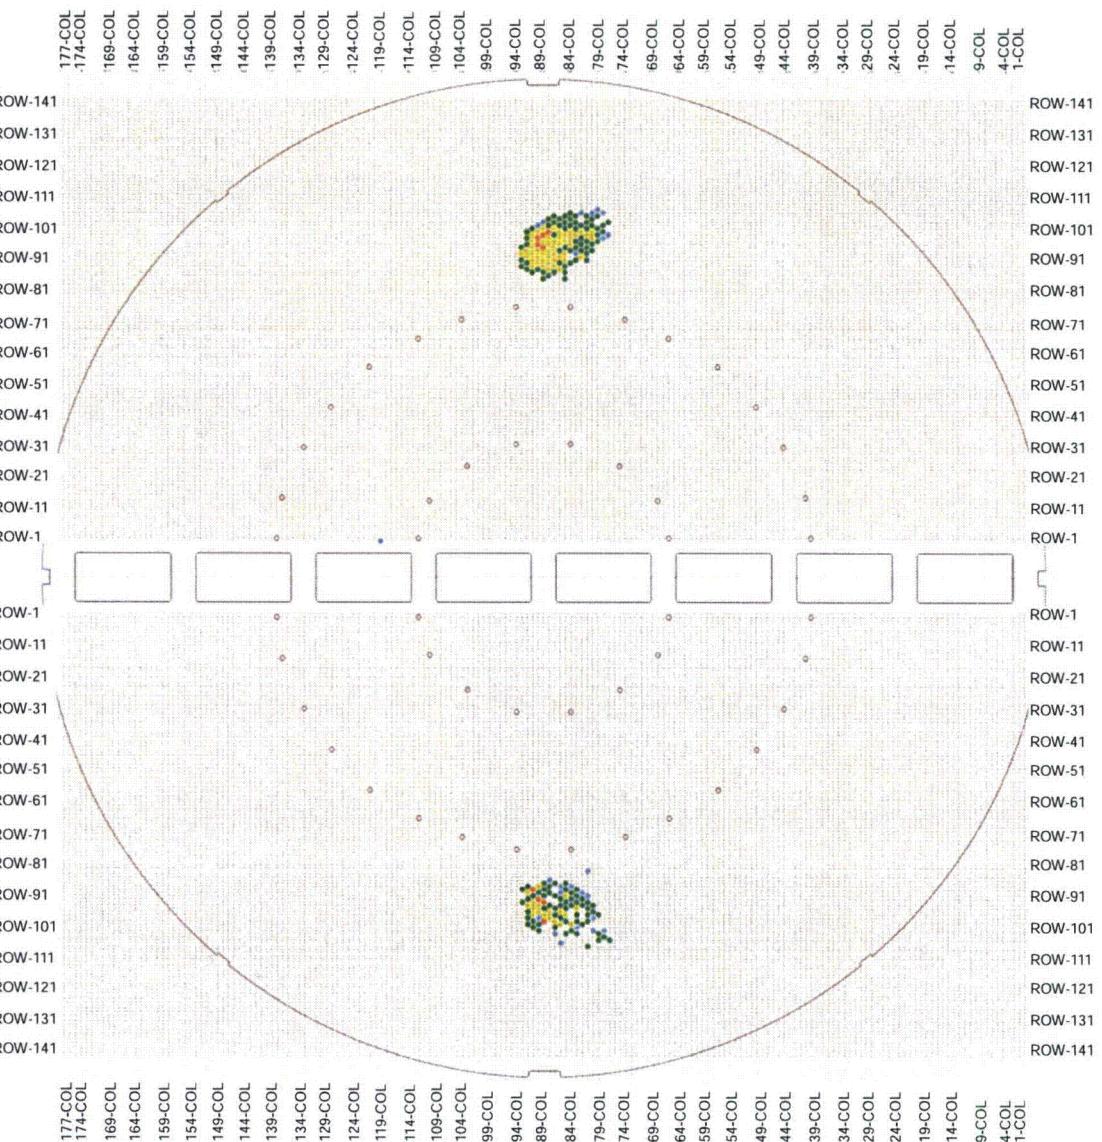
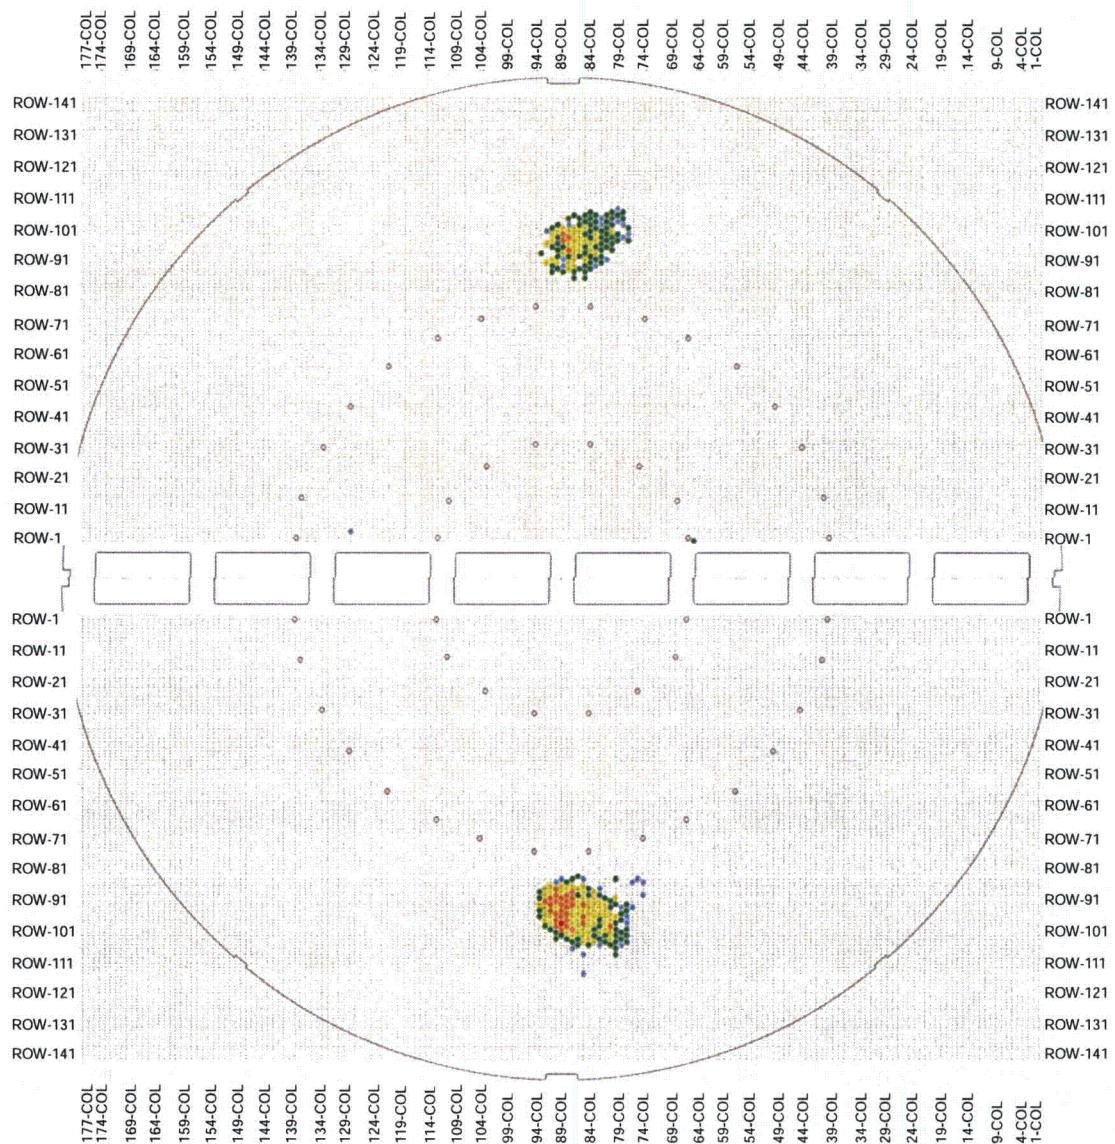
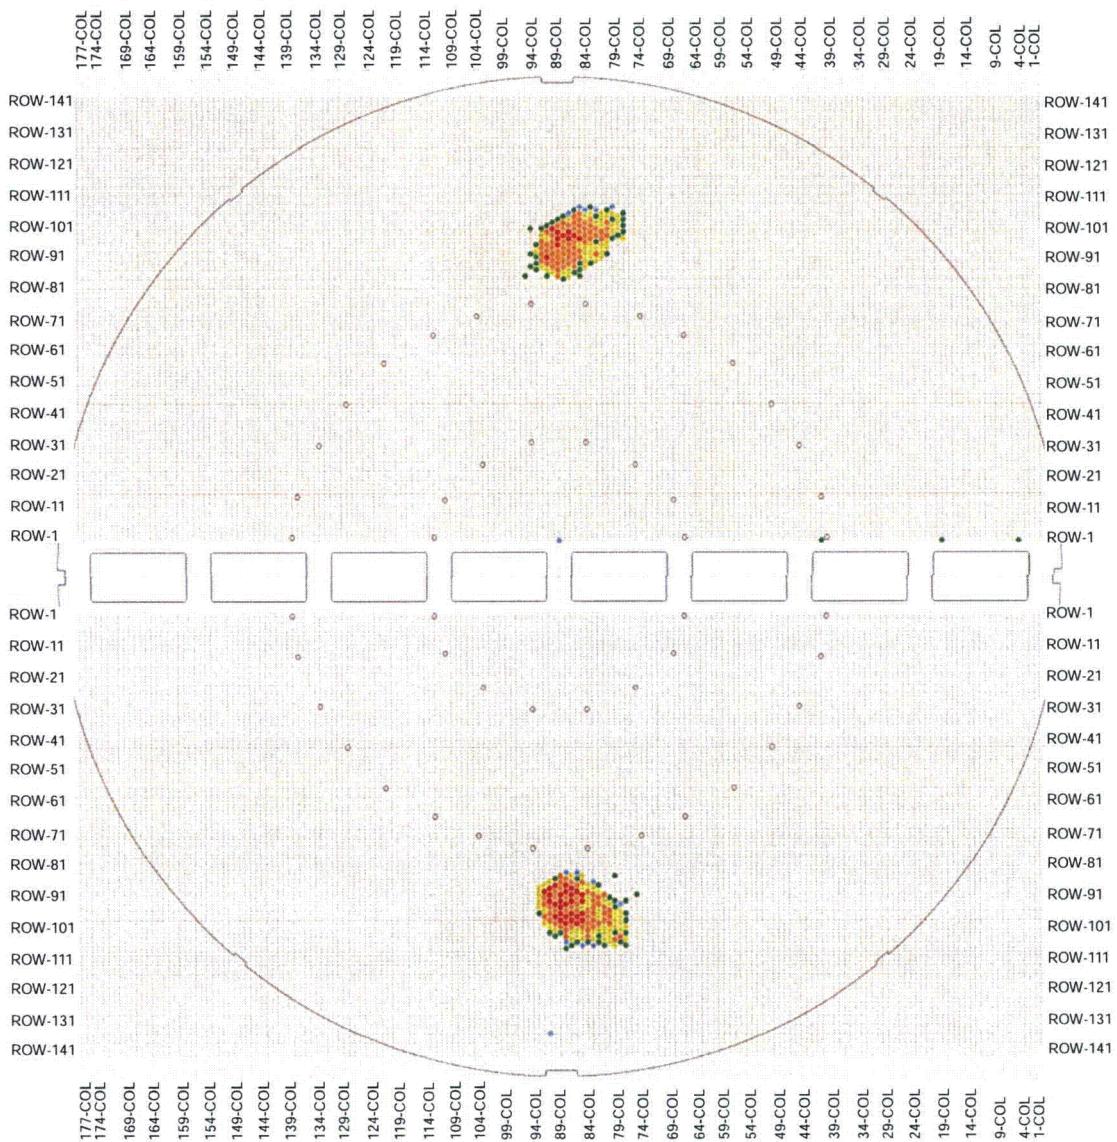
Fig 4.1.1-6 (1/7) Tubes with wear indications at TSPs

Fig 4.1.1-6 (2/7) Tubes with wear indications at TSPs

Fig 4.1.1-6 (3/7) Tubes with wear indications at TSPs

Fig 4.1.1-6 (4/7) Tubes with wear indications at TSPs

Fig 4.1.1-6 (5/7) Tubes with wear indications at TSPs

Fig 4.1.1-6 (6/7) Tubes with wear indications at TSPs
