## SONGS Unit 2 Return to Service Report

#### **MHI Document L5-04GA564 Tube Wear of Unit-3 RSG Technical Evaluation Report**

**Tube wear of Unit-3 RSG – Technical Evaluation Report**

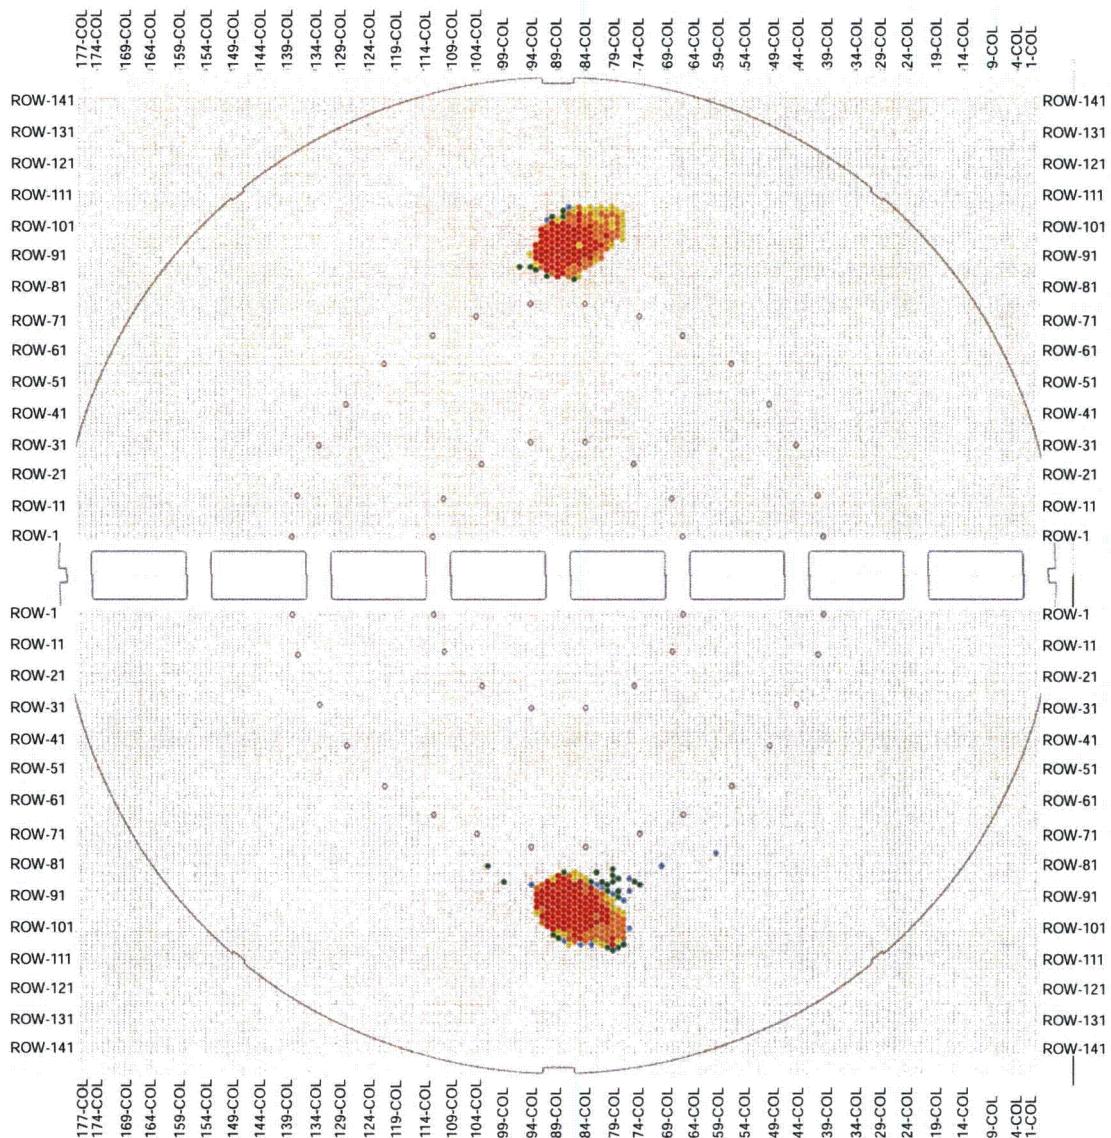
Fig 4.1.1-6 (7/7) Tubes with wear indications at TSPs

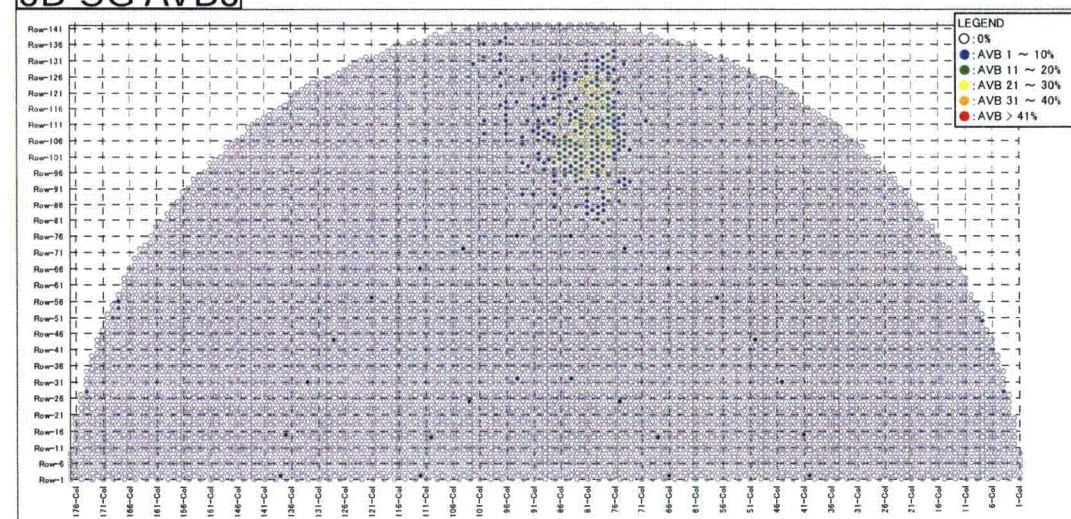
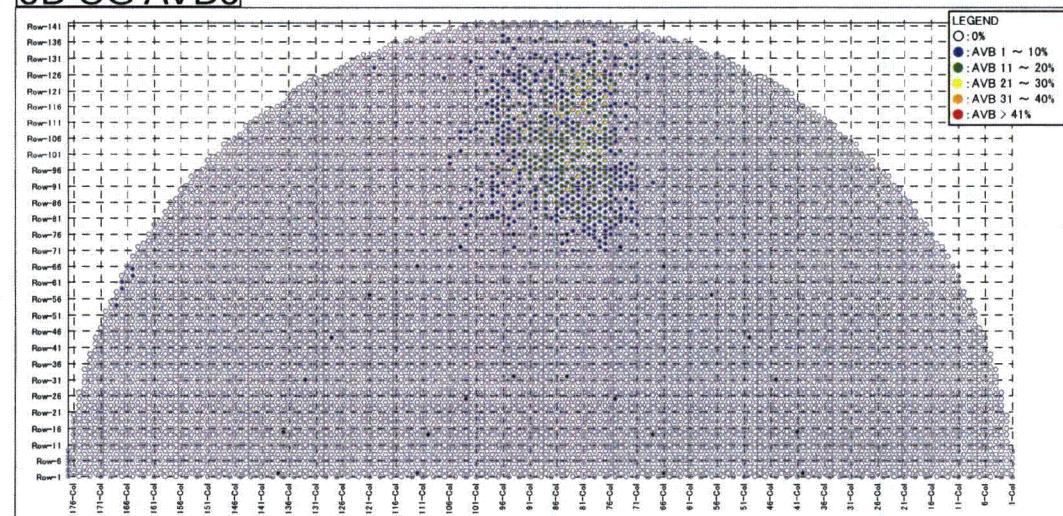
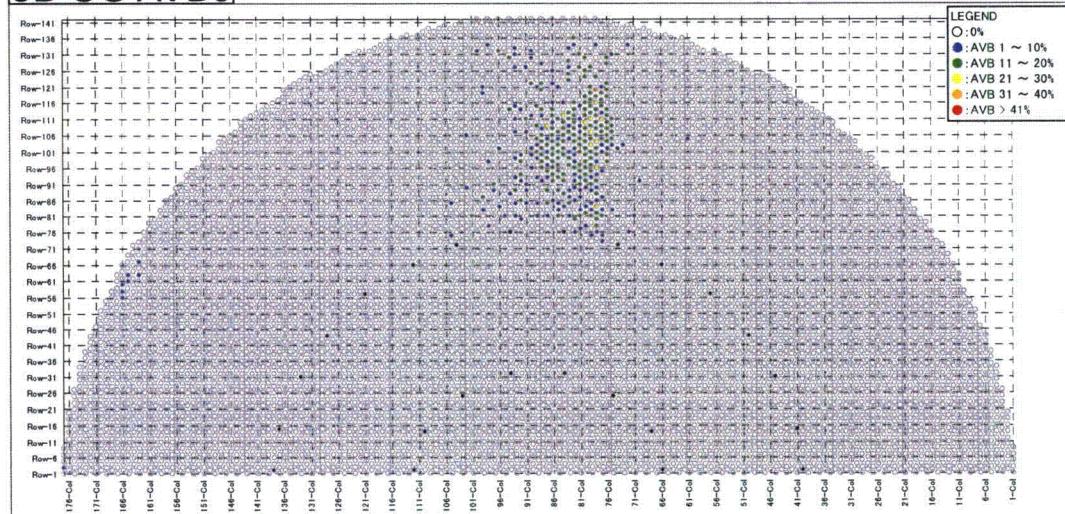
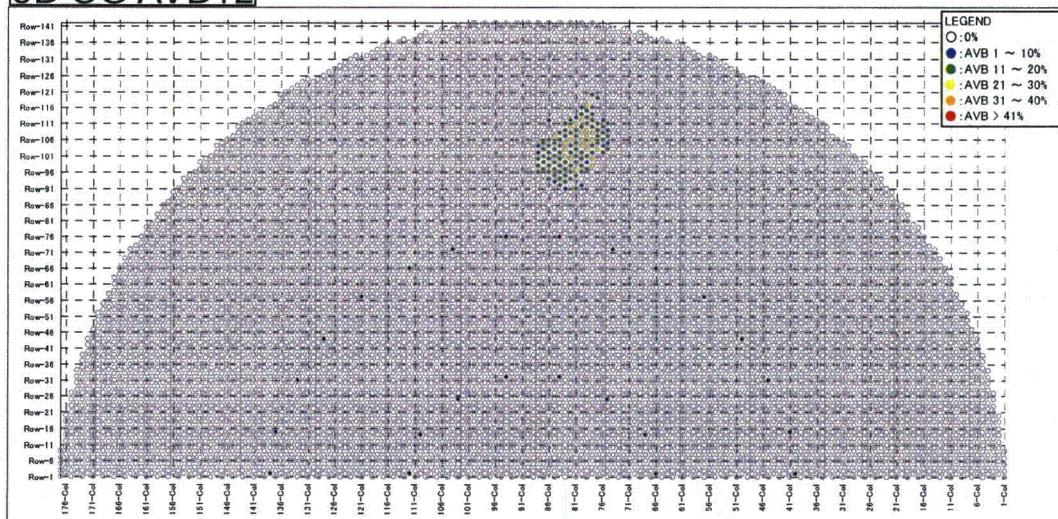
Fig 4.1.1-7 (1/4) Tubes with wear indication (at AVBs)

Fig 4.1.1-7 (2/4) Tubes with wear indication (at AVBs)

Fig 4.1.1-7 (3/4) Tubes with wear indication (at AVBs)

Fig 4.1.1-7 (4/4) Tubes with wear indication (at AVBs)

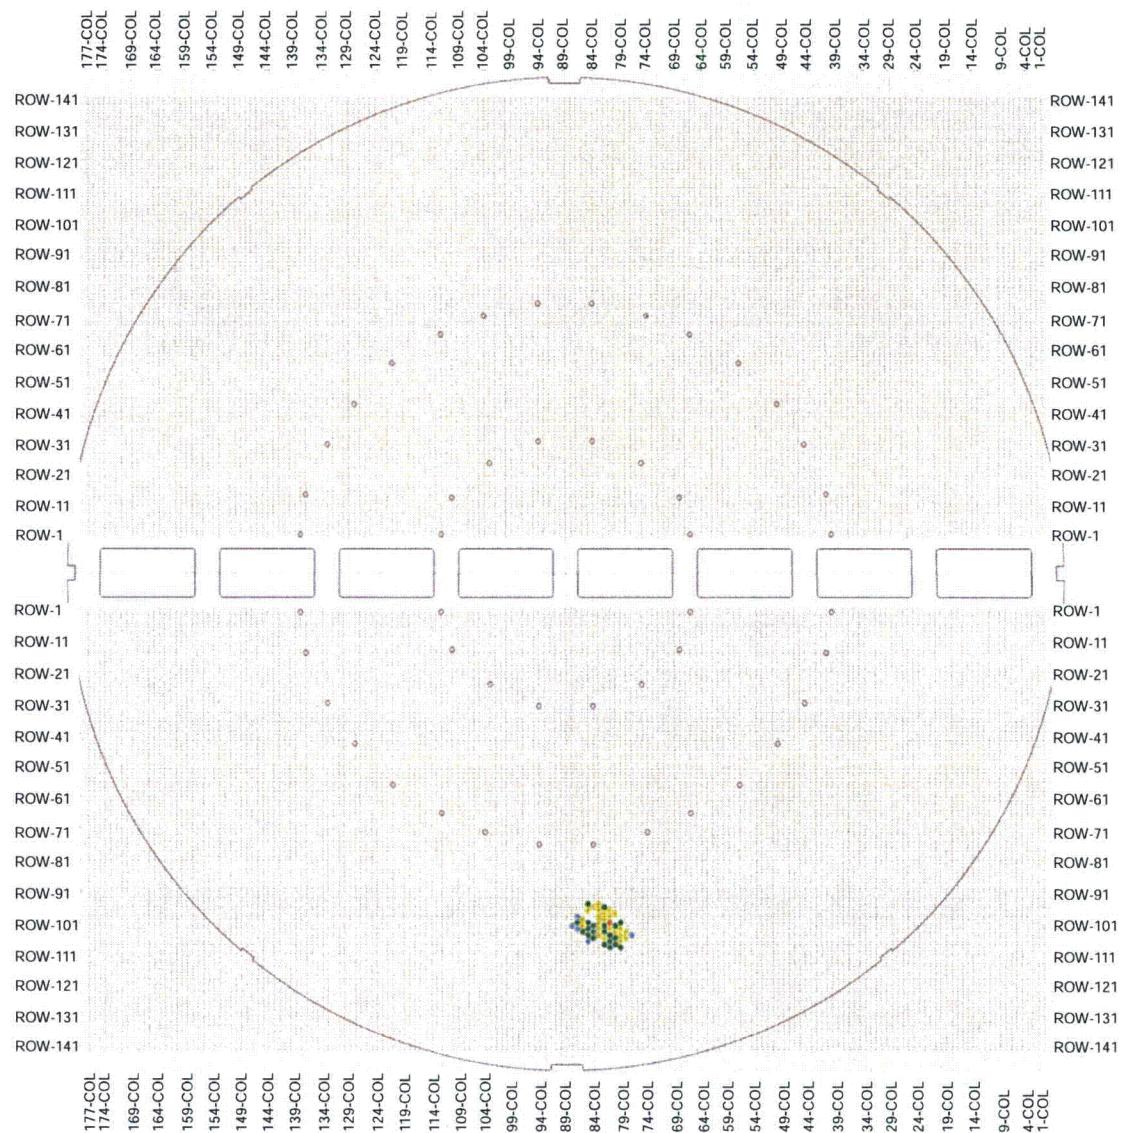
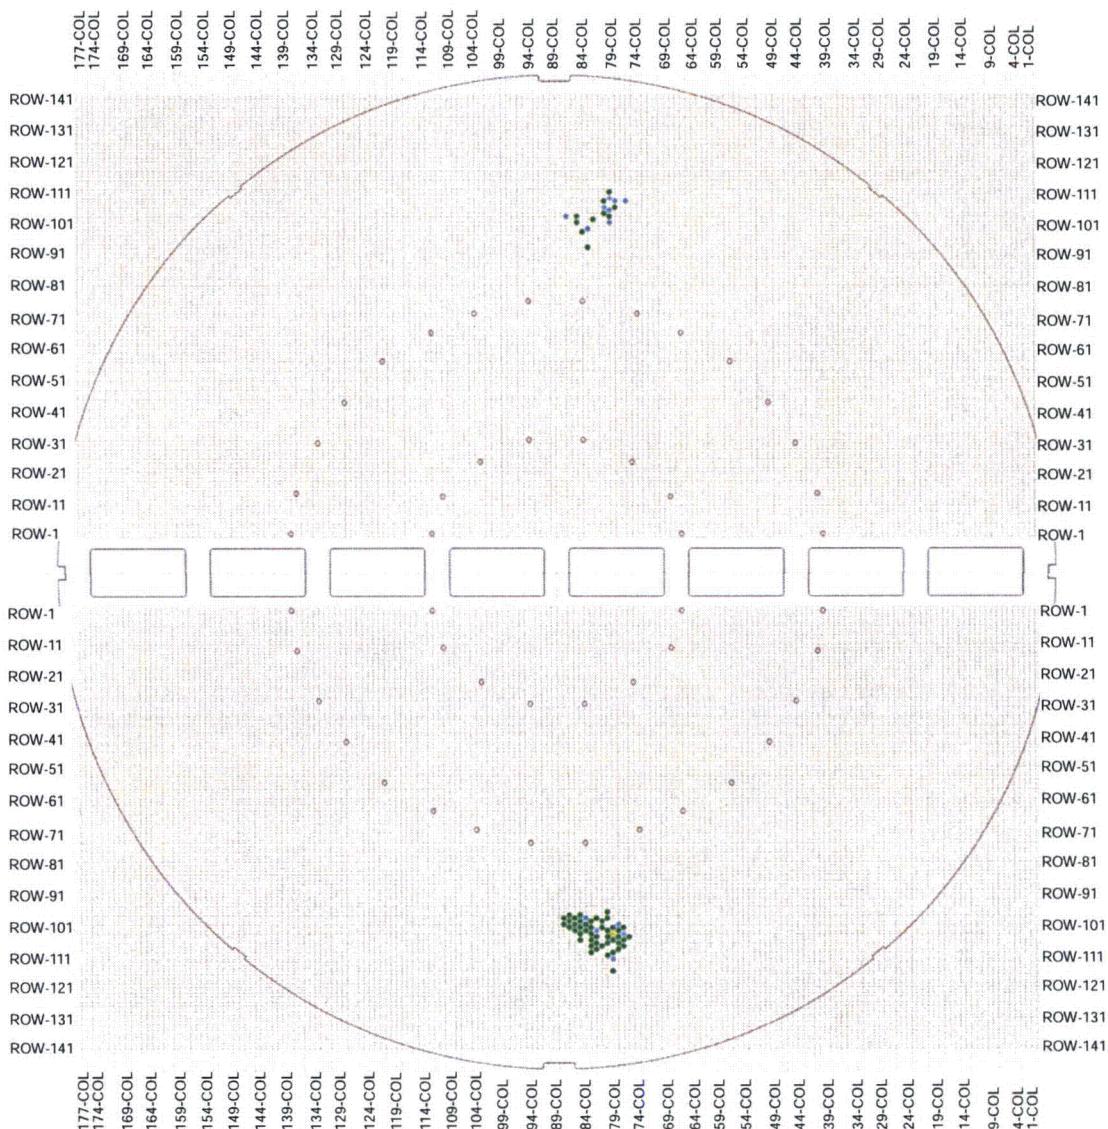
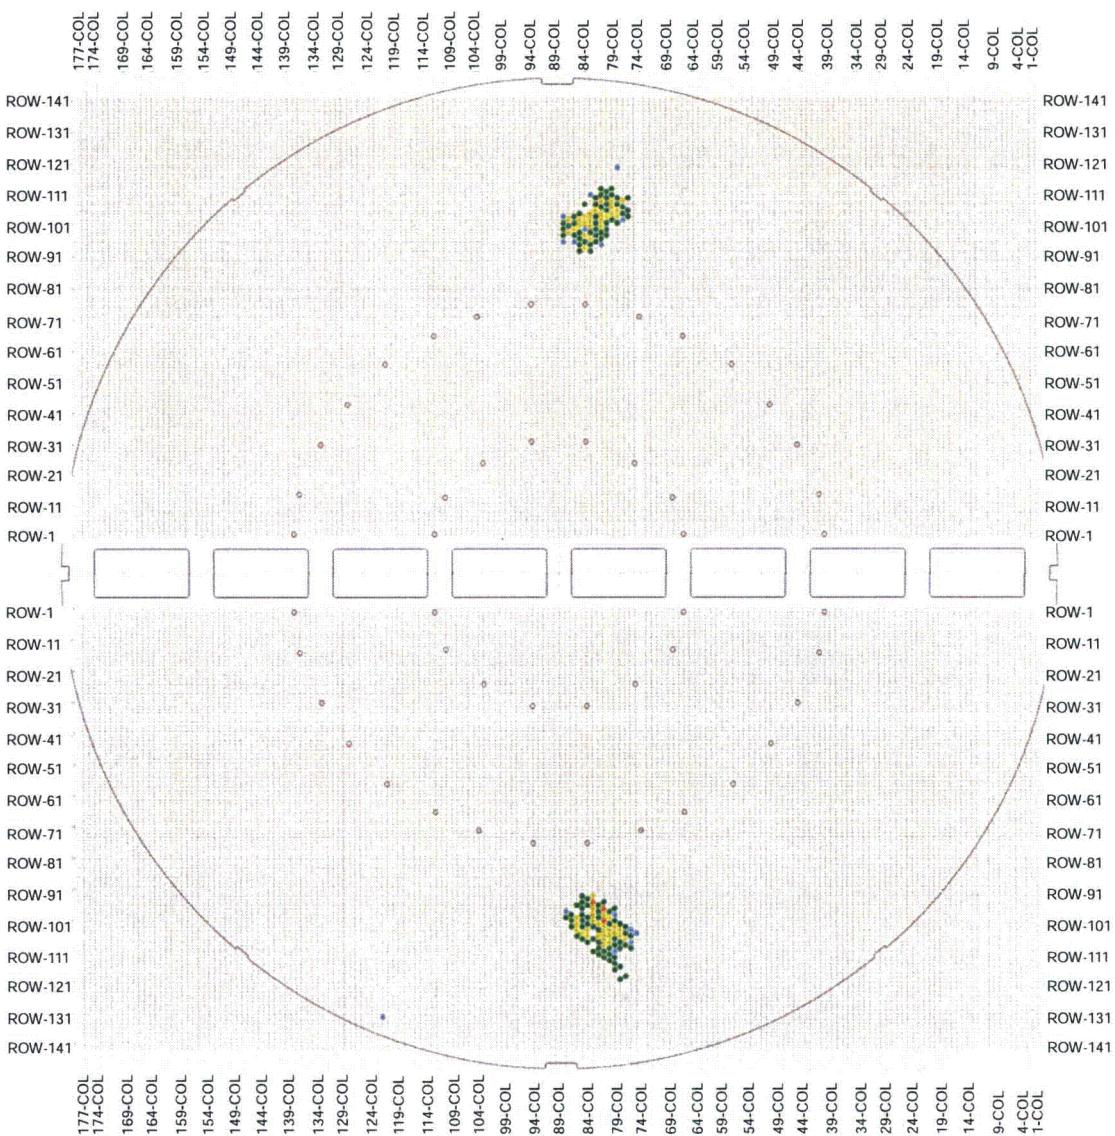
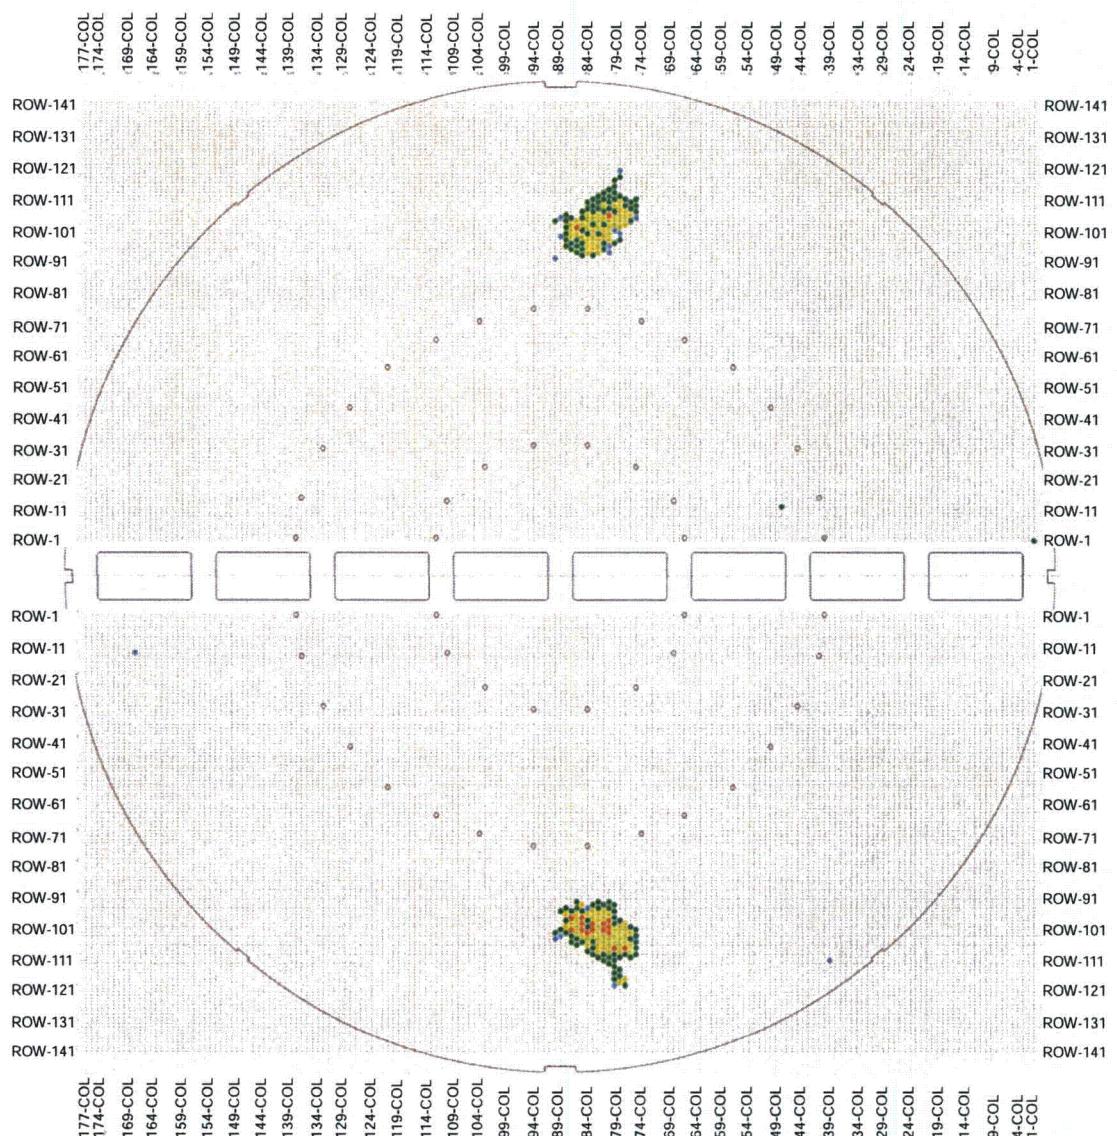
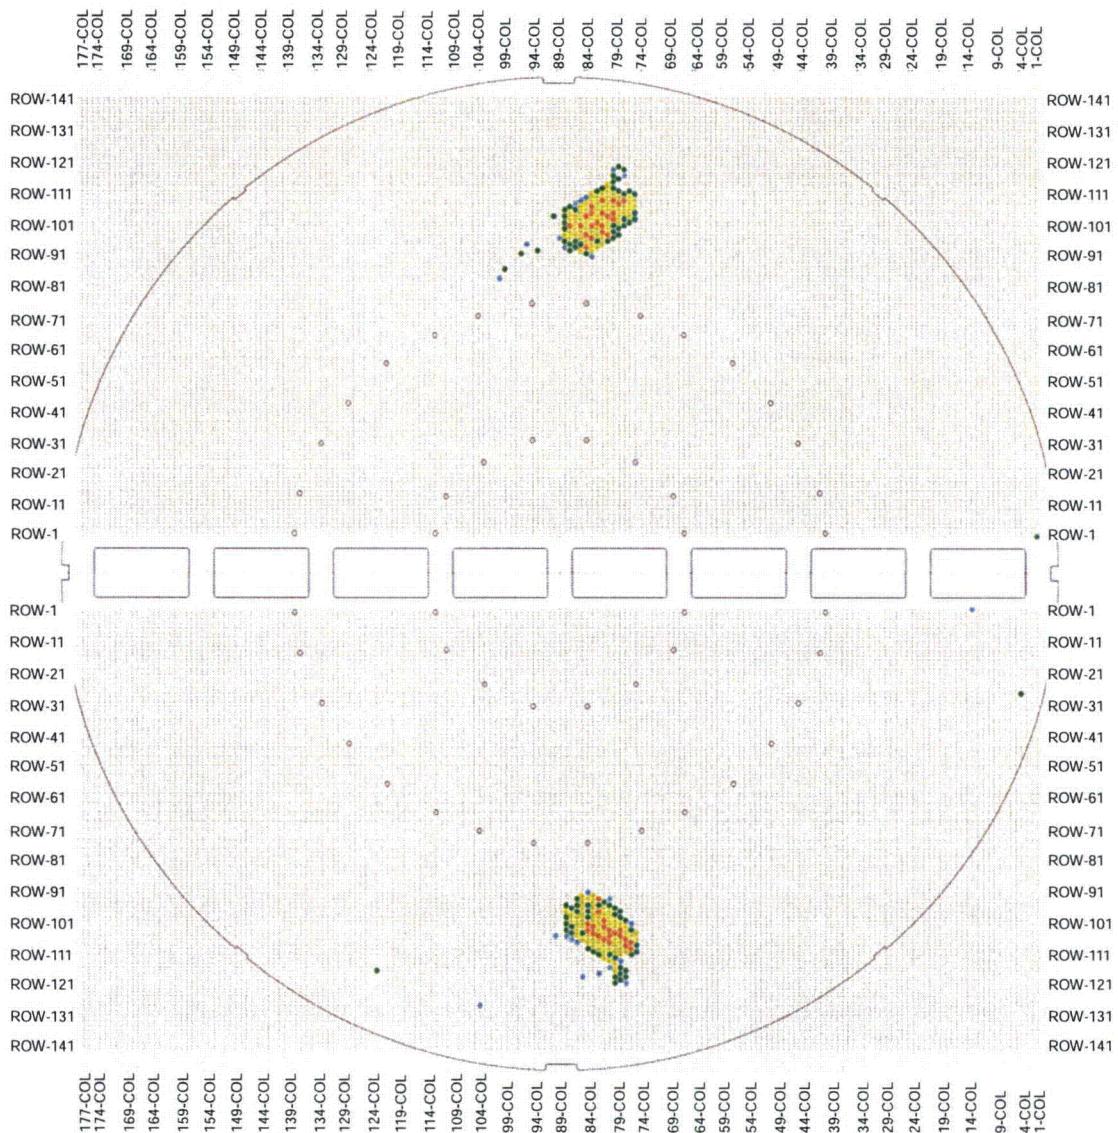
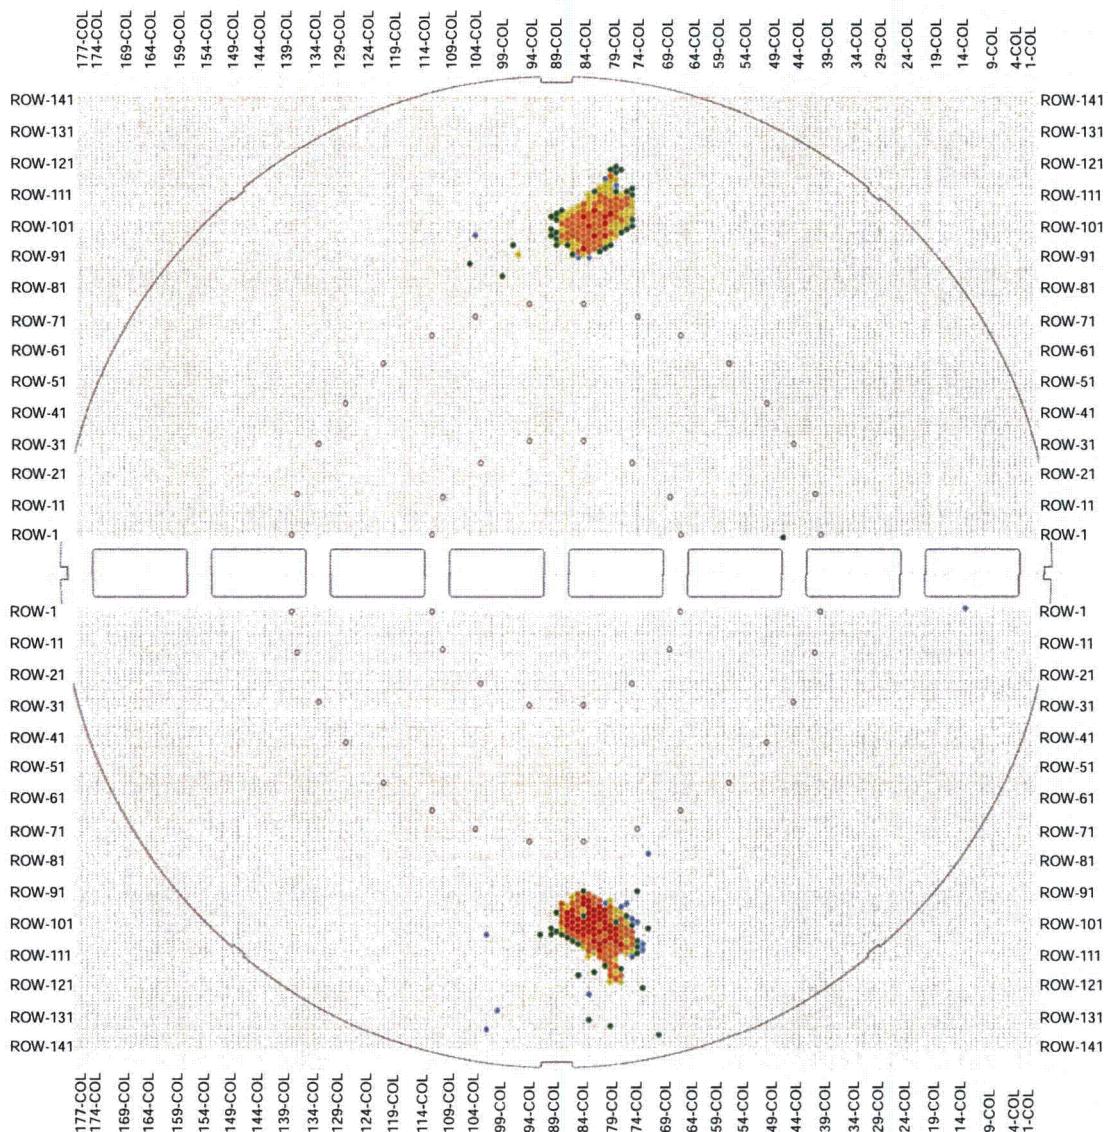
Fig 4.1.1-8 (1/7) Tubes with wear indications at TSPs

Fig 4.1.1-8 (2/7) Tubes with wear indications at TSPs

Fig 4.1.1-8 (3/7) Tubes with wear indications at TSPs

Fig 4.1.1-8 (4/7) Tubes with wear indications at TSPs

Fig 4.1.1-8 (5/7) Tubes with wear indications at TSPs

Fig 4.1.1-8 (6/7) Tubes with wear indications at TSPs

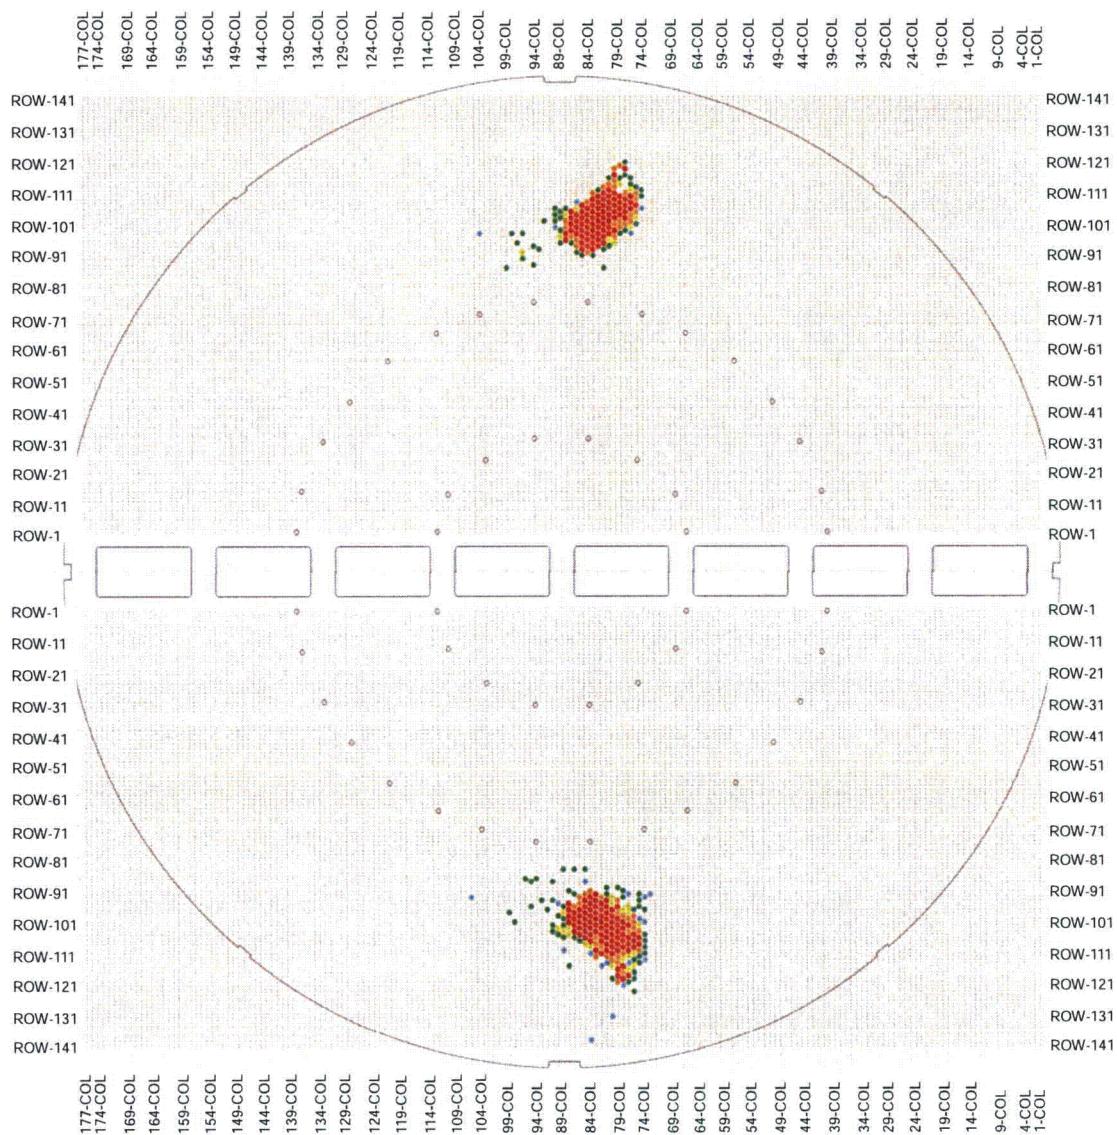
Fig 4.1.1-8 (7/7) Tubes with wear indications at TSPs

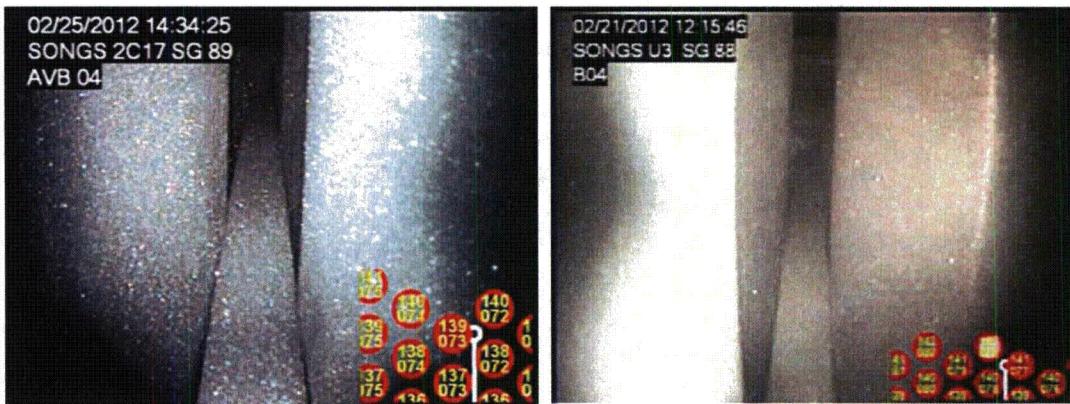
Pattern 2 wear seen in Unit-3 was also seen on the tubes with the Type 2 wear tubes.

Sample from SG-2A

Sample from SG-3B

Fig.4.2-1 Condition of Tube Wear in SONGS Unit-2 and Unit-3

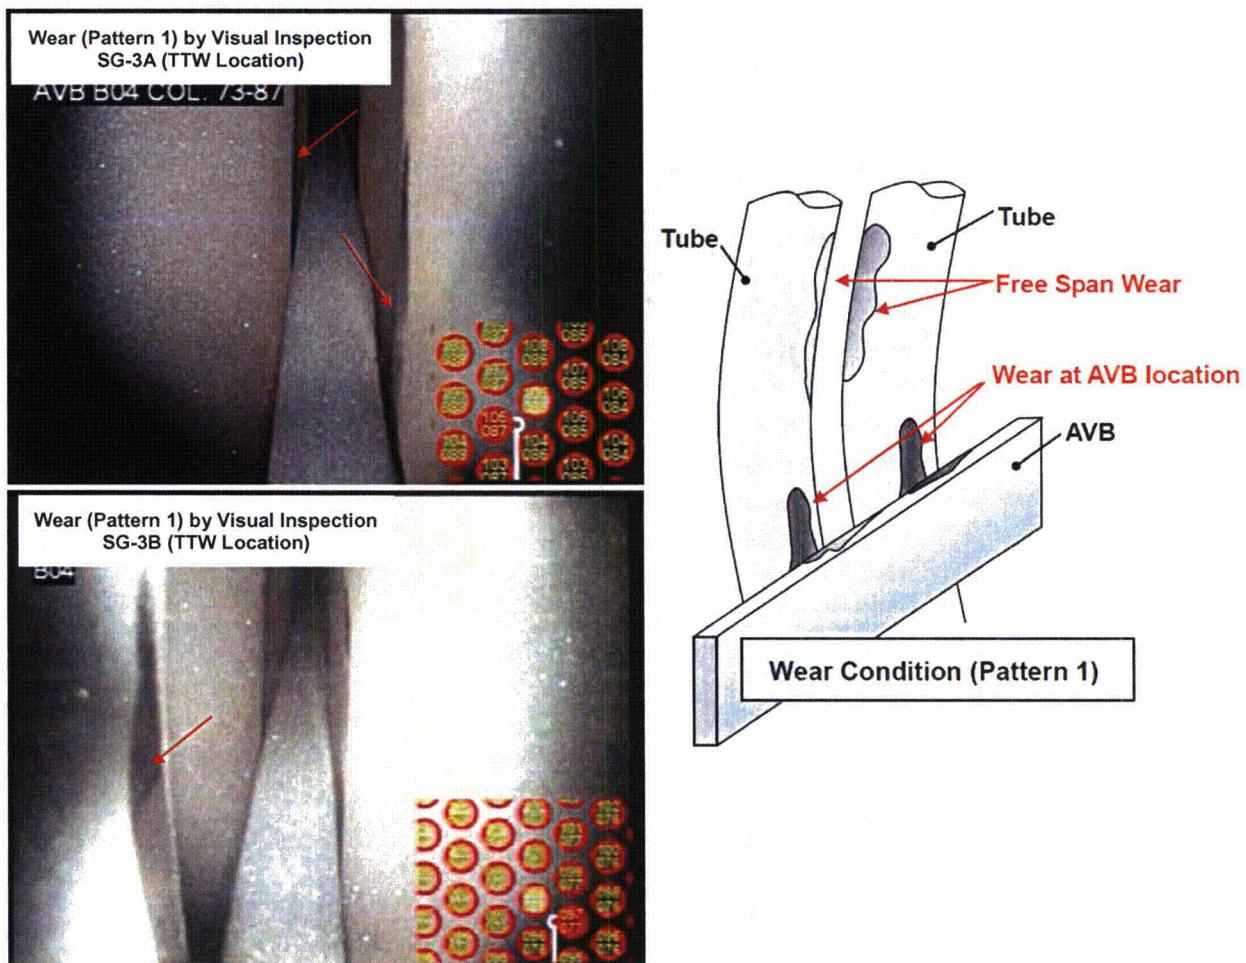
Fig.4.2-2 Illustration of Tube Wear Pattern 1

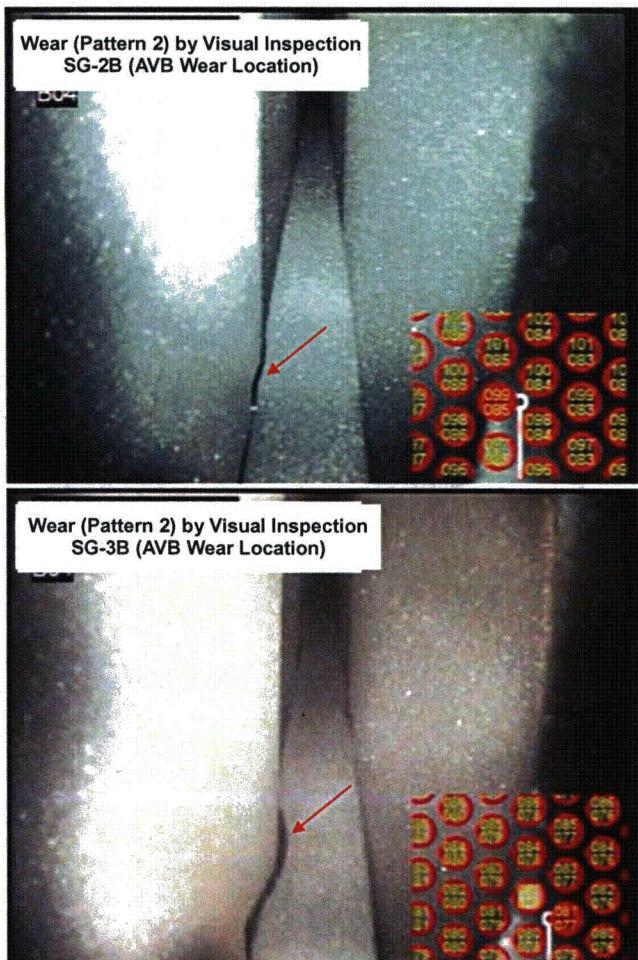
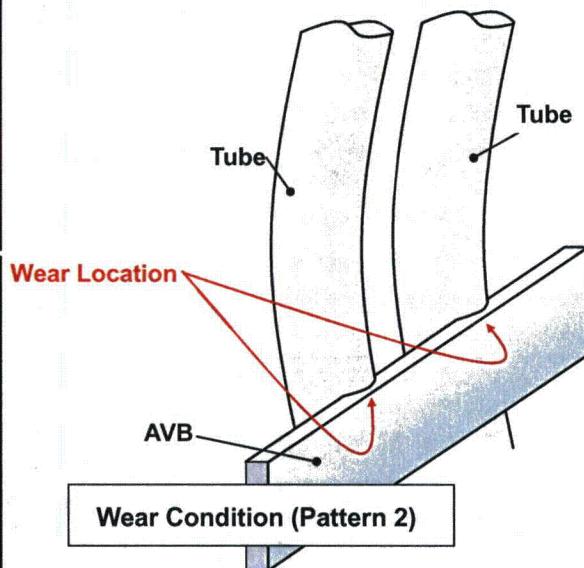
Fig.4.2-3 Illustration of Tube Wear Pattern 2

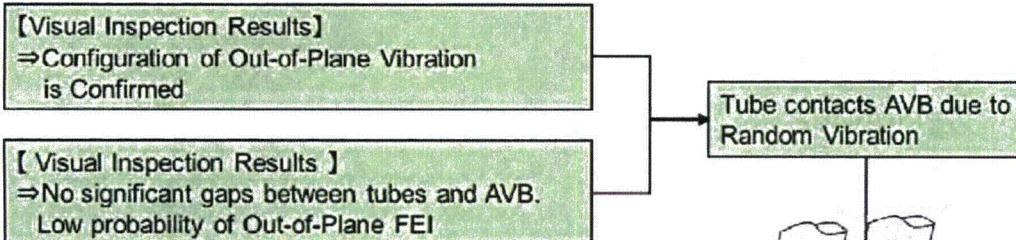
Fig.6.1-1 Type 1 Wear (TTW) Mechanism

- ✓ High Void Fraction Causes High two Phase Flow Average Velocity ⇒ Increase in Vibration Excitation Force
- ✓ High Void Fraction Causes Low Damping

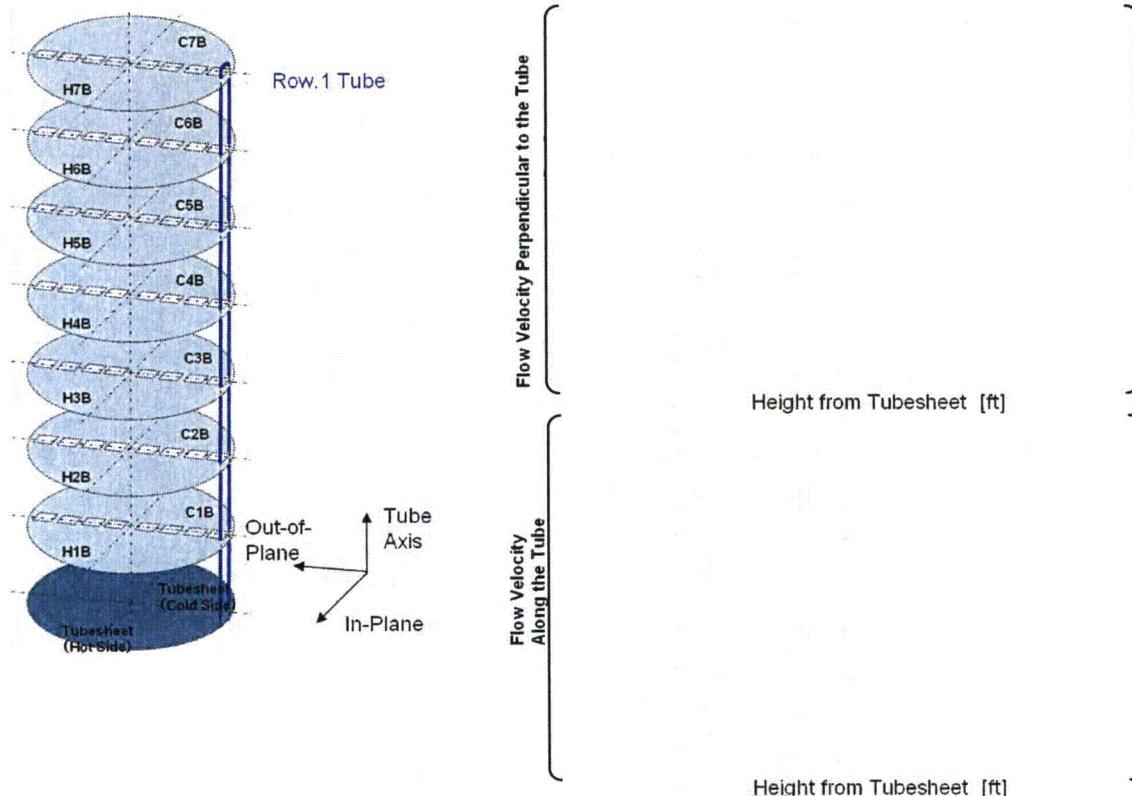
Fig.6.3-1 Flow Velocity Distribution at TSPs

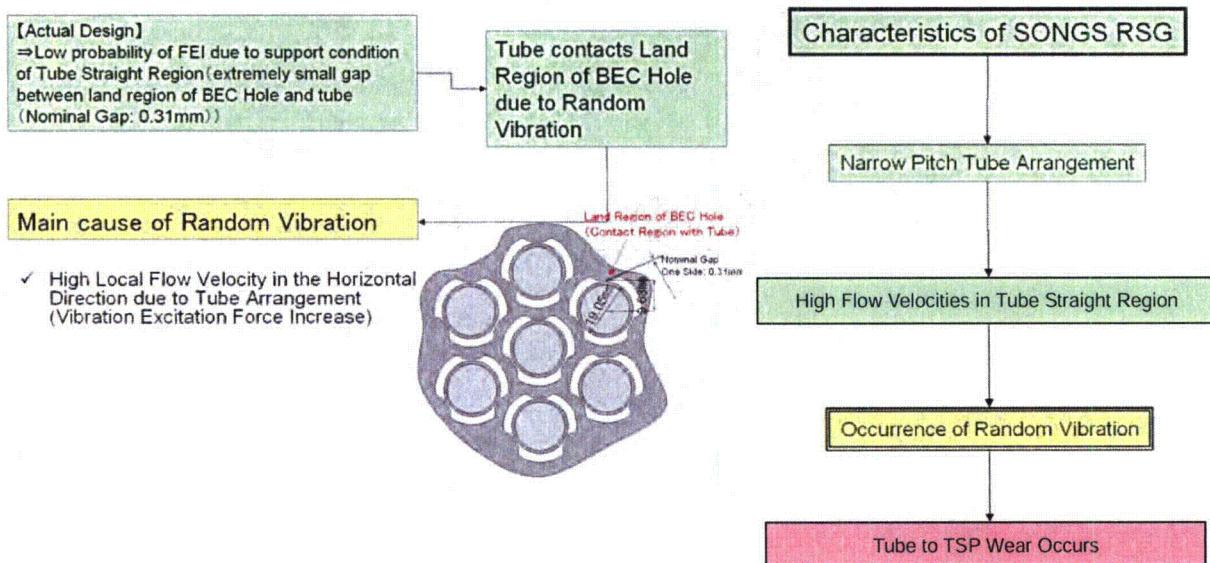
Fig.6.3-2 Type 3 Wear (TSP wear) Mechanism

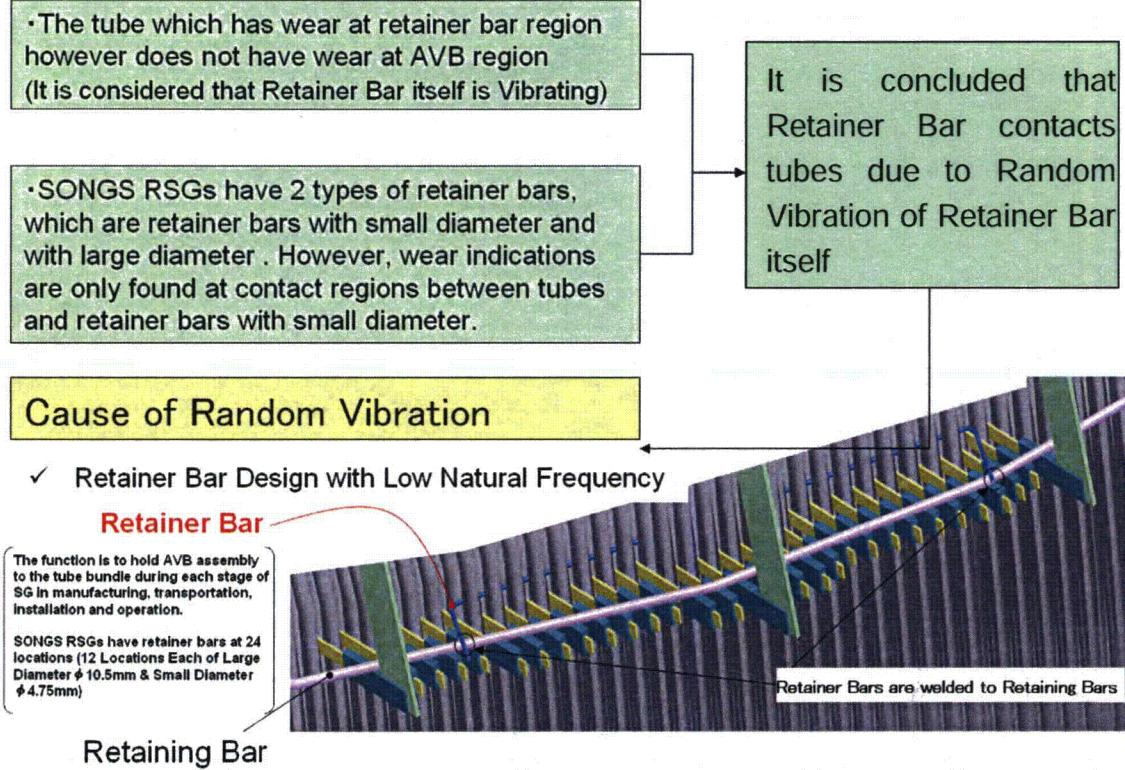
Fig.6.4-1 Type 4 Wear (RB wear) Mechanism

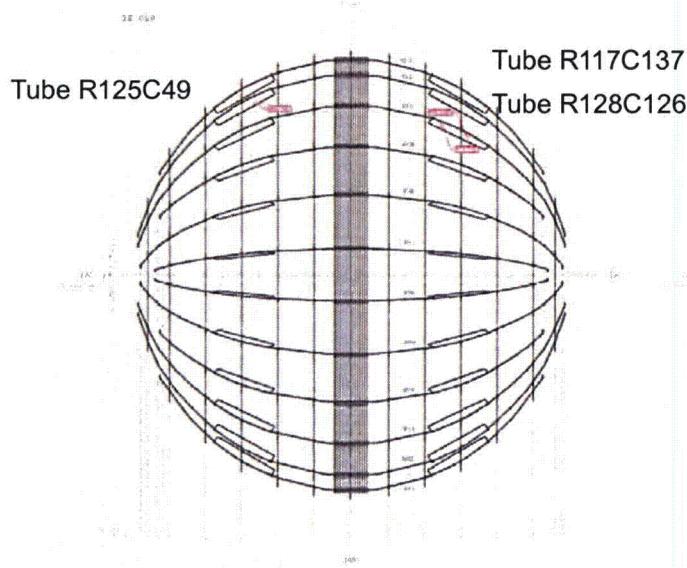
Fig.2-2 Indication locations for Unit-3B

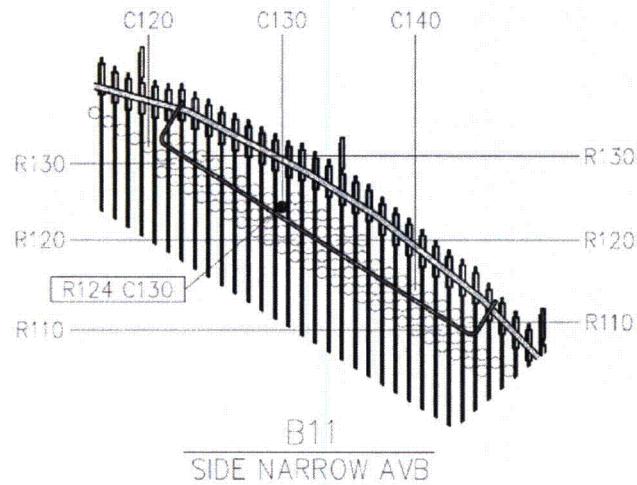
Fig.2-4 Location of 46% Wear (for Unit-3A, R124C130, AVB11 Retainer Bar)

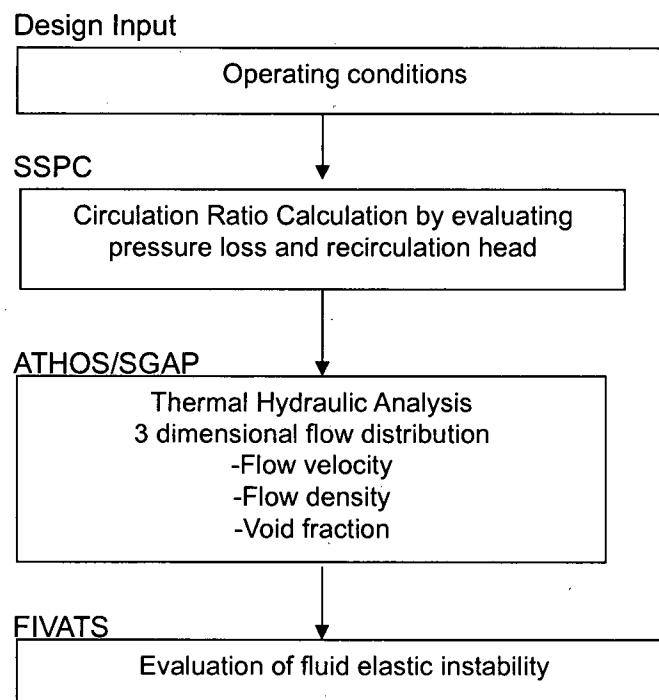
- ① Using a 1-dimensional Thermal and Hydraulic parameter code (SSPC), determine the tube bundle circulation ratio and other secondary side operating conditions for the normal operating condition (Ref.21).
- ② Using the flow analysis code (ATHOS/SGAP), determine the distributions of flow velocity  $U(x)$  and density of the fluid  $\rho(x)$  along the tube axis.
- ③ For the damping ratio  $h$  and critical factor  $K$ , the suggested values based on ASME Sec III Appendix N-1330 are used in conservative case, or eqs. (7), (11) are used in the best estimated case. And from eqs. (3) ~ (5) stability ratio is evaluated (Ref.25)

Figure 6.3-1 describes this process.

Fig.6.3-1 Flow of the evaluation

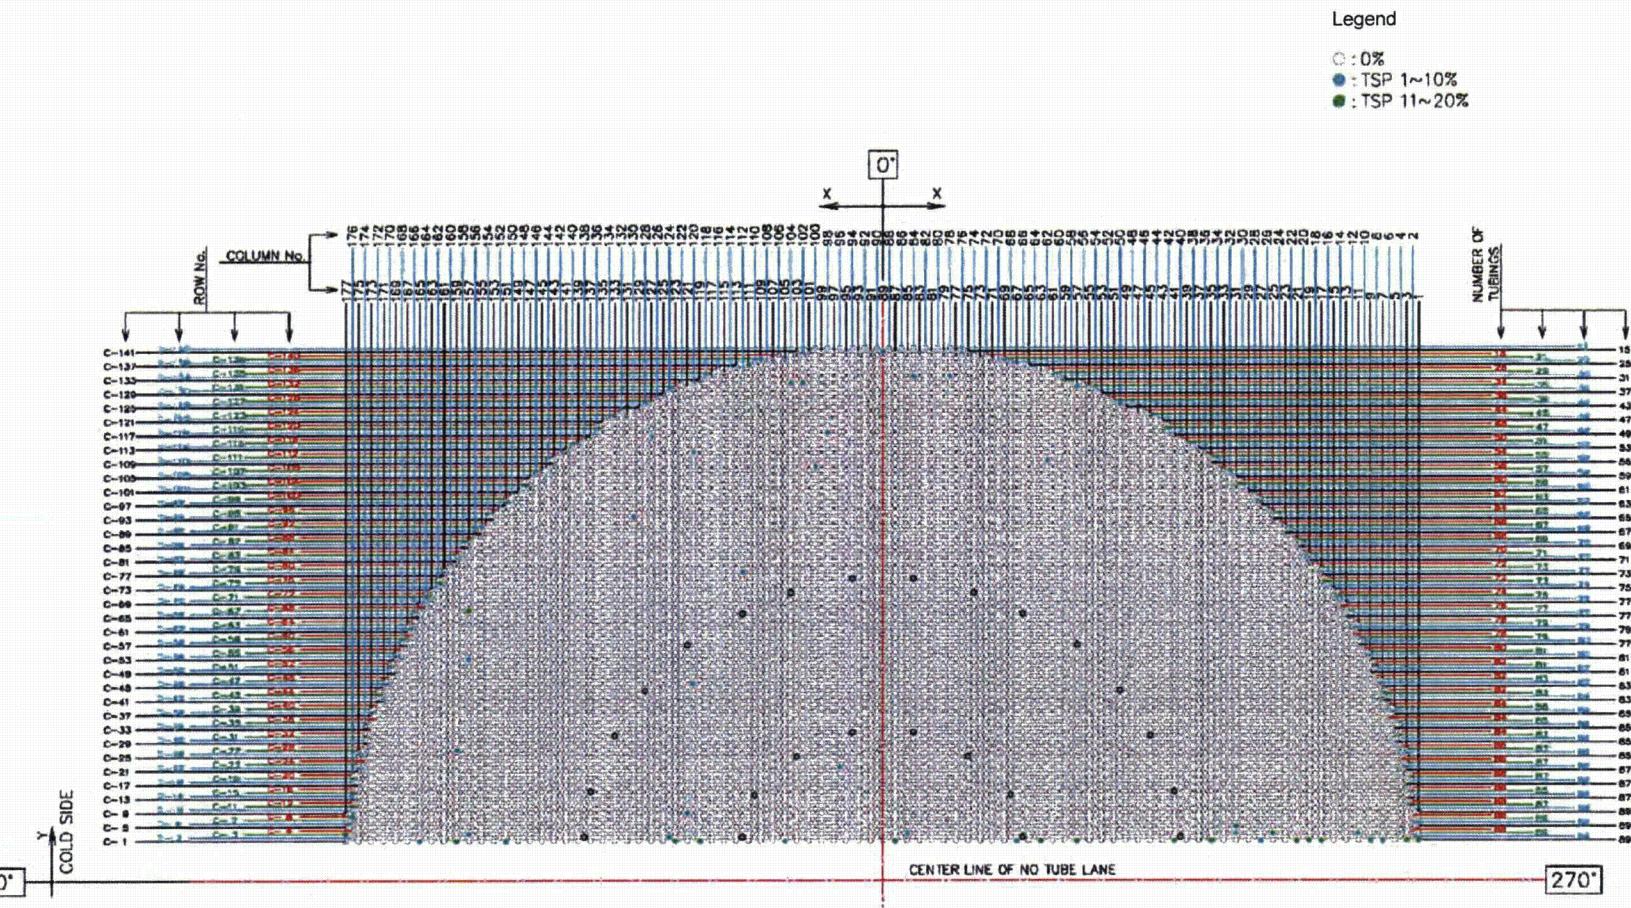
Fig. 6.5-1 Tube-to-TSP wear in 2A-SG

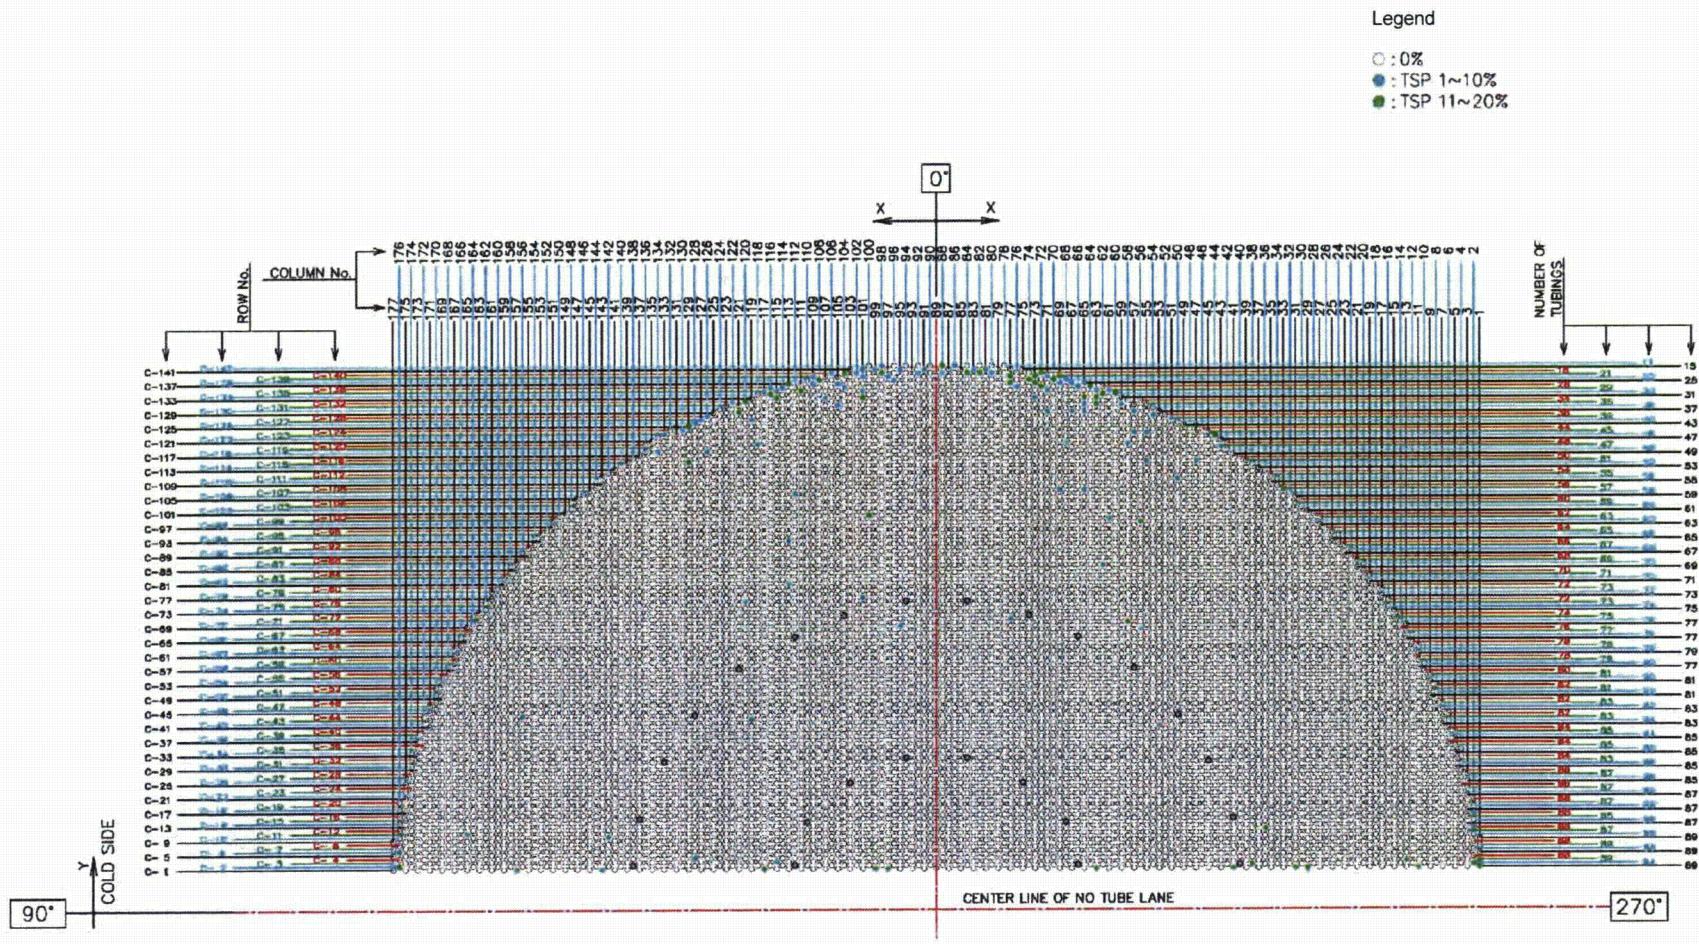
Fig. 6.5-2 Tube-to-TSP wear in 2B-SG
