## SONGS Unit 2 Return to Service Report

#### **MHI Document L5-04GA564 Tube Wear of Unit-3 RSG Technical Evaluation Report**

**Tube wear of Unit-3 RSG – Technical Evaluation Report**

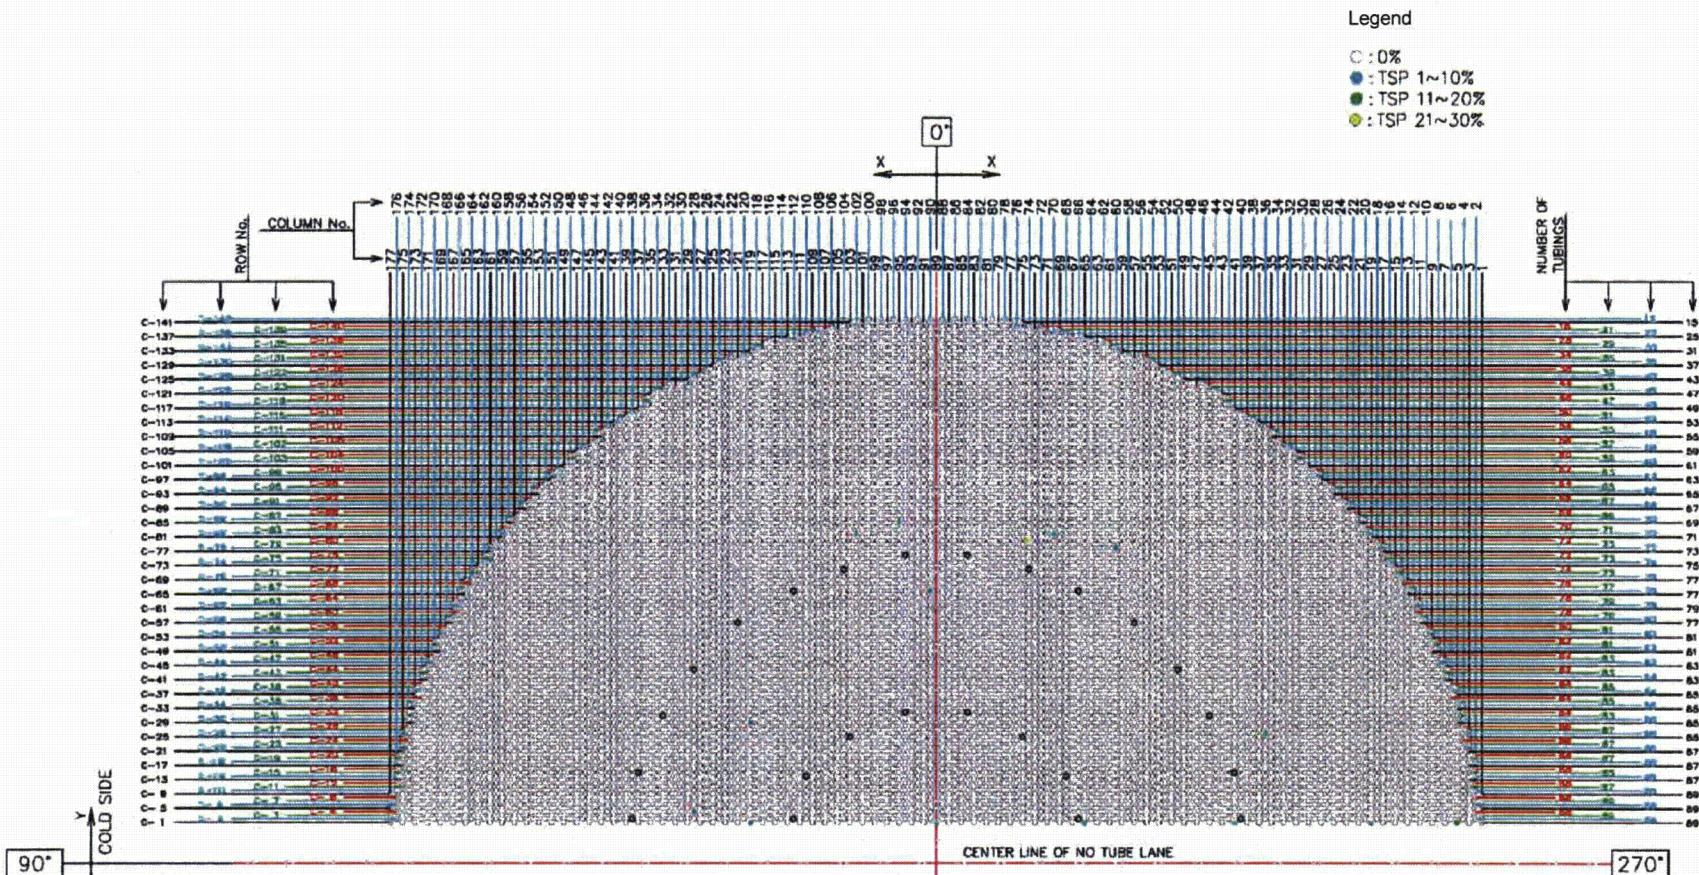
Fig. 6.5-3 Tube-to-TSP wear in 3A-SG

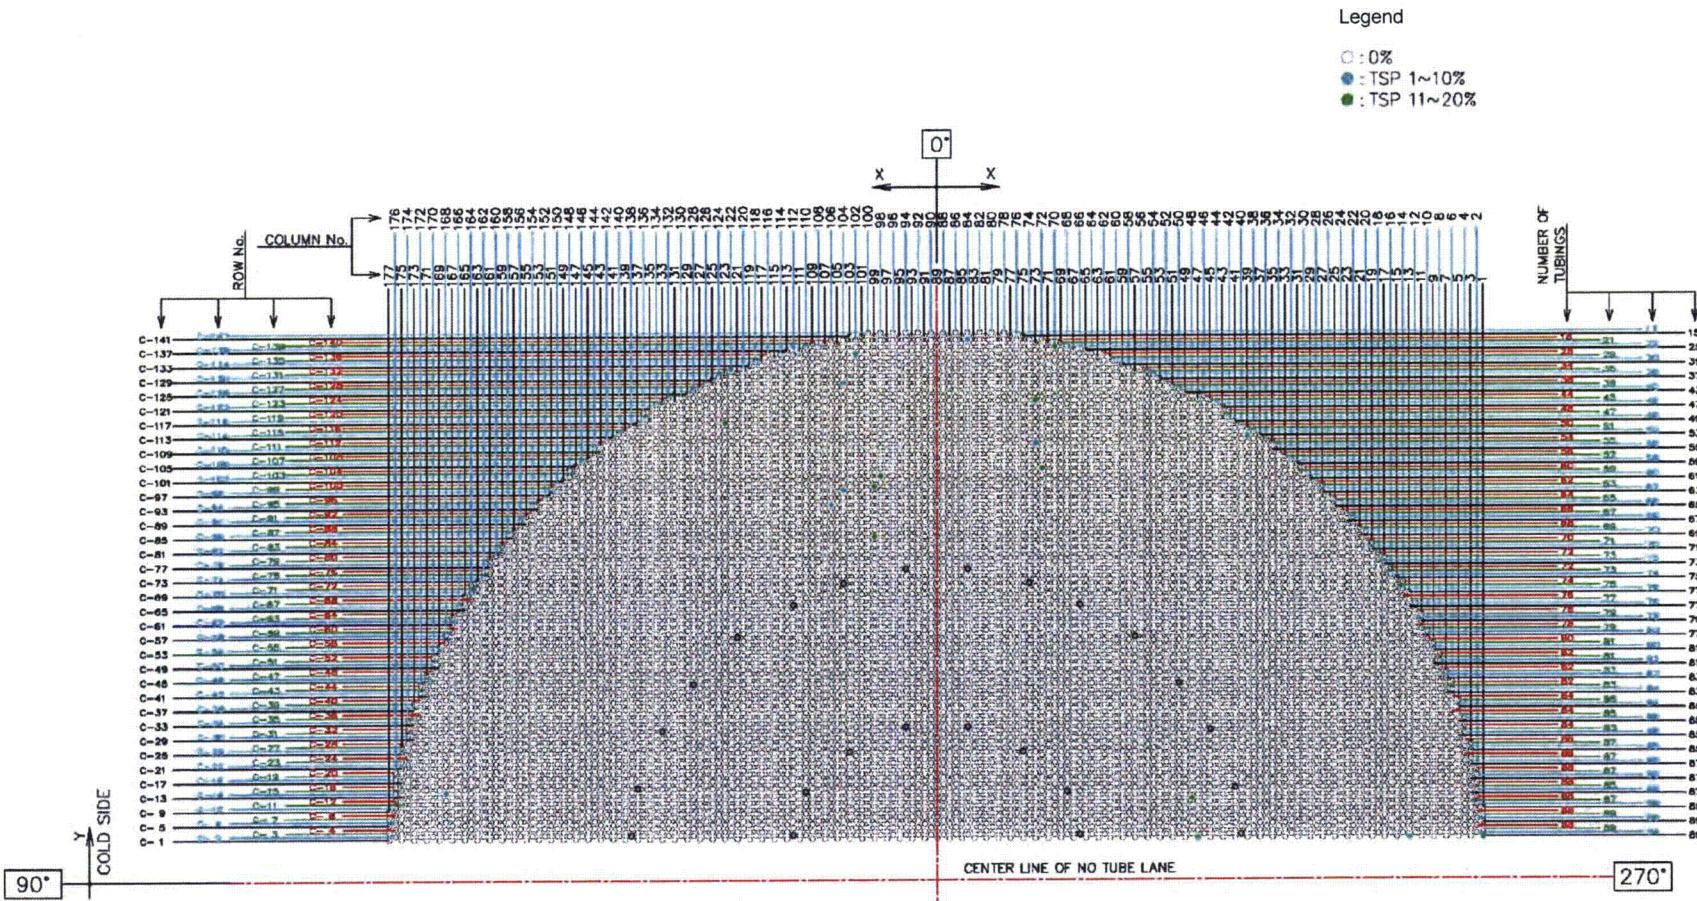
Fig. 6.5-4 Tube-to-TSP wear in 3B-SG
