Fukushima -  
Flooding Hazard Reevaluation  
Upstream Dam Failure Analysis

**NCR  
Technical  
Presentation**

**March 25, 2013**

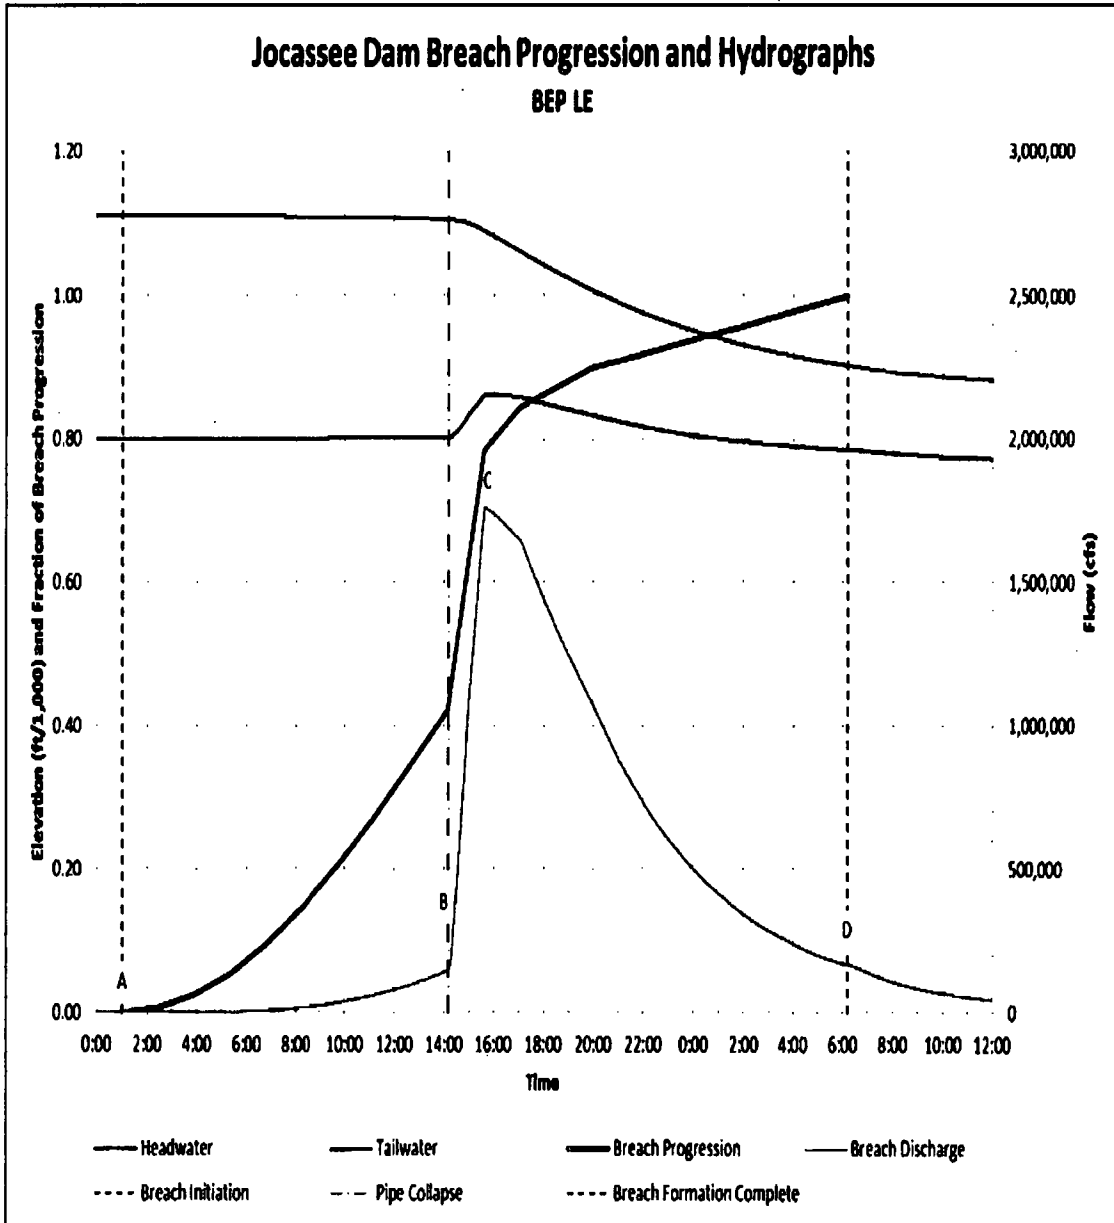
# Fukushima Model Jocassee Dam Breach Progression and Stage-Discharge Hydrographs

**Breach Formation Time:** Xu & Zhang definition: - 29.2 (13.2 hours piping + 16.0 hours open weir)    Froehlich definition: -16.0 hours open weir

JOCASSEE DAM BREACH PARAMETERS												
Structure	Crest Elevation (ft msl)	Reservoir Starting Elevation (ft msl)	Failure Mode	Bottom Breach Elevation (ft msl)	Bottom Breach Width (ft)	Average Breach Width (ft)	Right Side Slope (Zr)	Left Side Slope (Zl)	Time to Failure (Hr)	Top of Breach Width (ft)	Breach Progression	Breach Initiation Elevation (ft msl)
Jocassee Dam	1125	1,110	Piping	870	431	566	0.53	0.53	29.2	701	Sine Wave	1,020
