# Sea Area Monitoring

Nuclear Regulation Authority (NRA), Japan

## Fracture Found on Steel Members (Diagonal Bracings) in the Intermediate Section of the Exhaust Stack for Units 1 and 2 at Fukushima Daiichi NPS

# Investigation of the Inside of Tank No.5 in H4 Area

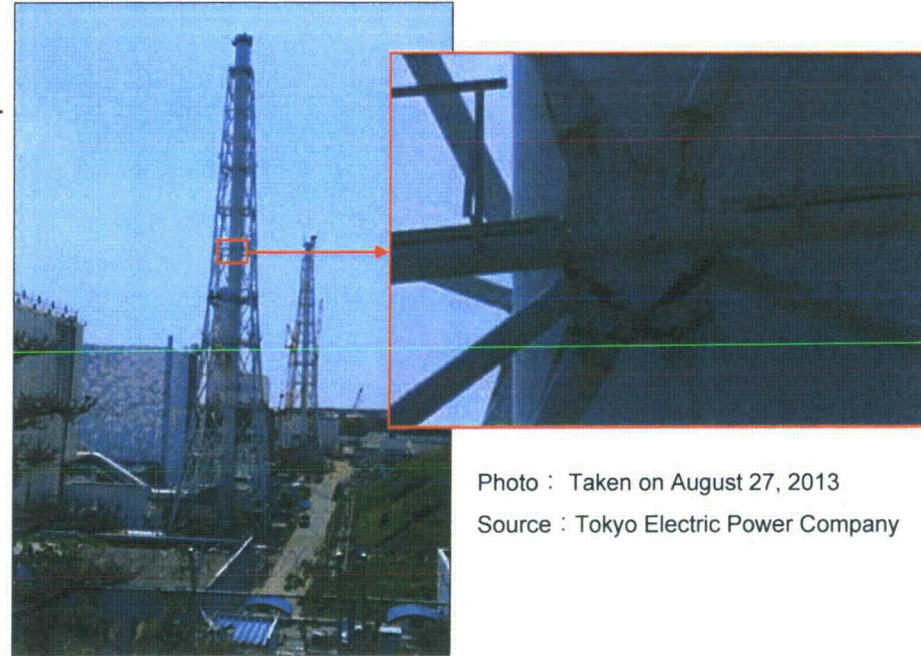
Photo : Taken on August 27, 2013

- We have been conducting an on-site inspection for seismic safety evaluation on the exhaust stack\* for Units 1 and 2 at Fukushima Daiichi NPS. Today (on September 18, 2013), in the inspection, we found fracture on steel members (diagonal bracings) of the exhaust stack.
- Although the main body and the principle members are estimated to be safe, we found fracture, fracture-like traces, and rust at 8 out of 440 points of the questioned exhaust stacks. We continue to monitor and analyze the situation.
- The exhaust stack in question has been out of use.

- As high radiation dose is detected in the stack area, investigations will be performed after the details of investigations are examined.

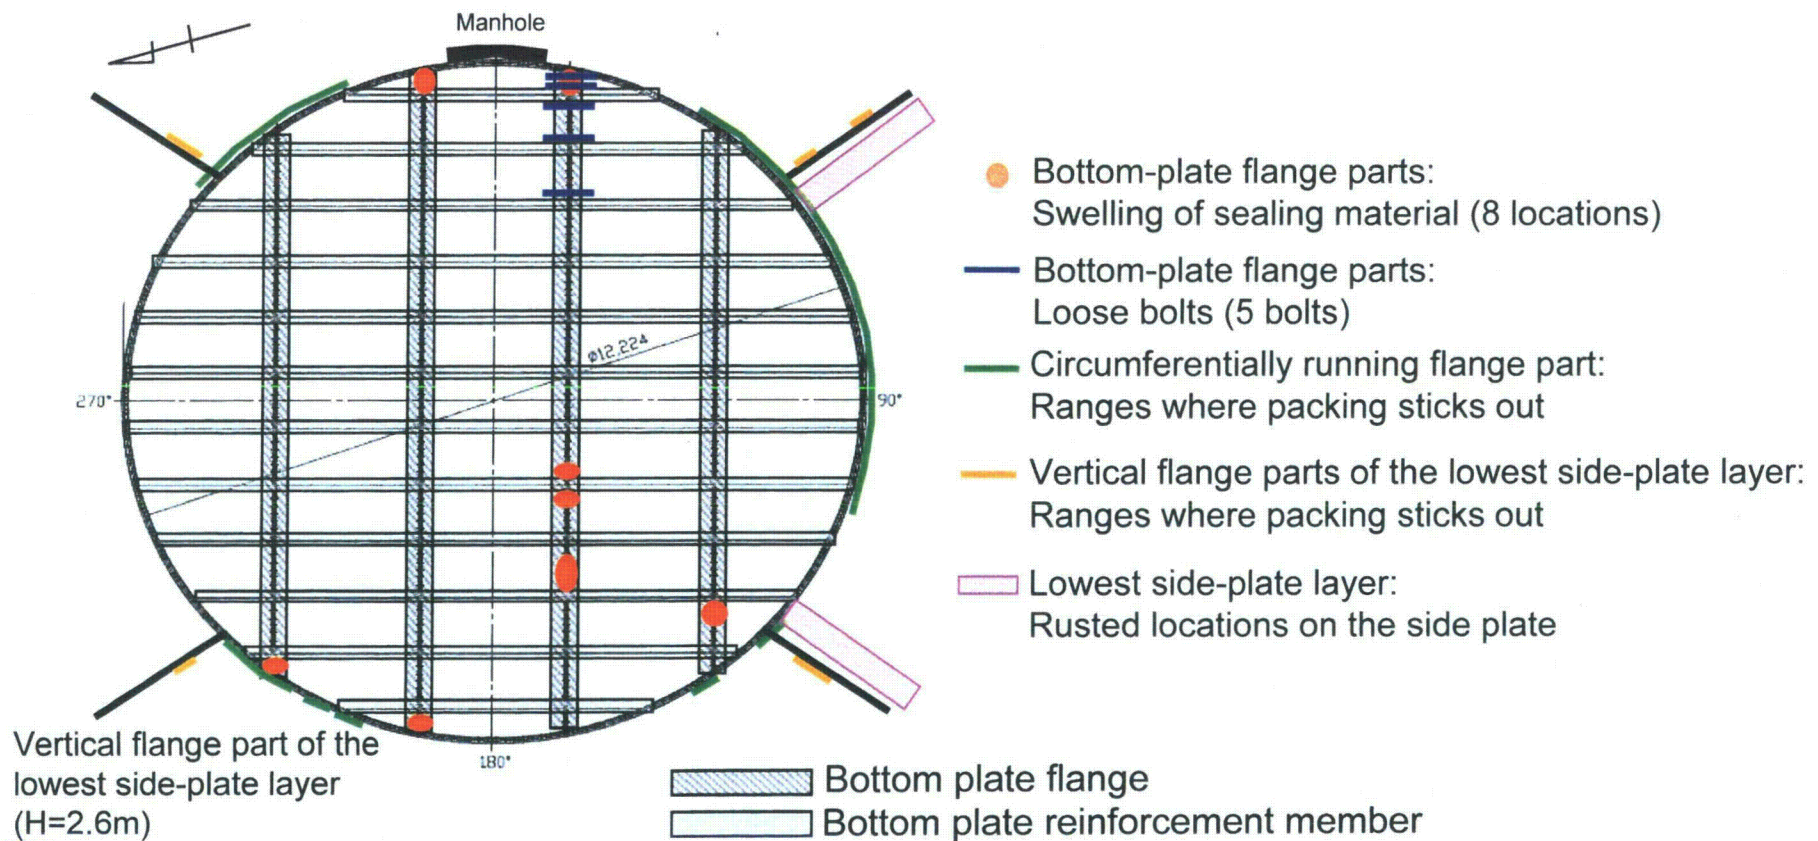
- The inside of the tank was visually checked. Deformed or damaged parts were found at the flange part connecting the lowest side-plate layer and the bottom plate, and at the flange parts of the bottom plate.
- Condition of fastening of the bolts was checked by sounding the bolts. Five bolts were found loose.

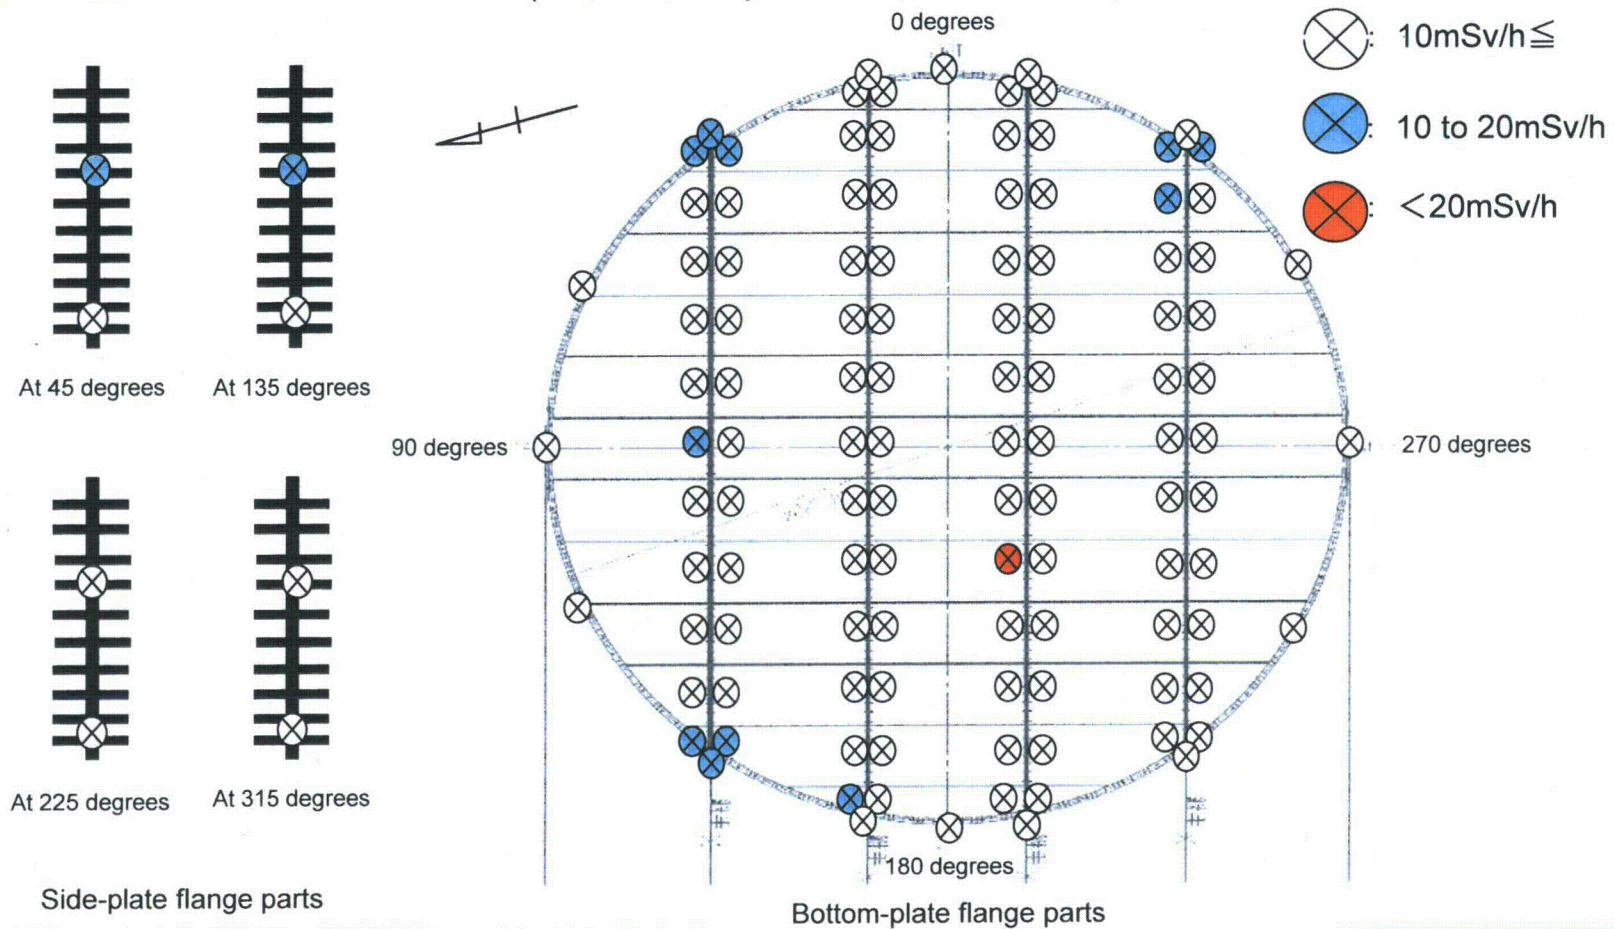
## Dose Measurement Results on the Flange Parts

- As a result of dose measurement on the flange parts, we found that dose rates on the flange parts were not more than 10mSv/h ( $70 \mu\text{m}$   $\beta$ -ray dose equivalent rate) for almost all over the flange parts, and approx. 22mSv/h at the maximum ( $70 \mu\text{m}$   $\beta$ -ray dose equivalent rate).

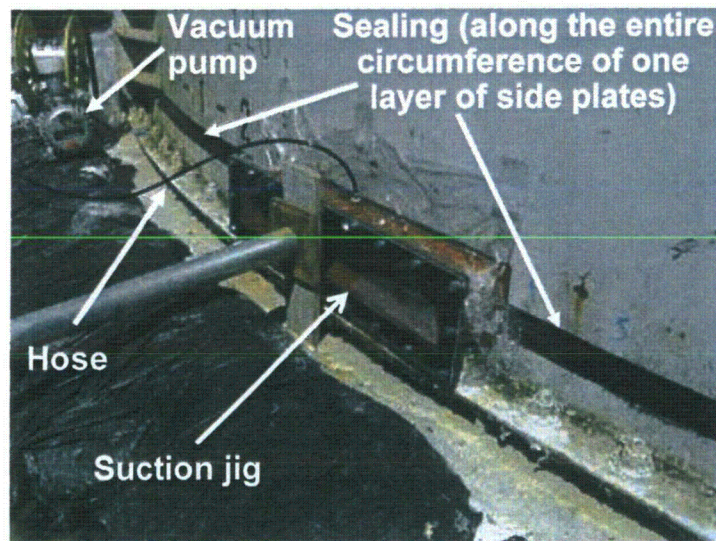
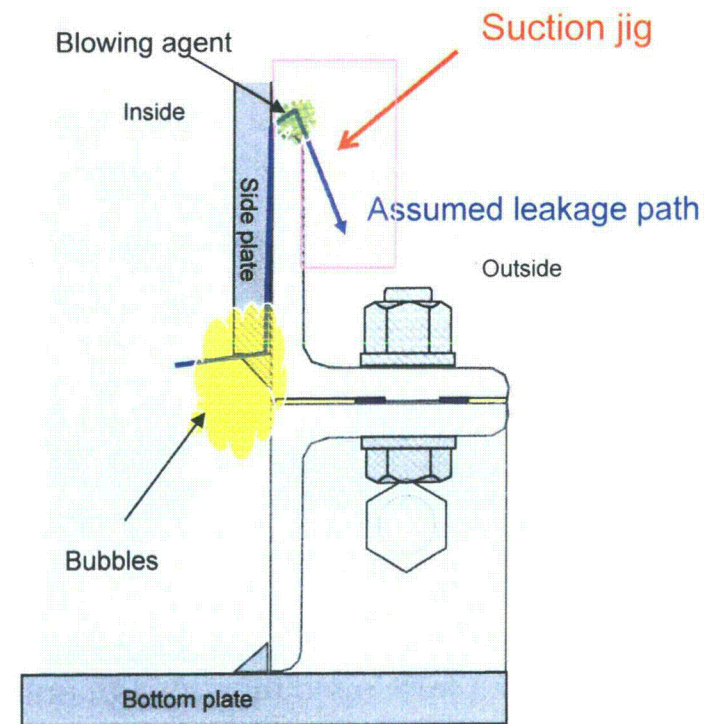
Cross-sectional view of a side plate flange part

- In a welded part joining the lowest side-plate layer of the tank and the flange part together, suction was conducted locally at a location (rusted location) that showed a relatively high dose rate.
- Continuous generation of bubbles from a blowing agent applied to this location was not observed. In addition, bubbles applied to the inside of the tank were not vacuumed up.

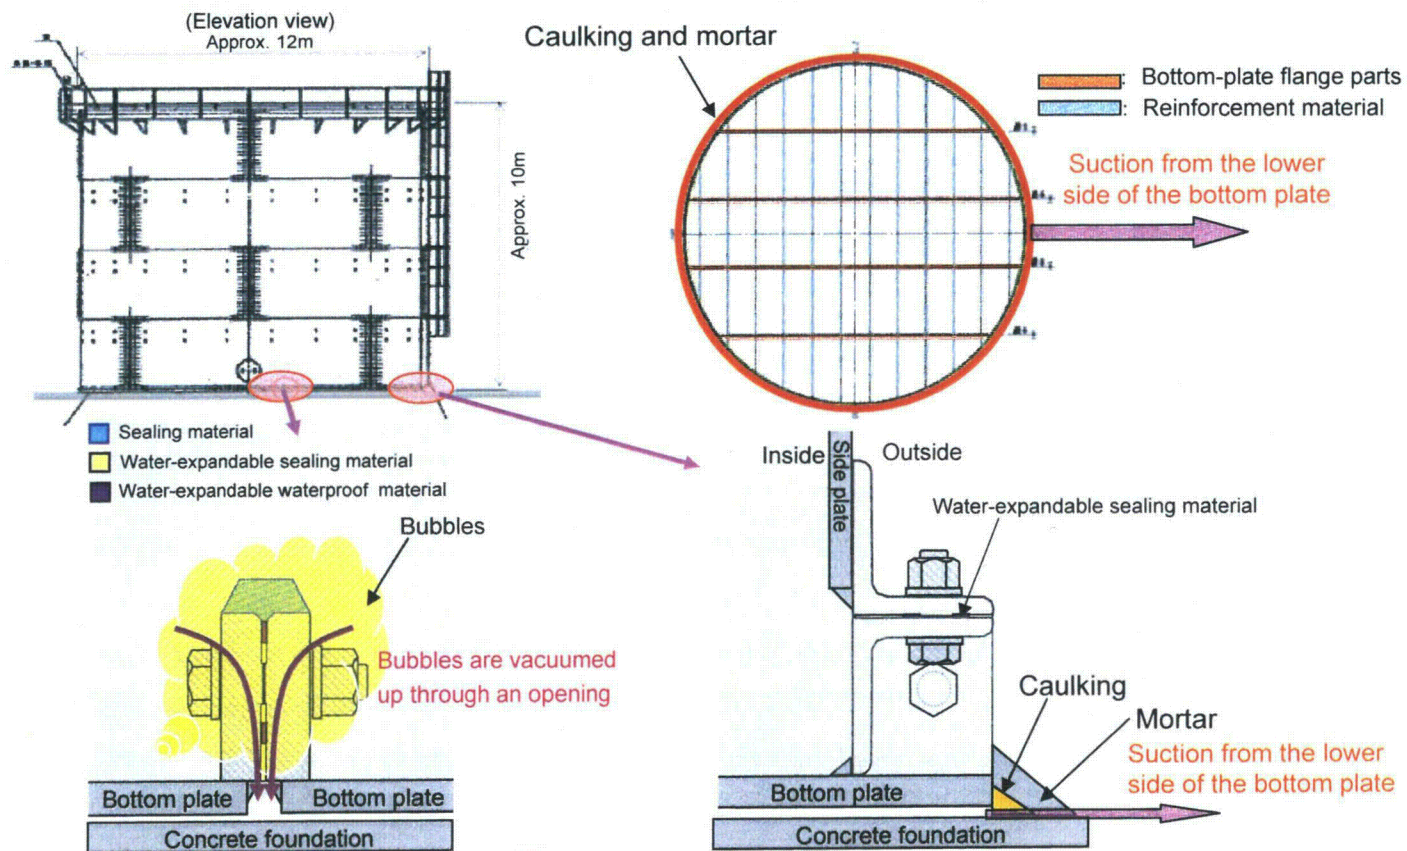
# Vacuum Test from the Lower Side of the Tank Bottom Plate

- This test is a method to locate openings by applying bubbles to the flange parts, etc., in the inside of the tanks, then conducting suction from the outside of the tank bottom plate, and then confirming whether there is any opening through which bubbles are vacuumed up.

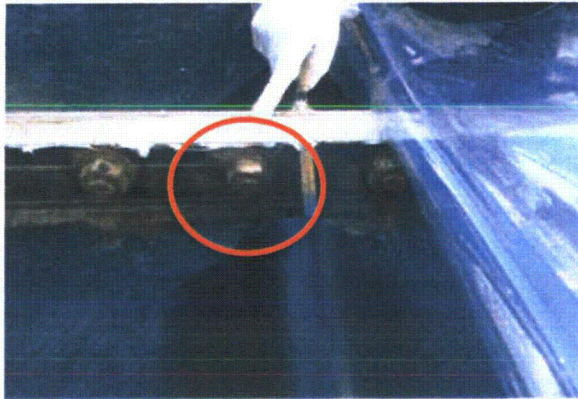
A loose blot at a flange part of the bottom plate  
(Photographed on September 19, 2013)

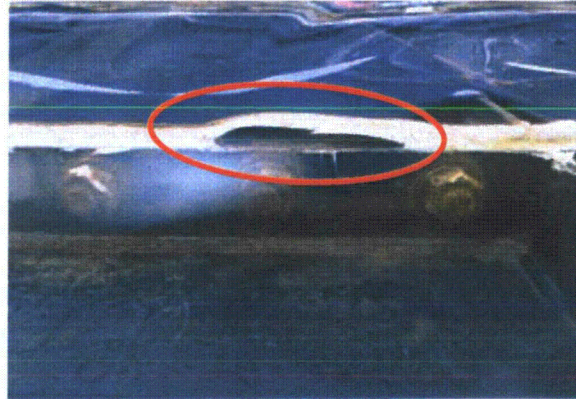
Swelling of the sealing material at a bottom plate flange part  
(Photographed on September 19, 2013)

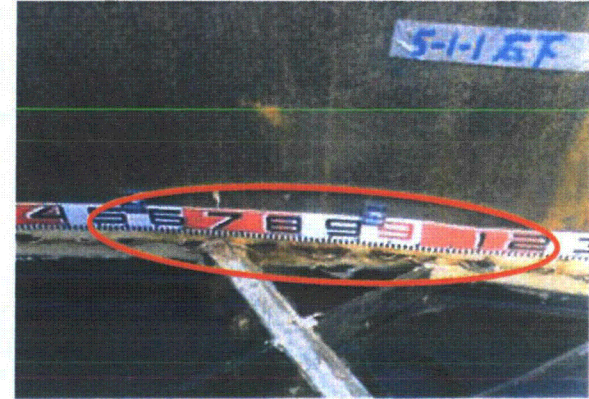
Sticking out of packing from the circumferentially running flange part  
(Photographed on September 19, 2013)

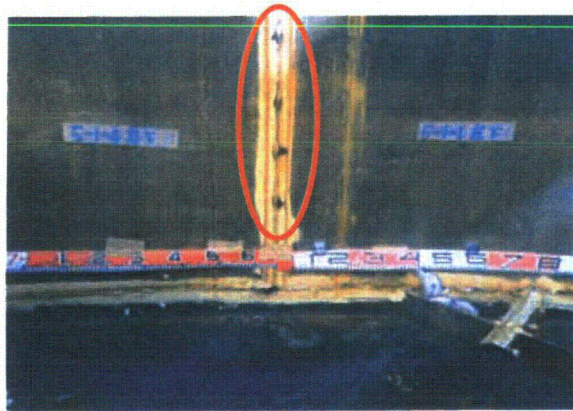
Sticking out of packing from a vertical flange part in the lowest side-plate layer (Photographed on September 19, 2013)

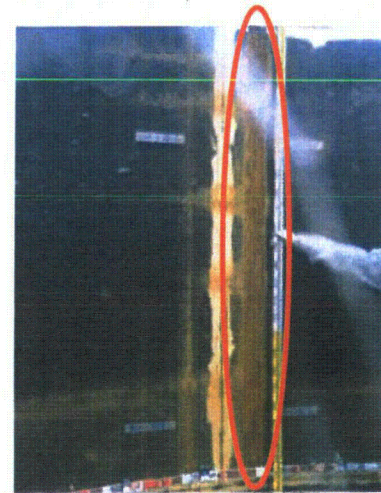
A rusted location on the lowest side-plate layer  
(Photographed on September 19, 2013)

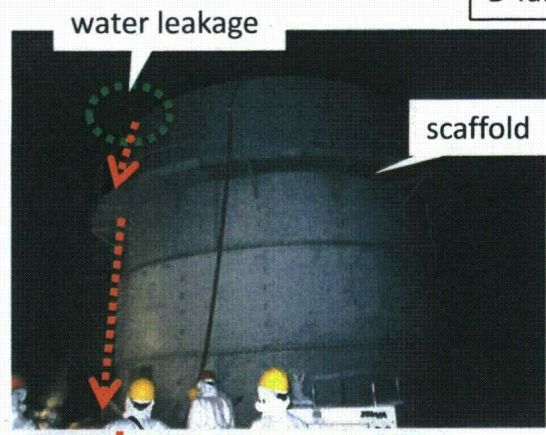
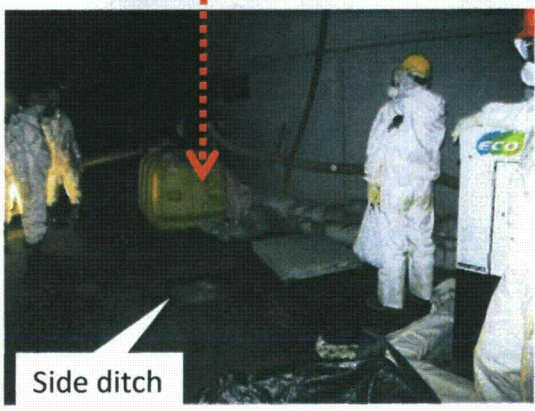
B-A5 Tank

The water was leaking from the top plate of storage tank(B-A5) in B Tank South Area into/outside of the dike surrounding the tank.

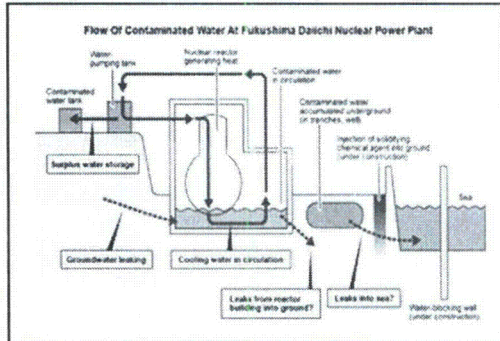
- 800 tons per day ground water flows through site
- 800 tons per day treated to remove salt and Cs
- 400 tons per day to cool reactors
- 400 tons per day to storage
- 400 tons per day to the ocean

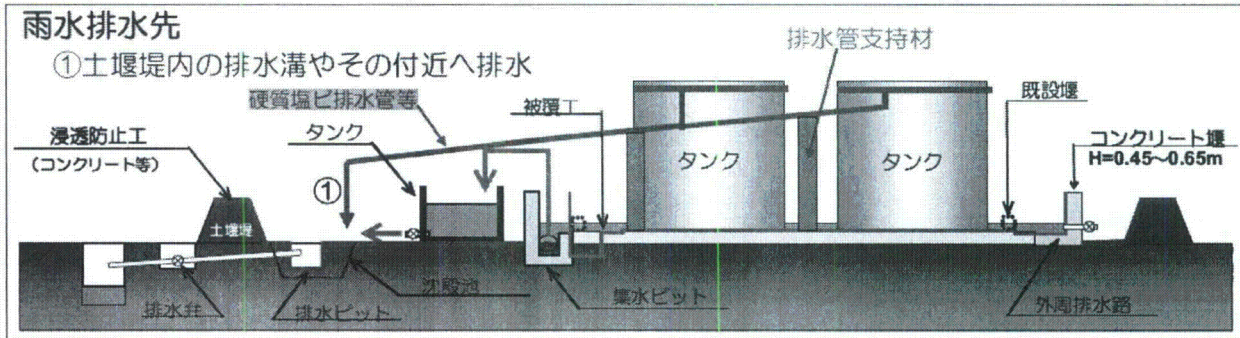
- 350,000 tons of highly contaminated water stored in 1000 above ground tanks

- Pad sealant, tank gutters, berm height doubled, radar tank level detectors, rain water tank, surrounding dike, letdown valve to ditch.

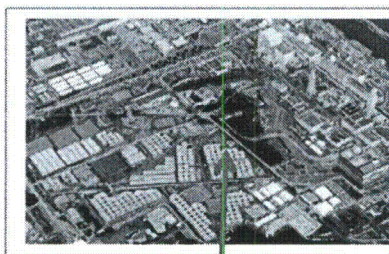
No. 5 Tank

The storage tanks holding the excess, contaminated water pumped out of the reactor building are also a concern. One of those tanks, Tank No. 5, leaked roughly 300 tons of highly contaminated water through an open berm drain valve to the surrounding soil. TEPCO is digging up soil to determine the extent of water migration and inspecting other tanks to determine if there are other leaks. The Japanese Nuclear Regulatory Authority (JNRA) declared this event a level 3, serious incident, on the International Nuclear and Radiological Event Scale based on the amount of radioactive material released from the storage tank. The Japan Nuclear Regulatory Authority released a public report on September 5, 2013, in which they describe the current situation of contaminated water leakage and possible issues with the storage tanks. The report may be found here: <http://www.nsr.go.jp/english/index.html#Highlights>. The tank farm's radioactive strontium levels represent a very significant potential contamination source, so Japanese officials are developing a system to remove the strontium from the stored water.
