SRR-CWDA-2014-00020
Revision 0

**Tanks 5 and 6 Final Configuration Report for
F-Tank Farm at the Savannah River Site**

July 2014

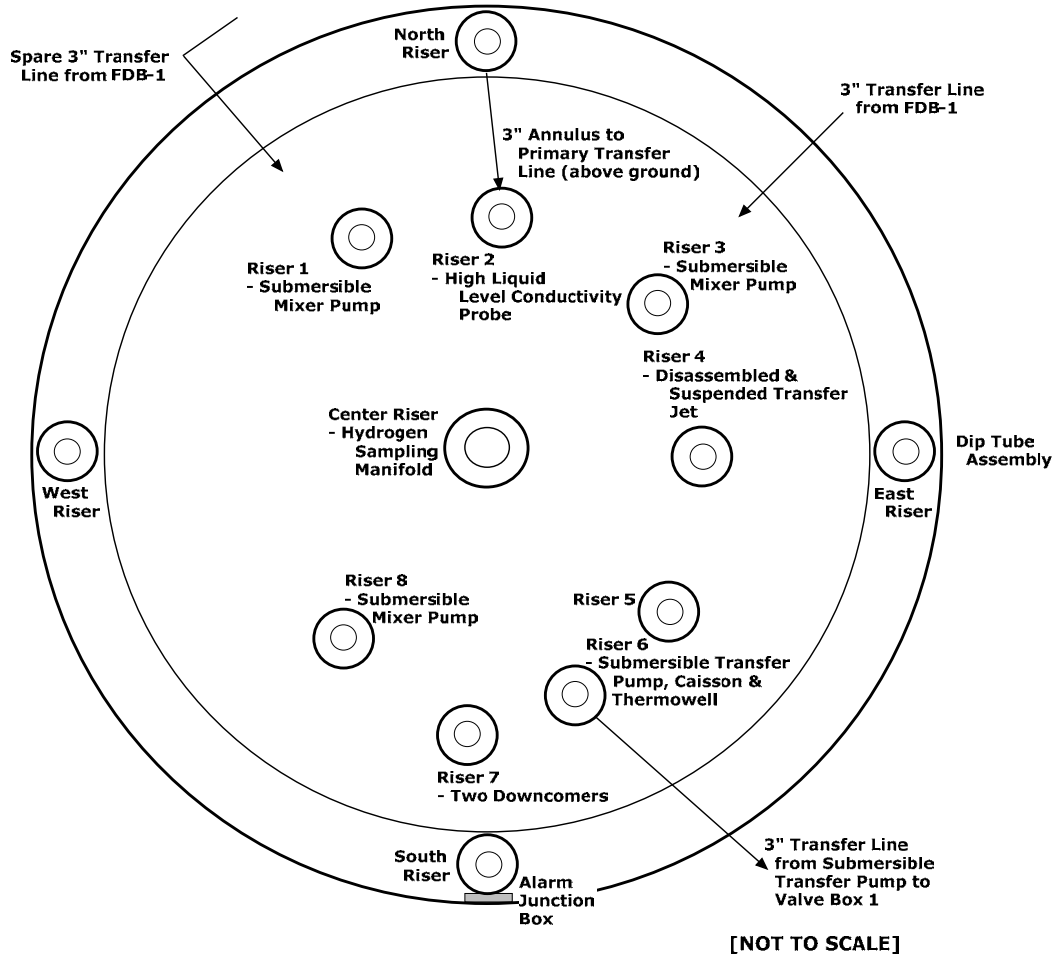
Figure 2.0-2: Typical FTF Type I Tank Plan View

Figures 2.0-1 and 2.0-2 depict the cross section and plan view outlining the general arrangement of waste tank equipment, respectively. The figures depict equipment typical of a Type I tank and are not intended to represent a specific waste tank configuration.

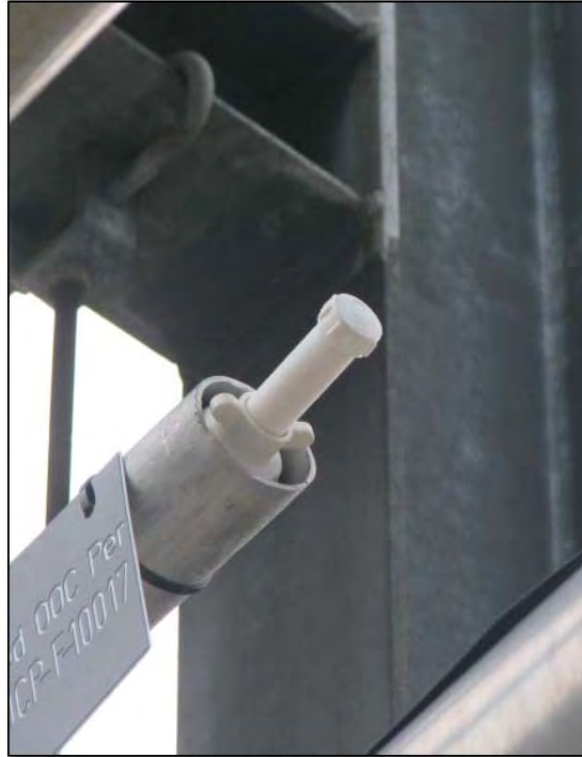
Figure 3.1-1: Tank 5 Bearing Water Supply Pipe Isolated (Tank 5)

Tanks 5 and 6 were isolated in accordance with the Tanks 5 and 6 CM Section 7.1 and are consistent with their respective waste tank closure isolation plans except as noted in Section 3.1.1 of this FCR. Mechanical and electrical isolation consisted of demolition and removal of piping and components, plugging lines, removal of equipment, identifying components as “Out Of Commission,” and removing obstructions from and around the risers. [M-CTP-F-00005 and M-CTP-F-00006] Both waste tanks were isolated from the FTF WTS and the FTF support systems (e.g., water, steam, air). The isolation strategy consisted of identification and isolation of transfer lines, drain lines, water, air, and steam supply lines, ventilation lines, power and instrumentation lines, and all other penetrations into or out of the waste tank. Isolation of these systems was performed at the electrical control rooms or field locations for electrical and instrumentation and at the system supply headers located off the tank top for mechanical systems. For example, Figure 3.1-1 shows a bearing water supply line that has been cut and plugged to isolate the bearing water system at Tank 5.

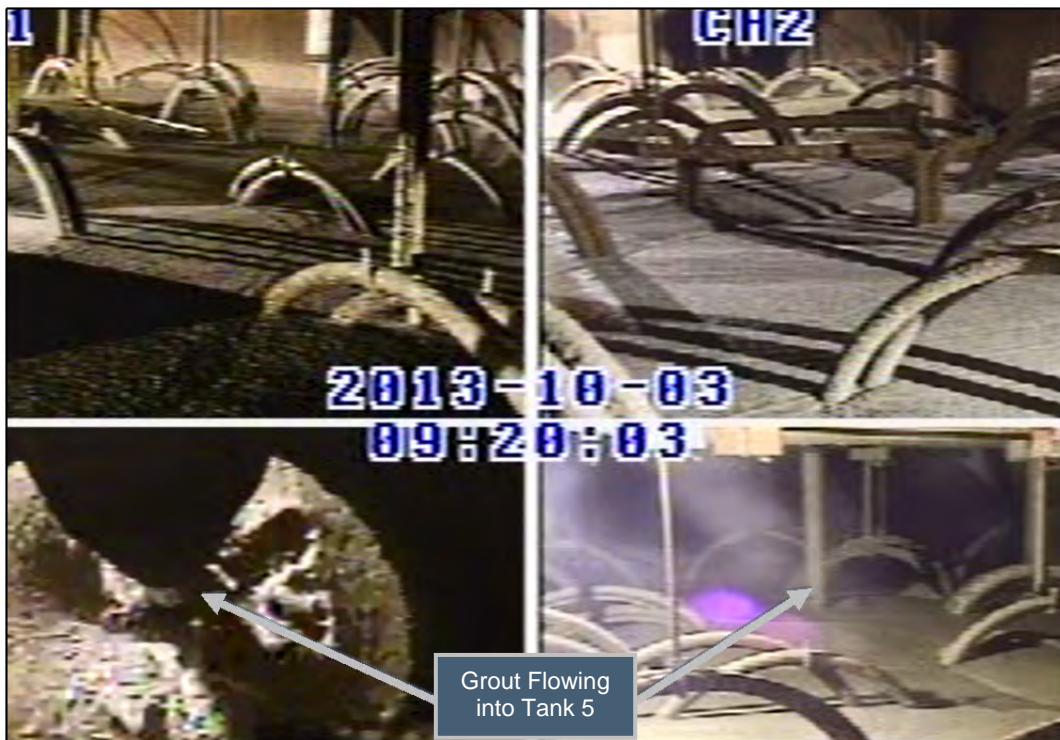
of the waste tanks were typically performed and recorded at the beginning, middle, and end of each day during the grouting process. These inspections indicated that the reducing grout flowed over the residual material to stabilize and immobilize it at the bottom of the waste tanks. The grout adequately flowed from the risers around internal obstructions (support columns and cooling coils) to other areas of the waste tank (Figures 3.2-2 and 3.2-3).

**Figure 3.2-3: Bulk Fill Grout in Tank 5 during the Filling Process (Lift 8)
Simultaneous Camera Views from Four Risers**

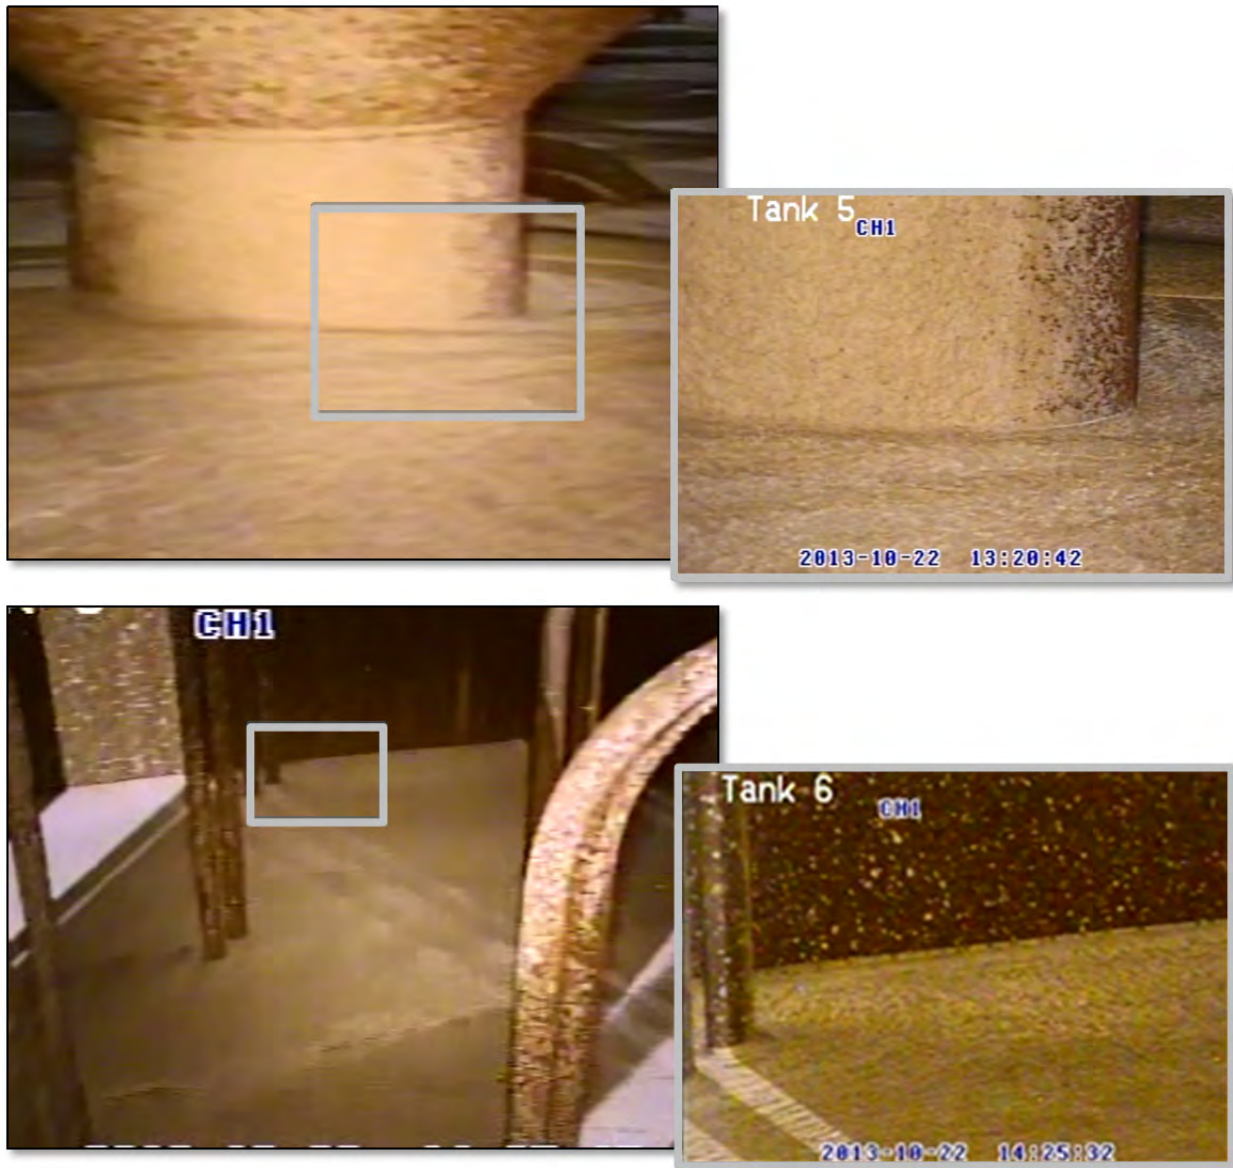
Due to a partial stop work because of a lapse of appropriations, grout operations were suspended in Tank 6 from September 27, 2013, until October 30, 2013. [CMD-14-001] Grout operations were suspended in Tank 5 from October 3, 2013, until October 28, 2013. A camera inspection was performed on October 22, 2013, to assess the condition of the grout after curing for 26 days in Tank 6 and 19 days in Tank 5. There was no evidence of void spaces, cracking or shrinkage of the grout in the interior of Tanks 5 and 6 (Figure 3.2-4)

Figure 3.2-4: Grout Conditions on October 22, 2013, in Tanks 5 and 6 after
Suspended Grout Operations

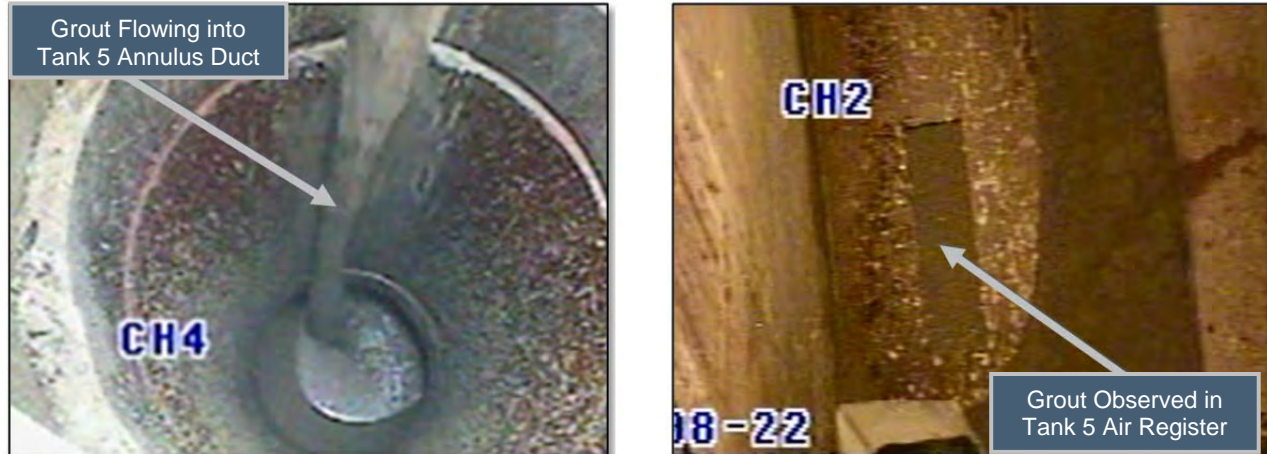
The annulus ventilation ducts were filled with grout by pouring grout into the air supply location at the tank top. Grout was observed flowing in the ducts and filling the ducts through the registers (6-inch by 14-inch openings in the top of the duct). In areas where grout may not have completely filled the duct, grout was expected to flow into the registers to fill the interior of the duct. Grout flowing into the registers during annulus bulk fill was observed in locations that could be viewed with cameras. (Figure 3.2-5).

Figure 3.2-5: Grouting the Tank 5 Annulus Ventilation Duct (Lift 3)

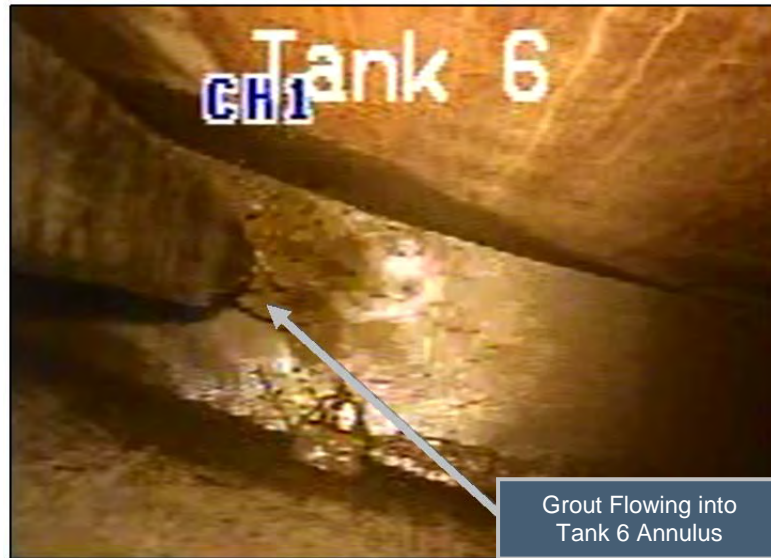
Figure 3.2-6: Annulus Bulk Fill Grout in Tank 6 during the Filling Process (Lift 5)
