# Biological Assessment of Upper Clearfield Creek Cambria and Clearfield Counties

## Technical Report Provided Through the Trout Unlimited AMD Technical Assistance Program

## June 2010

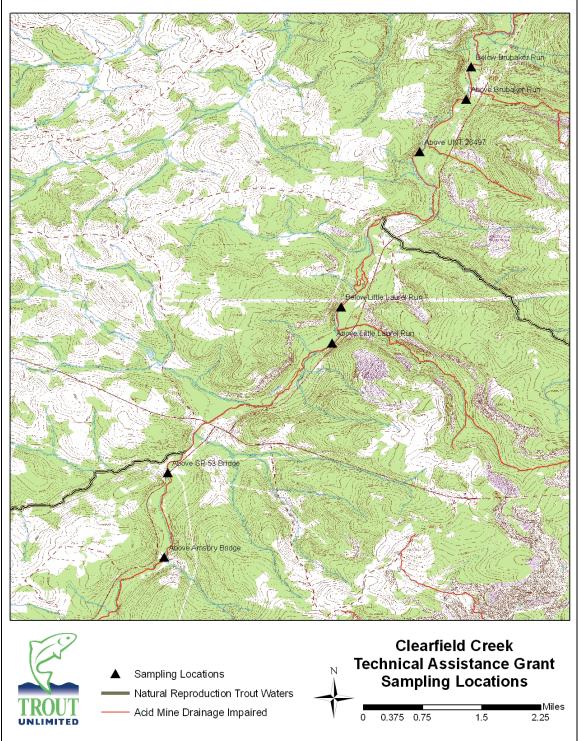
Figure 1. Data Collection Sites

Latitude	Longitude	Site Name	Benthic Macroinvertebrates	Fish	Habitat	Chemistry	Flow	Site Description
40.5362	-78.55946		Х	Х	х	Х	Х	Above Amsbry Bridge
40.5517	-78.55886	CC 2	Х		х	х		Above SR 53 Bridge
								Above Little Laurel
40.5756	-78.5287	CC 3	Х		Х	Х	Х	Run
40.5822	-78.52701	CC 4	х		х	х	х	Below Little Laurel Run
40.6106	-78.51265	CC 5	Х		х	х		Above UNT 26497
40.6202	-78.5041	CC 6	Х		х	х	х	Above Brubaker Run
40.6262	-78.50321	CC 7	Х	х	х	х	х	Below Brubaker Run
		TOTAL	7	2	7	7	5

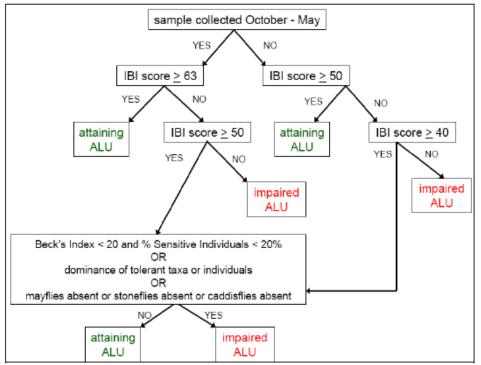
Figure 2. ALU Attainment and Impairment Thresholds for Cold Water Fishes (CWF), Warm Water Fishes (WWF), and Trout Stocked Fishes (TSF) Protected Uses (Department of Environmental Protection, 2009)

Benthic macroinvertebrate collections were made according to DEP's Instream Comprehensive Evaluation (ICE) protocol (specifically section C.1.b. Antidegradation Surveys). In short, benthic macroinvertebrate samples consisted of a combination of six D-frame efforts in a 100-meter stream section. These efforts were spread out so as to select the best riffle habitat areas with varying depths. Each effort consisted of an area of  $1 \text{ m}^2$  to a depth of at least 4 inches as substrate allowed and was conducted with a 500 micron mesh 12-inch diameter D-frame kick net. The six individual efforts were composited and preserved with ethanol for processing in the lab. No sub-sampling was required for these samples as the individual counts were less than or near 200. Individuals were identified to genus or to the next highest possible taxonomic level. The samples were evaluated according to the six metrics comprising the DEP's Index of Biological Integrity (IBI) (Total Taxa Richness, EPT Taxa Richness, Beck's Index V.3, Shannon Diversity, Hilsenhoff Biotic Index, and Percent Sensitive Individuals). These metrics were standardized and used to determine if the stream met the Aquatic Life Use (ALU) threshold for cold water fishes, warm water fishes, and trout stocked fishes (Figure 2).

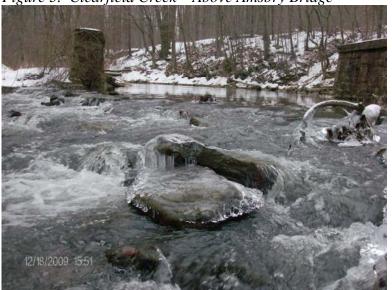
Figure 3. Clearfield Creek – Above Amsbry Bridge

CC 1 is the most upstream site in the study area and is located just below where Unnamed Tributary (UNT) 26554 enters Clearfield Creek and is approximately 8 stream miles above Brubaker Run. According to DEP's 2008 Integrated List, Clearfield Creek at this location is impaired with abandoned mine drainage (AMD) metals. The Sankertown Abandoned Mine Land (AML) Inventory site on the headwaters of UNT 26591 and the Gallitizin North AML on Bradley Run are the most likely sources of AMD to this part of Clearfield Creek (Figure 8).

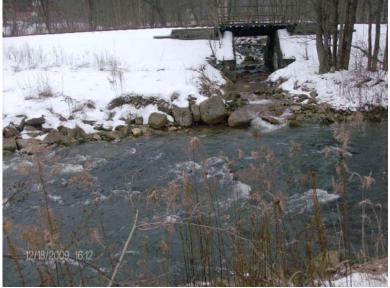
Figure 4. AMD entering Clearfield Creek below CC 1.

CC 2 is located on Clearfield Creek approximately 1 stream mile downstream of CC 1 and approximately 7 stream miles upstream of Brubaker Run. According to DEP's 2008 Integrated List, Clearfield Creek at this location is impaired with AMD metals. No tributaries enter Clearfield Creek between this site and CC 1, however a notable AMD discharge does enter the stream at the Amsbry bridge downstream of CC 1 (Figure 4).

Cambria County Conservation District staff have indicated a presence of untreated sewage in this segment of Clearfield Creek (verbal communication). Inputs of sewage would have a predicted detrimental effect on benthic populations however the chemical parameters used to detect sewage were not included in this AMD-based assessment. The AMD discharge entering Clearfield Creek near the Ambsry bridge (Figure 4) may also be contributing to the decreased benthic population, especially in low flow conditions. At the time of sampling, AMD from this site was probably diluted with high flows. However, during summer low flow periods this pollution input may be concentrated enough to have an effect on benthic macroinvertebrate populations downstream. Regardless of the cause, this noted biological change underscores the importance of collecting biological data in concert with the standard suite of AMD-chemistry data when conducting water quality snapshots.

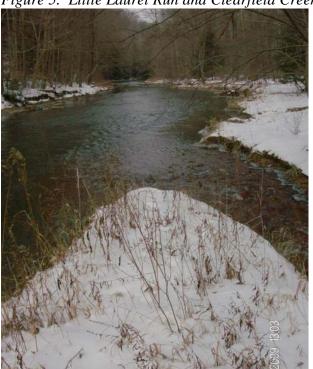
Figure 5. Little Laurel Run and Clearfield Creek

Habitat at this site was similar to habitat at CC 2 (Figure 9), however the population of benthic macroinvertebrates (Figures 10 & 11) at this location improved slightly. These improvements are corroborated by a reduction in AMD-metal concentrations (Figure 12) and are probably owed to the input of clean water and seed populations from the aforementioned six tributaries that enter Clearfield Creek between the SR 53 site and this location.

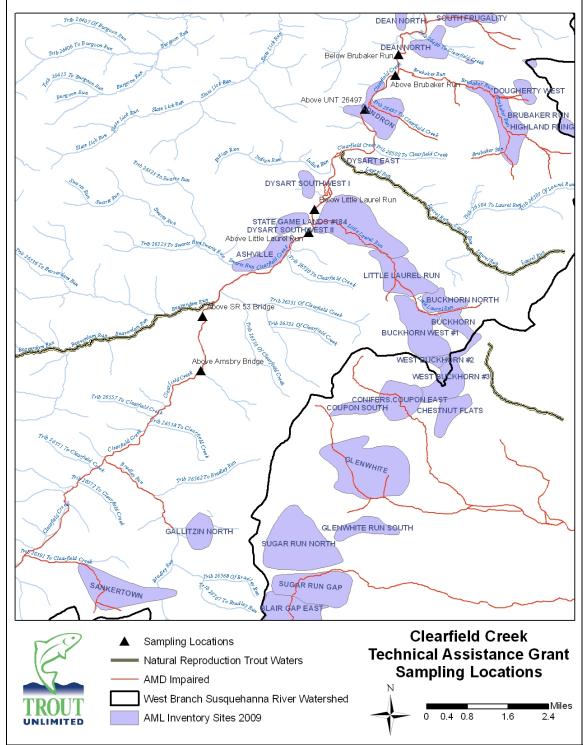
Figure 8. Sampling Locations, Stream Names, and AML Inventory Sites

Two existing AMLs presumably have an impact on water chemistry at CC 3: the Ashville AML located near the mouth of Swartz Run, and the Dysart Southwest II AML located on UNT 26519 (Figure 8).

Two AML's exist in proximity to Clearfield Creek between Little Laurel Run and CC 5 (Figure 8): Dysart East, located between Laurel Run and UNT 26500, and Condron which encompasses much of UNT 26498 and Clearfield Creek downstream to wellbelow CC 6.

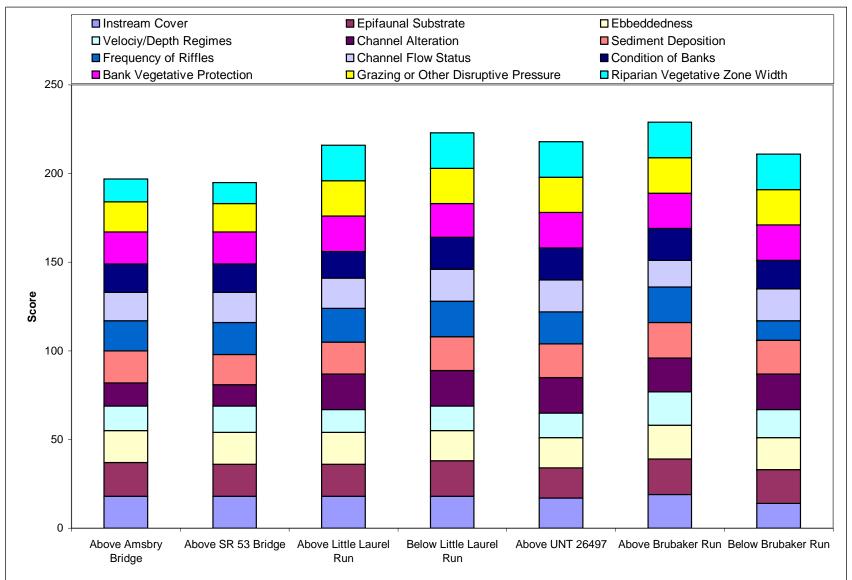
### Figure 9. Habitat Evaluation

*Habitat* - Habitat at this site was optimal with a total score of 197 out of 240 (Figure 9). Suboptimal rankings were only given for the categories of velocity/depth regime, channel alteration, and riparian vegetative zone width because only 3 of the 4 velocity depth regimes common for good habitat were found, historical channel alteration was present, and a minimal human impact to the riparian zone was present.

*Habitat* - Habitat at this site was optimal with a total score of 195 out of 240 (Figure 9). Suboptimal rankings were only given for the categories of velocity/depth regime, channel alteration, and riparian vegetative zone width because only 3 of the 4 velocity depth regimes common for good habitat were found, historical channel alteration was present, and minimal human impact to the riparian zone was present.

*Habitat* - Habitat at this site was optimal with a total score of 216 out of 240 (Figure 9). Suboptimal rankings were only given for the categories of velocity/depth regime and condition of banks because only 3 of the 4 velocity depth regimes common for good habitat were found and small areas of erosion were noted on the stream banks.

*Habitat* - Habitat at this site was optimal with a total score of 223 out of 240 (Figure 9). Suboptimal rankings were only given for the category of velocity/depth regime because only 3 of the 4 velocity depth regimes common for good habitat were found.

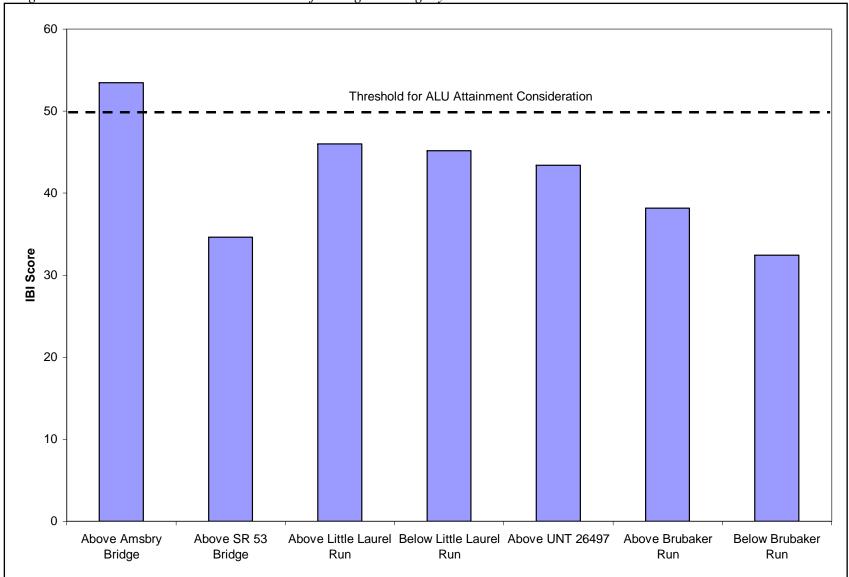
Figure 11. Benthic Macroinvertebrate Index of Biological Integrity Values

Although habitat at CC 4 is similar to that found at CC 3 (Figure 9), total benthic macroinvertebrate taxa (Figure 10) and IBI score (Figure 11) decreased. Furthermore, metals associated with AMD increased (Figure 12). These decreases in macroinvertebrate presence and water quality are more than likely attributed to Little Laurel Run.

Both habitat (Figure 9) and benthic macroinvertebrate IBI values (Figure 11) showed little variation at this location when compared to CC 4. However, the total number of benthic macroinvertebrate taxa found increased (Figure 10) and the concentration of metals associated with AMD decreased (Figure 12). In addition, Clearfield Creek was still net alkaline during the sampling period probably owing to the input of clean water from the aforementioned six tributaries that enter Clearfield Creek between Little Laurel Run and CC 5.

Although habitat at this site showed little variation when compared to CC 5 (Figure 9), benthic macroinvertebrate taxa (Figure 10) and IBI values (Figure 11) slightly declined. Water chemistry at this site was very similar to the Above UNT 26497 site (Figure 12) suggesting that the impact of the upstream AMD-impaired tributary to Clearfield Creek is more pronounced during low-flow conditions.

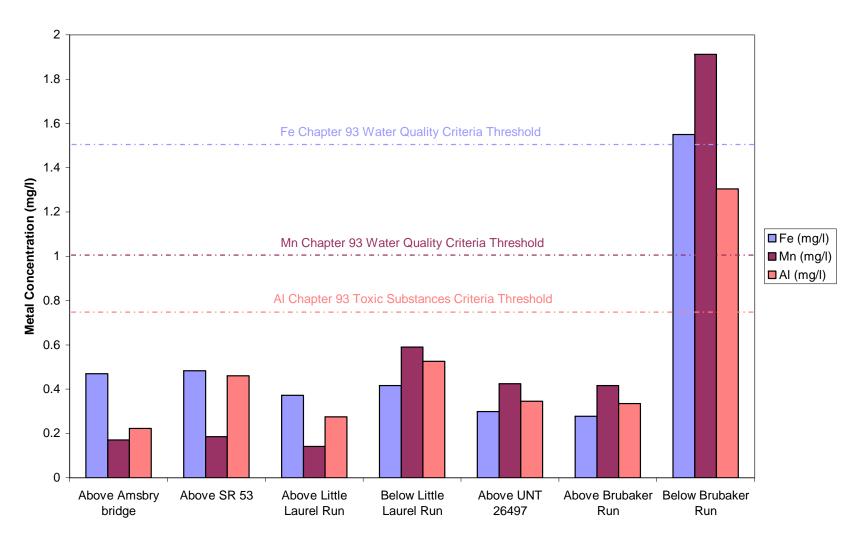
## Figure 12. AMD Metals

*Water Chemistry and Loadings* – Although the pH of Clearfield Creek below Brubaker Run is within the acceptable range for aquatic life, concentrations of iron, aluminum, and manganese are outside of DEP water quality criteria levels (Table 14, Figure 12).

Brubaker Run and the aforementioned discharge have a marked impact to the benthic macroinvertebrate population and chemistry of Clearfield Creek (Figures 10, 11, & 12). The individual stonefly, which is generally regarded as pollution sensitive, found at this site is believed to be an anomaly that perhaps drifted downstream during sampling. The concentrations of AMD metals at this location are very high making it unlikely that any pollution-sensitive macroinvertebrate would be able to inhabit this portion of the stream.
