EXECUTIVE SUMMARY

SITE STATUS REPORT

Property: New Opportunities Incorporated (NOW)
232 N. Elm Street and 39 Cherry Avenue
Waterbury, CT 06702

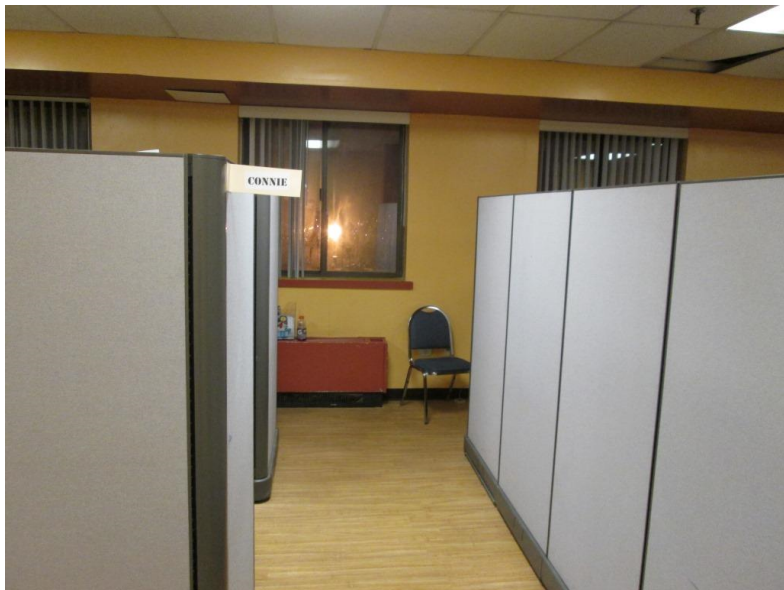
Surveys performed in Phase I, Room 426 identified two locations (measurement IDs 1-4-21 and 1-4-22) that had high exposure rate gradients from the floor to the ceiling. The high exposure rate gradients were due to suspected gamma shine from the location of measurement ID 1-5-3 on the fifth floor above. These two locations were along the north wall in Room 426 (see Appendix A Photo A-3 for measurement ID 1-4-21). The gross exposure rate peaked at 120 $\mu\text{R/h}$ near the ceiling (2-3 meters above the floor). Measurement ID 1-4-21 had a gross exposure rate above the Temporary Instruction threshold; however, when subtracting a conservative background (5 $\mu\text{R/h}$) the resulting exposure rate is below the Temporary Instruction threshold for applying immediate controls. An area of discrete contamination with a gross exposure rate of approximately 200 $\mu\text{R/h}$ on contact was identified on the floor under an occupant's desk in Room 426 (measurement ID 1-4-23). This workspace is the third cubicle (see Appendix A Photo A-4) from the east end of the room. The exposure rate where the occupant would sit at this workspace was 23 $\mu\text{R/h}$ measured at chest level and 15 $\mu\text{R/h}$ at 1 meter, which is below the Temporary Instruction threshold for applying immediate controls.

A-3 Rm 426 looking North. ID 1-4-21 located under chair. Cube with ID 1-4-23 is located on the right.

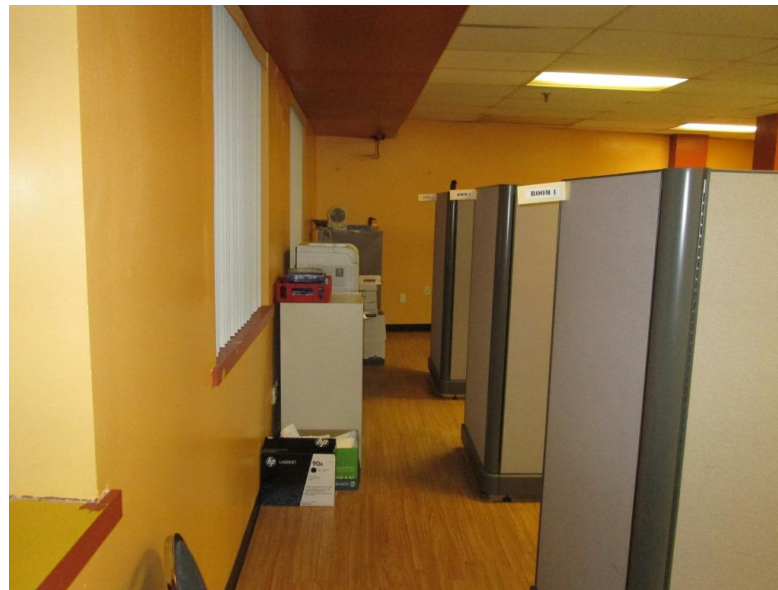
A-4 Rm 426 looking East from chair in Photo A.3. Cubicle with ID 1-4-23 is first on the right.
