**OAK RIDGE ASSOCIATED UNIVERSITIES:  
SITE STATUS REPORT FOR THE FORMER SESSIONS CLOCK COMPANY AT  
61 EAST MAIN STREET, BRISTOL, CONNECTICUT**

**[AUGUST 16, 2017]**

Property: Former Sessions Clock Factory  
61 East Main Street  
Bristol, CT 06010

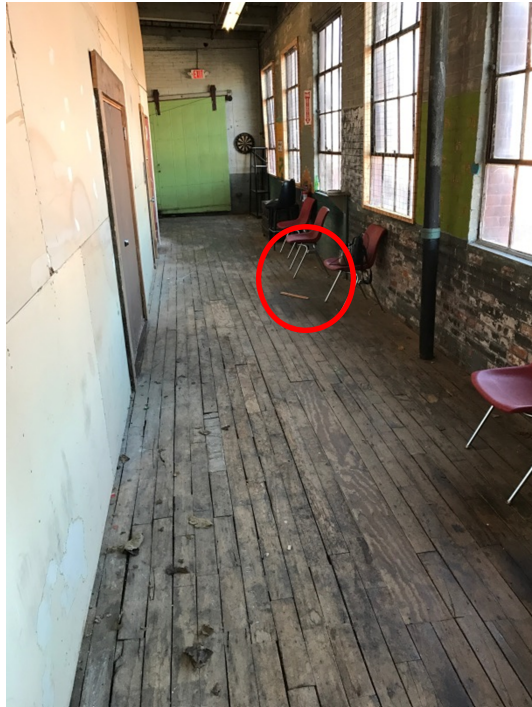
**A-1. Highest Gamma Response Located on the Fourth Floor of Building B (photo looking approximately east)**

Four areas of elevated direct gamma radiation were identified in Building B, all of which were located on the fourth floor. The highest exposure rate reading (see photo A-1) was 35 uR/h on contact, including a background contribution of 9 µR/h, and is below the NRC's threshold for implementing controls of 40 µR/h above background. The 2×2 response at the location was 31,000 cpm, which is similar to the 30,000 cpm value previously reported (Scientech 2003). The discrepancy may be due to the fact that measurement locations were not precisely the same. The gamma spectrum measurement using the NRC inspector's Model 702i at this location positively identified Ra-226 with a 94% confidence.

Based on the above observations, it is recommended that the NRC not perform a scoping survey. Based on the dose assessment considerations, and observations above, it is concluded that that doses will not exceed 25 millirem per year.

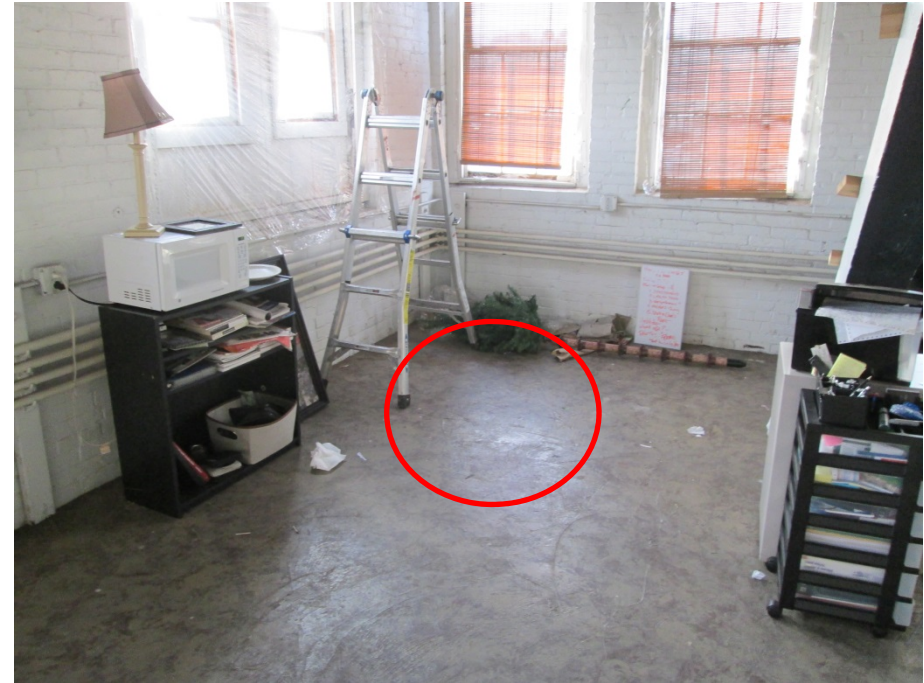
**A-2. Area of Contamination Identified on the Third Floor of Building D (photo looking approximately southwest)**

One area of radium contamination was identified on the third floor in Building D (see photo A-2). This location had an exposure rate reading of 20 uR/h on contact, including a background contribution of 9 µR/h, and is lower than the NRC's threshold for implementing controls of 40 µR/h above background. A previous report (ATSDR 1999) identified a maximum exposure rate of 40 uR/h, which may be associated with the same location. It is unknown whether the location identified by the ATSDR was remediated to any degree.

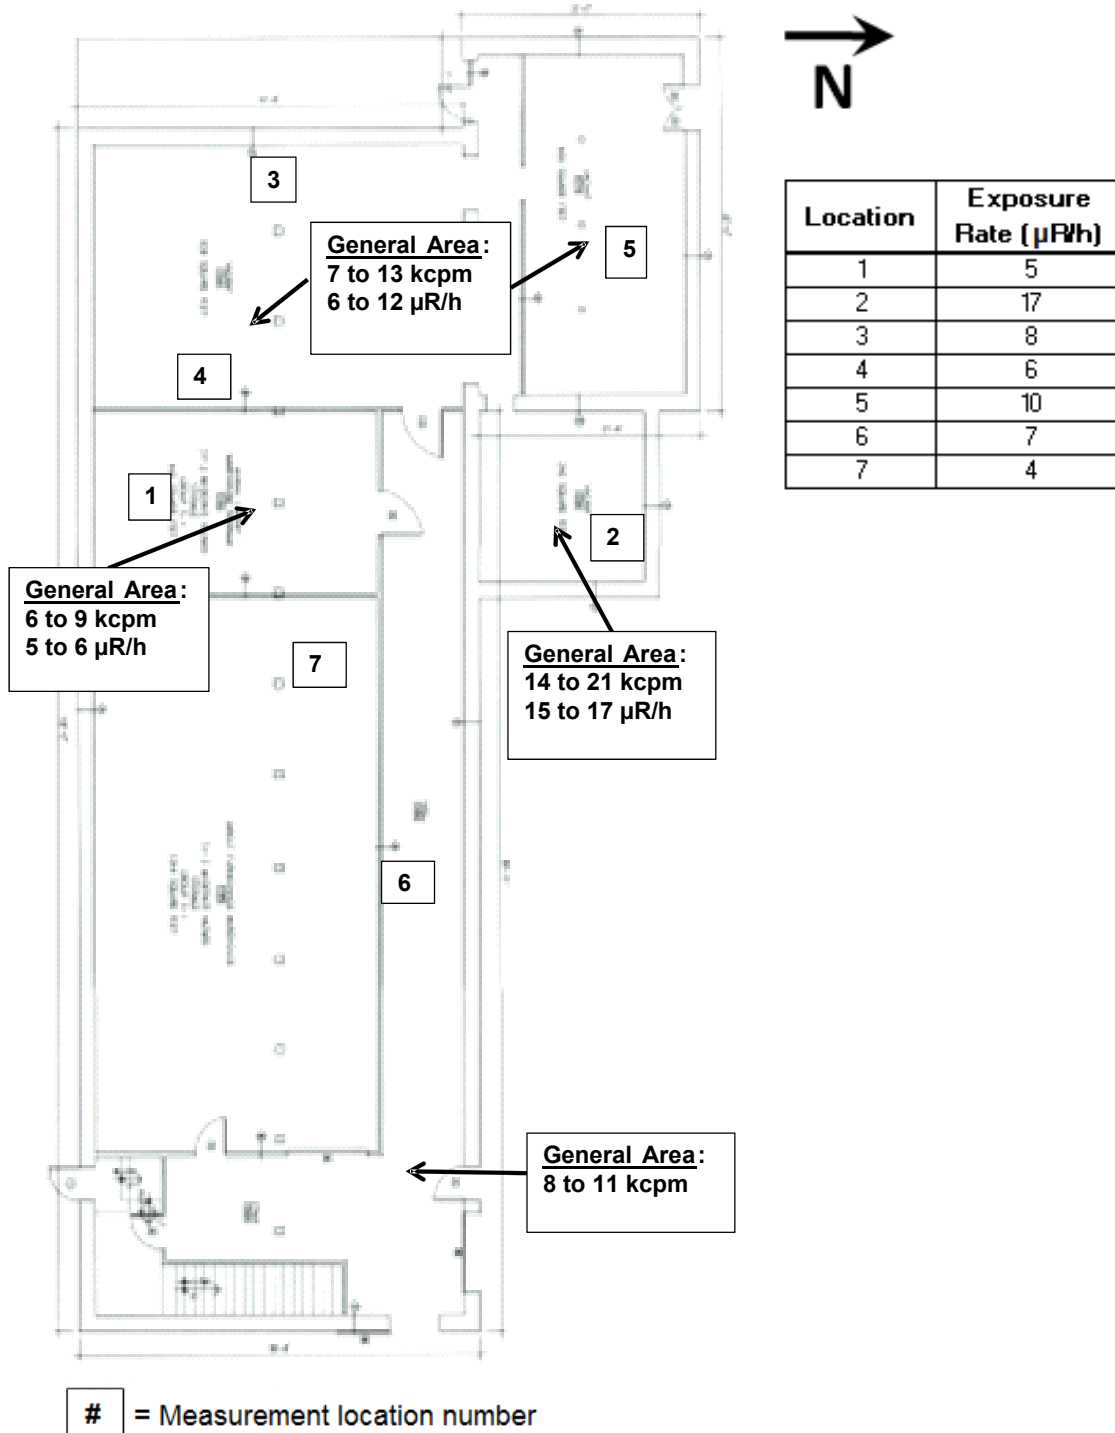
One area of elevated gamma radiation was identified on the first floor of Building A, Location 2 on page B-1, where a room was used to make pottery. The 2×2 response from the pottery was fairly uniform and not discrete, which indicated the presence of NORM in the pottery. Surveys performed in Building A did not identify any additional areas of direct gamma radiation distinguishable from ambient background. Historical survey data indicates that Ra-226
