CORROSION CONSIDERATIONS
IN THE
USE OF BORAL IN SPENT FUEL STORAGE POOL RACKS

J. R. WEEKS

JANUARY 1979
DEPARTMENT OF NUCLEAR ENERGY BROOKHAVEN NATIONAL LABORATORY
UPTON, NEW YORK 11973

Prepared for the U.S. Nuclear Regulatory Commission
Office of Nuclear Reactor Regulation
Contract No. DE-AC02-76CH00016

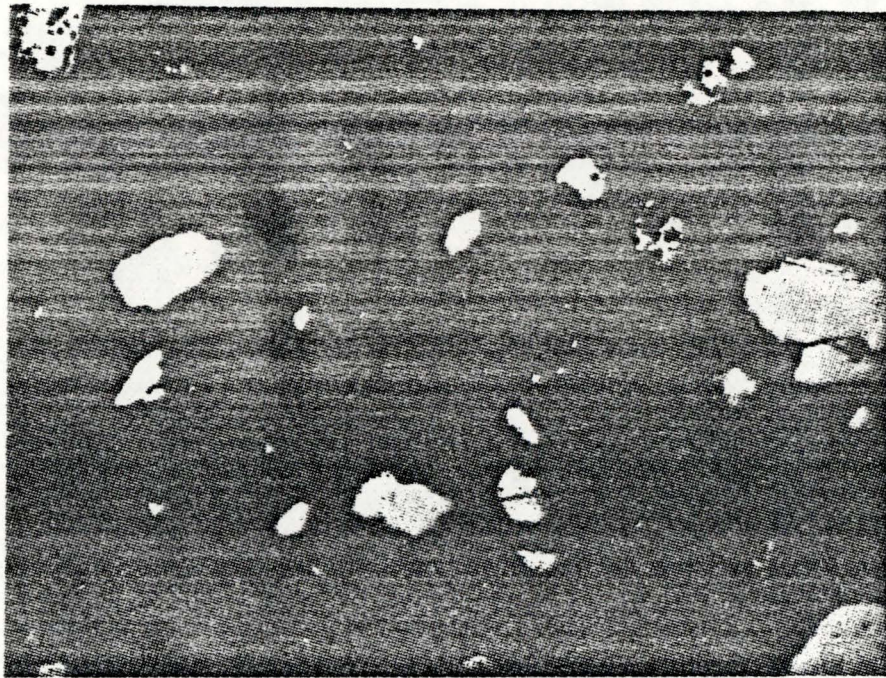
FIG. 5

Sample # 2

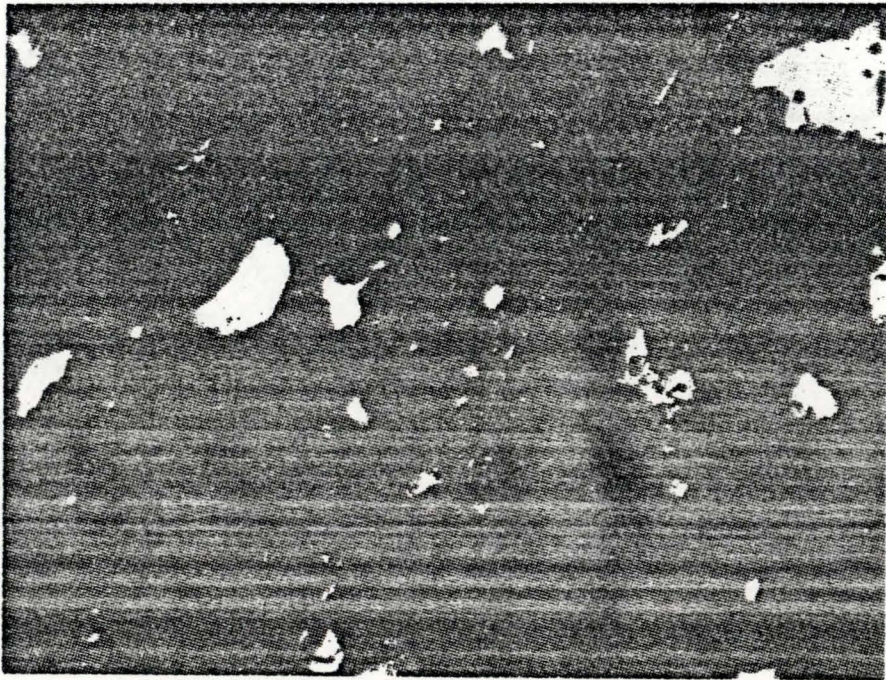
FIG. 7

Sample # 4

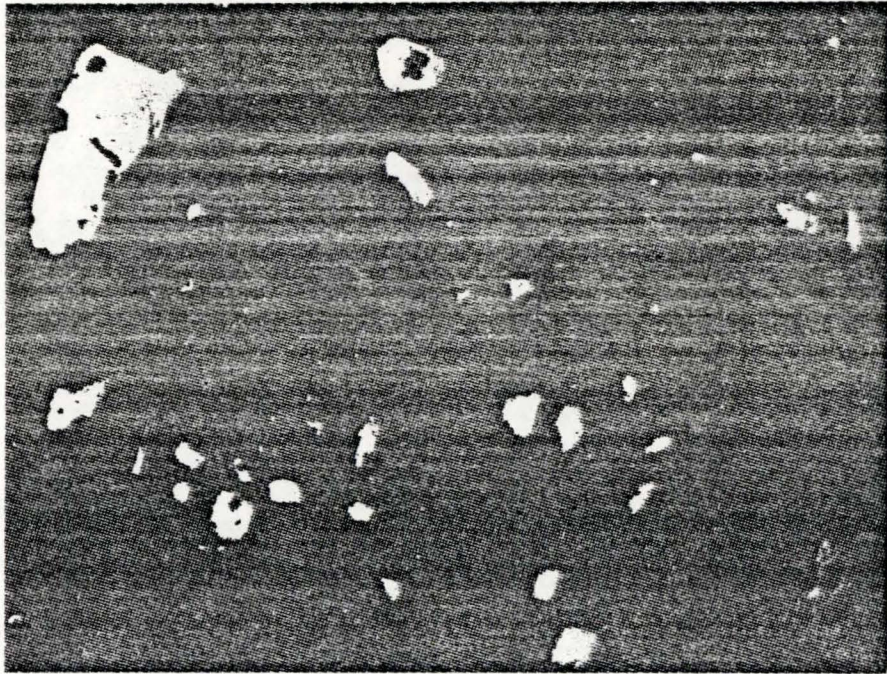
FIG. 8

Sample #5
