This is our Annual Report covering the period July 1, 2010, through August 31, 2011, for the activities of the TRIGA Mark I Reactor at the University of Arizona, Tucson, Arizona. This report is submitted in compliance with Section 6.7e of the Facility Technical Specifications and Section 50.59 of Title 10, Code of Federal Regulations, and will be the final report from this facility.

University of Arizona's Defueling & Decommissioning Chronology

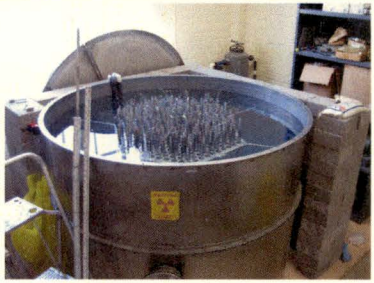
Date	Event(s)	Photograph
<b>July 1</b>	Removed three gallons of water from the Subcritical Assembly (SCA) tank for analysis by RCO <sup>3</sup> . The results would show the water activity well below limits.

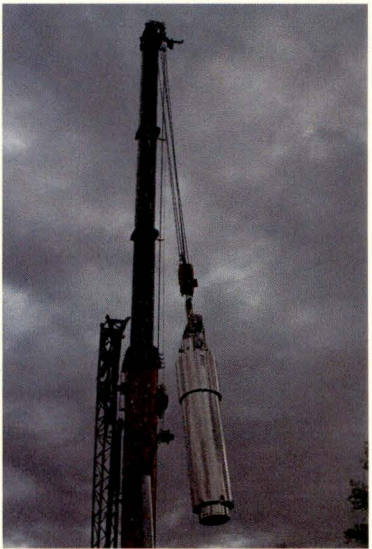
Date	Event(s)	Photograph
<p><b>December 18</b></p>	<p>NRL staff practice moving the failed fuel element container from storage pit #2 back into the reactor pool. The University's Key Shop removes all but two locks to Engineering Building's outer doors. The Engineering Building's handicap entrance (the SE door) and northwest door on the first floor have new locks. Two keys are made. The UAPD dispatchers have one key and the second one resides with the on-site police supervisor. INEL purges the canister containing element #4058 with helium. We move the canister from storage pit #2 to the reactor pool. The University Police sweep the Engineering Building to ensure no one, except reactor-associated personnel, remain within the building.</p>	
<p><b>December 19</b></p>	<p>University Police conduct another sweep within the Engineering Building. University Facilities Management installs I-beam floor supports to build a trolley for rolling the NAC Inner Shield in and out of the Reactor Room. Amid overcast, but not rainy, wintry skies NAC equipment arrives and gets set up. Temporary chain-link perimeter fencing installed. James E. Rogers Way is closed to traffic. Installed a 3-ton gantry crane over the reactor pool. RCO badges all personnel.</p>

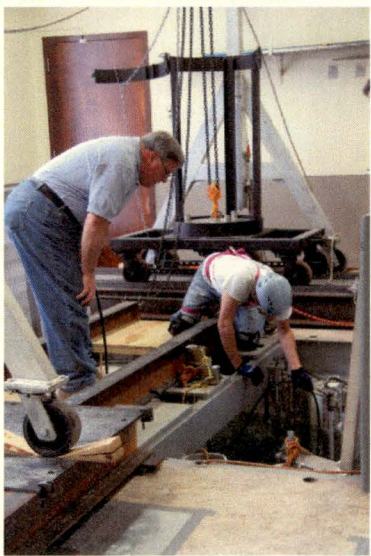
Date	Event(s)	Photograph
December 20	<p>The weather remains overcast and cool. We move our reactor fuel into the NAC Inner Shield. The University of Arizona Police Department (UAPD) provides continuous guard of the Engineering Building and the surrounding north side.</p>

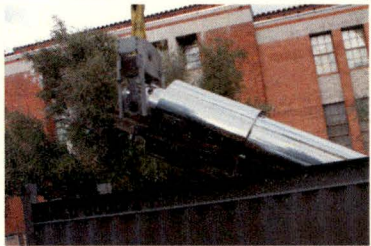
December 22	<p>DOE along with STS and NAC contractors load the transport trailer and pack their equipment up. Tucson receives on and off drizzle.</p>

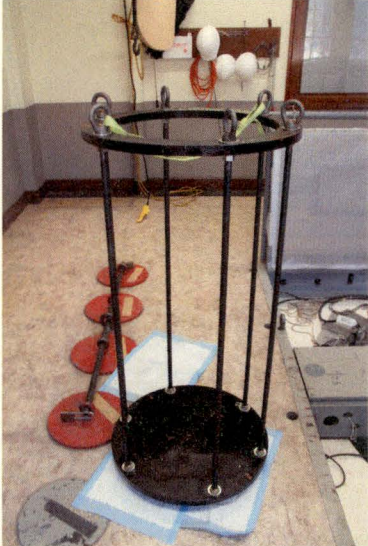
Date	Event(s)	Photograph
<b>Early January 2011</b>	The University of Arizona selects the LVI Services Inc. and ENERCON Services Inc. consortium to decommission our reactor.	
<b>January 20, 2011</b>	We removed the ISH from the reactor pool. This equipment remains available for other reactors where space constraints prohibit placing the NAC Inner Shield on the reactor tank structure directly.

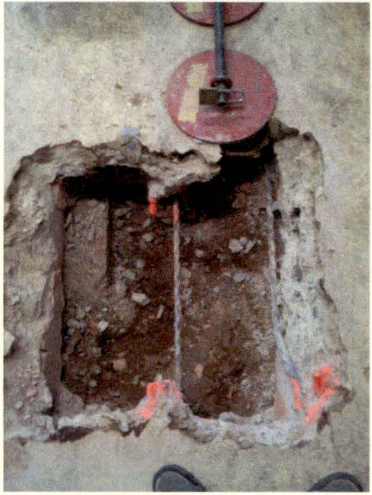
Date	Event(s)	Photograph
<p><b>May 17</b></p>	<p>We conducted our reactor annual emergency drill with the ENERCON and LVI personnel. The drill examined decommissioning planning and exercised the emergency notification and emergency reporting portions of our Nuclear Reactor Laboratory's Emergency Plan. LVI commenced coring the reactor room (Engineering 124) floor for building support system footers.</p>

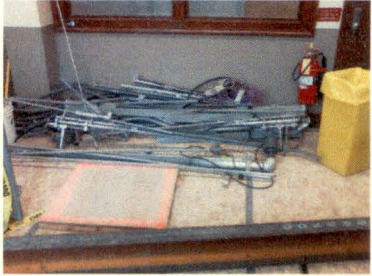
<p><b>May 18 to 23</b></p>	<p>LVI removed reactor power instrumentation, conductivity sensors, water thermometers, experiment apparatus, and irradiation facilities. We find tubing three feet or more above the core is "free release." We cut tubing there releasing the non-activated portions as scrap. The lower activated portions go into radwaste containers.</p>

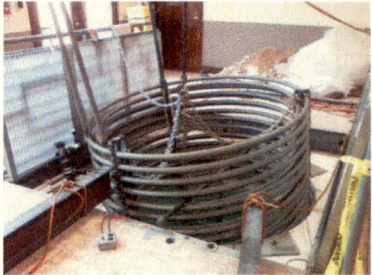
<p><b>May 25 to June 3</b></p>	<p>LVI dismantled the exterior water chiller unit and removed the cooling coils from the reactor pool. Neither the Freon compressor unit nor the expansion coils are activated or contaminated. Removed rabbit tubing and associated pneumatic equipment.</p>

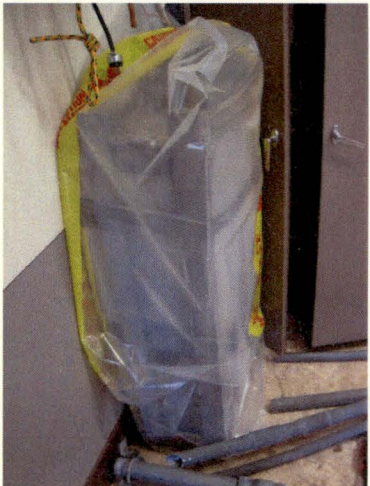
Date	Event(s)	Photograph
<p><b>June 7</b></p>	<p>LVI removes and cocoons the thermalizer.</p>

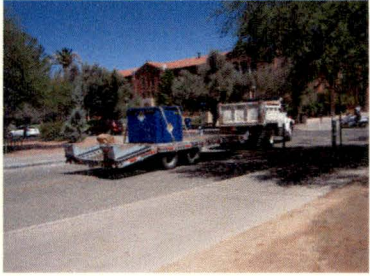
<p><b>June 9</b></p>	<p>After drying the reactor core overnight, we place the core into a blue, custom-made, steel container and move it to the University's Secured Radwaste Storage Facility with UAPD escort. We remove another four liters of reactor pool water for RCO to analyze. This way we have our routine quarterly pool water analyses, a sample taken just before we removed the core, and a sample just after the core removal.</p>

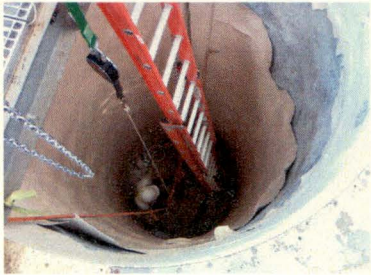
June 20 to 24	We continued taking cores from the reactor tank walls and bottom for analysis. Annual U.S. NRC inspection by Region IV Office's Robert Evans.

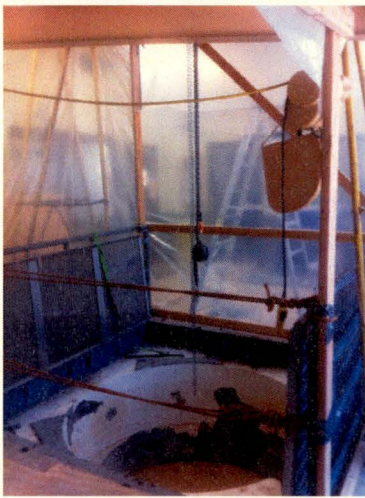
Date	Event(s)	Photograph
<p><b>June 27 to 29</b></p>	<p>Build dust barrier above pool in preparation for gunite removal.</p>

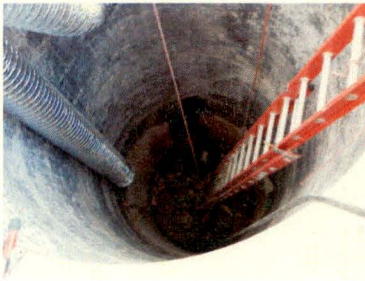
<p><b>June 30 to July 20</b></p>	<p>Chipped all gunite off the walls and floor of reactor pool. Contractors find the entire steel liner intact. No rust, no evidence of any leakage.</p>

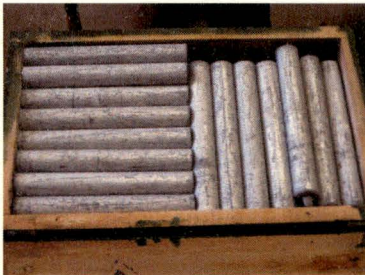
<p><b>July 21 to 25</b></p>	<p>Moved the uranium slugs from the subcritical assembly into surplus wooden ammunition boxes. The uranium within our subcritical assembly elevates the radiation background within Engineering Room 124A. The SCA must go before we can conduct the final status survey. We commence removing the lower six feet of the steel reactor liner. The contractor first uses a portable electric abrasive saw. This proves too slow due to the blade also sawing the concrete beneath the liner. The contractor switches to an oxy-acetylene cutting torch.</p>

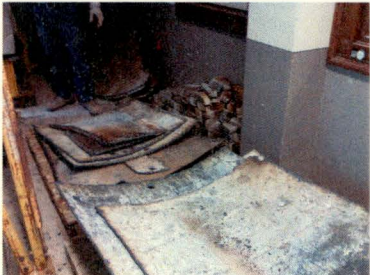
Date	Event(s)	Photograph
<b>July 26 and 27</b>	Continue to cut and remove the lower six feet of the steel liner. We discover a compartment filled with bricks behind the steel liner on the west side behind the thermalizer location.

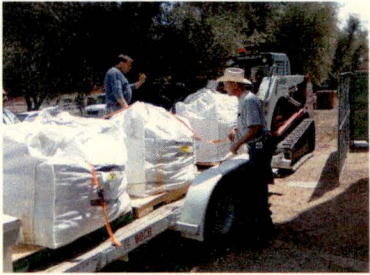
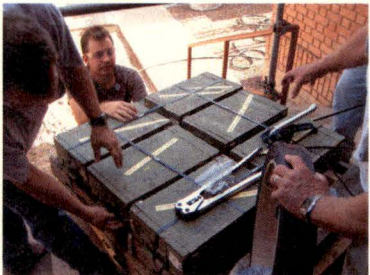
<b>July 28</b>	Contractors commence removing the lower six feet of concrete to a depth of 4-inches from the tank wall and floor.	
<b>July 29</b>	RCO informs us the SCA tank water is “less than background.”	
<b>August 1 and 2</b>	We pump the SCA tank water into the sink in Engineering Room 124A, and continue chipping away the activated concrete tank.	
<b>August 3</b>	Disassembled the dust containment structure over the reactor pool. Returned the removed soil to the floor excavations about storage pits #1, #5 and #6.	
<b>August 4</b>	We transported three flexbags of removed activated tank concrete and all remaining ammo boxes of subcritical assembly uranium slugs to RCO’s Radwaste Storage Facility. Receive a “good to go” for pumping two 55-gallon drums of ‘dust mitigation’ spray water into the sink in Engineering Room 124A.

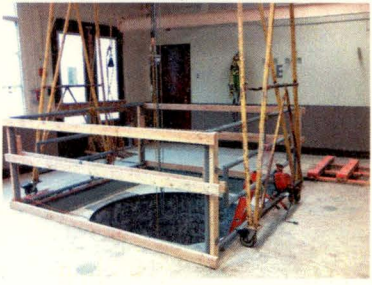
Date	Event(s)	Photograph
<b>August 5 to 11</b>	RCO surveyed all material, tools, and contractor equipment. Removed all equipment, material, and tools from reactor area. Remediated all rooms within the reactor area. Built fence around open reactor pool.
