**OAK RIDGE ASSOCIATED UNIVERSITIES:
SITE STATUS REPORT FOR THE DeLORENZO TOWERS
(FORMERLY INGRAHAM CLOCK COMPANY) AT
284 NORTH MAIN STREET, BRISTOL, CONNECTICUT**

November 9, 2018

SITE STATUS REPORT

Property: Ingraham Clock Company-1
284 North Main Street
Bristol, CT 06010

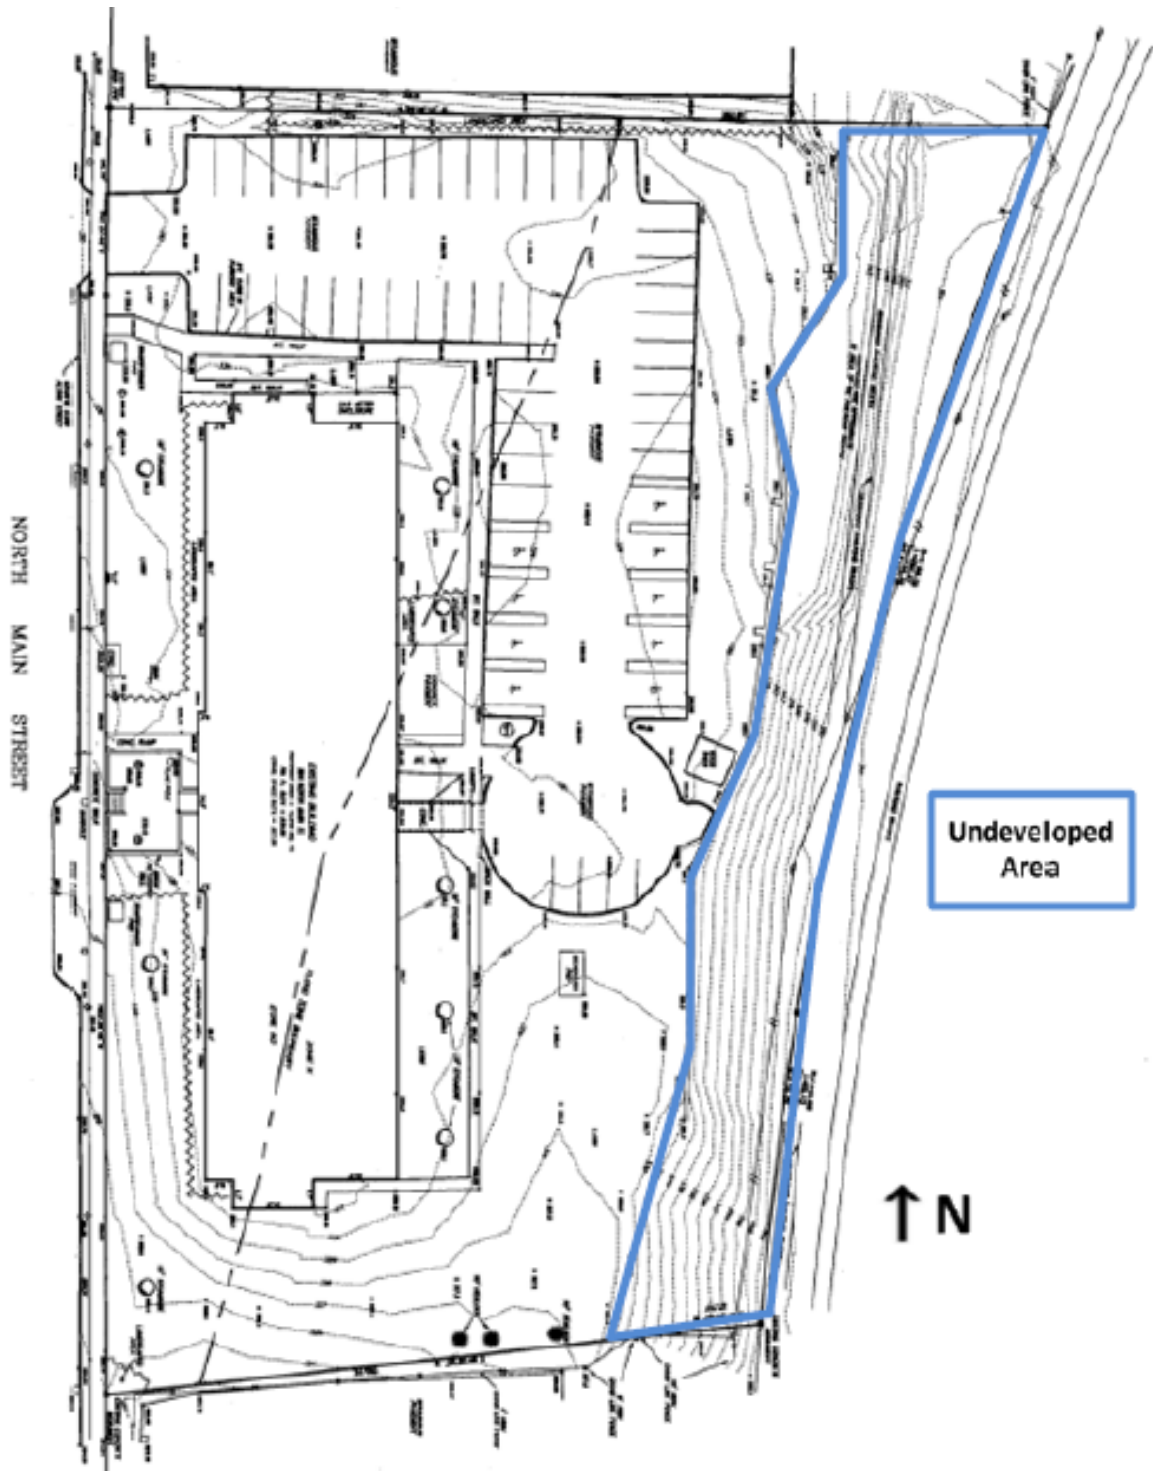
The scoping survey continues the same type of surveys as were performed during the initial site visit but more thoroughly considers the eastern embankment of the property. As shown in Figure 1, the specific area of interest is the undeveloped embankment located on the eastern edge of the property. The area is characterized by steep slopes and heavy undergrowth. The survey design includes scanning safely accessible portions of the hillside for gamma radiation emanating from Ra-226-containing materials, documenting the location and magnitude of contamination, and sampling potential discrete sources of Ra-226.

Figure 1. Undeveloped Embankment on the 284 North Main Street Property

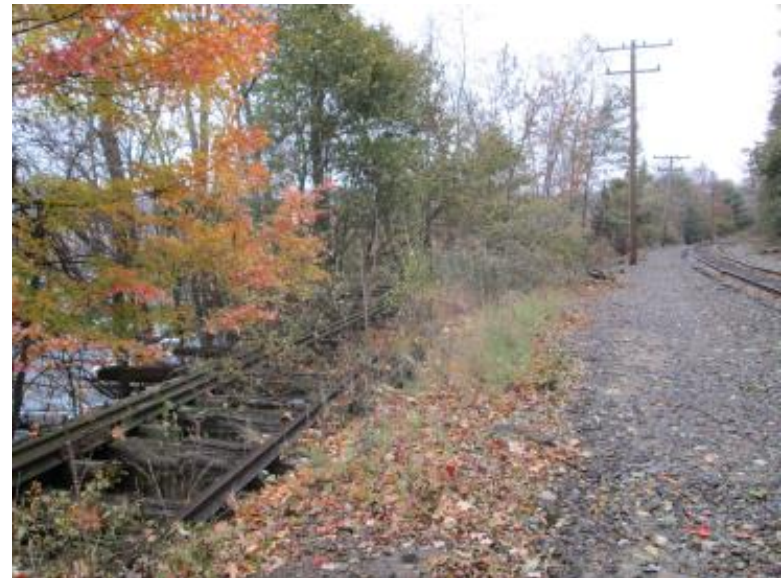
Figure A-4. Abandoned Railroad (left) in Eastern Embankment

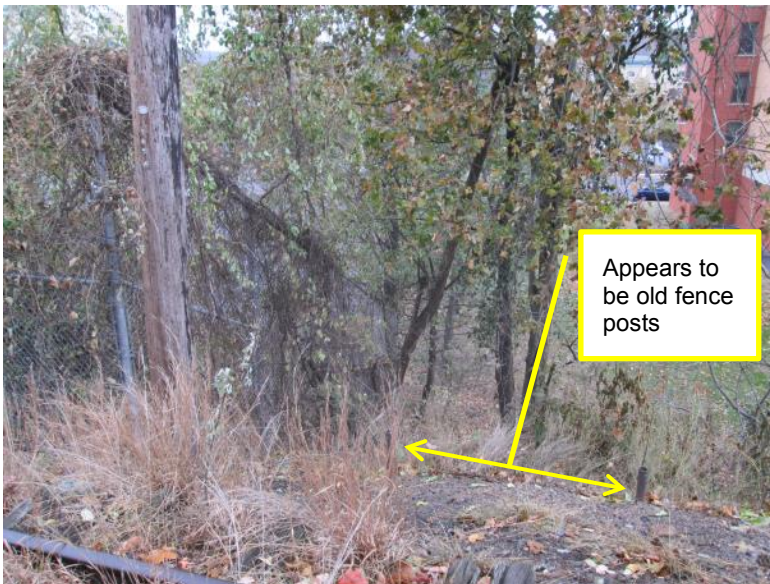
Appendix A presents photos from the scoping survey. Figures A-1 through A-10 present the eastern embankment from various angles. Figure A-11 shows what appear to be old chain-link fence posts located approximately 1 meter north of the current southern, physical boundary, suggesting the current property boundary is different from the historical property boundary. Figures A-12 through A-15 depict the inspectors performing surveys and the heavy undergrowth and steep slope of the area. Figure A-16 shows a rock with elevated radiation levels (up to 18,000 cpm) that is due to naturally occurring radioactive material (NORM) and is not associated with former Ra-226-related operations. Figures A-17 and A-18 show the approximate location in relation to the building where the slag-like materials were found during the initial site visit and the scoping survey. Figure A-19 shows the location of small areas of elevated radiation marked by blue flags. Note that not all identified pieces of slag-like material produced elevated radiation levels.

Figure A-11. Eastern Embankment South End

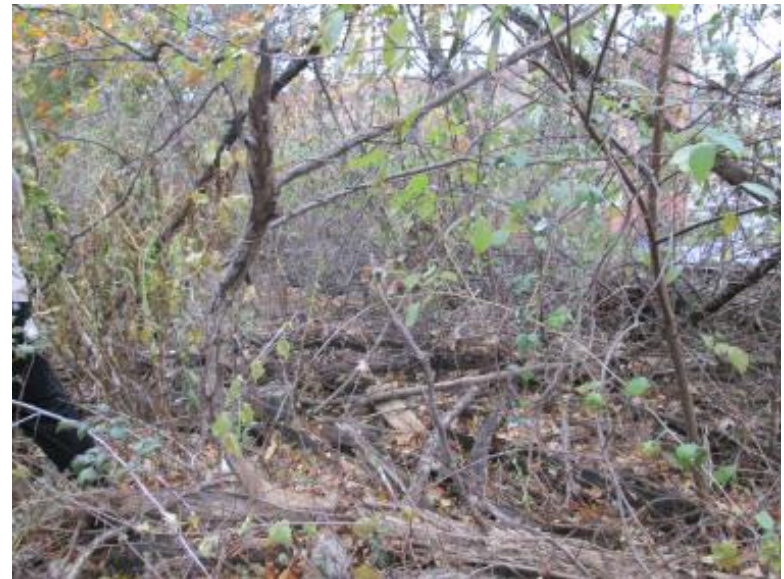
Figure A-14. Example of Heavy Undergrowth

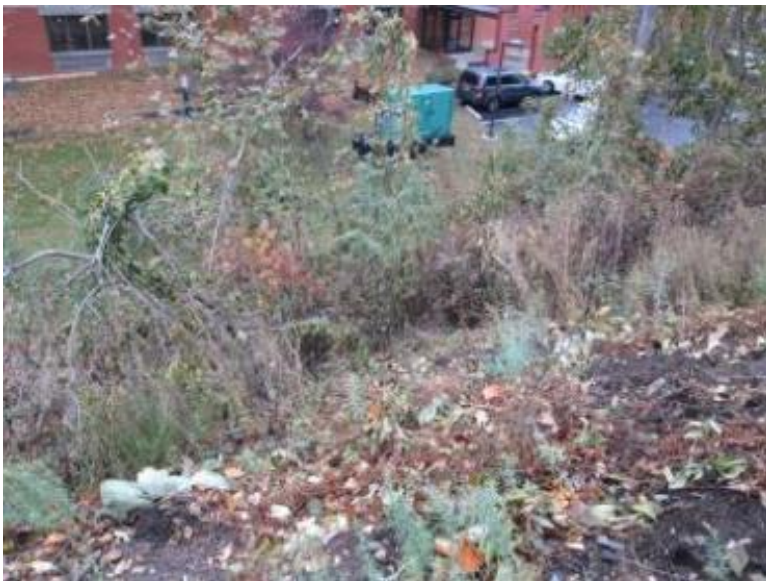
Figure A-15. Example of Heavy Undergrowth

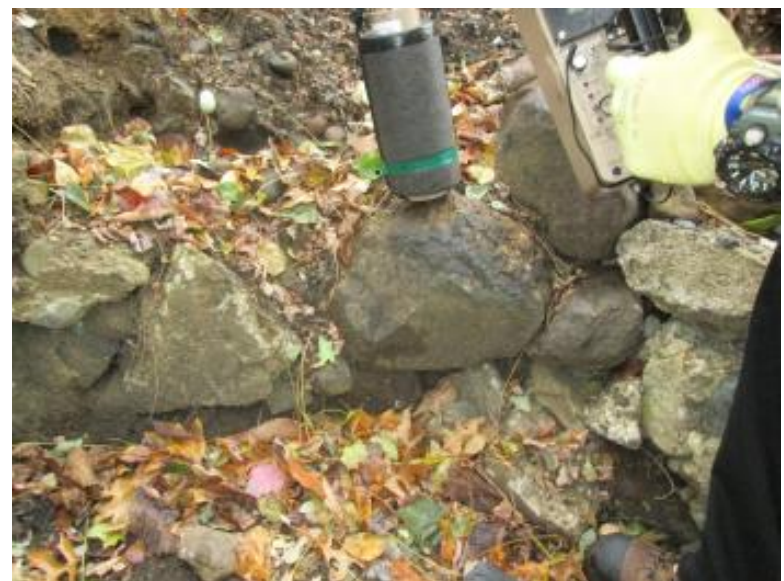
In general, the 2×2 sodium iodide detector background responses ranged from approximately 5,000 to 13,500 cpm. A rock in a wall was found to have 18,000 cpm and is due to NORM (Figure A-16), so the associated cpm result is not considered to be part of the ambient background distribution. The gamma exposure ratemeter background responses ranged from approximately 5 to 12 µR/h. Table B-2 presents summary statistics of the background survey data collected during the initial site visit (excluding the elevated radiation levels). For the 2×2 sodium iodide detector measurements, the mean is close to the median and 99+ percent of the data points fall within three standard deviations of the mean. The one anomaly is the above mentioned NORM rock. Likewise, exposure rate measurement data demonstrated similar statistical characteristics with 100 percent of the data points falling within three standard deviations with no anomalies. In the approximately 6-meter by 1-meter section with small areas of elevated radiation, the 2×2 sodium iodide detector responses ranged from 15,000 to 53,000 cpm on the surface. After some of the slag-like material was uncovered and samples were collected, the detector responses increased up to 280,000 cpm, 44 µR/h at 1 meter. This indicates that additional contaminated materials are likely present below the ground surface, which shielded radiation emanating from the slag-like material in its original configuration. The samples collected exhibited a maximum exposure rate of 34 µR/h,² on contact. Table B-3 provides a summary of the samples collected for analysis, and Figures B-3 and B-4 provide the SAM-940 output for the two samples submitted for analysis.

**Figure A-16. Rock with Elevated Radiation Levels
(due to NORM)**

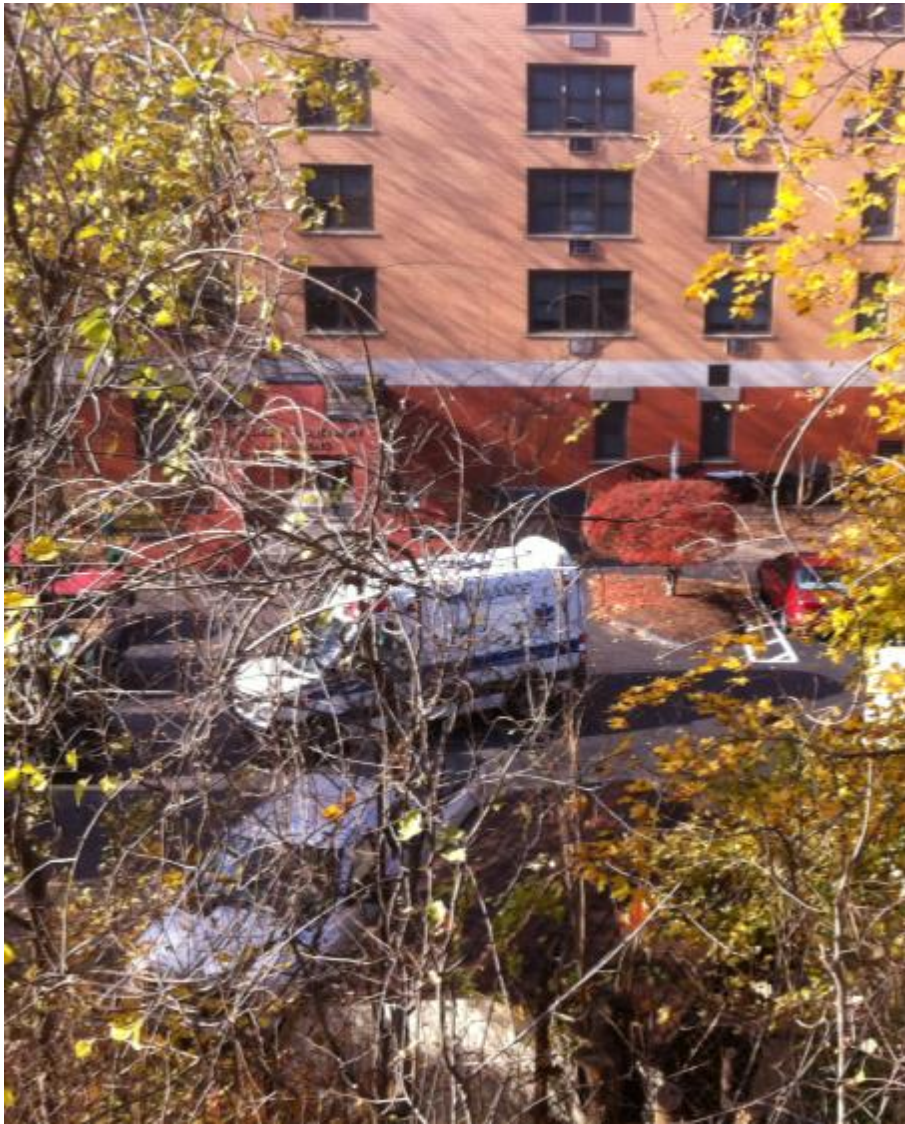
Figure A-17. Location of Slag-Like Material in Reference to the Building Found During the Initial Site Visit in November 2016

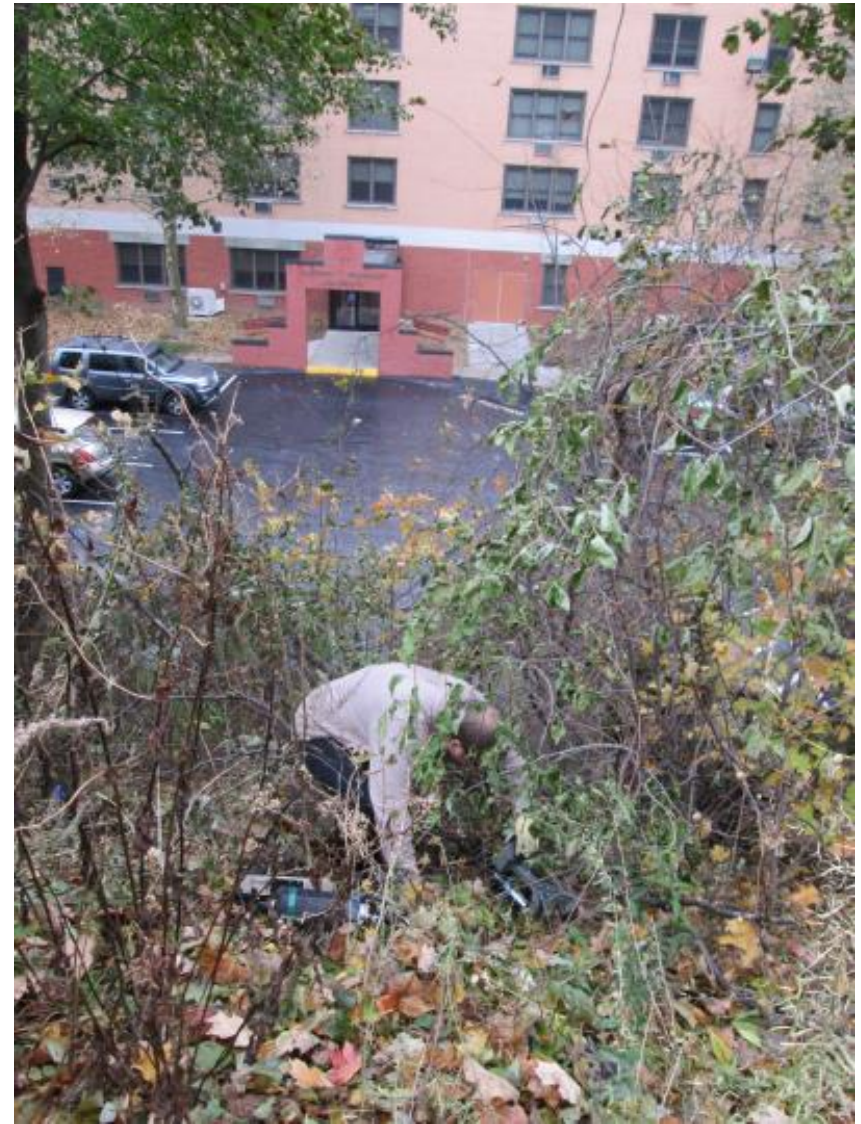
Figure A-18. Location of Elevated Area in Reference to the Building Found During the Scoping Survey in November 2017

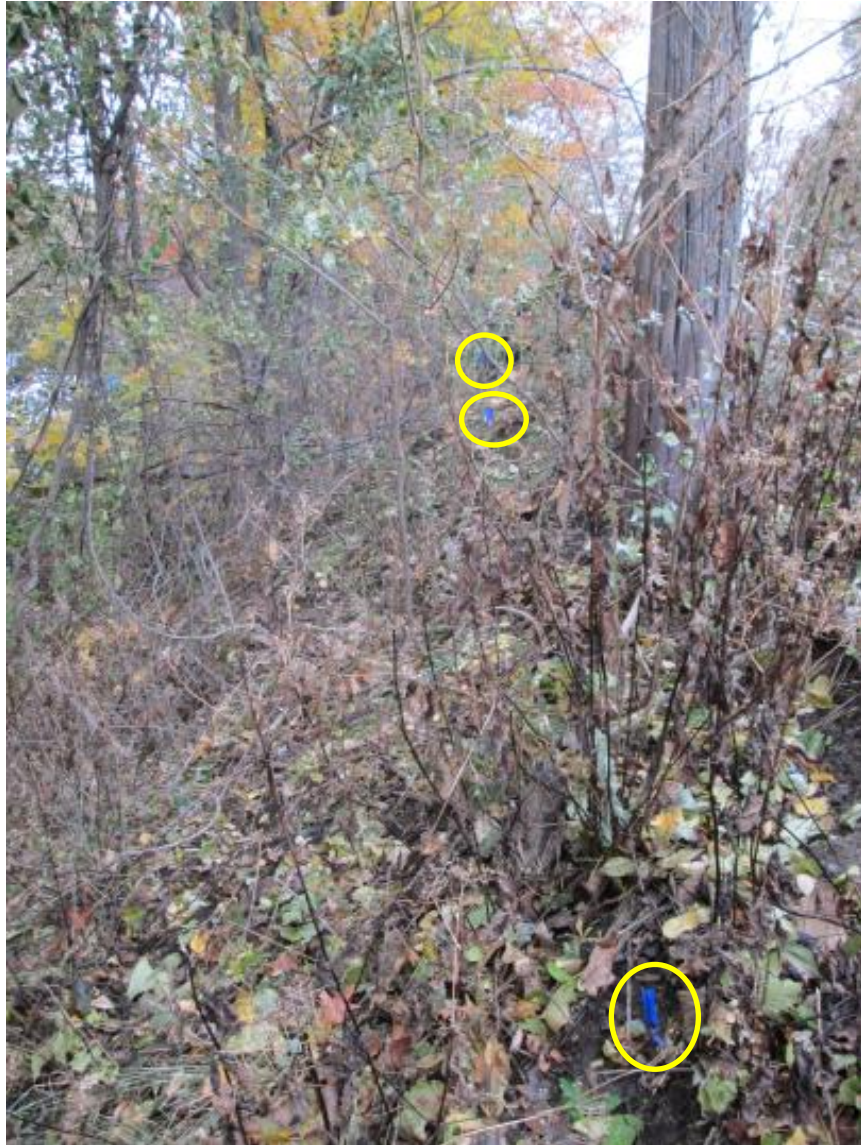
Figure A-19. Location of Elevated Areas (note blue flags)

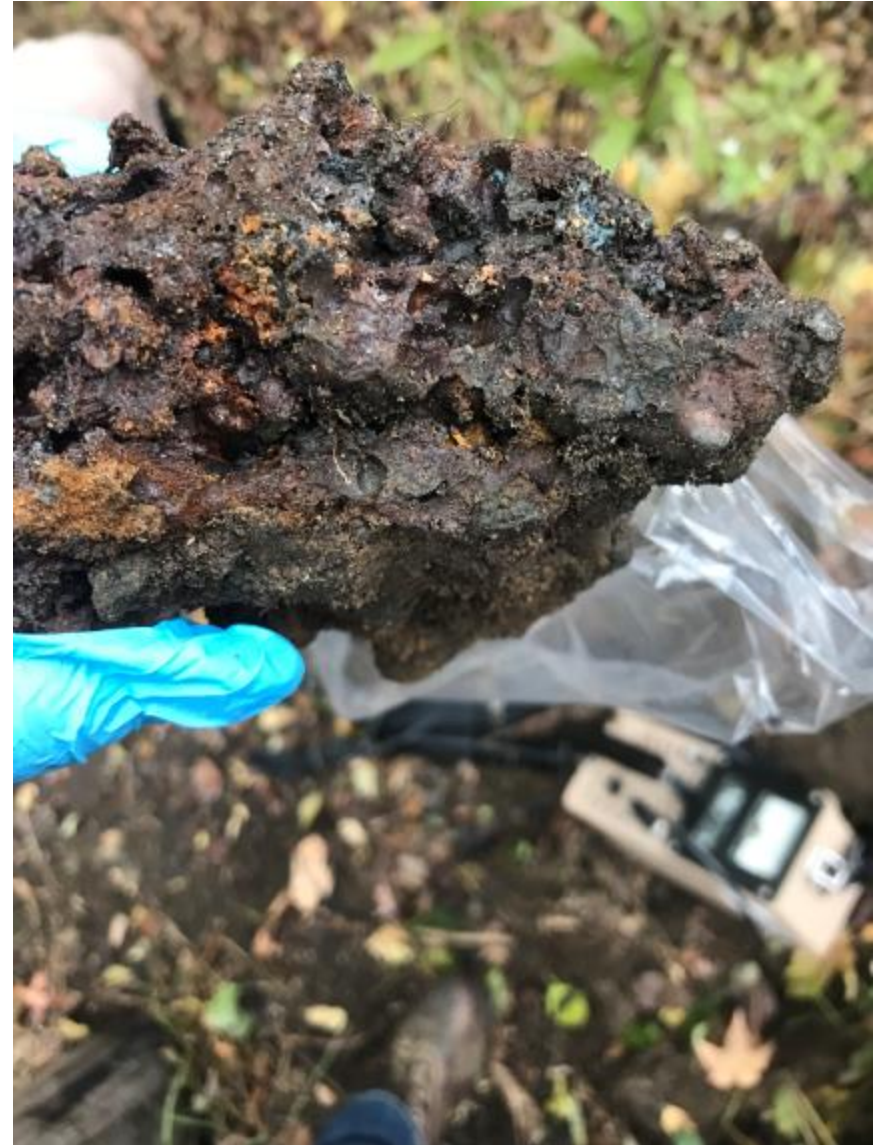
Figure A-20. Slag-Like Material (Sample 5307M0001)

Sample ID	Location (m)		Nal (cpm)	Exposure Rate (μ R/h)		Picture Figure
	Easting	Northing	Contact	Contact	1 m	
5307M0001	288457.3	246262.3	43,000	34	10	A-20
5307M0002	288457.5	246265.3	20,000	27	8.5	N/A

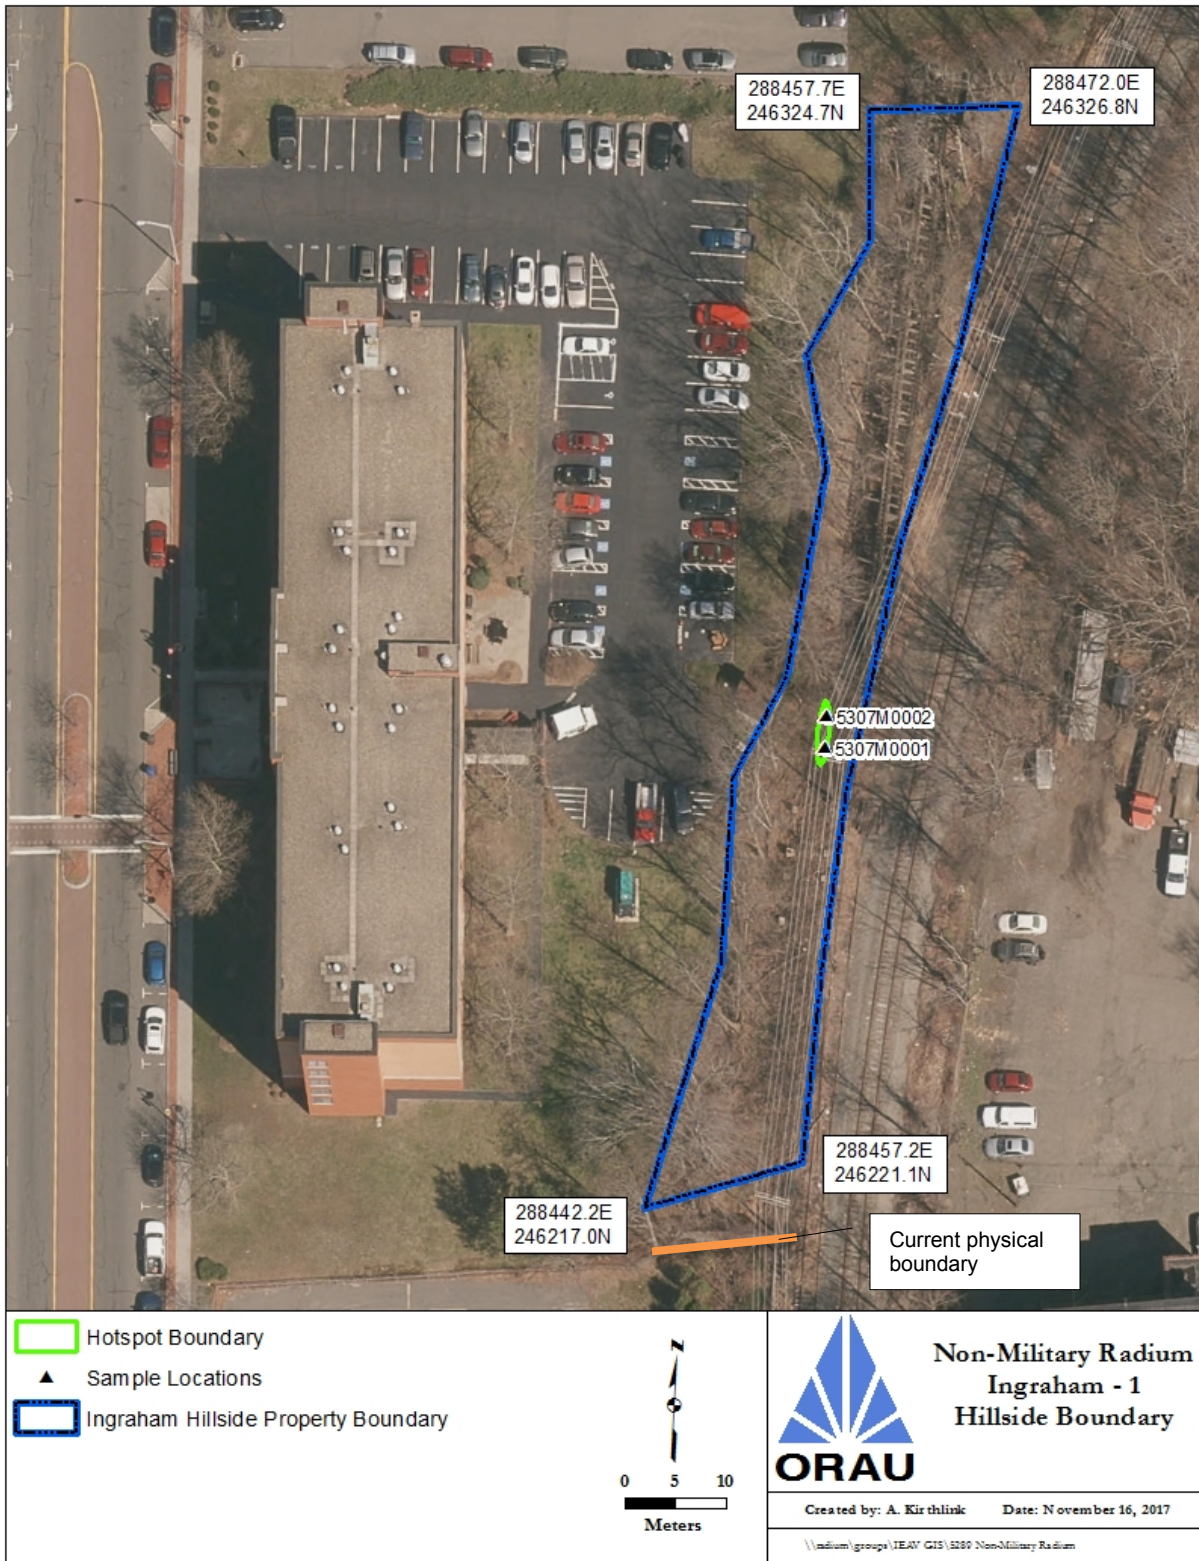
Appendix B presents survey data collected during the scoping survey. Figure B-1 outlines the eastern embankment targeted during the scoping survey (blue lines), and the area with elevated radiation levels (green lines). Figure B-2 provides a summary of the survey data with the area with elevated radiation levels outlined in green. Due to the large number of data points collected, the results have been summarized into ranges of 2×2 sodium iodide and exposure ratemeter responses. Table B-1 provides the tabularized survey data (excluding the elevated radiation levels).

Figure B-1. Map of Eastern Embankment and Elevated Radiation Area

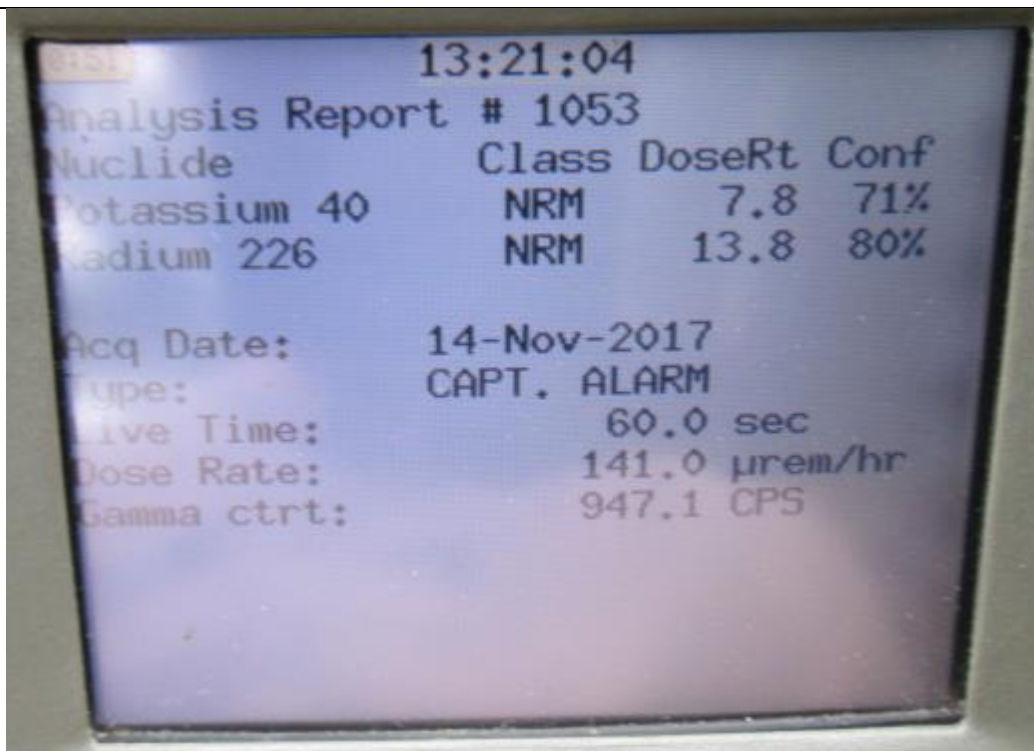
² As indicated in figures B-3 and B-4 the SAM-940 reported exposure rates of almost 150 µrem/h for each of the sample collection locations on contact with the slag-like material. The SAM-940 measurements were performed prior to the collection of the samples and the higher exposure rate is attributed to additional buried sources in the locality.

Figure B-3. SAM Report for Sample 5307M0001

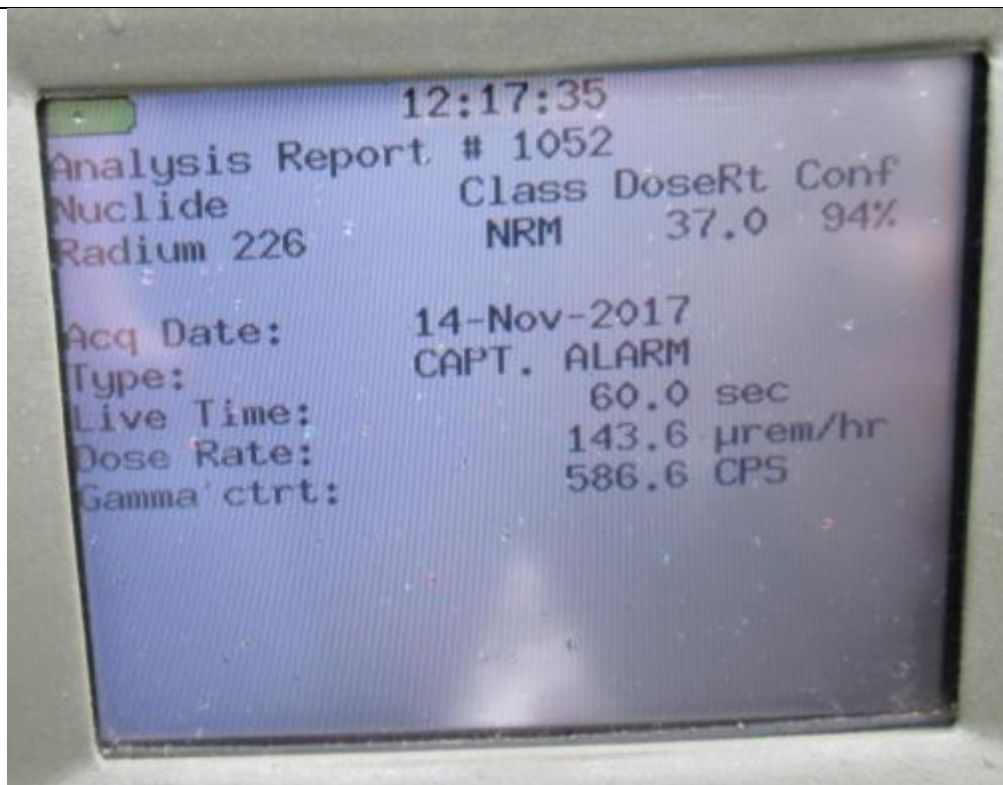
Figure B-4. SAM Report for Sample 5307M0002
