**Bell Bend Nuclear Power Plant
Stream and Wetland Mitigation Design Report
Walker Run Site**
Salem Township, Luzerne County, PA

Prepared for:
PPL Bell Bend, LLC.
38 Bomboy Lane, Suite 2
Berwick, Pennsylvania 18603

Rev 0, November 2010

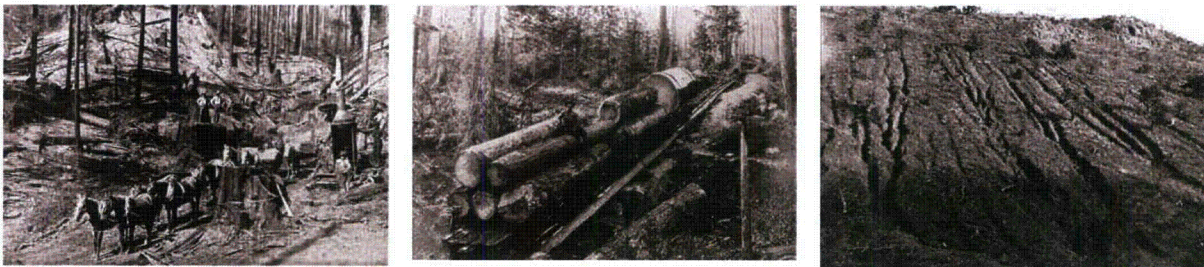
The Walker Run watershed exhibits effects of colonial and post-colonial (early 1700s to 1930s) land-use practices that are commonly found throughout the Eastern United States. Wholesale land clearing and poor farming practices led to widespread erosion of uplands and massive deposition of soils in the stream valleys (Caverns 1925, Costa 1975, Jacobson and Coleman 1986) (see *Figure 3-2*).

Figure 3-2. Indiscriminate land clearing caused massive erosion from hillsides.

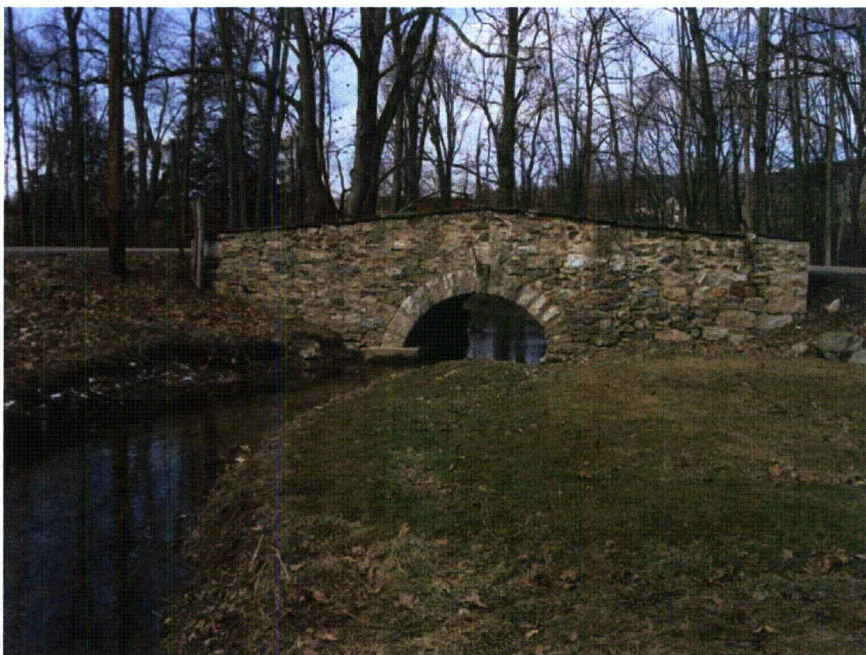
Figure 4-1. View of the south Market Street bridge crossing (facing downstream).

The base level control reach (hereafter BLCR) includes approximately 1,400 feet between the south Market Street bridge crossing and the downstream limit of the proposed restoration project site. The bridge crossing at Market Street is an open-bottomed stone arch bridge culvert (see *Figure 4-1*). Even though this bridge crossing does not appear to provide any natural or artificial grade control, it identifies the lower end of the base level control assessment. At the bridge, there appears to be some level of scour that has occurred as a result of higher flow events; however, there are no visible head-cuts downstream of the Market Street bridge that would affect the base level elevation of the streambed within the BLCR. The BLCR is slightly incised, or entrenched, which means there is a disconnection between the channel and its floodplain, from Market Street to an existing 36-inch pipe culvert crossing along a farm access road approximately 860 feet upstream (see *Figure 4-2*). With no obvious downstream base level control, it would be expected that the stream channel is only beginning to vertically degrade and lose its connection with its floodplain as it becomes more entrenched. However, the bed is composed of larger-sized (large gravel and cobble) substrate throughout this segment, which is helping to sustain current bed elevations and reducing the potential for future bed degradation.

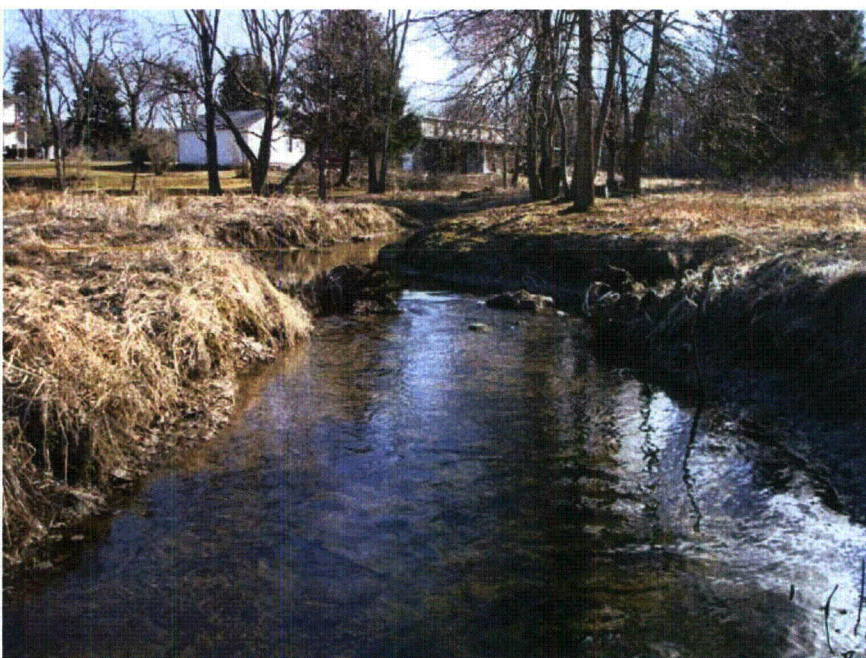
Figure 4-2. Typical conditions upstream of the south Market Street bridge showing moderately entrenched stream with minor bank erosion.

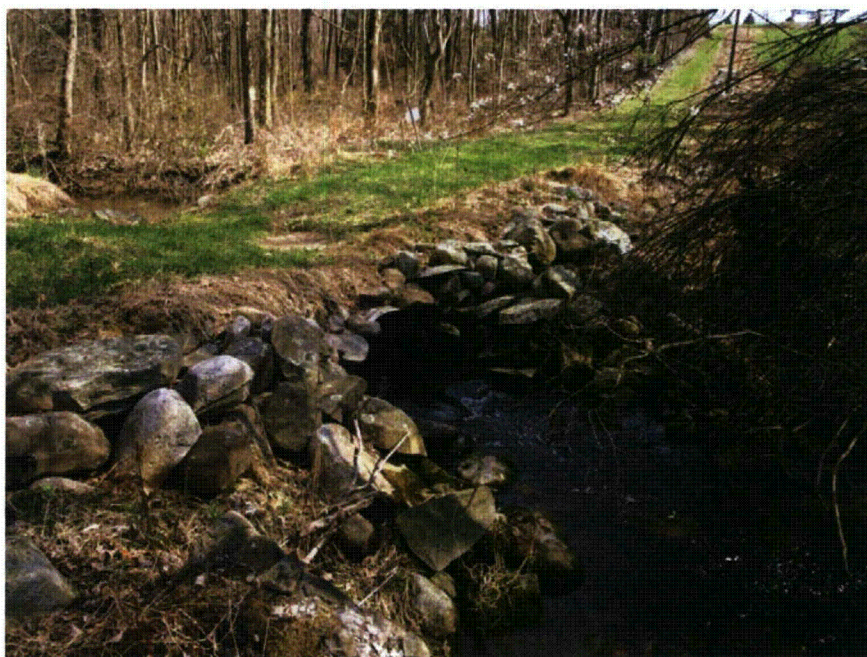
Figure 4-3. View of the culvert crossing along an existing farm access road, which provides the primary upstream base level control. This control structure prevents long-term vertical bed degradation upstream because of the fixed bed elevation of the culvert.

Approximately 800 feet upstream from Market Street is a 36-inch corrugated metal pipe culvert crossing, which conveys the base level flow of Walker Run under an existing farm access road (see *Figure 4-3*). It was determined that this culvert is the primary base level control for the project reach. The farm access road is at elevation higher than the existing floodplain, which obstructs flood flows. Flood flows that do not exceed the elevation of the road are forced through the undersized pipe culvert. This obstruction slows the velocities of flood flows and creates a backwater condition upstream that causes sediment to deposit within the channel.

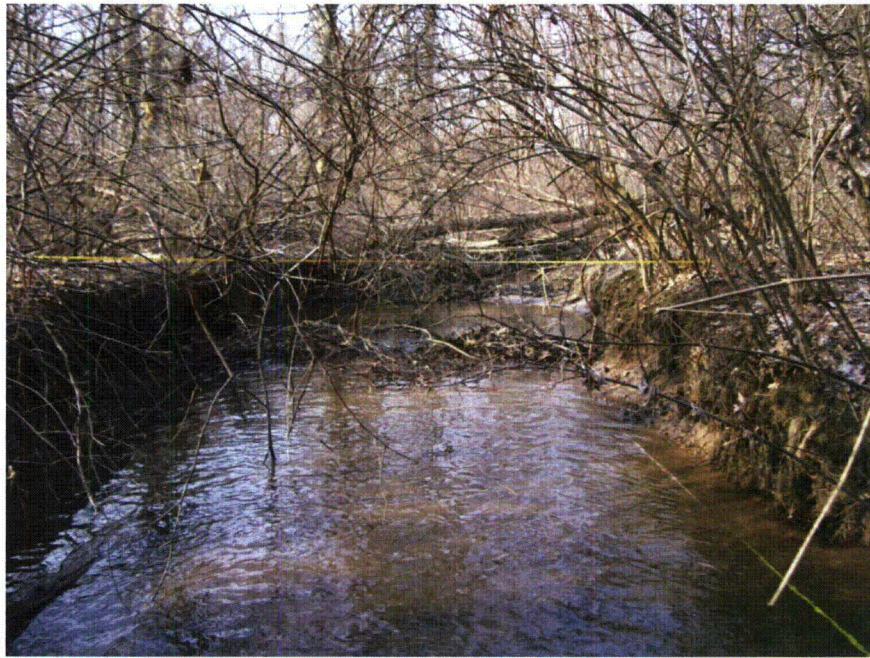
Figure 4-4. Typical conditions within forested segment of the BLCR upstream of the farm access road.

Upstream of the culvert crossing, Walker Run is more significantly entrenched and incised. The stream flows through a mature forest for approximately 850 feet between the farm access road and the existing tree-line near the downstream limit of the project reach. It appears that this forested segment of the BLCR has degraded vertically to match the invert elevation of the 36-inch pipe culvert located downstream. The channel is relatively straight and over-wide with a bed substrate dominated by very dense sandy clay (see *Figure 4-4*). The stream banks are 2-4 feet high and are composed of fine alluvial silts and sandy material. As with other described reaches of Walker Run, this reach appears to have been manipulated by human activities in the past, most likely ditching to drain surrounding swamp and wetland areas in an effort to generate more usable land. A beaver dam approximately 3-4 feet higher than channel bed existed near the transition between the BLCR and the project reach, which created a backwater condition that extended upstream well into the project reach. However, this beaver dam was removed in April 2010, which lowered upstream water surface elevations to match water surface along most of the BLCR.

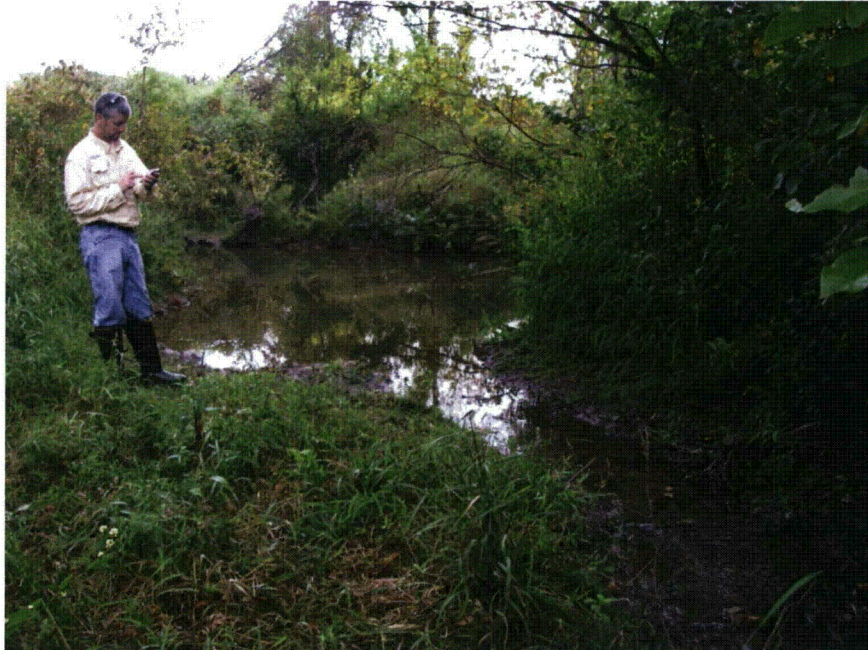
Figure 4-5. Approximate location of previously existing beaver dam where a well-defined riffle now exists. Note the establishment of vegetation on the low-lying bankfull bench (lower left quadrant of photo). This bench is a feature that is being incorporated into the restoration design.

In addition to the base level control provided by the culvert crossing, a well-defined riffle composed of gravel and some cobble-sized bed material exists at the approximate location where the beaver dam had been removed from Walker Run. This riffle sets a uniform grade across the entire stream channel and provides some degree of a localized base level control. This is also the approximate elevation where the proposed channel will tie into existing conditions.

reach is within mature forest. As discussed earlier, a well-defined riffle exists where the beaver dam had been near the downstream limit of the project reach (see *Figure 4-5*). A deep, wide pool exists near the forest boundary just upstream of the former beaver dam location where an unnamed tributary flows into Walker Run.

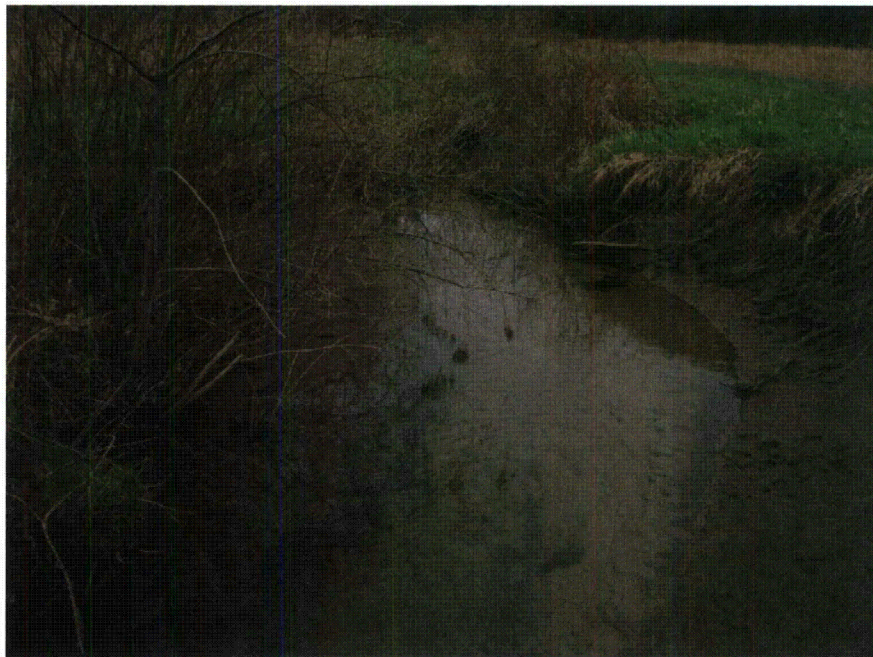
Figure 4-6. View of lateral migration just downstream of the existing BBNPP site access road.

Beyond the tree-line, the project reach is severely entrenched and surrounded by abandoned agricultural fields for approximately 1,430 feet before entering another stand of existing forest up to Market Street. Banks range between 4 and 5 feet in height and the channel is relatively straight from artificial channelization. There are 2 sets of truncated meanders just downstream of the BBNPP access road where Walker Run has undergone some natural lateral adjustment since being historically channelized (see *Figure 4-6*). The segment of channel downstream from the BBNPP access road generates significant volumes of sediment into the stream during high flows, which creates poor conditions for aquatic habitat.

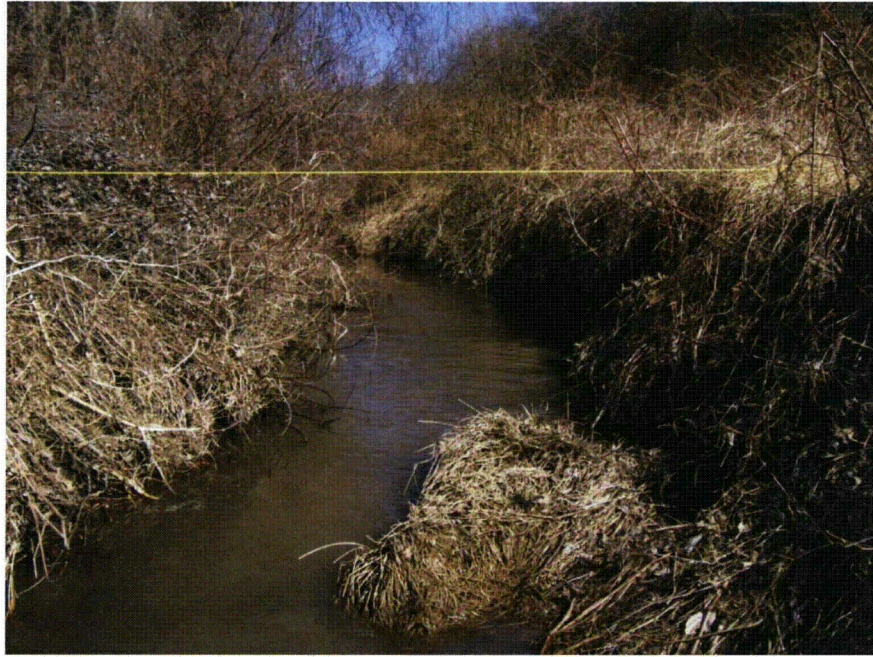
Figure 4-7. Typical conditions upstream of the BBNPP access road with 4- to 5-foot streambanks.

The project reach continues to be significantly incised and entrenched upstream of the BBNPP access road (see *Figure 4-7*), where Walker Run has been historically channelized and moved to the eastern edge of the valley in order to maximize usable agricultural land. This in effect has reduced stream lengths and therefore steepened stream slopes and increased shear stresses in the channel during the more frequent high flow events. This adjustment in profile and plan form has significantly impacted channel stability of the reach. Even though the stream banks appear to be fairly well vegetated, the channel is not connected with a functional floodplain. This channel incision promotes vertical and lateral adjustment during high flows. The streambed substrate consists mainly of silts and sands with the occasional large cobble and or boulder, most likely from being exposed as a result of the channel being moved to the eastern fringe of the valley. As a result of the highly entrenched conditions and the abundance of fine-grained sediments along the channel bed, conditions are less than ideal for sustaining diverse in-stream biological habitat for fish and macroinvertebrates.

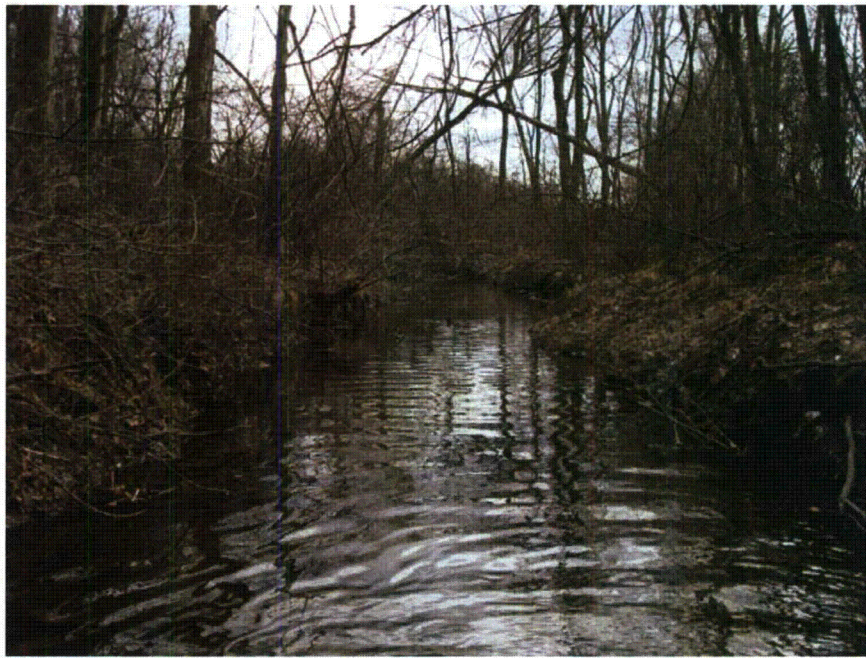
Figure 4-8. View of the project reach from the northern Market Street bridge crossing (facing downstream). The channel is an incised F5 stream type consisting of long flat pool.

The project reach is surrounded by forest again beginning approximately 770 feet upstream from the BBNPP access road. The channel bends sharply to the northwest after about 350 feet into the forest before continuing relatively straight towards Market Street. Along this forested segment, the channel is still pinned against the eastern valley wall. There are short, steep riffles where the bed appears to be perched on the larger colluvial material at the base of the valley slope that was likely exposed as a result of the historical channelization. This perched streambed condition creates a long backwater condition immediately downstream of the Market Street bridge crossing (see Figure 4-8). Here, the streambed substrate consists of silts and sands, most likely deposited as a result of the flattened stream slope.

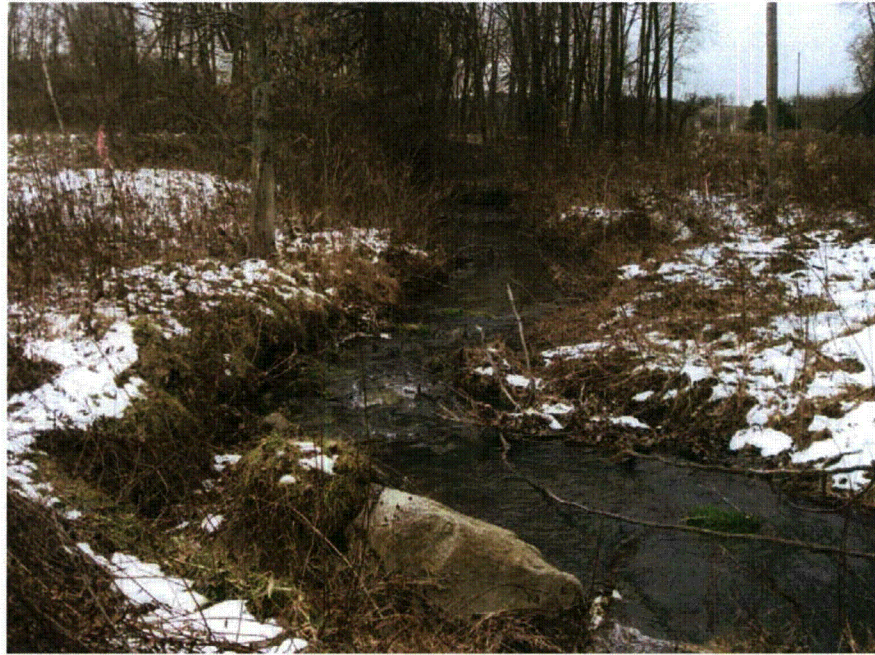
Figure 4-9. View of the project reach just upstream of the north Market Street crossing (facing downstream). Note large boulder material in foreground, which is also present in streambed immediately downstream. Through lateral migration, the channel has developed a low-lying bench feature (right side of photo), which is indicative of the stream's progression towards stability.

North of the Market Street bridge, Walker Run flows parallel with Market Street for approximately 100 feet before turning west. During high flows, the Market Street crossing is a constriction to the floodplain forcing all flows to be conveyed through the bridge culvert. Because it is an open bottom culvert, it does not appear to provide upstream base level control. However, along the first 150 feet upstream of the bridge crossing the bed is composed of large-sized gravels, cobbles, and even some boulders, which does control the grade. This large bed material is somewhat of an anomaly along the project reach and may be remnants from past human activity, such as roadway or bridge improvements or from intentionally placed bank armoring to stabilize the banks. This large bed material creates a series of few short, steep riffles and has prevented the channel from downcutting any further; however, upon reaching vertical stability, the channel now exhibits signs of moderate lateral migration as it approaches the bridge crossing. With that said, this portion of the project reach is only slightly entrenched and a low-lying vegetated bench feature has developed adjacent to a well-defined riffle surface as a result of the lateral migration. The development of this bench feature indicates that the channel is progressing towards a more stable condition by creating a new floodplain at lower elevations (see Figure 4-9). This bench feature is an important geomorphic feature that was helpful in determining proposed bankfull elevations and served as an appropriate tie-in location for the restored project reach (refer to Chapter 7 – Restoration Design for more information).

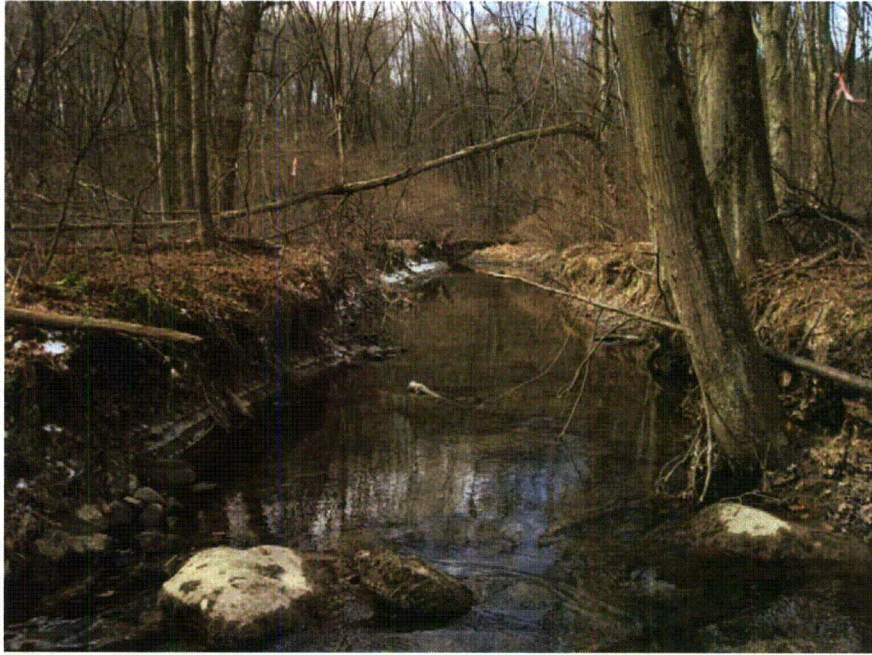
Figure 4-10. Typical conditions upstream of the well-defined riffle complex near the north Market Street bridge crossing. Low channel slopes create flat water that extends upstream through most of the project reach south of Beach Grove Road.

Continuing upstream, the channel slope flattens and stream becomes significantly entrenched as it turns west for approximately 200 feet across the valley bottom and becomes pinned along the western valley wall for another 200 feet. The channel then turns back toward the center of the valley and follows a series of meanders for approximately 450 feet. The existing stream banks range between 3 and 5 feet in height and are composed of silts and sands. The existing valley bottom consists of a fairly mature forest. However, trees and shrubs along the banks have minimal rooting depths and provide little bank stabilization due to the incised condition of the channel (see *Figures 4-10, 4-11, and 4-12*). This condition of high banks composed of easily-erodible fine sediments and elevated root systems does not provide adequate protection for long-term stream stability during frequent and higher flow events. As a result, this portion of the existing project reach is experiencing accelerated bank erosion during high flows. Trees are being undermined and are falling into the stream, which creates debris jams that further accelerated bank erosion and promote vertical bed scouring. Throughout this reach, the bed consists of primarily fine-grained alluvial sediments (silts and sands), which most likely originate from local stream bank erosion. These fines deposit along the channel bed as high flows recede due to the low average water surface slope along this segment. The abundance of these fines within the channel creates poor trout spawning potential and poor in-stream habitat for macroinvertebrates despite having adequate overhead cover provided by the forest.

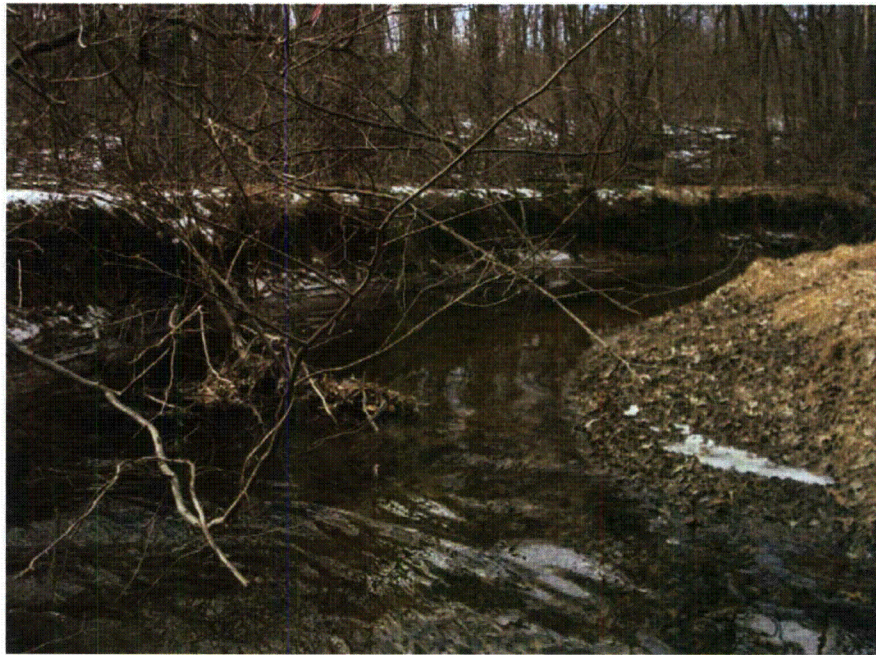
Figure 4-11. View of typical stream conditions showing bank erosion between Market Street and Beach Grove Road.

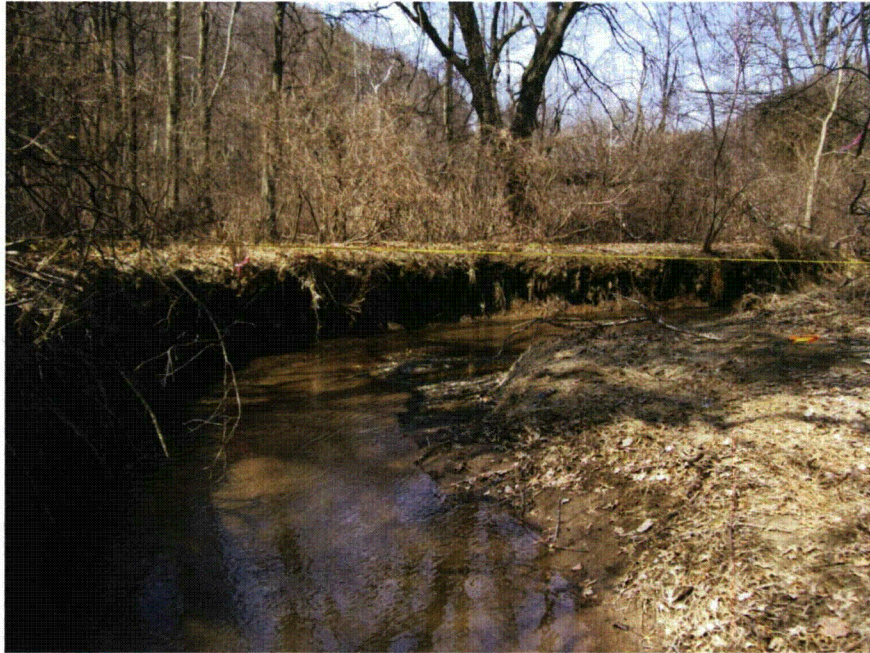
Figure 4-12. View of typical stream conditions showing bank erosion approximately 400 downstream of Beach Grove Road.

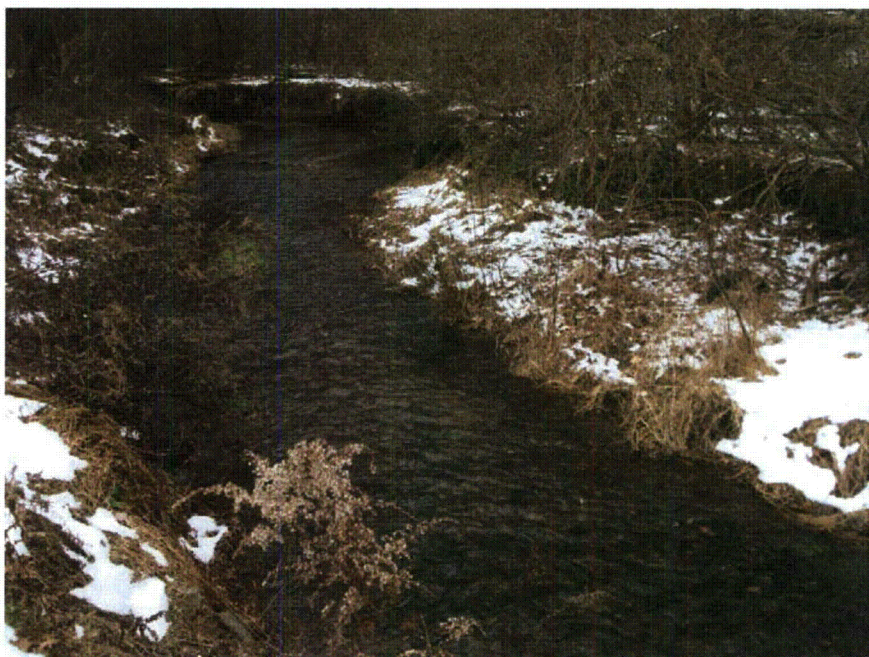
Figure 4-13. View of well-defined riffle with an adjacent low-lying bankfull bench feature located approximately 300 feet downstream of Beach Grove Road that resembles some degree of stability. This segment serves as an appropriate location to begin the proposed channel relocation.

The conditions described above are representative of typical conditions throughout the majority of the project reach segment between Market Street and Beach Grove Road. However, approximately 300 feet downstream of Beach Grove Road where the channel is no longer surrounded by forest, there is a well-defined riffle segment where the stream bed consists of small- to medium- sized gravels and a distinct low-lying bench feature has developed along the west bank (see *Figure 4-13*). Even though this reach is moderately entrenched, the bench feature indicates some stability and the streambed substrate appears to be sustainable in the long-term and provides suitable habitat for aquatic organisms. This is the approximate location where the proposed channel profile will tie into the existing profile of Walker Run and proposed floodplain elevations will tie into the elevation of the existing bench feature.

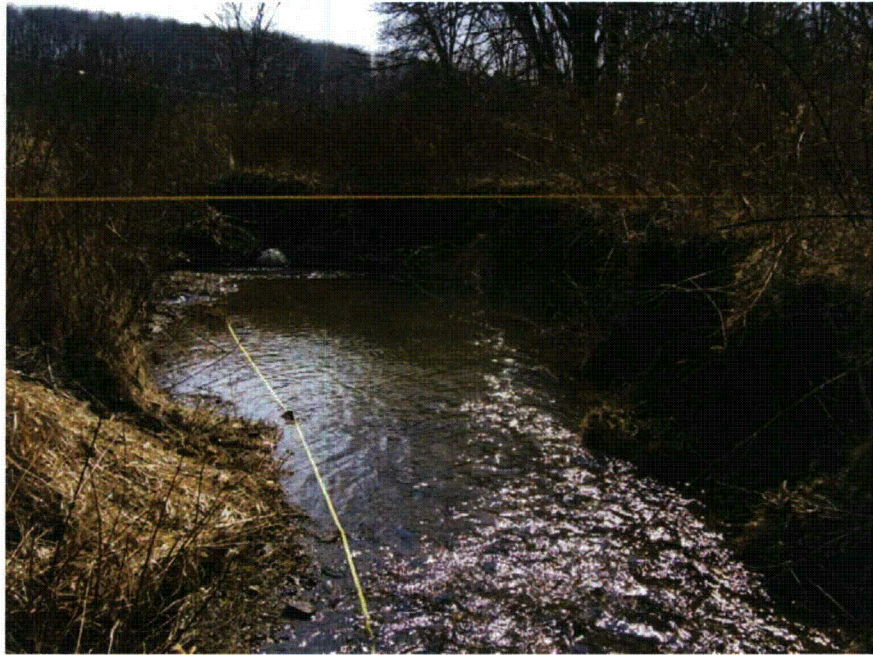
Figure 4-14. View of severely-eroded vertical bank immediately downstream of Beach Grove Road at a 90-degree bend to the left (facing downstream).

Approximately 150 feet downstream of the Beach Grove Road bridge crossing, the project reach makes 2 truncated 90-degree bends before continuing relatively straight towards the bridge crossing. At the upstream 90-degree bend, the outside meander bank is approximately 5 feet in height and consists of silts and sands (see *Figure 4-14*). The bank erosion at this meander bend is a significant source of the sediment being contributed to the downstream channel segments. The straight segment between this meander and the Beach Grove Road bridge crossing is entrenched with banks ranging between 3 to 4 feet in height. A deep plunge pool exists immediately downstream of the Beach Grove Road bridge crossing where an elevated high-pressure gas line crosses the project reach (see *Figure 4-15*).

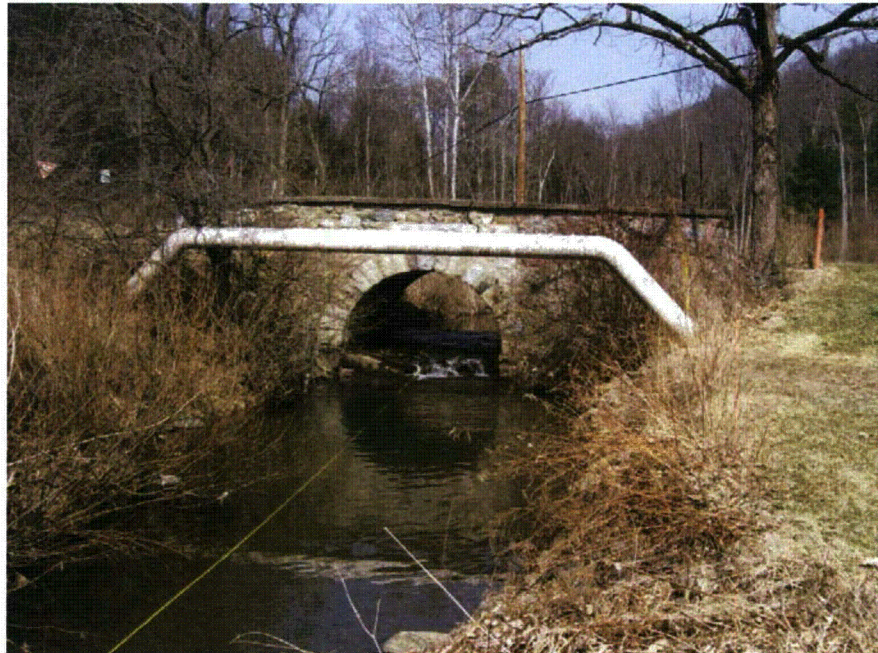
Figure 4-15. View of Beach Grove Road bridge crossing with elevated high-pressure gas line.

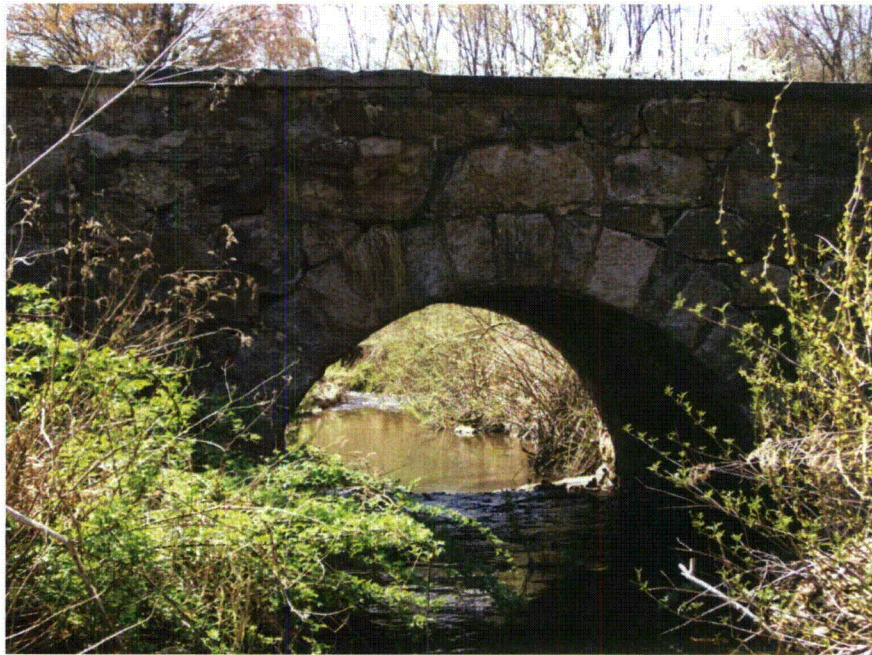
Figure 4-16. View of the Beach Grove Road bridge culvert (facing downstream). The undersized opening creates an upstream backwater condition during high flows, which limits sediment transport.

The Beach Grove Road bridge crossing is a stone mortared closed-bottom culvert, which provides upstream base level control (see *Figure 4-16*). During high flows, the road obstructs the floodplain and forces all flows through the undersized bridge opening, which creates a backwater condition upstream. The backwater condition flattens out the water surface slope and reduces sediment transport through the culvert. As a result of this backwater condition, it is likely that most sediments mobilized during high flows are deposited upstream of the bridge crossing.

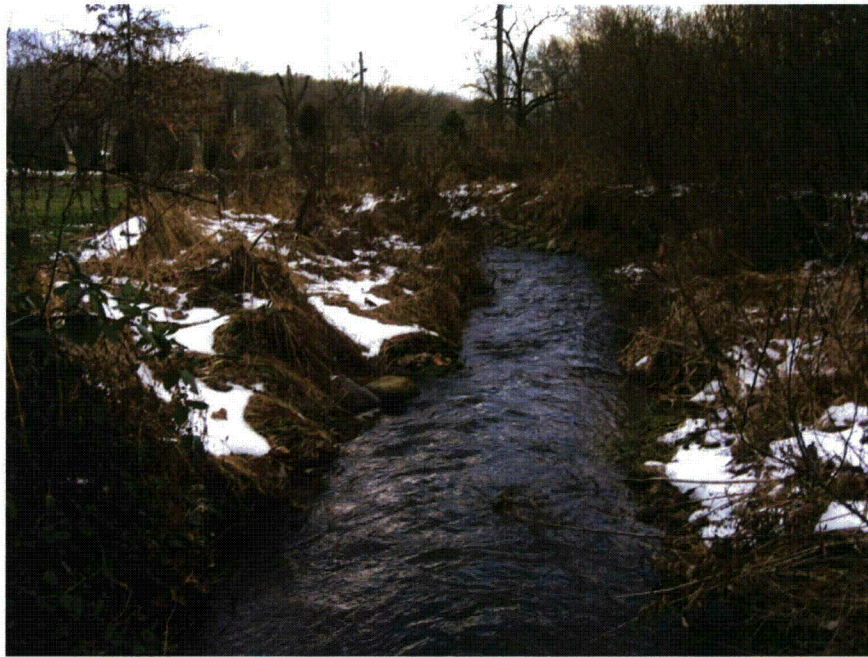
Figure 4-17. View of supply reach approximately 200 feet upstream of the Beach Grove Road bridge crossing (facing downstream). The channel flows relatively straight between a residential lawn to the east (left side in photo) and a steep slope up to Stone Church Road to the west (right side in photo).

The first 400 feet of Walker Run upstream of the Beach Grove Road bridge crossing is a relatively straight riffle-dominated segment that flows northwest to southeast (see *Figure 4-17*). It is pinned against a steep valley wall that rises up to Stone Church Road on the west, while mowed residential lawn exists along the east side of the channel. This segment is only slightly steeper than the upper portion of the project reach.

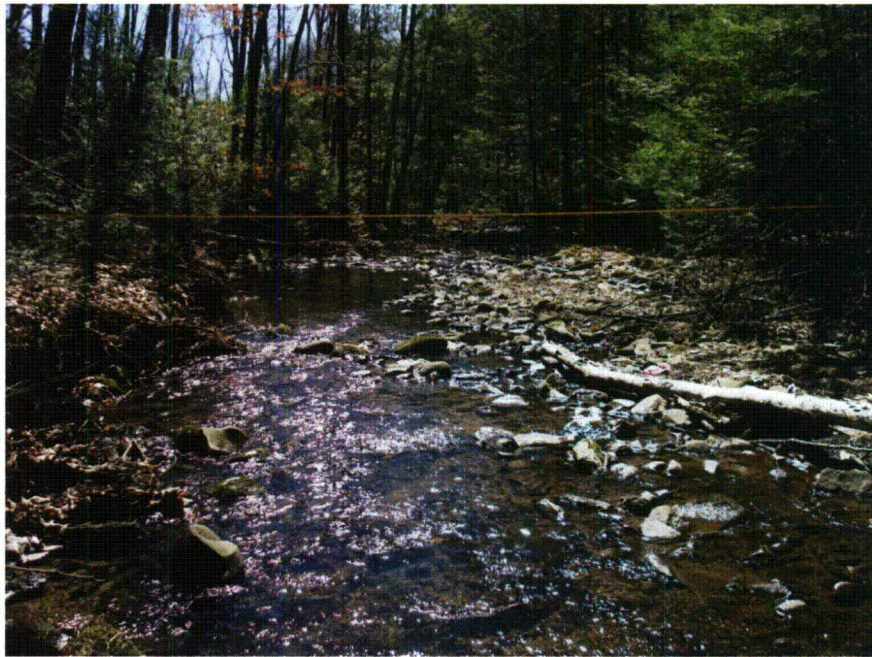
Figure 4-18. View of supply reach (facing downstream). The channel is well-connected to its floodplain (right side in photo) despite having a steep side slope to the east (left side in photo).

Then Walker Run bends north into a forest dominated by a mix of coniferous and deciduous trees and the valley begins to exhibit characteristics typical of an upper watershed (headwater) stream system with a narrow valley width, steep side slopes, and steeper valley slope. This upper watershed portion of Walker Run appears to be in a relatively stable condition. Stream banks are fairly low and there is a good connection between the channel and its floodplain, or floodprone area (see *Figure 4-18*). With steeper slopes, the reach flows relatively straight with large colluvial bed materials providing channel roughness that limits flow velocities and shear stress (see *Figure 4-19*). In addition, the reach exhibits minor lateral extension as it occasionally branches into a series of channels, a condition that could be considered anabranching. As a result of this anabranching condition, shear stress energies are minimized further. For these reasons, it was determined that this reach does not provide a significant source of large-sized bed material to the downstream sections of Walker Run including the project reach. In addition to the low sediment supply being contributed from the upstream condition, the backwater condition associated with the Beach Grove Road bridge during higher flows causes more deposition of mobilized sediments and further limits sediment transport. Therefore, the sediment being contributed by the supply reach and transported into to the project reach would consist mainly of silts, sands, and small gravels.

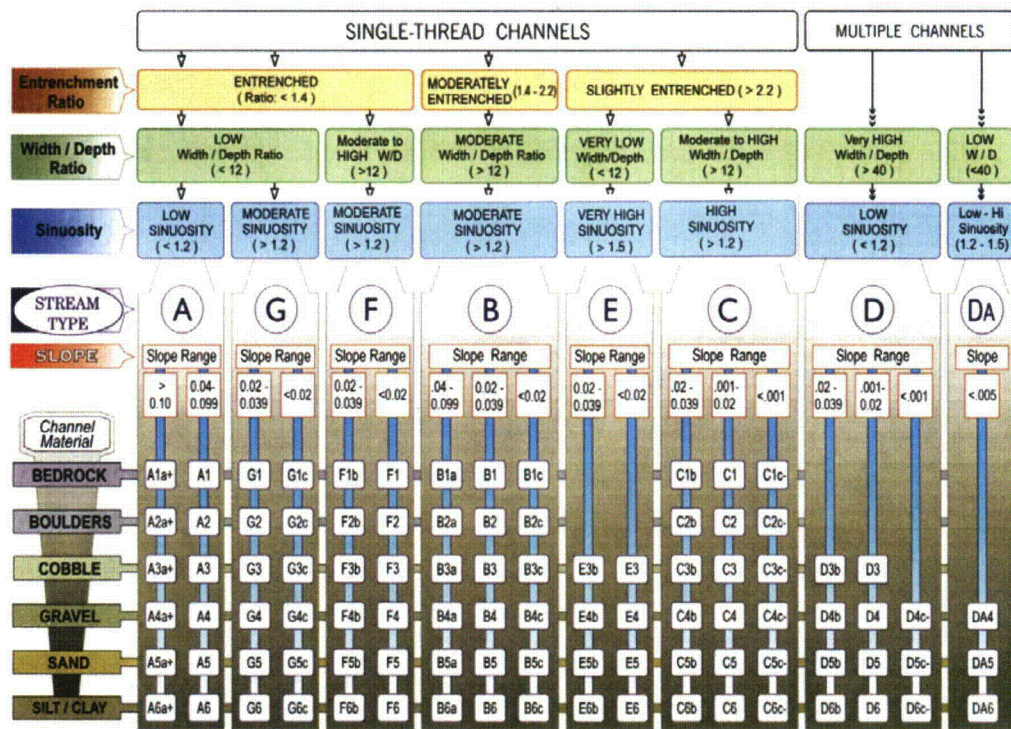
KEY to the ROSGEN CLASSIFICATION of NATURAL RIVERS. As a function of the "continuum of physical variables" within stream reaches, values of **Entrenchment** and **Sinuosity** ratios can vary by +/- 0.2 units; while values for **Width / Depth** ratios can vary by +/- 2.0 units.
