Structural Integrity Assessment of Flaw Found in Service Water Line 24"-JGD-6

00-CP-02958M2	00	Service Water	
CALCULATION No.	**Revision No.**	**System Name**	
N/A	AB	2326A	SK0923
VENDOR CALCULATION No.	**Structure**	**System Number**	**Component**

Calculation Title: Structural Integrity of Flaw Found in Service Water Line 24-JGD-6

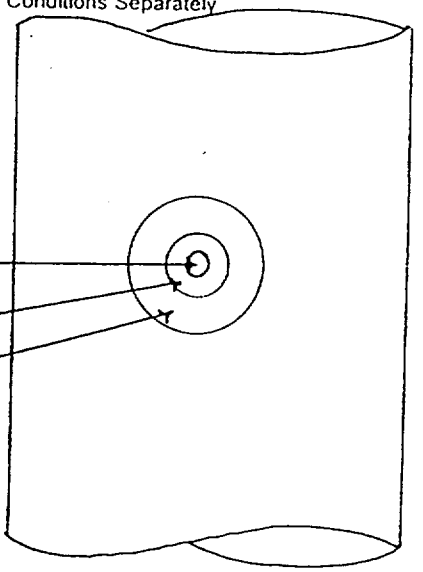
Performed UT Scan of 2 Areas around Blistered Paint. recorded a UT thickness range in 2" Area of .060" – .260"

2" Area ~~.696~~ MCB .676" – .694"

½" dia. Blistered Paint
2" dia. .060" – .260
12" dia. .676" – .694"

* No Paint thickness data taken due Area requiring A Mechanical Patch Based on initial UT. per Eng.

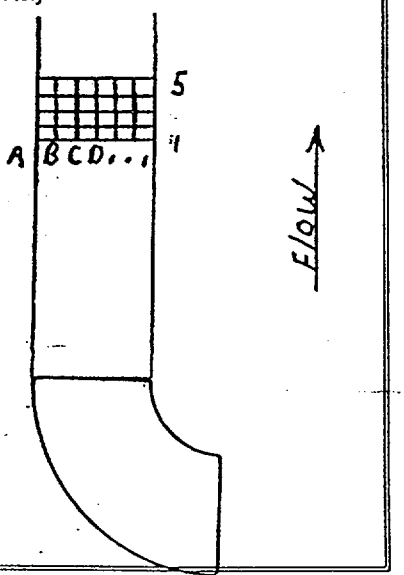
Performed Grid + UT
Around Pipe in leak Area.
2" Grid A1 - AL5
See Attached For
UT data.

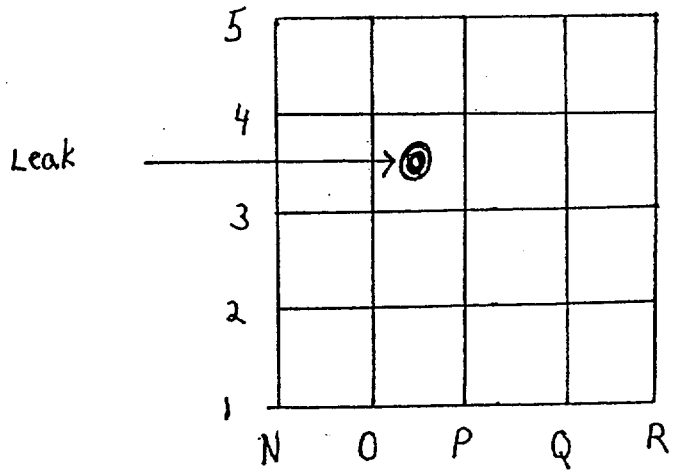
ection Summary
aximum Reading = 0.719 (4, M) Average = 0.691
inimum Reading = 0.636 (4, P) Standard Deviation = 0.692
otal Readings = 190
